Stormy Reach Assessment Entiat River

Chelan County, Washington

U.S. Department of the Interior
Bureau of Reclamation
Pacific Northwest Region
Boise, Idaho

November 2009

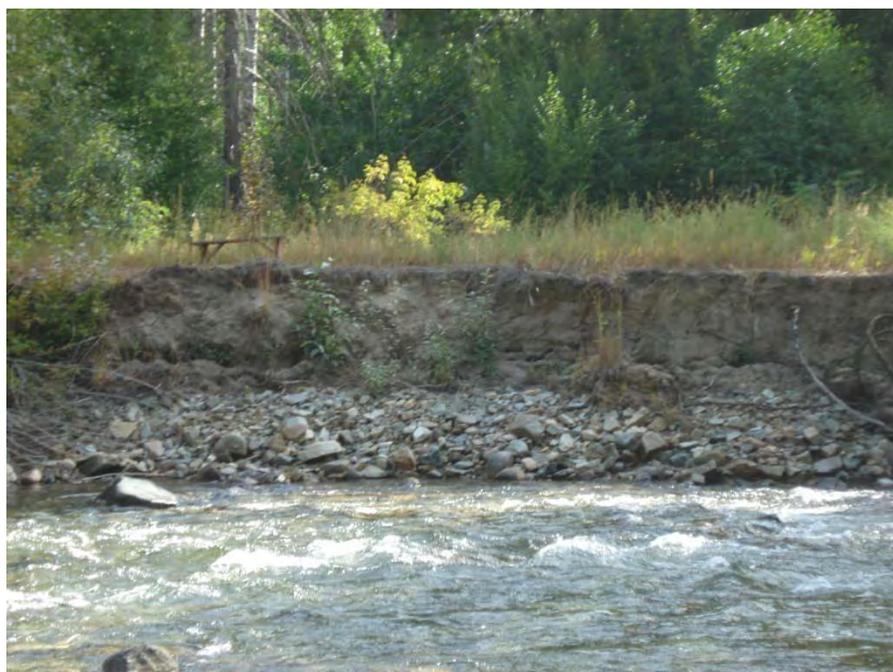
Photograph No. 1. View to the east showing a channel unit of rapids with boulder and cobble substrate. Note the local bank erosion. Stormy Reach – Entiat Subbasin, Washington – Bureau of Reclamation. Photograph by R. McAfee, August 5, 2008.

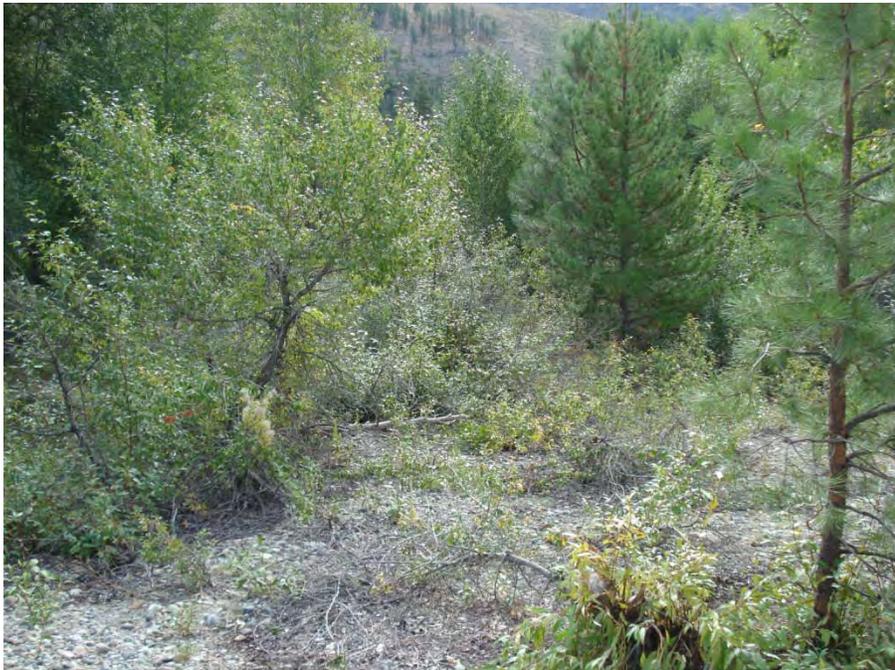
Photograph No. 6. View is to the east of an access road that is connected to the back side of the levee in the historic channel path. Stormy Reach – Entiat Subbasin, Washington – Bureau of Reclamation. Photograph by R. McAfee, August 6, 2008.

Option	Habitat Action	Prioritized Habitat Actions	VSP Parameters Addressed	Geomorphic Potential
1	Rehabilitation	Reconnect Processes: By removal of the historic access road behind the levee to reconnect the historic channel path and floodplain processes, if the levee is addressed to some degree.	2; Productivity and Abundance	High
2	Protection	Protect and maintain rehabilitated levels of geomorphic, hydrologic, and improved vegetation function.	2; Productivity, Abundance, Diversity, and Structure	Low

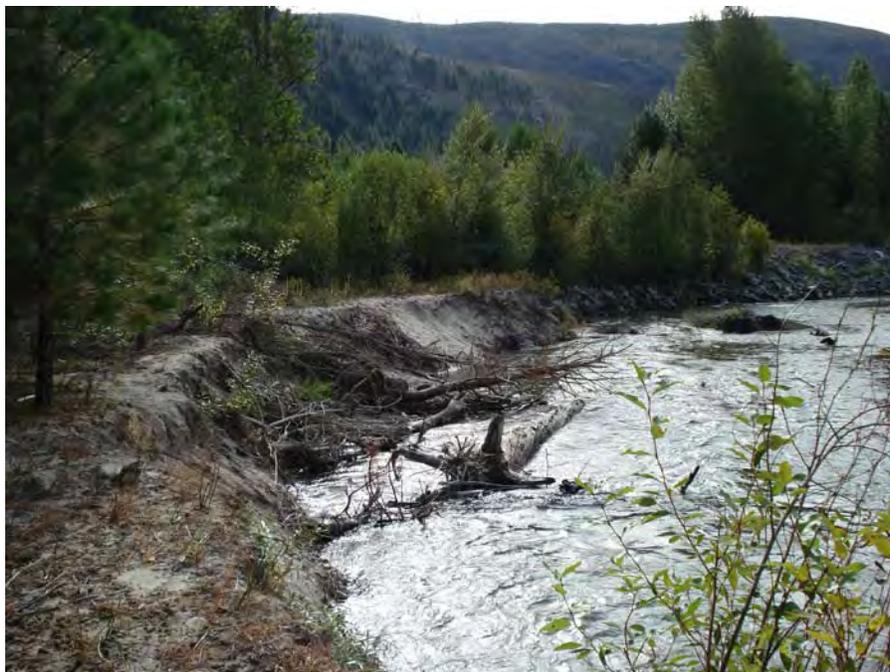
Photograph No. 33. View to the southeast of sandy flood-deposits along the top of the left bank. Stormy Reach – Entiat Subbasin, Washington – Bureau of Reclamation Photograph by R. McAfee, August 6, 2008.

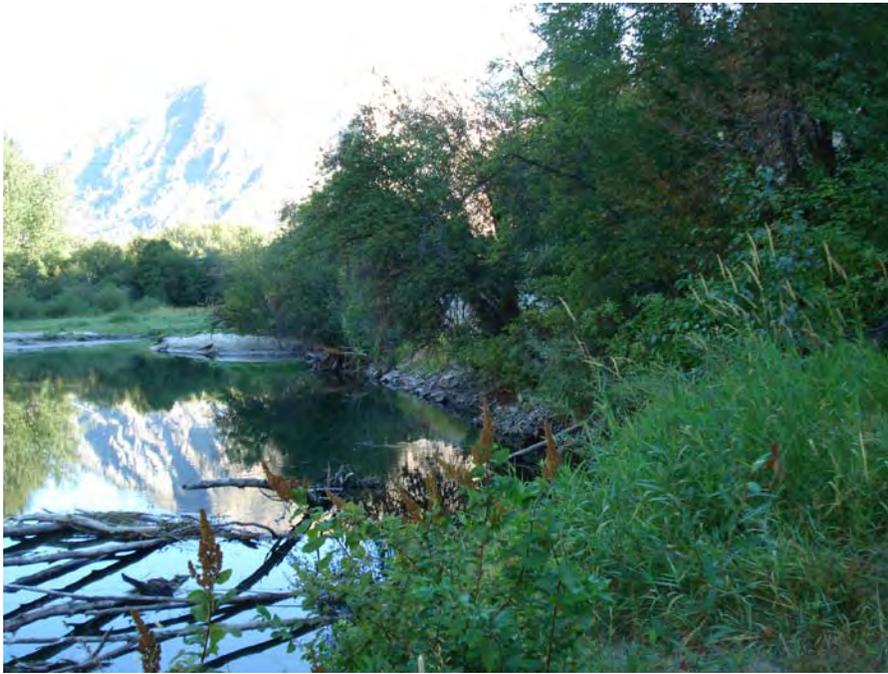
Photograph No. 55. View to the northeast of riprap along the road-base along the left bank. Stormy Reach – Entiat Subbasin, Washington – Bureau of Reclamation Photograph by R. McAfee, August 7, 2008.

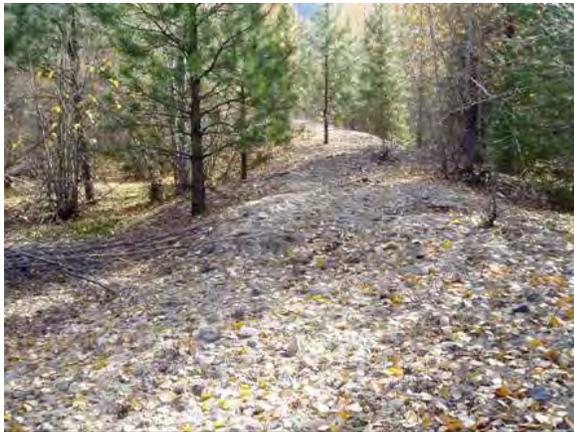
Dike above left bank at RM 22.4

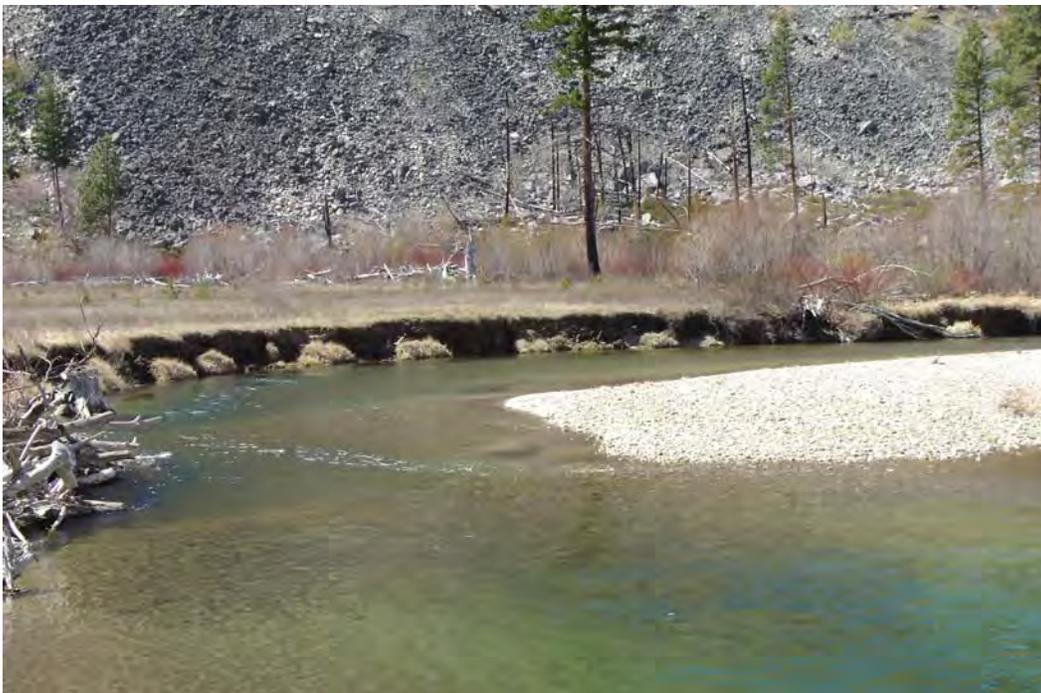
Figure 6. Erosion along bank with cleared vegetation near RM 18.35. (Photo looking downstream).

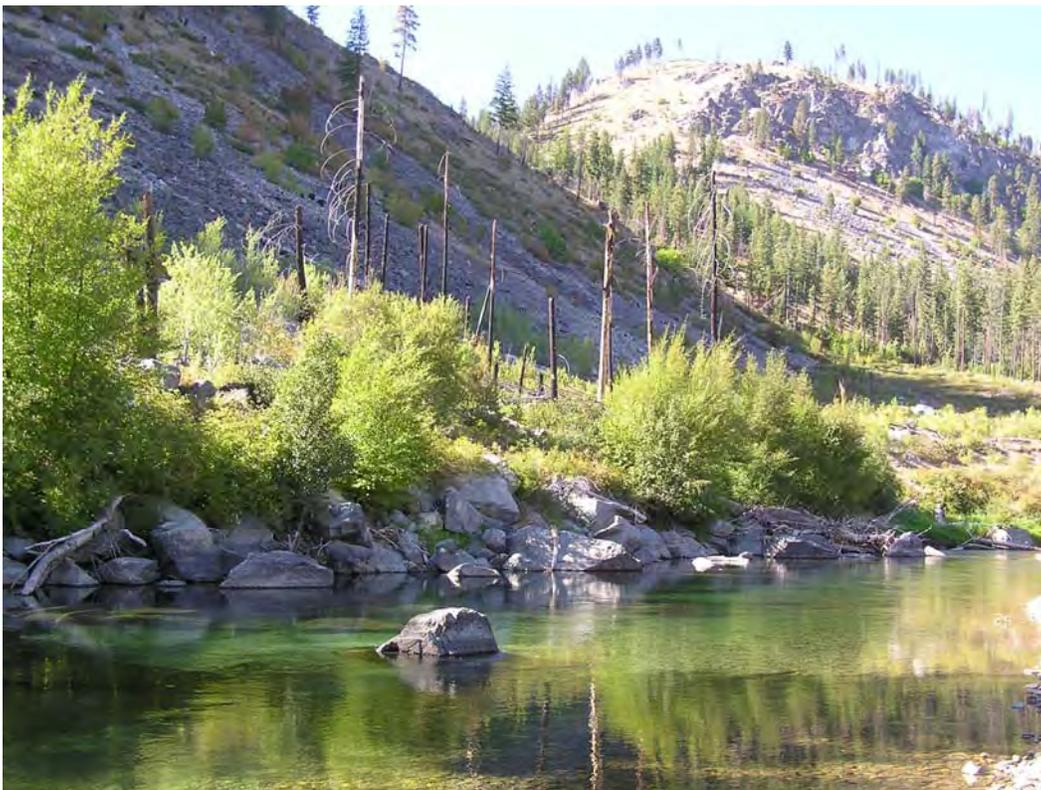
Figure 7. Hillslope material that has fallen into the active channel. (Photo looking upstream).

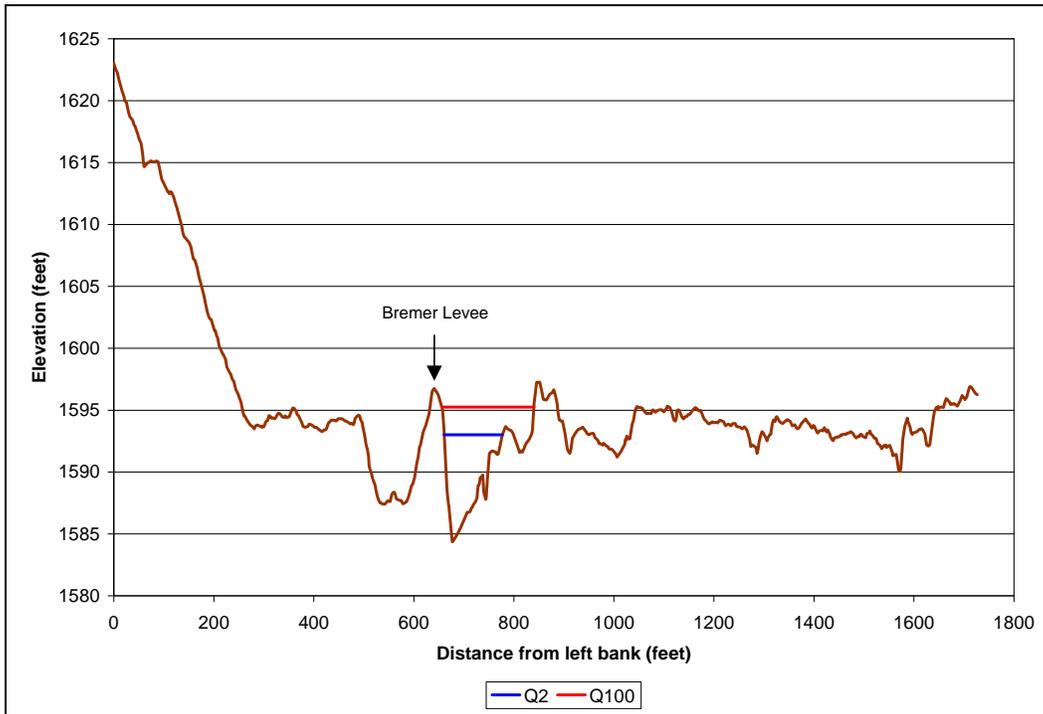
Figure 20. Cross section at RM 19.75 showing Bremer Levee with modeled water surface elevations for the 2-year and 100-year events.

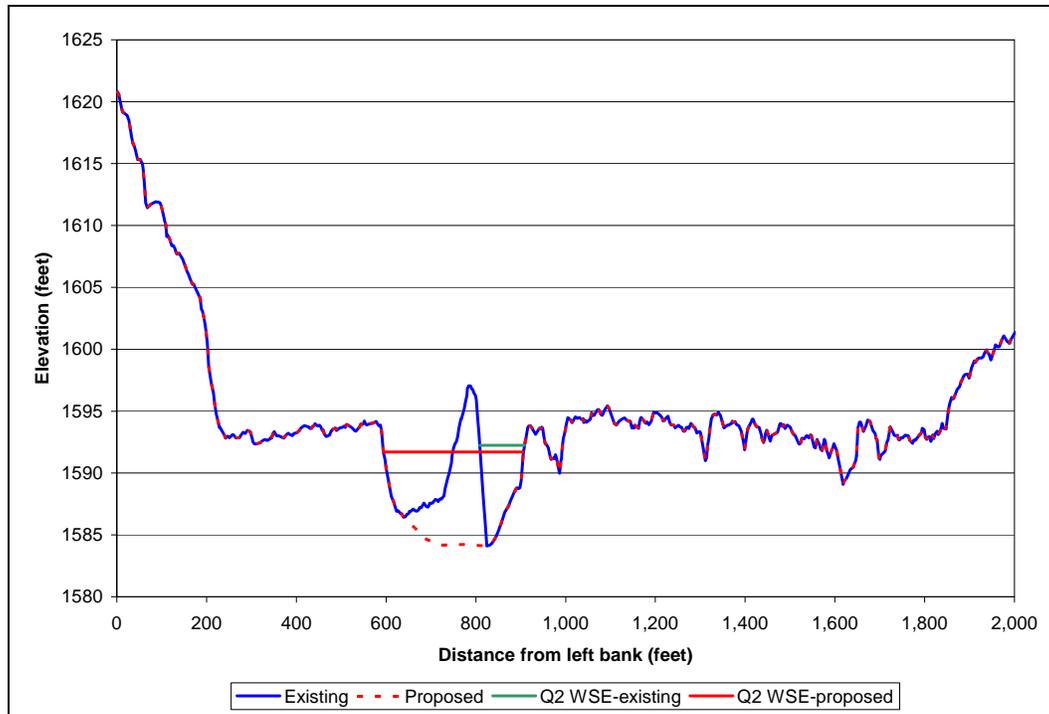
Figure 21. Cross section at RM 19.75 showing pre/post levee removal geometry and resulting 2-year water surface elevation.
