DOT US Department of Transportation
PHMSA Pipeline and Hazardous Materials Safety Administration
OPS Office of Pipeline Safety
Eastern Region

Operator, Location, & Consequences

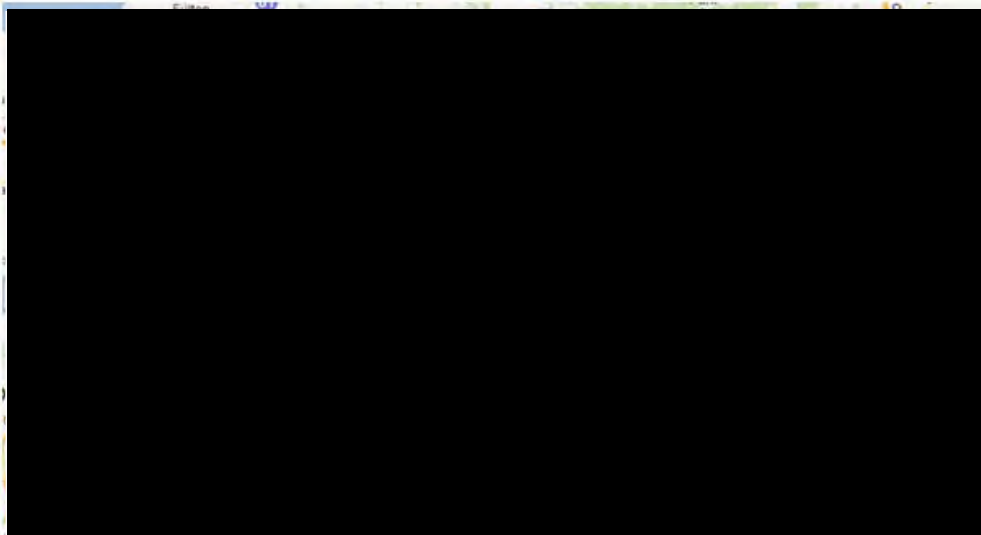
Failure Investigation Report Enterprise Products Propane Line Crack

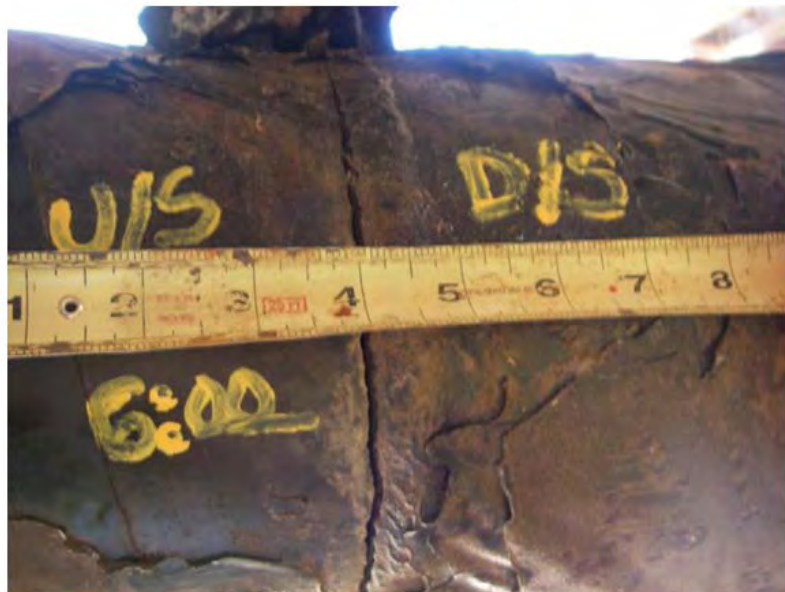
Crack on bottom quadrant of pipe – 09/02/2011

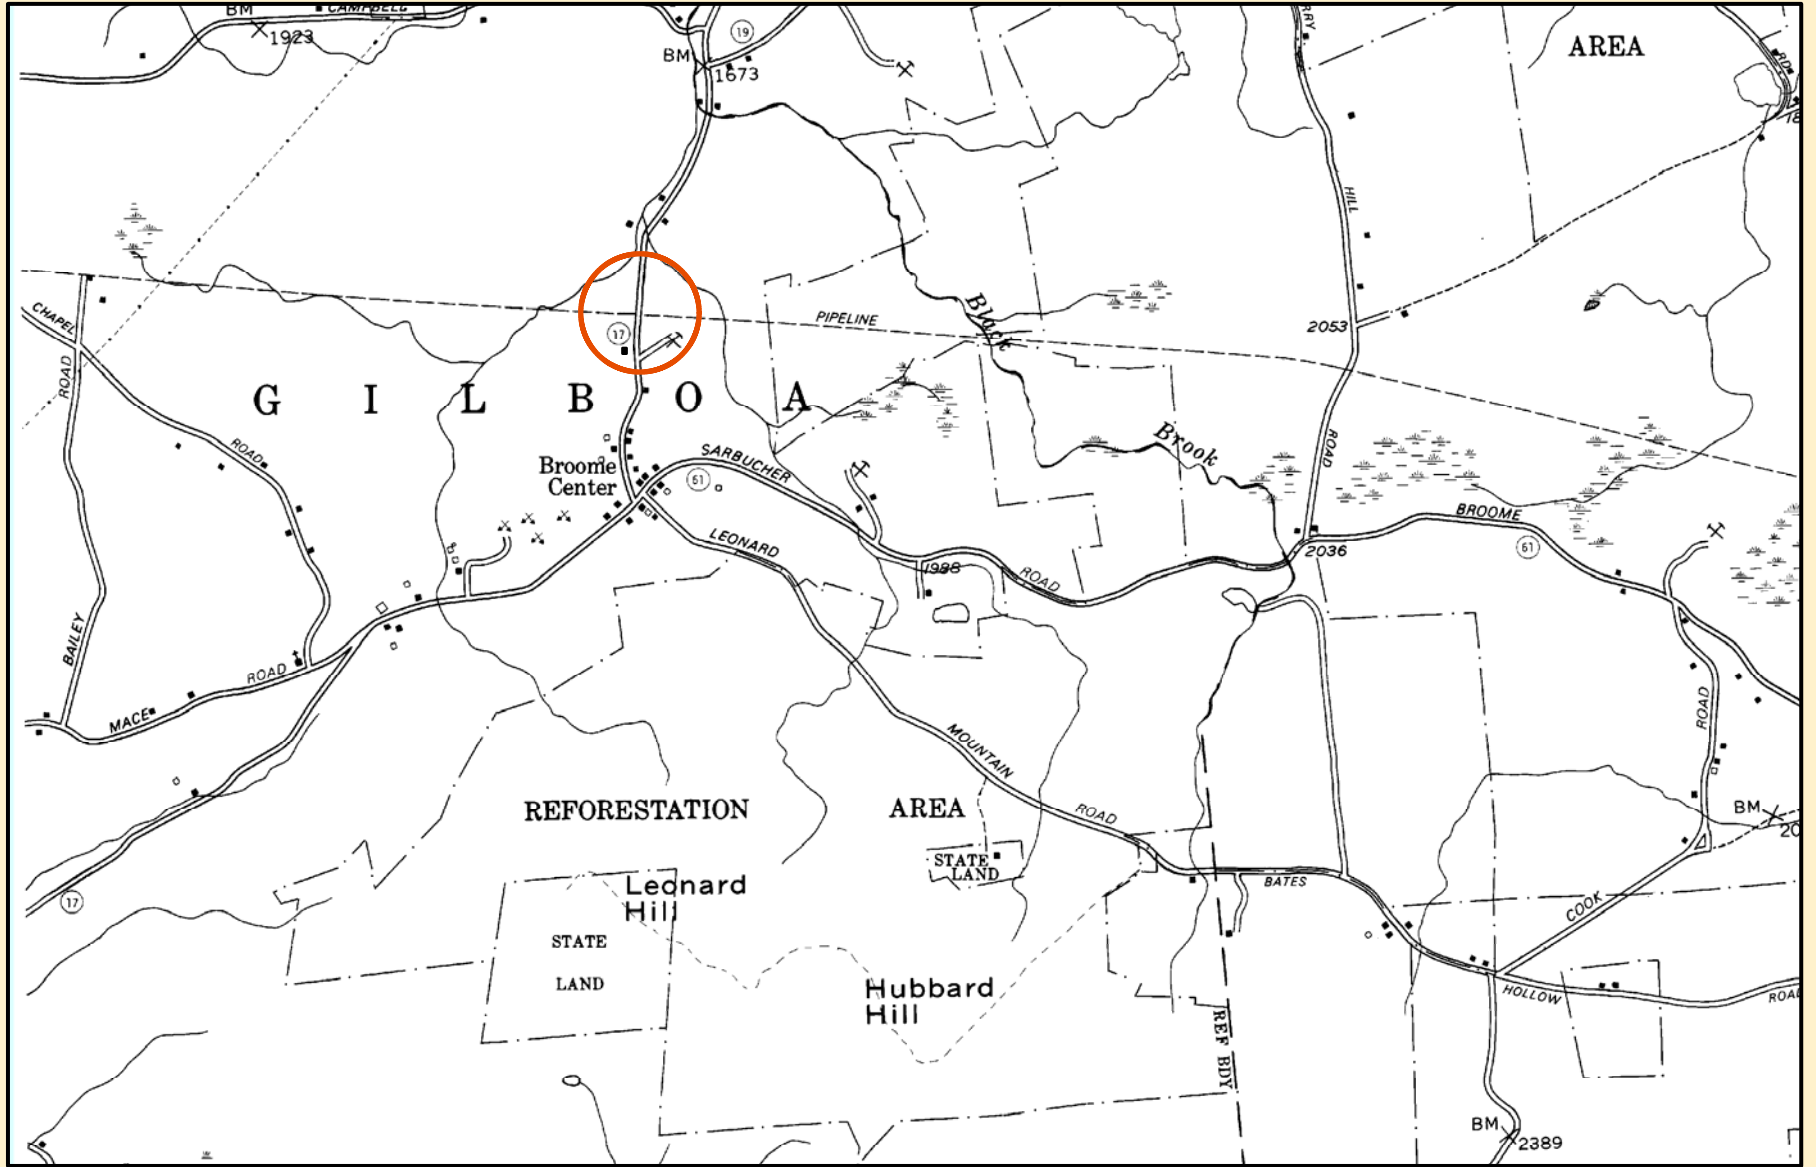
TEPPCO P-41 PIPELINE, SCHOHARIE COUNTY, NY
Keyserkill Road Crossing with 660' radius

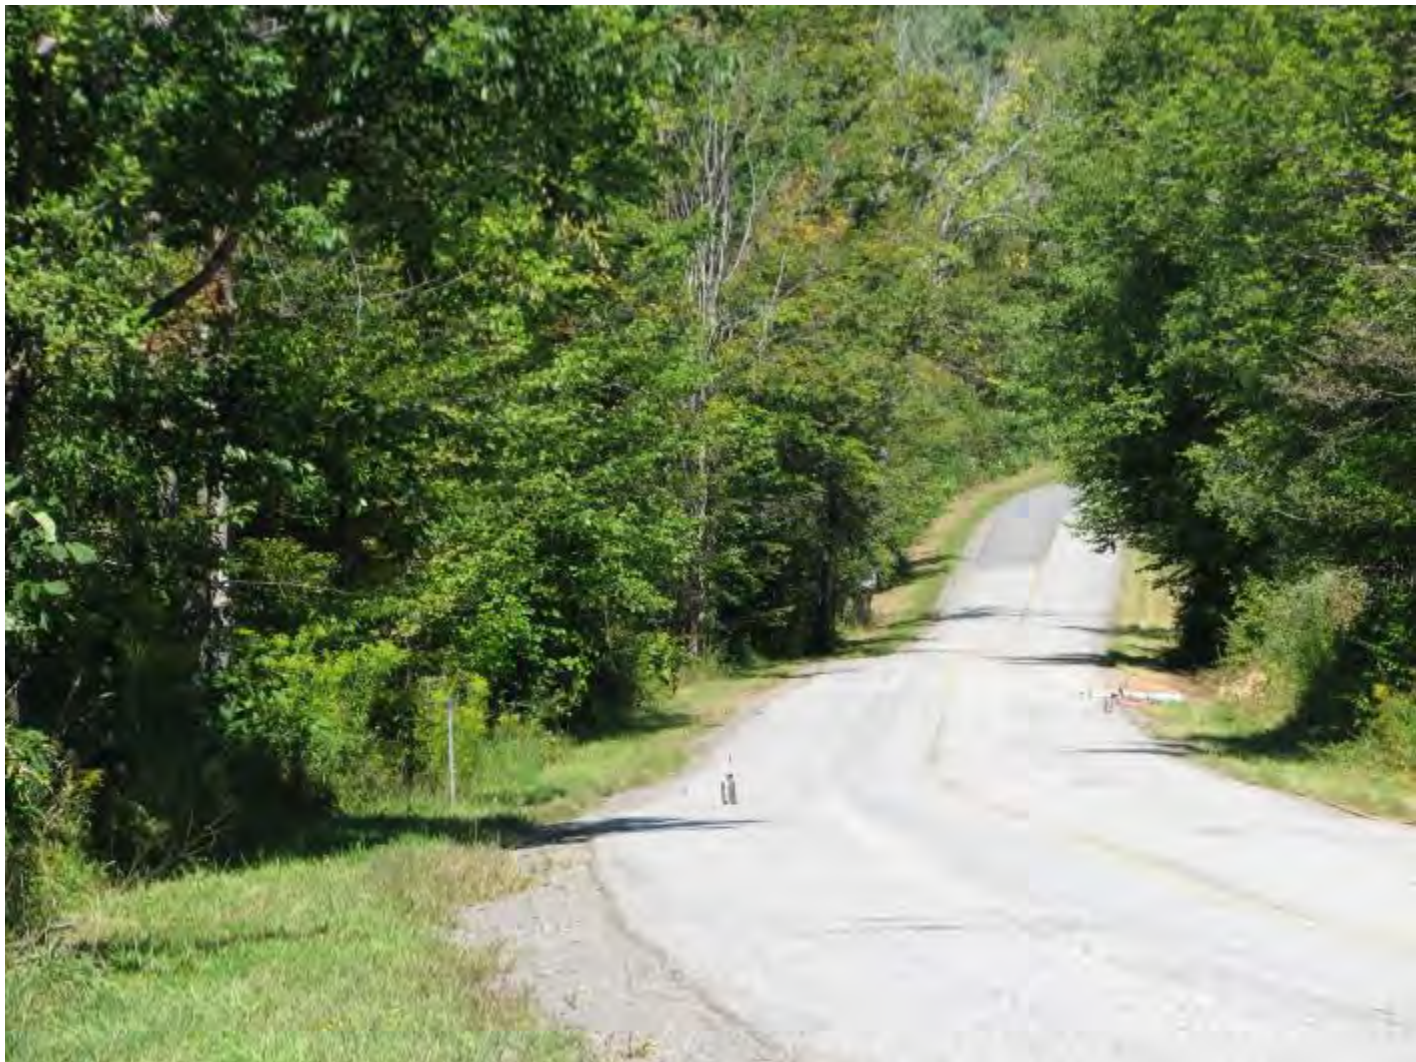
PHOTO 1: FACING NORTH ON KEYSERKILL ROAD (AIR MOVER @ 3:30 POSITION)

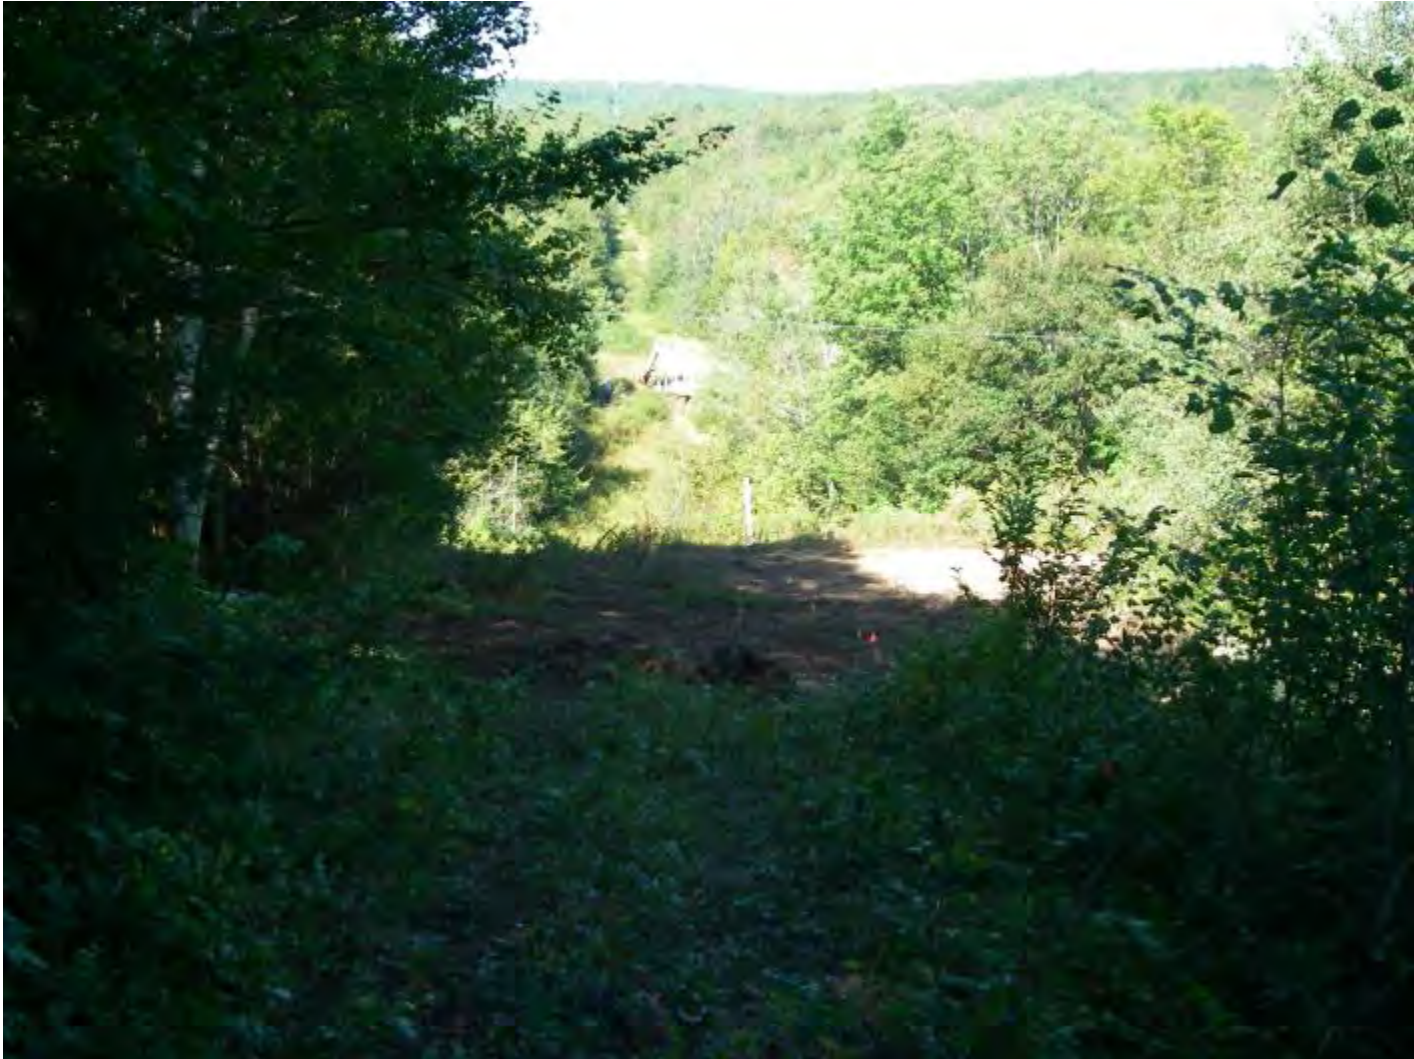
PHOTO 4: DOWNSTREAM LOOKING UPSTREAM 8/29/10

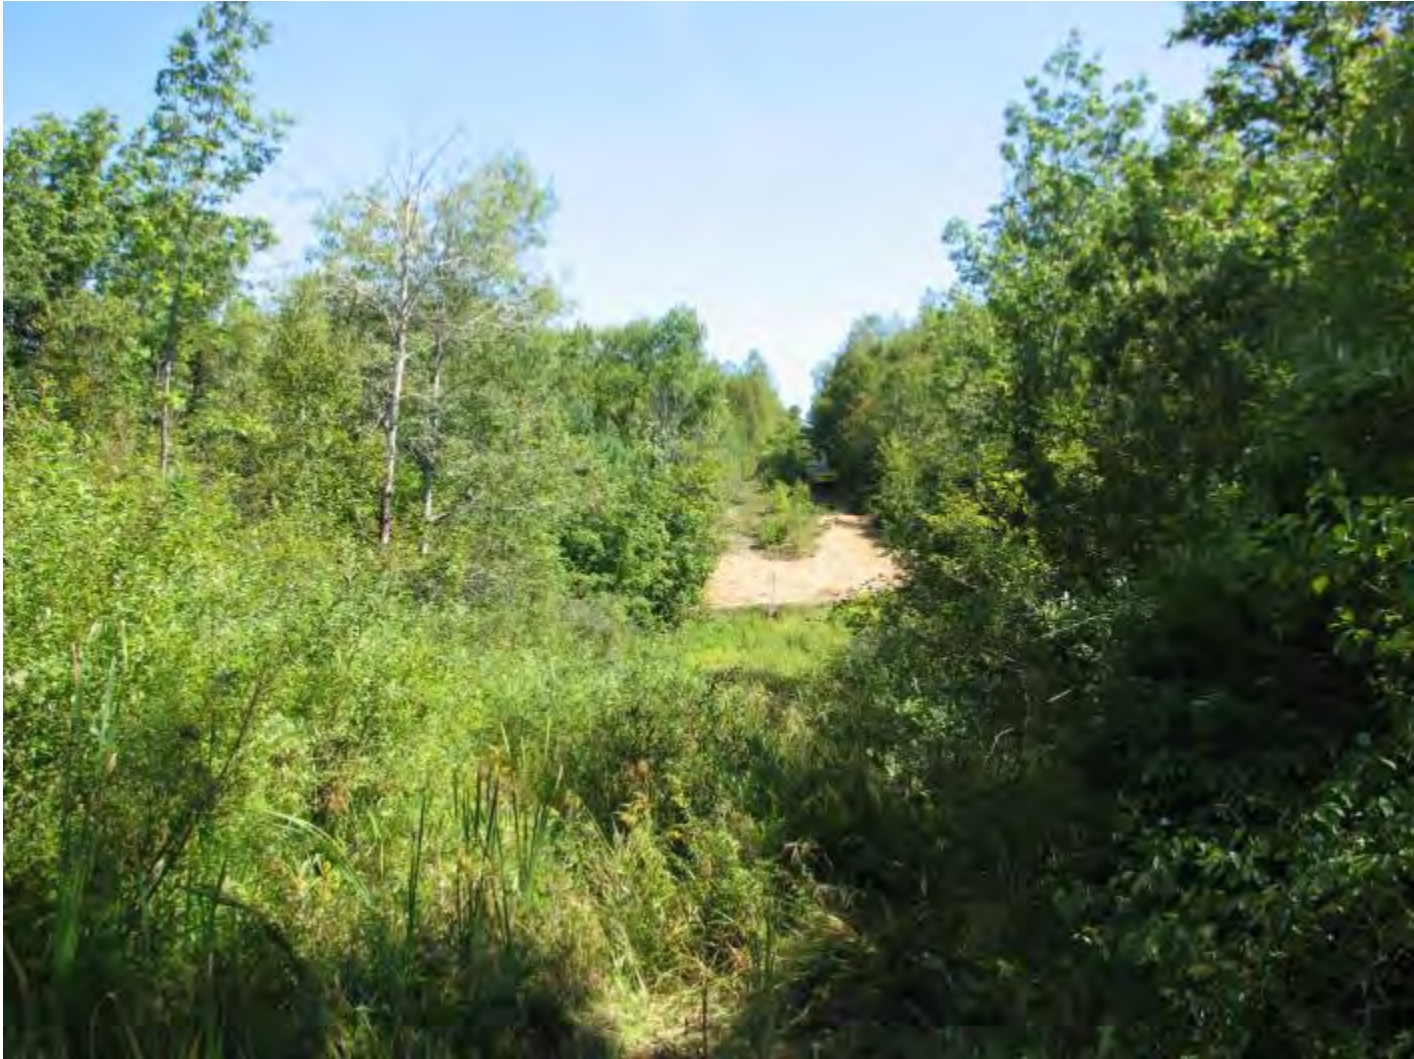
PHOTO 5: SUSPECTED LEAK IS LOCATED NEAR MARKER (UNDER STRAW)
8/29/10

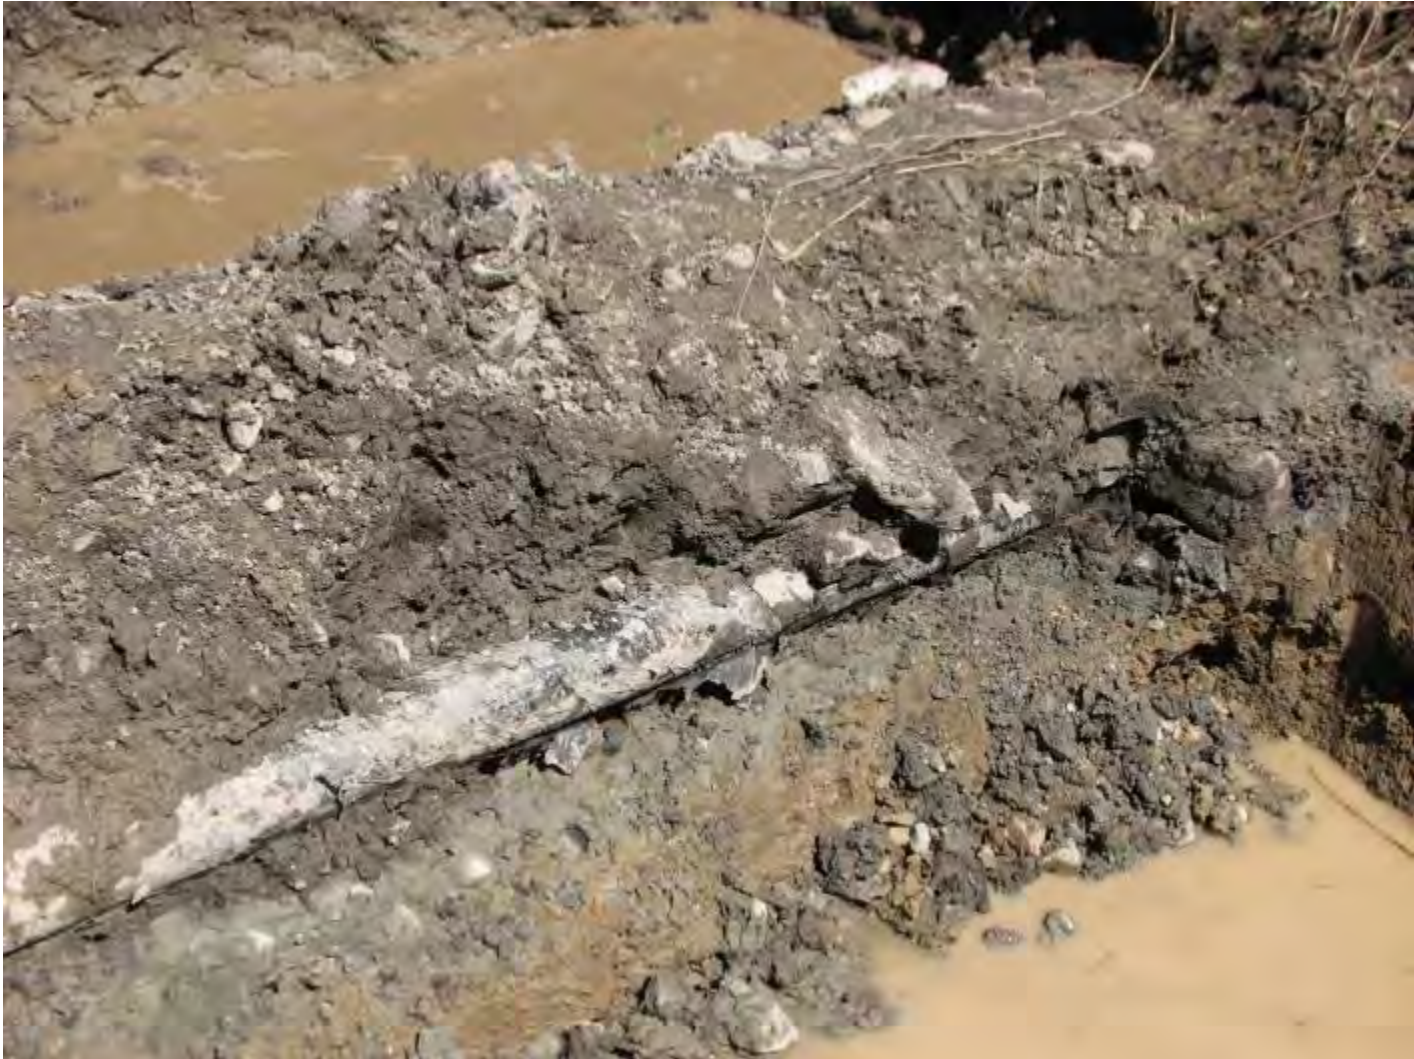
PHOTO 6: ROCKY SOIL AROUND PIPE UPSTREAM DIG 8/29/10

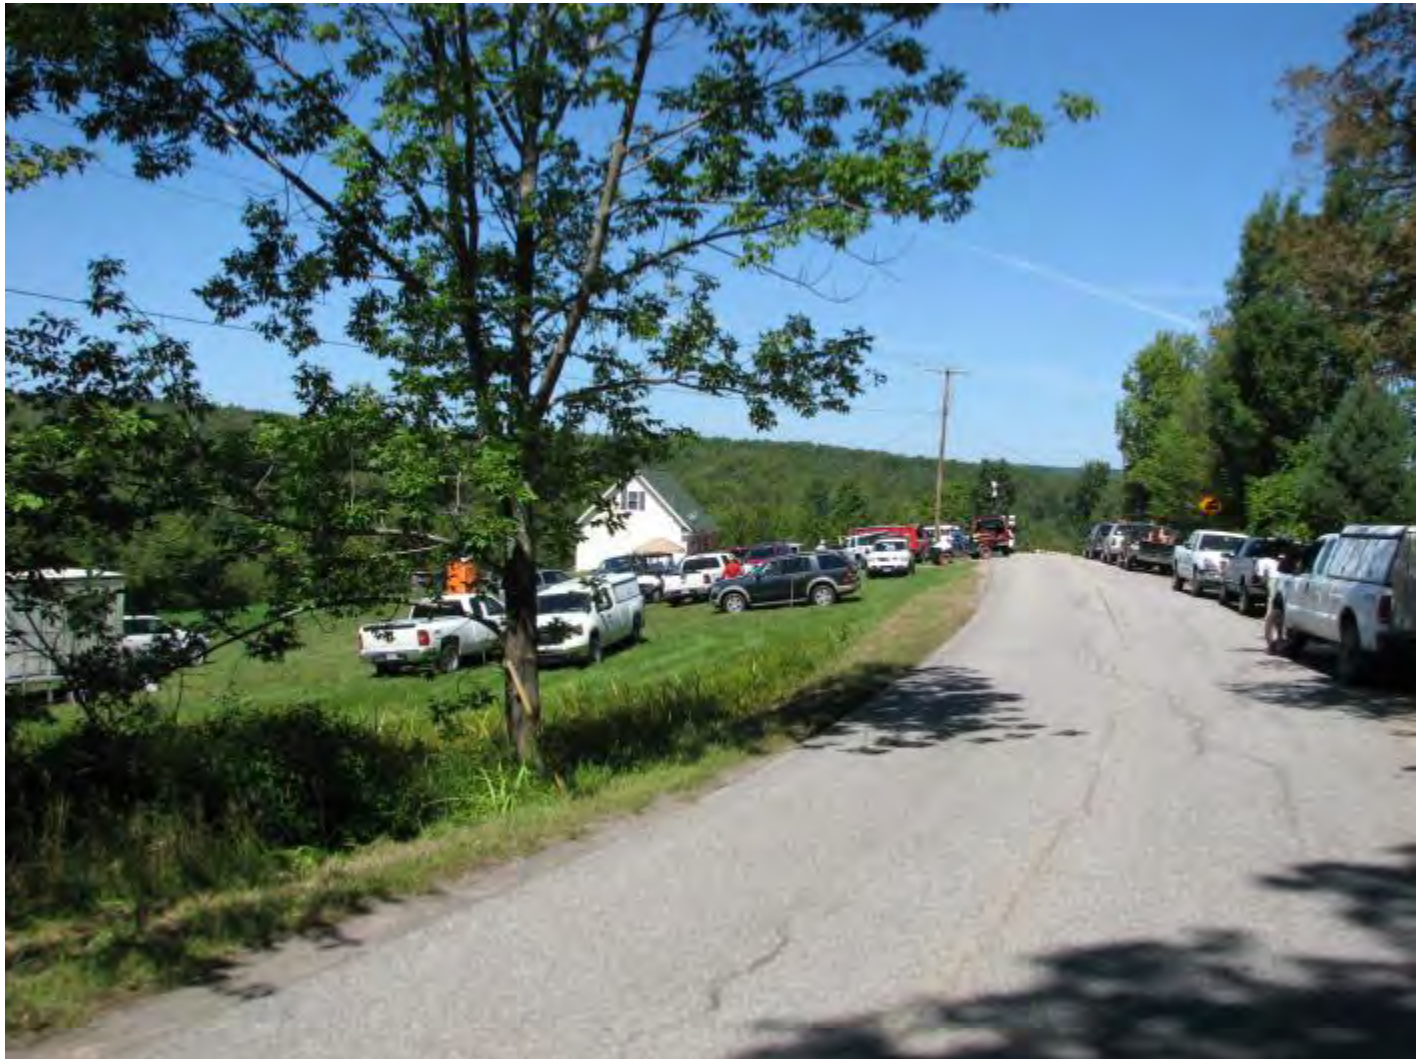
PHOTO 7: STAGING AREA (APPROXIMATELY 1000' SOUTH OF PIPELINE) 8/29/10

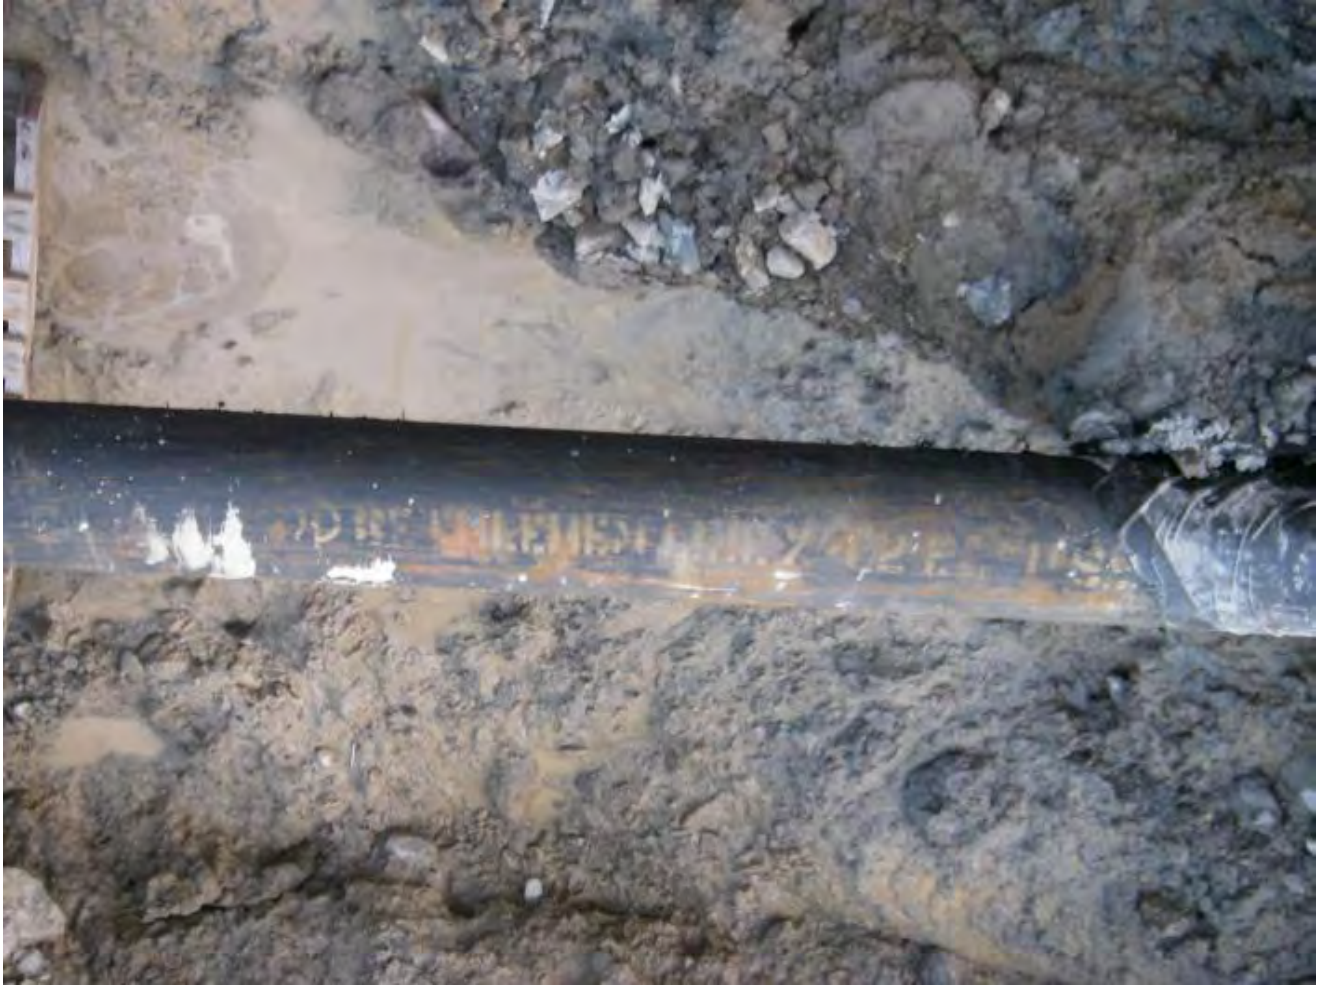
PHOTO 12: PIPE DATA ON TOP OF PIPE UPSTREAM DIG 8/30/10

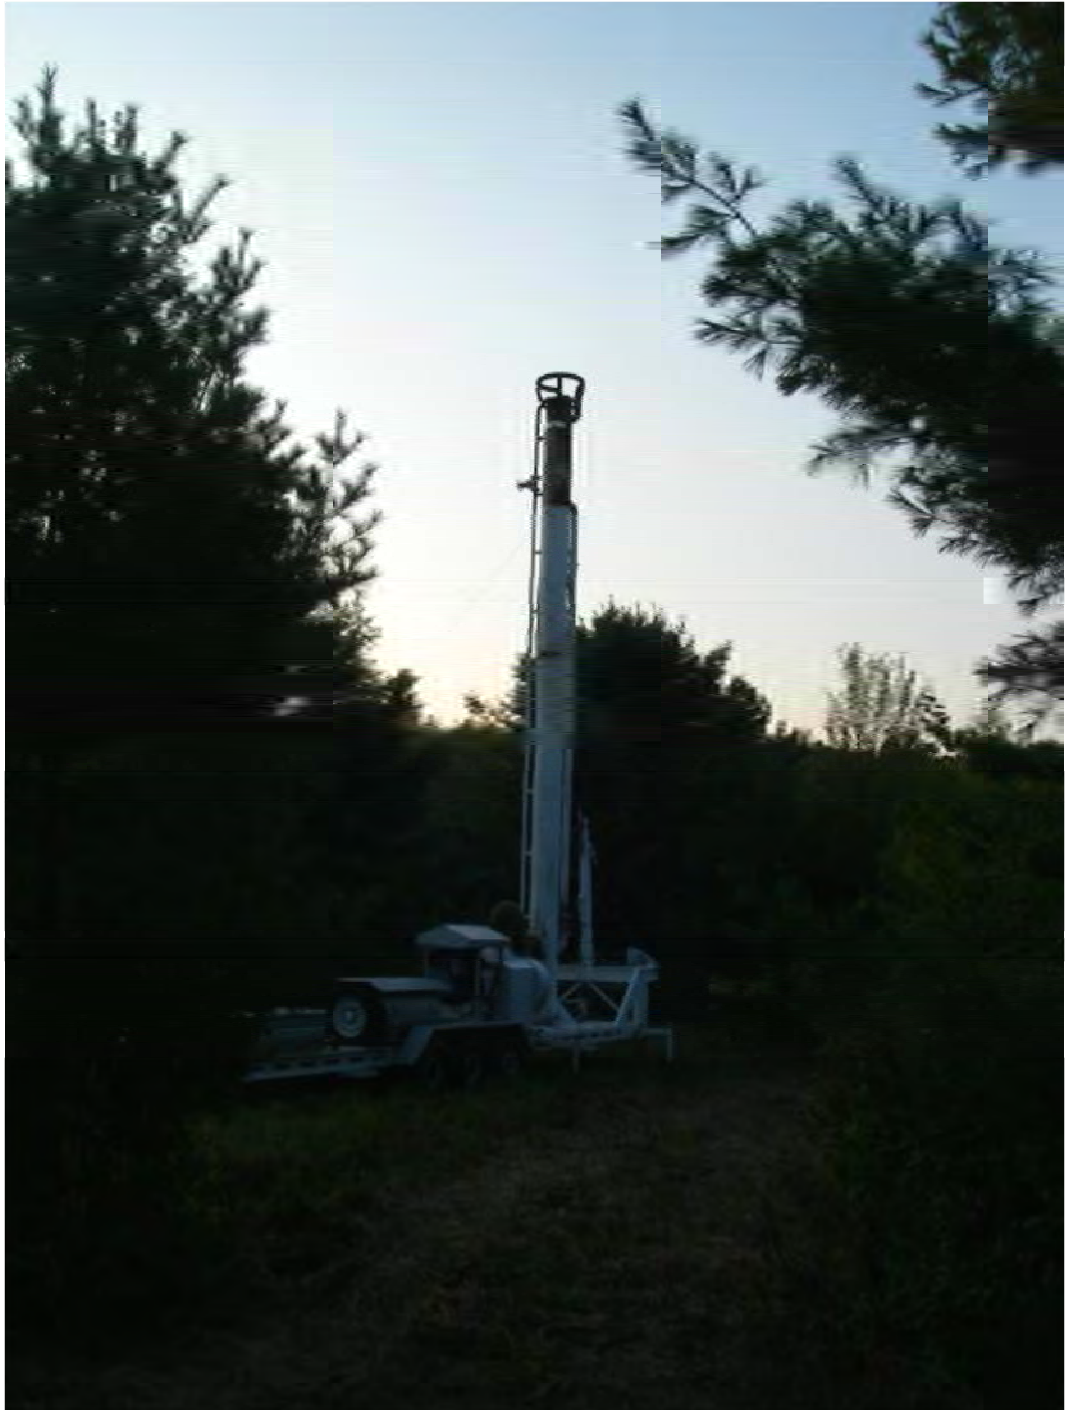
PHOTO 14: FLARE SET UP 8/30/10

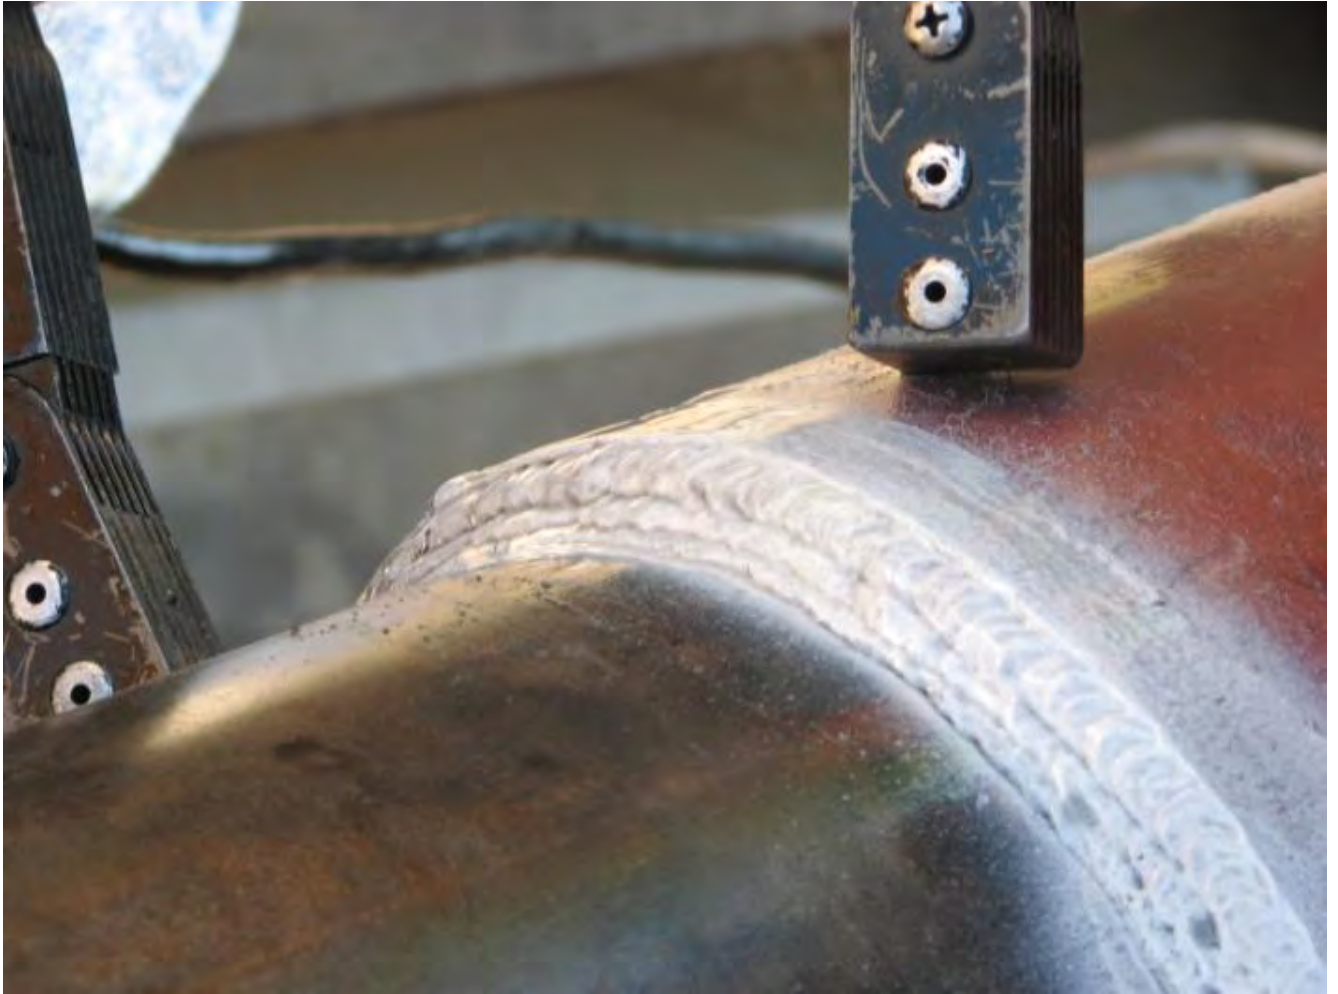
PHOTO 16: MAG PARTICLE 2 UPSTREAM DIG 8/31/10

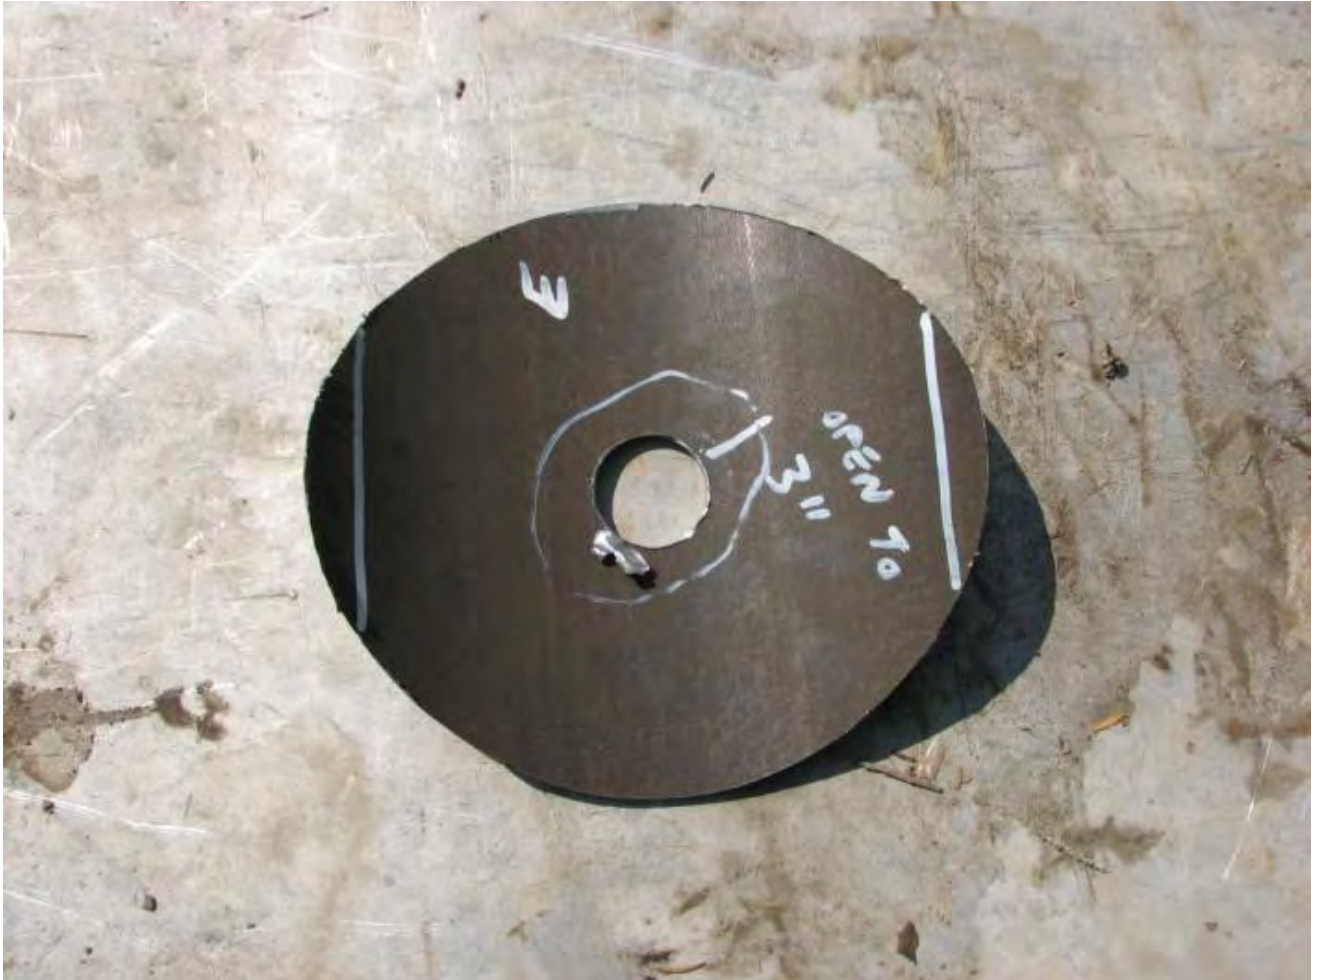
PHOTO 18: COUPON REMOVED FROM DOWNSTREAM TAP 8/31/10

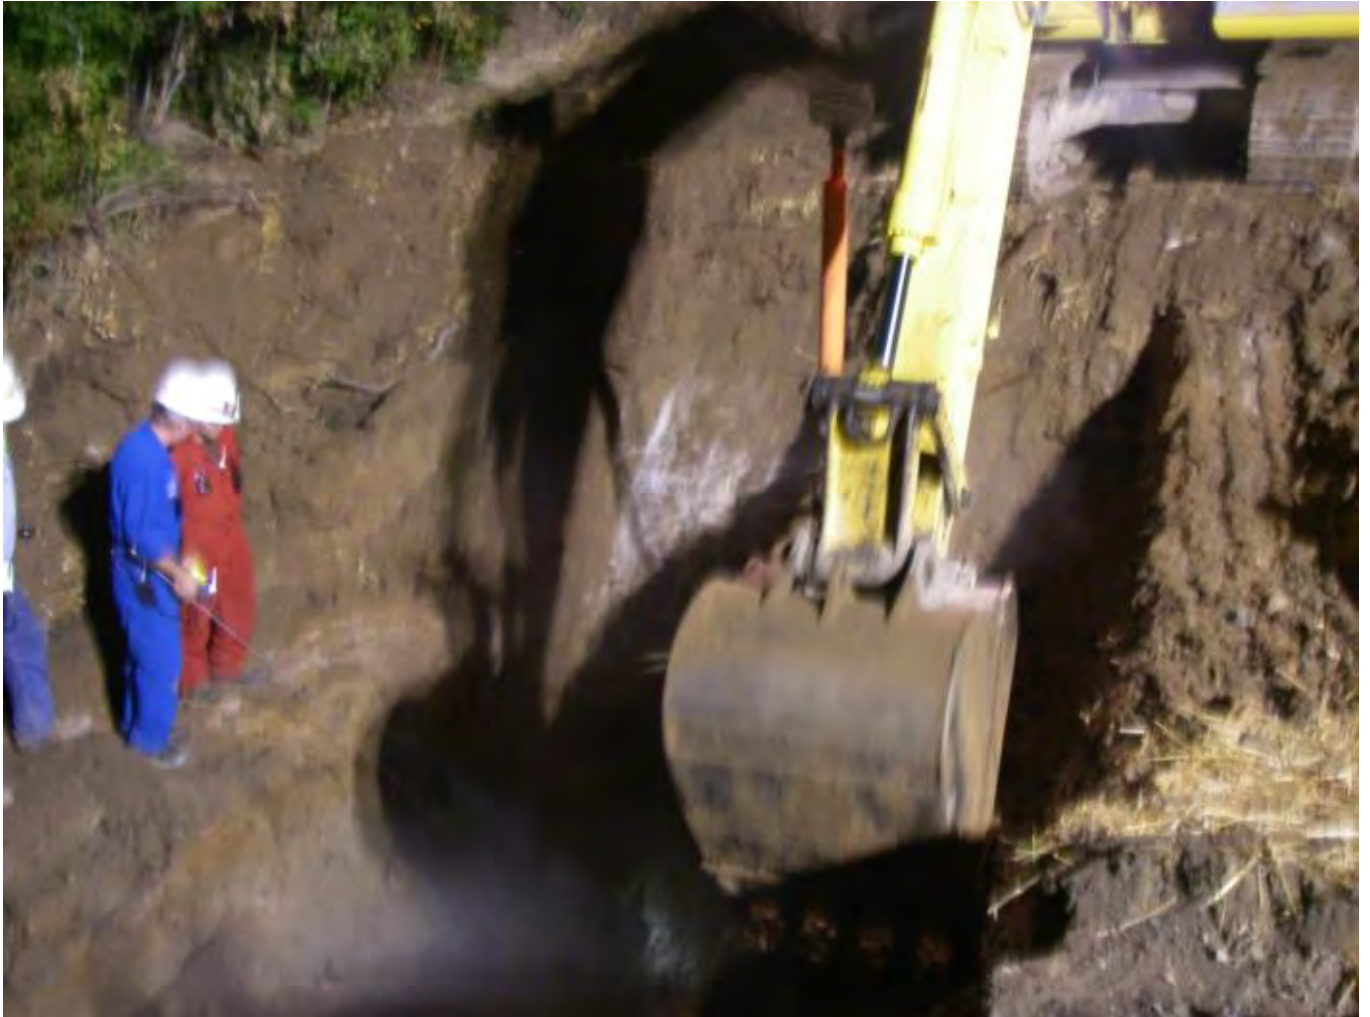
PHOTO 19: EXCAVATING FROST BALL AROUND PIPE 09/01/10

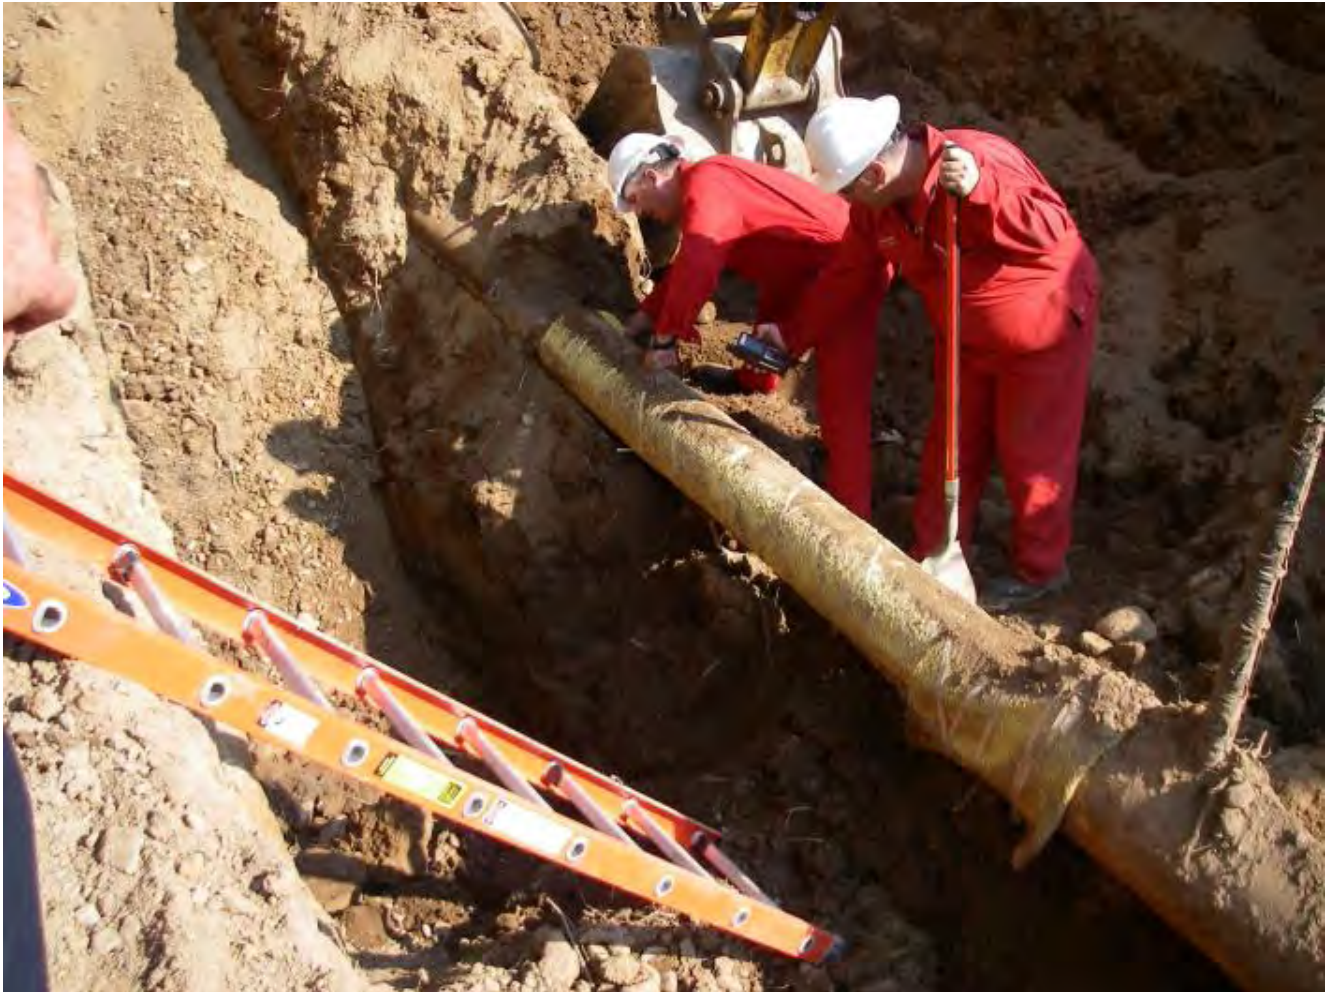
PHOTO 20: CASING, CARRIER PIPE AND VENT STACK EXPOSED,
DOWNSTREAM SIDE 09/01/10

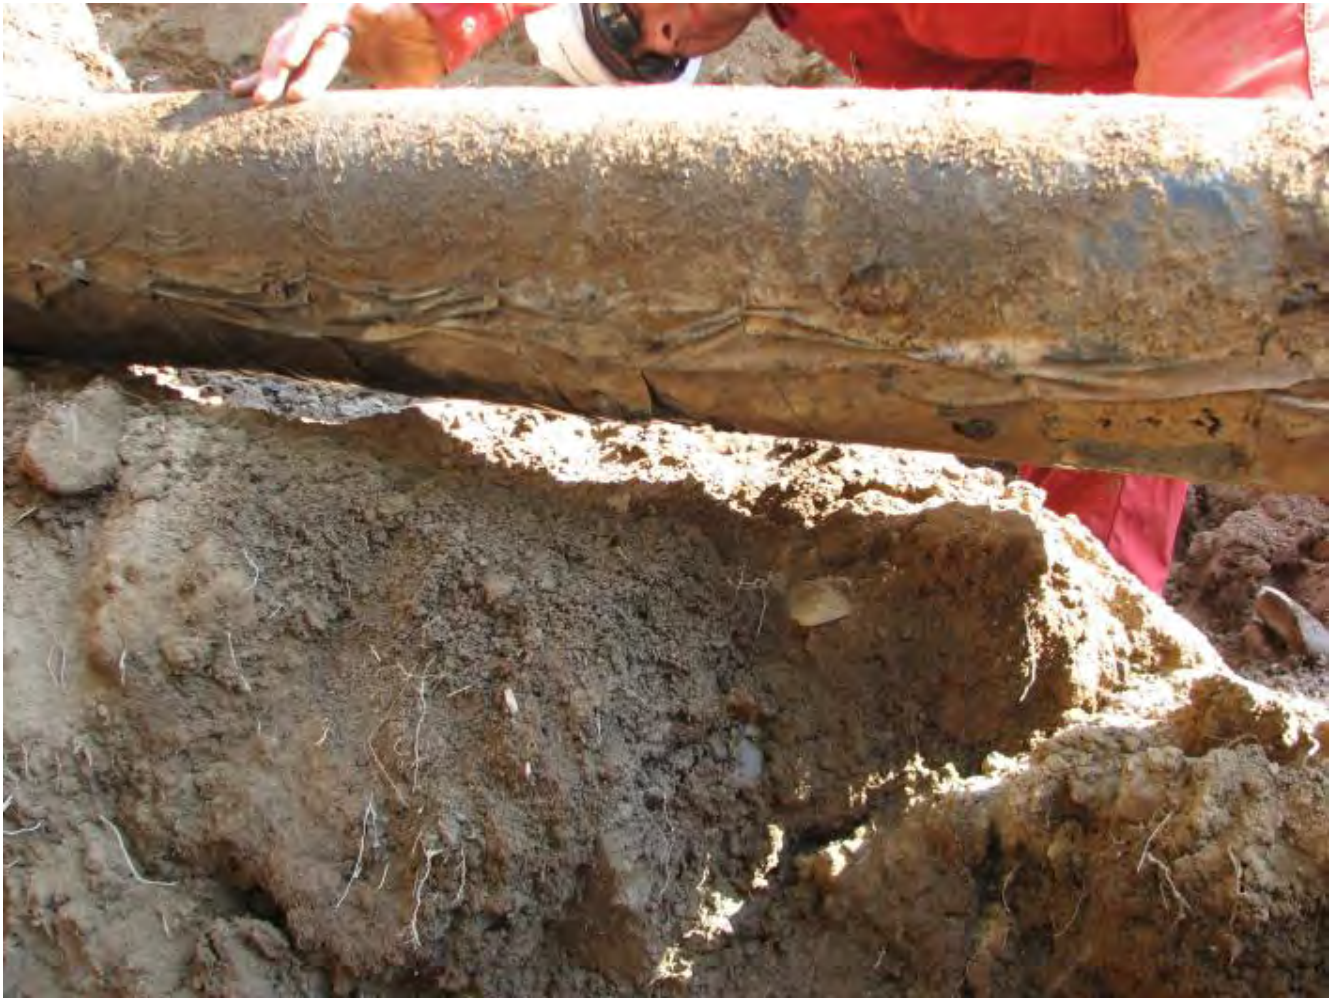
PHOTO 21: EXAMINING PIPE IN AREA OF SUSPECTED LEAK 09/01/10

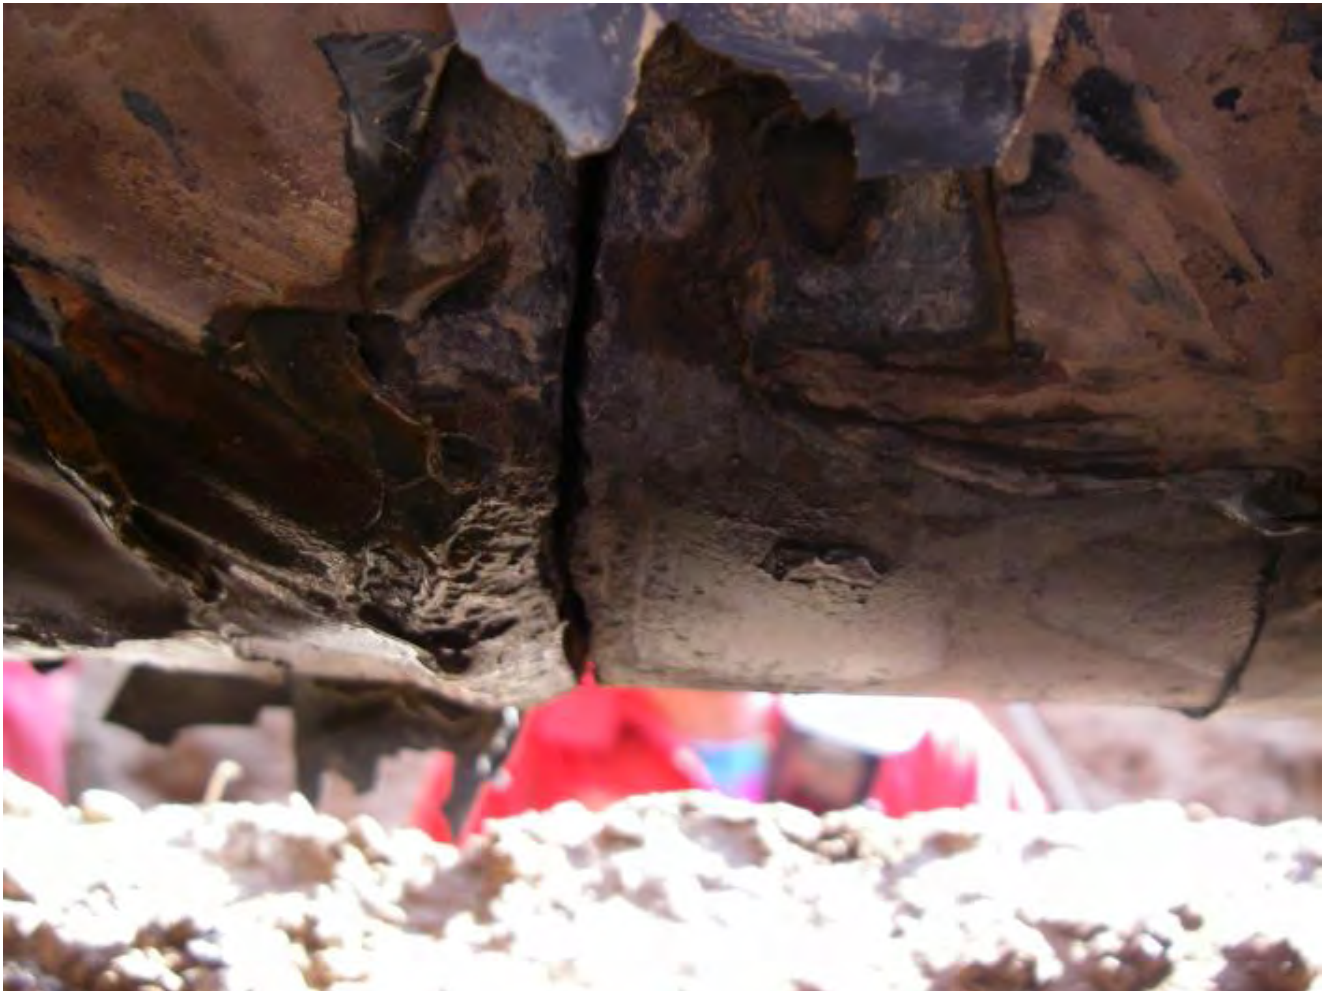
PHOTO 22: CRACK PARTIALLY EXPOSED 09/01/10

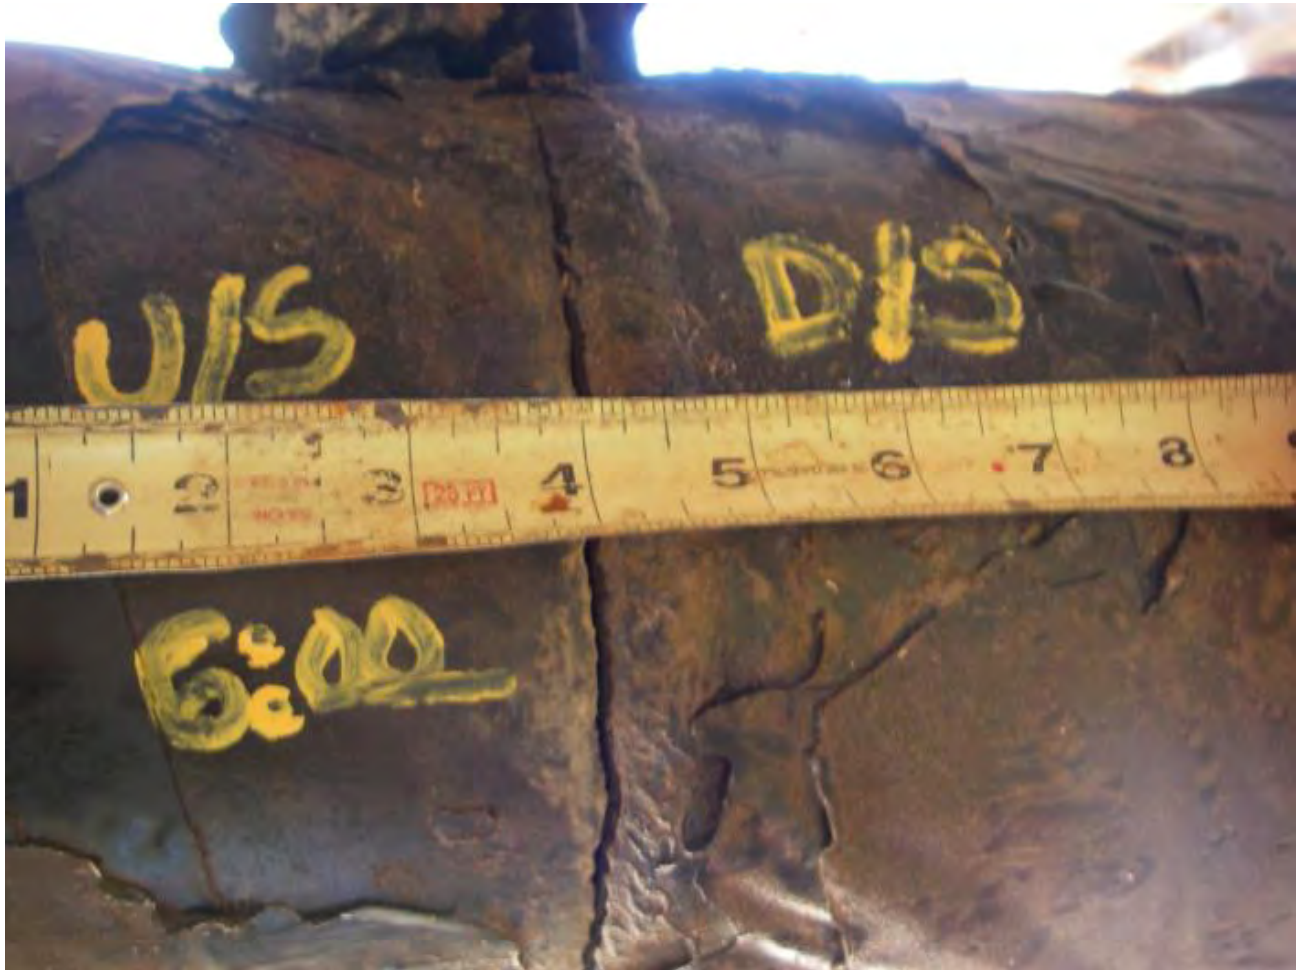
PHOTO 23: CRACK ON BOTTOM QUADRANT'S OF PIPE 09/02/10
