DOT US Department of Transportation
PHMSA Pipeline and Hazardous Materials Safety Administration
OPS Office of Pipeline Safety
Eastern Region

Operator, Location, & Consequences

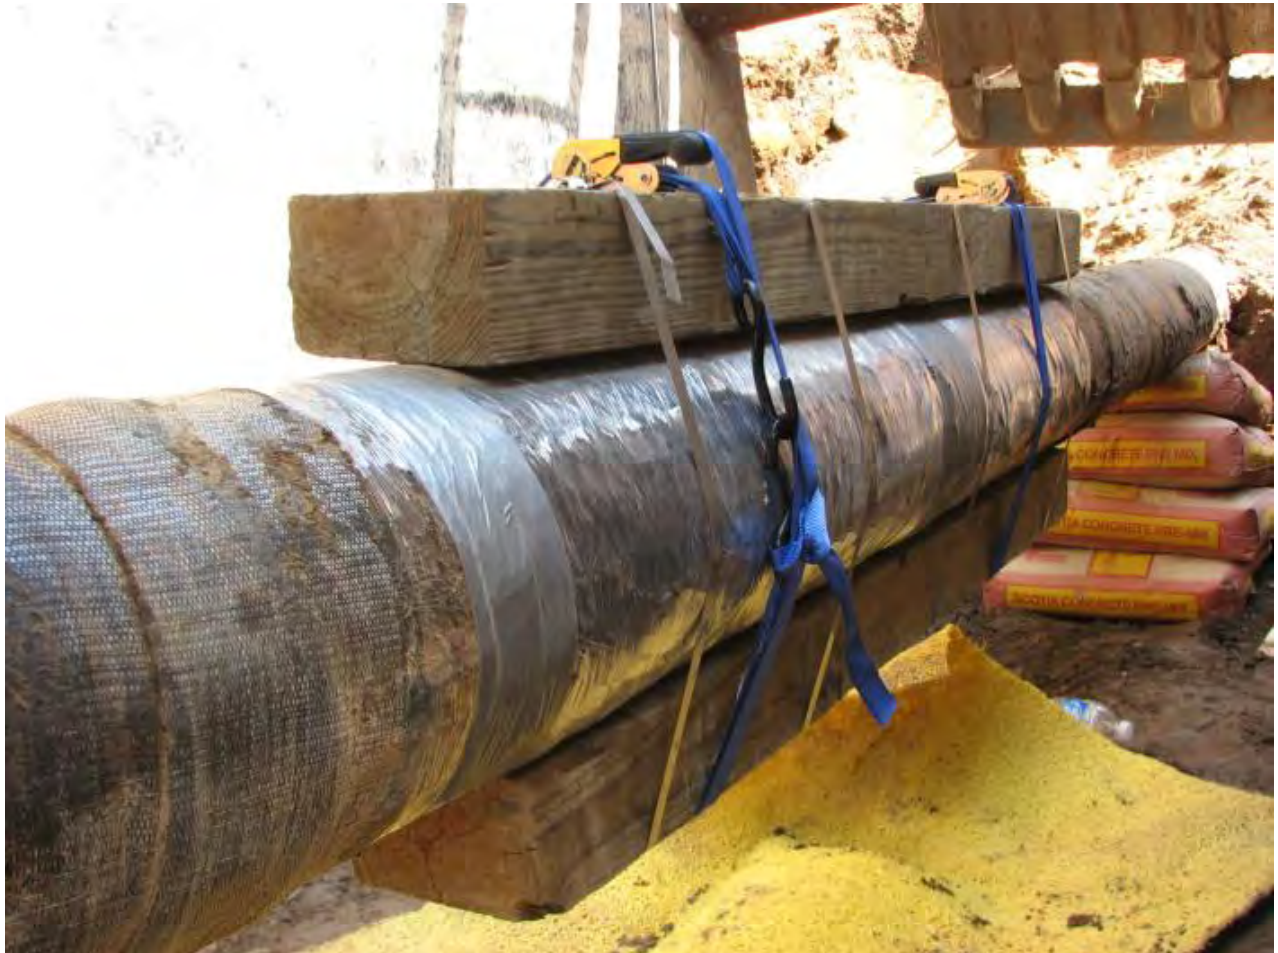
PHOTO 24: PIPE SPECIMEN PREPARED FOR REMOVAL 09/02/10

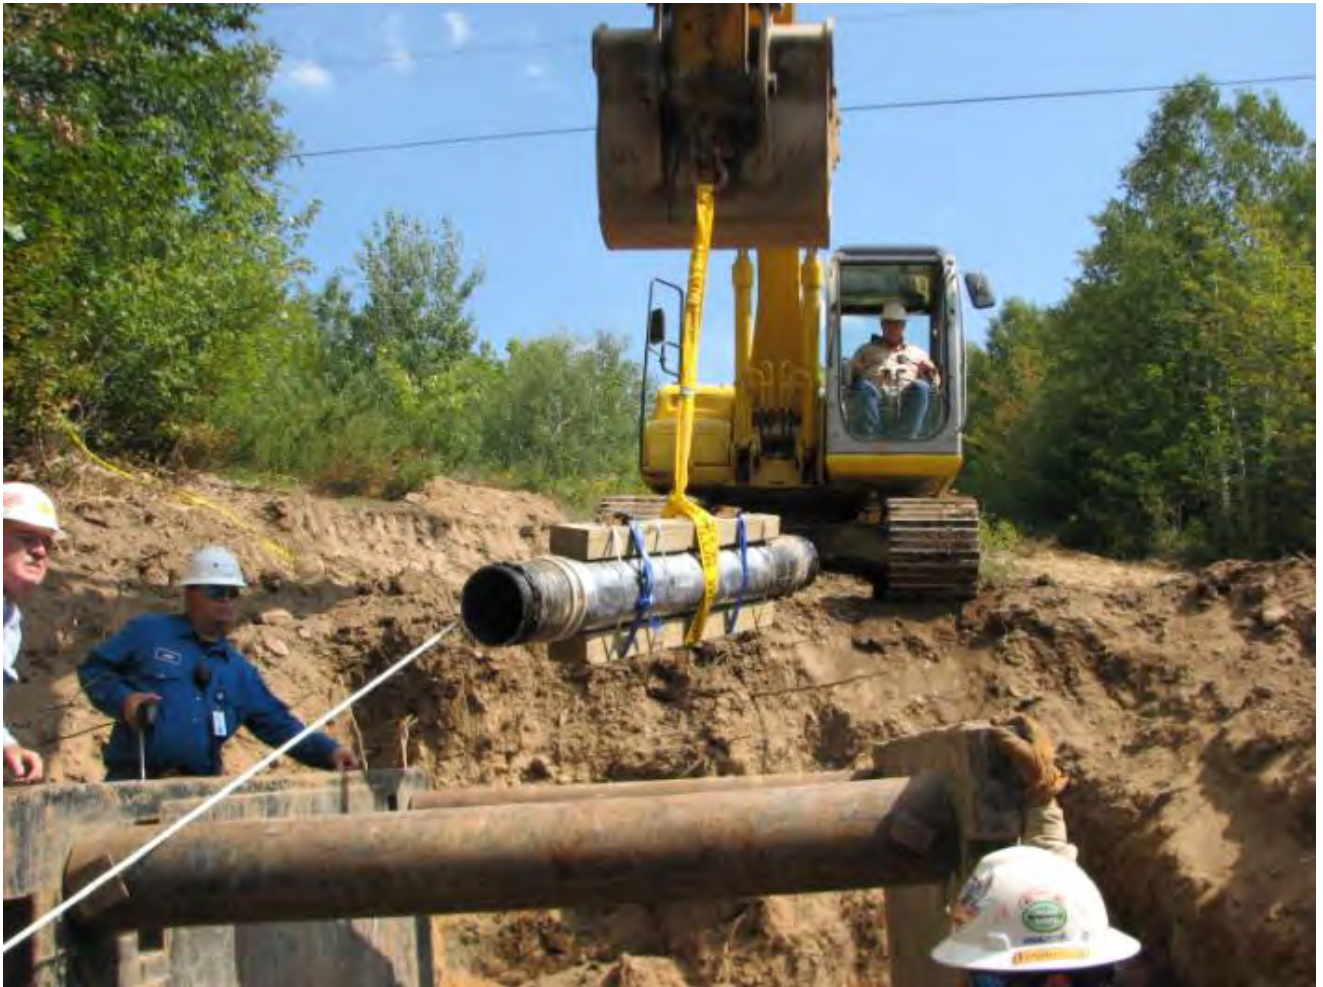
PHOTO 25: PIPE SPECIMEN REMOVED 09/02/10

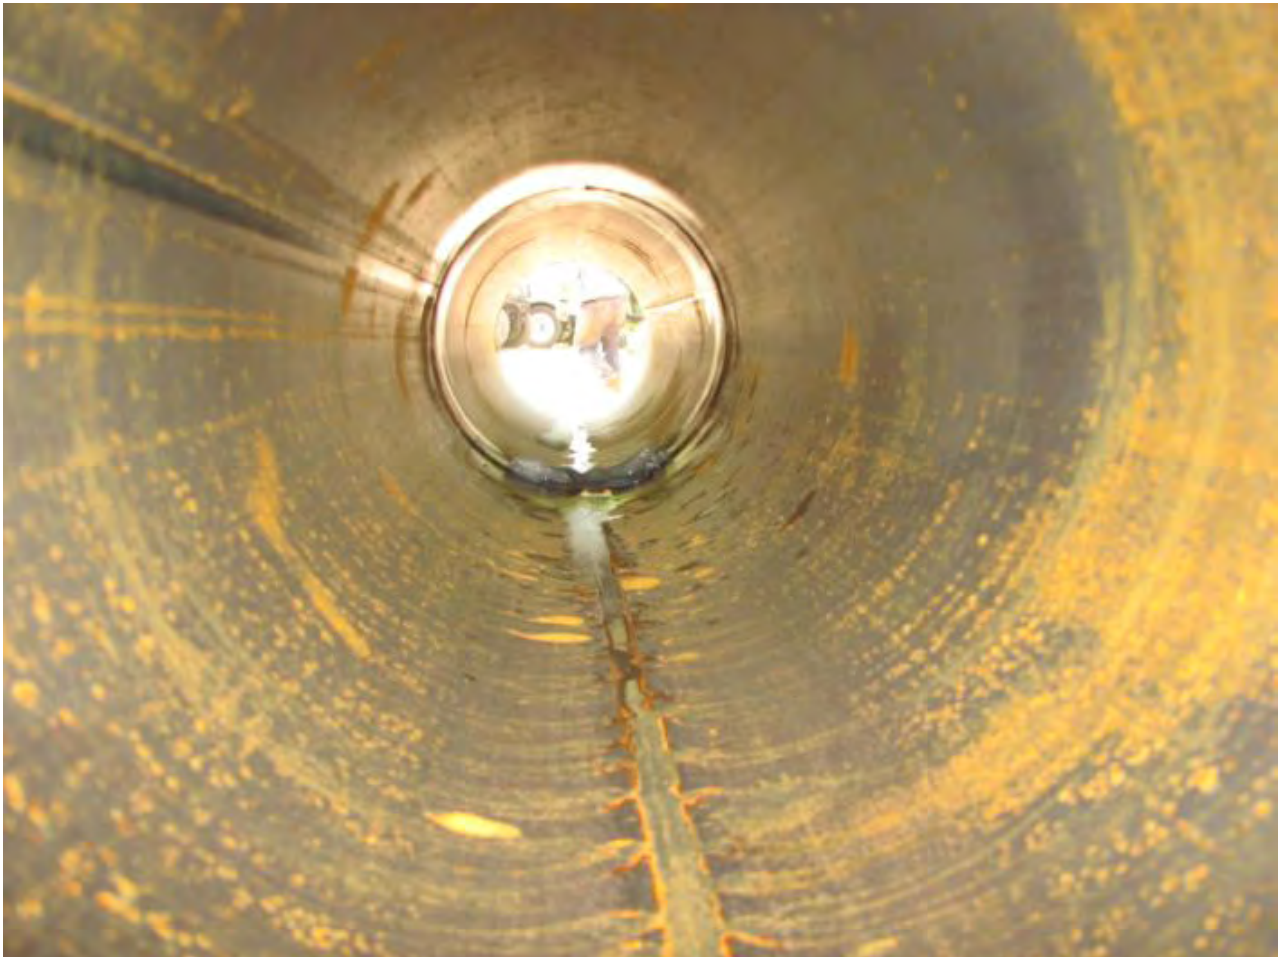
PHOTO 26: INTERNAL VIEW OF PIPE (WD 40 & PLASTIC WRAP
VISIBLE) 09/02/10

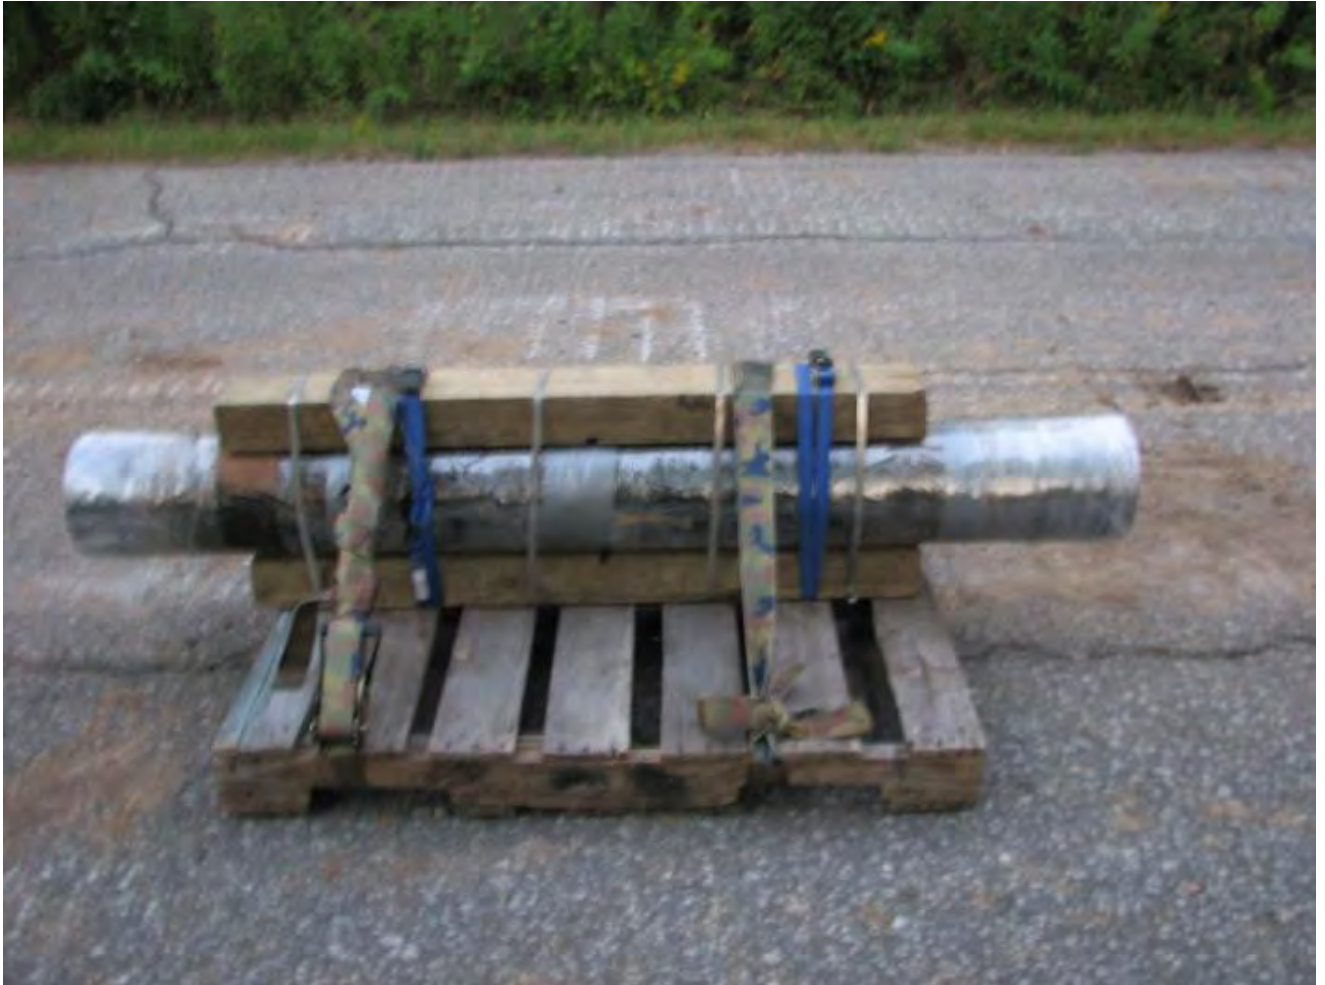
PHOTO 27: PIPE SPECIMEN PREPARED FOR SHIPPING 09/02/10
