#### Federal Aviation Administration Airfield Pavement Working Group

Airport Authority Pavement Perspective Seattle-Tacoma International Airport Ralph L. Wessels, PE

#### **#1 Runway Pavement Pop-Outs**

## Evaluation of RW 16R/34L

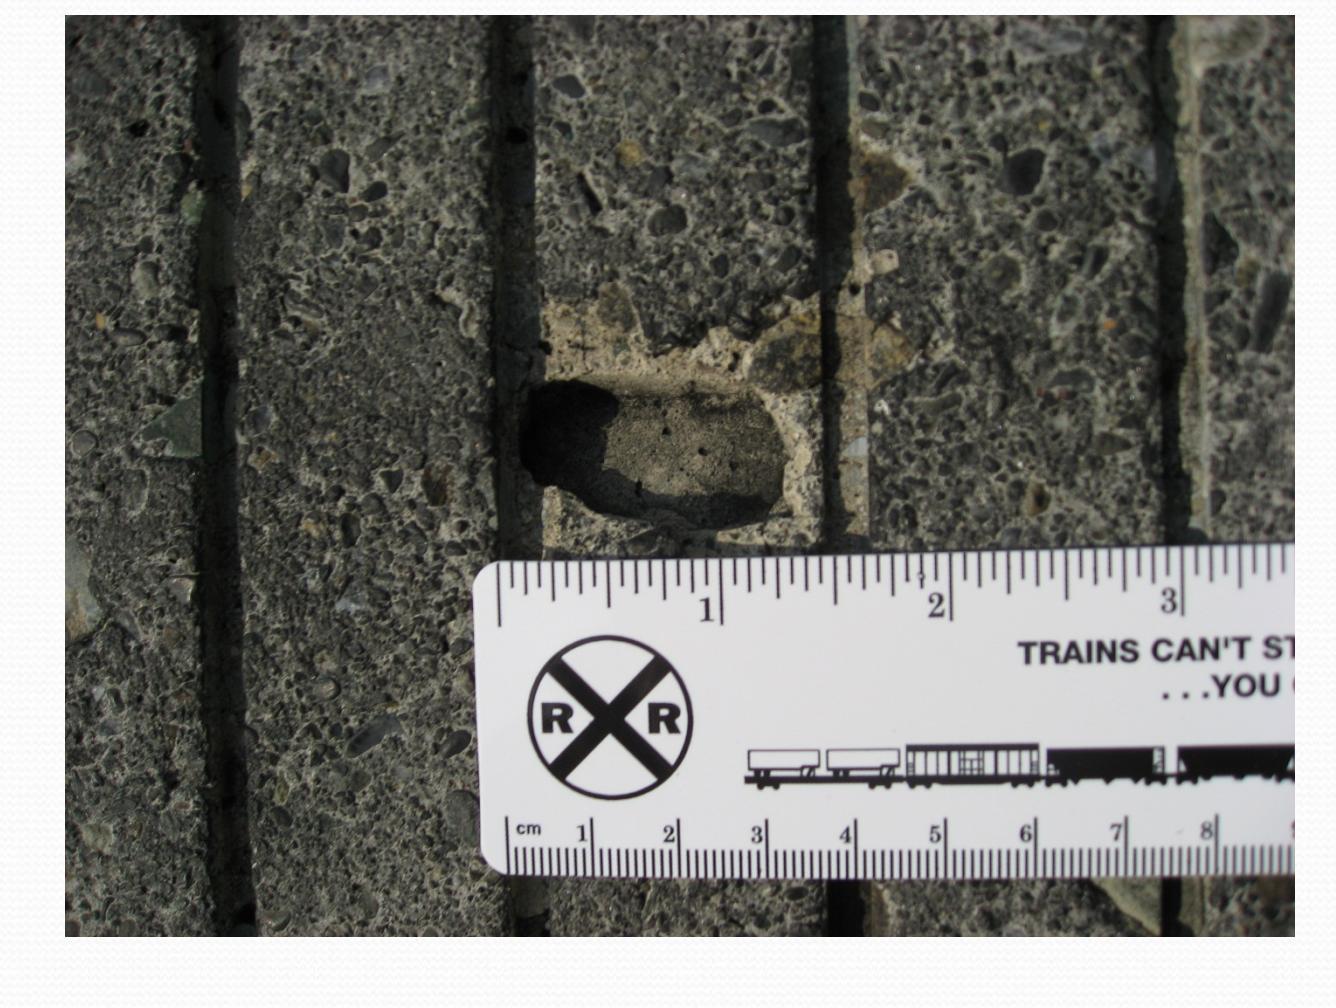
## **Typical Size**

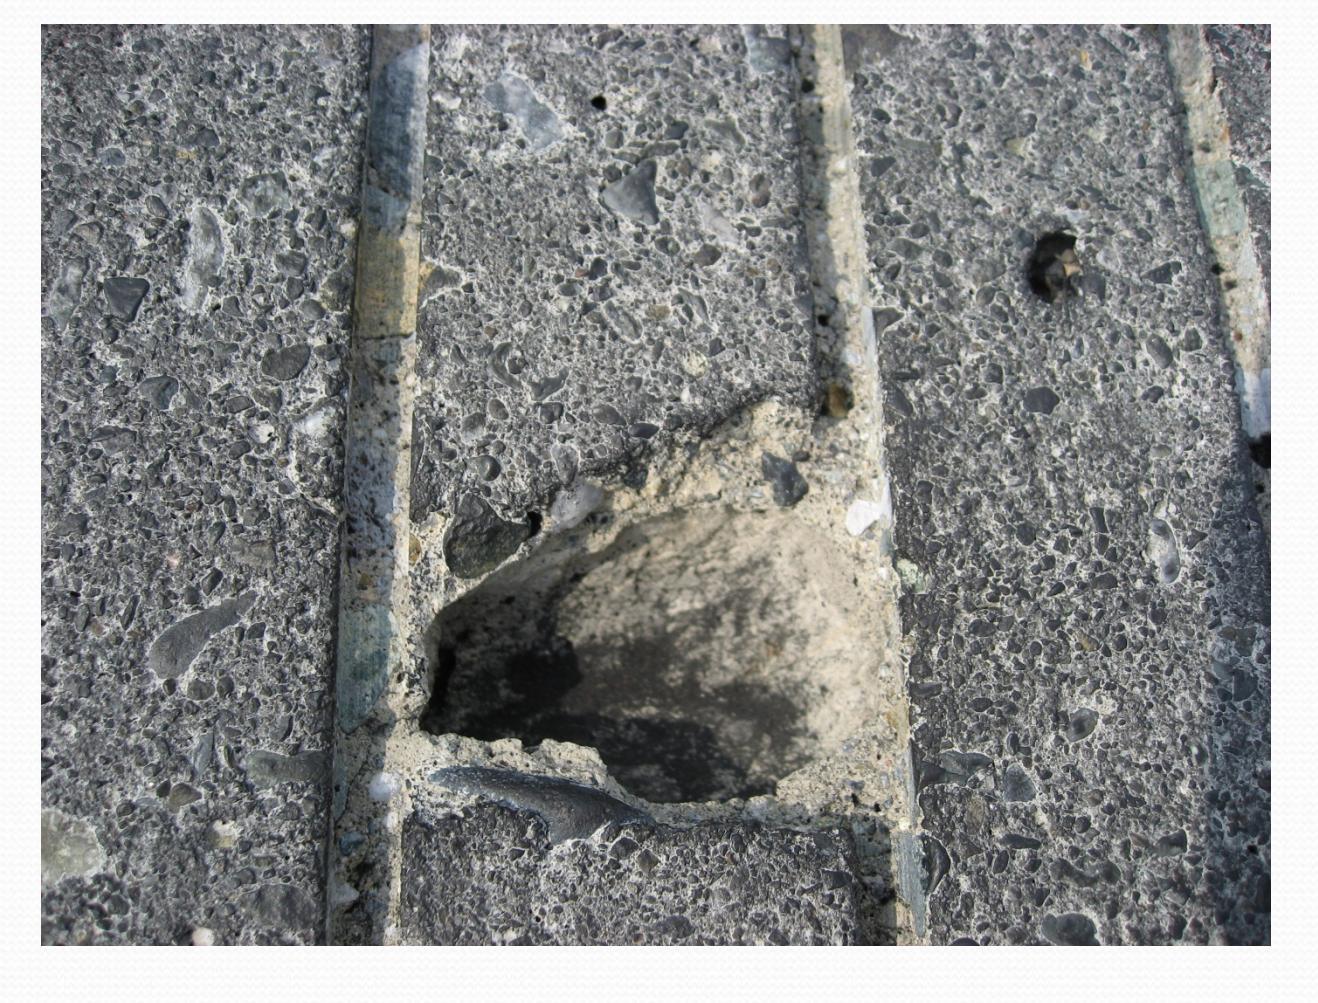
#### **Black Indicates Coal**

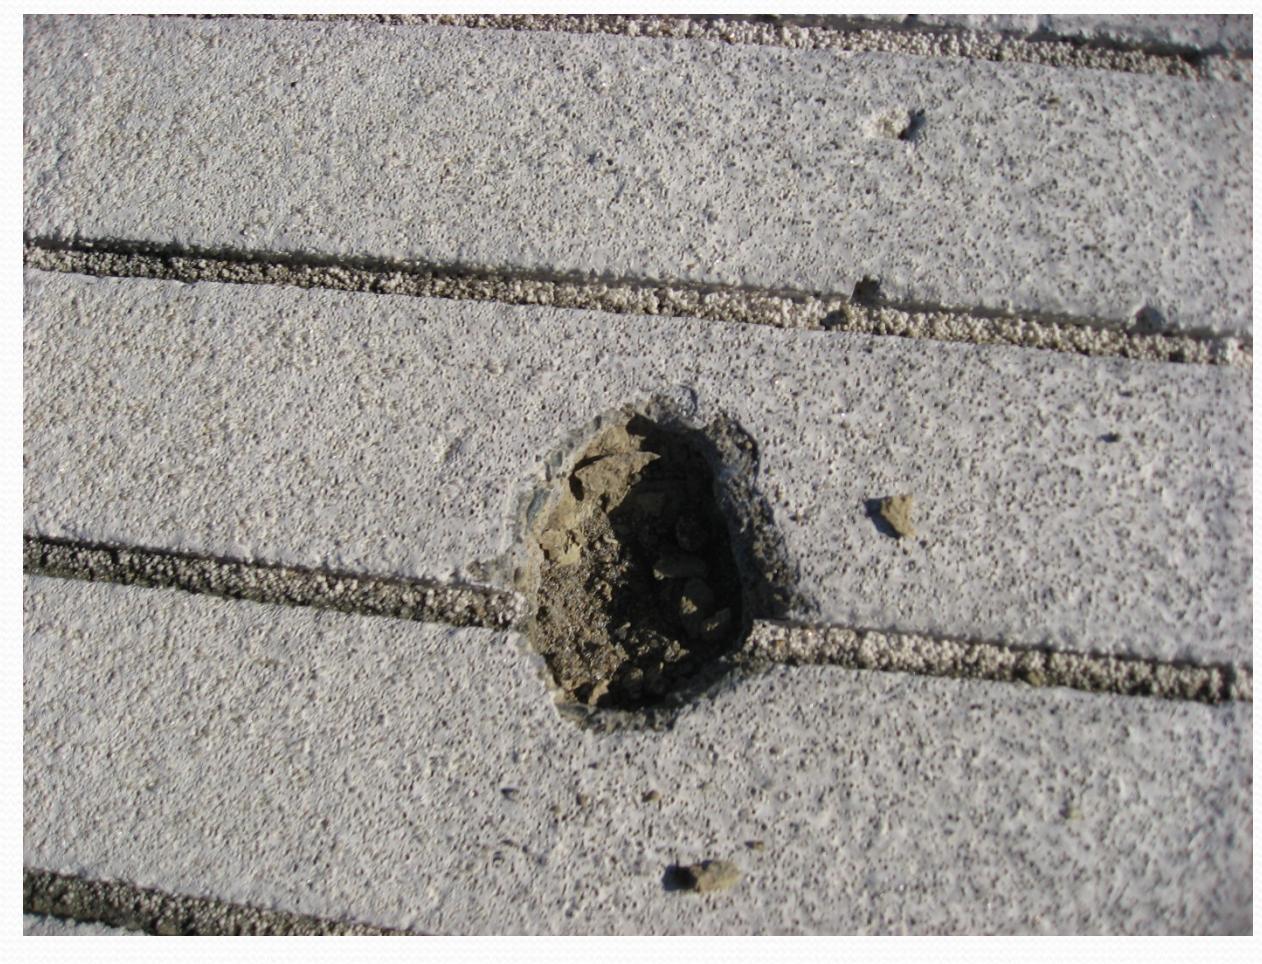
#### **Clay Dislodged in Small Pieces**

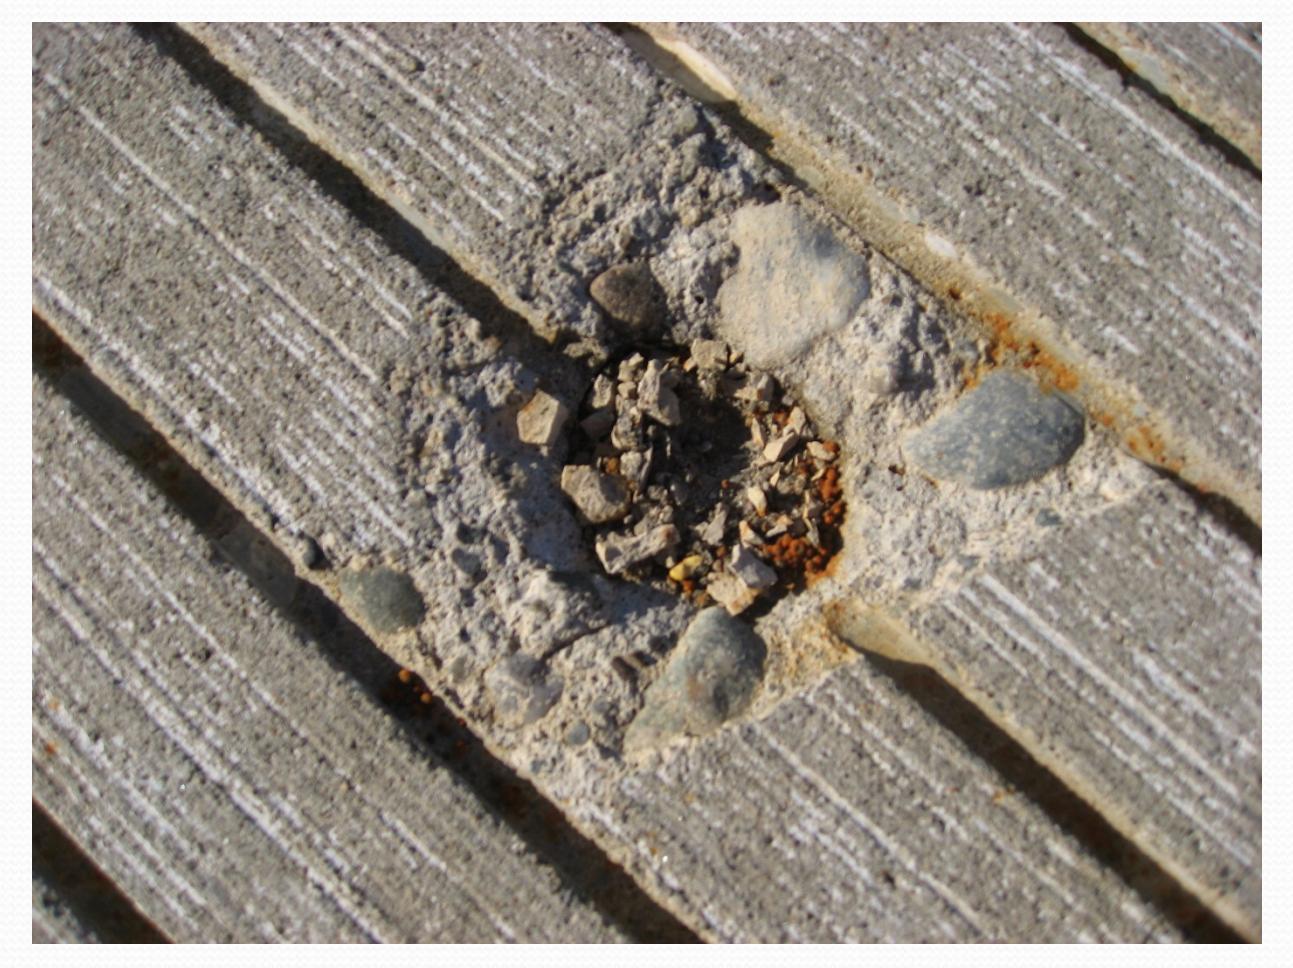
## Pop-out Size ≠ FOD Size

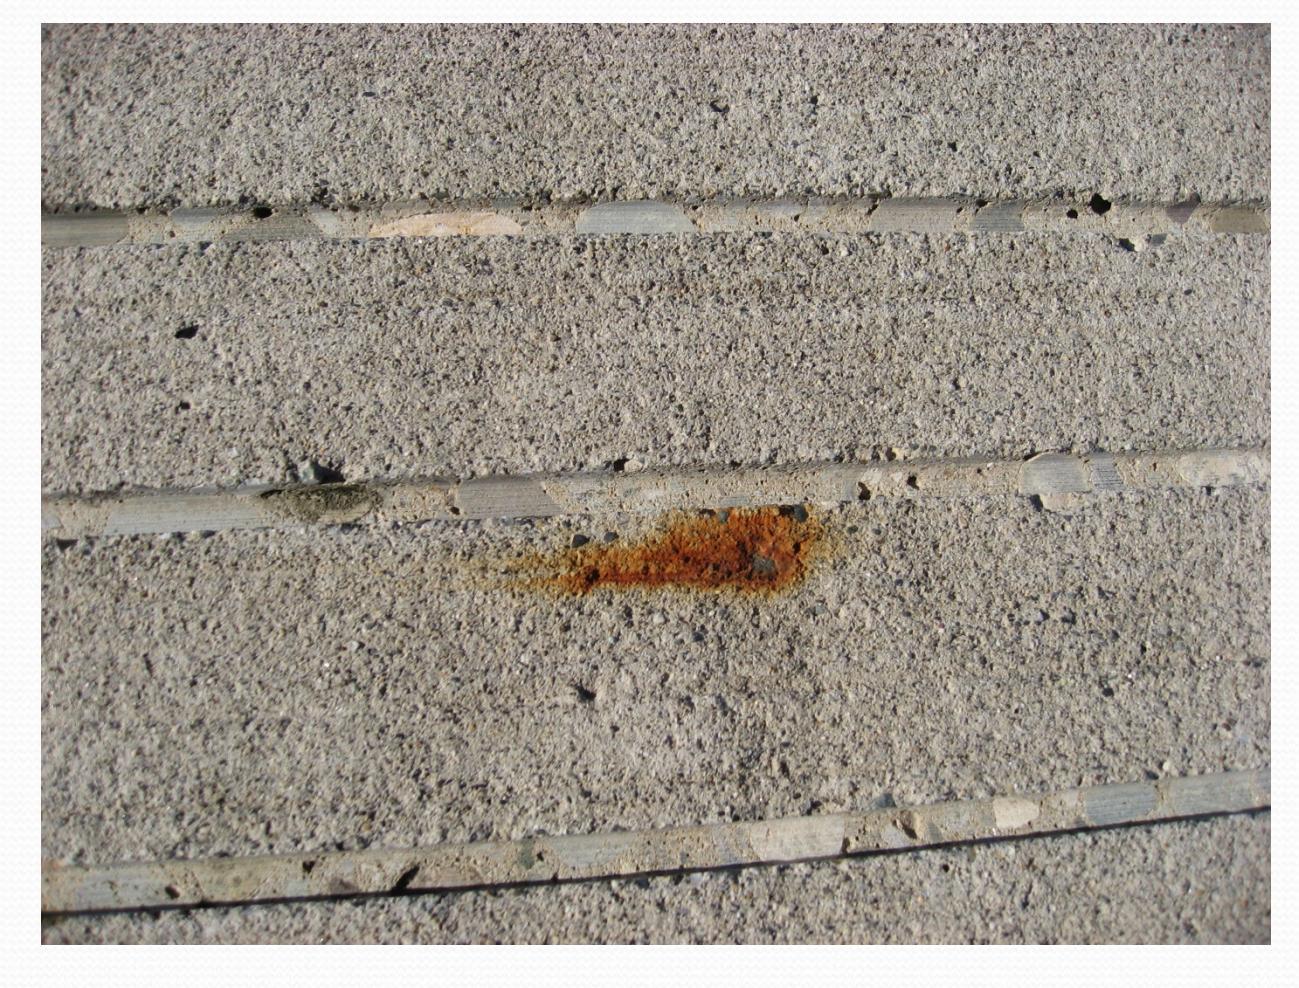
## **Small Rust Stain**

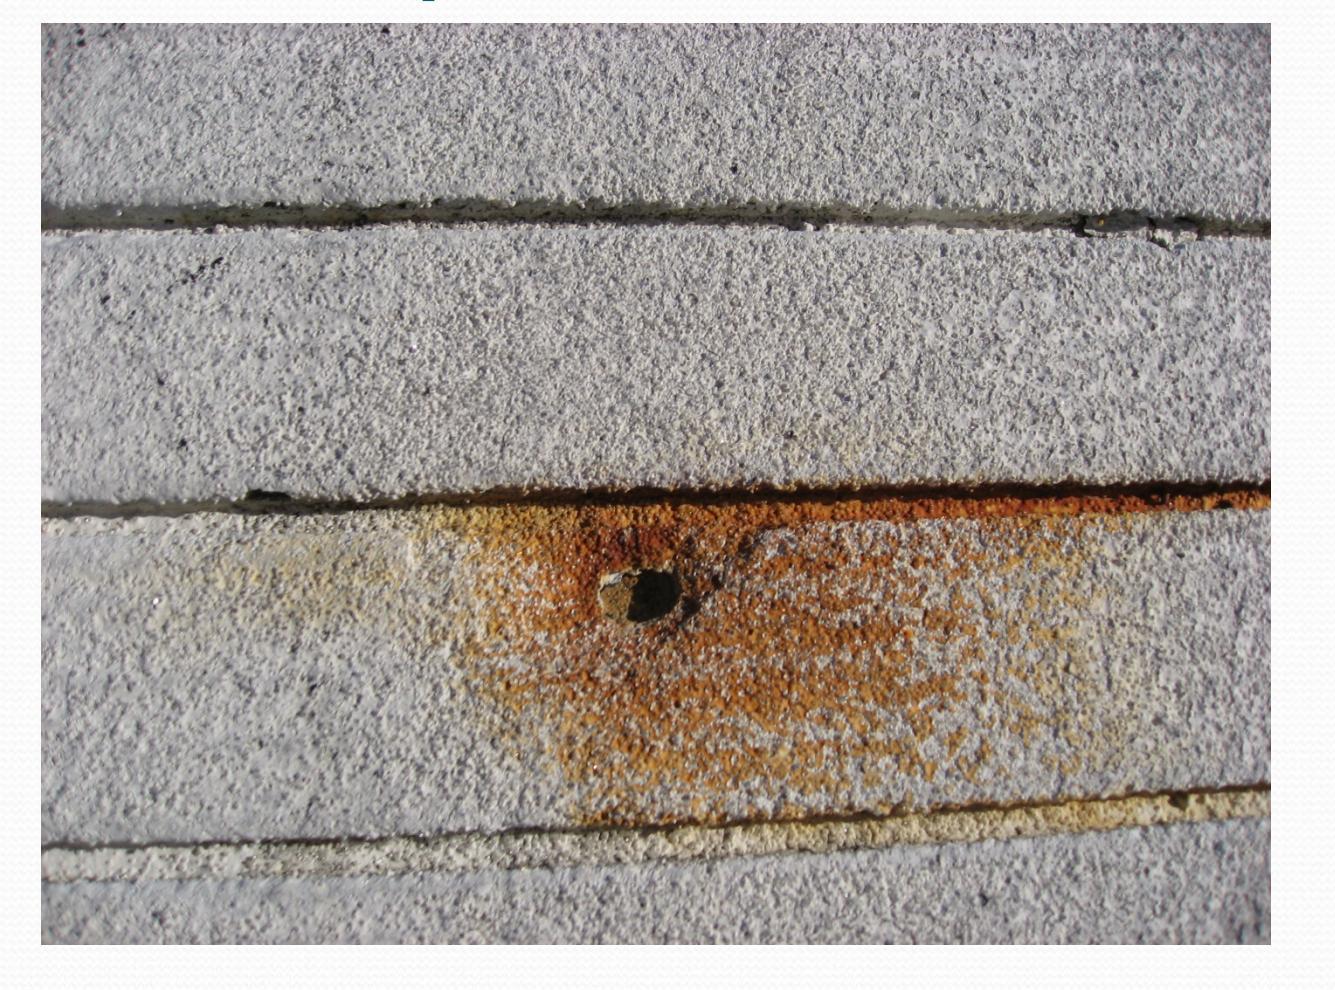
## **Recent Pop-out**

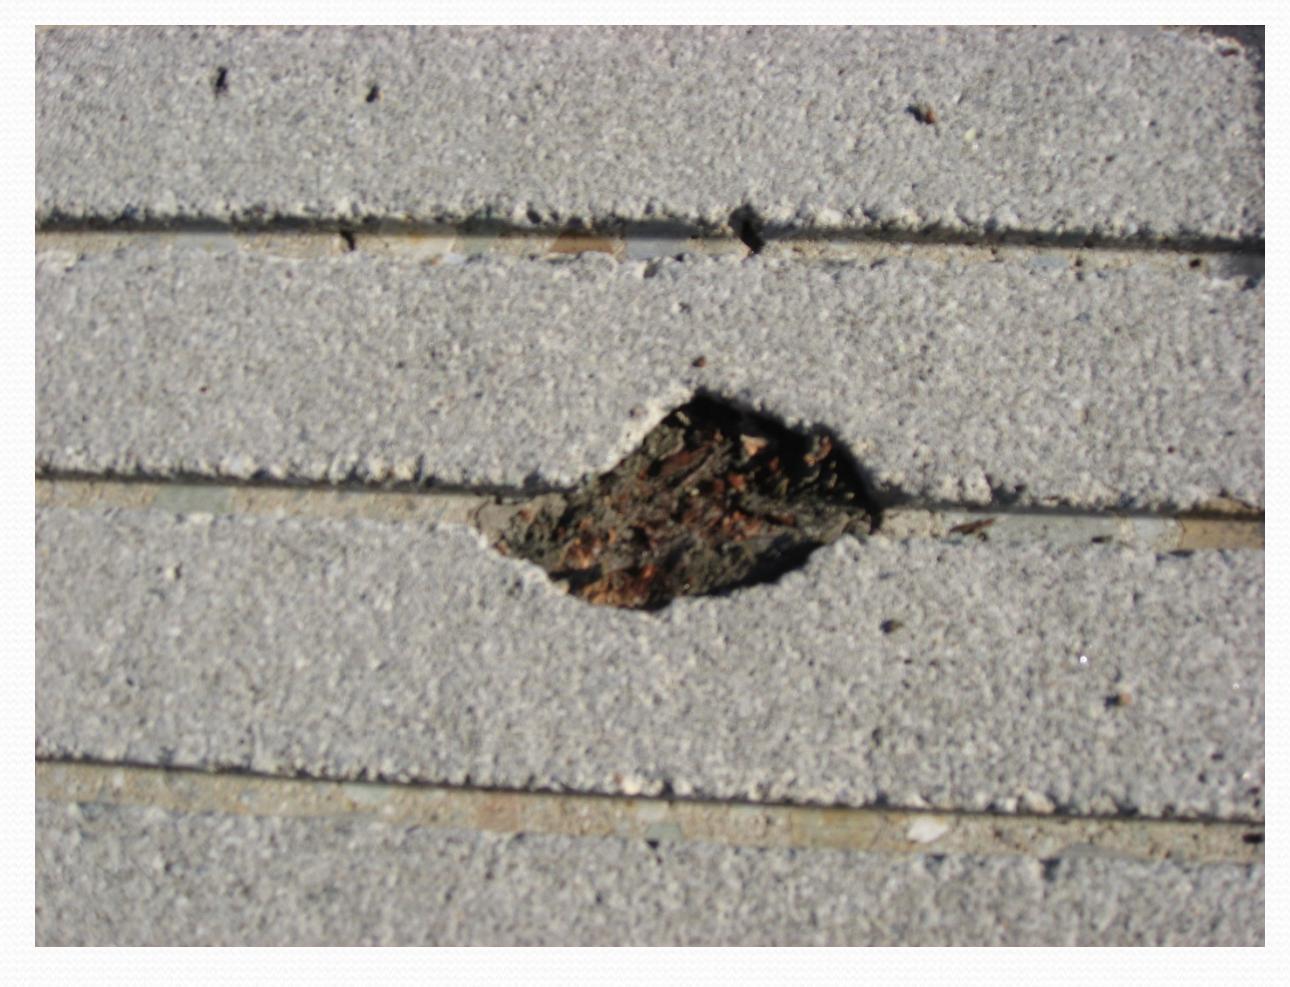
#### **Rust Remnant**

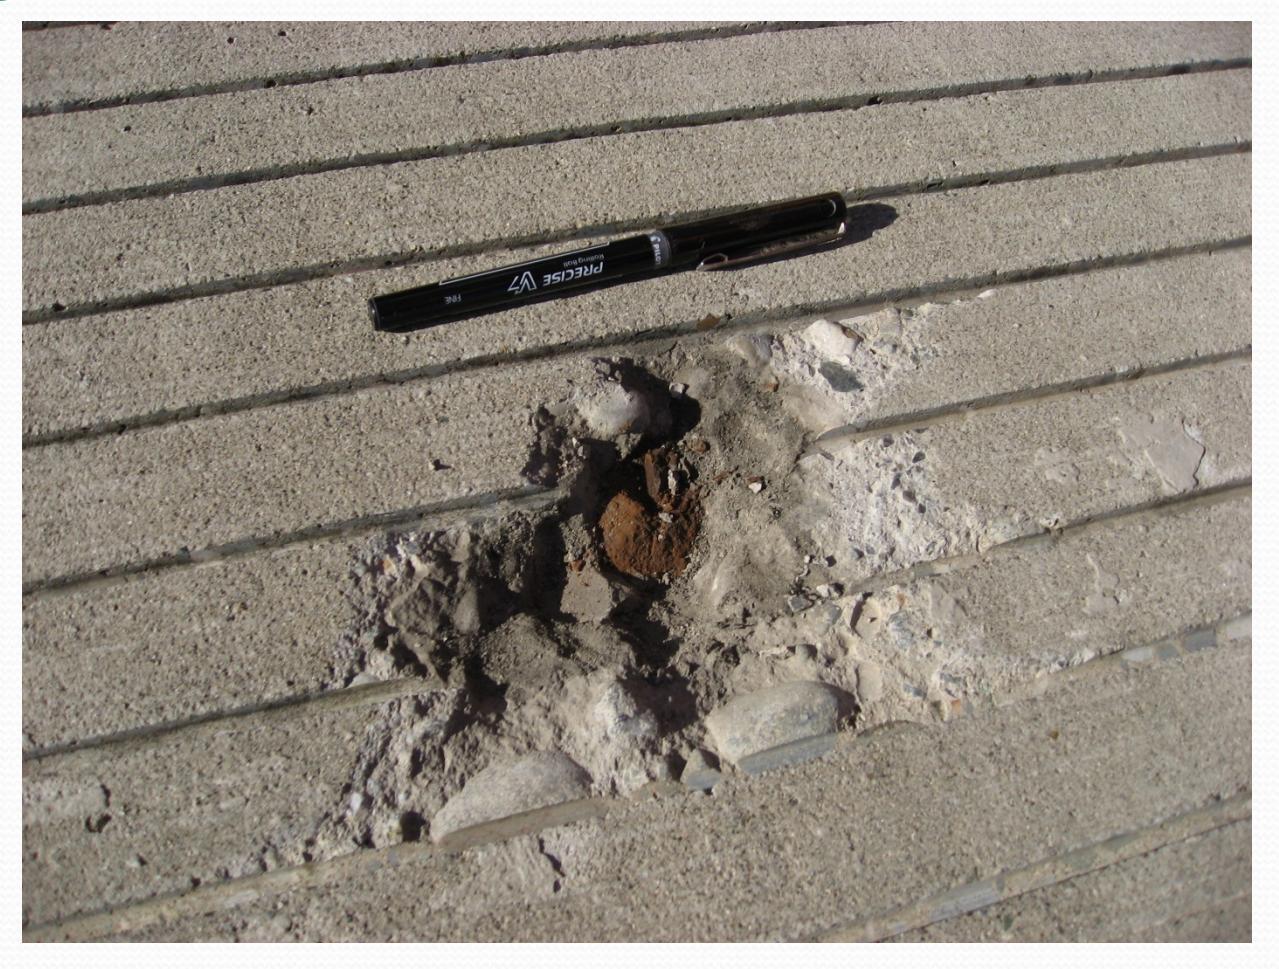
## Larger Area Affected

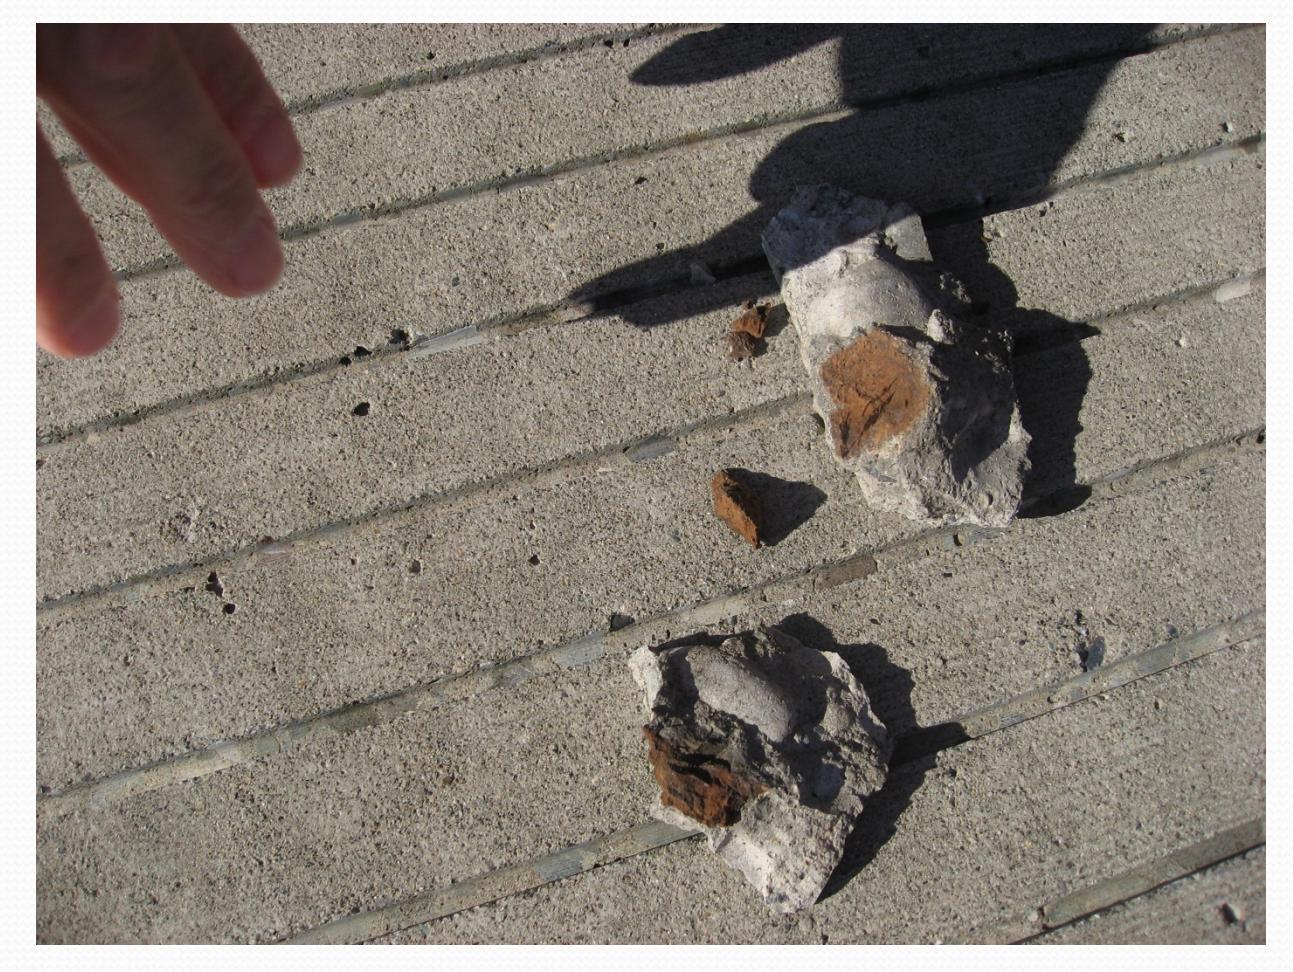
## **Definite FOD**

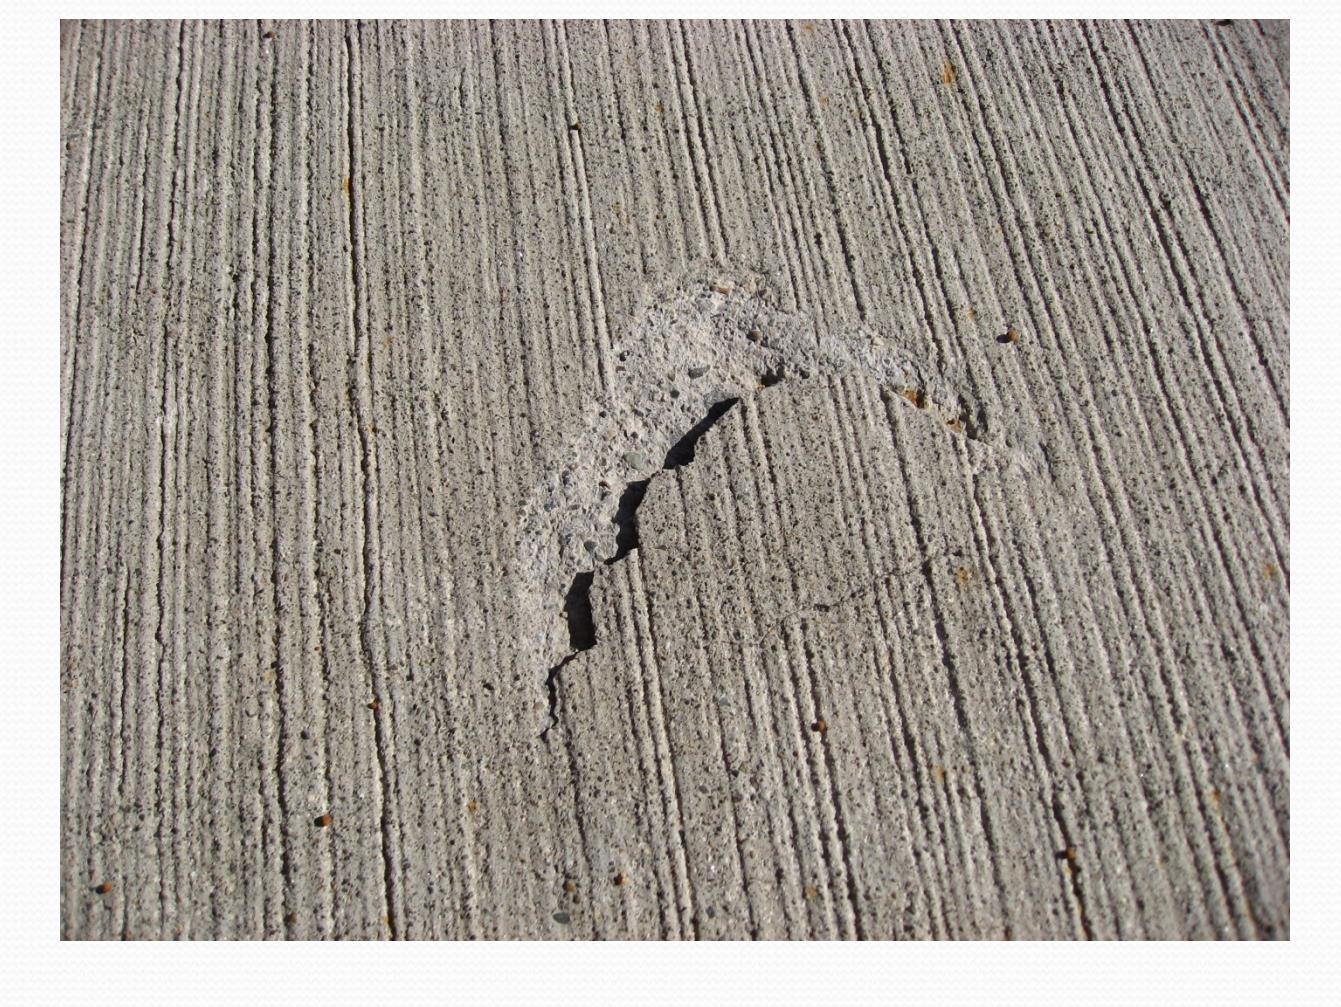
## FOD Waiting to Happen
