2. EQUIPMENT INSTALLATION

2.3 AVC SYSTEM INSTALLATIONS

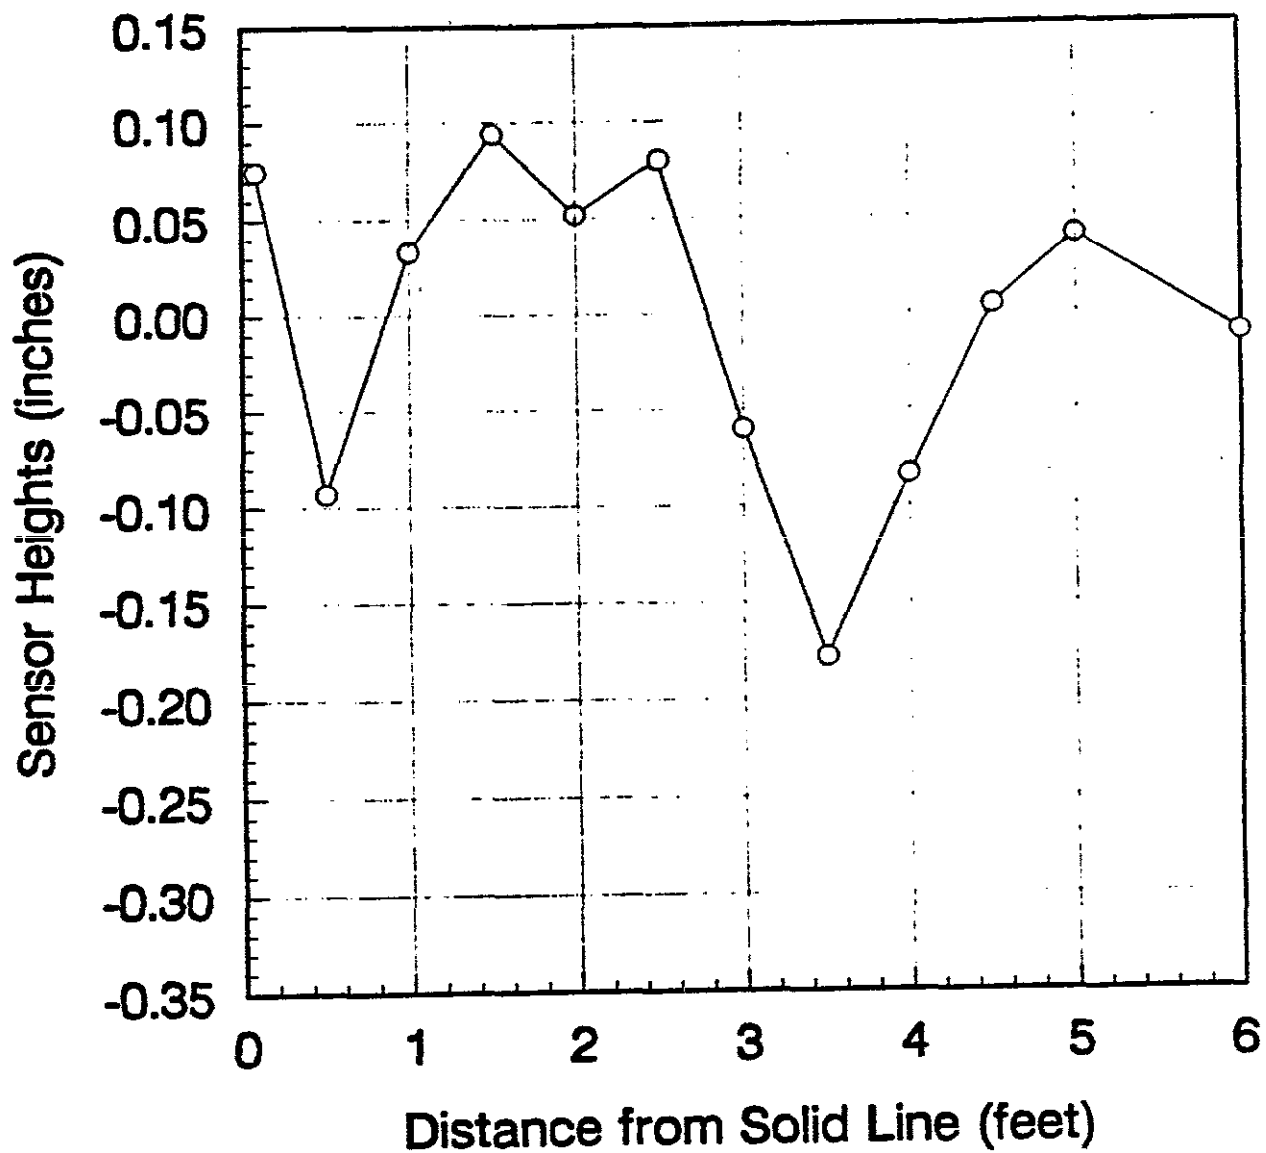
Figure 4. Mikros Axle Sensor Profile

After the installation was complete, the sensor height profile relative to the pavement surface was measured to determine how well the sensor conforms to the road surface. The measurements were performed by placing a special jig over the sensor with supports resting on the pavement on either side and measuring the height of the sensor surface with a dial caliper. The sensor profile is shown in Figure 4. A sensor height of zero indicates the sensor is flush with the surrounding pavement; negative heights indicate sensor surfaces below pavement level. The rutted area of the road extended from approximately 1.5 feet to 2.5 feet. The plot shows that the sensor was as much as 0.1 inches above the road surface level in the rutted wheel path and was as much as 0.18 inches below the surface at around 3.5 feet.

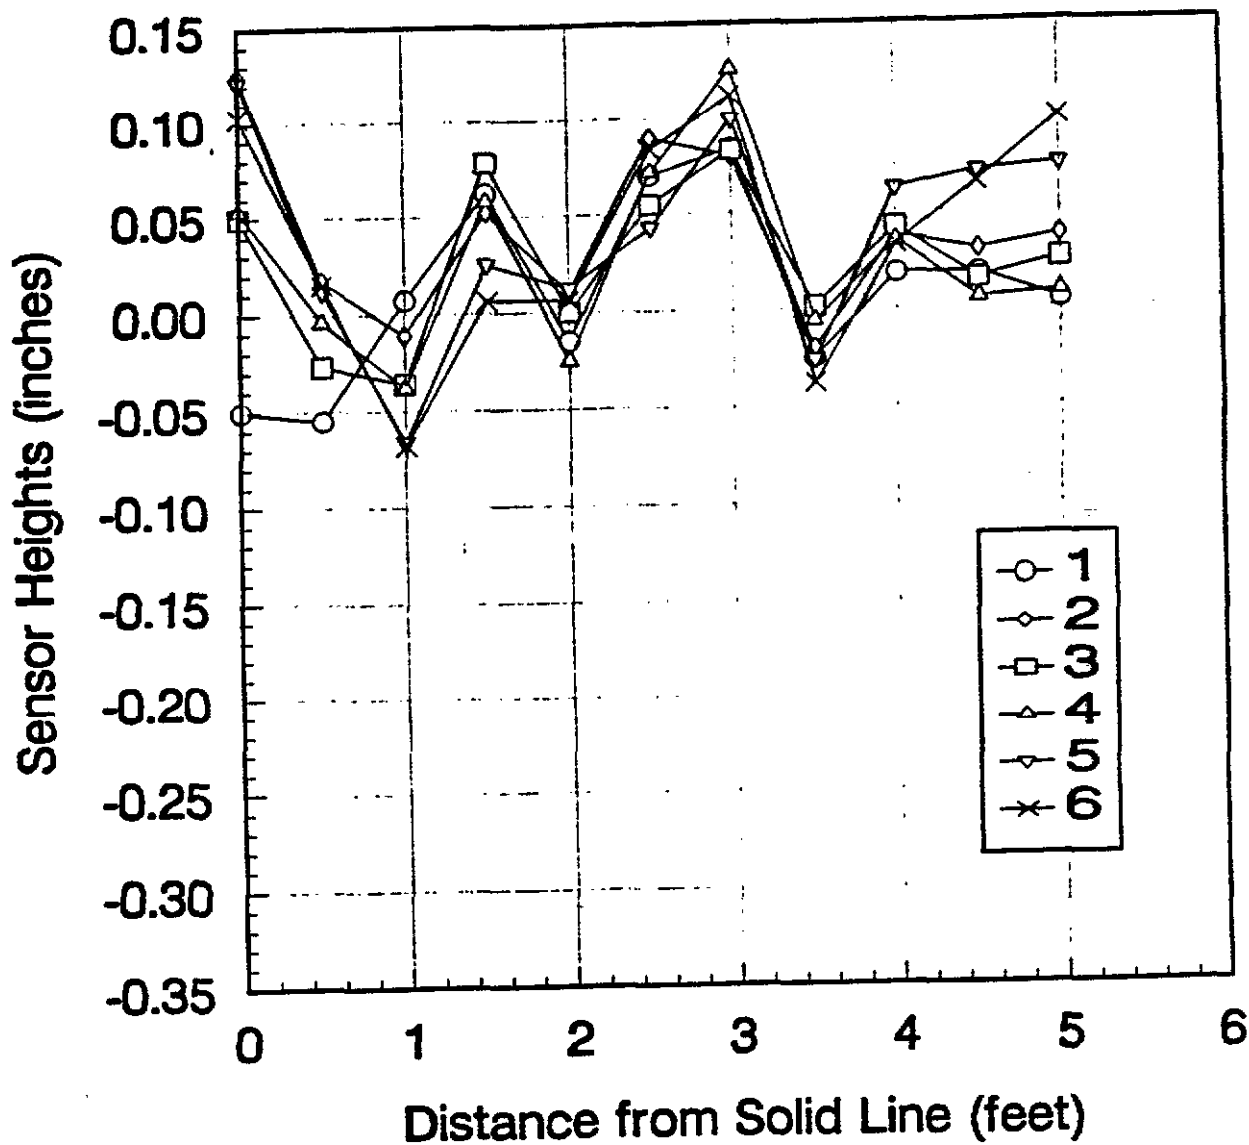
Figure 6. Peak Axle Sensor Profiles

The general axle sensor and loop installation procedures were followed. The slots were dried with compressed air, and the epoxy was cured under ambient conditions (no heaters were used). Three layers of duct tape were used along the top of the slot. A strip of duct tape was also used on the top of sensor; it was peeled off after the epoxy cured resulting in a clean sensor surface. The epoxy used was Traffic Coil. The axle sensors were pre-bent slightly to conform to the local rutting, and were installed using 4 leveling plates. The resulting sensor profiles in Figure 6 show that all of the sensors were close to, or above, the pavement surface level over most of their length. The worst case height variation for any sensor is 0.2 inches (sensor 4).

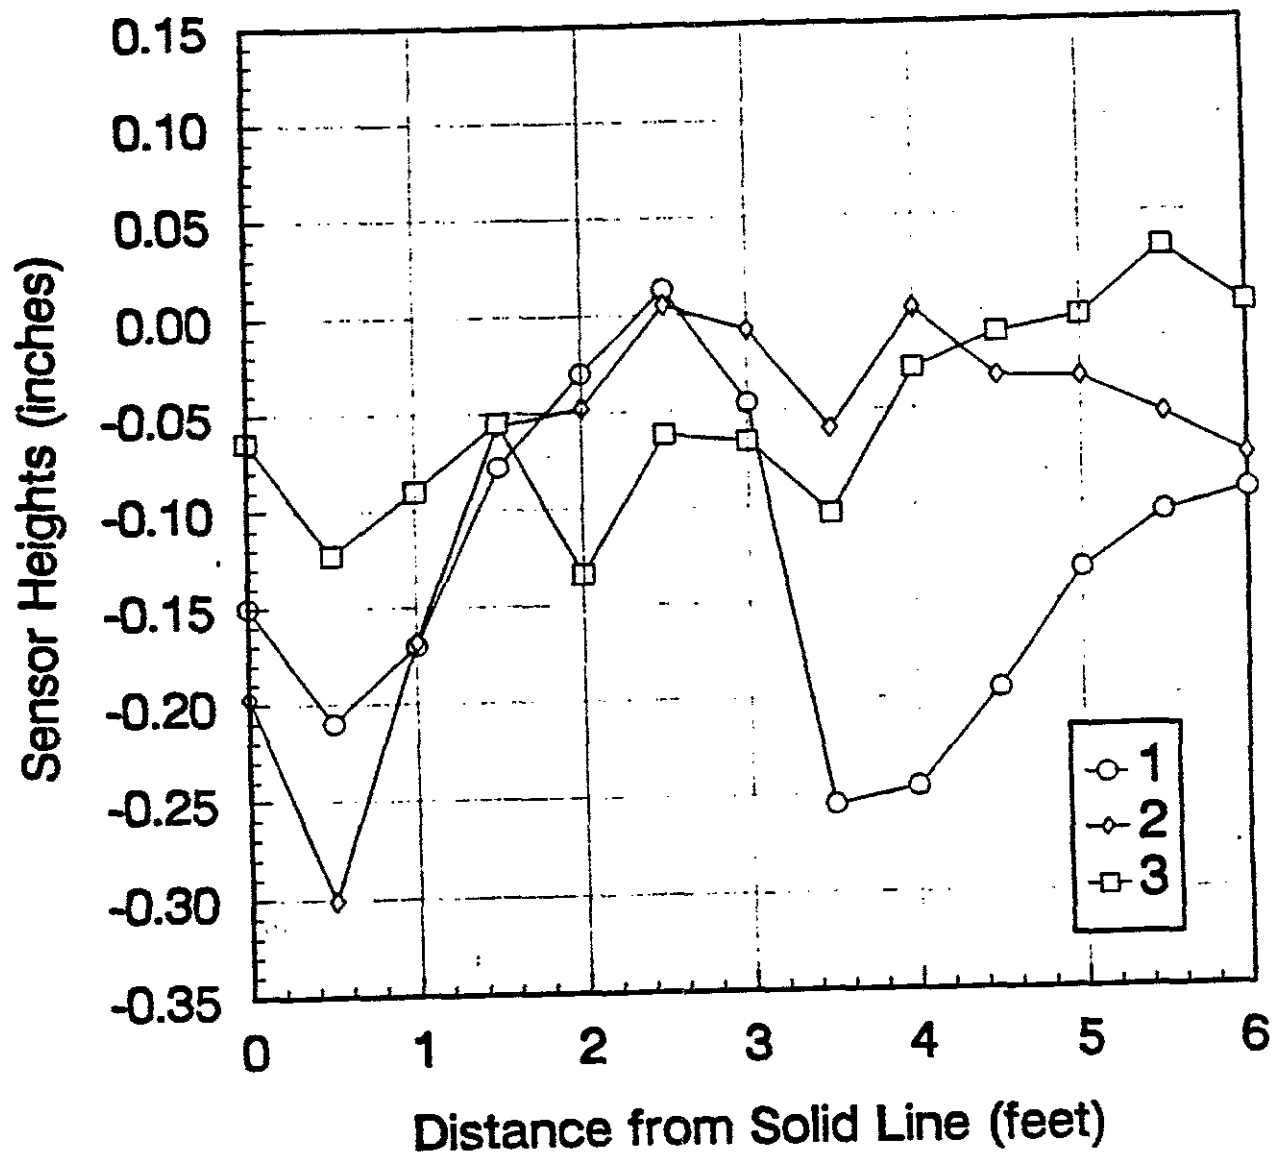
Figure 8. PAT Axle Sensor Profiles

The sensor profile in Figure 8 shows that the number one sensor is flush with the pavement in the wheelpath as intended, and is below the pavement everywhere else. The number two sensor is very low (-0.3 inches) near the solid line, but is near or only slightly below the pavement in the wheelpath and beyond. The number three sensor is at -0.05 to -0.13 inches from the solid line out to well beyond the wheelpath.

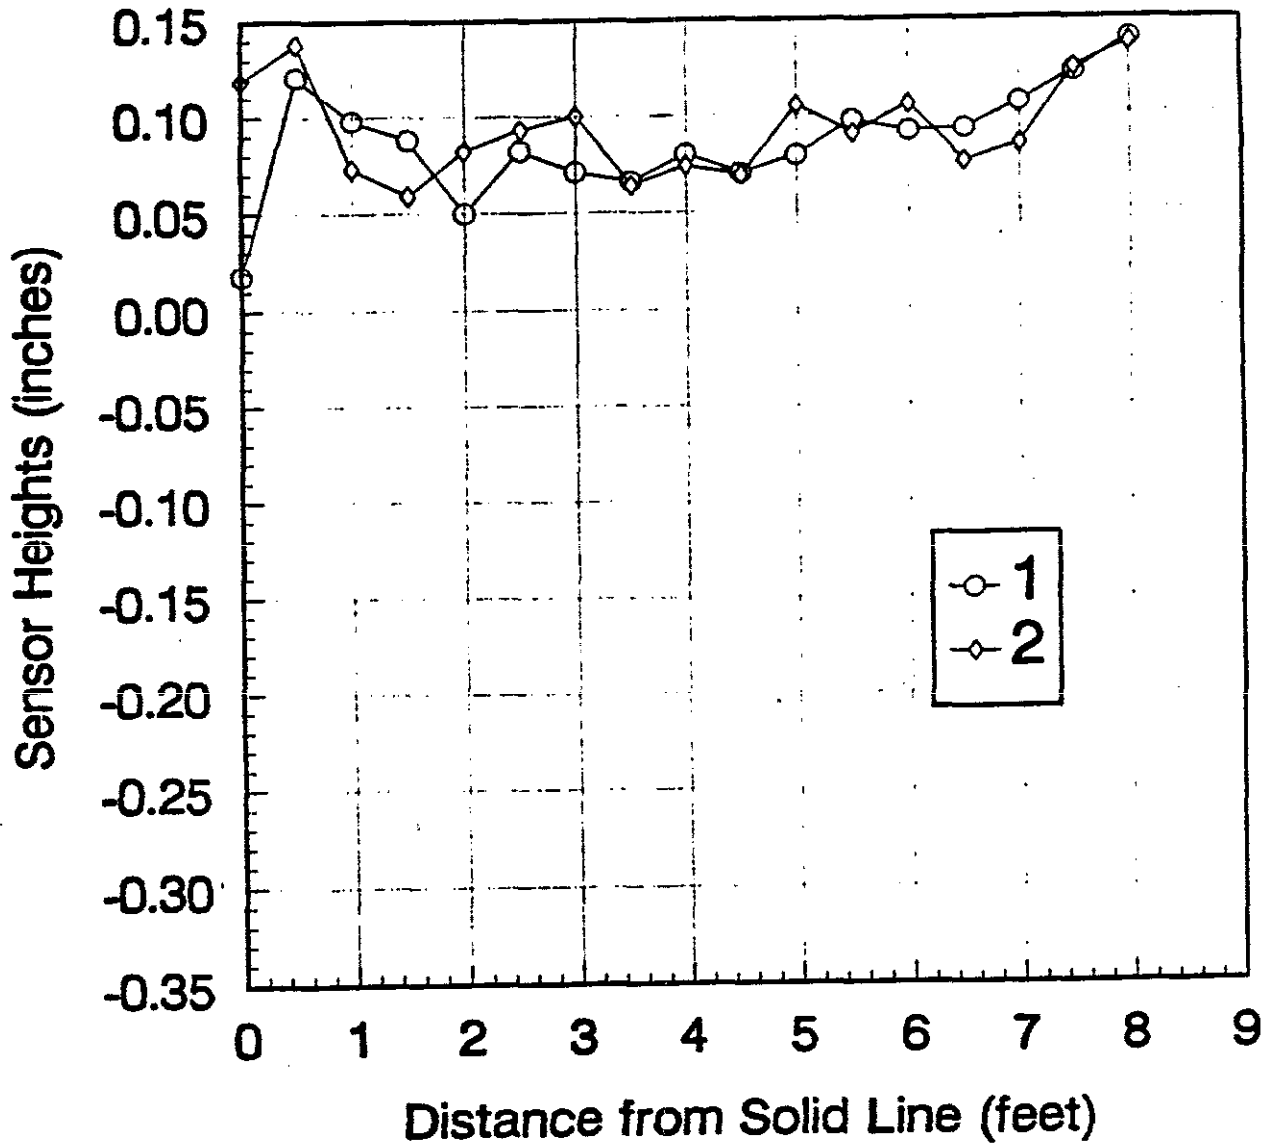
Figure 10. Mitron Axle Sensor Profiles

Initial tests of the axle sensor with oscilloscope indicated outputs slightly lower than desired by the vendor. The first set of elements were damaged by snow plows as well, and were replaced on 2/11/93. The replacement procedure involved removing the screws and pulling up the sensor element then installing a new one as before. The coax on one of the replacements was very difficult to feed through the conduit, which probably should have been a little larger.

evaluation. The installed sensor element profile in Figure 10 shows that the elements protrude above the channel slightly (+0.05 to +0.14 inches) and conform fairly well to the road surface.

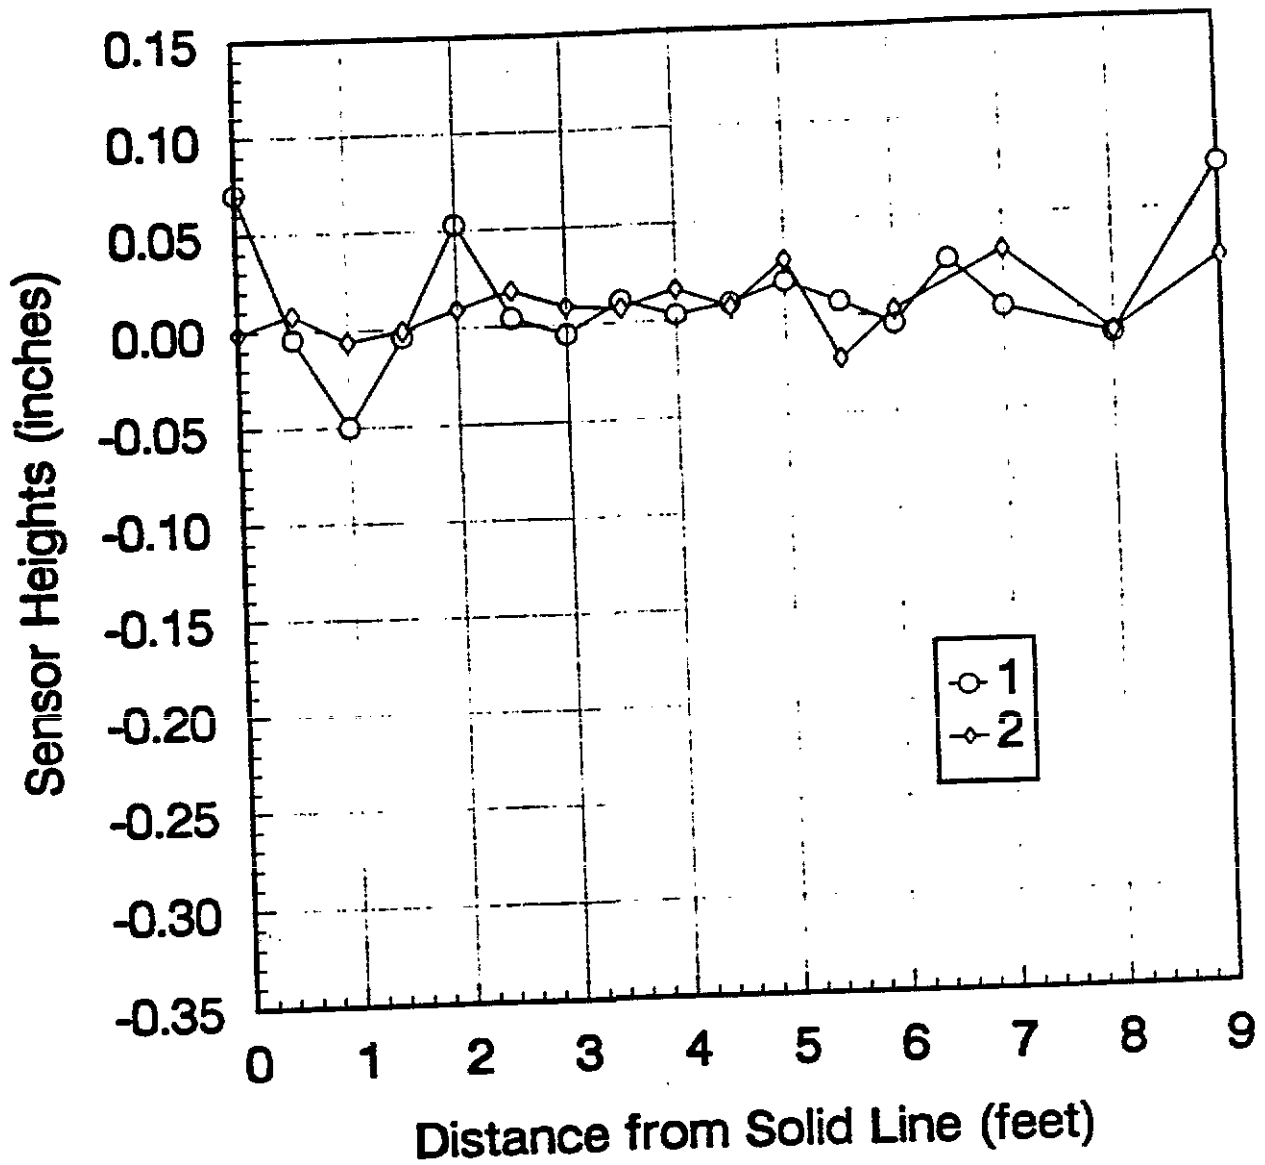
Figure 12. ECM Axle Sensor Profiles

The general axle sensor installation procedures were followed. The slots were cut one day, but because of the rain, the installation could not be completed. The slots were filled with sand and one turn of loop wire was installed in the loop cuts to protect them. The next day the loop wire was pulled from the cuts to clean out any debris, and the sand was cleaned out of the sensor slots. The slots were washed out, dried and preheated with torpedo heaters. Two layers of duct tape was used along the top of the slot. The epoxy used was ECM proprietary. The sensors were installed using 11 leveling plates, and since the sensors were flexible, good conformity to the rutting profile was achieved. Because of their flexibility, the sensors are always kept in an aluminum channel to protect them from bending and possible damage until they are installed. Sufficient epoxy was poured such that when the sensor was placed in the slot, epoxy was forced out. The epoxy was then smoothed with a putty knife. Weights were placed on the plates to hold the sensor in place until the epoxy starts to harden. The plates were then removed, and the epoxy was heated using torpedo heaters and a full length cardboard tunnel until completely cured. The installed sensor element profiles in Figure 12 show that these sensors are nearly level with the pavement and conform very well to the rutting.

Loop measurements indicated 139 microhenries and good stability. Initial tests of the axle sensors with an oscilloscope indicated outputs slightly lower than desired by the vendor and somewhat erratic for one sensor. The number one sensor frequently gave negative output voltages, low voltages, and occasionally missed axles completely. The number two sensor output was low but fairly consistent. Sensor number one was later replaced. The replacement procedure involved cutting the old sensor out with multiple passes of the asphalt saw. All of the sensor was removed and most of the old epoxy. The same installation procedure was used for the new sensor. The new sensor was slightly different in that it was manufactured with molded-in metallic strips to limit the flexibility and protect the sensor from bending damage.

After the sensor replacement, the classifier was functional but missed too many vehicle axles due to low sensor output levels. In order to get acceptable signals, strips of bituthane tape approximately one inch wide were placed over the entire length of both sensors. The classifier was then approved by the vendor for testing.
