# 11 Designing the Building Envelope

This chapter provides guidance on the design of the building envelope in the coastal environment.<sup>1</sup> The building envelope comprises exterior doors, windows, skylights, exterior wall coverings, soffits, roof systems, and attic vents. In buildings elevated on open foundations, the floor is also considered a part of the envelope.

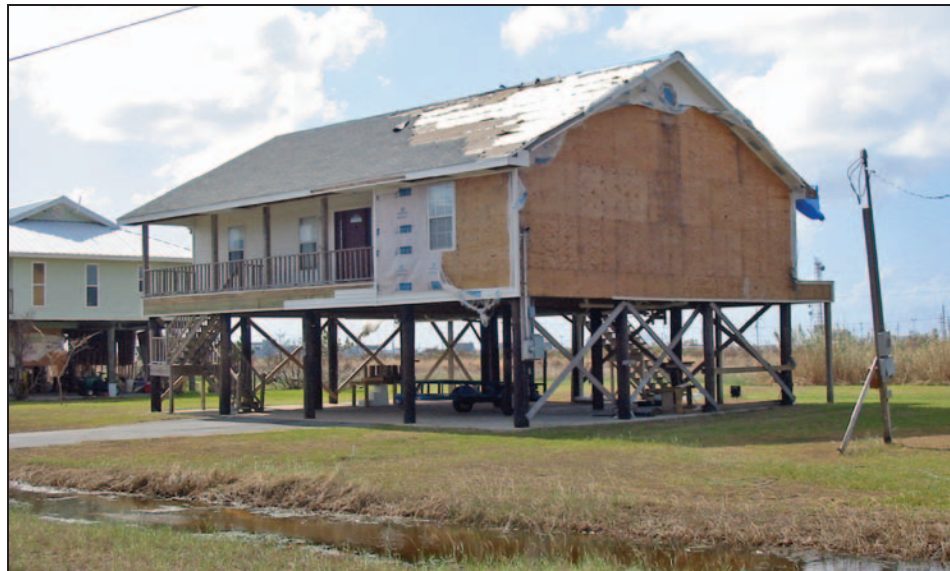
The predominant cause of damage to buildings and their contents during high-wind events has been shown to be breaching of the building envelope, as shown in Figure 11-1, and subsequent water infiltration. Breaching includes catastrophic failure (e.g., loss of the roof covering or windows) and is often followed by wind-driven water infiltration through small openings at doors, windows, and walls. The loss of roof and wall coverings and soffits on the house in Figure 11-1 resulted in significant interior water damage. Recommendations for avoiding breaching are provided in this chapter.

**Figure 11-1.**  
Good structural system performance but the loss of shingles, underlayment, siding, housewrap, and soffits resulted in significant interior water damage. Estimated wind speed: 125 mph.<sup>3</sup> Hurricane Katrina (Louisiana, 2005)

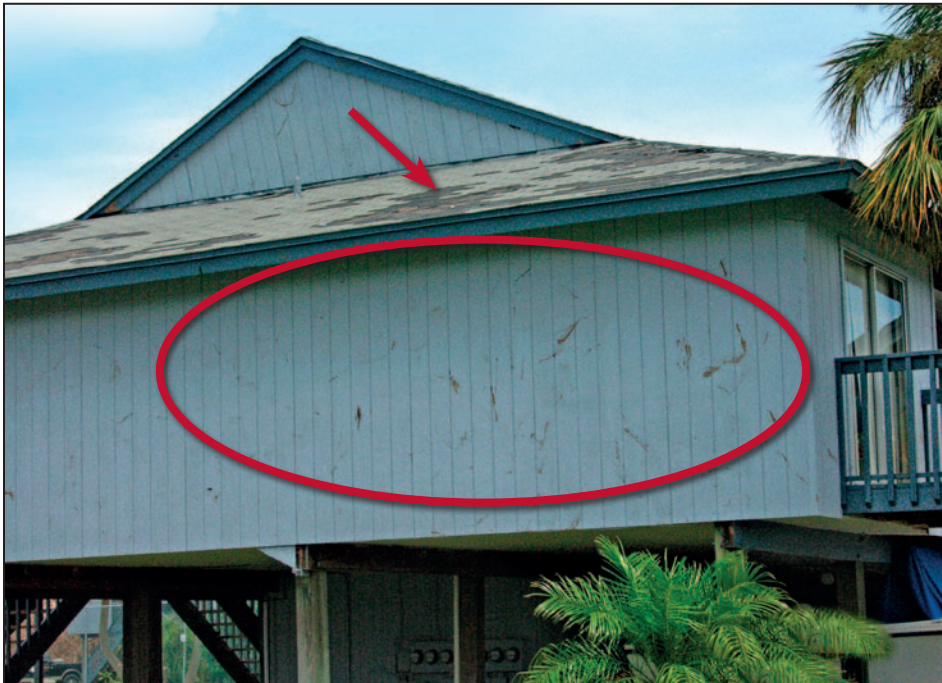
**Figure 11-2.** Numerous wind-borne debris scars on the wall of this house and several missing asphalt shingles. Estimated wind speed: 140 to 150 mph. Hurricane Charley (Florida, 2004)

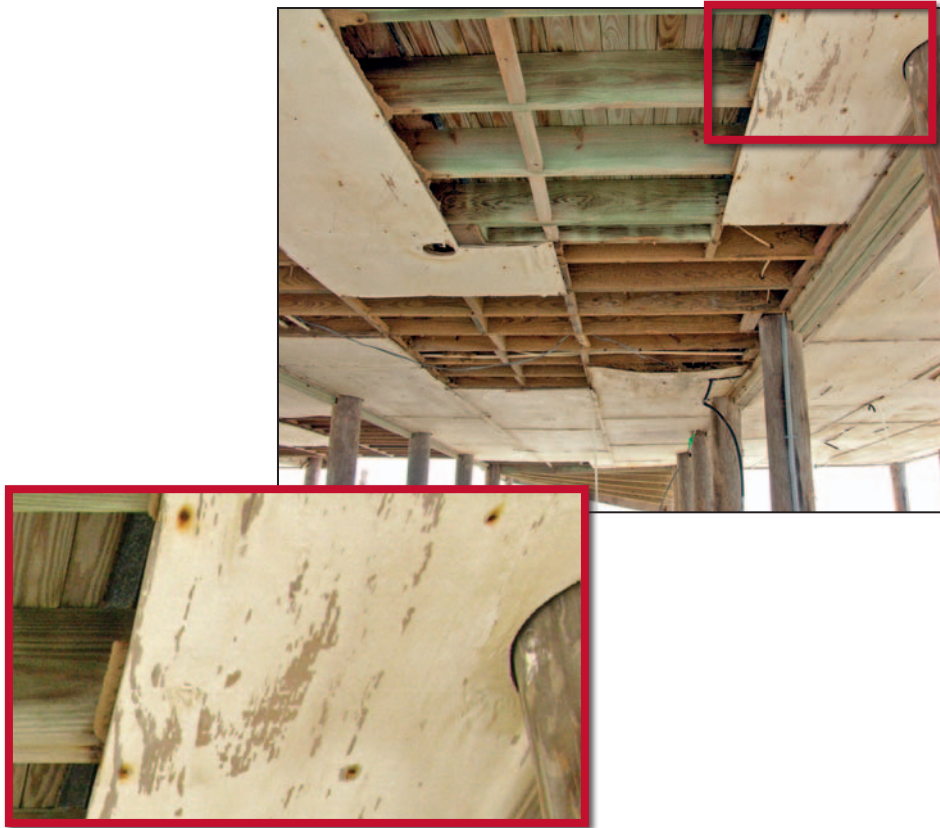
Figure 11-4. Plywood panels on the underside of a house that blew away because of excessive nail spacing. Note the corroded nails (inset). Estimated wind speed: 105 to 115 mph. Hurricane Ivan (Alabama, 2004)

To achieve good long-term performance, exterior grade plywood attached with stainless steel or hot-dip galvanized nails or screws is recommended (see the corroded nails in Figure 11-4).

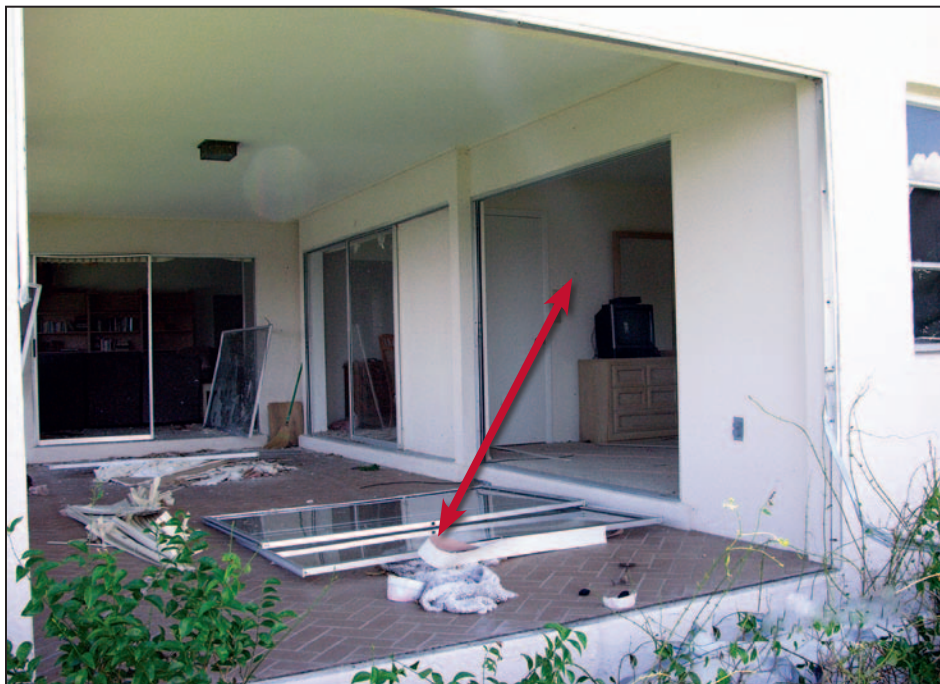
Figure 11-5. Sliding glass doors pulled out of their tracks by wind suction. Estimated wind speed: 140 to 160 mph. Hurricane Charley (Florida, 2004)

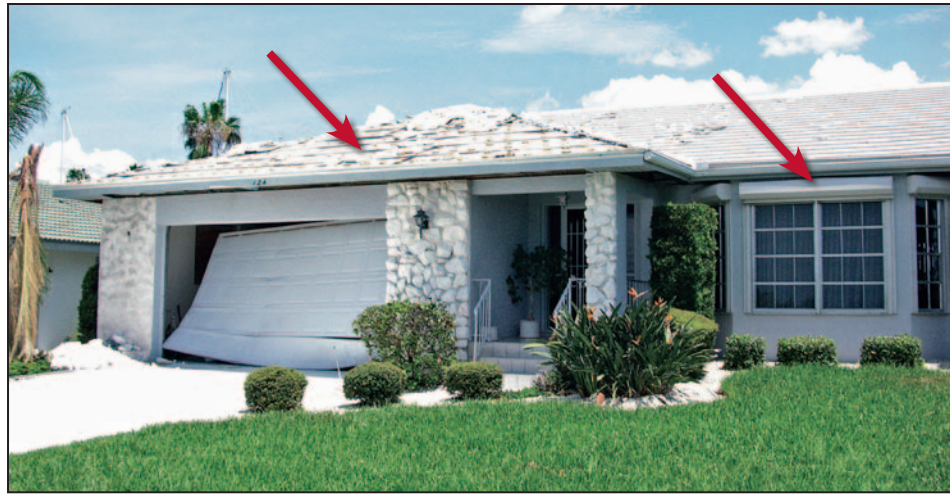
**Figure 11-6.** Garage door blown from its track as a result of positive pressure. Note the damage to the adhesive-set tiles (left arrow; see Section 11.5.4.1). This house was equipped with roll-up shutters (right arrow; see Section 11.3.1.2). Estimated wind speed: 140 to 160 mph. Hurricane Charley (Florida, 2004)

It is recommended that design professionals specify that garage doors comply with wind load testing in accordance with ANSI/DASMA 108. For garage doors attached to wood nailers, design professionals should also specify the attachment of the nailer to the wall.

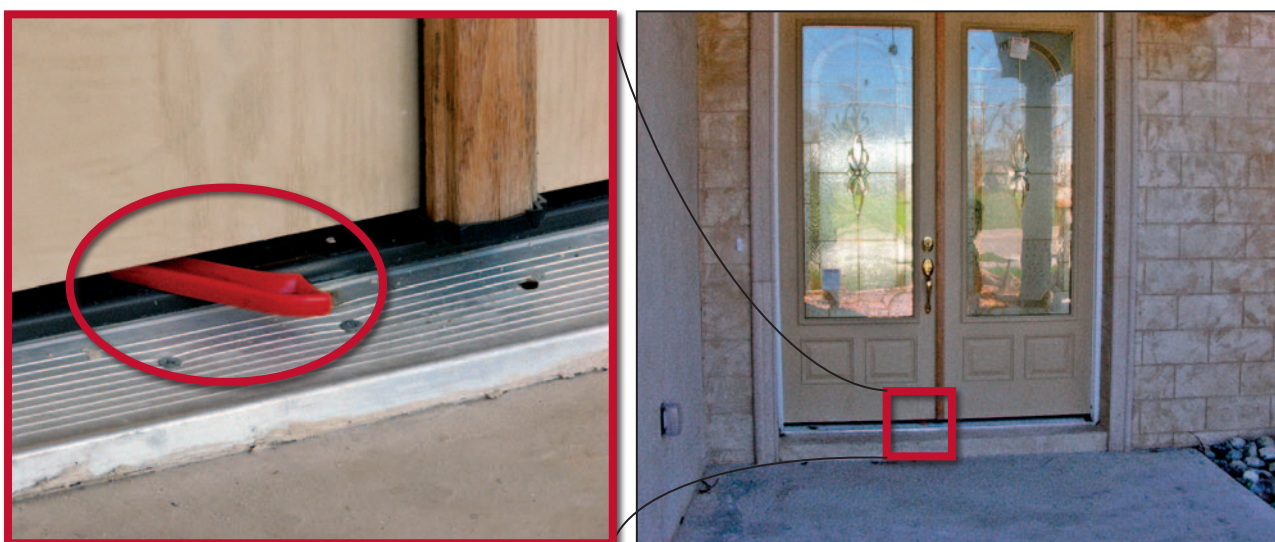
Figure 11-7.

Figure 11-7 shows a pair of doors that successfully resisted winds that were estimated at between 140 and 160 mph. However, as shown in the inset, a gap of about 3/8 inch between the threshold and the bottom of the door allowed a significant amount of water to be blown into the house. The weatherstripping and thresholds shown in Fact Sheet 6.1 in FEMA P-499 can minimize water entry.

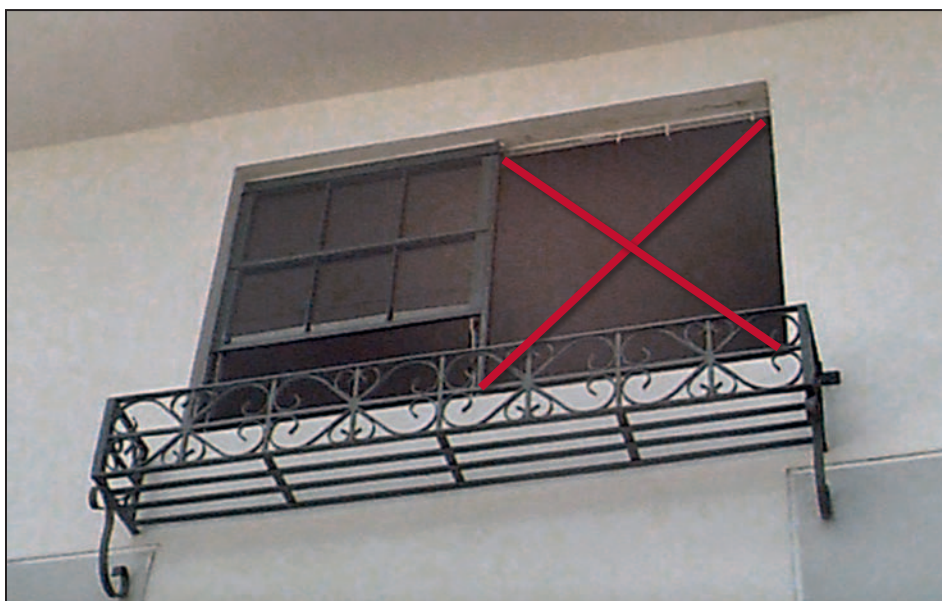
**Figure 11-8.** Window frame pulled out of the wall because of inadequate window frame attachment. Hurricane Georges (Puerto Rico, 1998)

windows and skylights comply with wind load testing in accordance with ASTM E1233. ASTM E1233 is the recommended test method in high-wind areas because it is a cyclic test method, whereas ASTM E330 is a static test. The cyclical test method is more representative of loading conditions in high-wind areas than ASTM E330. Design professionals should also specify the attachment of the window and skylight frames to the wall and roof curb (e.g., type, size, spacing, edge distance of frame fasteners). Curb attachment to the roof deck should also be specified.

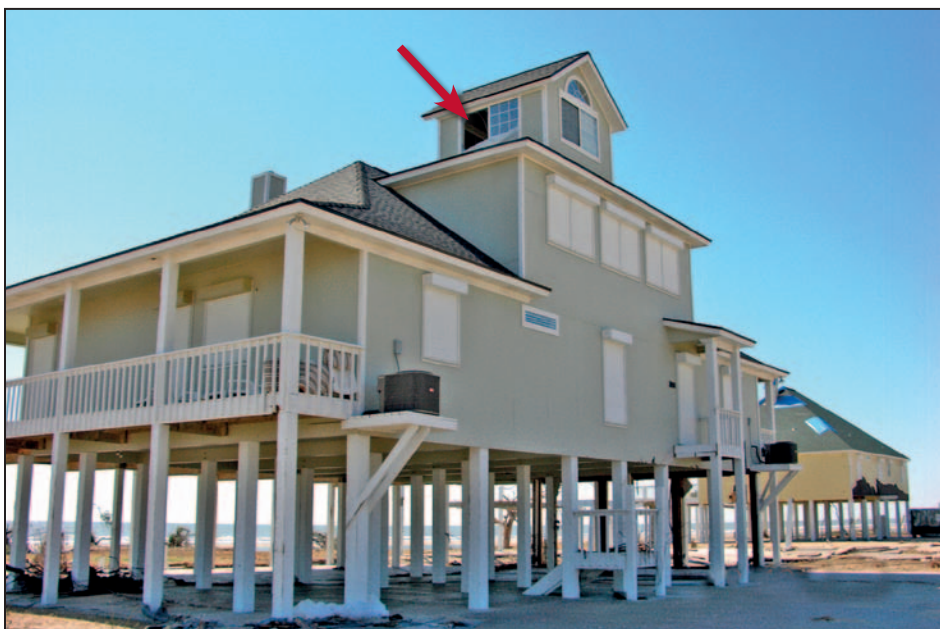
**Figure 11-10.**  
Unprotected cupola  
window that was broken.  
Estimated wind speed:  
110 mph. Hurricane Ike  
(Texas, 2008)

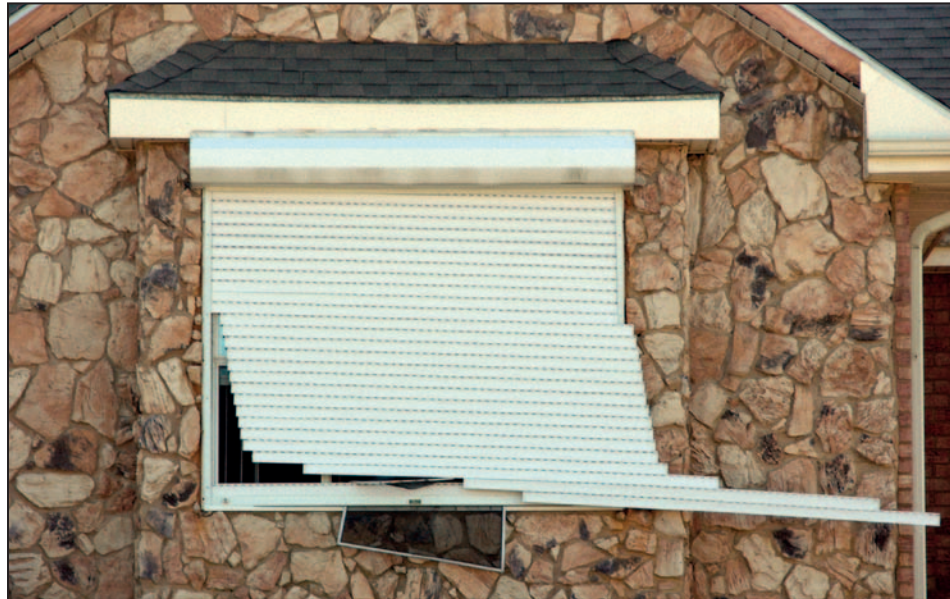
**Figure 11-12.**  
Roll-up shutter slats that detached from the tracks. The lack of a label makes it unclear whether the shutter was tested in accordance with a recognized method. Estimated wind speed: 110 mph. Hurricane Katrina (Louisiana, 2005)

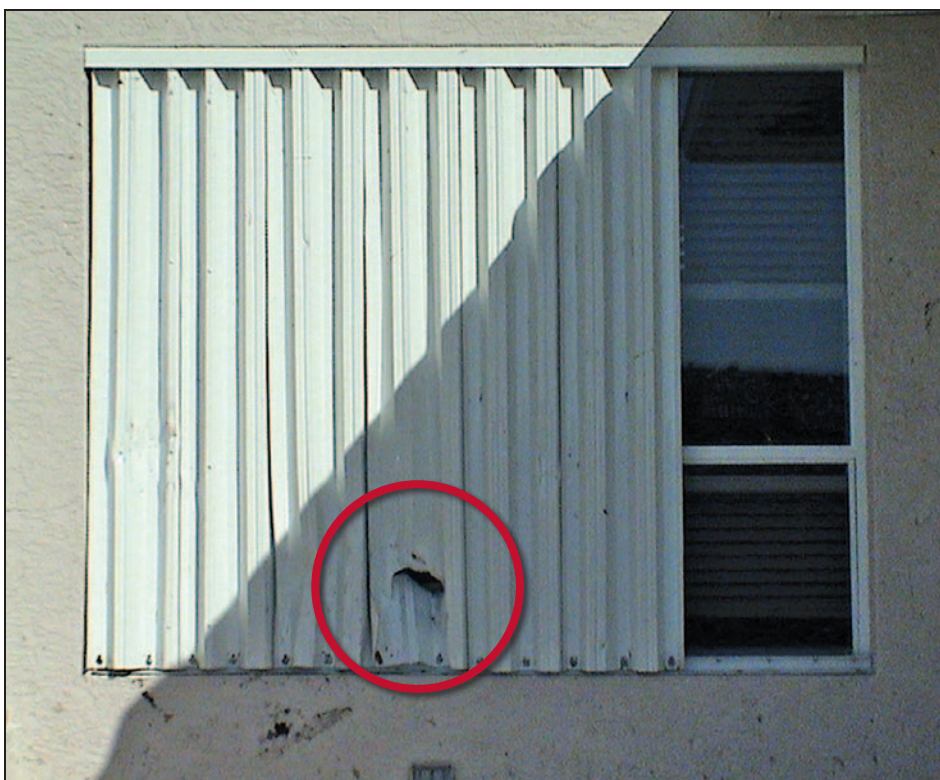
Figure 11-13.  
Shutter punctured by  
roof tile. Estimated  
wind speed: 140 to 160  
mph. Hurricane Charley  
(Florida, 2004)

Residential glazing in wind-borne debris regions is required to resist the test missile C or D, depending on the basic wind speed. However, field investigations have shown that roof tile can penetrate shutters that comply with test missile D (see Figure 11-13). Laboratory research conducted at the University of Florida indicates that test missile D compliant shutters do not provide adequate protection against tile debris (Fernandez et al. 2010). Accordingly, if tile roofs occur within 100 to 200 feet (depending on basic wind speed), it is recommended that shutters complying with test missile E be specified.

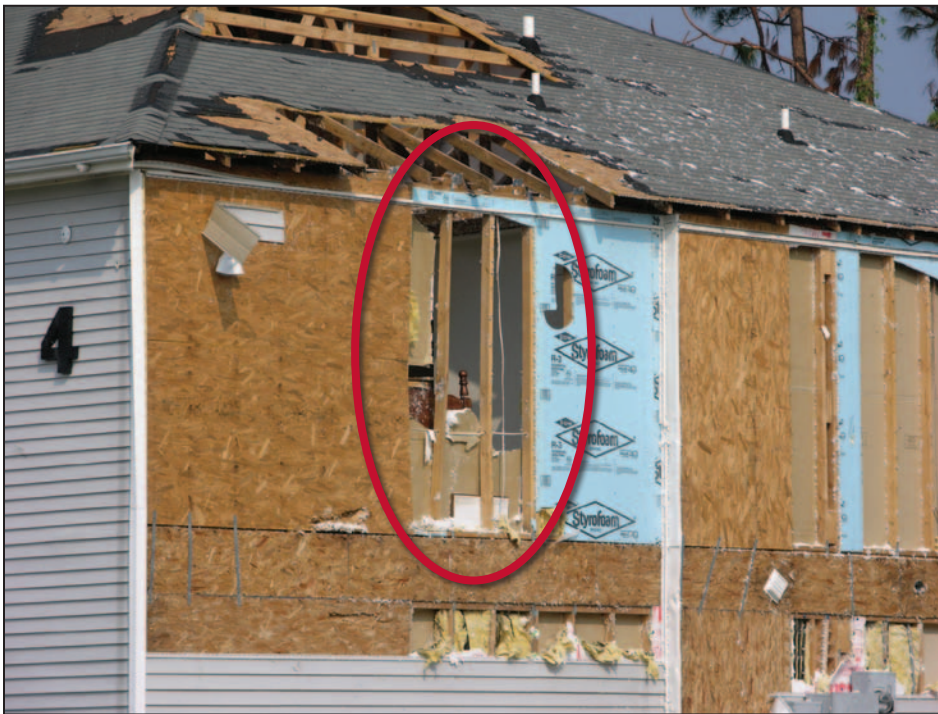
**Figure 11-15.** Blown-off vinyl siding and foam sheathing; some blow-off of interior gypsum board (circle). Estimated wind speed: 130 mph. Hurricane Katrina (Mississippi, 2006)

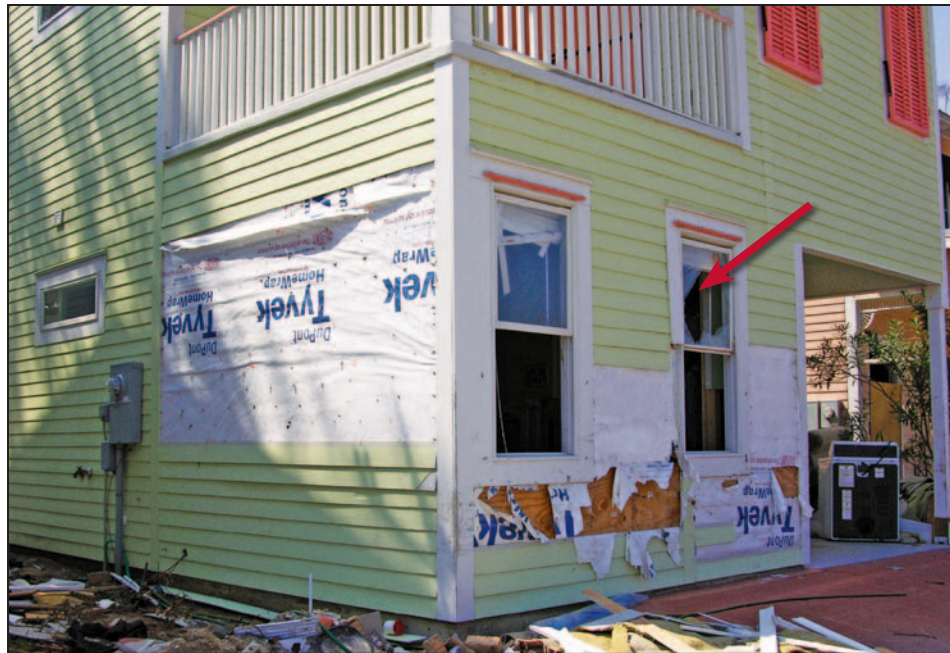
Figure 11-16.  
Blown-off fiber cement siding; broken window (arrow). Estimated wind speed: 125 mph. Hurricane Katrina (Mississippi, 2006)

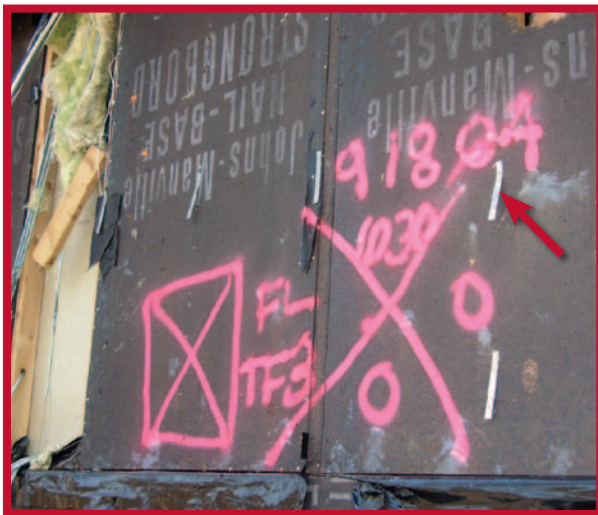
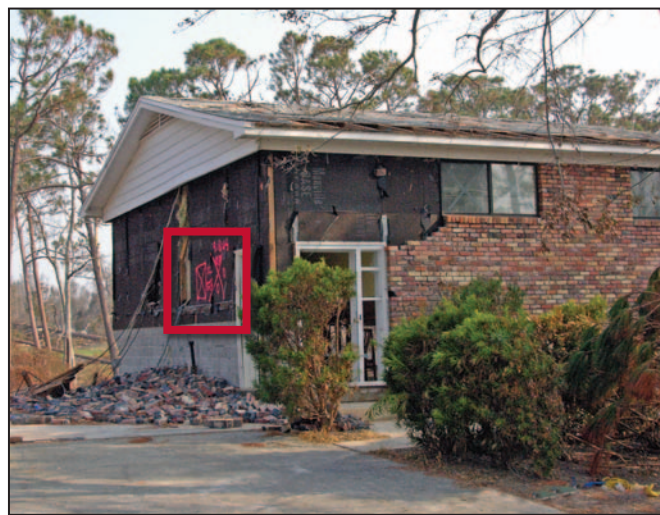
Figure 11-17.  
Four brick veneer failure modes; five corrugated ties that were not embedded in the mortar joints (inset). Hurricane Ivan (Florida, 2004)

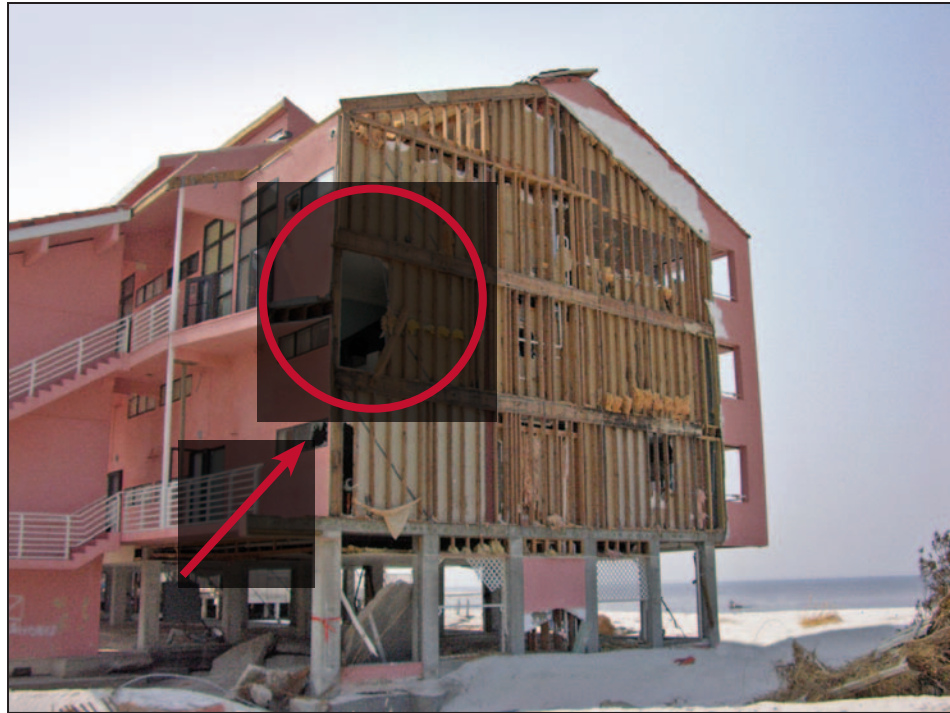
Figure 11-19. Blown-off EIFS, resulting in extensive interior water damage; detachment of the gypsum board or stud blow off (circle); two windows broken by debris (arrow). Estimated wind speed: 105 to 115 mph. Hurricane Ivan (Florida, 2004)

Several of the studs shown in Figure 11-19 were severely rotted, indicating long-term moisture intrusion behind the MEPS insulation. The residence shown in Figure 11-19 had a barrier EIFS design, rather than the newer drainable EIFS design (for another example of a barrier EIFS design, see Figure 11-21). EIFS should be designed with a drainage system that allows for dissipation of water leaks.

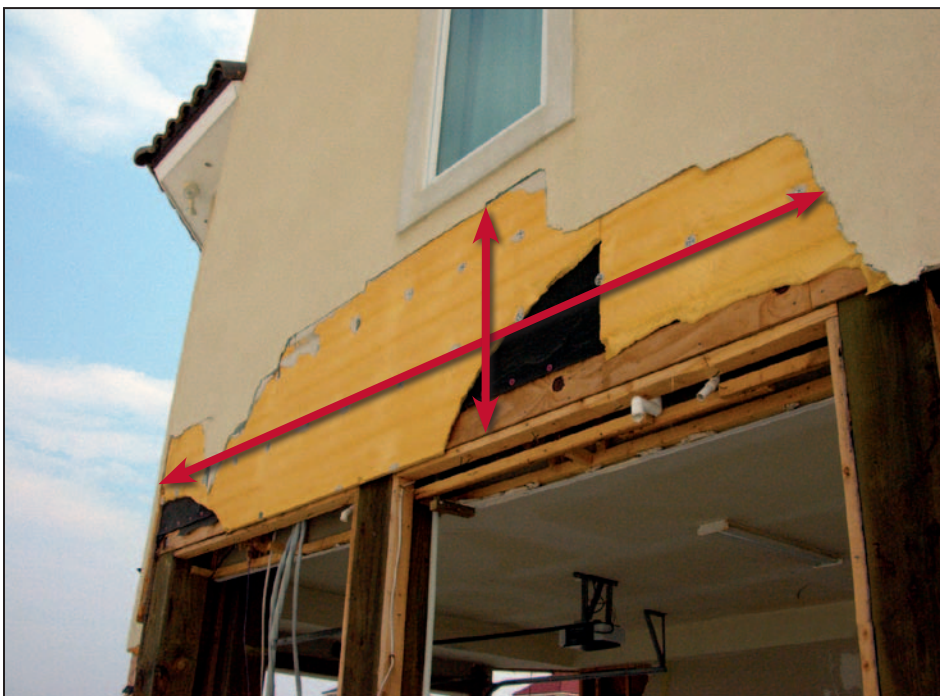
At the house shown in Figure 11-20, floodwater collapsed the breakaway wall and initiated progressive peeling of the EIFS wall covering. A suitable flashing at the top of the breakaway wall would have avoided the progressive failure. When a wall covering progressively fails above the top of a breakaway wall, wave spray and/or wind-driven water may cause interior damage.

**Figure 11-20.** Collapse of the breakaway wall, resulting in EIFS peeling. A suitable transition detail at the top of breakaway walls avoids the type of peeling damage shown by the arrows. Estimated wind speed: 105 to 115 mph. Hurricane Ivan (Alabama, 2004)

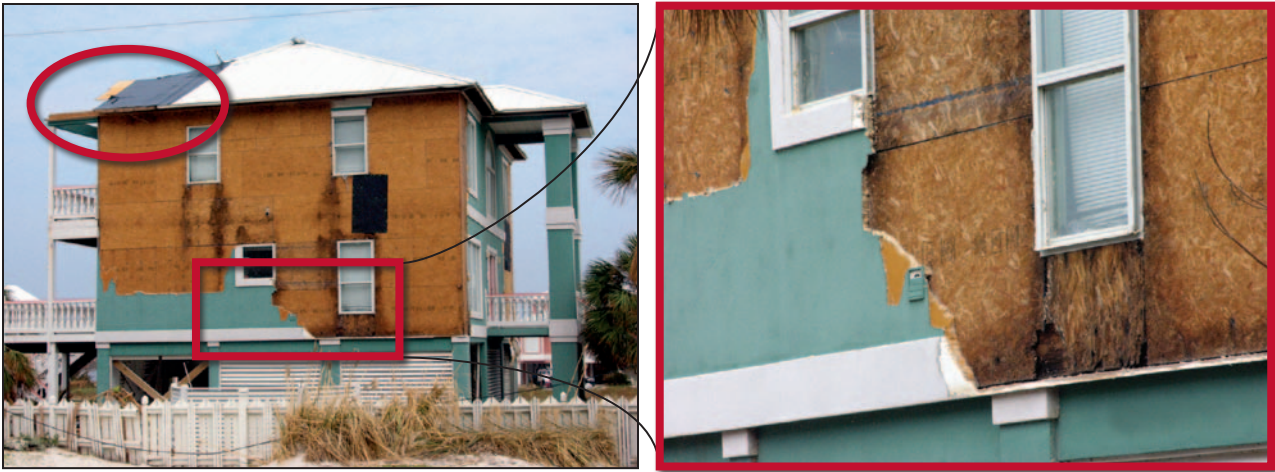
Figure 11-21.  
EIFS with a barrier design: blown-off roof decking (top circle); severely rotted OSB due to leakage at windows (inset). Hurricane Ivan (2004)

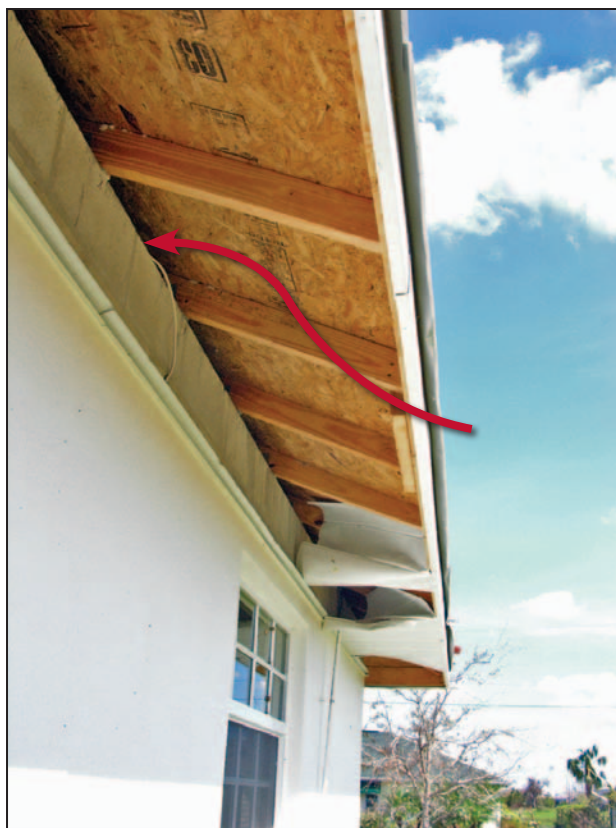
Figure 11-22. Blown-away soffit (arrow), which allowed wind-driven rain to enter the attic. Estimated wind speed: 140 to 160 mph. Hurricane Charley (Florida, 2004)

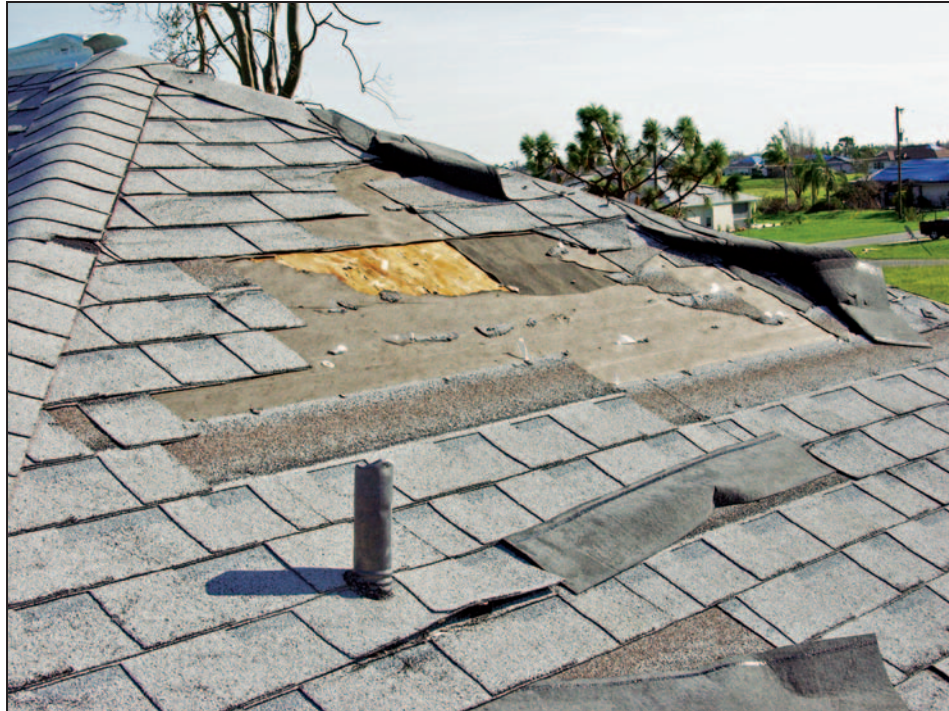
Figure 11-25.  
Typical underlayment  
attachment;  
underlayment blow-off is  
common if the shingles  
are blown off, as shown.  
Estimated wind speed:  
115 mph. Hurricane  
Katrina (Louisiana, 2005)

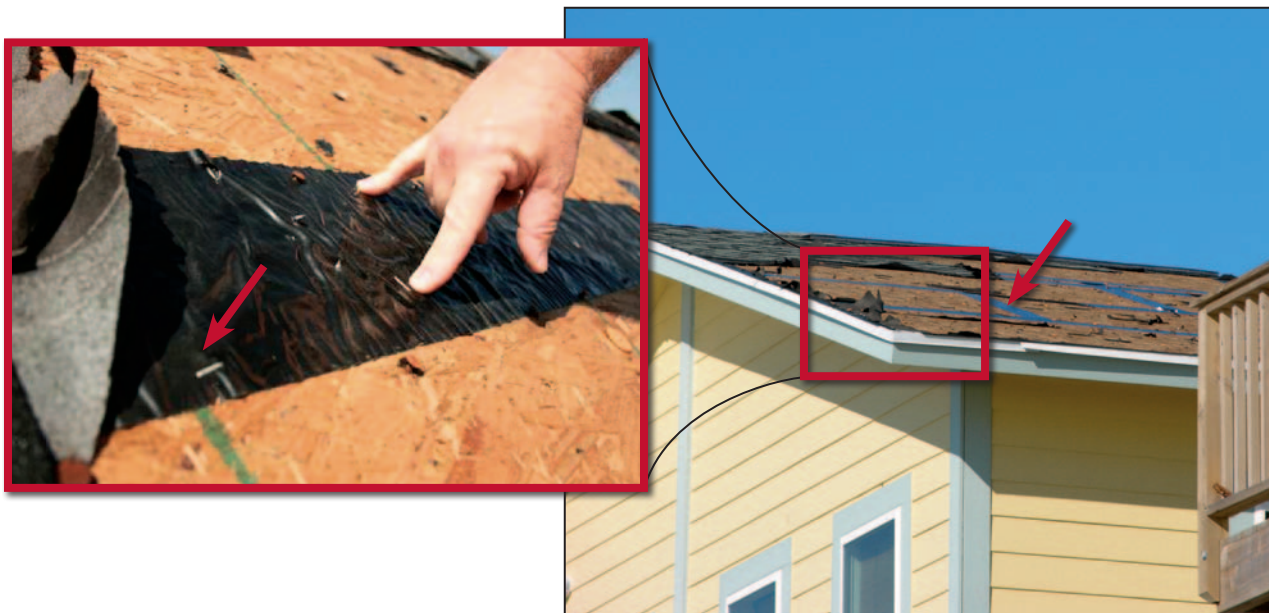
**Figure 11-28.** House that used enhanced underlayment Option 3 with taped sheathing joints (arrow). The self-adhering modified bitumen tape (inset) was stapled because of bonding problems. Estimated wind speed: 110 mph. Hurricane Ike (Texas, 2008)

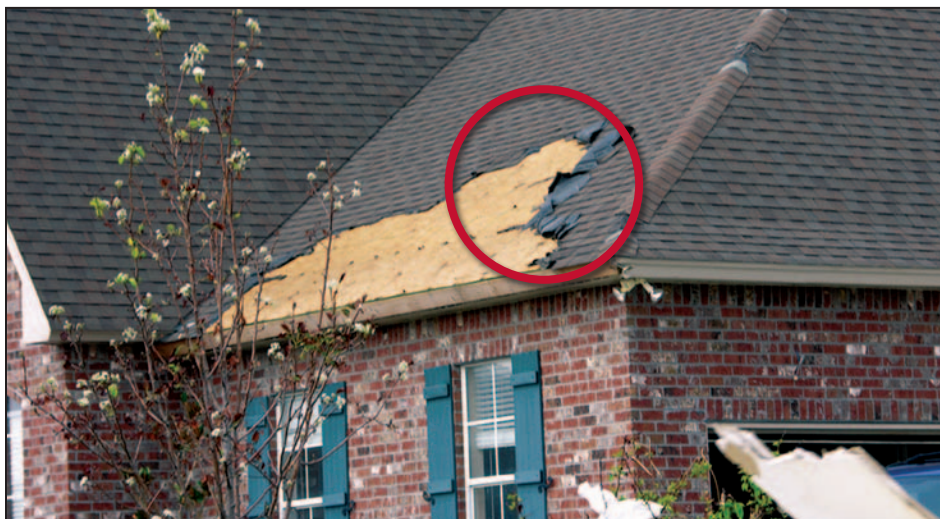
Figure 11-30. Loss of shingles and underlayment along the eave and loss of a few hip shingles. Estimated wind speed: 115 mph. Hurricane Katrina (Louisiana, 2005)

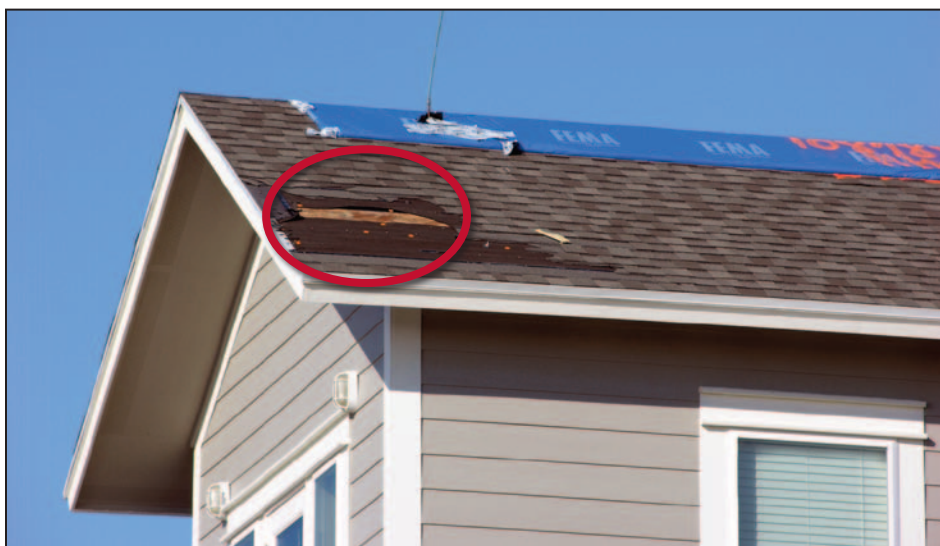
Figure 11-31. Loss of shingles and underlayment along the rake. Estimated wind speed: 110 mph. Hurricane Ike (Texas, 2008)

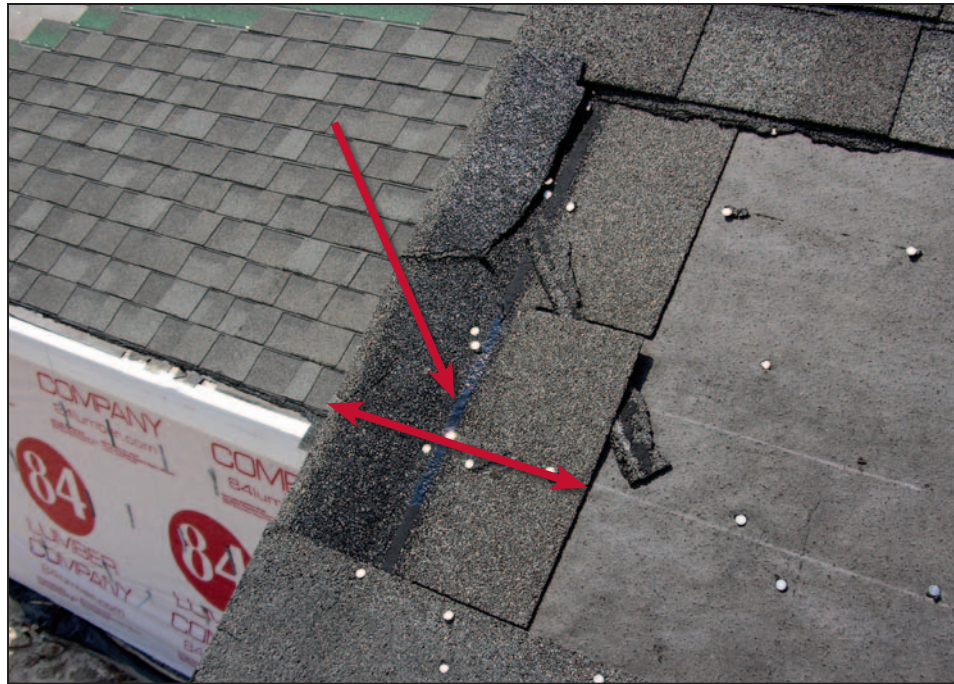
Figure 11-35.  
Inadequate sealing of the self-sealing adhesive at a hip as a result of the typical hip installation procedure. Estimated wind speed: 105 mph. Hurricane Katrina (Mississippi, 2005)

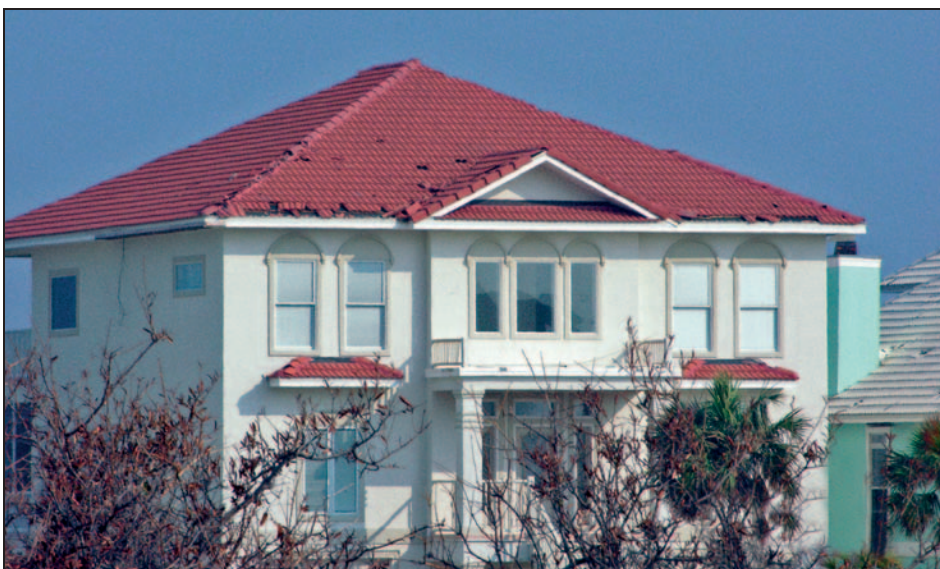
Figure 11-39.  
Blow-off of eave and hip tiles and some broken tiles in the field of the roof. Hurricane Ivan (Alabama, 2004)

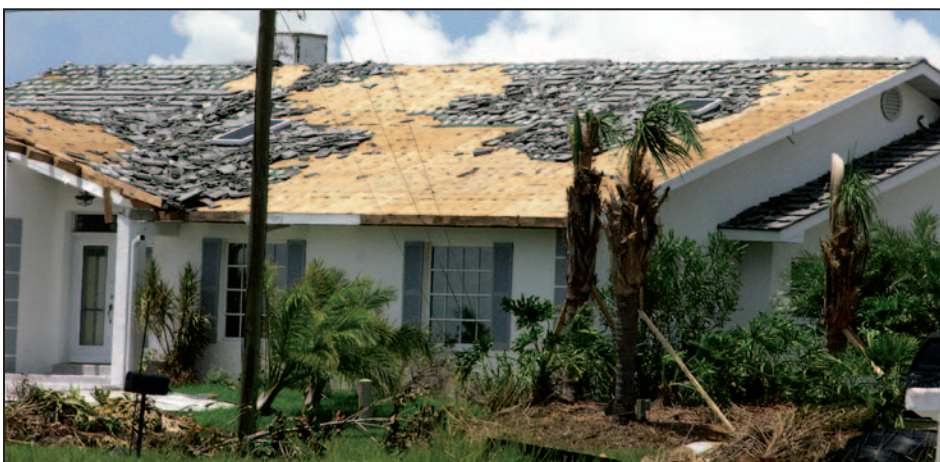
Figure 11-40.  
Large area of blown-off underlayment on a mortar-set tile roof. The atypical loss of waterproofing tile underlayment resulted in substantial water leakage into the house. Estimated wind speed: 140 to 160 mph. Hurricane Charley (Florida, 2004)

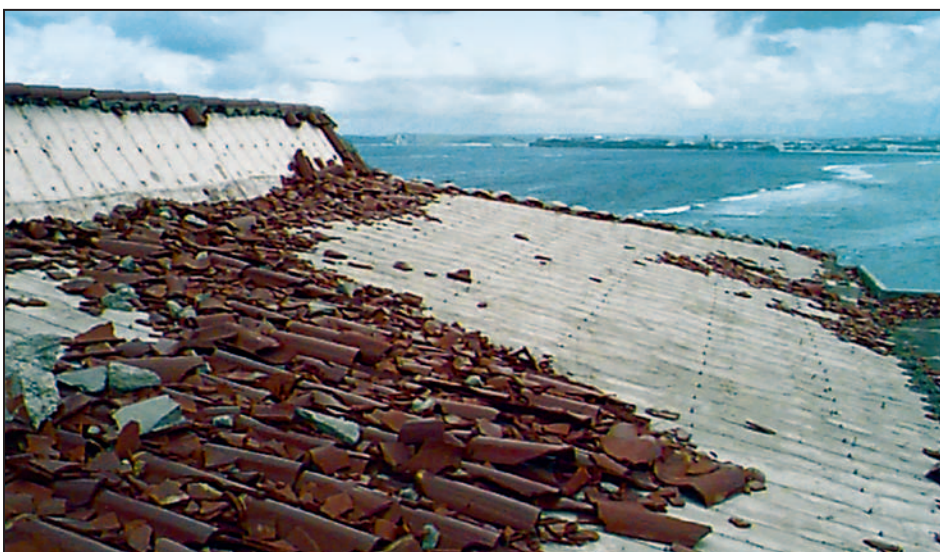
Figure 11-41.  
Blow-off of wire-tied tiles installed over a concrete deck. Typhoon Paka (Guam, 1997)

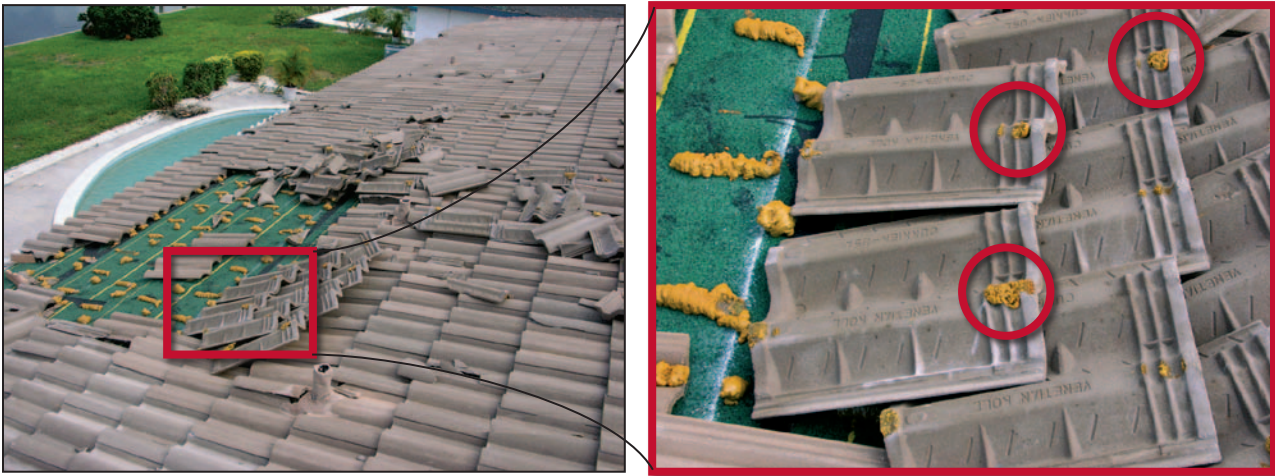
Figure 11-43.  
Blown-off adhesive-set tile. Note the very small contact area of the foam at the tile heads (left side of the tiles) and very small contact at the nose (circles). Estimated wind speed: 140 to 160 mph. Hurricane Charley (Florida, 2004)

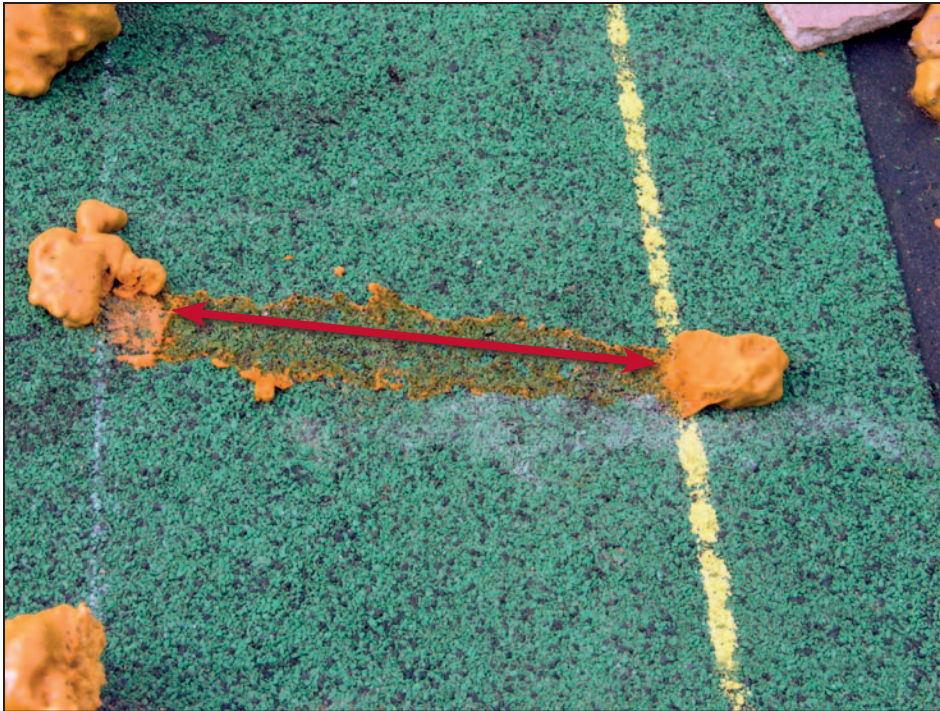
Figure 11-44.  
Adhesive that debonded  
from the cap sheet

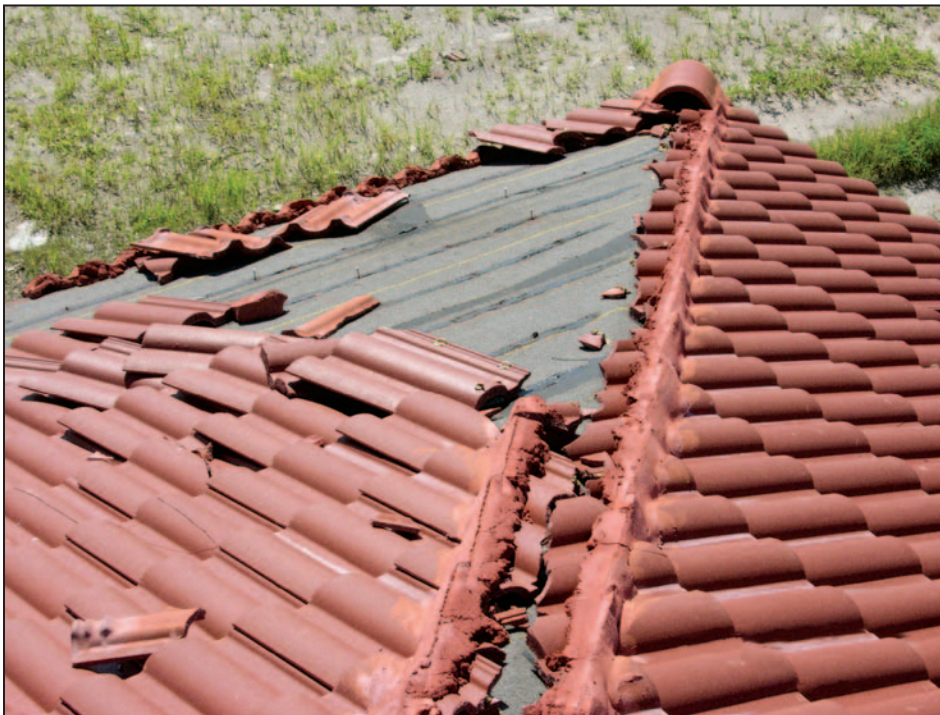
Figure 11-45.  
Blow-off of mechanically  
attached tiles. Estimated  
wind speed: 140 to 160  
mph. Hurricane Charley  
(Florida, 2004)

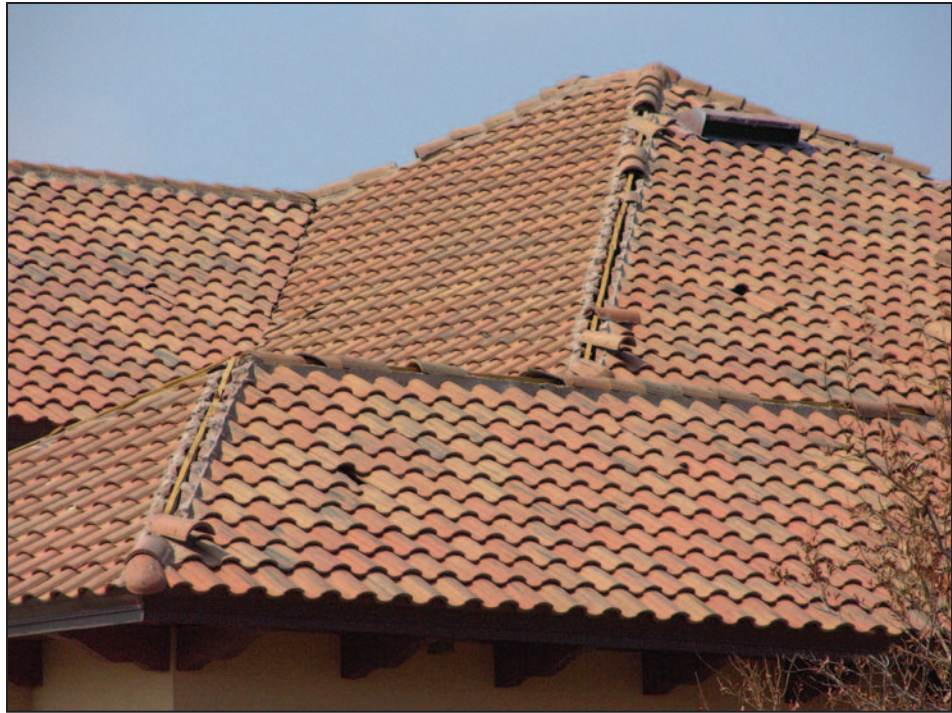
Figure 11-47.  
Damage to field tiles  
caused by tiles from  
another area of the  
roof, including a hip  
tile (circle). Estimated  
wind speed: 140 to 160  
mph. Hurricane Charley  
(Florida, 2004)

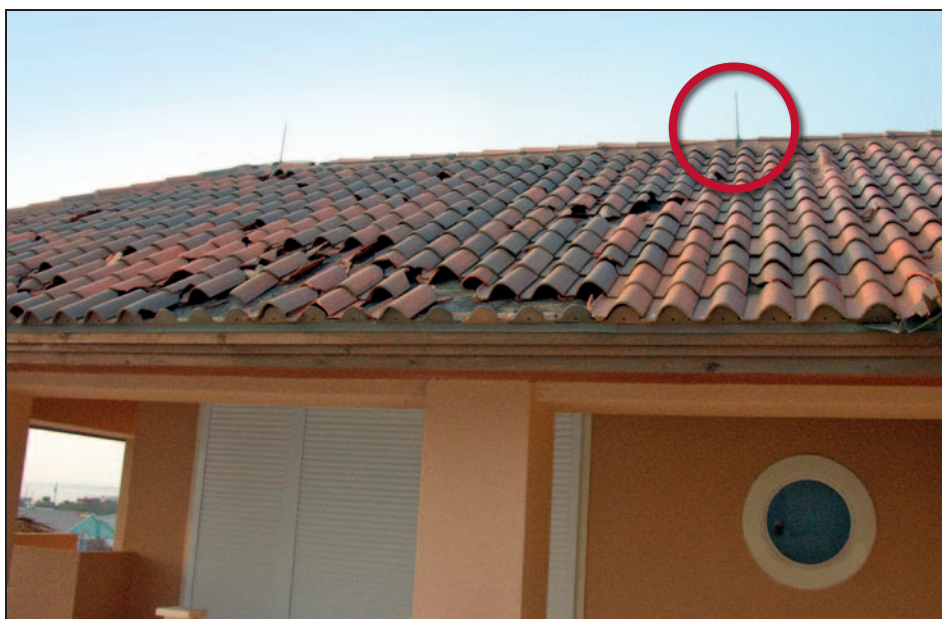
The house in Figure 11-48 had a lightning protection system (LPS), and the LPS conductors were placed under the ridge tile. Conductors are not susceptible to wind damage if they are placed under the tile and the air terminals (lightning rods) are extended through the ridge.

**Figure 11-48.**  
The fastener heads on this mechanically attached tile roof had corroded; air terminals (lightning rods) in a lightning protection system (circle). Hurricane Ivan (Alabama, 2004)

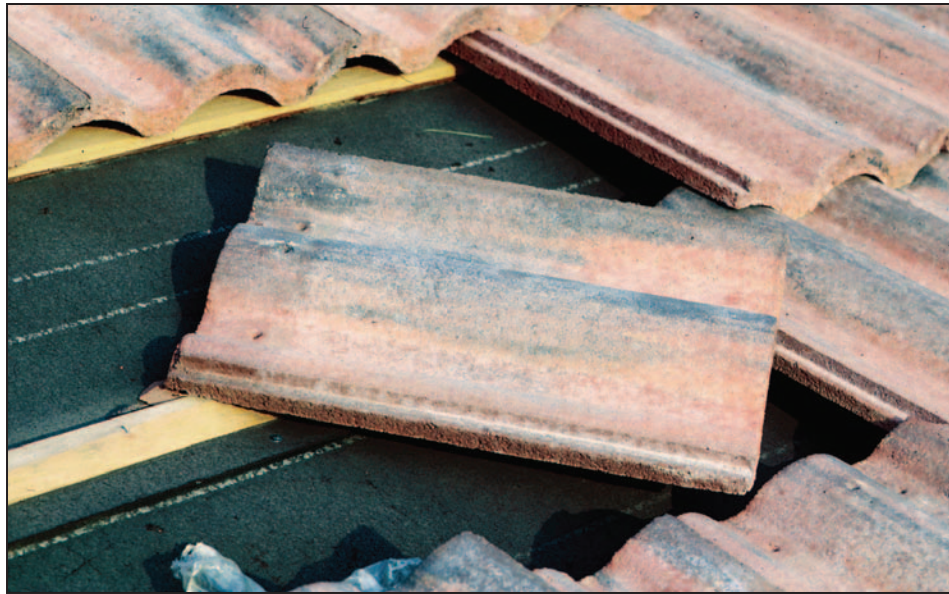
Figure 11-50.  
Tiles that were nailed  
to thin wood sheathing.  
Northridge Earthquake  
(California, 1994)

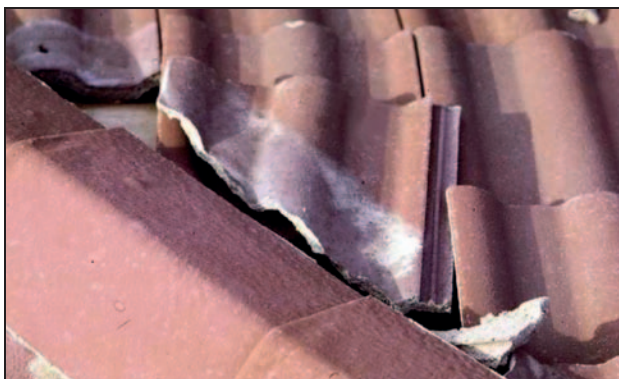
Figure 11-51.  
Tile that slipped out from under the hip tiles.  
Northridge Earthquake (California, 1994)

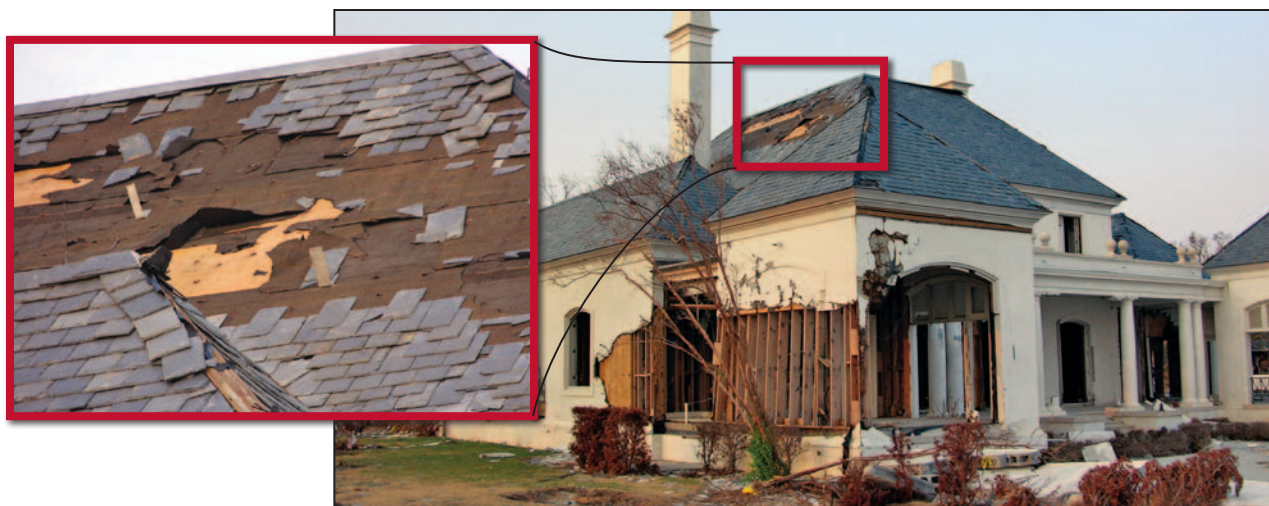
**Figure 11-53.**  
Damaged slate roof with nails that typically pulled out of the deck. Some of the slate broke and small portions remained nailed to the deck. Estimated wind speed: 130 mph. Hurricane Katrina (Mississippi, 2005)
