Effective Well Control - Prevention & Response

2013 LWC Incidents of Interest

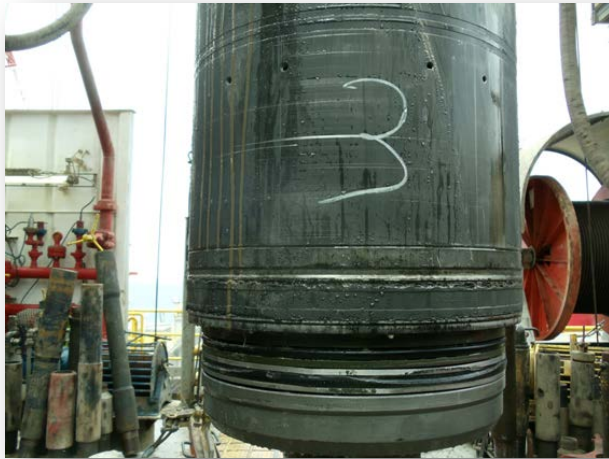
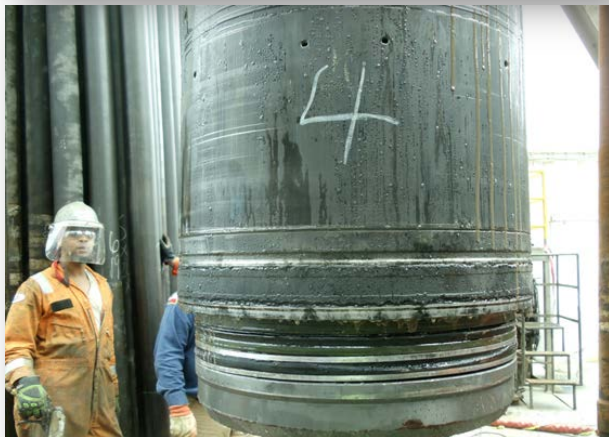
MP 295 #1 / ENSCO 87

Incident: On 5 February 2013 at approximately 0700 hours, a well control event occurred on the jack-up rig Ensco 87 that resulted in an underground blowout. The Ensco 87 was drilling an exploratory well for Apache Corporation, Lease OCS-G32263, Main Pass (MP) Block 295, Gulf of Mexico (GOM), offshore the State of Louisiana.

District Investigation concluded the causes of the incident were:

- 1) The 18" liner top seal assembly failed.
- 2) The cement barrier between the conductor casing and the surface liner failed.

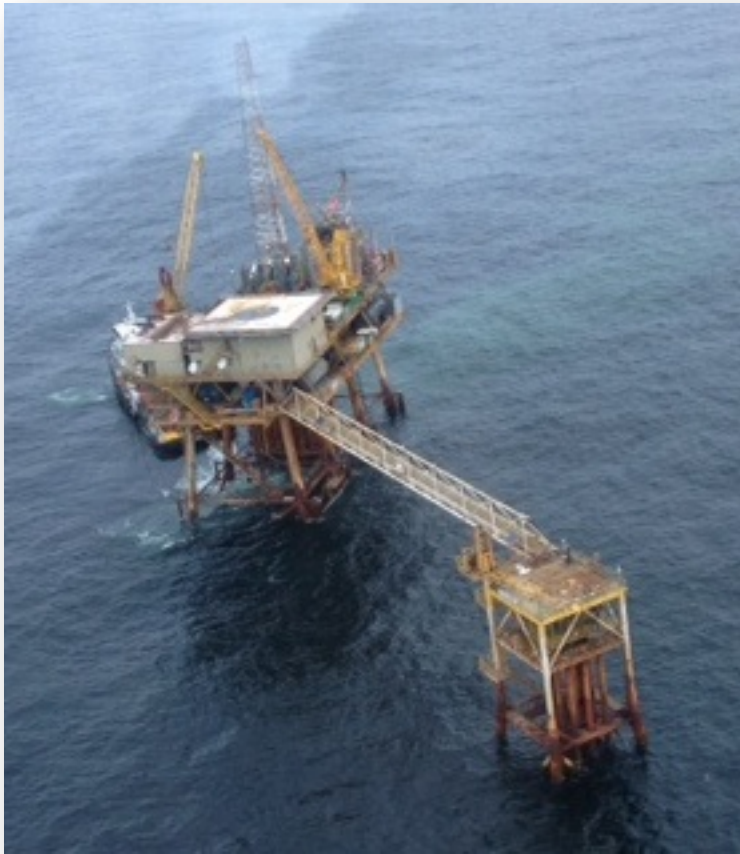
Ship Shoal (SS) 225 B

Incident: During a temporary abandonment procedure on July 7, 2013, while attempting to pull a tubing plug hold down stop in the short string of the B002 well, unexpected pressure was encountered. Well control was lost due to leaks in the tubing, production casing, and surface casing to an unsealed annulus. Well control was regained and the well has since been plugged. There were no injuries but there was a loss of hydrocarbons to the waters of the Gulf of Mexico (GOM).

District Investigation concluded the probable cause of the loss of well control was pulling the short string plug at 2550 feet without confirming the existence of pressure below the plug.

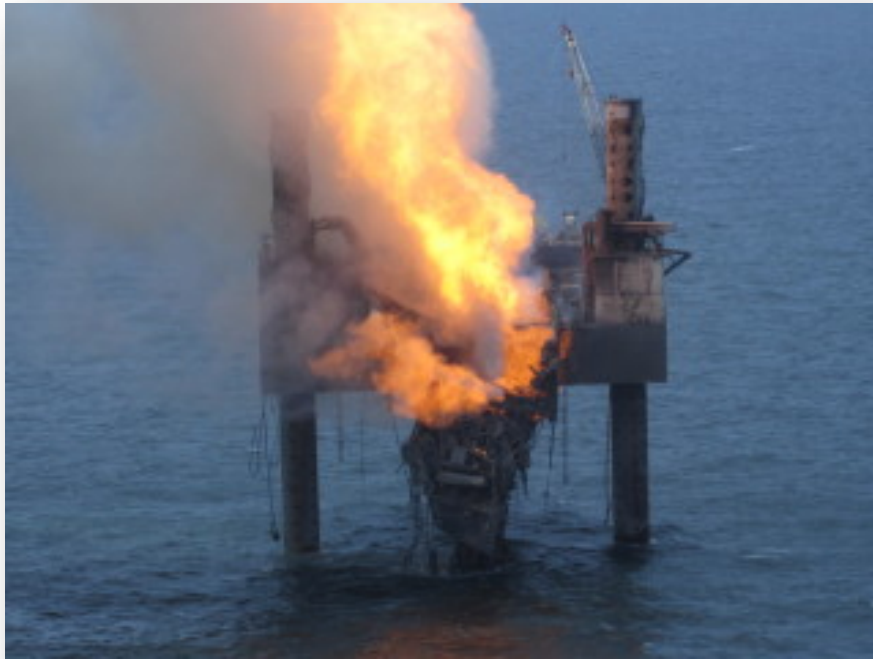
ST 220 A / Hercules 265

Incident: On 23 July 2013, the rig was performing approved completion operations, and the formation had been perforated the previous day. After perforation the well was taking 30bbl/hr of fluid. The fluid was circulated from a 15.7ppg filtered brine to a 15.3ppg, after which the well was taking 7bbl/hr, a pill was also spotted. The rig then snapped in and out of the sump packer (to confirm no fill) at which time the well was still taking fluid. At 0300hrs this morning the rig began to trip out of the hole. At 0813 it was reported that the well was still taking 3bbl/hr of fluid. It is estimated that the blowout occurred at 0845.

Relief well operations were not completed until 15 October 2013 – 74 days after the initial LWC

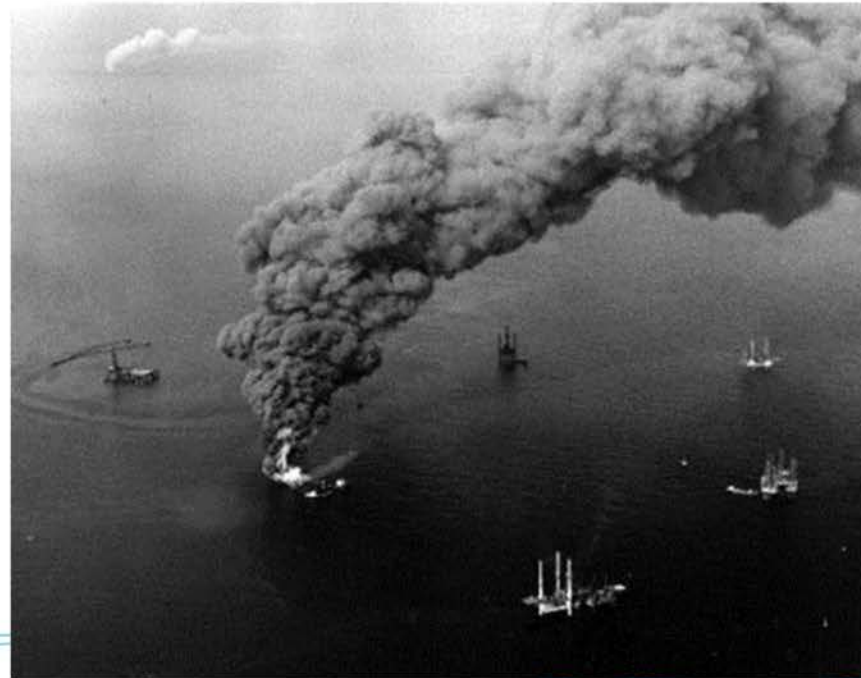
12/01/1970 South Timbalier(ST) 26 B – Bay Marchand

Approximately 8 miles from shore
Four fatalities, thirty six injuries, lost platform and
2 drilling rigs, minor amounts of oil on beaches.
53,000 bbls estimated to be spilled.

10th and final relief well killed blowout on April 7th, 1971.
