An Inventory of Submerged Aquatic Vegetation and Hardened Shorelines for the Peconic Estuary, New York

Ralph W. Tiner, Herbert C. Bergquist, Denise Siraco, and Bobbi Jo McClain

Prepared for the Peconic Estuary Program of the Suffolk County Department of Health Services, Office of Ecology, Riverhead, NY*

December 2003

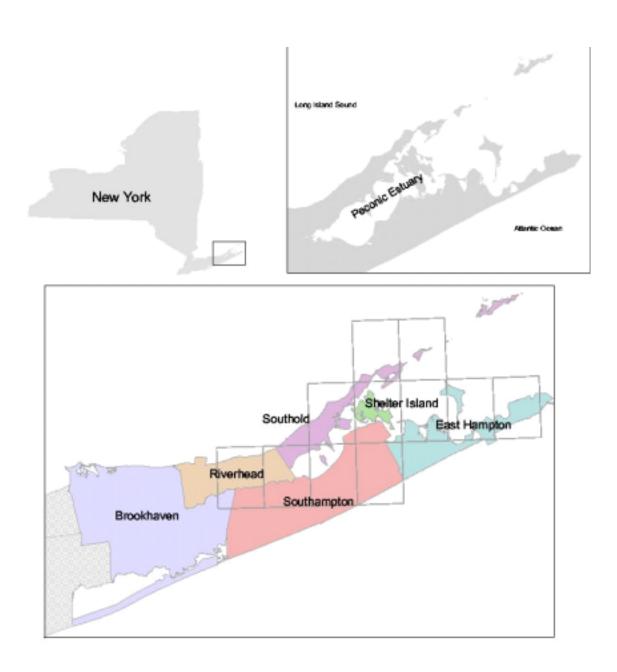
Figure 1. Location of Peconic Estuary in eastern Long Island, New York. The map at the bottom of the page shows towns and the limits of 1:24,000 maps (rectangles not labeled).

The study area is the Peconic Bay Estuary on the eastern end of Long Island, New York (Figure 1). It includes parts of 12-1:24,000 maps on the eastern end of Long Island: Montauk Point, Gardiners Island East, Gardiners Island West, Plum Island, Orient, Greenport, Southold, Napeague Beach, Sag Harbor, Southampton, Mattituck, and Riverhead. Five towns are located in the study area: East Hampton, Riverhead, Shelter Island, Southampton, and Southold.

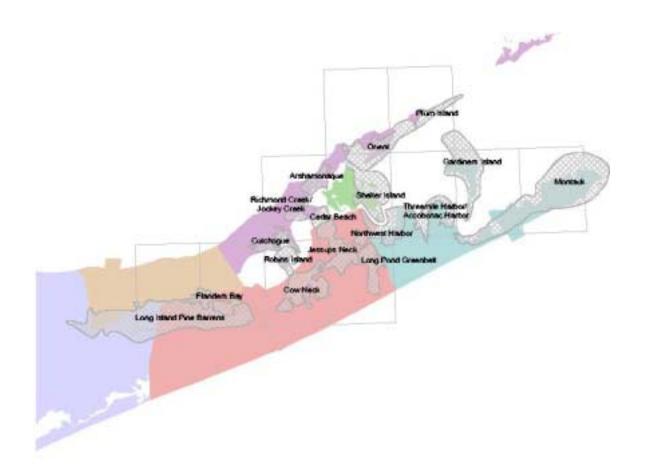
Figure 2. Location of critical natural resource areas associated with the Peconic Estuary.

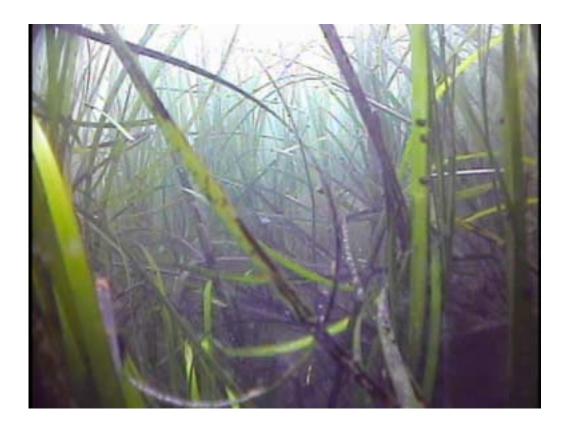
Figure 3. View of eelgrass bed taken by underwater camera.

A total of 1,339 beds comprising 3,539 acres of submerged aquatic vegetation (SAV) was inventoried in the Peconic Estuary (Table 2). Eelgrass (Figure 3) and "other algae" occupied over 2,660 acres, accounting for about three-quarters of the bed acreage (44% and 31%, respectively). Green fleece (including mixtures with red algae) accounted for about 11 percent of the SAV acreage.

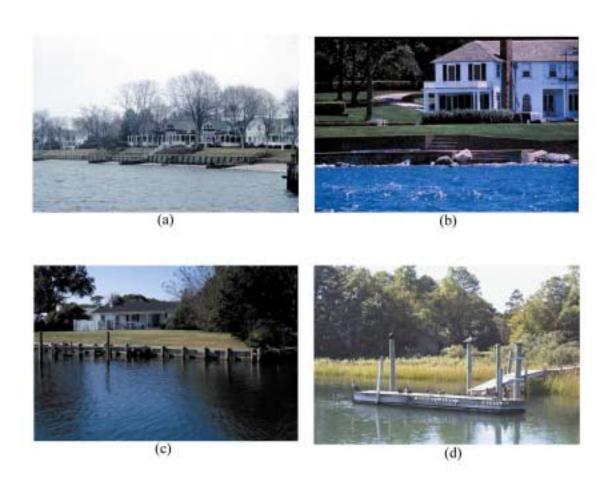
Figure 4. Examples of hardened shoreline features (a-c) and dock (d). (photos by The Nature Conservancy)

Hardened shorelines and docks were inventoried for the Peconic Estuary (see Figure 4 for examples). All data are reported in linear miles or feet. Almost 29 miles of hardened shorelines and nearly 9 miles of docks were mapped (Table 5). Eighty-two percent of the hardened shorelines were comprised of bulkheads and seawalls.

Wayne Grothe of The Nature Conservancy kindly provided photos of shoreline features for use as Figure 4 in this report.

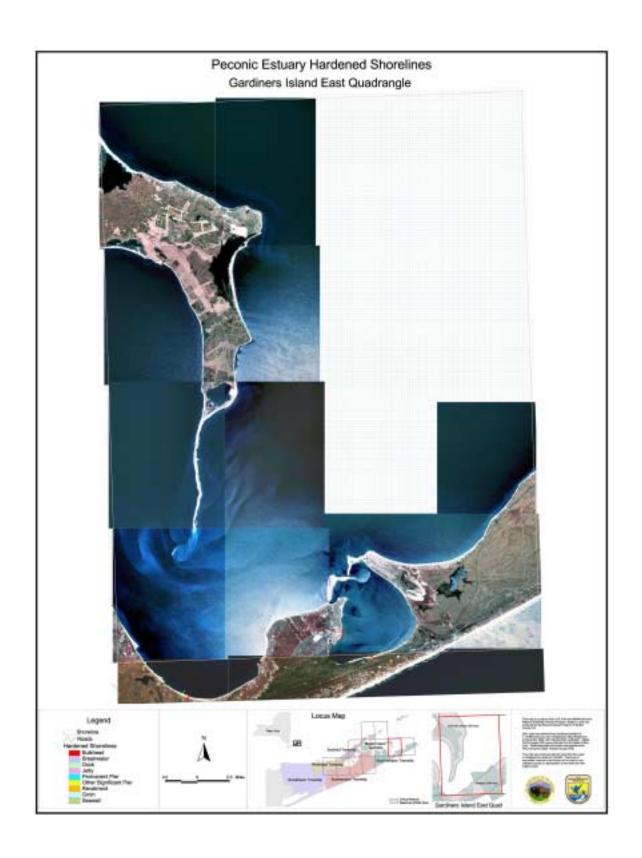
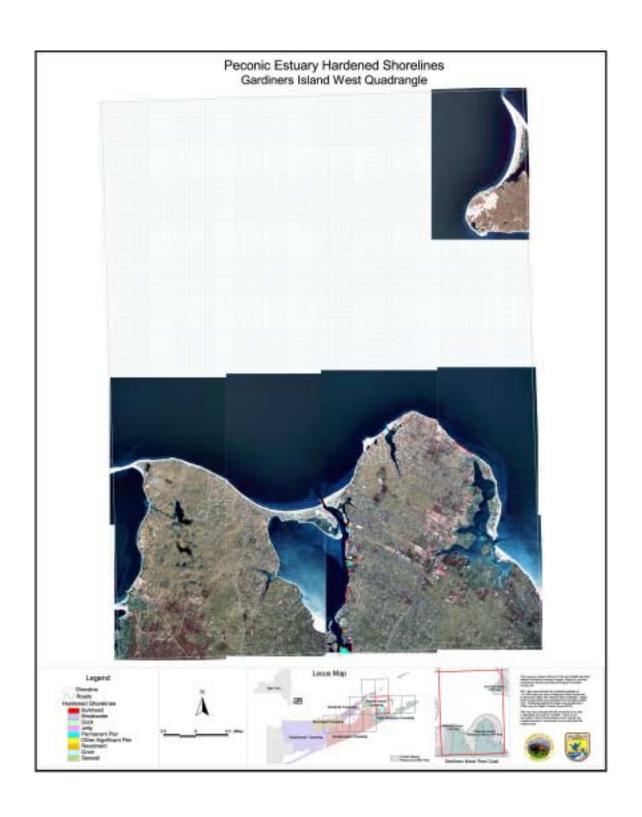
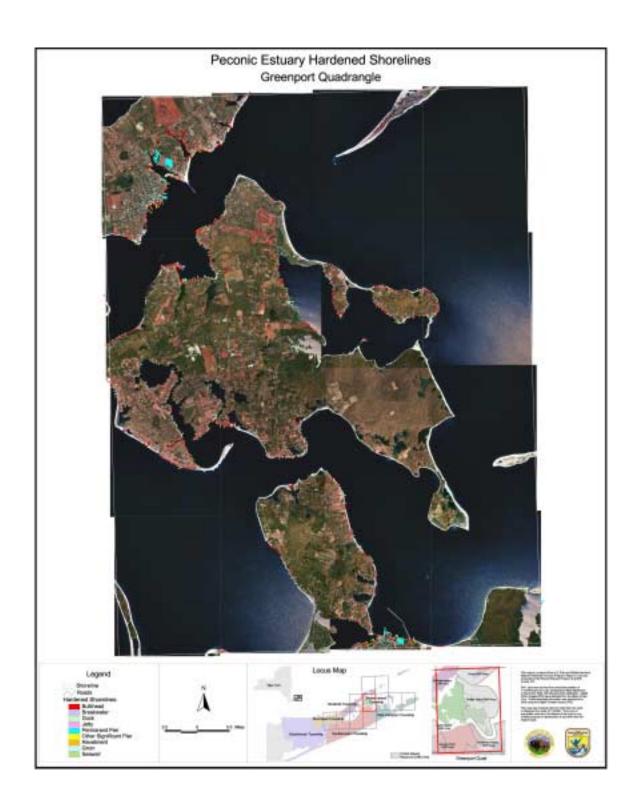
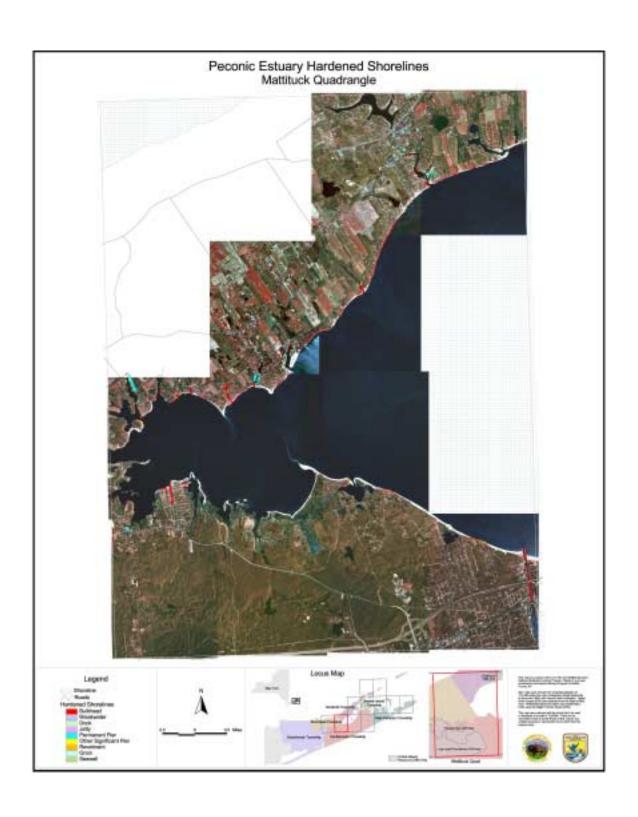
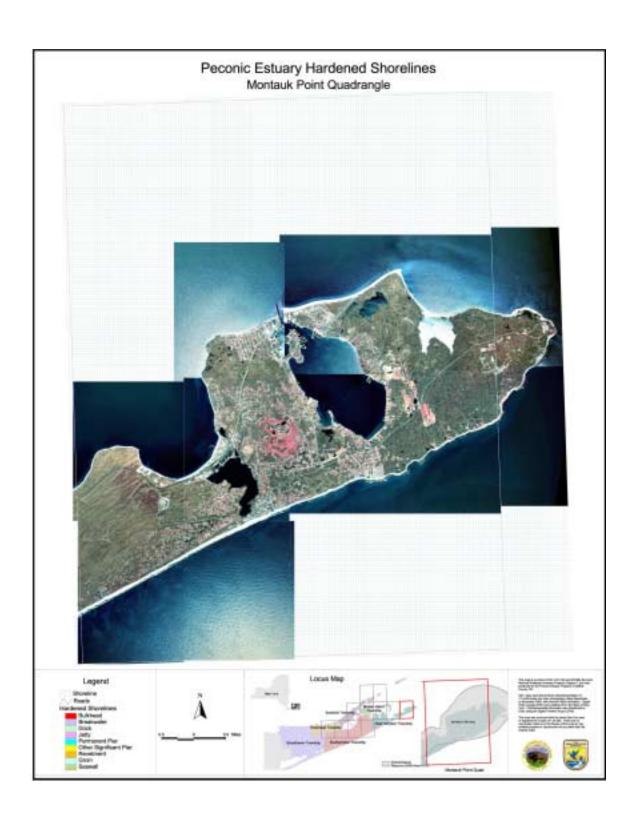
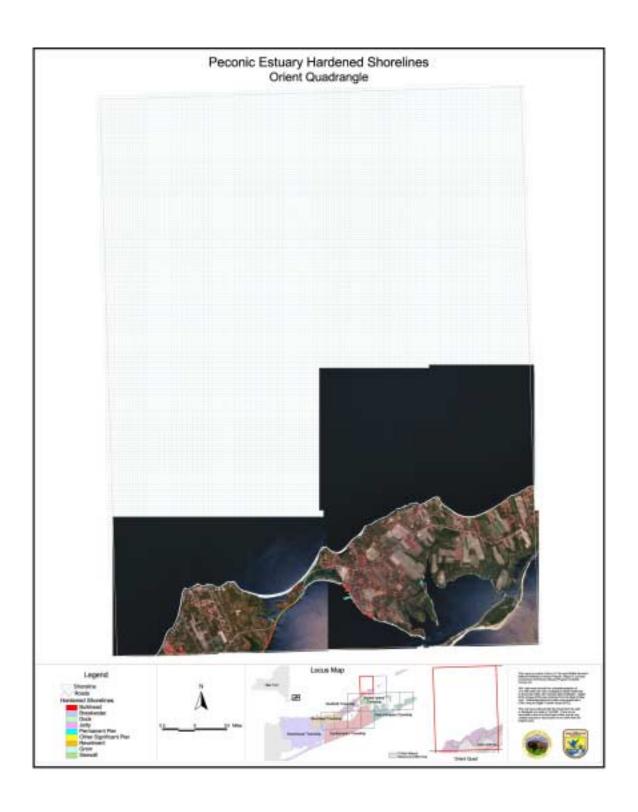
Maps showing the extent of hardened shorelines and docks in the Peconic Estuary

(Note: The Gardiners Island East map includes part of the Napeague Beach quadrangle)
