Bull Shoals Unit 1 161kV Switchyard Feeder Repair

Mark Dixson
Little Rock District

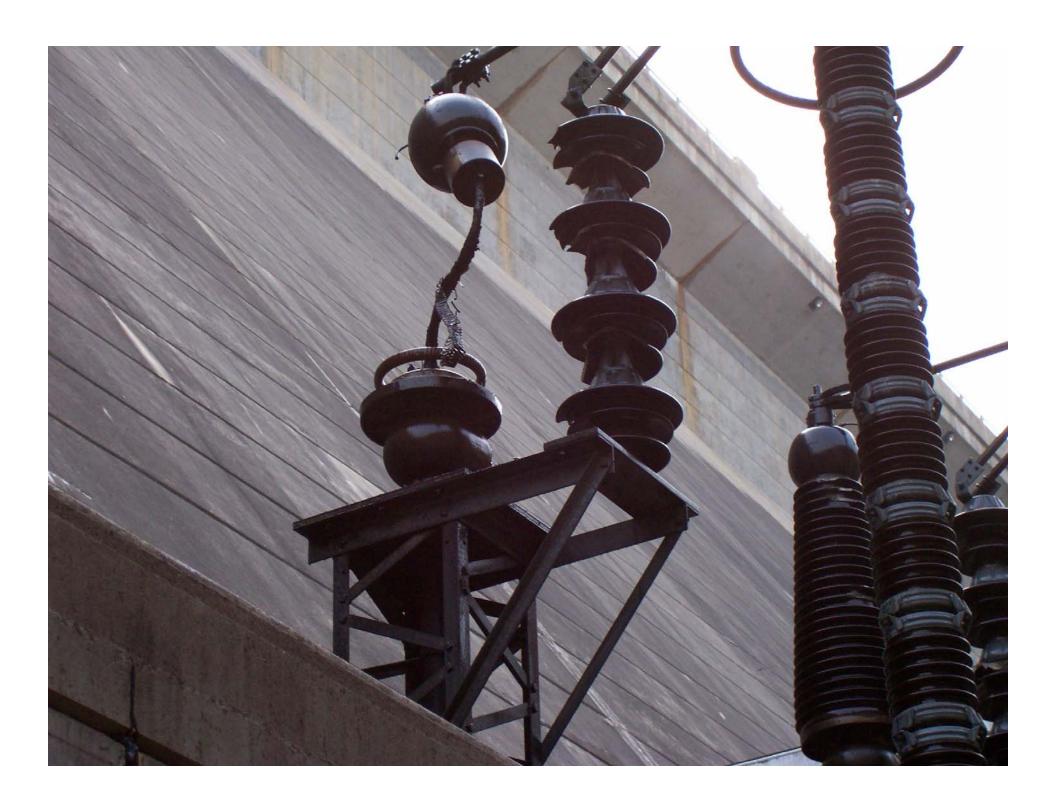
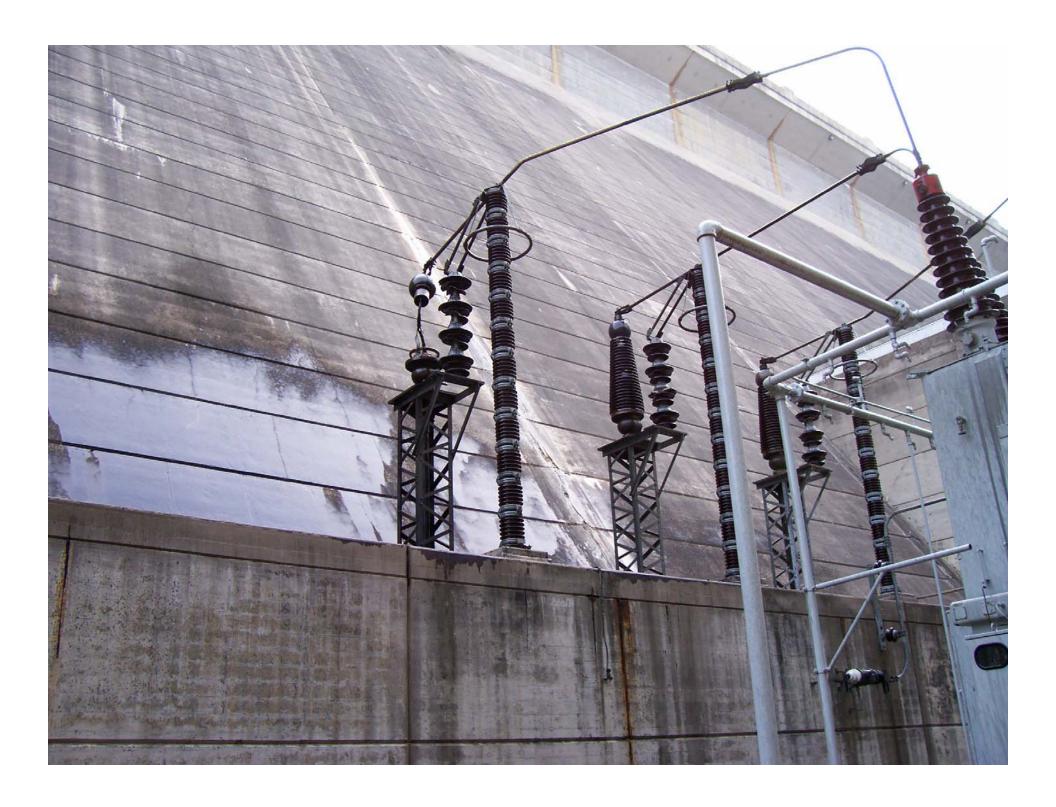
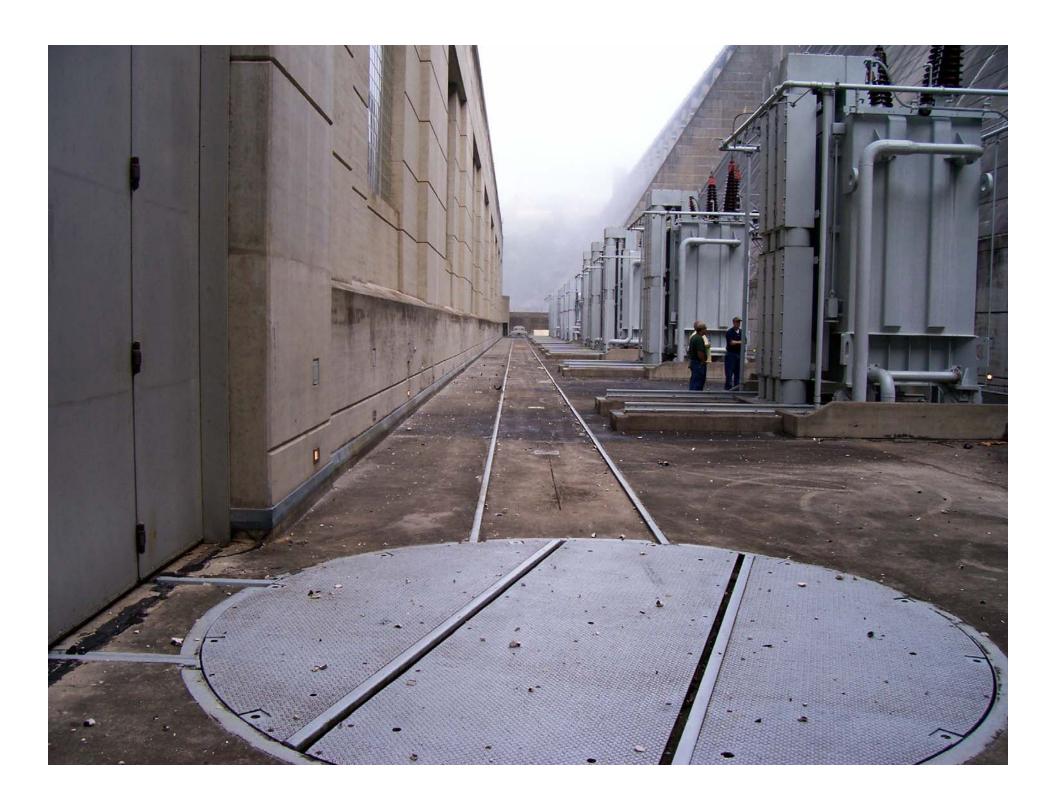
- Original Equipment 52 years old.
- Unit 1 Oil filled cable pothead failed and exploded on Sept 6 2006.
- Resulting fire and fire suppression damaged oil insulated cable system
- Minor damage to power plant.

- Transformer Unit 2 damaged and removed from service.
- Cause of fire Failure of Pothead stress cone assembly and build up of combustible gas
- Power Plant lost all power and went in the Black. Power Plant Personnel restored service to plant in about 4 hours

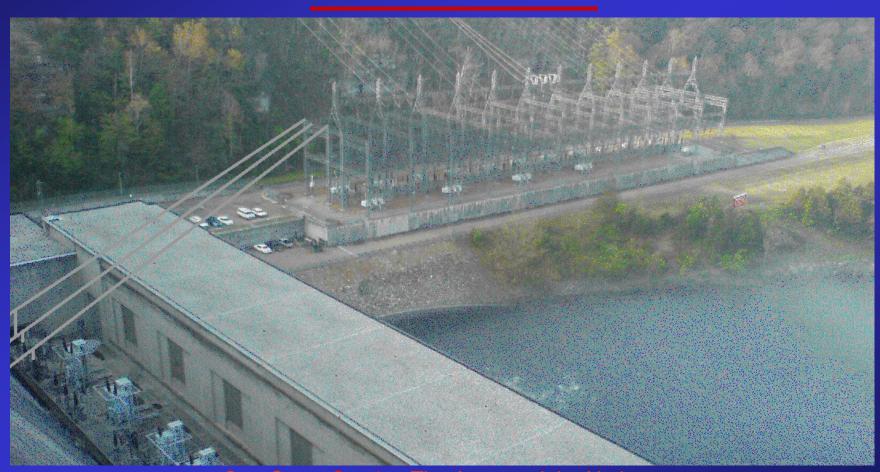
Overhead Line Option

Installation of Overhead Cables (from the dam to the switchyard) for Unit 1
By SWPA and Corps

Shorter Time to Repair
Least Cost to Repair
Decrease Mean Time To Repair
SWPA has many components on hand
SWPA and COE to do Engineering Design In House
Maintains the reliability of the existing cable system
