# Omaha, Nebraska School Bus Run Off Bridge

October 13, 2001

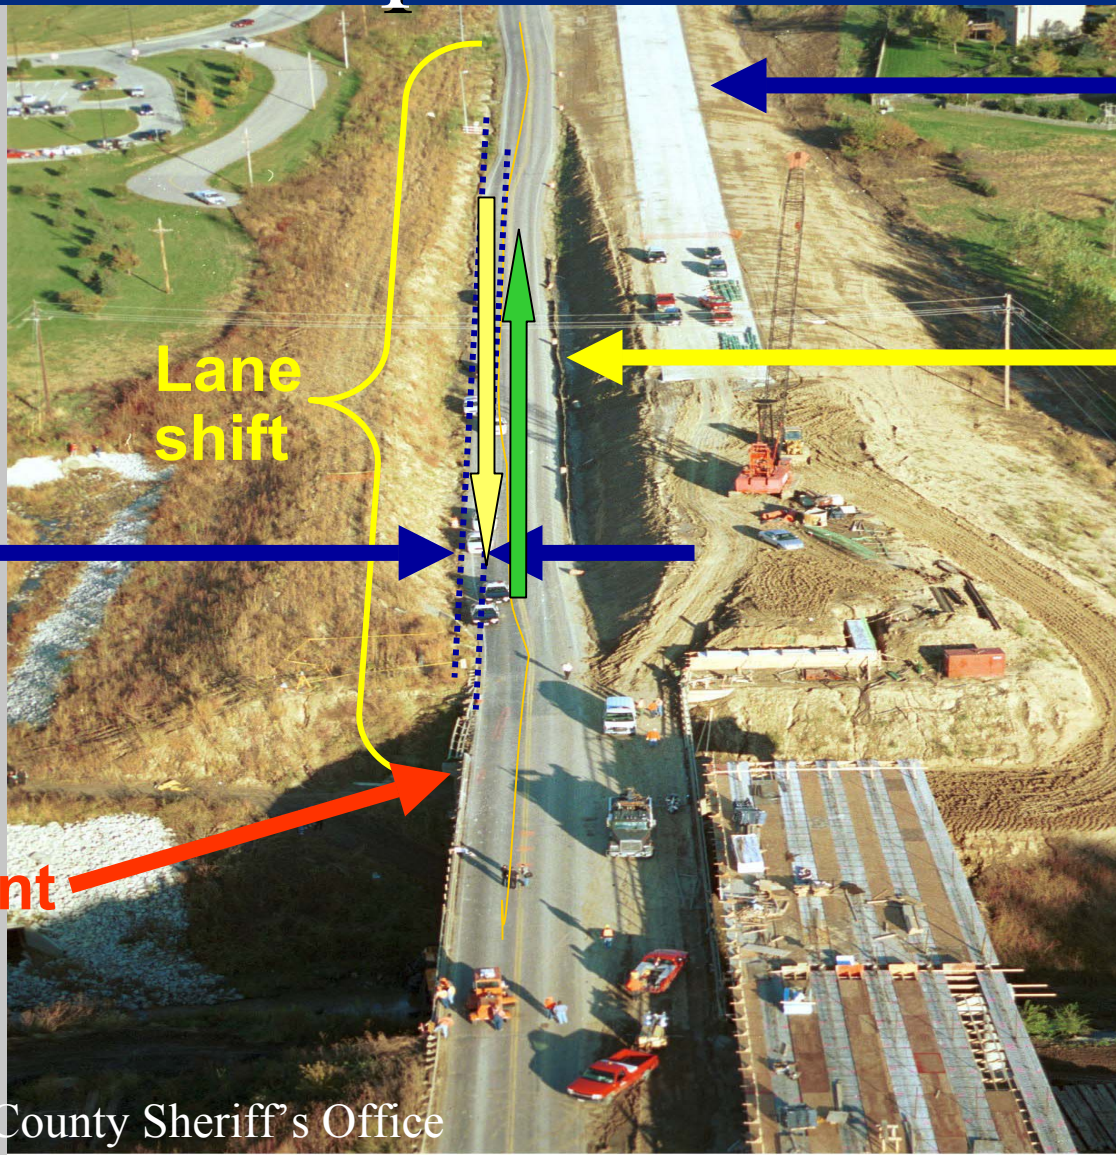
# U.S. 6 at East End of West Papillion Creek Bridge

Lane shift

Offset  
5½ ft.

Accident  
site

New  
lanes

Begin  
3%  
grade

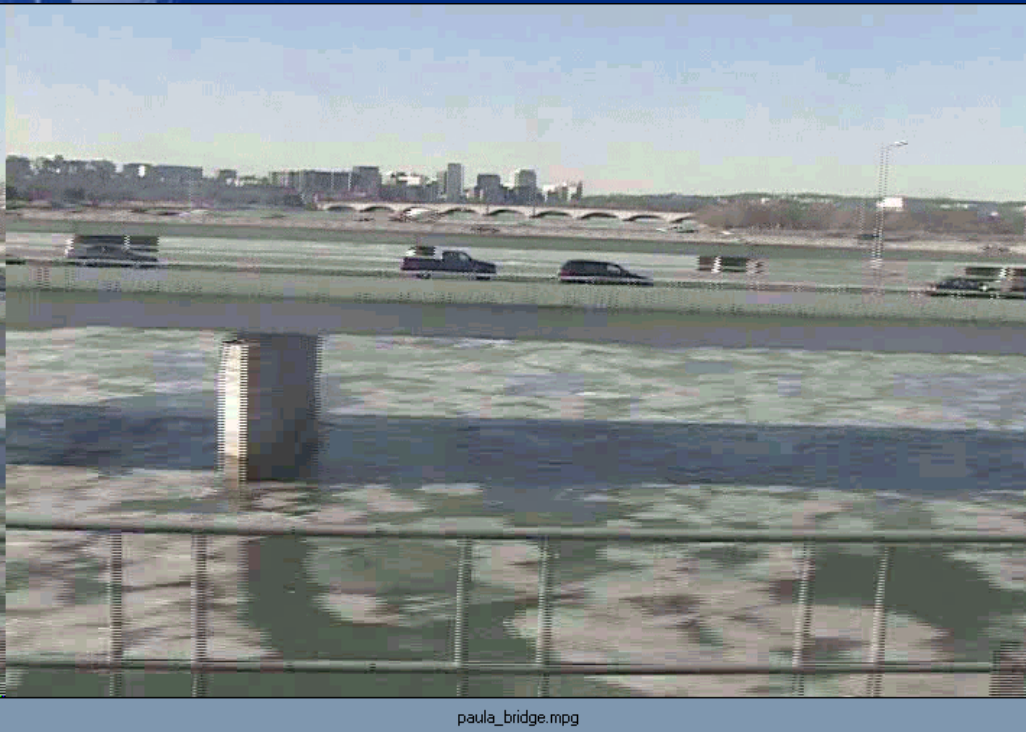
# Perception of Depth/Distance

Motion parallax:  
*Objects near an observer appear to move faster and opposite in direction, compared with moving objects that are farther away*

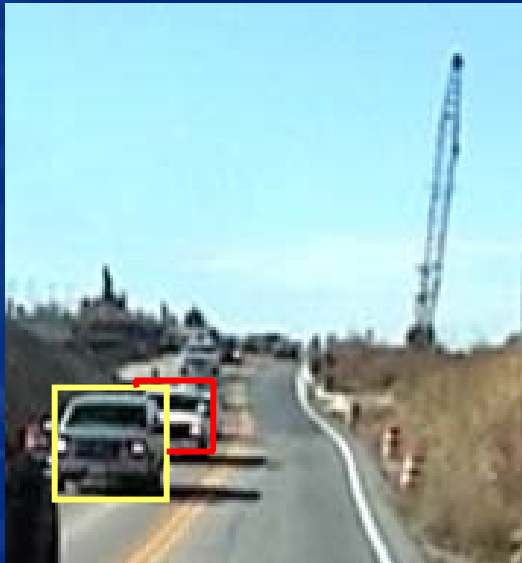
# Perception of Depth/Distance

Interposition:

*Objects that are nearer to an observer obscure objects that are farther away*

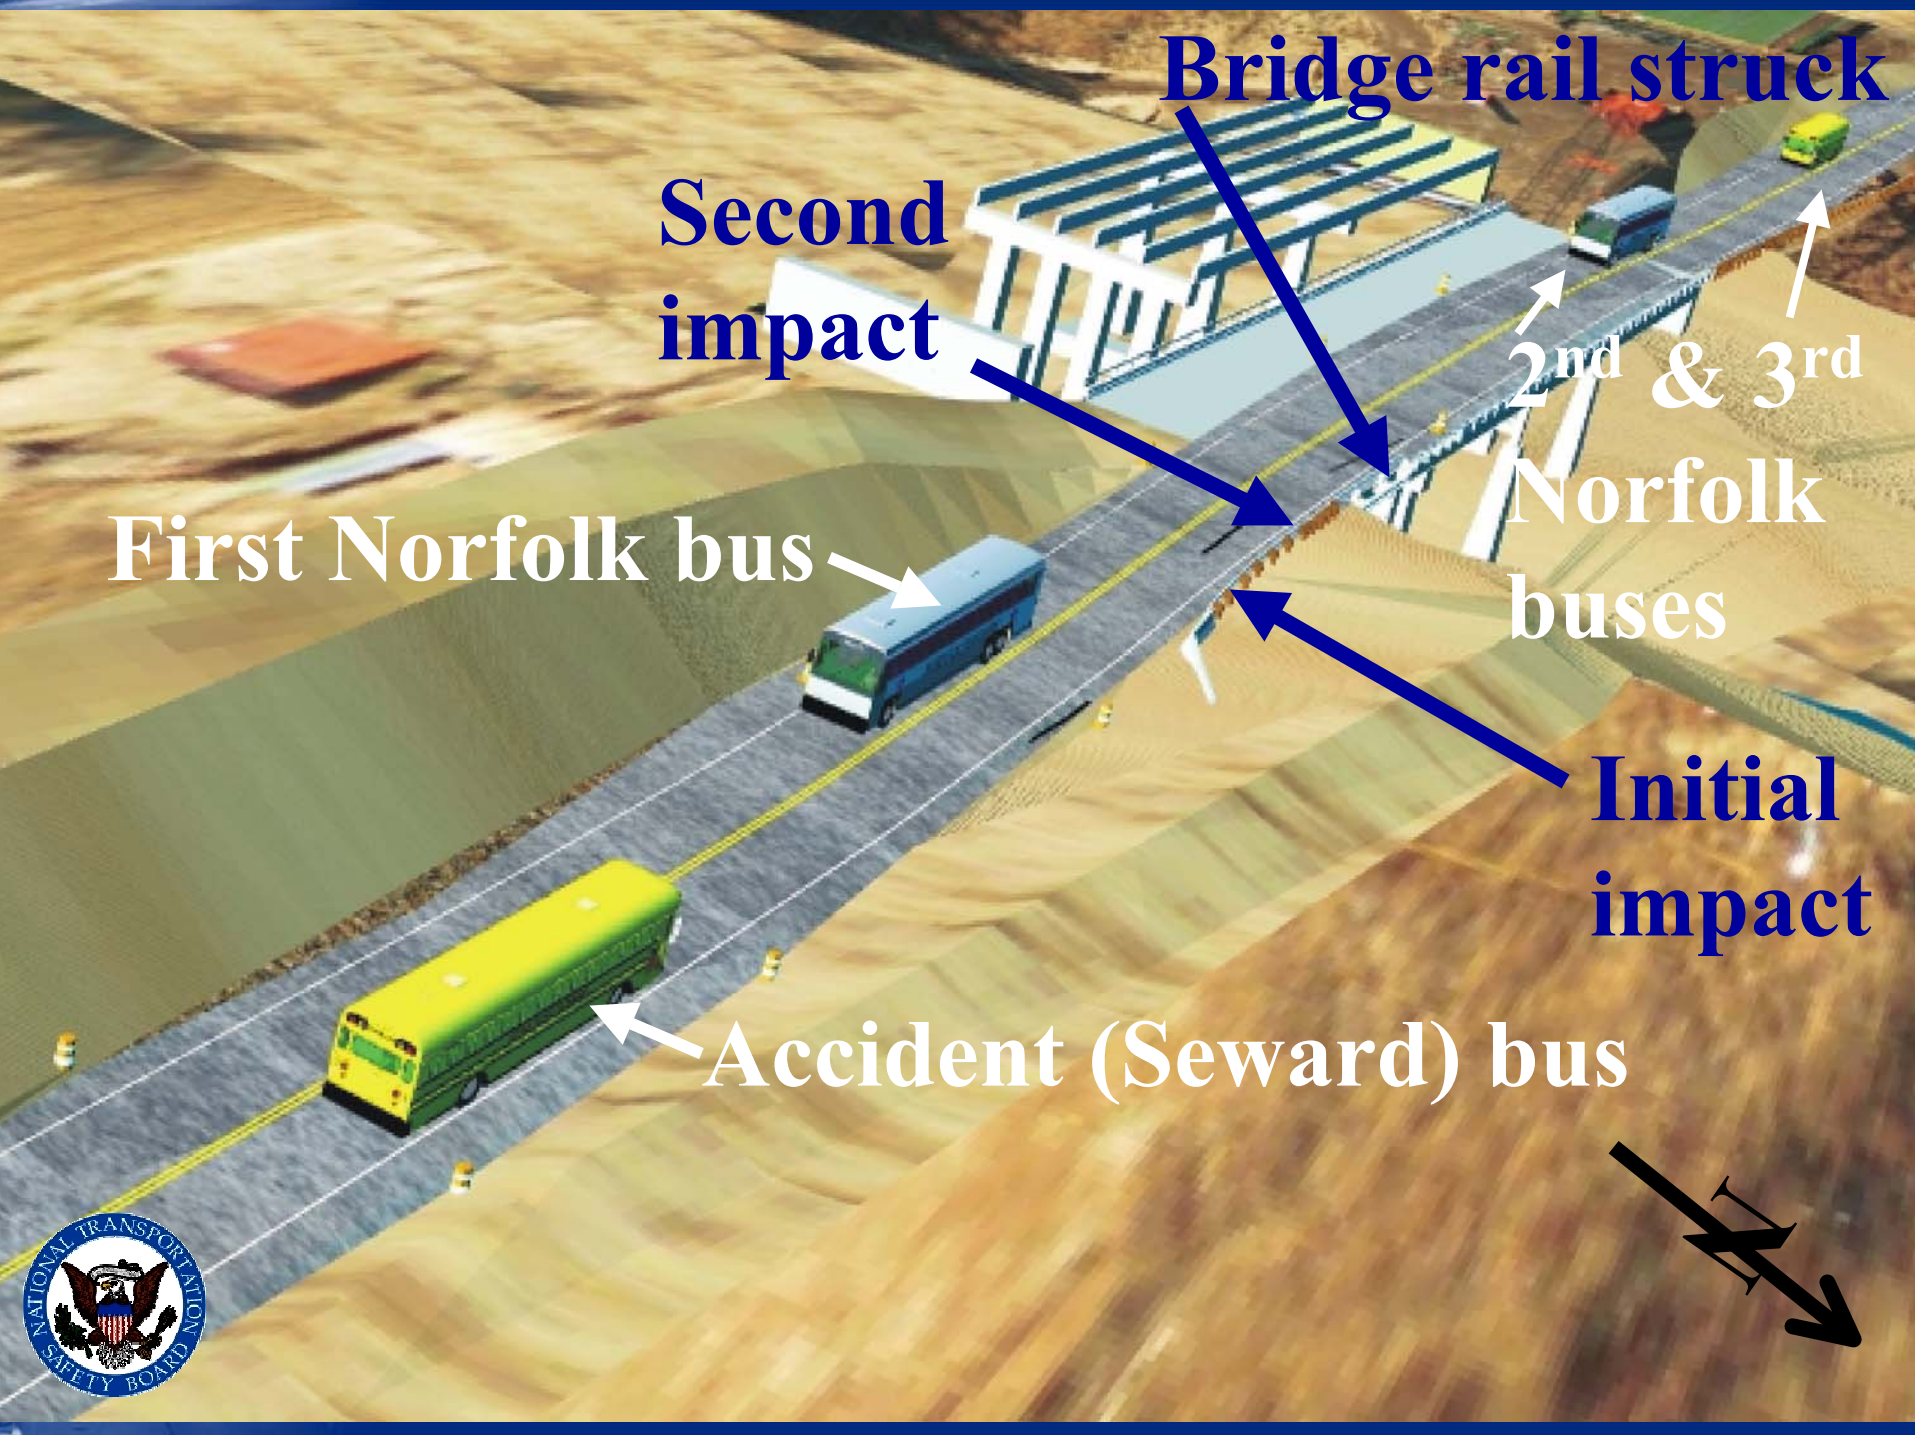
**Bridge rail struck**

**Second impact**

**First Norfolk bus**

**2nd & 3rd Norfolk buses**

**Initial impact**

**Accident (Seward) bus**

**Off-tracking Norfolk motorcoach**  
3 inches

1. First Norfolk motorcoach appears headed toward Seward bus
2. Second and third Norfolk buses appear to be in oncoming lane
3. Seward bus strikes guardrail and appears headed toward second Norfolk motorcoach

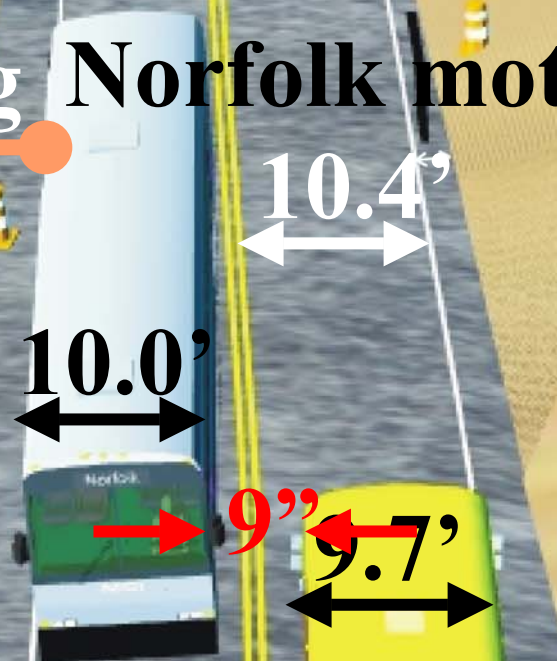
**Seward schoolbus**

**Off-tracking**  
4 inches

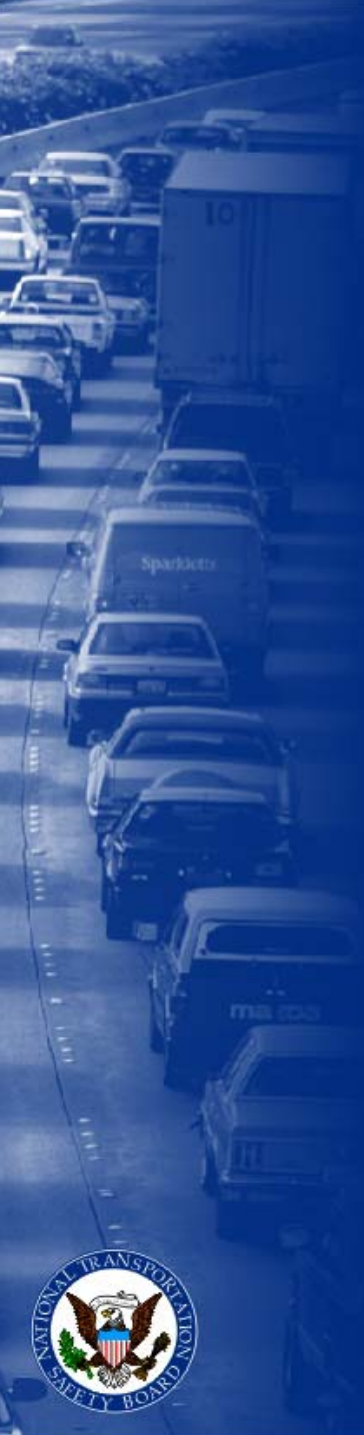
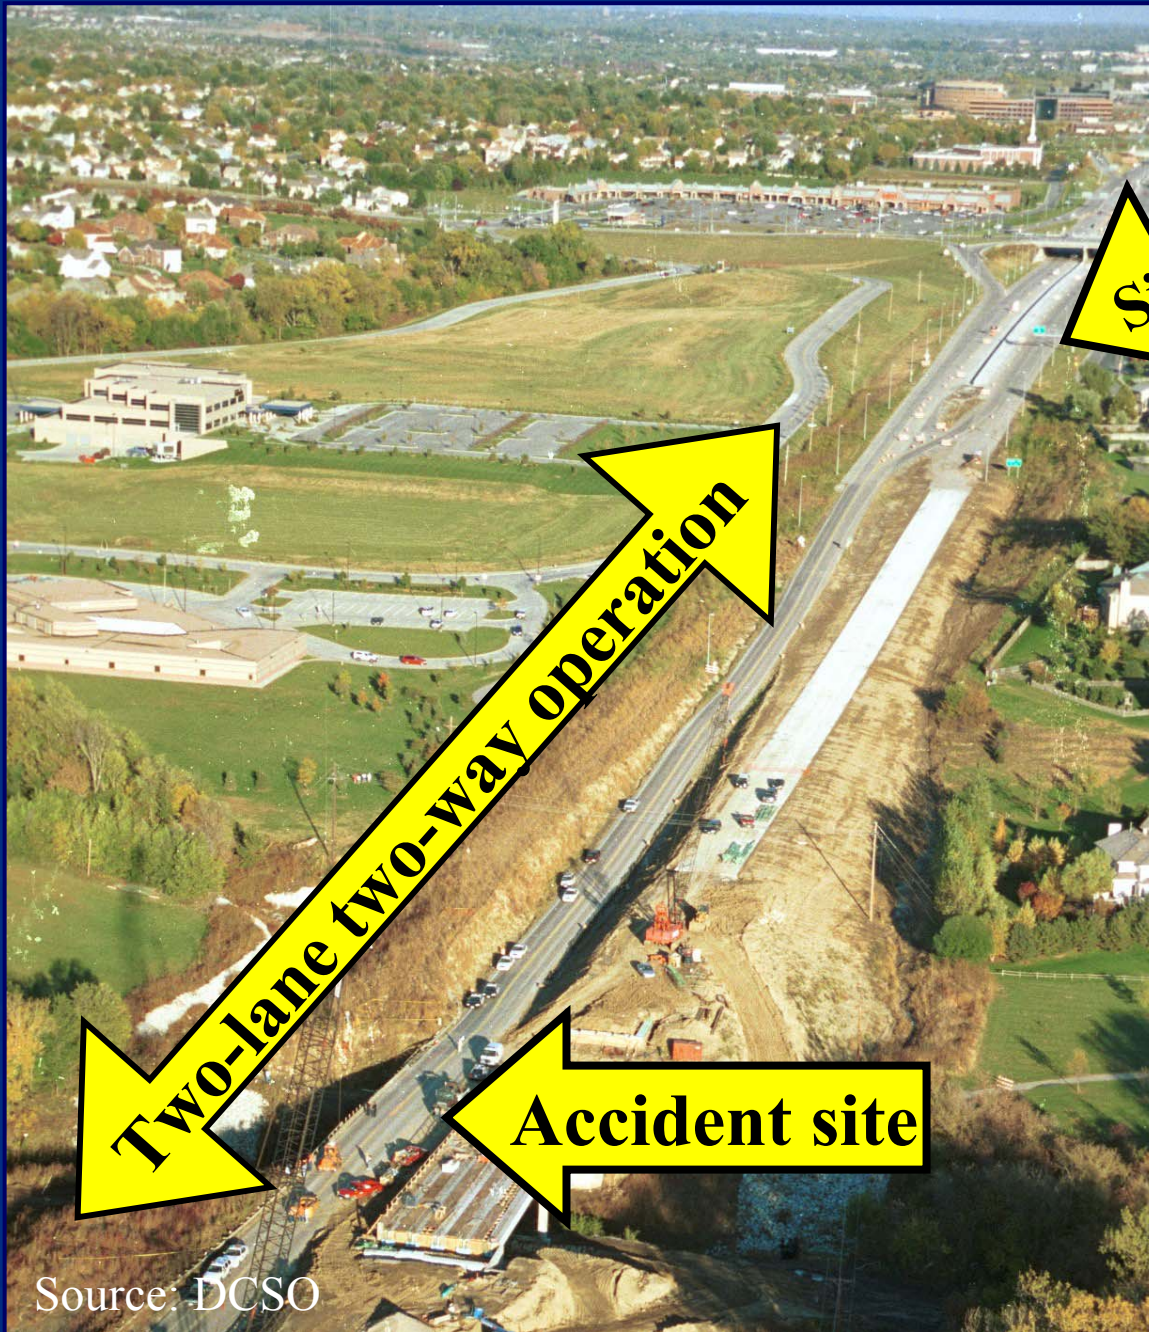
**Six-lane freeway**

**Two-lane two-way operation**

**Accident site**

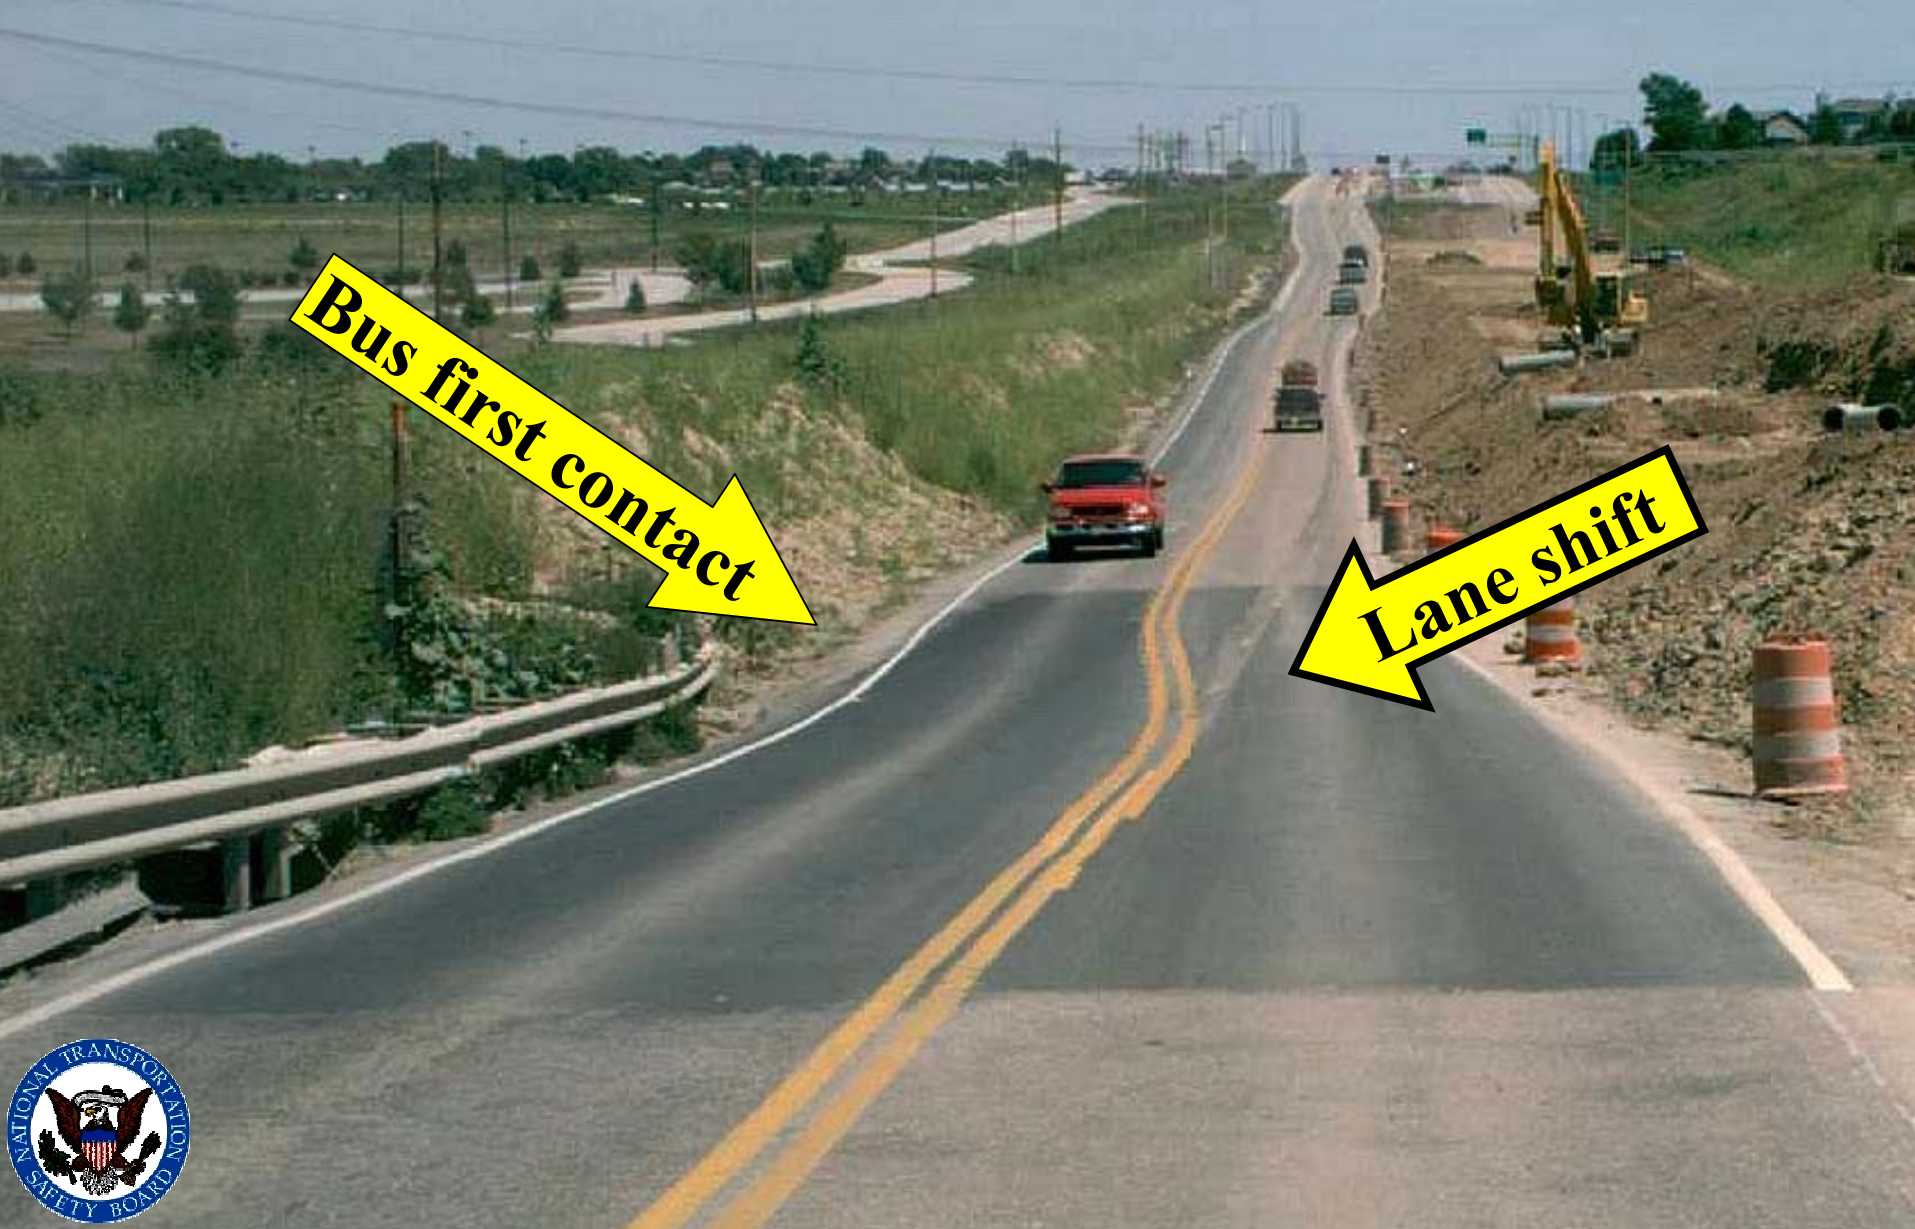
# Lane Shift at Bridge

**Bus first contact**

**Lane shift**

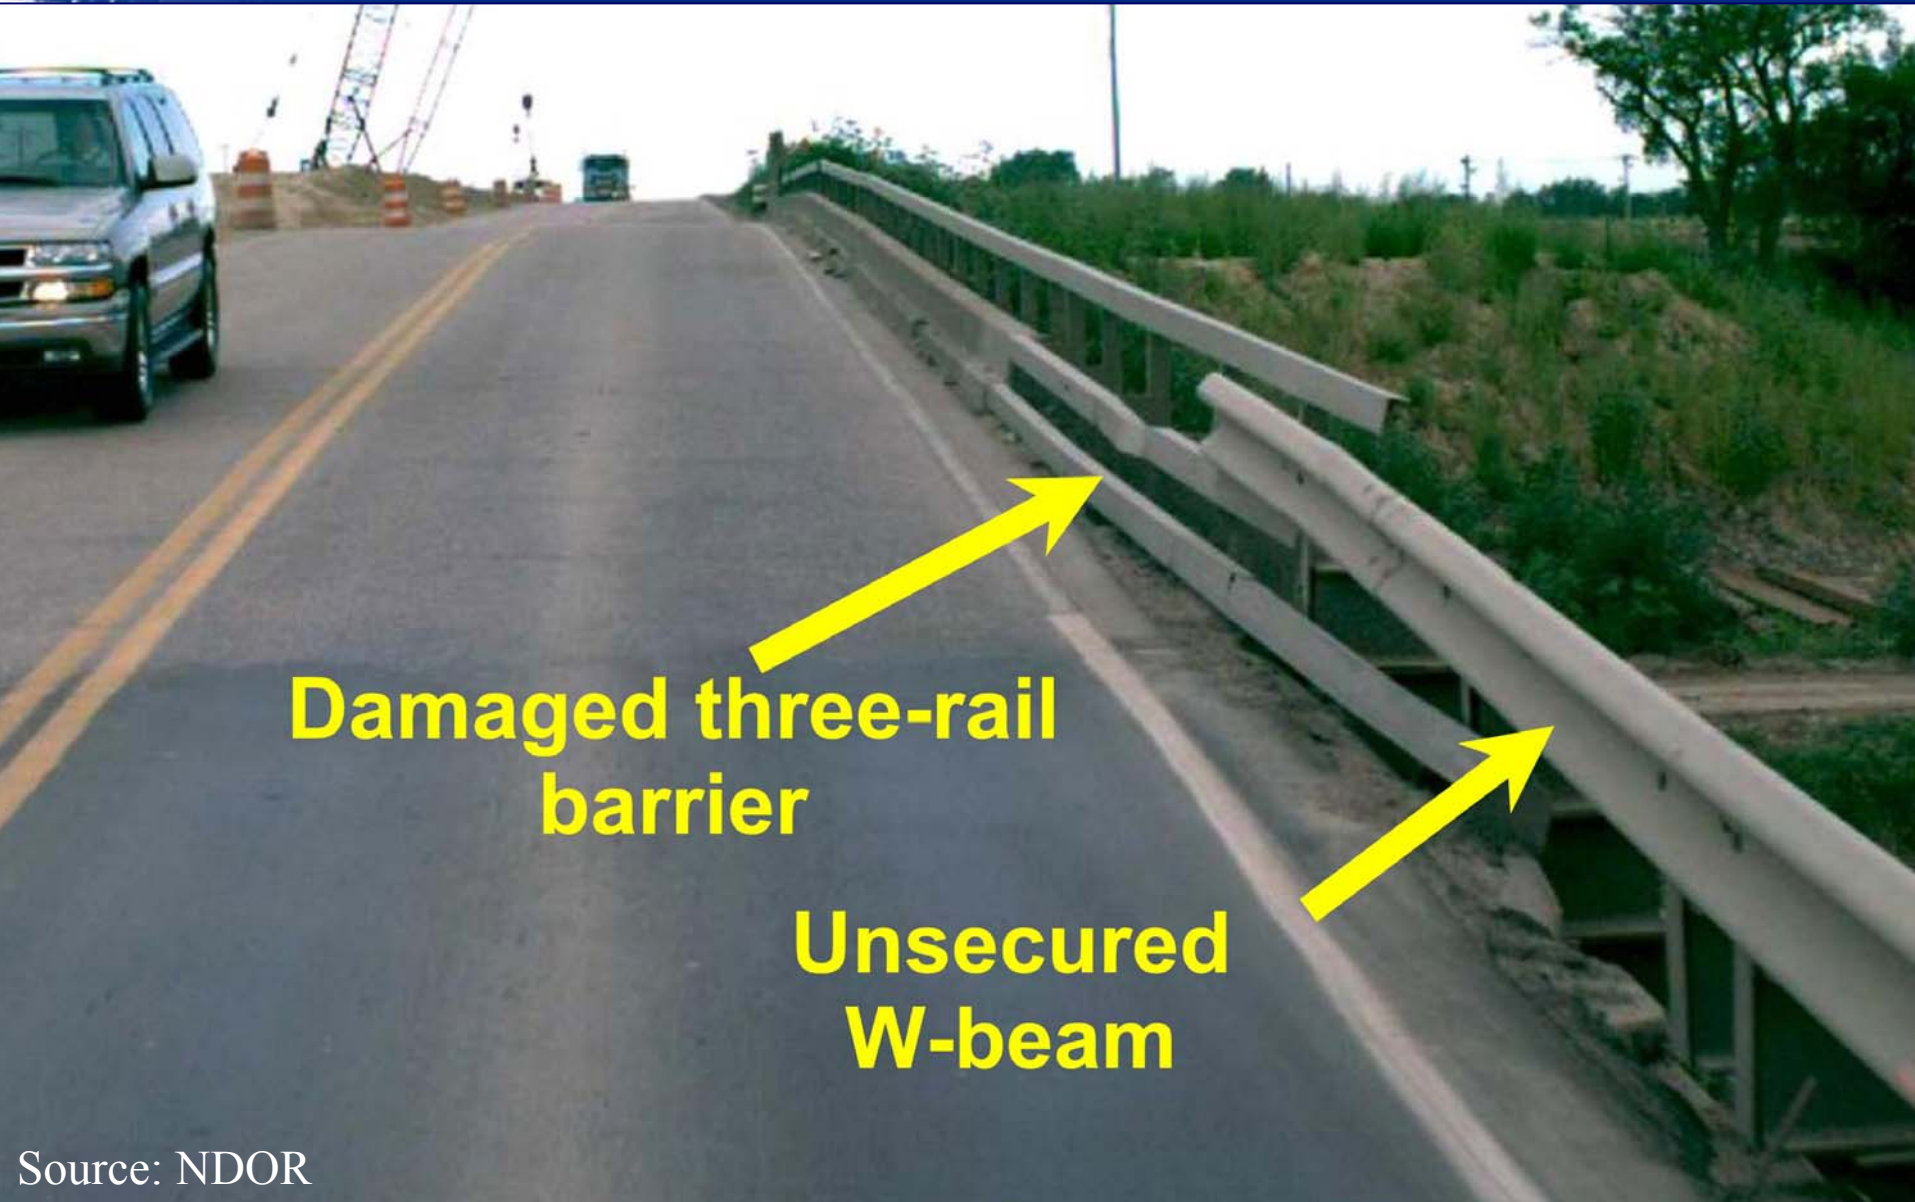
# Barrier After 2001 Damage

**Damaged three-rail  
barrier**

**Unsecured  
W-beam**

- No Federal guidance
- Important in work zones
- Contractor reportedly repaired barrier  
Did not meet accepted standards
- NDOR staff did not detect inadequate repair
- Review did not document damage
