#### 6.4 INTERPRETING CONTRAILS

### 6.5 OTHER VISUAL INDICATIONS OF AIR MOTION NEAR COMPLEX TERRAIN

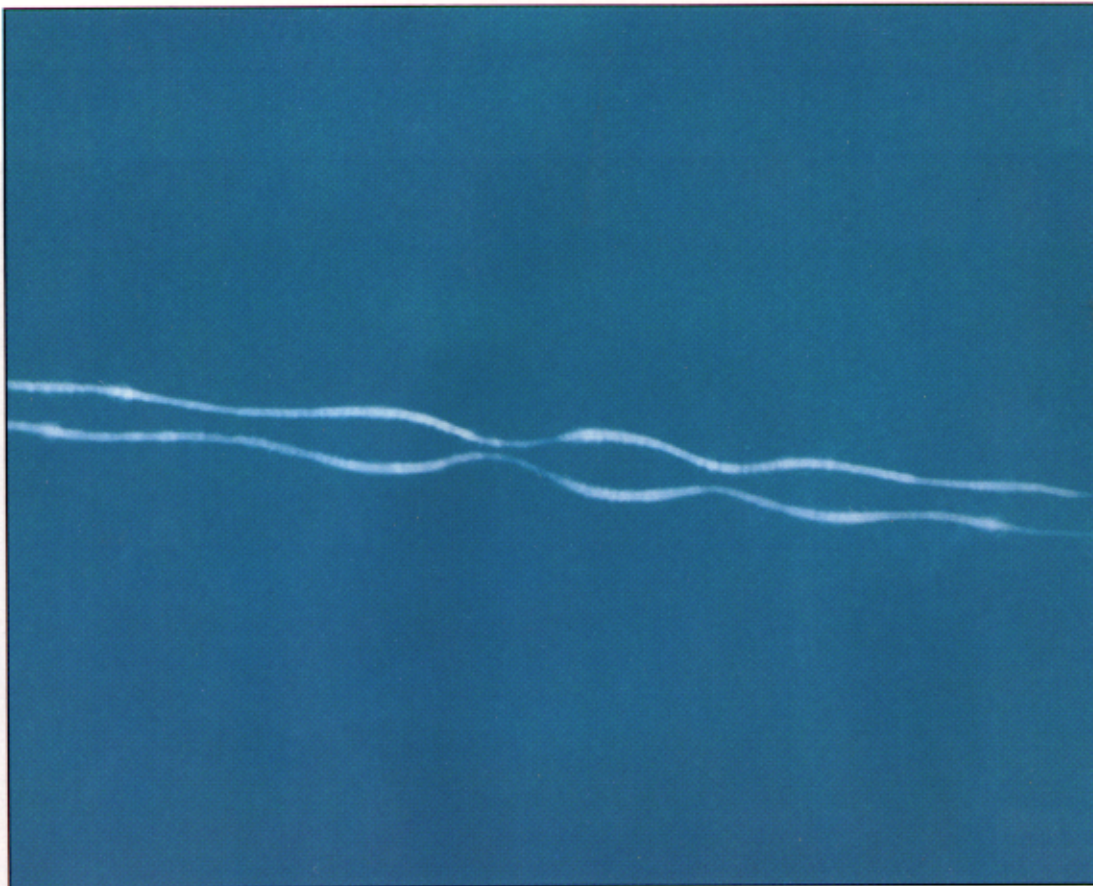
Figure 6-18. A linear contrail showing relatively smooth air (photograph ©, 1991, A.J. Bedard, Jr.)

In relatively undisturbed air, contrails will usually remain linear and smooth in appearance (Figure 6-18). They may spread out because of the natural diffusion of the aircraft exhaust, or they may occasionally exhibit small-scale oscillations caused by the interplay of wingtip vortices in air that is only slightly disturbed. Flight through the air mass depicted in Figure 6-18 will most likely be turbulence-free.

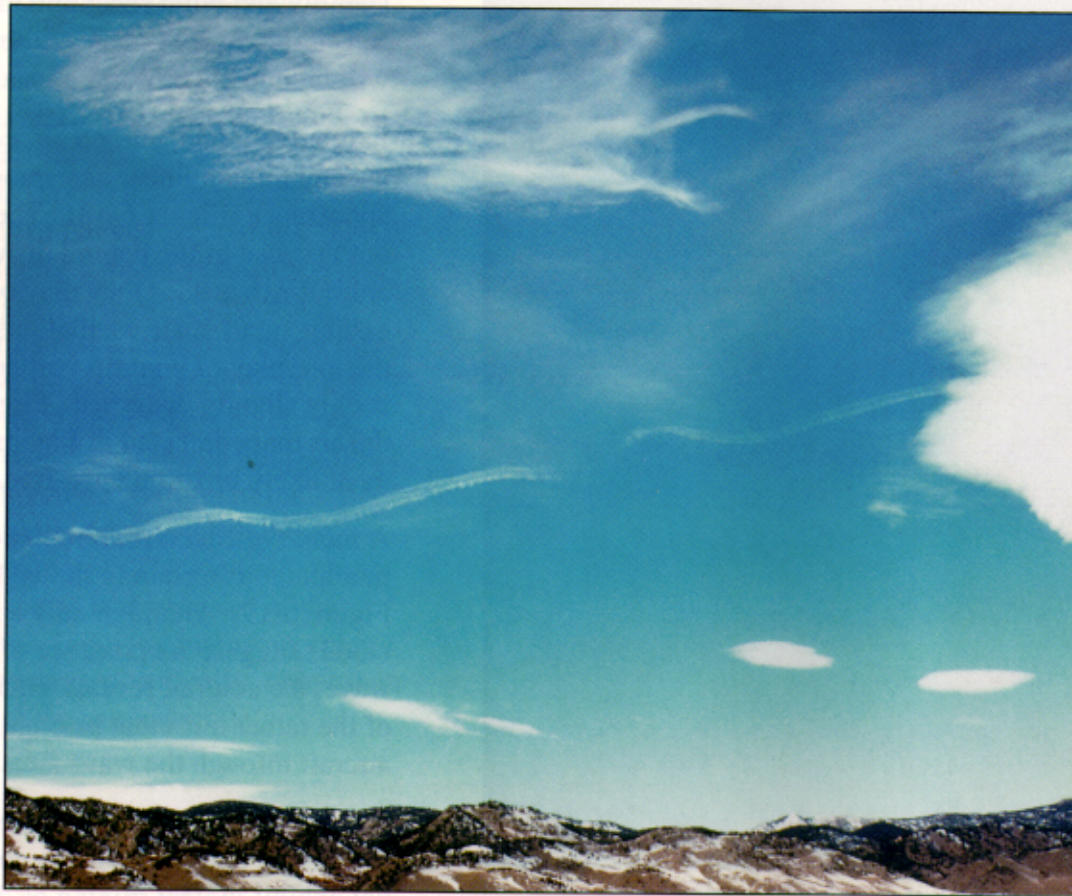
*Figure 6-19. A contrail in the vicinity of mountain wave activity near Boulder, Colorado, showing areas of turbulence (photograph ©, 1988, R. Holle).*

A more typical contrail found over mountainous terrain is shown in Figure 6-19. Although only a few lenticular clouds suggest the presence of a mountain wave, the contrail reveals a detailed history of the rather turbulent passage of this aircraft through the wave area.

The aircraft was flying from left to right in the picture and, because the contrail does not exhibit violent mixing or dissipation over most of the area shown, strong and persistent turbulence was probably not encountered. However, it appears that the aircraft had encounters with large-scale (on the order of 10 km) waves, with superimposed strong chop at several locations.

Another significant event is located at the point in Figure 6-19 where the contrail has nearly vanished because of the turbulent mixing that is occurring. The amplitude of the wave is largest here, while the wavelength is shorter than is found in the other portions of the visible contrail. This is an indication of a major vertically propagating gravity wave. Supporting evidence of this is the lenticular cloud that appears above the exiting contrail on the right side of the picture. This latter area should be avoided, or if that is not possible, the aircraft should be configured for turbulent air penetration prior to the turbulence encounter. The contrail appears to straighten out as it moves east of the mountain range, implying that wave energy was being transported vertically, rather than downstream at the same altitude.

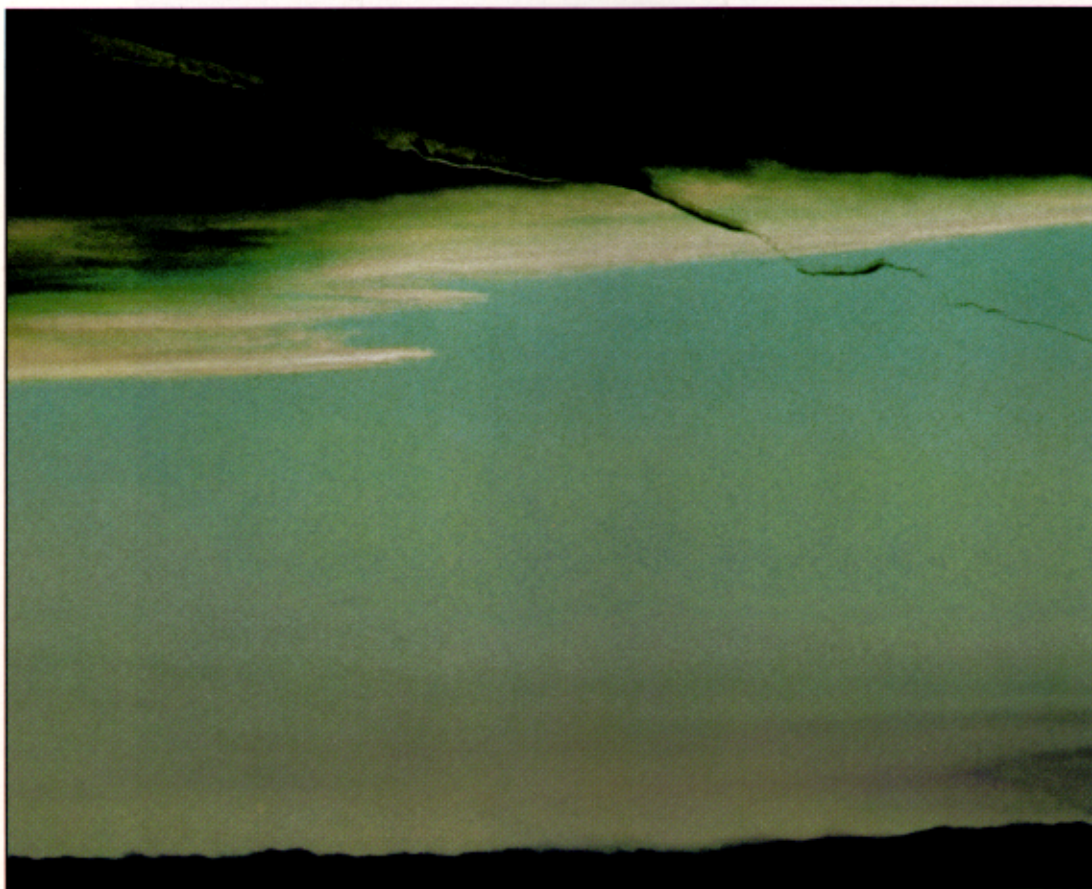
Figure 6-20. A contrail showing a significant area of turbulence aloft (photograph ©, K Langford).

Other turbulent histories are evident from the contrails in Figures 6-20 through 6-23. In Figure 6-20, the aircraft flew beneath an area of standing lenticular clouds, encountering a significant area of turbulence that peaked at the upstream edge of the cloud. Here the atmosphere has strong rising motion and the contrail is highly contorted and twisted, in contrast to that seen in the rest of the photograph. Once the aircraft cleared the leading edge of the cloud area, the contrail became smooth and laminar, indicating that the turbulence had probably ceased.

Figure 6-21 shows yet another encounter with a turbulent zone near the upwind edge of a lenticular cloud. The highly turbulent mixing of the contrail at this point leaves no question about the strong shear present, a characteristic of this upstream region. Figures 6-20 and 6-21 point to the fact that the upwind edge of an area of lenticular clouds is frequently quite turbulent. As the aircraft in Figure 6-21 continued on course, it encountered a longer-wavelength oscillation and then a smooth flight path. It should be noted that similar concern should be given to the downwind edge of lenticular clouds.

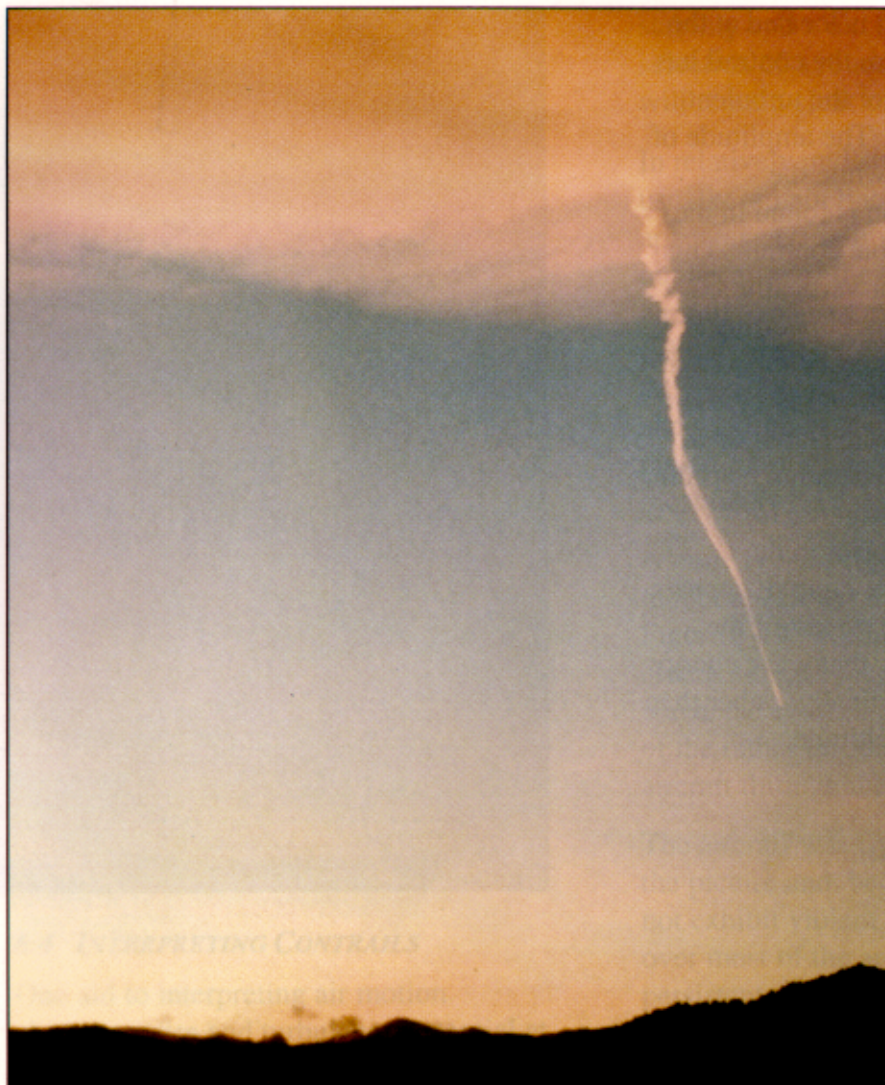
Figure 6-21. Contrail with turbulent zone, over Boulder, Colorado (photograph ©, F.M. Ralph).

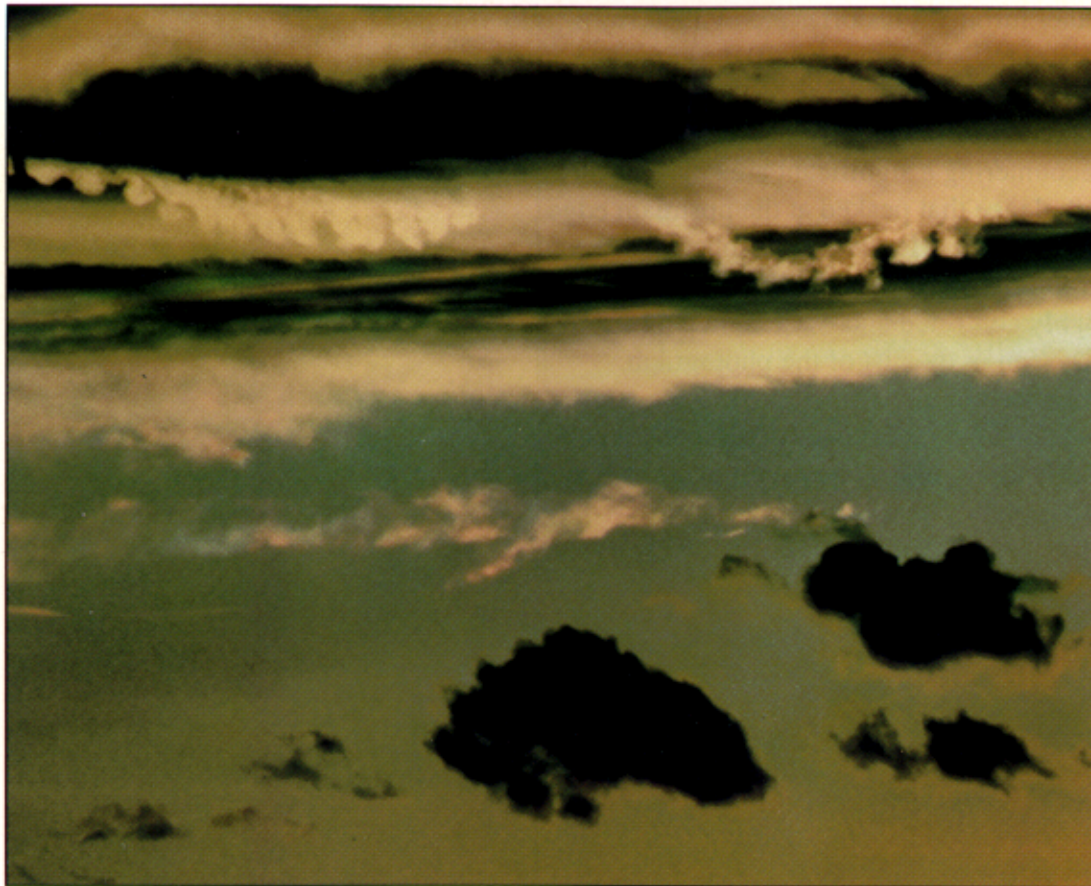
*Figure 6-22. Contrail associated with lenticular and rotor clouds, showing very turbulent conditions aloft (photograph ©, K. Langford).*

A striking photograph of very turbulent conditions is shown in Figure 6-22. This contrail, located below lenticular clouds and above an area of rotor clouds, shows evidence of wave disturbances and very turbulent conditions that were likely manifested as severe turbulence. In this instance, disturbed parcels are violently displaced on very small horizontal scales. The longer-wavelength disturbance in Figure 6-22 is likely contributing to passenger and crew discomfort, but the more serious problem is defined by the puffy nature of the contrail.

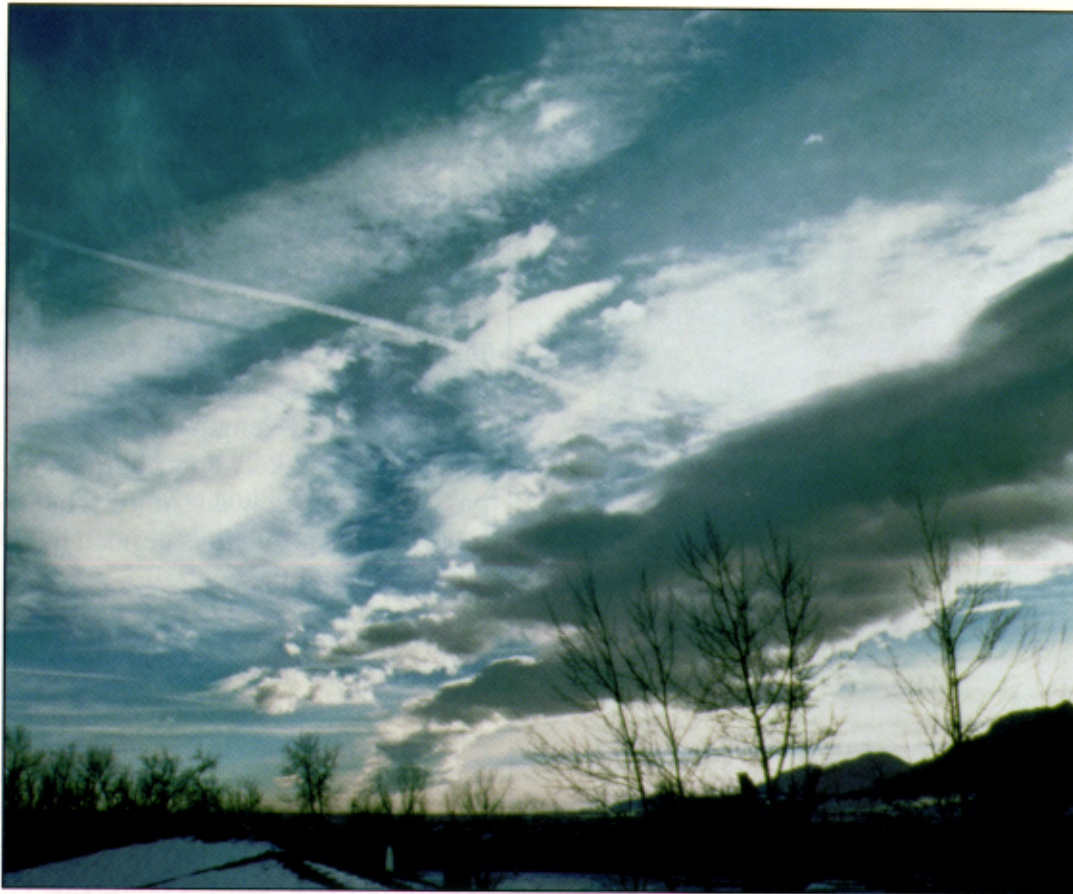
*Figure 6-23. Contrail located above rotor and lenticular clouds, indicating smooth conditions aloft (photograph ©, 1988, R. Holle).*

The final contrail photograph (Figure 6-23) shows that (as most pilots know) there are always exceptions to the rules applied to descriptions of the atmosphere. Even though lenticular clouds and rotor clouds indicate the potential for turbulence, a contrail often can provide some indication of the most turbulence-free altitude in such an area. In Figure 6-23, the cloud signature is indicating a rotor cloud topped by a series of lenticular clouds that are related to vertical gravity wave propagation. However, the contrail history indicates that the conditions encountered by the aircraft were relatively benign. Thus, the presence of laminar contrails in areas that contain mountain waves can aid pilots in selecting turbulence-free altitudes.

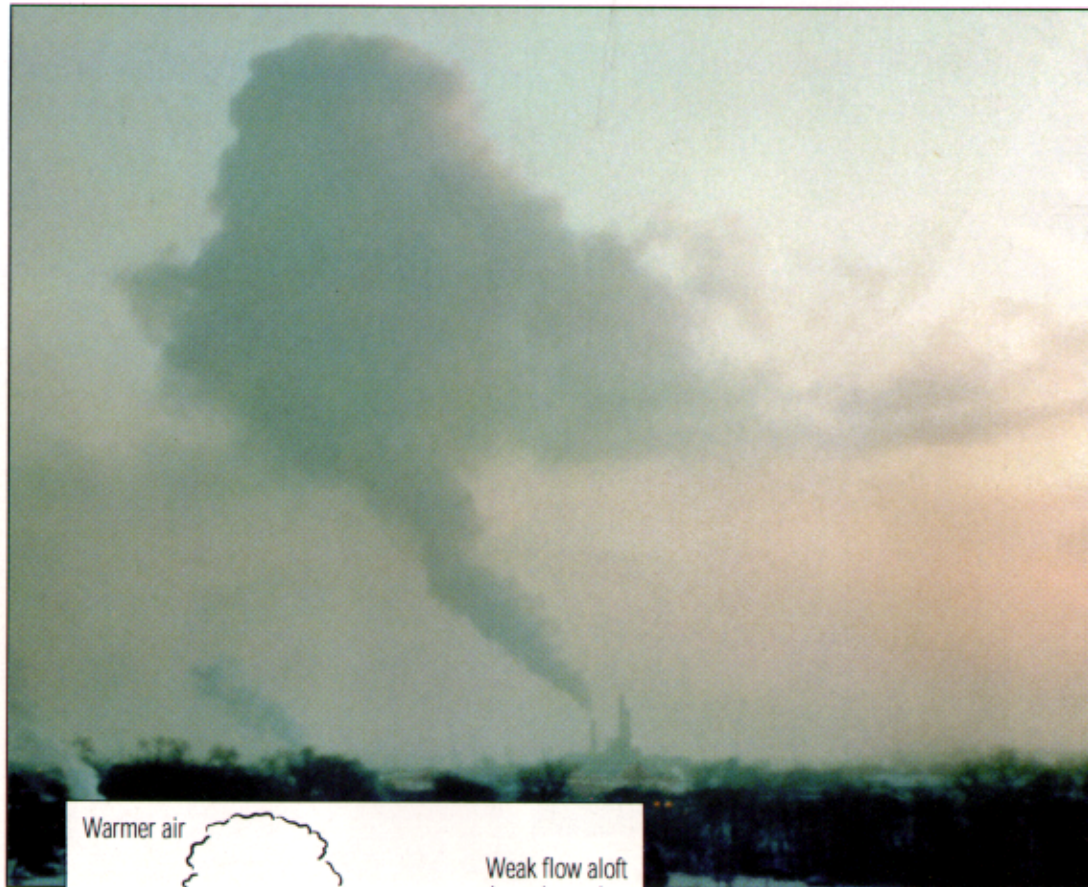
Figure 6-24a. Smokestack plumes with an inversion layer in Boulder, Colorado (photograph ©, 1992, P. Neiman).

Figure 6-24a depicts the plumes from several smokestacks located in Boulder, Colorado. Perhaps you have encountered similar patterns on your way to the airport before a trip. In this example, the light wind at lower levels is blowing from right to left, and the plumes do not significantly expand with height. This indicates that the steam is moving upward rapidly and that the plume is much warmer than the low-level air. As the plumes penetrate higher, the largest plume breaks through the stable (inversion) layer into warmer air and expands more rapidly. This process is shown schematically in Figure 6-24b. Although not depicted in Figure 6-24, had the wind flow above the inversion been stronger, the plume would have been sharply bent downwind as it penetrated the stable layer and encountered the wind shear.

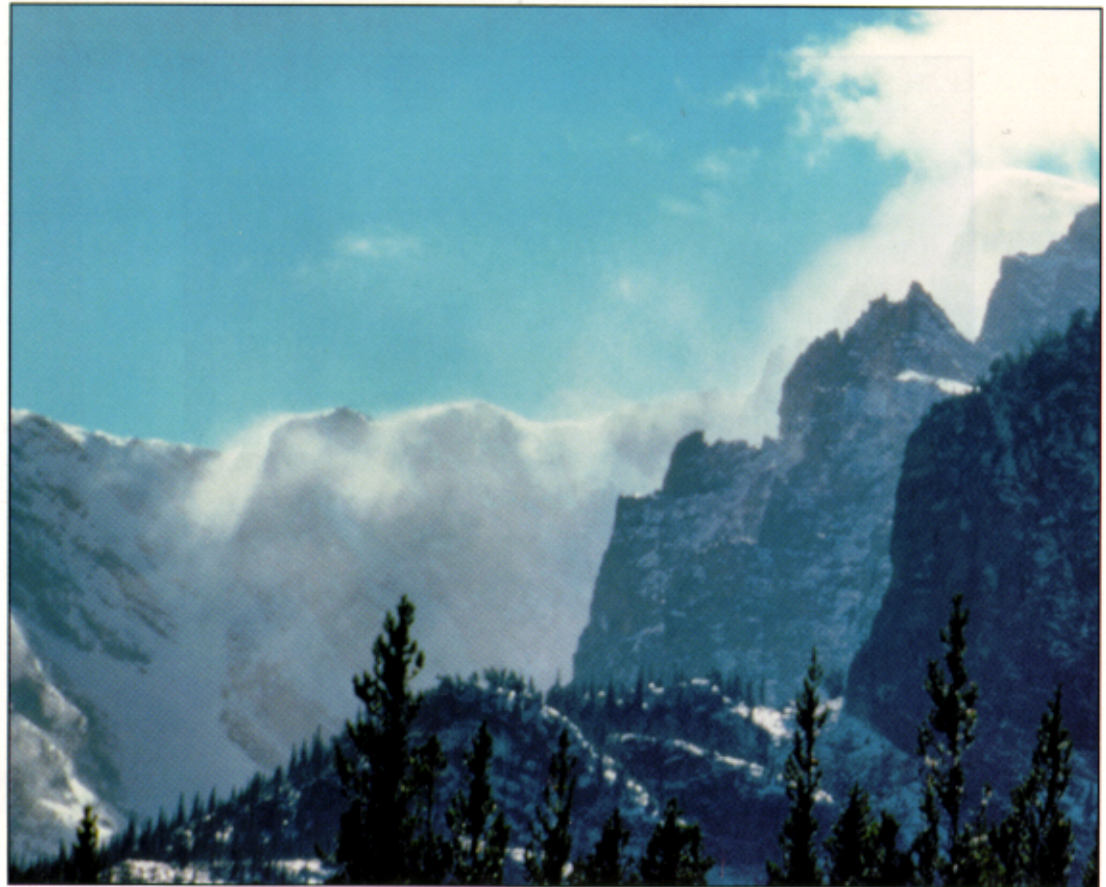
*Figure 6-25. Blowing snow near mountain peaks, indicating likely wave activity (photograph ©, R. Reinking).*

Blowing snow around mountain peaks, shown in Figure 6-25, is an indication of strong wind and turbulence, and the likelihood of mountain wave activity. Similarly, wave disturbances on the surfaces of lakes can warn of strong and turbulent air motion near the ground (Figure 6-26). The latter wave features can be seen as flecks of ground clutter on airborne radar imagery of larger bodies of water.

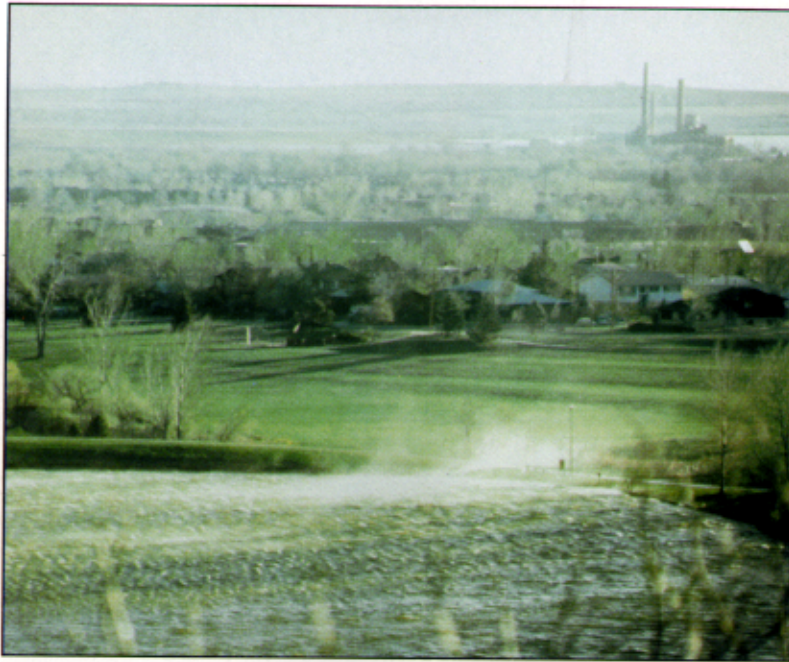
*Figure 6-26. Low-level wind indicators on a lake surface (photograph ©, 1988, A.J. Bedard, Jr.).*

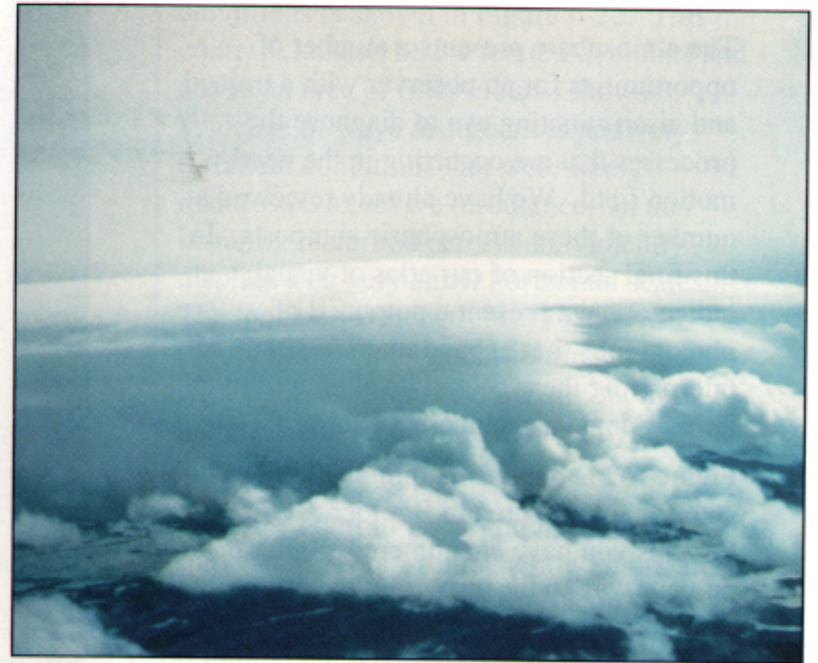
*Figure 6-27. Wave cloud occurring above a layer of weak instability (photograph ©, NCAR).*

Although we have discussed the fact that mountain waves require a degree of stability for their existence, they may occur with weak convection nearby. This situation is shown in Figure 6-27, with a wave cloud overlying a field of shallow convective clouds. Figure 6-28 shows a similar situation near Mount Shasta, California, in which the convection below the cap cloud has probably resulted from heating of the lower terrain upstream of the mountain.

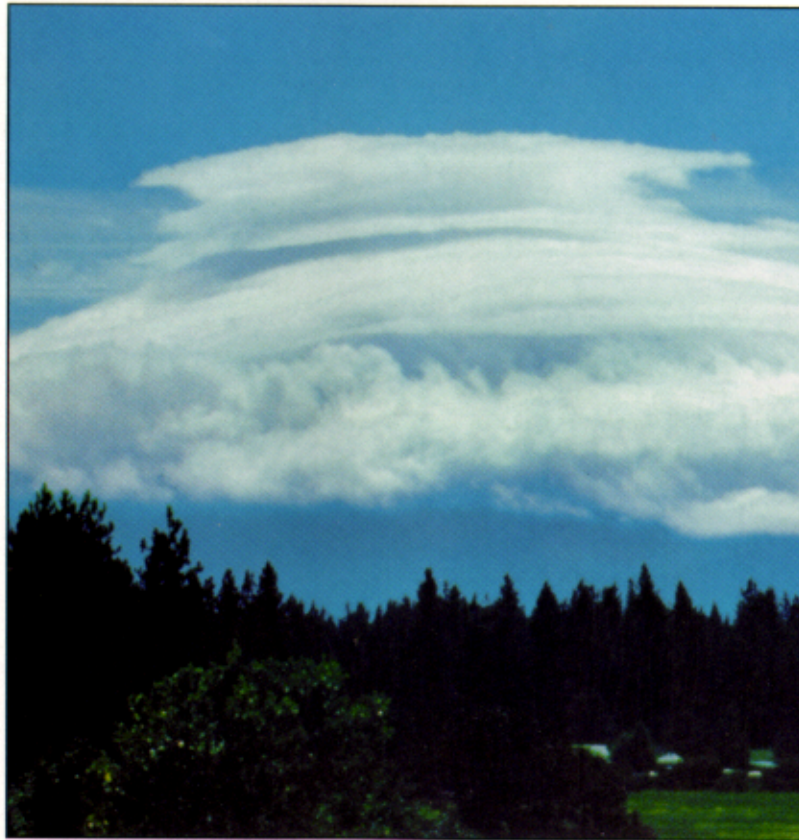
*Figure 6-28. Cap cloud over Mt. Shasta, California, with low-lying weak convection (photograph ©, 1972, R. Reinking).*

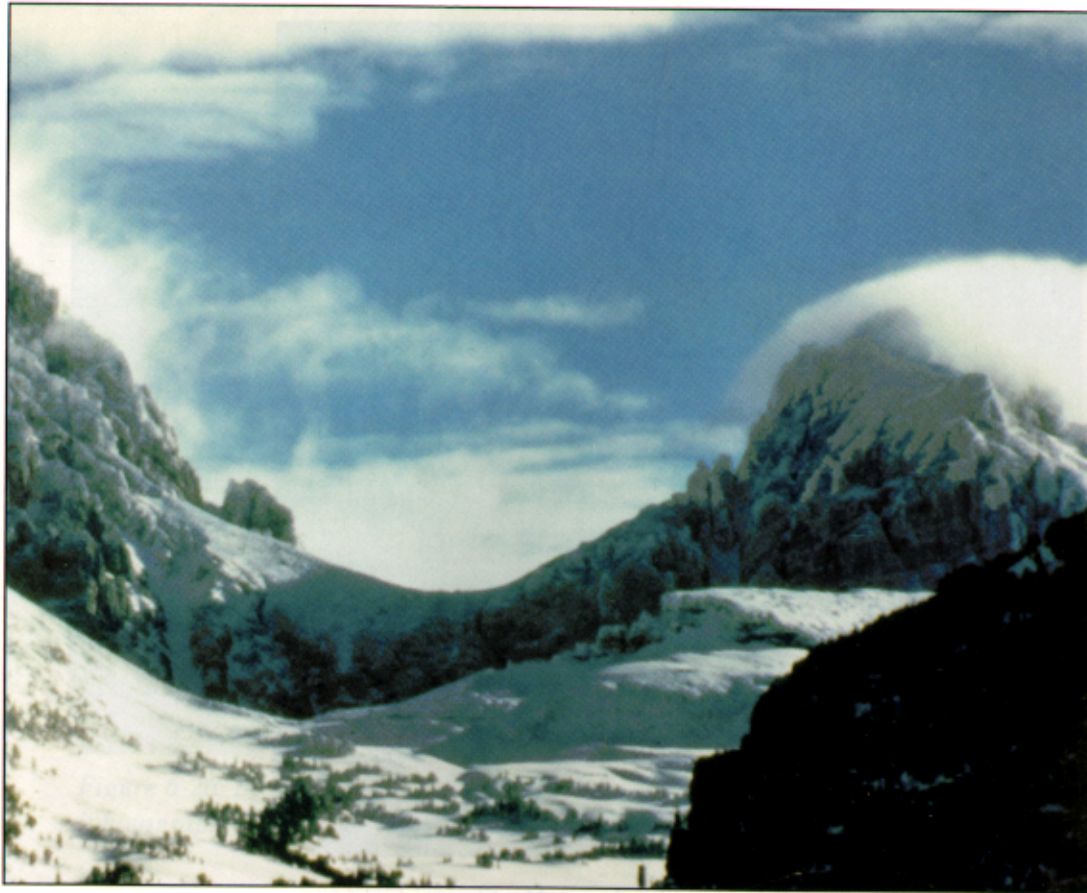
*Figure 6-29. Banner and cap clouds occurring in the Grand Tetons, Wyoming (photograph ©, B. Martner).*

Condensation occurring in air that has been constrained to ascend a mountain or ridge can produce banner clouds and cap clouds. Figure 6-29 depicts two closely spaced peaks in the Grand Tetons of Wyoming, the left peak exhibiting a banner (or flagging) cloud and the right peak showing a cap cloud. These features are signs of strong flows and turbulence near ridge levels. Blowing snow would provide similar clues of this air motion.

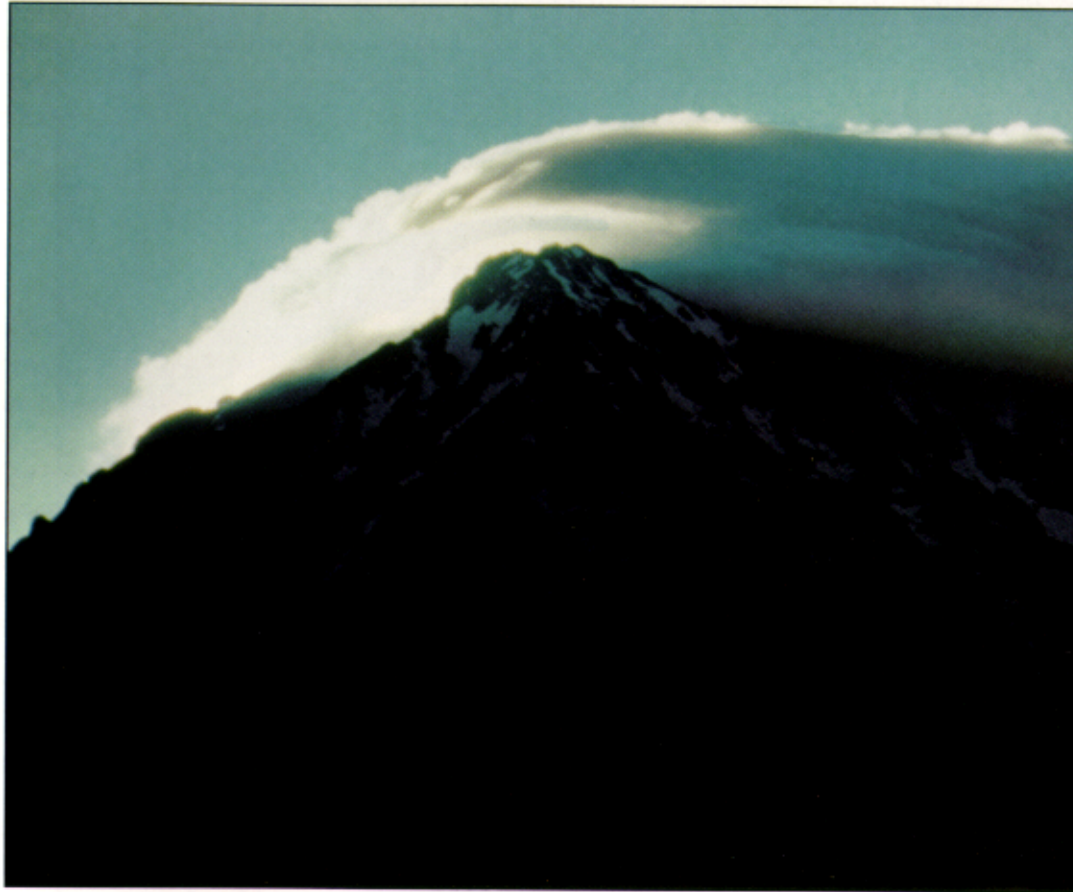
Figure 6-30a. Cap cloud, or cloud associated with a bora (photograph ©, K. Langford).
