FY08 1st Quarter Construction Contractor Safety Seminar

October 16, 2007 Meeting Minutes

QUARTERLY CONSTRUCTION SAFETY SEMINAR

SNL FACILITIES

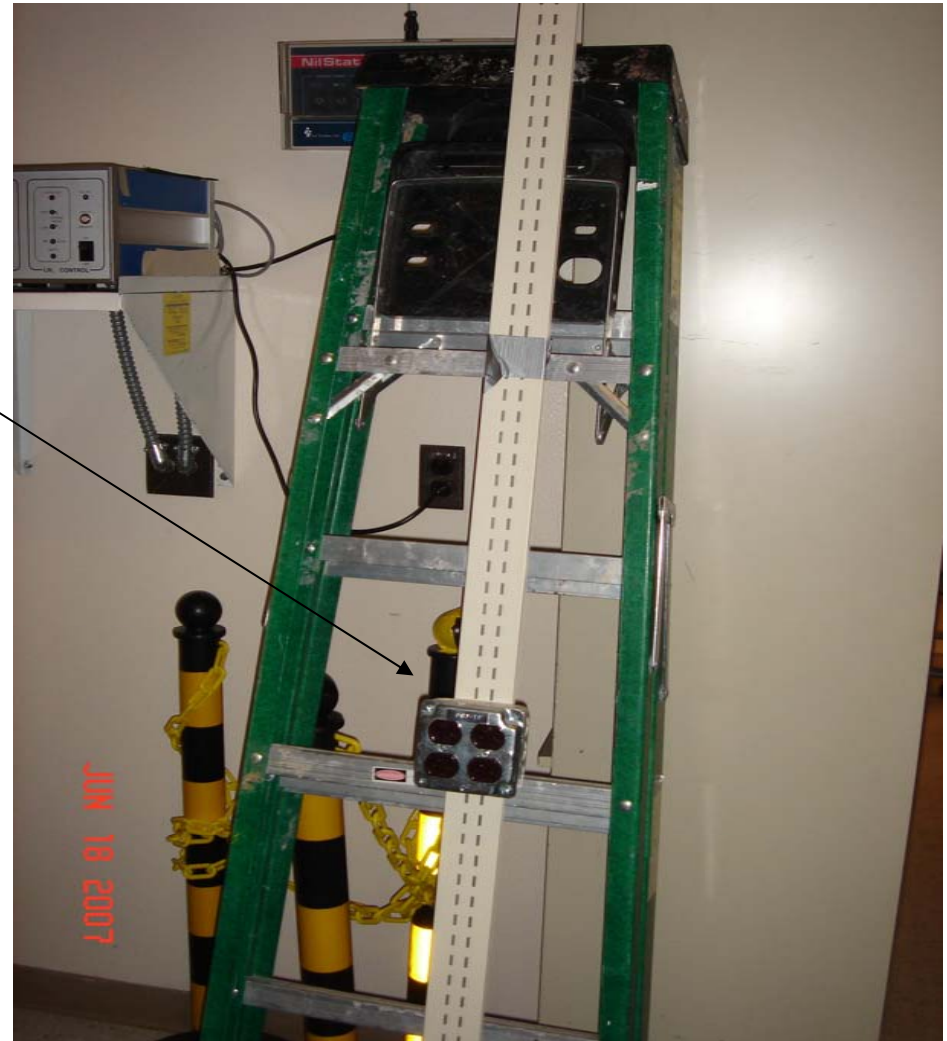
**Channel with
receptacle**

- June 2007, a crew was working in the basement of a building removing Dowcraft panels for a remodel project. The task consisted of relocating 2 doors which required swapping wall panels to make the new configuration work.
- The electrical subcontractor was not on site that day as they were caught-up with their demolition activities.
- When the crew encountered a surface mounted receptacle located on the channel cap strip adjacent to a panel that needed to be removed, they presumed that the receptacle was de-energized.
- This is where they should have stopped and evaluated the situation.

- The crew proceeded to remove the cap strip which held the receptacle and noticed the conductors were not in the conduit.
- They made the decision to continue with removing the panel. It was during this process that a corner of the panel snagged the wire and pulled on it.
- This caused the circuit to short and trip the breaker at the panel.
- No one received a shock.

- Work was immediately stopped and SNL was notified.
- The area was barricaded with caution tape and the electricians were called to make repair.

- We reviewed the lesson learned from this incident with the workers stressing the following:
 - Reminding workers of the company's safety plan requirement to stop work when unexpected conditions are encountered or new hazards are identified;
 - Workers or the foreman should have notified the electrical subcontractor to remove the conductors so that the wall panels could be removed and relocated in a safe manner;
 - Workers have the right and responsibility to stop and evaluate all work which appears to be hazardous. There will not be any negative consequences for stopping work even if the activity is determined to be safe.

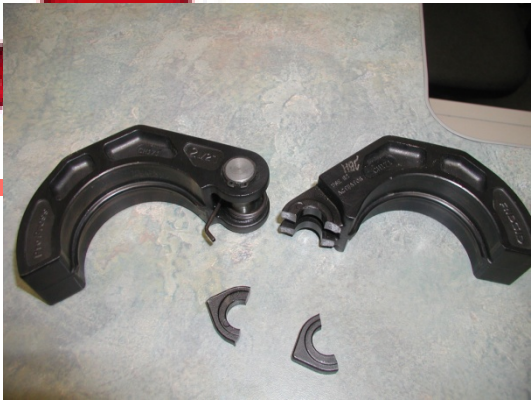
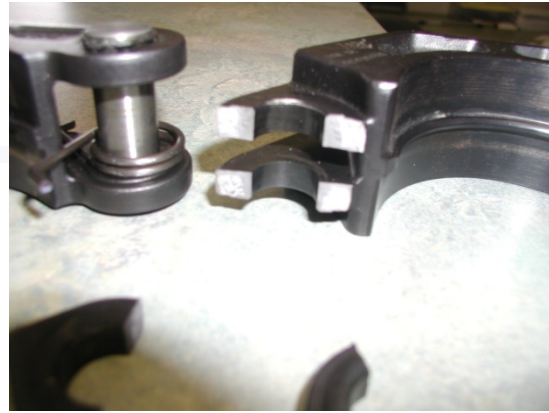
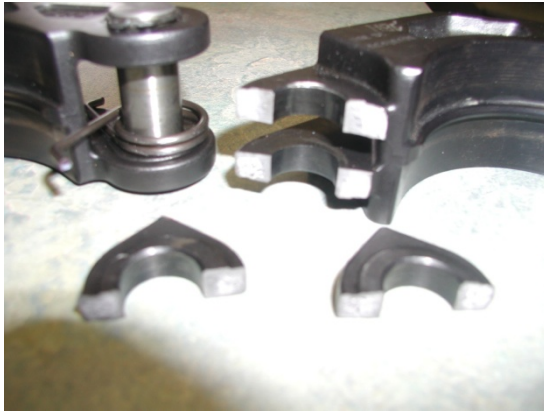
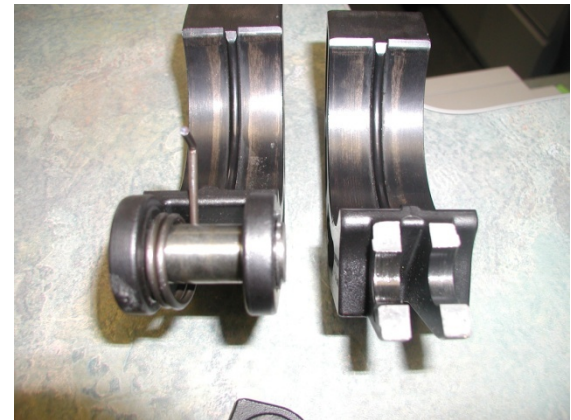
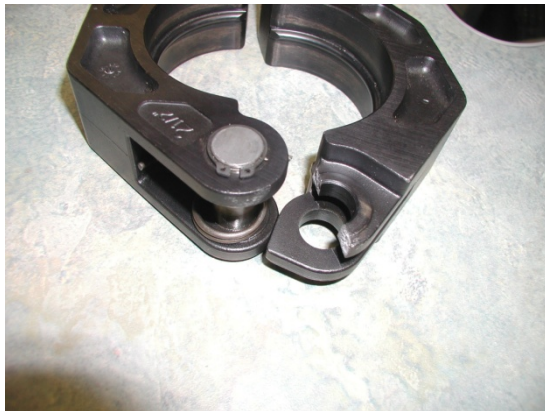
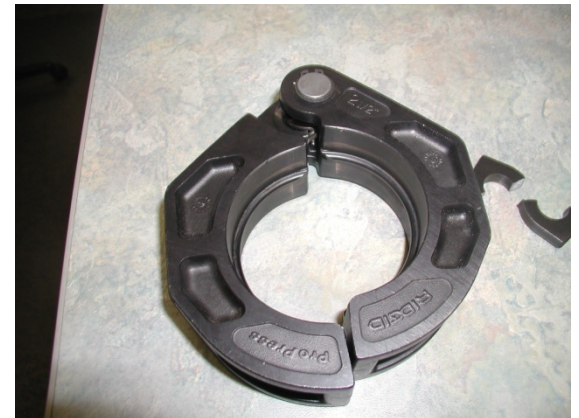
- While working at Sandia, an employee was working on the installation of some piping with the aid of a ProPress machine. While using this device, the collets broke while the device was under pressure, hitting the individual on the leg.

- The collets were found to have metallurgy issues, which were addressed by the manufacturer.
- A recall was issued on the range of collets suspected of being defective. A retrofitted guard was designed, implemented, and made available to all users.
- We re-trained all users on this product and its new parts, then allowed use of this product to continue.

- The employee was monitored, and treated with first aid.
- The broken device was barred from use pending investigation and recovery plan.
- The pieces of the device were gathered, photographed, and sent to the manufacturer for analysis.
- The manufacturer worked with our employees to gain needed information.

- Manufacturer's Recommendations:
 - Follow RIDGID Strap Retrofit of ProPress XL/R2 Press Rings
 - If you have any questions, please contact Ridge Tool Technical Services at (800) 519-3456 or TechServices@ridgid.com.

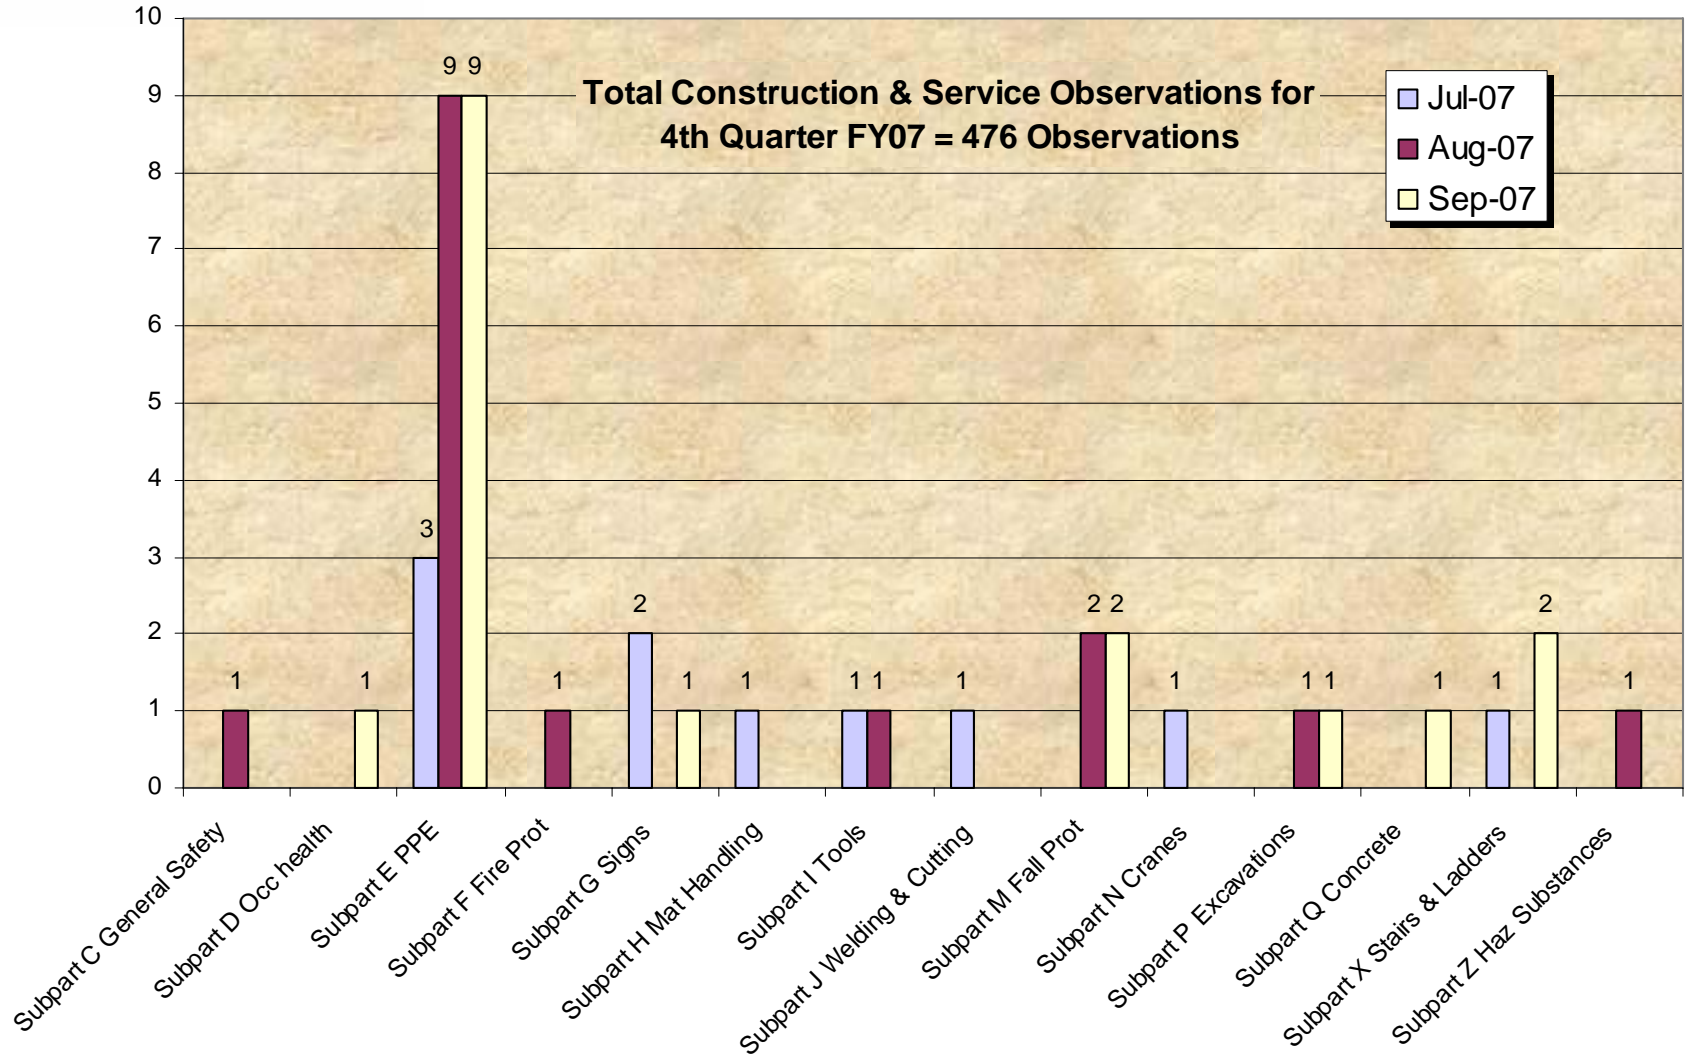
Non-compliant Observations OSHA 1926 for Jul - Sep 2007

Graphs were provided showing observations by OSHA 1926 Subpart and ES&H 01065 Specification categories, discipline trends, construction deficiencies and injuries for the period July – September 2007.

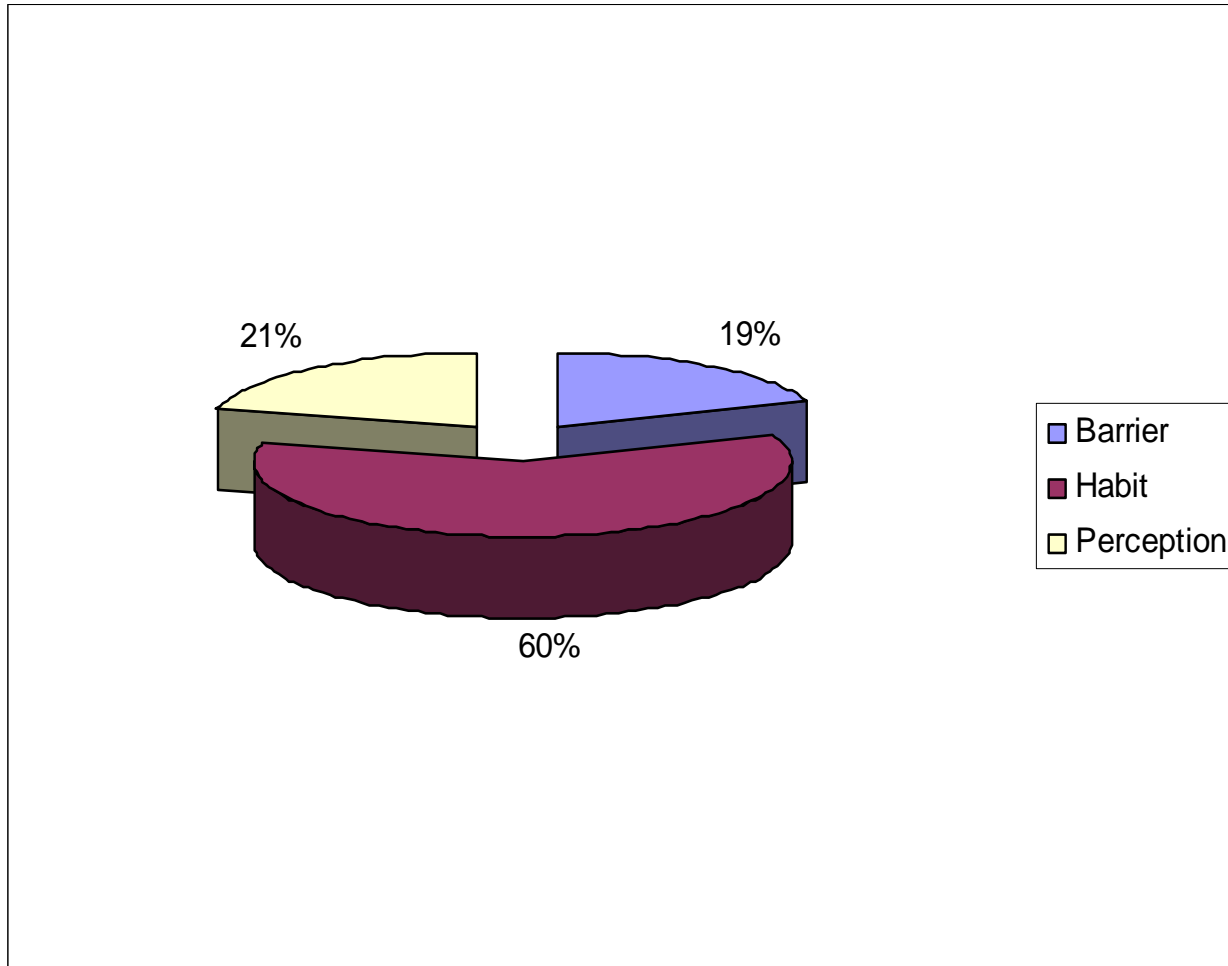
Data Categorization: June-August

- Habit was largest category
 - Large number of concerns for PPE Eyes/Face and Hands
 - Forgot/Left somewhere
 - PPE Lanyards and email reminder
- Perception was second category
 - Highest number of concerns Pre-Job Inspection (PJI) and Proper Tools
 - Need to educate workers on proper methods/techniques
- Barriers was second category
 - Highest number of concerns PJI and Proper Tools
 - Company does not require PJI
 - Tool not provided
 - Easiest to correct, eliminate barrier once determine what it is
