TN-PLANT MATERIALS-61

Erosion Control Effectiveness of Vegetative Practices After the 1993 Southern California Wildfires

EROSION CONTROL EFFECTIVENESS OF
VEGETATIVE PRACTICES AFTER THE 1993
SOUTHERN CALIFORNIA WILDFIRES

July 1995

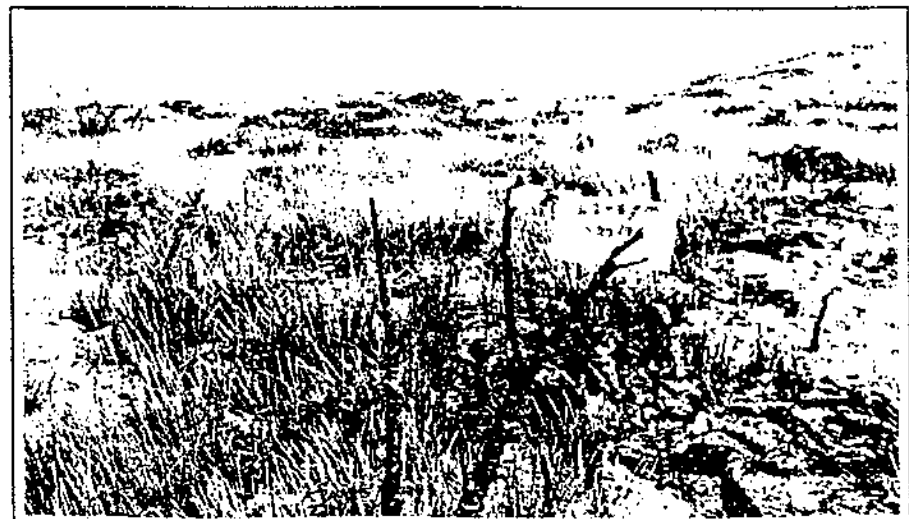
Laguna Beach Fire of 11-2-93

Hydromulched and Seeded 11-22-93±
(Bonded Fiber Matrix)

13. Observations suggest that hydromulch provided protection from sheet and rill erosion immediately on application. The degree to which the mulches were intact and offering erosion protection when we observed the sites in April varied; mulch at T3 (which was apparently applied with a solids content below specifications), had significantly degraded and was failing as platy fragments up to one foot or so in diameter. Sheet and rill erosion at T1 had 'sliced' through the mulch and was attacking the underlying soil, although protection was still afforded areas where the mulch was intact. At the other end of the spectrum, the bonded fiber matrix applied at L2 was only slightly degraded, with an essentially intact mat up to 1/4" thick.

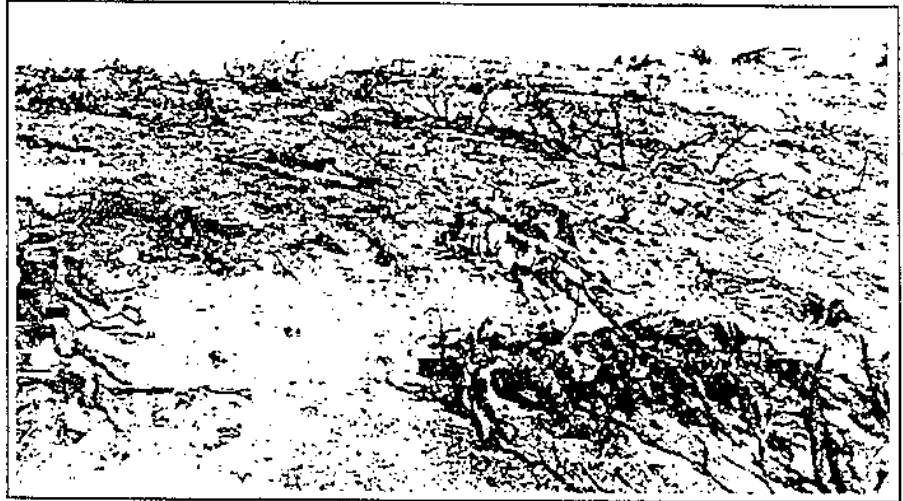
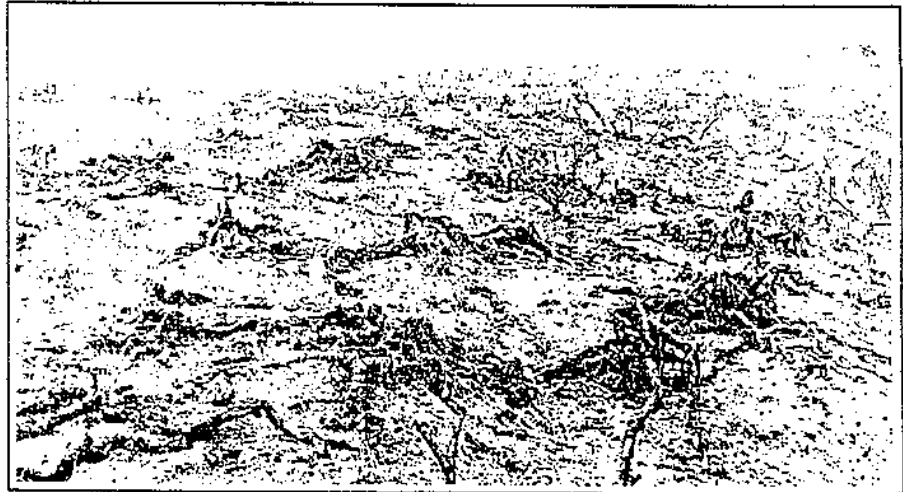
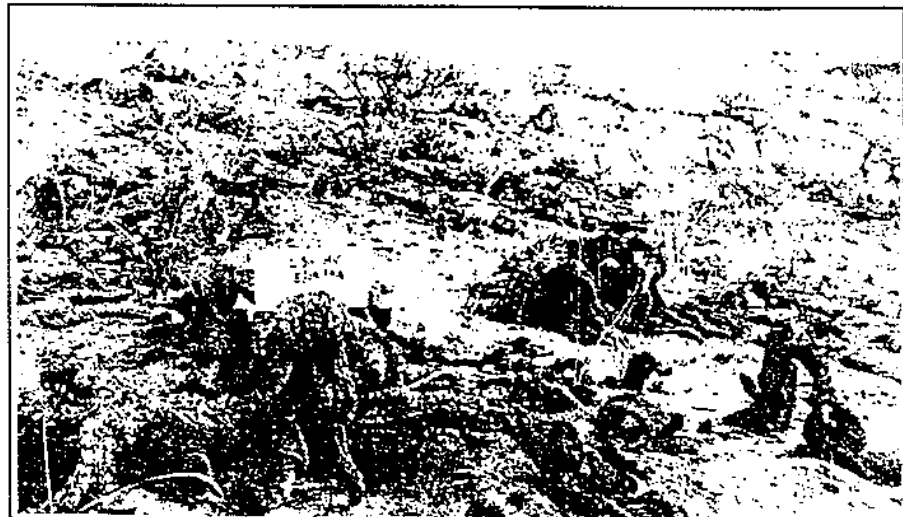
Laguna Beach Fire of 11-2-93

Control -
No Seeding or Mulching

(left 1/3 of photo shows
edge of bonded fiber
matrix application)

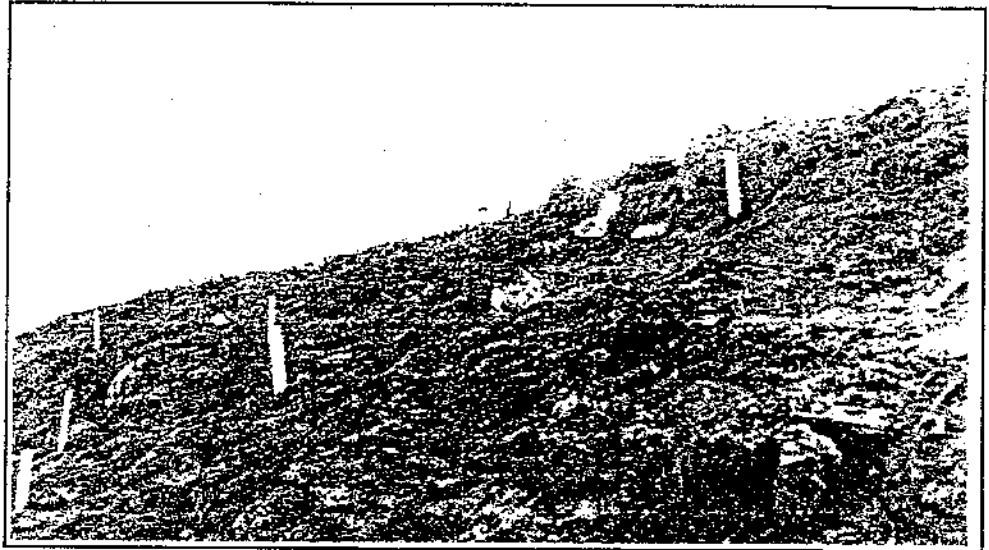
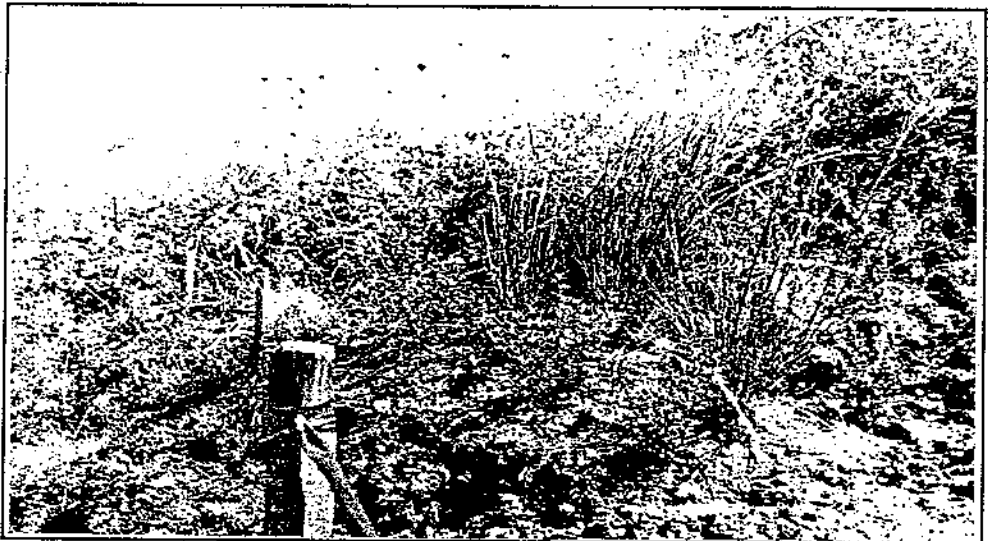
Study Site L-6

Loc: S 1/2, SE 1/4, Sec 182, near T7S, R9W (Laguna Beach 7.5')
Elev: 300' **Slope:** 42% (variable to 70%)
Aspect: N20W
Geology: On or near landslide in siltstone & sandstones that dip obliquely into slope; Laguna Canyon Fault
Soil Series: Cieneba-Rock Outcrop complex (6)
Vegetation/Habitat: California Sagebrush-California Buckwheat scrub

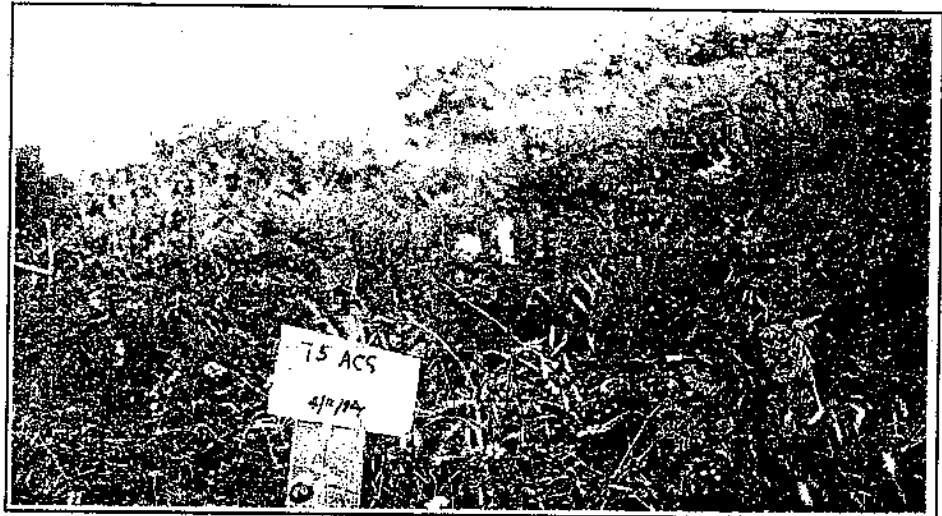
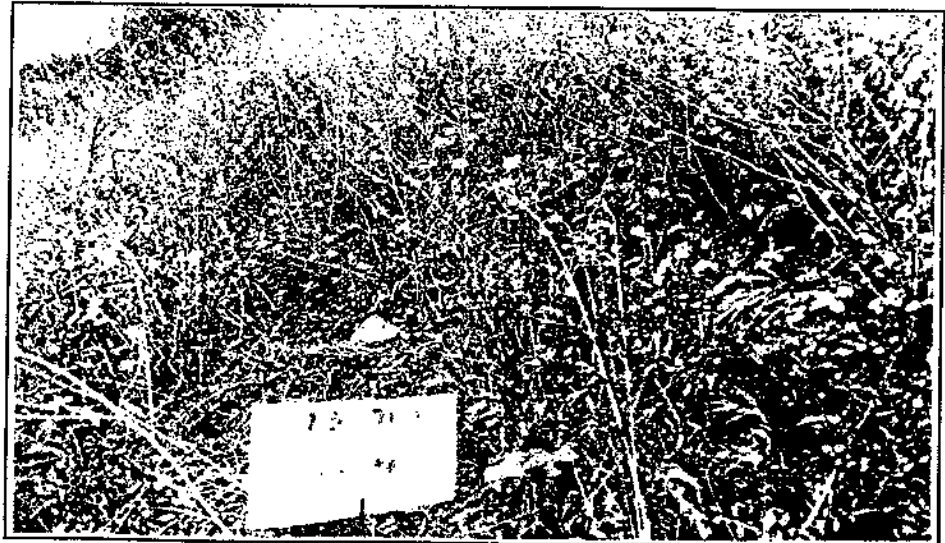
Study Site T-5

Vegetation: Coastal Scrub (1)

15. Slight to moderate post-fire rilling had occurred at most of the sites to varying degrees. Where good cover was established by April (as at T5), rills were present but obscured, and the potential rill erosion rate declined between January and April as growing vegetation offered increasing protection. Rilling was most apparent on some of the plots where cover was poor and where flow was concentrated as it was forced around cobbles and boulders at rocky sites such as at T8. However, the degree of rilling observed in April did not appear to be directly correlated to either percent cover or to whether sites were or were not seeded.

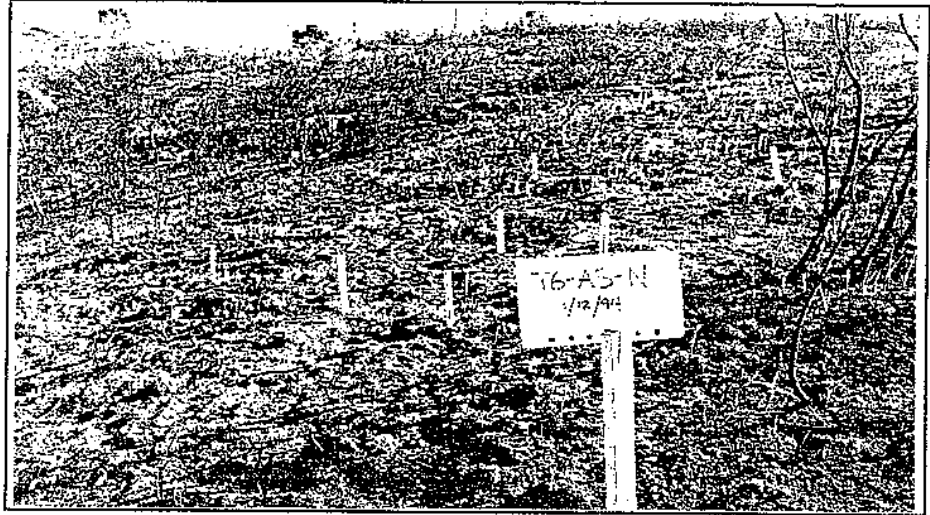
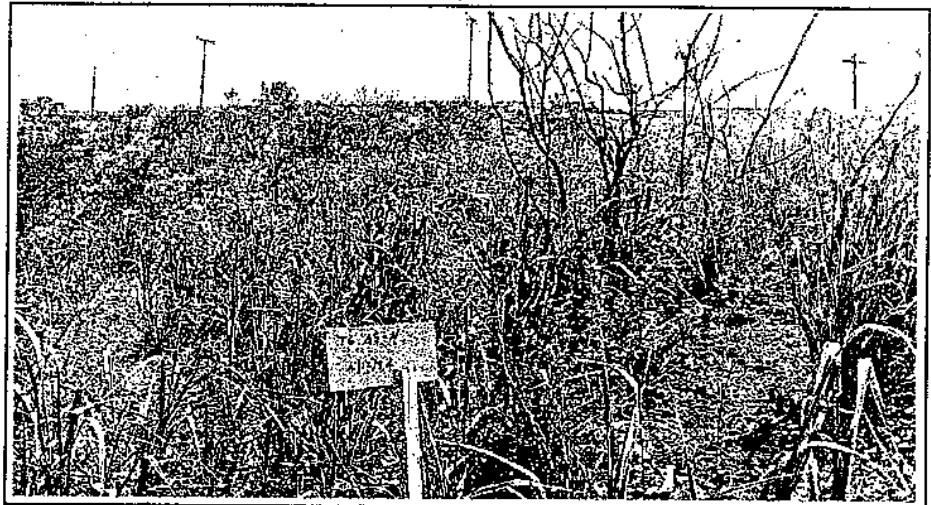
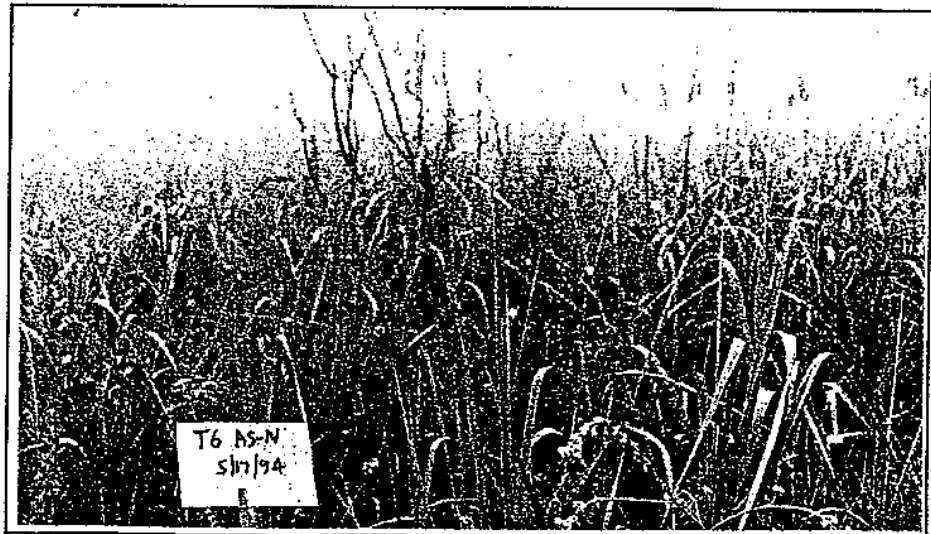
Study Site T-6
Aerially Seeded 12/4/93±

Loc: SE 1/4, SW 1/4, Sec 22, T1S, R17W (Malibu Beach 7.5')
Elev: 1450' Slope: 34%
Aspect: N55W
Geology: Landslide in fractured sedimentary beds that dip steeply, obliquely into slope; Complex structure.
Soil Series: Millshoim (5)
Vegetation: Coastal Scrub (1)
