# San Diego CIREN Center

Rollover crash research:

Anatomy of a Rollover

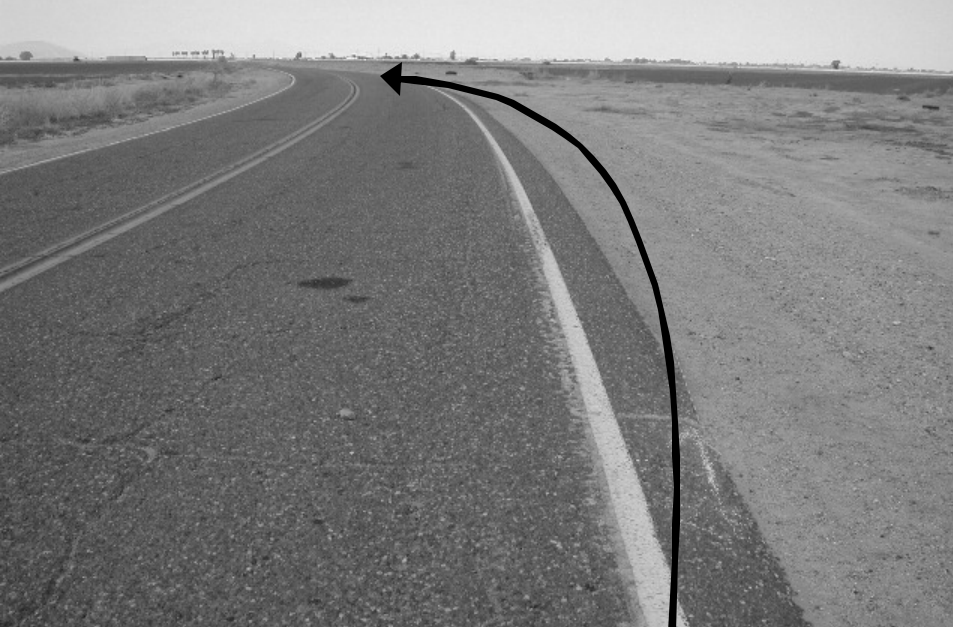
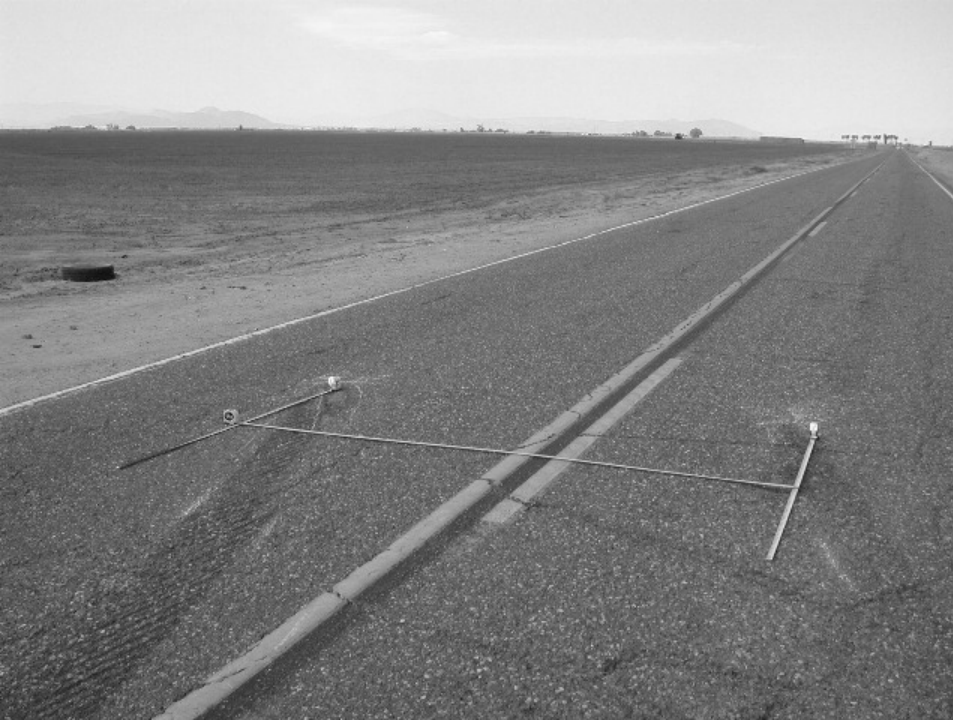
# Single Overcorrection steering

**Trip Right**  
**12 quarter-turns**  
**1<sup>st</sup> landing top**  
**left front (+ A-**  
**pillar junction)**

SCALE: 1cm = 2.5m

Speed Limit:  
88.5 kmph  
55 mph

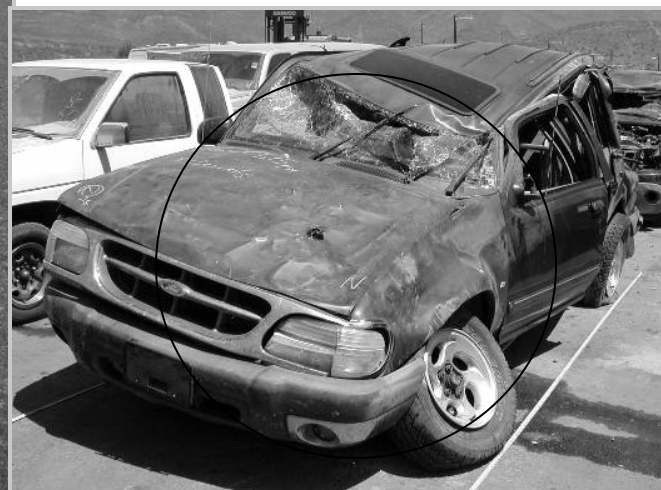
35 cm M/C... 1<sup>st</sup> landing @ left A, W/S header

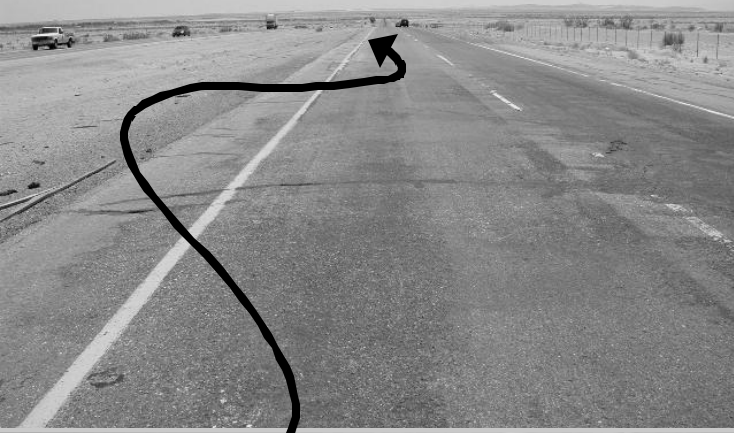
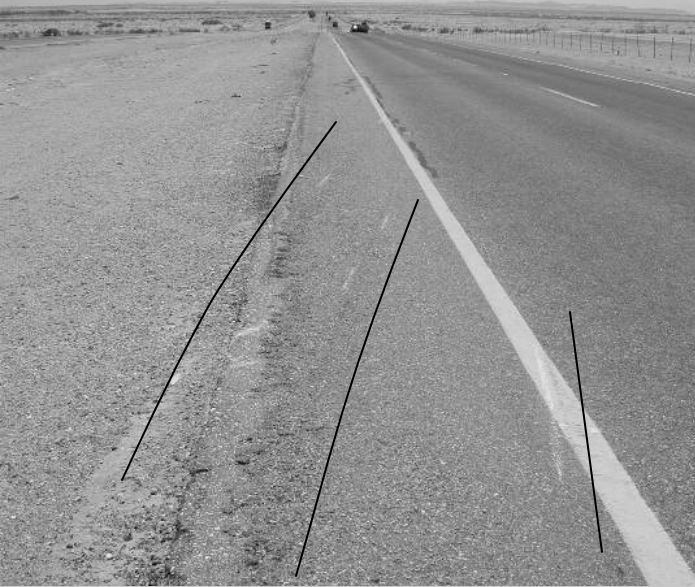
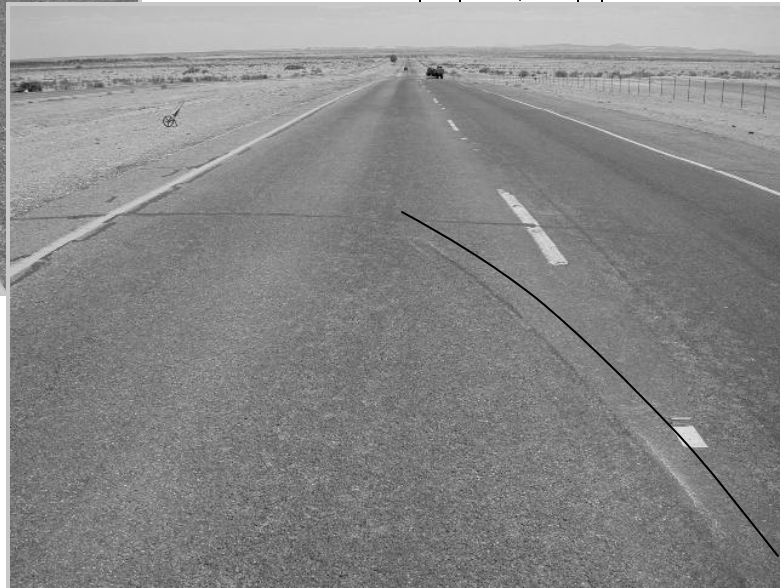
# Double overcorrection steering

**Trip-over, right**  
**16 quarter-turns**  
**1<sup>st</sup> landing top left**  
**A-pillar & roof rail**  
**Velocity @ Trip \* 27 mph**

N  
04-19/20  
Not To Scale

- ← 2nd greenhouse impact, Right roof rail (6th 1/4 turn)
- ← wheel gouges
- ← 1st landing, Left roof rail (2nd - 3rd 1/4 turn)
- ← trip point

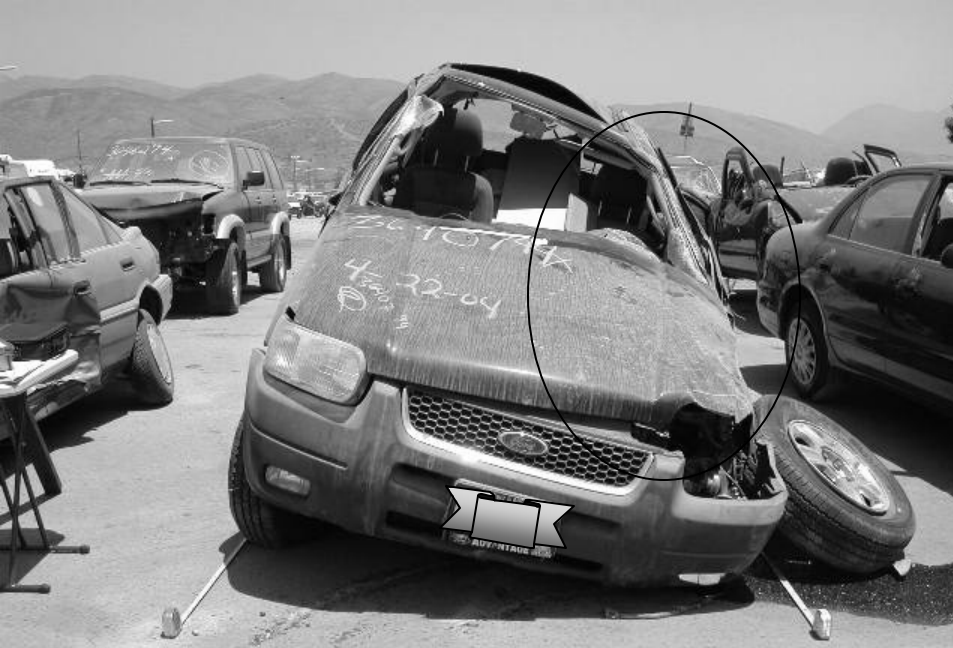
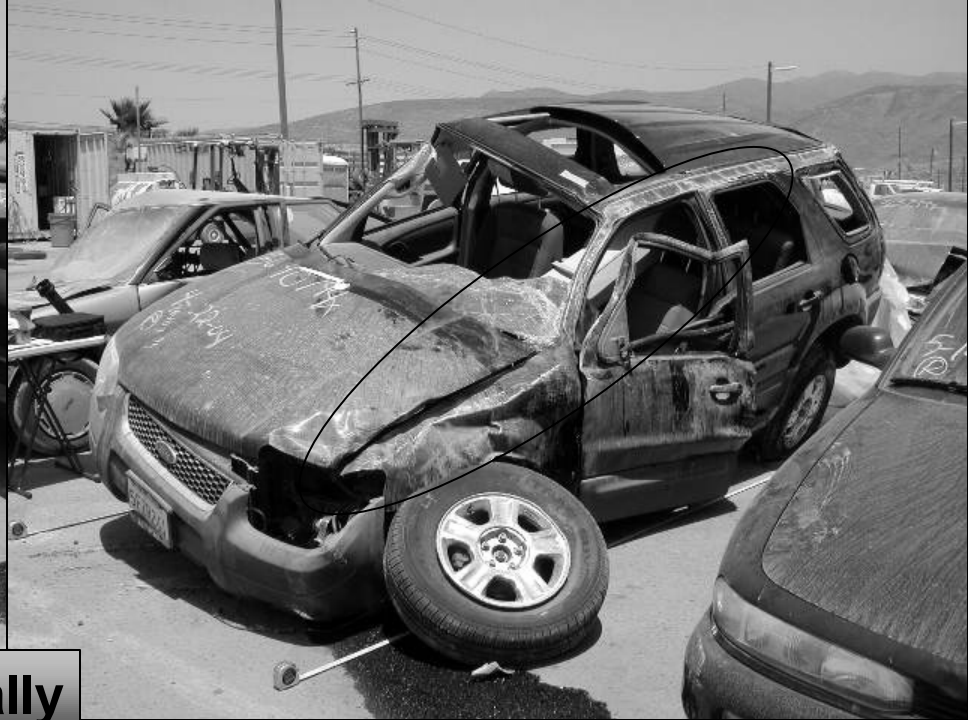
**Max. greenhouse crush 35cms laterally**

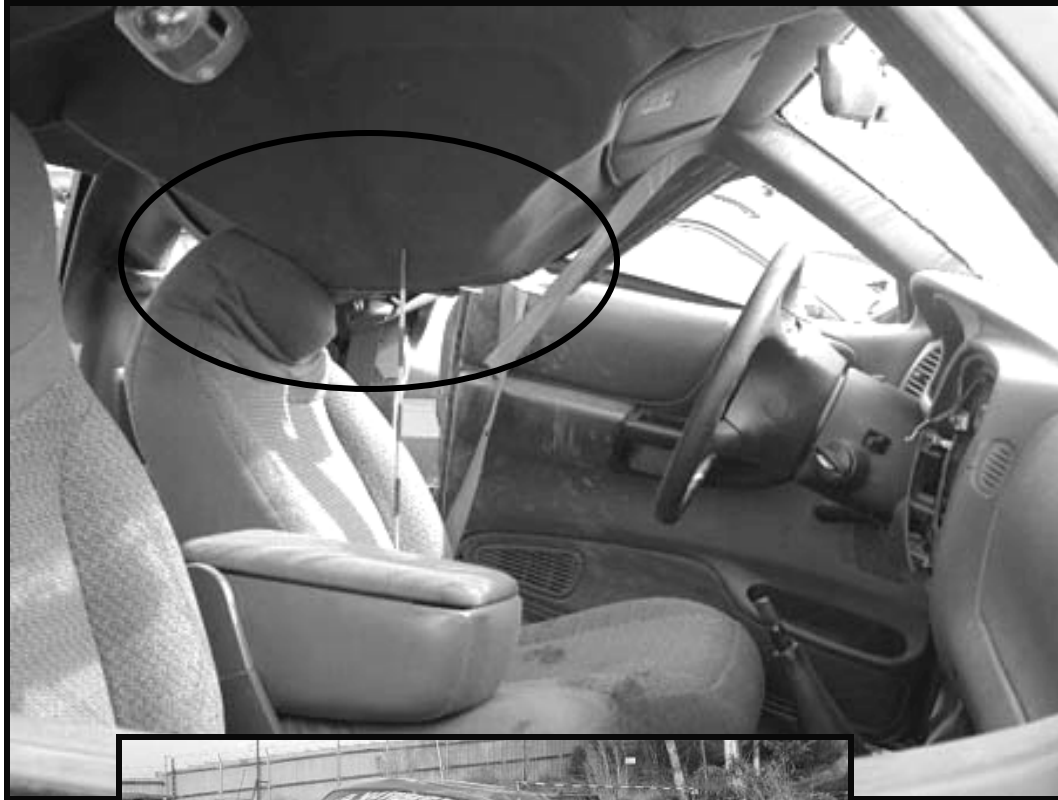
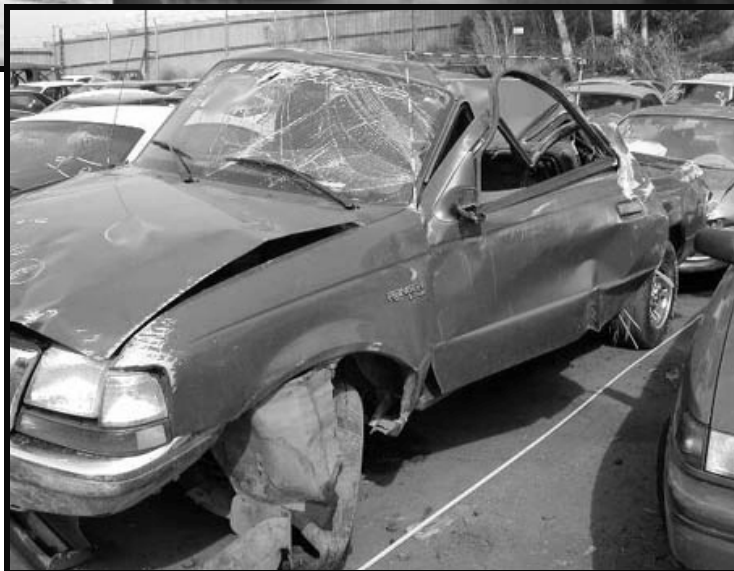
# NO SIGNIFICANT HEAD INJURY: Left rib fractures 7 -10 @ costotransverse junction, Splenic laceration, Grade 3

- Driver - 24 y/o male
- Lap & shoulder belt
  - (no pre-10, not integrated)
- Left Trip-over
- 10 ¼-turn
- 1999 Ford Ranger XLT
- 40 cm M/C @ left roof
- 2 greenhouse impacts

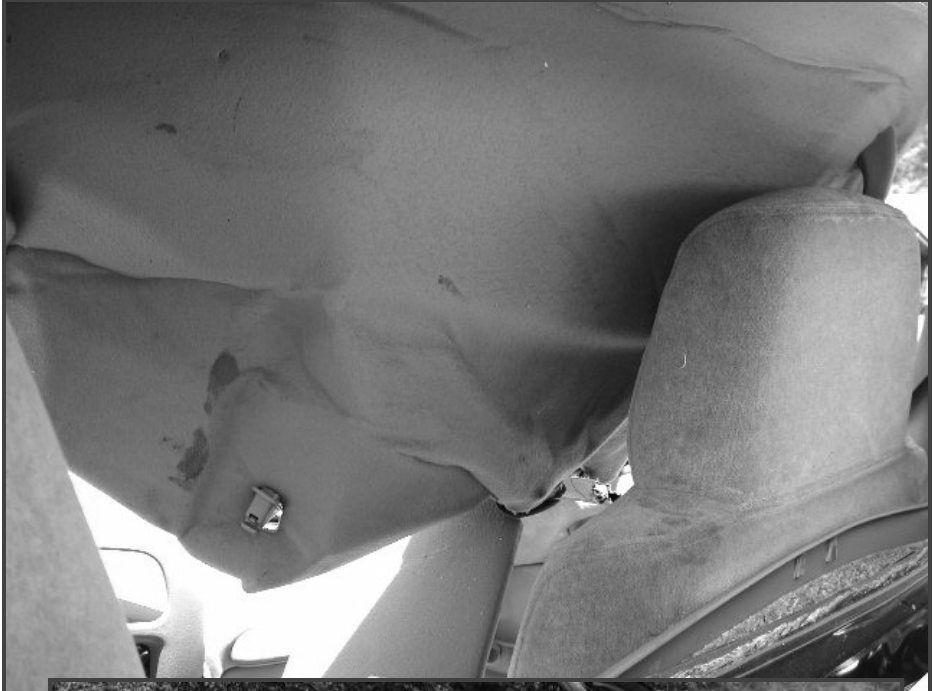
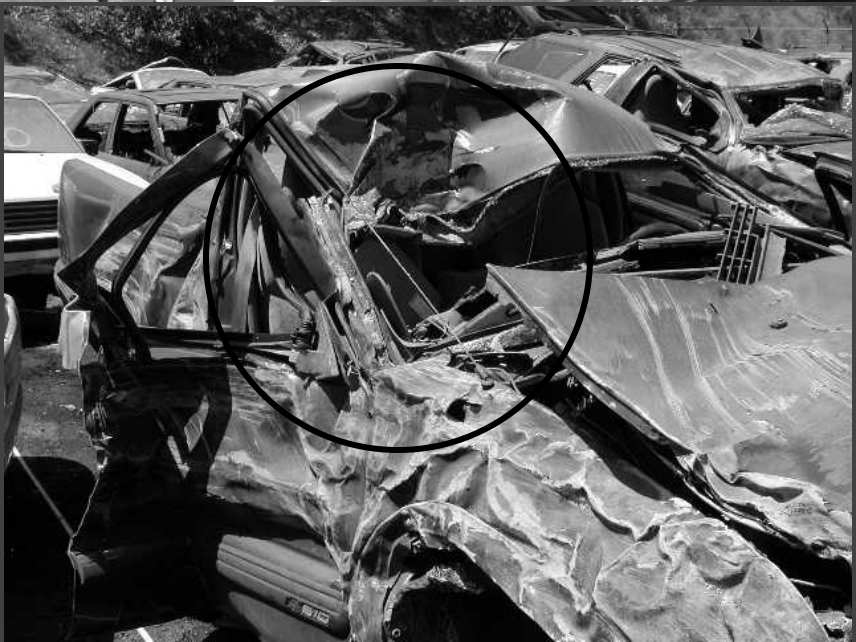
**NO SIGNIFICANT HEAD INJURY: Left forehead abrasions  
Left proximal humerus fracture**

- RF passenger, 25 yo female
- Lap/shoulder belt used
  - (no pretensioner, not integrated)
- Right Roll
- 8 quarter-turn fall-over
- 1999 Chevrolet S-10 pick-up
- 50 cm max crush
- 2 greenhouse impacts

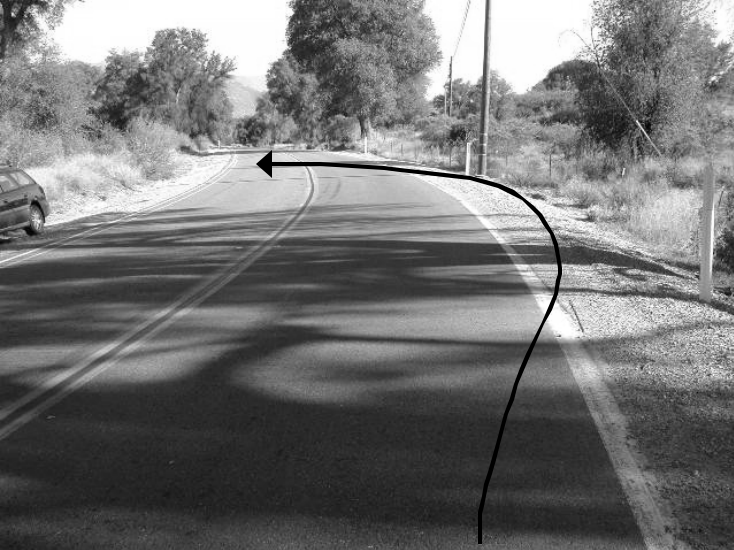
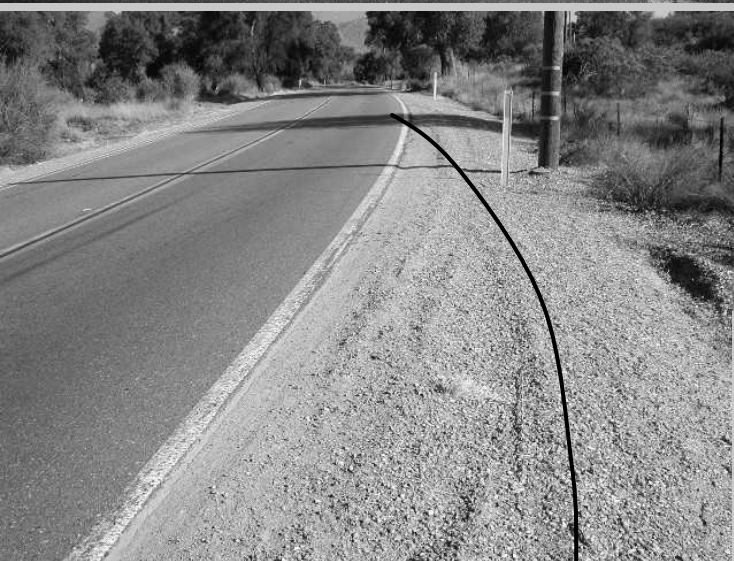
# Trip-over (lateral)

Right side leading  
8 quarter-turns  
1<sup>st</sup> landing top left  
roof rail  
12 cms max. crush  
Velocity @ trip  
21mph

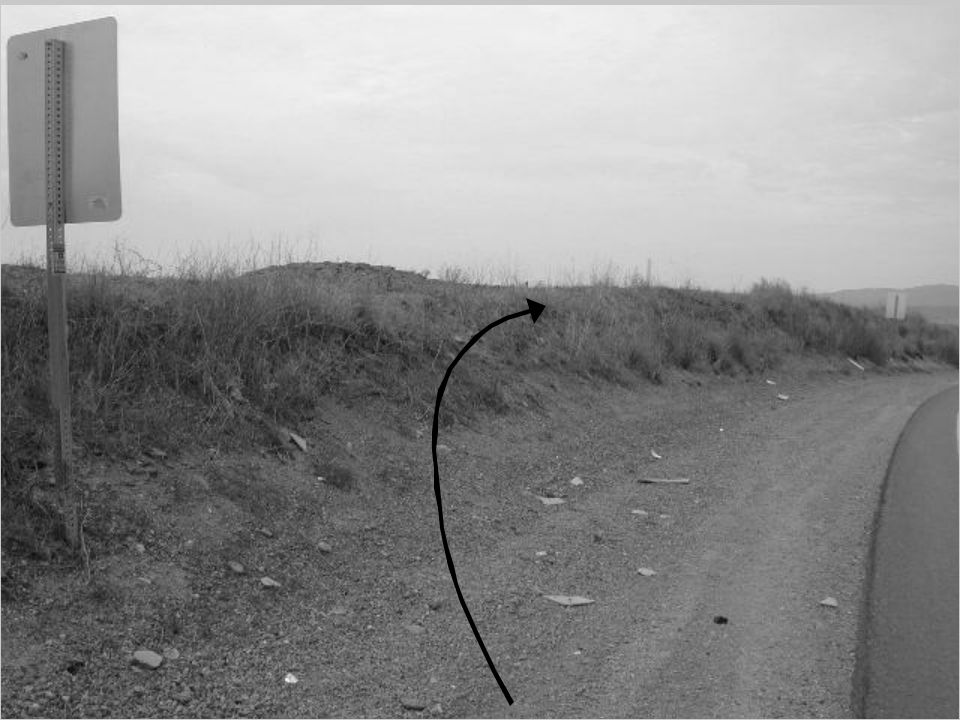
# Flip-over (corkscrew)

SCALE: 1 cm = 2.5 m  
0 2.5 5

**4 quarter-turns  
scratching to  
roof/ no crush**

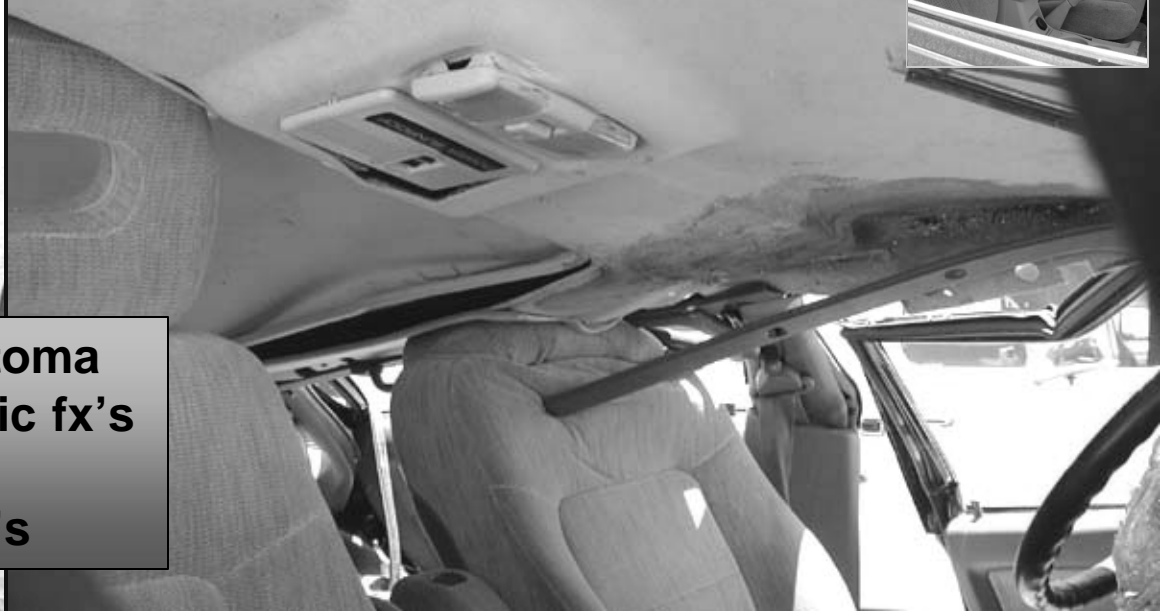
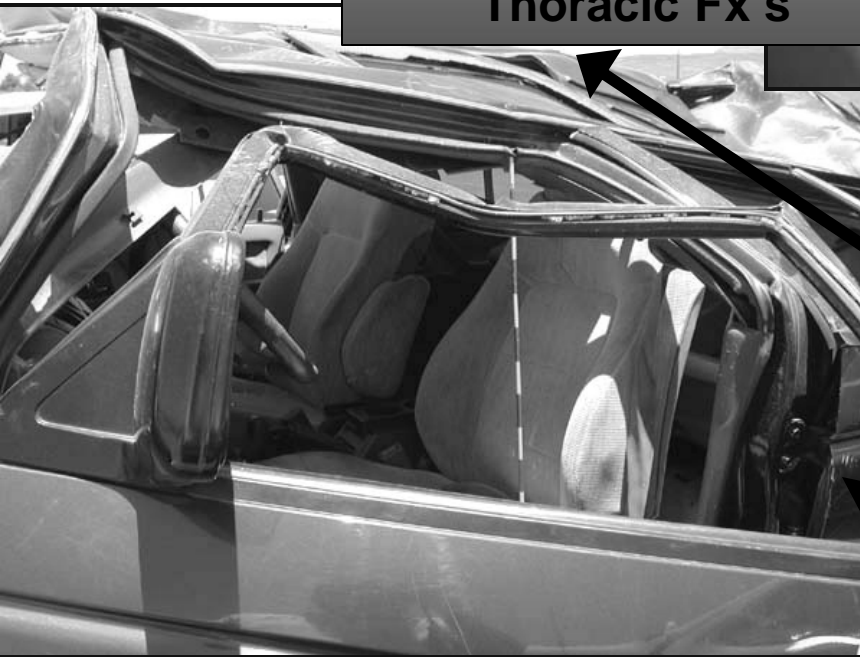
**Note  
"Side-  
sway"  
'A' folded  
mid pillar,  
'B' folded  
@ beltline**
