# Evaluating Incompatibility in Side Impacts

Seattle CIREN Team – Mock, Kaufman University of Washington

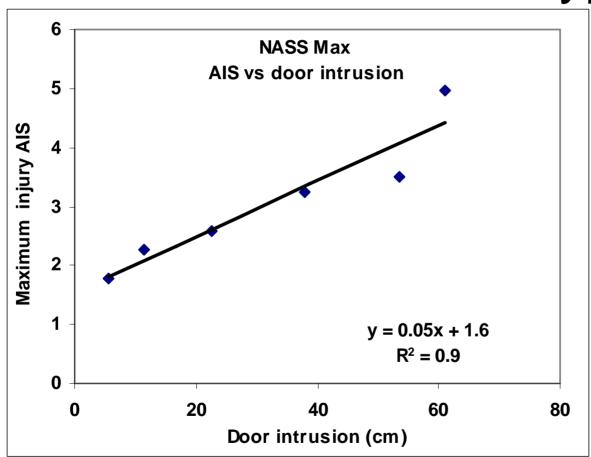
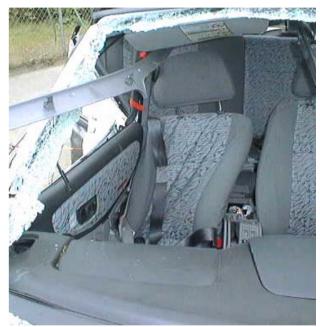
### NASS MAIS v Door Intrusion All Crash Types

MAIS for Thorax, Abdomen, Pelvis

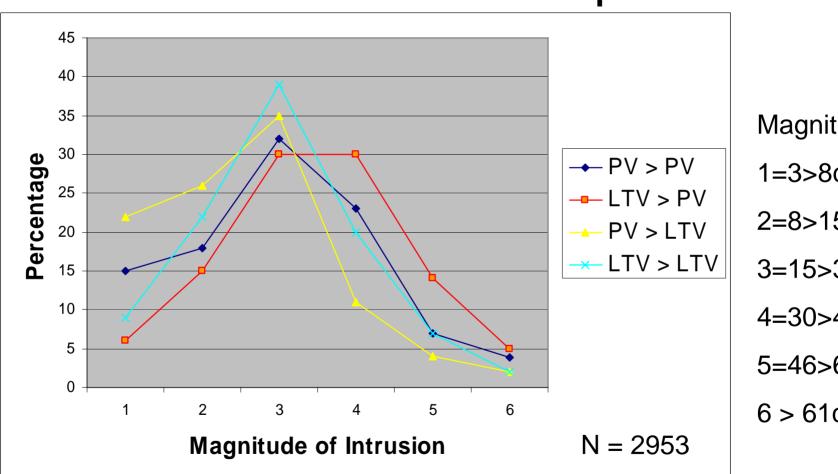
### Side Impact Groups Intrusion in front seat positions

Magnitude

1=3>8cm

2=8>15cm

3=15>30cm

4=30>45cm

5=46>60cm

6 > 61cm

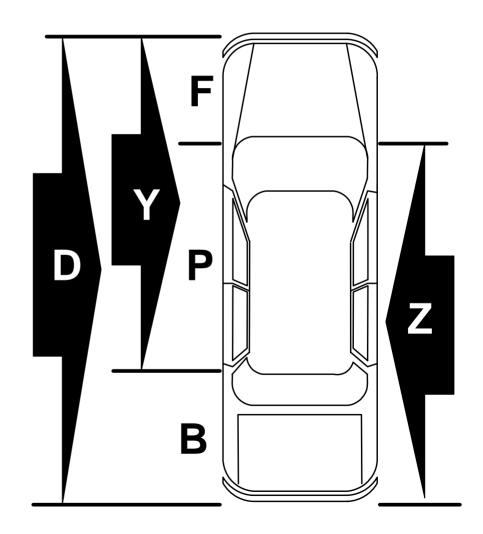
### Side Impact Collision Deformation Classification (CDC)

Longitudinal Locations

For both Left or Right side

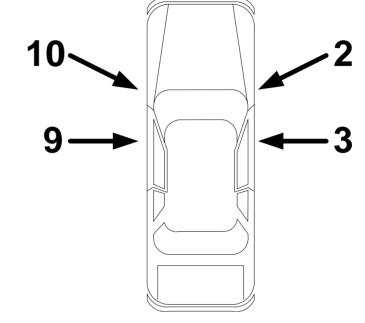
#### Principal Direction of Force - PDOF

- In all the side impact groups 10 and 2 o'clock occurred twice that of 9 and 3 o'clock.
- The PDOF's were evenly distributed among all the side impact zones in each side impact group.

PV > PV
LTV > PV
PV > LTV
LTV > LTV

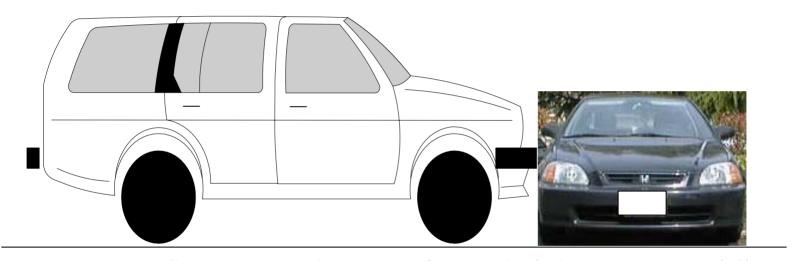
### LTV > PV - Side Impacts

Some LTV bumper frame heights are overriding the lateral side impact support beams

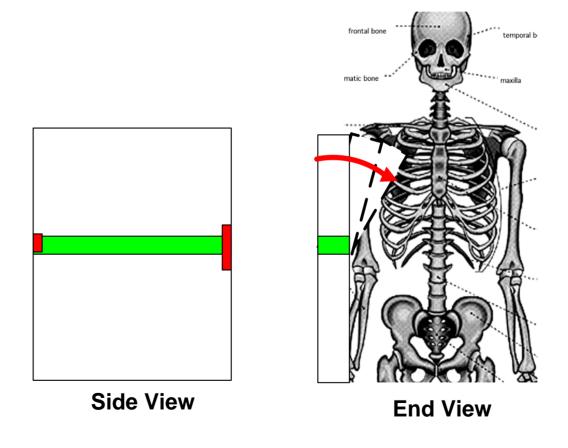
# Side impacts with LTV's impact above lateral door support beams

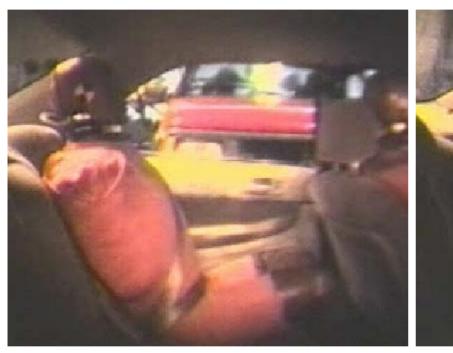
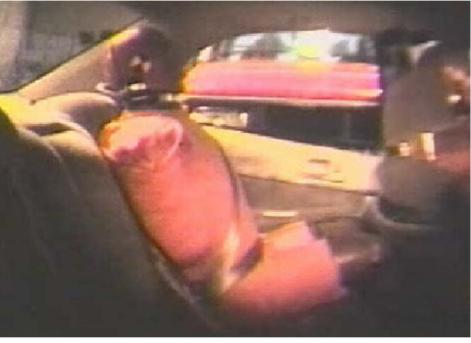
### Side impact crash test LTV > PV

Front of LTV hood and grill into window area at time of impact creating potential direct contact with the occupant's head

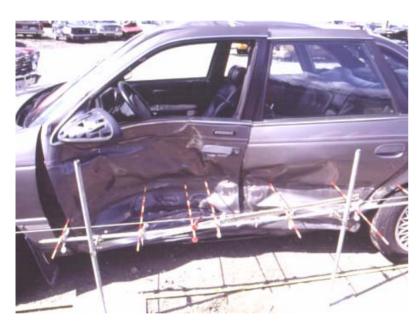
### Lower lateral door intrusion associated with pelvic fractures

Moderate Pelvic Fracture

No center console

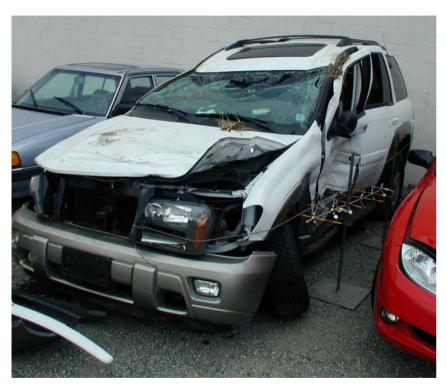
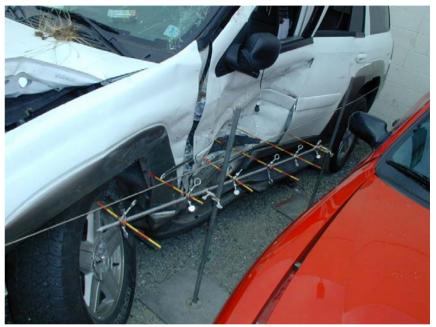
# Side Impact – 10 o'clock Y zone Low door impact – induced rollover

Light Truck Vehicle

Moderate Side impact w/rollover

40's yr. – Female – Lap/shoulder restrained, no air bag deployments

Struck by PV

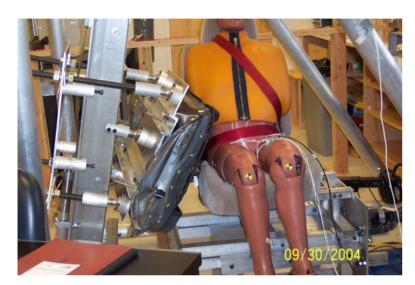
#### Door Angle and Peak Acceleration Results (g)

Peak accelerations at T4 and pelvis

T4
Pelvis

(b) 25
very 10
5
0
30
15
0
Door vertical angle (deg)

The Role of Door Orientation on Occupant Injury in a Nearside Impact. A CIREN, MADYMO modeling and experimental study. Traffic Injury Prevention, 6:372-378, 2005 – Seattle CIREN Team

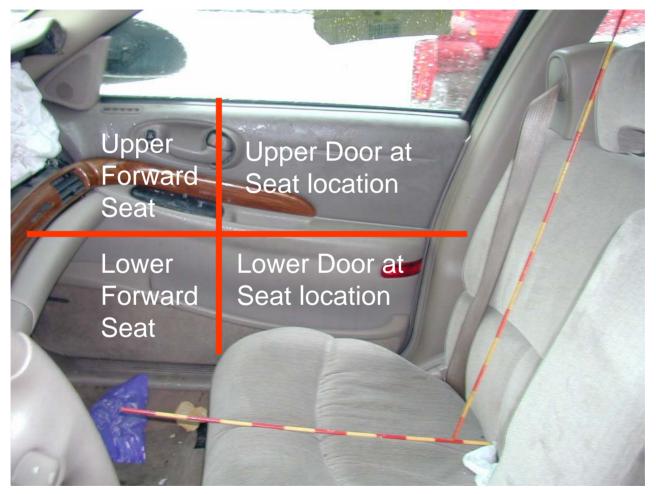
### Quadrant locations on Door Panel

Divided by top of armrest and front of seat cushion at time of impact

- Limitation of NASS data: all door panel intrusion measurements are taken at the max point on any location of the door panel
- CIREN data allowed evaluation of door intrusion height with linked images to each intrusion.
- Suggest creating a quadrant location method to document door panel intrusion in respect to seat locations

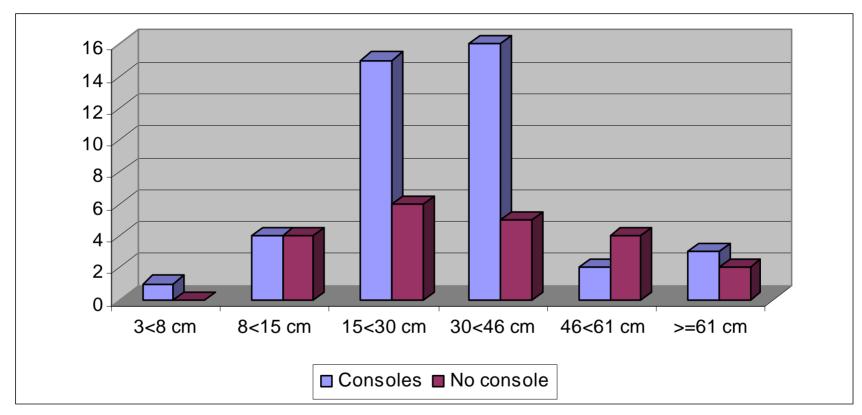
# Moderate and serious pelvic injury in nearside crashes by magnitude of intrusion

REDUCING PRIMARY AND SECONDARY IMPACT LOADS ON THE PELVIS DURING SIDE IMPACT -2005 ESV PAPER NUMBER 05-0036 Seattle CIREN Team and San Diego CIREN -Carol Conroy

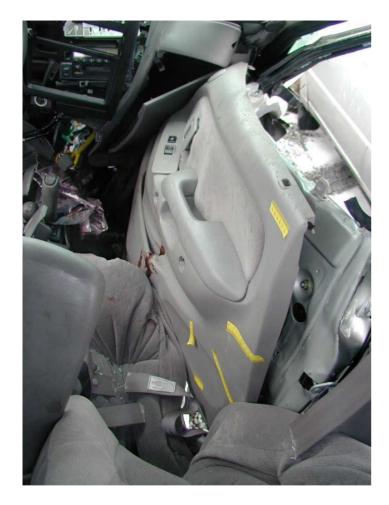
Door panel intrusion = 45 cm/17.7 inches

Contact evidence on door panel and center console

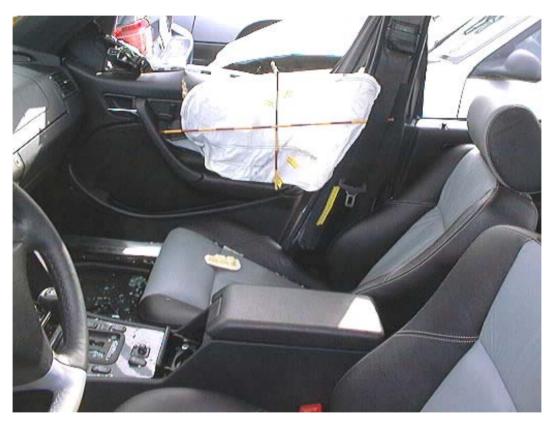
# Door Mount Side Air bag

Main protection to upper thorax, but extends enough upward for some head protection

Upper chest and head appear to be protected by door mount thorax air bag considering an SUV upper door impact.
