## THE RELATIONSHIP BETWEEN CRASH SEVERITY AND INCOMPATIBILITY IN FRONTAL CRASHES

A CIREN CENTER  
THE WILLIAM LEHMAN INJURY RESEARCH CENTER  
Jeffrey S. Augenstein, Kennerly Digges, George Bahouth., James Stratton, Elana Perdeck, Jerry Phillips, Jeffrey Mackinnon, and Luis Labiste, M.D.  
Professor of Surgery  
Director, WLIRC

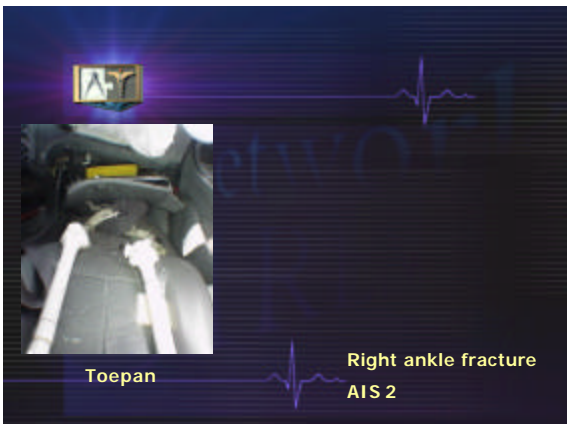
Toepan

Right ankle fracture  
AIS 2

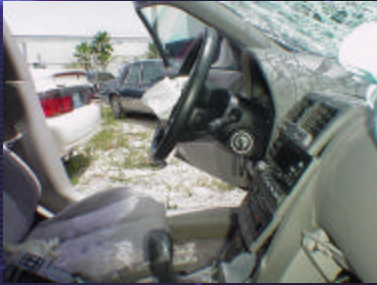
Lateral view of steering wheel from right

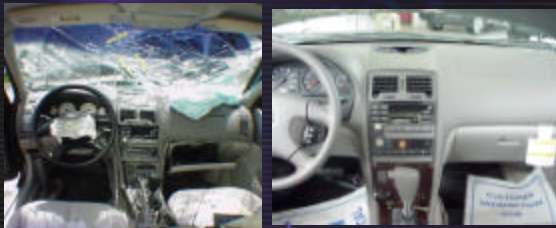
### Interior Nissan Maxima Comparison

No driver toepan intrusion!

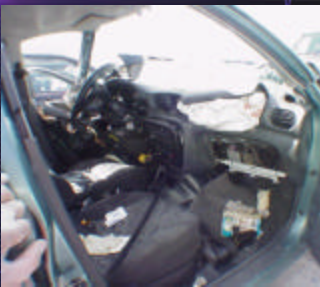
### INTERIOR HYUNDAI ACCENT DAMAGE

Right front overview

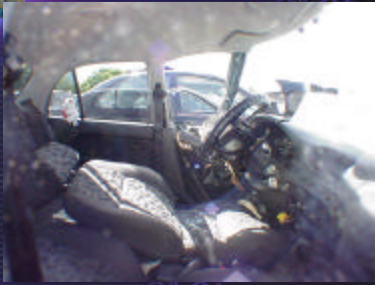
INTERIOR HYUNDAI  
ACCENT DAMAGE

Left instrument panel intrusion 15"
