### 2006-2008 MAINTENANCE OF THE RIO GRANDE CHANNEL IN THE AREA OF EL PASO, TEXAS-CD. JUAREZ, CHIH.

### RIO GRANDE: WORKS CARRIED OUT IN 2006-2007

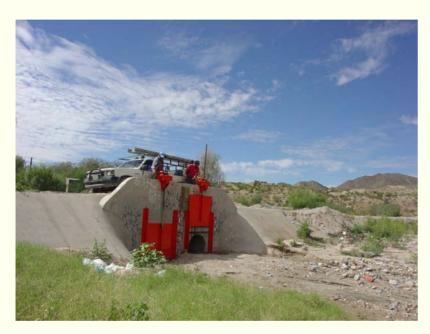
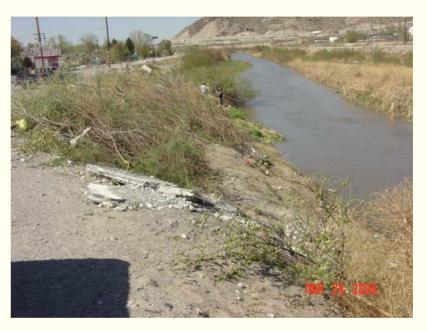
- Repair of storm drain gates on the Mexican levee, located between American Dam and International Dam over a 2-mile (3.2 Km) reach.
- Clearing and cleanup of the Mexican berm in the same reach.

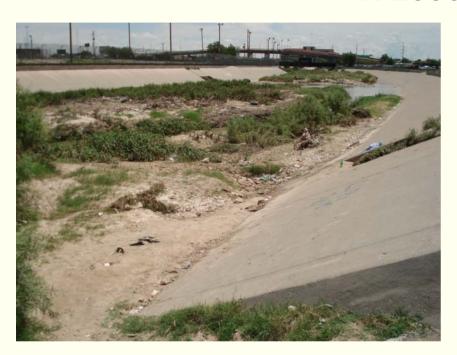
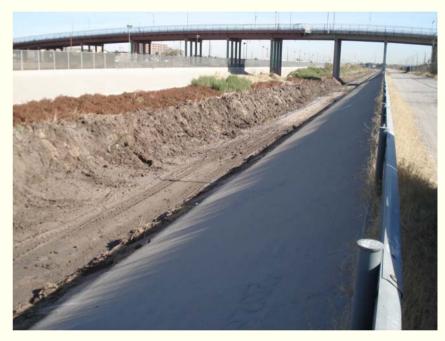
At the end of 2006, the Mexican Section carried out works in the Rio Grande to make an opening in the blockage formed by accumulated sediment in the 1.2 miles (2 Km) upstream, which would allow flood flows to pass through.

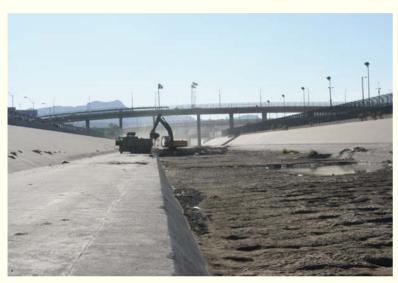
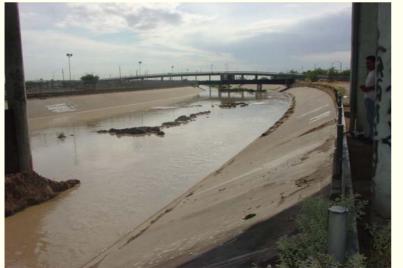
- out using a Mexican contractor with U.S. funds.
   The material removed in the process was deposited in Mexico.
  - A total volume of 124,467 m3 (163,000 yd3) was removed from a 2.6-mile (4.2 Km) reach.

Desilting work was carried

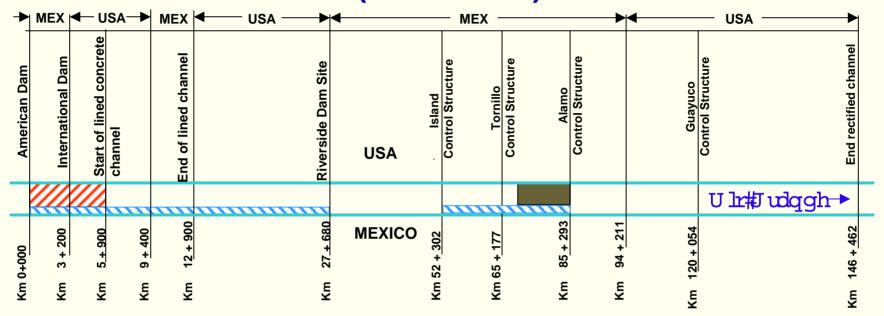
- ☑ Topographic survey and executive project to define the current hydraulic capacity of the river and determine the volume of silt to be removed. 3.7 miles (6 Km)
- No Topographic survey to locate and determine the grade of the Mexican levee for it to be reinforced. 28 miles (45 km.)
- Desilting the pilot channel and clearing of the Mexican berm for a 7.5-mile (12 Km) reach, upstream of the Alamo grade control structure (400,000 m3 sediment removed)

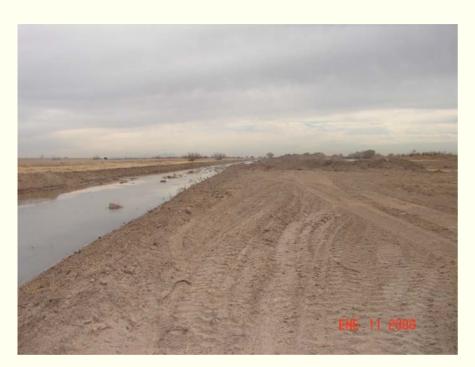
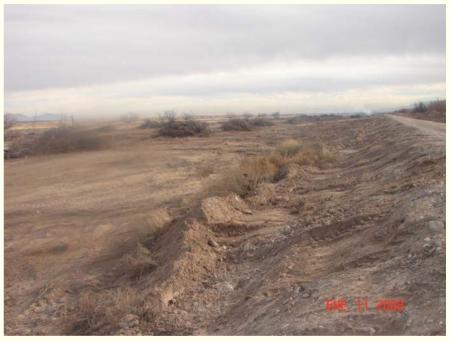
Desilting the pilot channel and clearing of the Mexican berm, upstream of the Alamo grade control structure 7.5mile (12 Km). 400,000 m3 sediment removed.

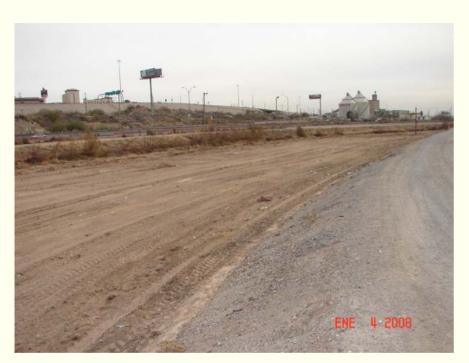
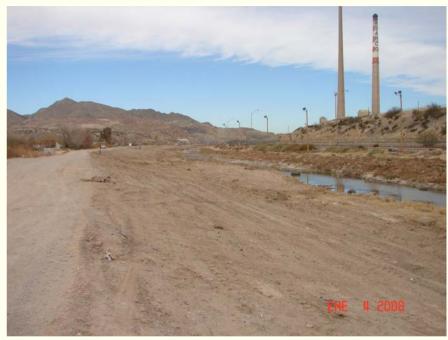
• Clearing and cleanup of the Mexican berm in the reach located between American Dam and International Dam over a 2-mile (3.2 Km) reach.
