National Transportation Safety Board

Safety Recommendation

Date: April 29, 2004

In reply refer to: A-04-36 through -41

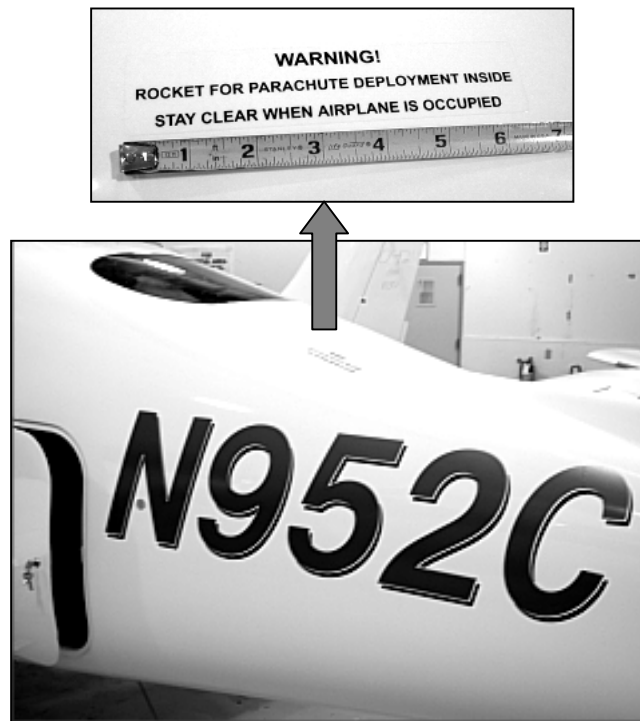
Figure 1. CAPS warning label for Cirrus SR20 and SR22 airplanes

As shown in figure 1, the Cirrus warning label does not use the panel format. Although it contains an appropriate signal word (in this case, “warning”), it does not contain a safety alert symbol, nor does it use the recommended orange background. The label also lacks a message panel that provides information regarding steps that emergency workers can take to avoid the hazard and that explains the potential consequences of failing to avoid the hazard (in this case, that a person struck by the rocket or flying debris or exposed to the blast during an accidental firing could be killed or seriously injured). Although the Cirrus label instructs those outside the airplane to “stay clear when [the] airplane is occupied,” there are no markings showing the exit point of the CAPS rocket, or otherwise indicating unsafe areas outside the airplane. Moreover, the instruction to stay clear is not useful information for emergency workers who may need to rescue trapped occupants. It does not explain that moving or cutting the wreckage after an accident could cause the rocket to fire and does not point emergency workers to the appropriate location to cut the activation cable if they need to disable the ballistic parachute system. In addition, the text size on the current Cirrus label does not allow personnel to identify the hazard from a safe viewing distance. The largest letters (in the word “warning”) are 1/4 inch high, which requires the reader to get quite close to the rocket exit point to read the label. Furthermore, the label lacks a safety pictorial that warns those who do not or cannot read the written message. Finally, Cirrus does not currently affix any warning label to the rocket canister, which would increase the difficulty of identifying this component if it were to become displaced from its normal position during a crash.

Work with Ballistic Recovery Systems, Inc., Cirrus Design, the National Fire Protection Association, and the airport rescue firefighting working group to establish design requirements for warning labels and exterior markings for airplanes equipped with ballistic parachute systems that meet the American National Standards Institute's guidelines (ANSI Z535.4) for conspicuity, coloration, visibility, and content. (A-04-39)

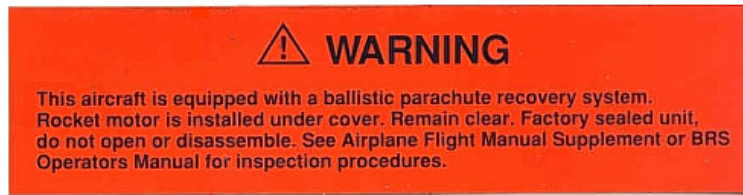
Figure 2. BRS Warning Labels for the Cessna 172

The BRS-designed labels are superior to the Cirrus warning label in some respects. For example, both labels feature an ANSI-style safety alert symbol and the signal word “warning” in black letters against an orange background, as recommended by ANSI Z535.4.¹⁵ In addition, on the canister label, the signal word and safety alert symbol are presented in their own panel, as

recommended by ANSI Z535.4. The canister label also describes the potential consequences of failing to avoid the hazard and provides specific information on how to avoid the hazard. Although the BRS warning labels are an improvement over the Cirrus label, they also have shortcomings. Like the Cirrus warning label, the message panel on the BRS label intended for use on the aircraft exterior contains small lettering that would be difficult to read from a distance. Also like the Cirrus label, the BRS exterior label provides the reader with an instruction to “remain clear,” a safety precaution that may not be specific enough to be useful to emergency workers. Information for avoiding the hazard, which is included on the canister label, would not be seen easily from outside the aircraft. Like the Cirrus label, the BRS labels do not provide a safety pictorial illustrating the nature of the hazard and hazard consequences.
