# Effects of Historical Land-Cover Changes on Flooding and Sedimentation, North Fish Creek, Wisconsin

By Faith A. Fitzpatrick<sup>1</sup>, James C. Knox<sup>2</sup>, and Heather E. Whitman<sup>1</sup>

<sup>1</sup>U.S. Geological Survey, Water Resources Division; <sup>2</sup>University of Wisconsin–Madison, Department of Geography

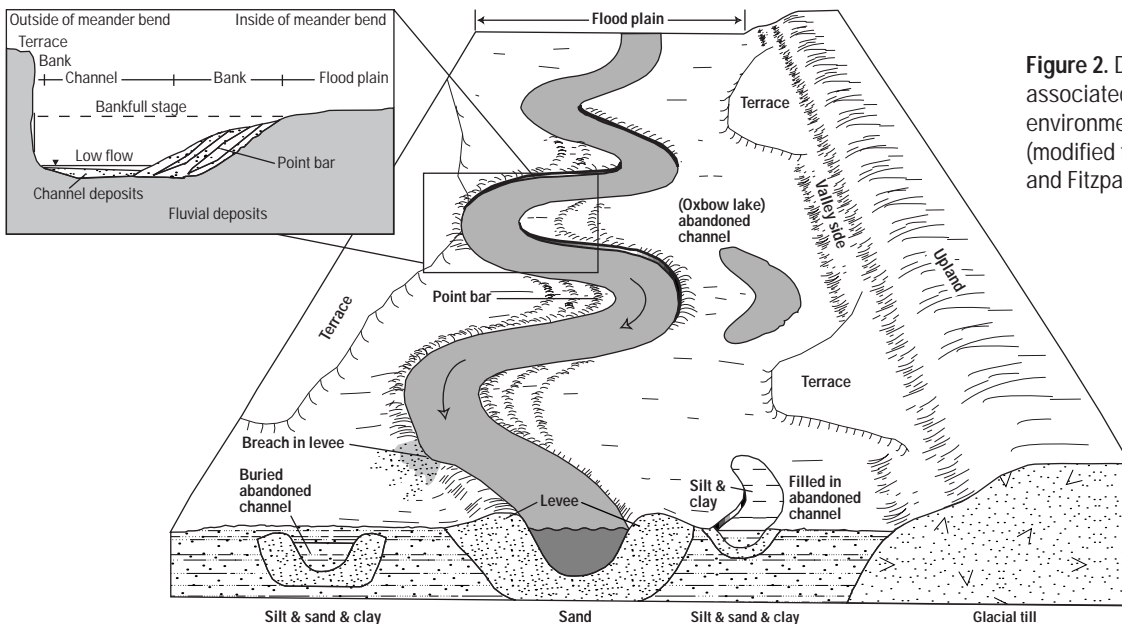
**Figure 2.** Diagram of common landforms associated with stream and valley environments in North Fish Creek (modified from Ludman and Coch, 1982 and Fitzpatrick and others, 1998).

A stream channel is just one of many landforms created by flowing water (fig. 2). Streambanks form the steep or sloping ground that borders a channel and confines the water to the channel when the water level, or flow, is normal. The flood plain is generally a flat to gently sloping depositional surface adjacent to the channel that is occupied by the modern stream. The elevation of this active flood plain is considered here to be the same as bankfull stage. The bankfull stage is the point at which water just begins to overflow the channel and spill out onto the flood plain. Field indicators used for determining bankfull stage include any breaks in the slope along streambanks, and the average maximum elevation of sand deposition on point bars (Wolman and Leopold, 1957). In general, bankfull flows are expected to occur on average every 1 to 2 years (Leopold and others, 1964), although considerable variability in the recurrence interval has been found among streams (Williams, 1978). A terrace is an abandoned flood plain that formed when the stream flowed at a higher elevation than at present. Terraces are no longer related to the modern flow regime of the stream.

abandoned when curves in the course of the stream, or meanders, migrate laterally and eventually intersect. The characteristics of these abandoned channels are preserved in flood-plain deposits. Some abandoned channels may be filled with water (oxbow lakes), whereas other channels may become buried by sediment deposited on the flood plain during floods (fig. 2).

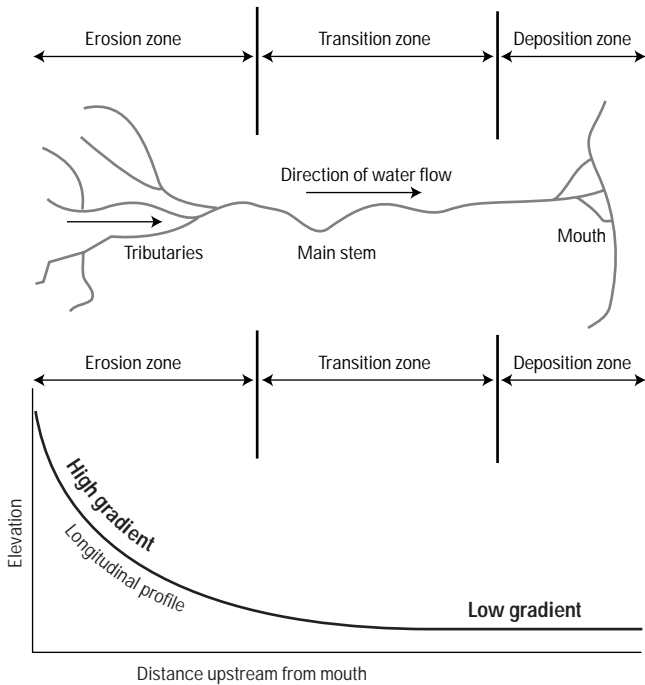
**Figure 3.** Overhead view and longitudinal profile of geomorphic zones within a stream network (modified from Schumm, 1977).

Stream networks commonly consist of an erosion zone (where sediment and runoff are generated), a transfer or transitional zone (where sediment and water are transferred through with no gain or loss of material), and a deposition zone (where sediment from upstream erosion is dropped out of transport) (Schumm, 1977) (fig. 3). The longitudinal profile of a stream illustrates how the gradient, or slope, of a stream changes from relatively high in the erosion zone to relatively low in the depositional zone near the mouth.

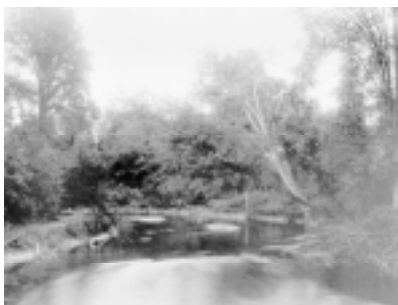
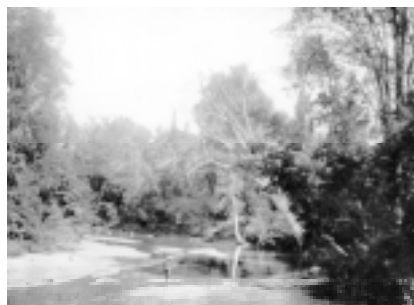
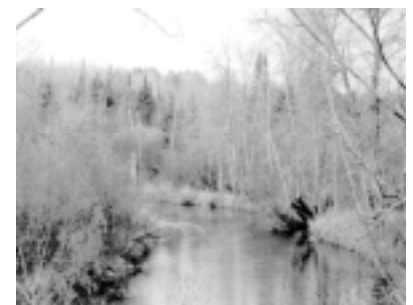
**Figure 6.** Photographs of North Fish Creek at railroad crossing, Ashland Junction, Wis., sec. 2/3, T. 47 N., R. 5 W., Ashland Junction, Wis.

A) circa 1885–88 (J.M. Turner and Co., 1889), reproduction courtesy of State Historical Society of Wisconsin, negative no. WH:(X3)51439,

B) circa 1888–98 (Turner and Turner, 1898),

C) 1997 (courtesy of D. Pratt, Wisconsin Department of Natural Resources, Superior, Wis.).

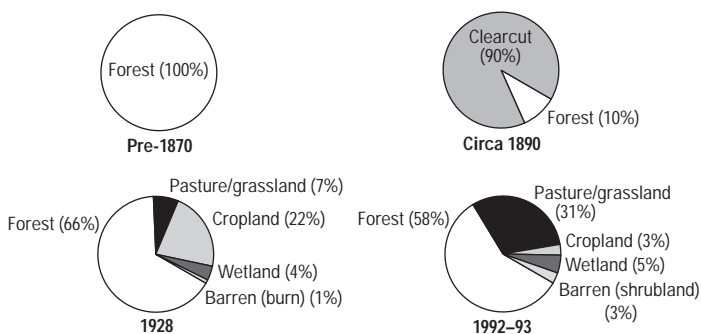
**Figure 7.** Land-use history in the North Fish Creek Basin (pre-1870, 1855 government land office surveys; circa 1890, historical accounts, and newspaper articles; 1928, Land Economic Inventory; 1992–93, WISCLAND satellite data).

After the decline in logging, major agricultural development in the region occurred from 1895 to 1920 (Mahaffey and Bassuk, 1978). Agricultural activity peaked in the mid-1920's to mid-1930's, with much of the upland areas consisting of cropland (forage crops and some corn) and pasture for dairy cattle (fig. 7). Since the peak agricultural activity, the relative amount of agricultural land (cropland and pasture/grassland) and forest has changed little; however, the amount of cropland was about 22 percent in 1928 compared to 3 percent in 1992–93 (fig. 7). In 1992, nearly one-third of the basin (31 percent) was classified as grassland, which is a combination of grazed or abandoned pastures for dairy or beef cattle (Lillesand and others, 1998). The average age of forests in the basin was probably less in 1928 than in 1992–93, based on the small size of trees recorded in the 1928 Land Economic Inventory (Wisconsin Department of Agriculture and Wisconsin Geological and Natural History Survey, 1928).

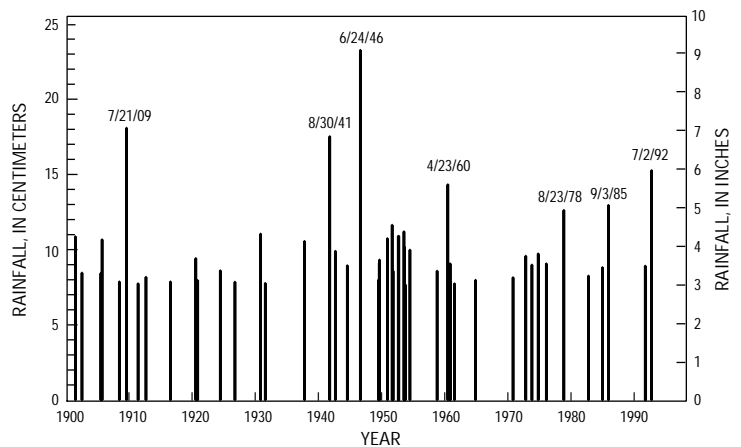
**Figure 8.** Rainfalls greater than 7.6 centimeters (3 inches), Ashland Experimental Farm, Wis., 1900–97.

No long-term streamflow records are available for North Fish Creek; therefore, its flood history was reconstructed from the precipitation record at the Ashland Experimental Farm (fig. 1) and from local newspaper accounts. Because large floods can destabilize a river system, rainfalls greater than 7.6 cm (3 inches) were identified for the period of record (1900 to 1997) at the precipitation station (fig. 8). These rainfalls are greater than the 2-year, 24-hour rainfall for the area, which is approximately 6.4 cm (Hershfield, 1961). The precipitation record shows that the temporal distribution of large storms from 1900 to 1997 was episodic. Multiple rainfalls greater than 7.6 cm occurred in some years, whereas no rainfalls exceeded 7.6 cm during several 2- to 5-year periods (fig. 8). The most obvious 5-year periods without major rainfalls were 1932–37, 1965–70, and 1986–91. In contrast, frequent large rains between 1949 and 1954 followed the exceptionally large rains of August 1941 and June 1946.

The 1946 storm was by far the largest on record. Total precipitation over the 2-day period was greater than 23 cm. For comparison, the estimated 100-year, 24-hour rainfall for the Ashland area is 11.4 cm (Hershfield, 1961). Several roads, buildings, and rail bridges were washed out along the tributaries and main stem of North Fish Creek and at the mouth of Fish Creek.

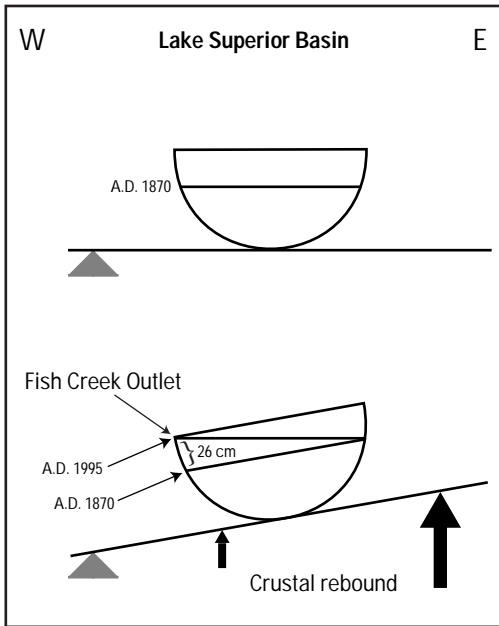
**Figure 9.** Effects of differential crustal rebound on shoreline elevations for Lake Superior.

control gage near its outlet has been fairly constant at about 183 meters (m) because of human stabilization (International Joint Commission, 1976; U.S. Department of Commerce, 1973); however, the elevation of the water surface of the Chequamegon Bay area has increased by about 26 cm relative to the land surface since the 1870's (fig. 9). This increase is caused by regional differences in crustal rebound after glacial ice melted from the region about 10,000 to 11,000 years ago (Larsen, 1994). The land on the eastern half of Lake Superior, which was more depressed by glacial ice, is rising at a faster rate than land on the western half (fig. 9).

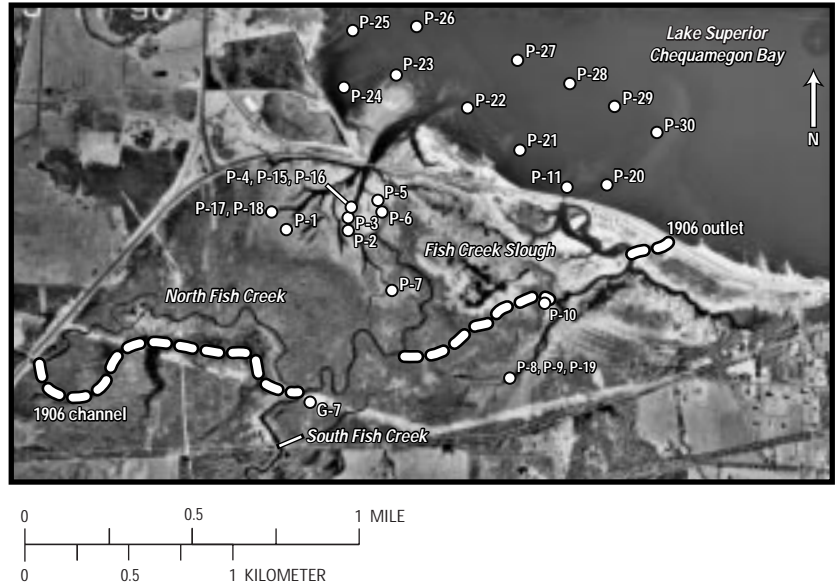
**Figure 11.** 1990 aerial photograph of Fish Creek Slough with locations of cores collected in 1995. The 1906 channel location was interpreted from historical maps.

Core data collected near the confluence of North and South Fish Creeks in Fish Creek Slough (fig. 11, G-7) indicate that approximately 1.8 m of post-settlement sediment, mainly fine sand, has accumulated on the flood plain surface at a location 20 m from the modern channel (fig. 18). Radiocarbon ages of wood samples from buried soils below the pre-settlement soil indicate that the post-settlement sedimentation rate of 1.4 cm/yr at this site is 5 times greater than the average rate of 0.28 cm/yr during the 500 years preceding European settlement. Particle-size data (fig. 18) indicate an increase in the sand content of post-settlement flood-plain deposits compared to silt and clay-rich pre-settlement deposits. Percentages of organic carbon increase near the modern flood-plain surface, indicating a relatively recent decrease in flood-plain sedimentation. (Organic material from flood-plain vegetation is easily diluted by sediment deposition or removed by flood flows.)

The position of the outlet of Fish Creek into Chequamegon Bay changed significantly after European settlement (fig. 11). There are two modern outlets from the slough into Chequamegon Bay. The western outlet is the primary outlet of flow from Fish Creek. The eastern outlet of the slough is approximately 1 km east of the modern outlet of Fish Creek. Sandy sediment is mainly confined to channels that feed from Fish Creek in the western part of Fish Creek Slough, whereas the spring-fed channels and backwater areas in the eastern part of the slough are mainly characterized by silt and clay. In the eastern slough, sandy streambed sediment is found only in the channel of Fish Creek abandoned around 1920. Water depths in the modern channel of Fish Creek in the slough tend to be less than 0.5 m, whereas springfed channels flowing into the eastern slough are more than 1 m deep. Approximately 0.5 to 1.5 m of post-settlement medium to very coarse sand has accumulated in the modern channel of Fish Creek near the mouth of Fish Creek in Fish Creek Slough. Dense silt and clay with variable amounts of organic debris underlie the sand filling the modern channel. The fine-grained sediment probably represents pre-settlement backwater sediment deposited when the mouth of Fish Creek was 1.5 km east of its present location.

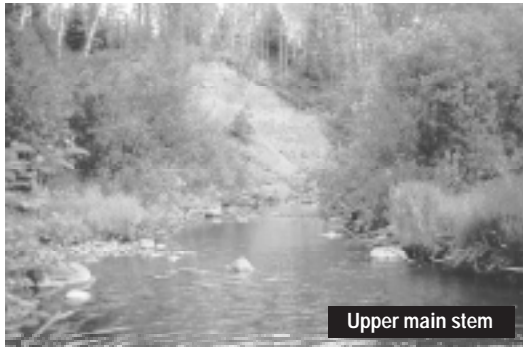
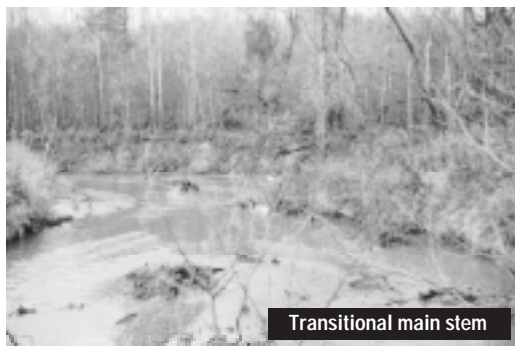
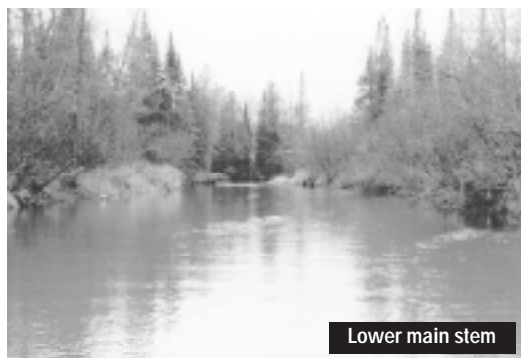
**Figure 10.** Photographs of the upper, transitional, and lower main stem of North Fish Creek.

In this section, post-settlement flooding and sedimentation changes in North Fish Creek are described for three reaches along the main stem and Fish Creek Slough (fig. 5). Example photographs illustrate the modern differences in channel characteristics along the main stem (fig. 10). The upper main stem is characterized by a cobble/boulder and sand channel bed, eroding bluffs, and a high gradient (0.0159 m/m). In the transitional main stem, a shift from high to low gradient is reflected by a progressive downstream change from cobble/boulder and sand channel bed to a gravel and sand channel bed. The lower main stem is characterized by a predominantly sandy channel bed, low streambanks, and a relatively low gradient (0.00127 m/m). The main channel of Fish Creek through Fish Creek Slough (fig. 11) also contains a sandy channel bed.

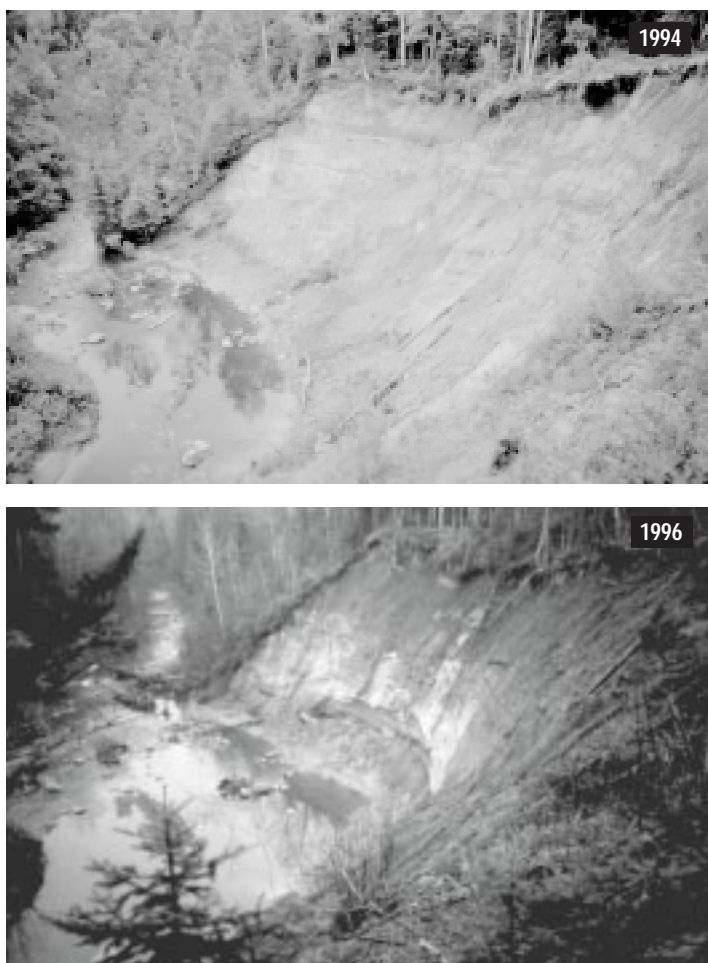
**Figure 12.** Photographs of eroding bluff along North Fish Creek, upper main stem, 1994 and 1996.

A study of sediment loadings in North Fish Creek at the gaging station (fig. 1) indicated that upland erosion is not a major source of sediment to the creek (Rose and Graczyk, 1996). A comparison of eroding bluff locations (fig. 5) from 1938 and 1990 aerial photographs indicate that bluff erosion along the upper main stem can account for most of the sediment load observed at the gaging station. On the basis of the aerial photograph comparisons, bluffs retreated at an average rate of 25 m over 52 years, or about 0.5 m/yr. The combined amount of sediment lost from all the bluffs over this 52-year period is about 9,800 m<sup>3</sup>/yr, or 14,100 tonnes/yr. Photographs of a large bluff along the upper main stem of North Fish Creek in 1994 and again in 1996 (fig. 12) show

observable bluff retreat and substantial change in the channel location over only a 2-year period. The eroding bluffs along North Fish Creek expose varied sedimentary beds, ranging from clayey tills and boulders deposited in former glacial ice-contact settings to sand and silt deposited by former glacial-meltwater runoff and ponding. On the whole, the eroding bluffs are sources for substantial amounts of sand. They average about 49 percent sand, with individual beds ranging from nearly all silt to nearly all sand. Rose and Graczyk (1996) estimated an average annual total sediment load at the gaging station of approximately 13,800 tonnes/yr in 1990–91, and 60 percent of that sediment load was sand.

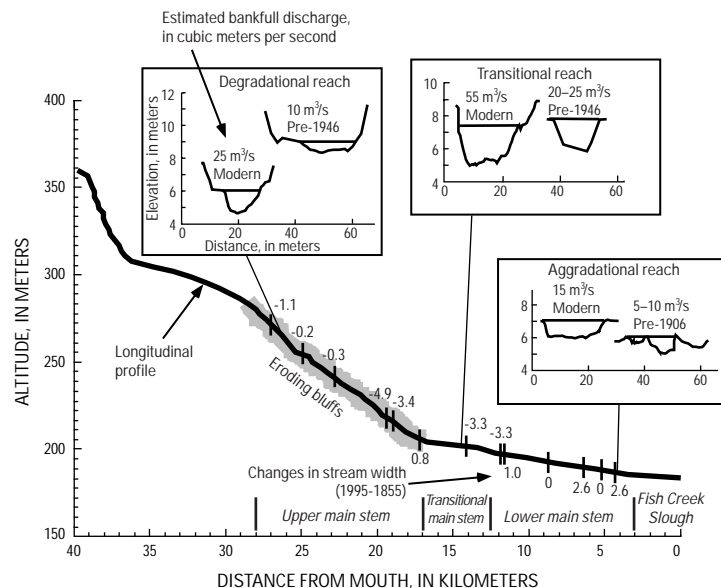
**Figure 13.** Longitudinal profile of North Fish Creek with changes in channel width, 1855–1990 and estimates of bankfull flow capacity. Stream-width changes calculated from 1855 Government Land Office surveys and from cross-section surveys done as a part of this study in 1995.

Post-settlement changes in channel width were dependent on the location along the main stem. Comparisons of 1995 and 1855 channel widths indicate that the channel narrowed somewhat in the upper main stem and widened in the lower main stem (fig. 13). The change from narrowing to widening corresponds with a shift from a high gradient to a relatively low gradient channel from upstream to downstream.

Geomorphic evidence indicates that the modern bankfull flow along the upper and transitional main stem is as much as 2.5 times greater than the pre-1946 bankfull flow (fig. 13). The pre-1946 channel cross sections shown in figure 13 are from channels abandoned during the 1946 flood. Bankfull flows and the sizes of the modern and pre-1906 channels appear to be about the same in the lower main stem.

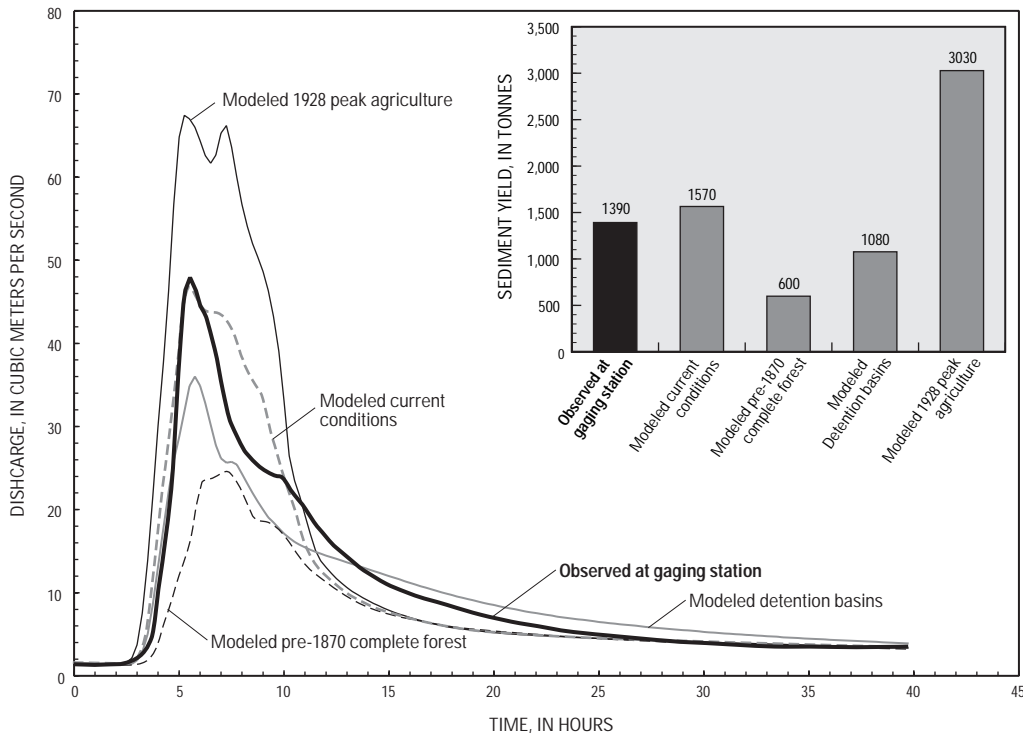
**Figure 14.** Storm hydrographs and sediment loads for North Fish Creek near Moquah, Wis., for a historical storm on September 3, 1991, under four land-cover conditions.

Rainfall/runoff model simulation results for the gaging station near Moquah (fig. 1) indicate that under peak agricultural land use in the basin (about 1928), flood peaks expected to occur on average every 2 years were about 3 times greater than under pre-settlement forest cover. Flood peaks of this recurrence interval under modern land cover are about twice as large as their pre-settlement counterparts (fig. 14). An actual flood peak under complete forested conditions probably was even smaller than the modeled flood because the model did not account for potential decreases in the thickness of an organic detritus layer on the forest floor after logging and burning.

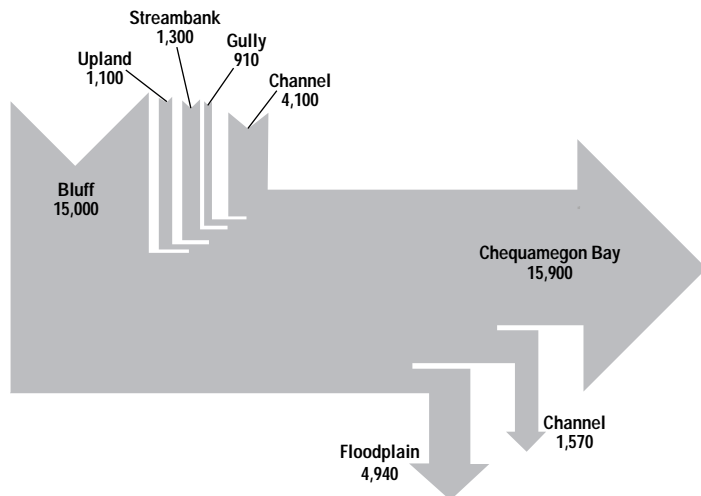
**Figure 19.** Historical annual sediment budget for North Fish Creek near Moquah and near Ashland Junction, Wis. (All inputs and outputs are in tonnes per year).

Overall channel adjustments along the main stem of North Fish Creek are illustrated in two ways: (1) by a post-settlement sediment budget and (2) by overall changes in the longitudinal profile along the main stem. The post-settlement annual sediment budget for North Fish Creek at the mouth (fig. 19) shows the sources and sinks of sediment in North Fish Creek. Except for upland erosion rates, which were estimated from sediment-load data from Rose and Graczyk (1996), this budget relies on post-settlement erosion and sedimentation rates derived from geomorphic field data (Fitzpatrick, 1998). Annual variations in erosion and deposition are highly dependent on the size of floods during each year. Post-settlement inputs of sediment from erosion in the upper and transitional main stem (22,000 tonnes) are greater than long-term outputs to Chequamegon Bay (15,900 tonnes) because of long-term sediment deposition in the flood plain and channel along the lower main stem. The sediment budget again illustrates the overwhelmingly large contribution of sediment from bluff erosion along the upper main stem.

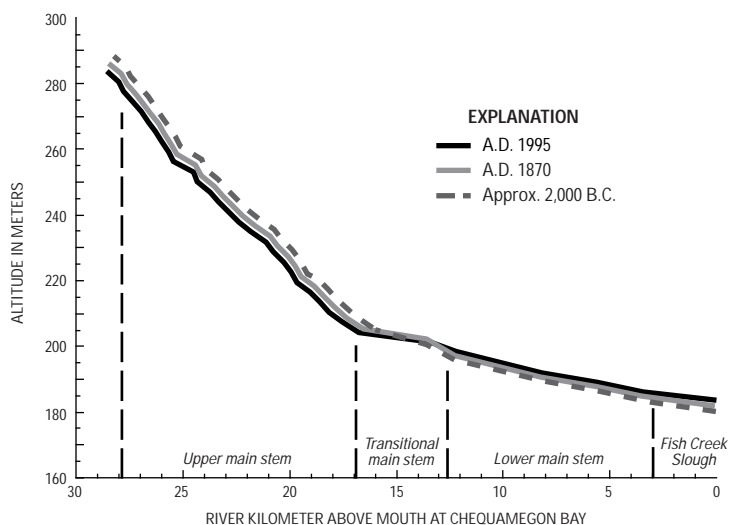
**Figure 20.** A comparison of the modern (A.D. 1995) North Fish Creek longitudinal profile with profiles from A.D. 1870 and approximately 2,000 B.C.

Estimated longitudinal profiles for North Fish Creek over the last 4,000 years indicate how the elevation of the main stem has changed in response to natural changes in climate and base level before European settlement and to human changes in land cover after European settlement (fig. 20). Near the mouth of Fish Creek, the amount of channel sedimentation caused by land-cover changes over the 125 years after European settlement is about equal to that caused mainly by an increase in base level over 4,000 years before European settlement.
