NIST Response to the World Trade Center Disaster

Federal Building and Fire Safety Investigation of the World Trade Center Disaster

August 21, 2008

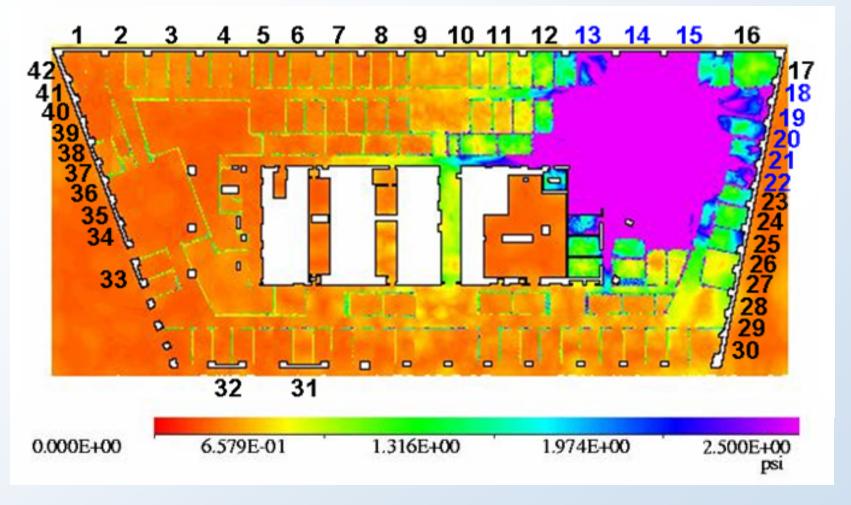
Hypothetical Blast Simulations

Peak over pressures for 9 lb shaped charge.

- The reason for the collapse of World Trade Center 7 is no longer a mystery
- WTC 7 collapsed because of fires, fueled by office furnishings
- It did not collapse from explosives or from fuel oil fires

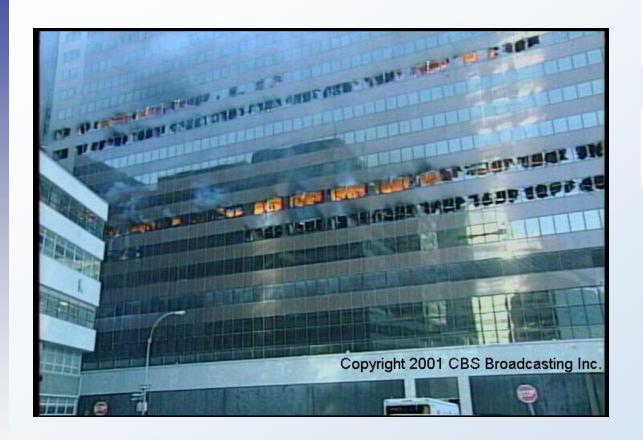
Fire Growth and Spread

Progression of fires on Floor 12

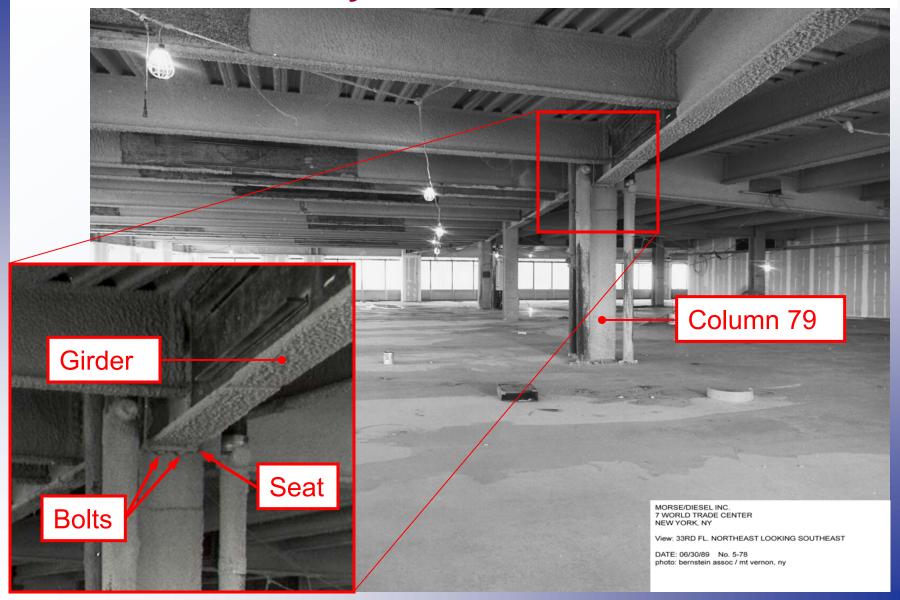
North East Floor System Near Column 79

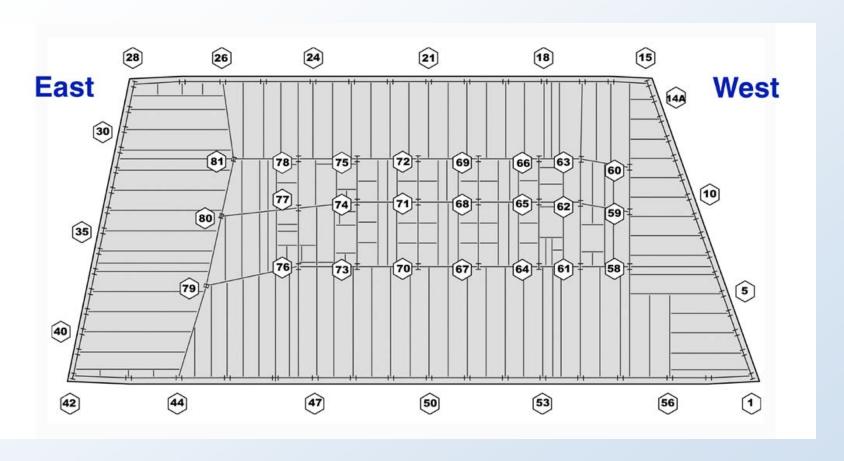
Typical Layout: Interior Columns, Floor Framing

WTC 7 Typical Floor

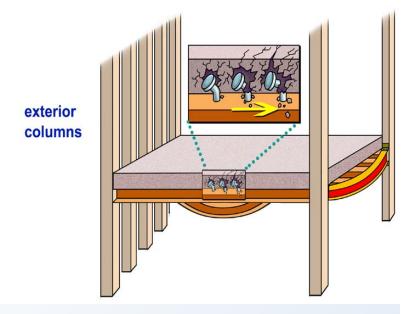
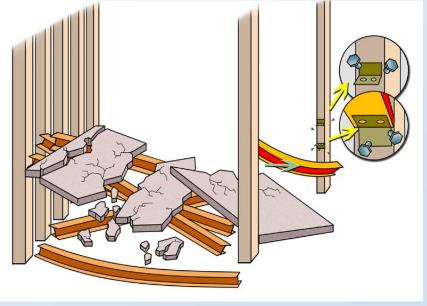
Thermal Expansion Causes Floor Failures

interior columns

Building owners, operators and designers should evaluate fire performance of structural systems, especially

- Long-span floor systems;
- Connections not designed for thermal effects
- Asymmetric floor framing
- Composite floor systems

- Strengthen connections
- Strengthen floor framing
- Increase structural redundancy
- Add additional fireproofing in vulnerable areas

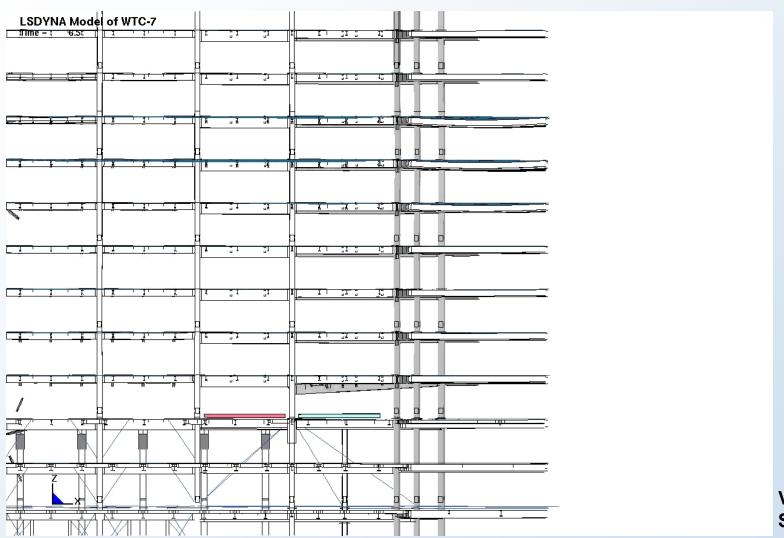
Collapse Initiation—Physics-Based Model

View from South

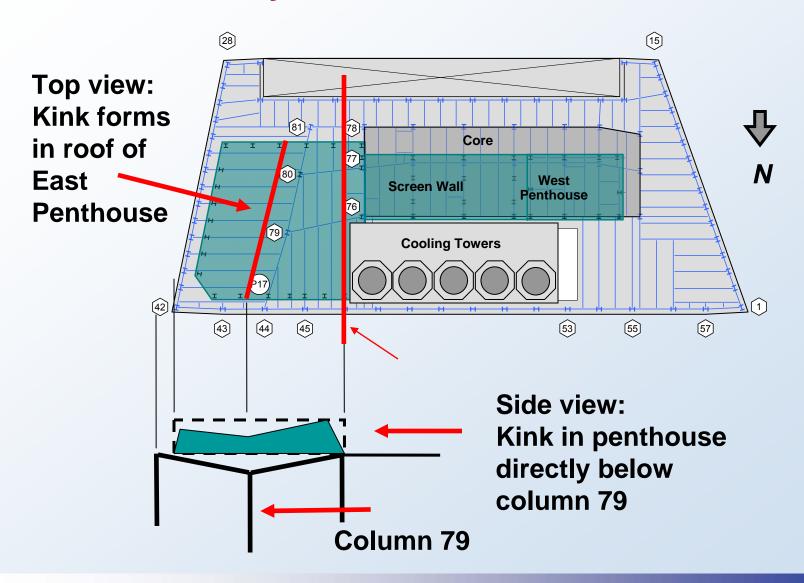
Penthouse Layout Overlaid on Floor Framing

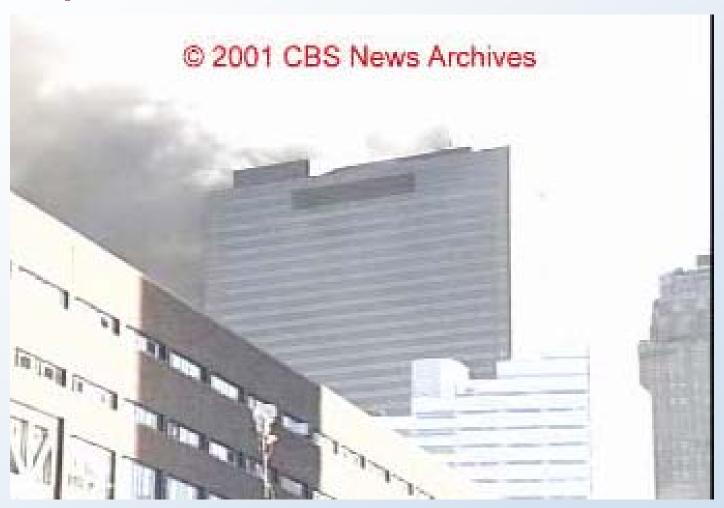
Comparison of Visualization and Video

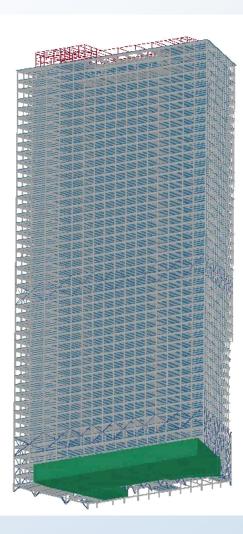
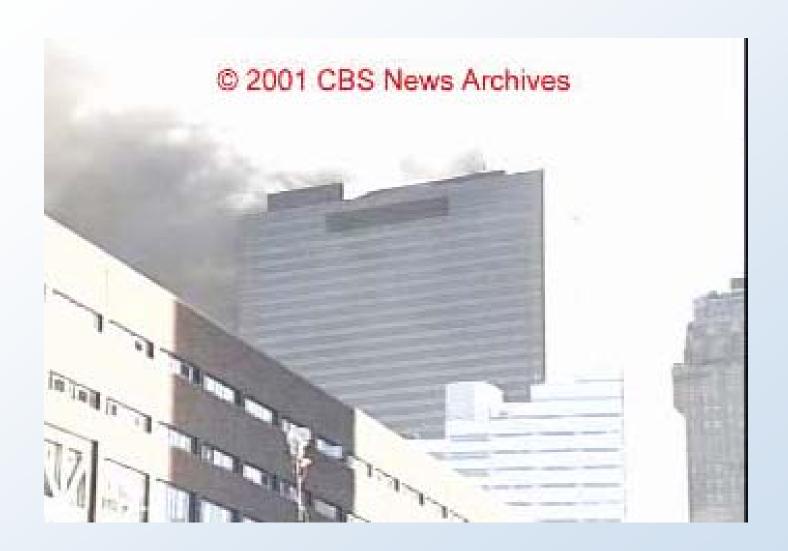
Visualization Model of WTC Collapse
