The Fallacy of Monitoring Surge Voltages: SPDs and PCs Galore!

Reprinted from Proceedings. PQA '99 Conference

Abstract

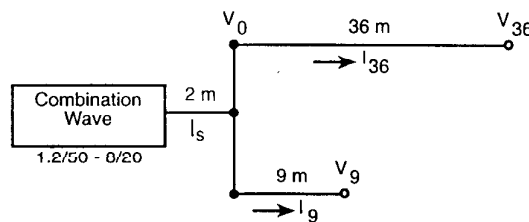
Figure 1 - Upside-Down House branch circuits

To illustrate the effect of nonlinear SPDs as well as linear capacitors connected across the mains, the Power Electronics Applications Center (PEAC) “Upside-Down House” [Key et al., 1994] was used to inject surges into the service entrance of the Upside Down House with various combinations of SPDs and/or personal computer (PC) power supplies connected at the end of two branch circuits, one 9-m long, the other 36-m long. In Figure 1, currents in the branches and voltages at the nodes are identified respectively as I_s , I_9 , I_{36} , and V_0 , V_9 , V_{36} . The charging voltage setting of the Combination Wave surge generator was kept constant to provide a 2 kV, 1.2/50 μ s open-circuit voltage (OCV). In a second series of experiments, the setting was increased to 4 kV. This second series, not reported here in detail because of limited space, confirmed the expected nonlinear response of varistors and the linear response for capacitors only.

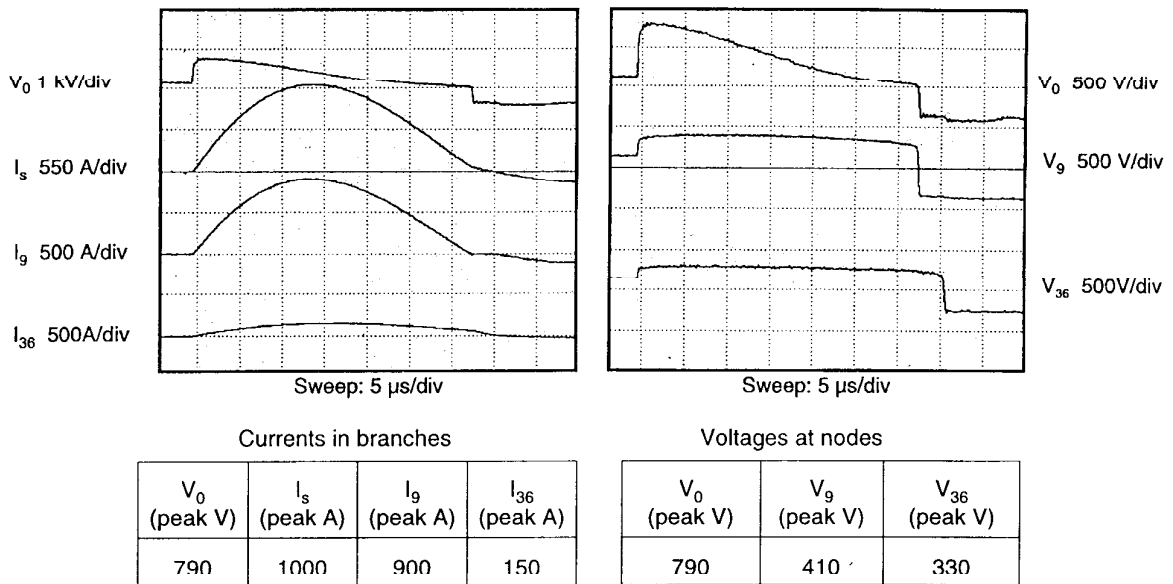
Figure 2 - Typical recordings¹ made during the first experiment – SPDs only.

In Figure 2, the current traces (left oscillogram) show the unequal sharing between the two MOVs, reflecting the difference in the inductance of the two branch circuits. Because the peaks of the two branch-circuit currents are not simultaneous (the current in the longer branch circuit takes longer to build up) their sum seems to exceed the peak of the injected current, I_s .

The voltage traces (right oscillogram) show how the voltage at the service entrance, V_0 , is mitigated from the 2 kV open-circuit voltage supplied by the generator that would propagate without attenuation in the absence of a surge-mitigating device [Martzloff et al., 1986]. This voltage V_0 is the sum of the clamping performed by the varistor at the node V_g , and the inductive voltage drop in the 9-m long connection. Note that this inductive voltage is additive during the rise of the current I_g , and subtractive during the fall, hence the apparent “overshoot” in the trace of V_0 , compared to the flat-top trace of the varistor at V_g . The voltages at V_g and V_{36} are the typical clamping voltages of the MOVs corresponding to the current they carry.

Given the known and predictable behavior of multiple SPDs — often reported in the literature to the point that bibliographic citations would take several lines to list all of them — this part of the experiment was performed only to provide a baseline. Metal-oxide varistors (MOVs) rated 150 V, 20 mm diameter, were used for this experiment. To record all interesting currents and voltages, two shots are necessary when using the 4-channel digital signal analyzer; therefore each oscillogram in the figures contains the trace of V_0 to serve as a common reference (Figure 2).

In a subsequent experiment with a 4 kV open-circuit voltage setting of the generator (twice the value of Figure 2, but not reported here in detail because of limited space), the voltages across the varistors, predictably, were not substantially increased. However, the substantially increased current in the 9-m long branch circuit (from 1000 A to 2800 A, resulting from the nonlinear response of the varistor) produced an increased inductive effect to the point that the voltage at the service entrance was raised to 1300 V from the 790 V recorded for the case of Figure 2. Table 1, at the end of this section, presents a summary of the peak values recorded in the various combinations of components, branch circuits, and amplitudes of the injected surge.

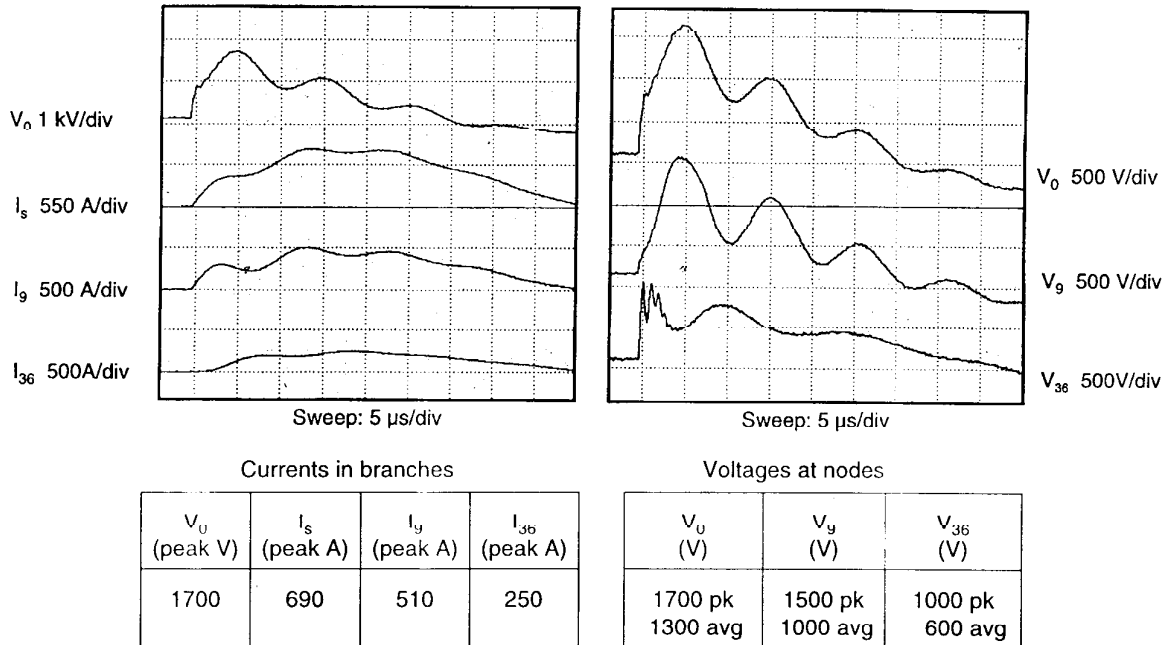
Figure 3 - Typical recordings made during the second experiment – Capacitors only

In Figure 3, the voltage at the service entrance, V_0 , is mitigated from the 2 kV open-circuit voltage supplied by the generator. However, because of the interaction between the RLC components in the wave-shaping network of the Combination Wave generator on the one hand, and the capacitances of the PC power supplies and inductances of the branch circuits on the other hand, this voltage rings around an average voltage level of 1300 V, reaching a peak of 1700 V. To reflect this situation, the tabulation of the voltages in the figure shows two lines, peak and average. Thus, the mitigation effect is degraded by the ringing. Nevertheless, one can expect that as more PCs would be added, the ringing frequency would become lower and the voltage peaks lower.

In a second set of experiments, less easily predictable would be the behavior of the still all-linear circuit involving the capacitors of a PC power supply (440 μF each in this experiment) when receiving a surge originating from the complex RLC wave-shaping network of a Combination Wave surge generator (Figure 3).

Experiments 2 and 3 (Figures 3 and 4) do show decreasing levels of voltage surges at various points of the Upside Down House, compared to the open-circuit conditions. However, the interactions between the capacitors of the generator RLC wave-shaping network on the one hand, and the PC capacitors on the other hand, make detailed interpretation of the waveforms tedious and beyond the scope of our illustrative examples. Numerical modeling with a current source, as reported in the following section, avoids this interaction and provides further evidence on the “PCs Galore” effect. For readers interested in the details, Table 1 documents the results concerning peak voltages noted from the oscillograms kept on file but not reproduced here. Readers interested primarily in the big picture may skip a close examination of this table.

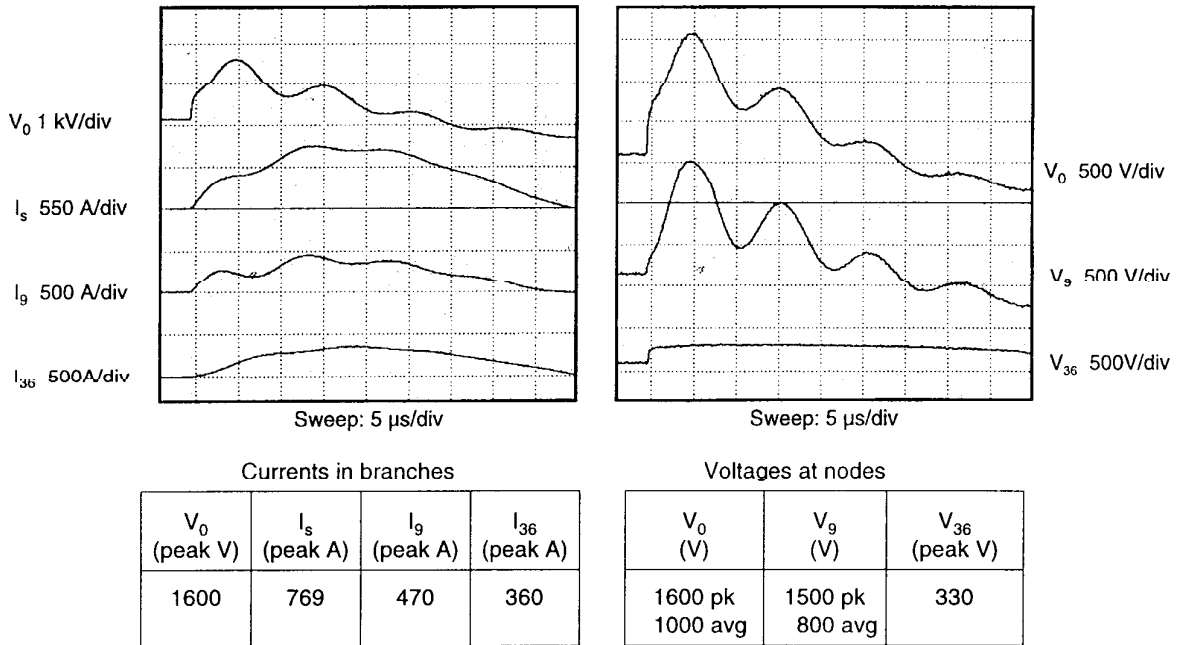
Figure 4 - Typical recordings made during the third experiment – capacitor and MOV.

In a third set of experiments, a capacitor was connected at the end of the 9-m branch circuit and an MOV was connected at the end of the 36-m branch circuit. Interest in this particular configuration was motivated by the desire to show how an MOV would mitigate the ringing that was observed in the preceding experiment at the end of the 36-m line (V_{36} in Figure 3).

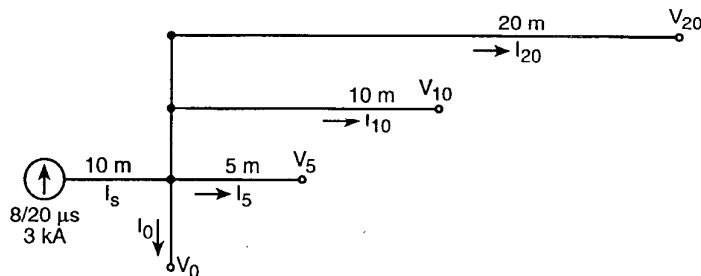
Figure 5 - Service drop and branch circuits for modeling combinations

In a series of modeling runs similar to the combinations of the experimental measurements, the model used the circuit of Figure 5. A current source feeds a fixed current surge via a common service drop to the panel bus of the service entrance, where three branch circuits made of 2-mm diameter conductors (#12 AWG) take off, with length of respectively 5 m, 10 m, and 20 m. The choice of these lengths was based on curiosity about the effect of the long distance connection (and thus an effect that might be delayed or degraded) to the immediate occurrence of an overvoltage at the end of shorter branch circuits. The currents in the circuit are identified in Figure 5 respectively as I_s , I_0 , I_5 , I_{10} , and I_{20} , with the node voltages at the service bus and branch circuit ends respectively as V_0 , V_5 , V_{10} , and V_{20} .

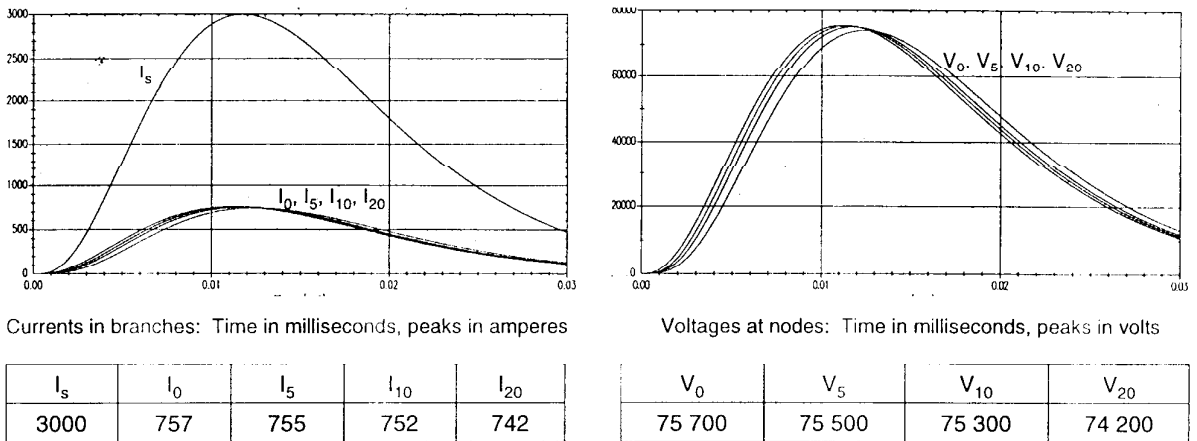
Figure 6 - Currents and voltages for the baseline case of $100\ \Omega$ loads without SPDs

Just to illustrate the point of a readily predictable behavior of a purely linear circuit, Figure 6 shows the voltages and currents for the case of $100\ \Omega$ loads confronted with a current source. Compared with the $100\ \Omega$ load at the end of the branch circuits, the series impedance has a very small effect and the impinging surge current I_s divides almost equally ($3000\ \text{A} / 4 = 750\ \text{A}$) in the nearly identical four branches I_0 , I_5 , I_{10} , and I_{20} (I_0 being the current in the service entrance ‘branch’, with a length of 0). Thus, the voltage developed by this 750 A current across $100\ \Omega$ would simply be expected to be 75 000 V (seventy five thousand volts). We say “would be expected” because, of course, the insulation level of a real-world low-voltage insulation cannot withstand such a voltage. The result of this theoretical case is another illustration of the theme “More Begets Less,” according to which a high-amplitude, steep-front surge cannot propagate in branch circuits because a flashover will occur at the origin [Mansoor et al., 1998].

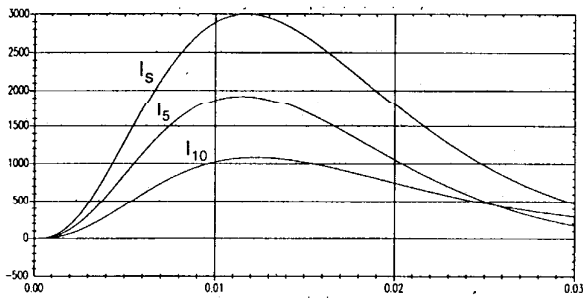
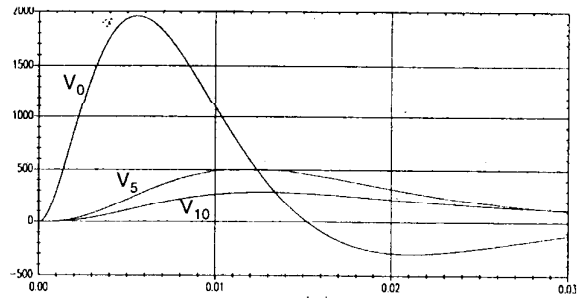
Figure 7 - Currents and voltages for the case of two PCs without SPDs

Figure 7 shows the example of two PCs, one at the end of the 5-m branch circuit, the other at the end of the 10-m branch circuit: the surge current is shared (unequally) between the two capacitors, with a corresponding decrease of the voltage level at each DC link, and also a reduction of the voltage at the open end (unprotected) of the 20-m branch circuit. This example shows the beginning of the “PCs Galore !” effect. Several intermediate and further steps were modeled by adding combinations of surge-mitigating devices to build our case file and confirm the expected effects, but we will spare the reader from a tedious recitation.

Currents in branches: Time in milliseconds, peaks in amperes

I_s	I_0	I_5	I_{10}	I_{20}
3000	0	1920	1080	0

Voltages at nodes: Time in milliseconds, peaks in volts

V_0	V_5	V_{10}	V_{20}
1960	507	290	1960

- The unequal division of the currents I_s and I_{10} reflects the effect of the larger impedance of the 10-m branch circuit, compared to the 5-m branch circuit.
- Substantial mitigation is obtained at the nodes V_5 and V_{10} , as a result of the filter-like action of the line inductance and the capacitance of the PC power supply.
- The voltage surge developed at the node V_0 propagates, unabated, to the end of the open-circuited 20-m branch circuit, a reminder that the notion of voltage surges being attenuated as they propagate in building wiring [IEC Report 664, 1980] was incorrect.

- From the (impossible) high voltages of the 100 Ω baseline (no SPDs), the voltage that would be recorded by a monitor installed at the service entrance is now reduced to “only” 1960 V.

- A **voltage-only monitor** installed at the point of use of the power (typical selection of point of installation in many surveys), namely the two receptacles at 5 m and 10 m feeding the PCs, would report respectively 510 V and 290 V, **creating the illusion (fallacy) that there is no significant surge activity** at these points.

- In reality a current surge I_5 of nearly 2000 A is carried by the PC rectifier into the capacitor, via a line fuse. Such a high current — **undetected by a voltage-only monitor** — could very well be fatal for the rectifier or the input fuse, or for the capacitor of the PC power port. Such failures were found in post-mortems of equipment recently performed at PEAC. That scenario is also what occurred in the experimental test of Section 3 for a 4 kV open-circuit voltage and capacitor-MOV combination (shown in next-to-last row of Table 1).
