## CHAPTER 3. RESULTS OF FIELD AND LABORATORY INVESTIGATIONS

### 3.1 Field Test Sites

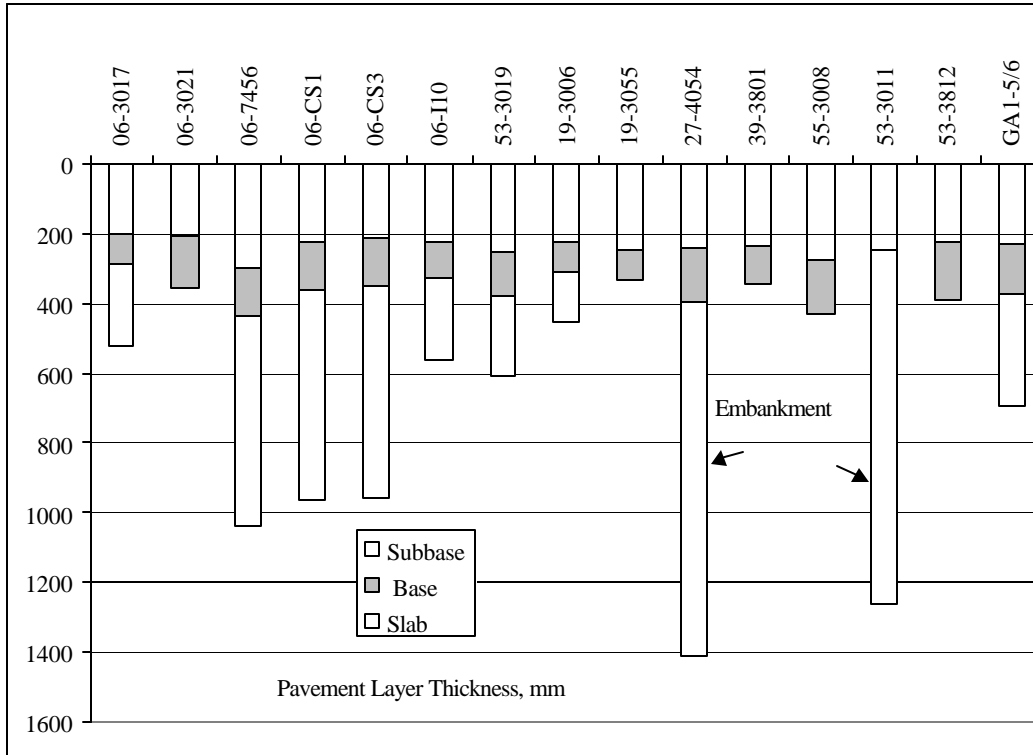
Figure 3.1.2 Pavement layer thickness for the studied pavements (mm).

The PCC slab thicknesses are nearly constant for the tested sites, with average value of 237 mm (9.3 in). The largest slab thickness, 297 mm (11.7 in), was found on the thickened slab section of the experimental test road 06-7456 on I-5 near Tracy,

California. Figure 3.1.2 shows the pavement layer thicknesses of the concrete slab, base and subbase layers for each test section.

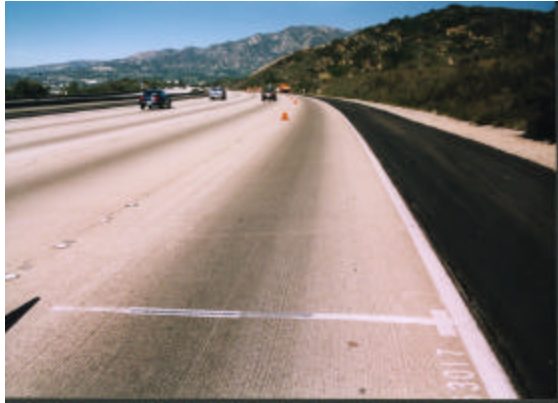
*Figure 3.1.4 Overview of test site 06-3017.*

The test section was in excellent condition with only a minor amount of faulting, which was on the order of 0.5 to 2 mm, with two joints having faulting of 5.7 mm. Three longitudinal joints exhibited medium severity of spalling with a total length of 0.8 m (31 in). The concrete surface showed map cracking, but it did not appear to have affected the concrete durability or the concrete surface condition.

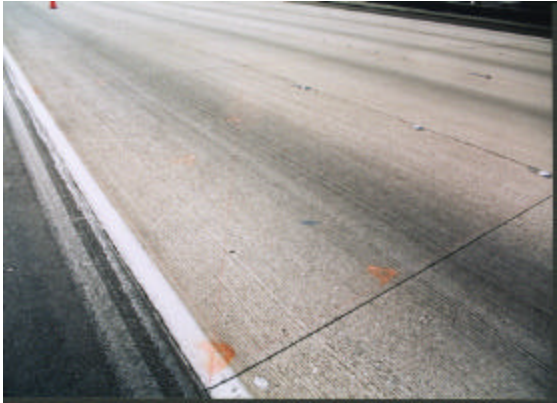
*Figure 3.1.5 Distress free slab and joint in test site 06-3017.*

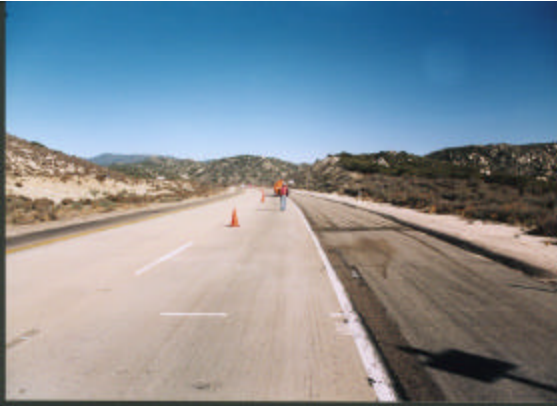
*Figure 3.1.6 Overview of test site 06-3021.*

The test section was in good condition and had undergone some maintenance work (patching). The test section had only a minor amount of faulting that was on the order of 1 to 3 mm, with the largest faulting of 4.5 mm. About 75 percent of the transverse joints suffered from low severity spalling, and some spalling was observed for longitudinal joints. The concrete surface showed map cracking, but it did not appear to have affected the concrete durability or the concrete surface condition.

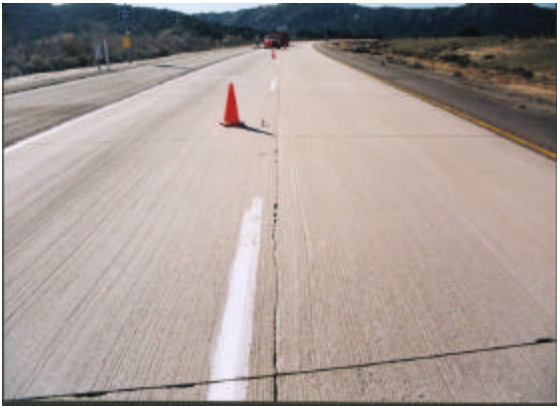
*Figure 3.1.7 Distress free slab at test site 06-3021.*

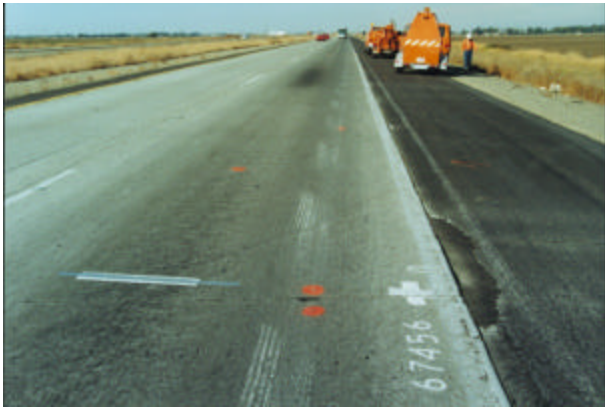
*Figure 3.1.8 Overview of test site 06-7456, Tracy Test Road.*

The test section was in excellent condition. The test section had only a minor amount of faulting, on the order of 0 to 4 mm.

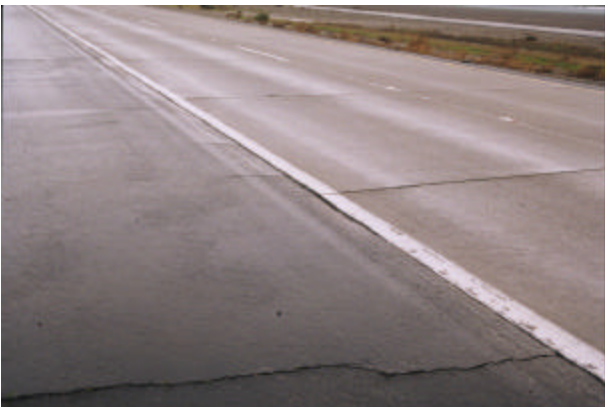
*Figure 3.1.9 No slab distress at test site 06-7456, Tracy Test Road.*

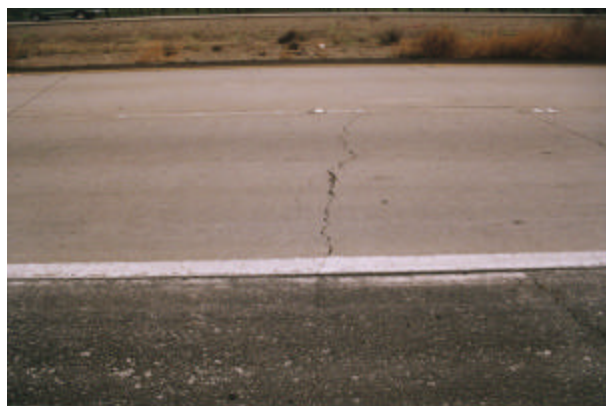
***Figure 3.1.10*** Medium severity transverse crack at 06-CS1, Tracy Test Road (control section).

The test section was in fair condition. On the longer slabs, low and medium severity corner breaks and transverse cracks were observed. The shorter slabs were found in very good condition. The test section had only a minor amount of faulting, on the order of 0 to 5 mm. Residue left from pumping of fines at the pavement edge adjacent to many transverse joints was observed. The pumping evidence was also observed at some transverse cracks. The concrete surface showed map cracking, but it did not appear to have affected the concrete durability or the concrete surface condition.

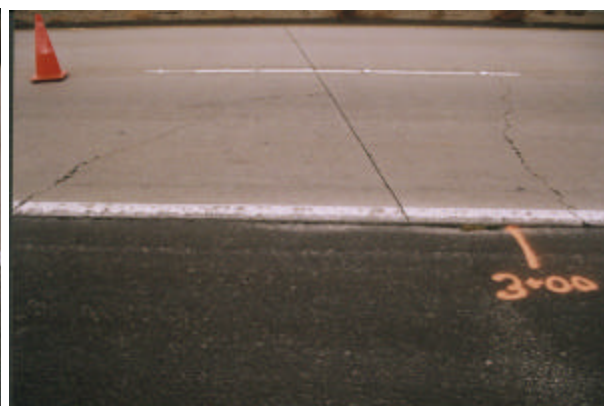
***Figure 3.1.11*** Corner break near approach joint at 06-CS1, Tracy Test Road (control section).

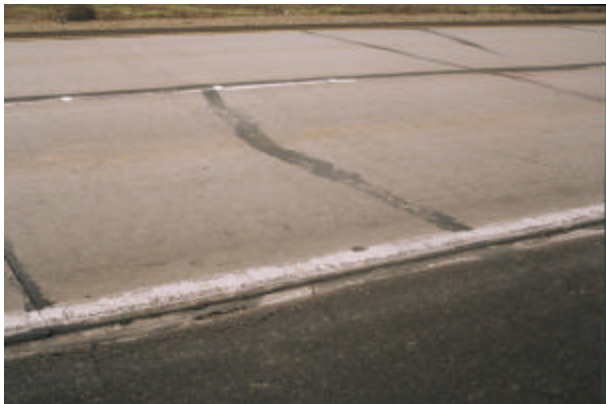
***Figure 3.1.12*** Crack only in truck lane at 06-CS3, Tracy Test Road (control section).

The test section was in fair condition. Low to medium severity transverse cracks were observed on 2/3 of the slabs, with only the 3.65-m (12-ft) slabs unaffected. There were two locations with low severity corner breaks. The test section had only a minor amount of faulting, on the order of 0 to 6 mm, with an average of 2 to 3 mm. Residue left from pumping of fines at the pavement edge adjacent to many transverse joints was observed. The concrete surface, the wheel path in particular, showed map cracking, but it did not appear to have affected the concrete durability or the concrete surface condition. This test section, 06-CS3, exhibited twice the number of transverse cracks as compared to the control section, 06-CS1, and also the amount of faulting was higher for this section. However, the spalling of this section was only half of that observed at the control section.

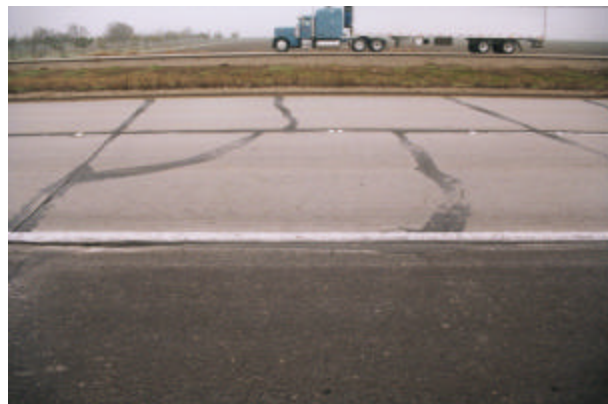
***Figure 3.1.13*** Corner break in truck lane at 06-CS3, Tracy Test Road (control section).

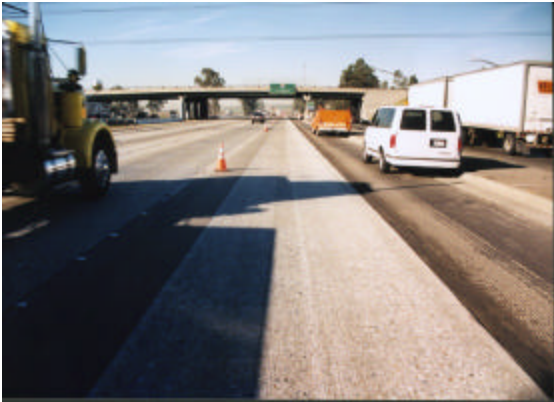
*Figure 3.1.14 Overview of test site 06-I-10.*

The test section was in good condition. Low to medium severity transverse cracks were observed on 25 percent of the slabs, and tended to occur on the 5.5- and 5.8-m (18- and 19- ft) slabs. About 2/3 of the transverse joints were observed to have low severity of spalling, and most of the joints had minor severity faulting averaging about 2 to 3 mm.

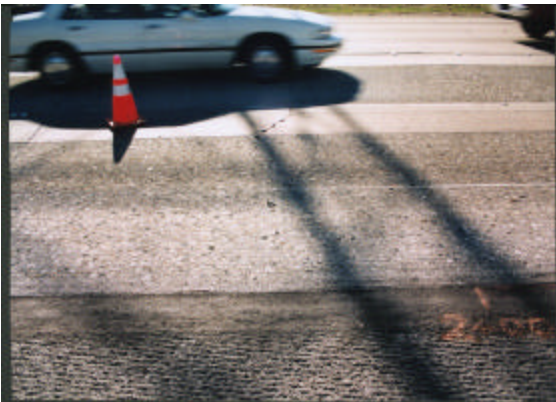
*Figure 3.1.15 Transverse crack at test site 06-I-10 closer to leave joint.*

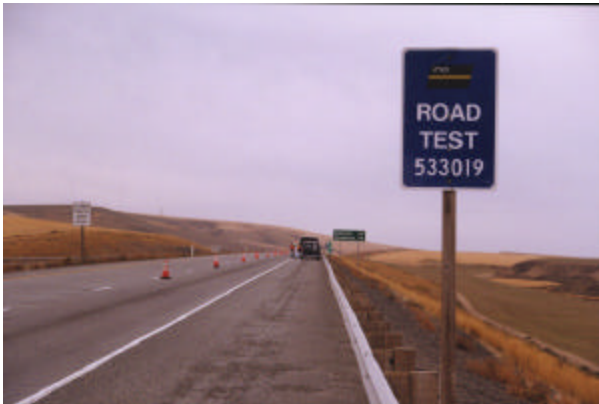
*Figure 3.1.16 Overview of test site 53-3019.*

This pavement section was in excellent condition. There was abrasion of the pavement surface in the wheel paths, likely caused by use of tire chains and/or studded tires. The finer aggregate and paste had eroded projecting the coarse aggregate above the surrounding pavement surface. There had been no maintenance activities on the test section. Most transverse joints exhibited low severity spalling, and an isolated longitudinal joint suffered from spalling. Transverse joint faulting ranged from 0 to 1.6 mm.

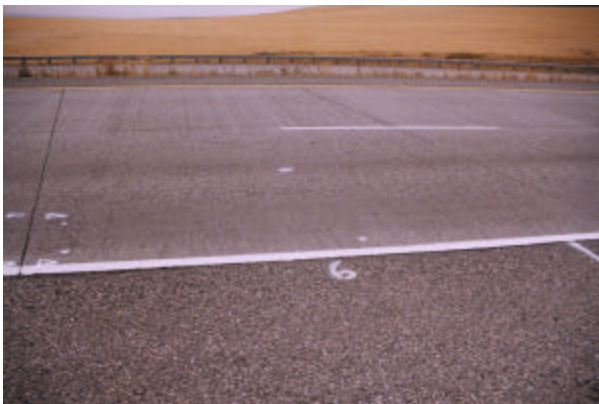
*Figure 3.1.17 Typical distress free slab at 53-3019.*

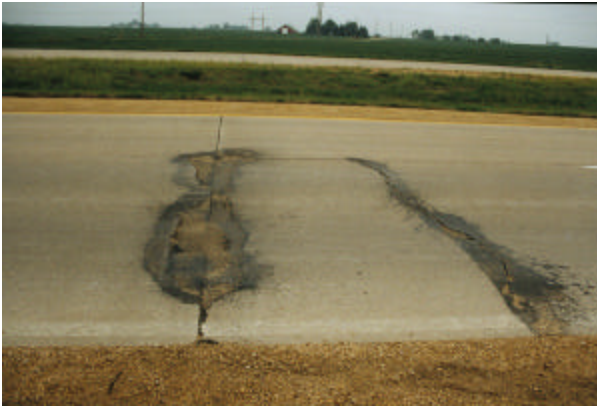
*Figure 3.1.18 Typical transverse joint distress at 19-3006.*

The test section was in very poor condition with all joints exhibiting some degree of spalling. High and low severity spalling with loss of material was noted at 22 of the 26 joints. Transverse joint faulting ranged from about 0.2 to 8.5 mm, with an average of about 3 mm. Previous survey records indicate that this section has been deteriorating rapidly since 1994.

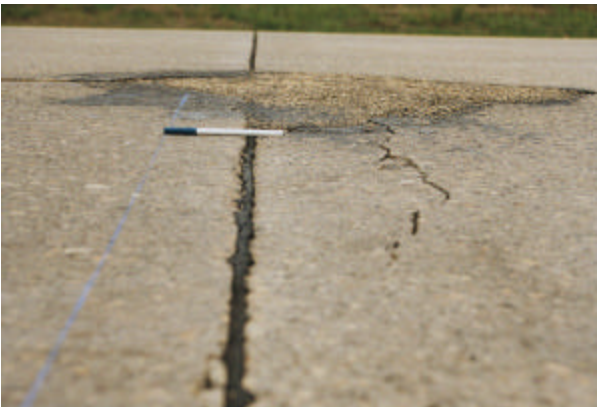
*Figure 3.1.19 Close-up on transverse joint spalling at 19-3006.*

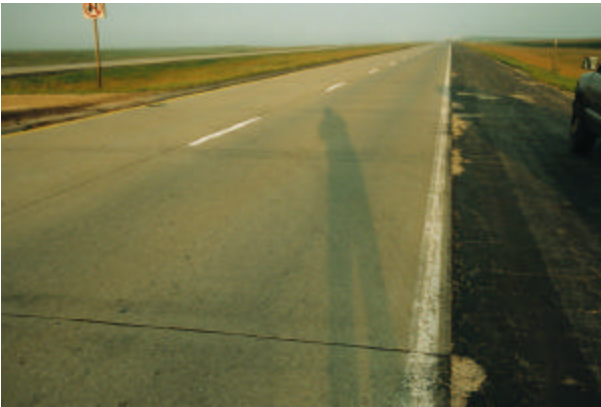
*Figure 3.1.20 Typical distress free slab at 19-3055.*

The test section was in very good condition with only low severity spalling of the transverse joints and transverse joint faulting ranging from 0 to 6.6 mm with an average of 3 mm. Some of the light spalling may have been due to snow plowing.

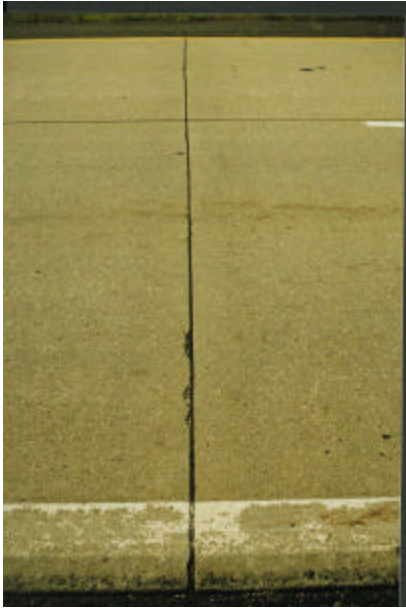
*Figure 3.1.21 Transverse joint in good condition at 19-3055.*

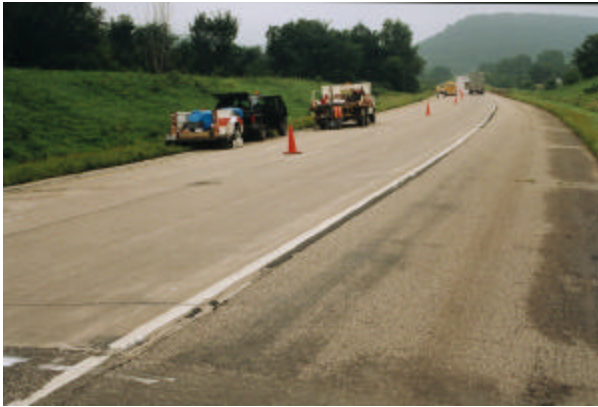
*Figure 3.1.22 Overview of test site 27-4054.*

The test section was in a relatively good condition except for the faulting, which ranged from 0.8 to 7.5 mm, two small high severity corner breaks, and low severity transverse joint spalling due in part to snow plowing.

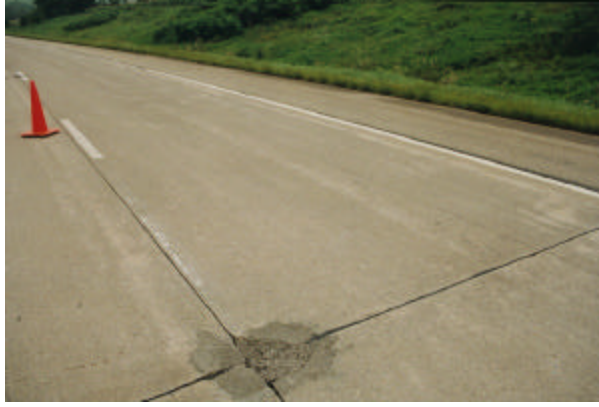
*Figure 3.1.23 Corner break and repair at 27-4054.*

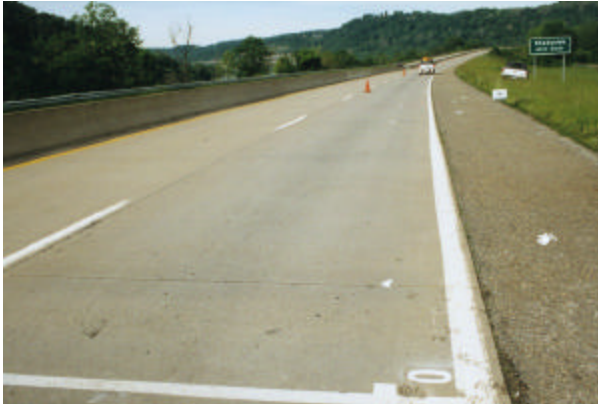
*Figure 3.1.24 Overview of test site 39-3801.*

The test section was in good condition. All transverse joints exhibited low severity of spalling, and faulting which ranged from -1.3 to 0.7 mm. Furthermore, a significant amount of low severity longitudinal cracking was observed at dowel bars.

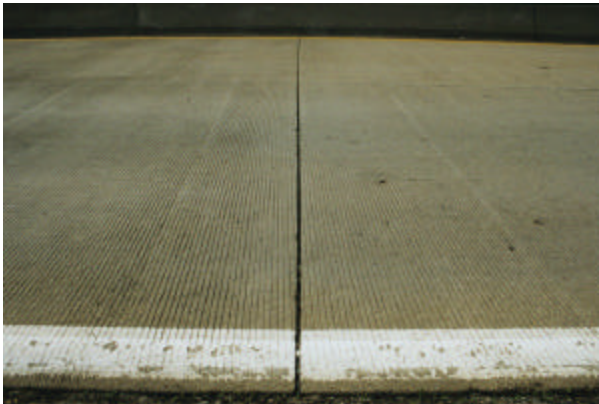
*Figure 3.1.25 Close-up of distress free transverse joint at 39-3801.*

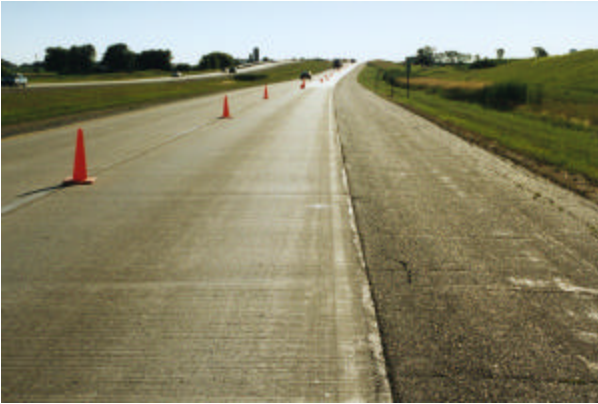
*Figure 3.1.26 Overview of test site 55-3008.*

The test section was in good condition except for faulting, which ranged from 4.3 to 15.2 mm, and low severity of transverse cracking. In addition the outside lane was faulted 3 to 6 mm relative to the inside lane. One medium severity crack was observed. There was no evidence of pumping of the subgrade, nor had any maintenance been required (except diamond grinding before and after the test section).

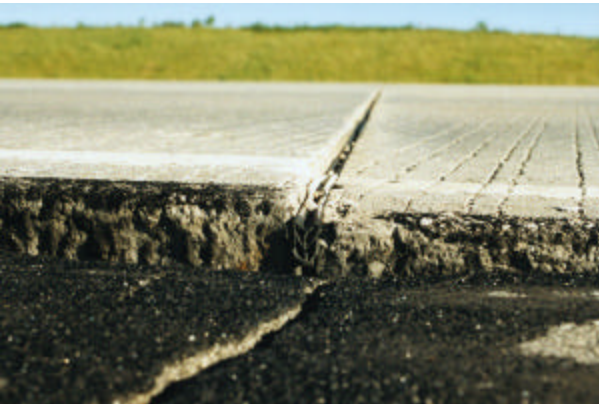
*Figure 3.1.27 Transverse joint at 55-3008 (faulting of shoulder).*

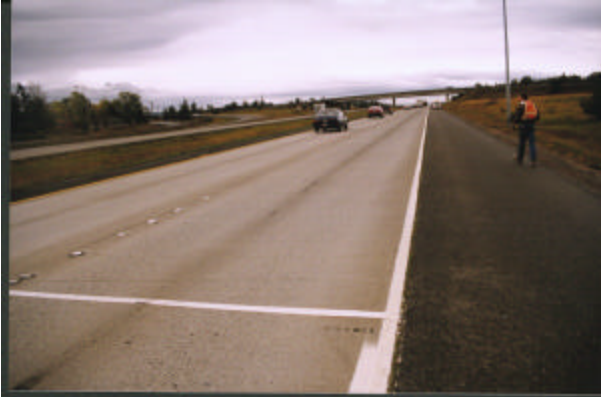
*Figure 3.1.28 Overview of test site 53-3011 (above).*

The test section was in very good condition, and there were no maintenance activities on the test section. Most transverse joints exhibited low severity spalling, and a few isolated longitudinal joints suffered from spalling. The transverse joint faulting ranged from 0 to 5 mm. There was abrasion of the pavement surface in the wheel paths, likely caused by use of tire chains and/or studded tires. The finer aggregate and paste had eroded, projecting the coarse aggregate above the surrounding pavement surface.

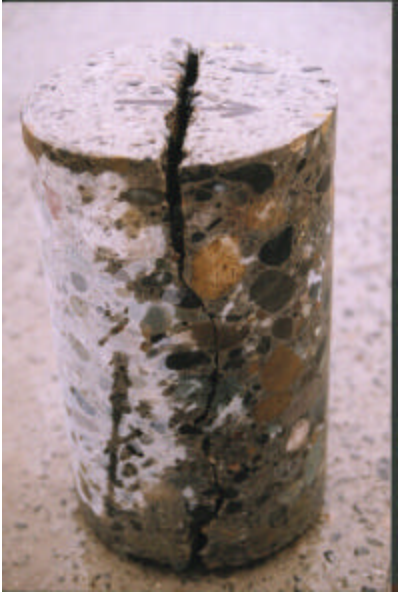
*Figure 3.1.29 Joint core sample in good condition from section 53-3011 (right).*

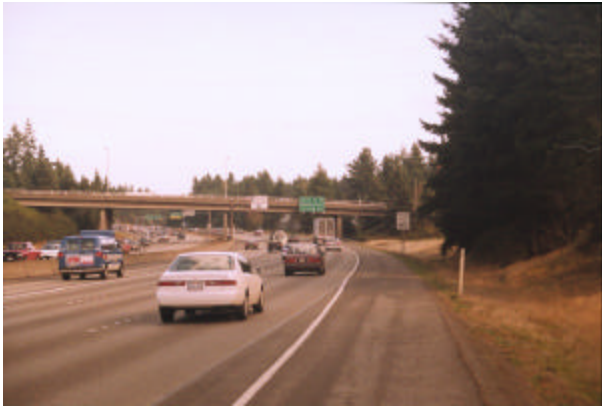
*Figure 3.1.30 Overview of test site 53-3812.*

This pavement section was in excellent condition. There was abrasion of the pavement surface in the wheel paths, likely caused by use of tire chains and/or studded tires. The finer aggregate and paste had eroded projecting the coarse aggregate (many particles exceeding 25 mm) above the surrounding pavement surface. No maintenance activities had been performed on the test section. Most transverse joints exhibited low severity spalling, and three isolated longitudinal joints suffered from spalling. The transverse joint faulting ranged from -3.0 to 2.5 mm. The faulting appeared to be related to the abrasion of the concrete surface and may not represent true faulting.

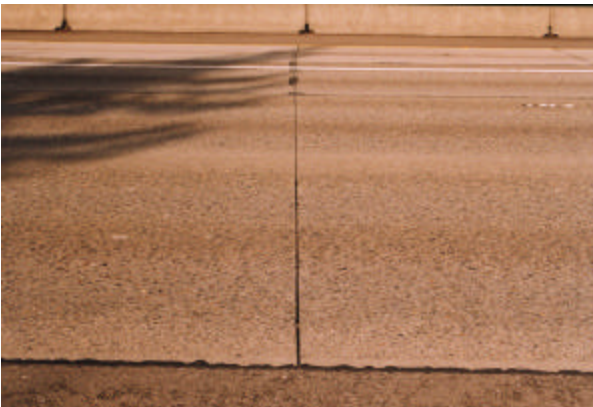
*Figure 3.1.31 Close-up of a distress free transverse joint at 53-3812.*

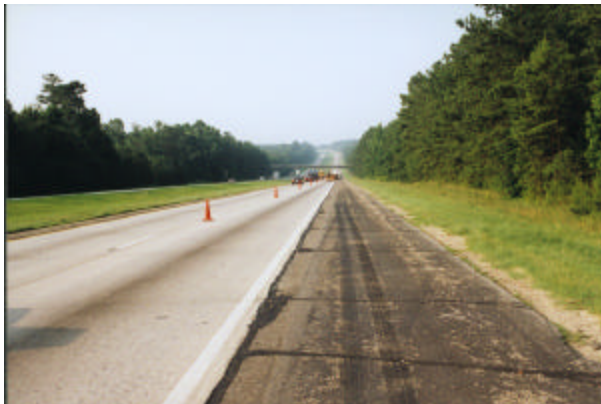
*Figure 3.1.32 Overview of test site 13-GA1-5.*

These pavements were in excellent condition, with negligible faulting which was typically less than 1 mm. Section 13-GA1-6 exhibited very minor transverse joint spalling.

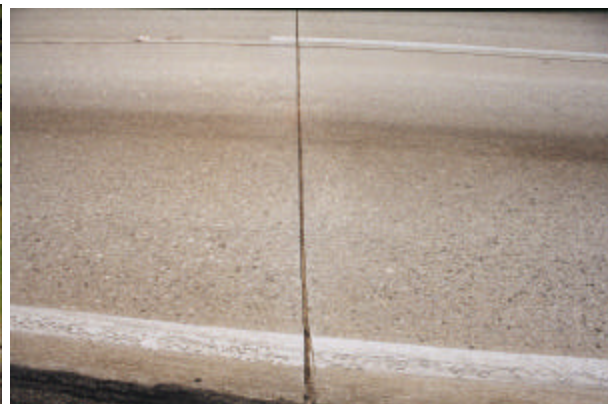
*Figure 3.1.33 Distress free transverse joint at 13-GA1-5.*

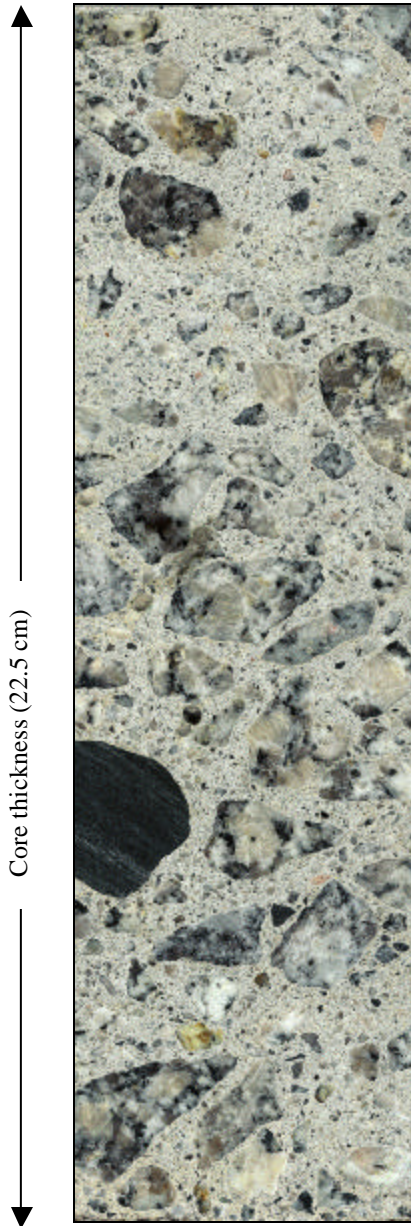
The drill-core of pavement 13-GA1-5 is 22.5 cm long and shows a concrete composed by crushed rock-fragments embedded in a pale gray cement paste (figure 3.2.15). Carbonation was not noted. The packing of the coarse aggregate appears close.
