## **Flood of October 8 and 9, 2005, on Cold River in Walpole, Langdon, and Alstead and on Warren Brook in Alstead, New Hampshire**

Open-File Report 2006-1221

By Scott A. Olson

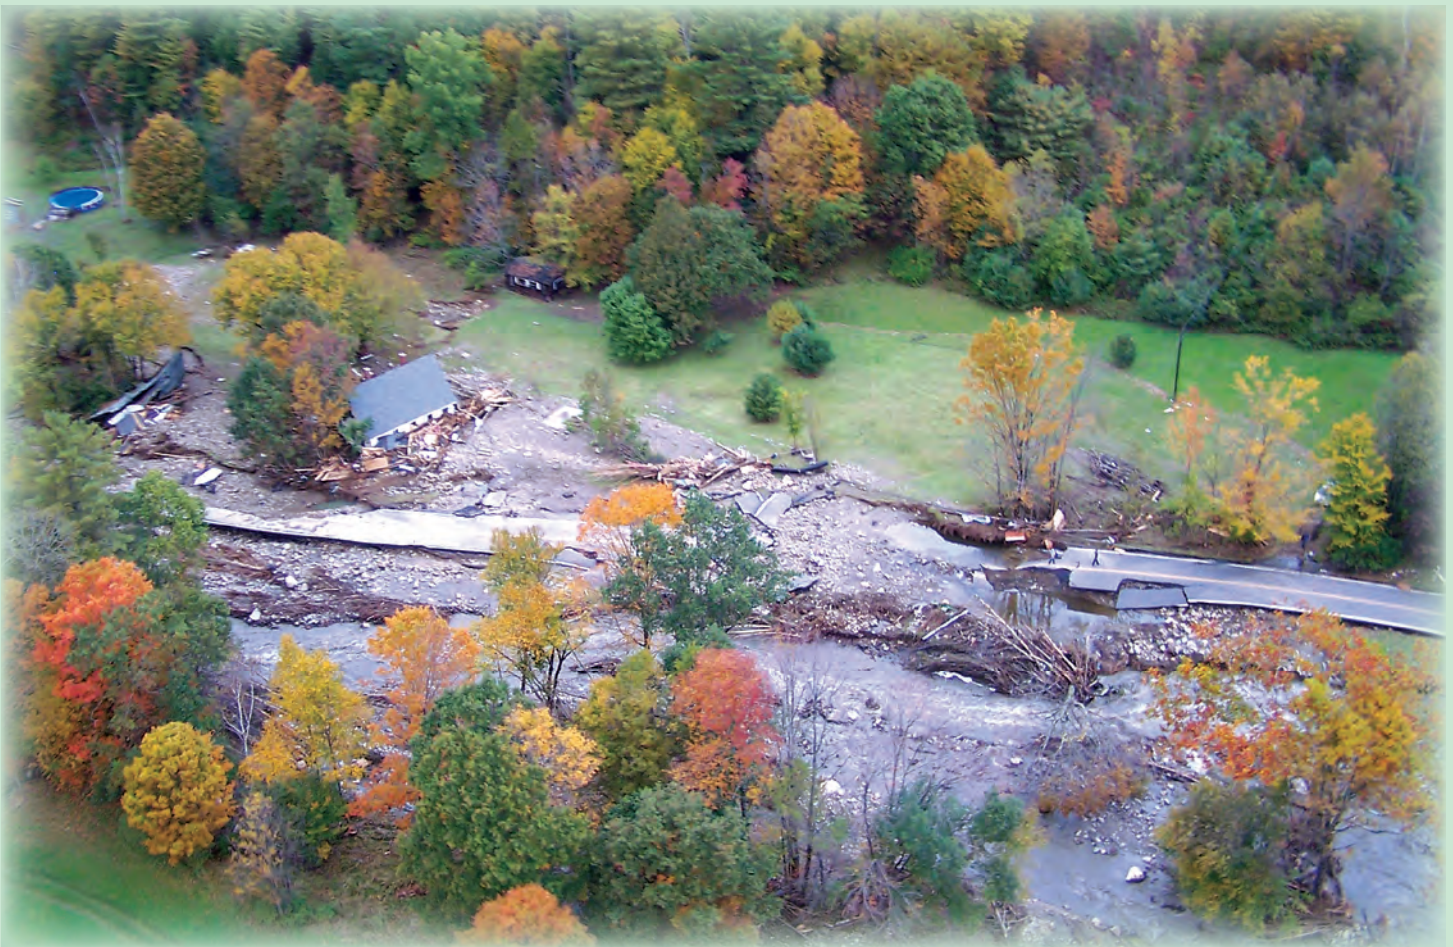
**Cover.** Devastation along Warren Brook, Route 123 in Alstead, NH, after the October 8 and 9, 2005 flood. (Photograph courtesy of the New Hampshire State Police Aviation Unit)

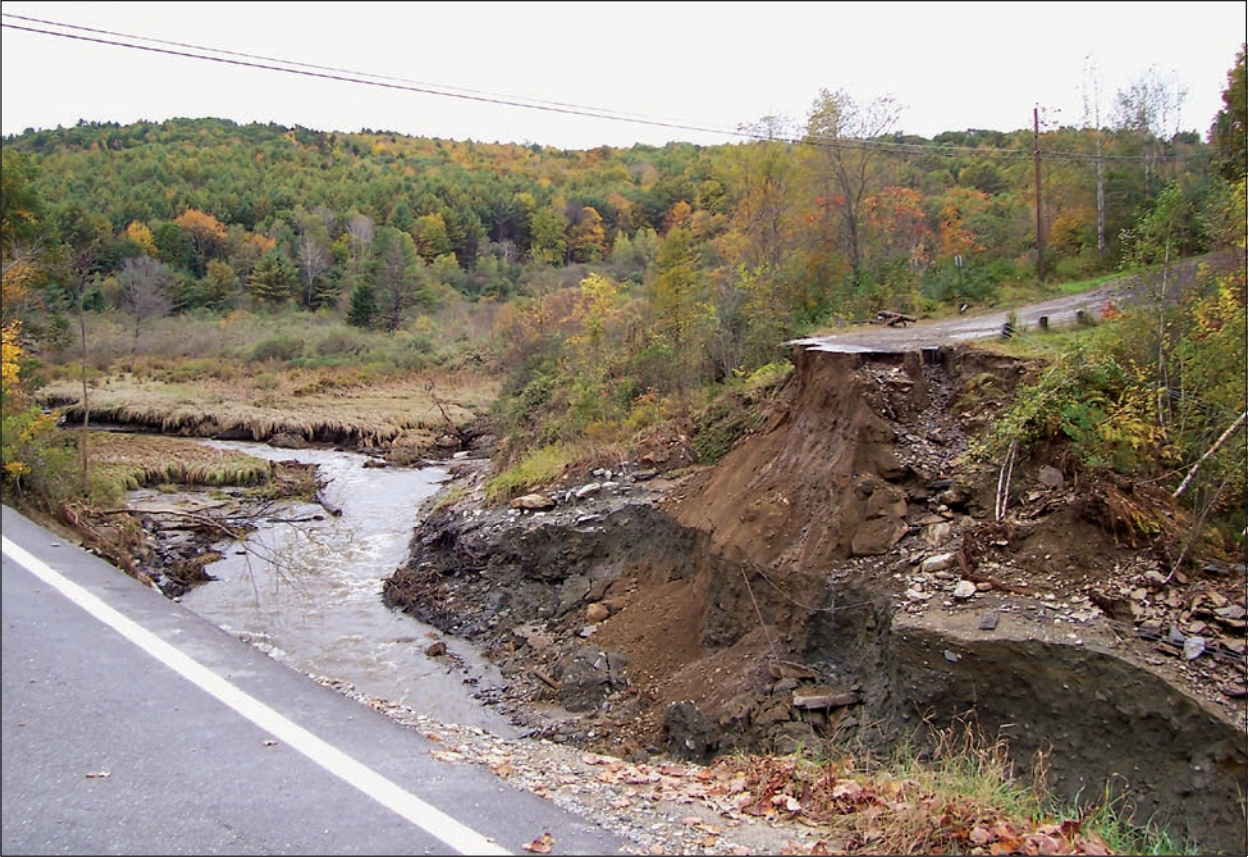
**Figure 3.** View looking upstream at the Cooper Hill Road embankment failure October 2005 in Alstead, NH.

Peak-discharge estimates were determined immediately downstream of the Cooper Hill Road crossing of Warren Brook. During the flood, the Cooper Hill Road embankment impounded flood waters flowing down Warren Brook. Using the National Elevation Dataset (U.S. Geological Survey, 2001), the impoundment was computed to be 421 acre-ft of water. When the nearly 30-ft tall road embankment was overtopped, it breached, sending the entire impounded pool of floodwaters rushing downstream.

Because of the apparent similarities of the impoundment failure to an earthen dam failure, the National Weather Service's Simplified Dam-Break (SMPDBK) Flood Forecasting Model (Wetmore and Fread, 1991) was used to estimate the peak discharges downstream of the breached road embankment. The geometry of the breached road embankment was surveyed and used as input along with the impoundment volume. Additional cross sections downstream of the Cooper Hill Road crossing along Warren Brook to its mouth were estimated from the USGS 1:24,000 topographic map (U.S. Geological Survey, 1998a) and also used as input to the model. The additional cross sections allowed the SMPDBK model to route the peak discharge down Warren Brook to its mouth where it drains into Cold River.

The discharges computed by the SMPDBK model were sensitive to the amount of time that the road embankment was given to completely breach. The breach occurred in about a 20- to 30-minute timeframe (David Crosby, town of Alstead Director of Public Works, oral commun., December 19, 2005). Thus, a breach time of 25 minutes was used in the model. The results from SMPDBK indicate a peak discharge immediately downstream of Cooper Hill Road of 24,900 ft<sup>3</sup>/s and a peak discharge of 20,100 ft<sup>3</sup>/s at the confluence with Cold River. Decreasing the time to 20 minutes increased peak discharges by approximately 7 percent; increasing the breach time to 30 minutes decreased peak discharges by about 3 percent.

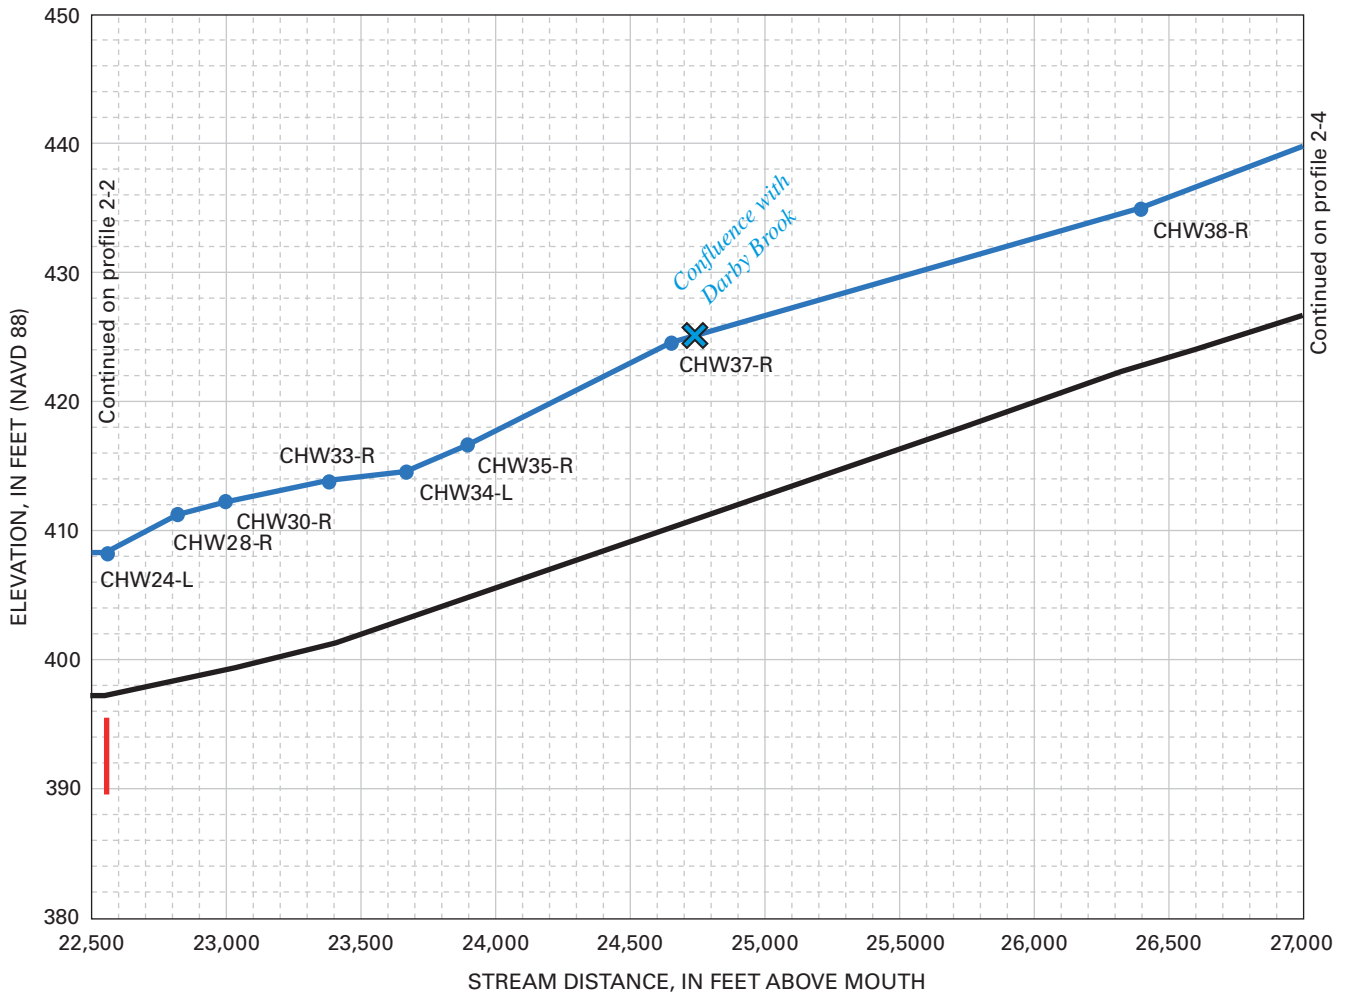
- CHW24-L
- High-water profile, October 2005 flood
- Minimum channel elevation
- | Location of cross section shown in figure 1-3

Figure 2-3. Profiles for Cold River, Langdon and Alstead, NH.

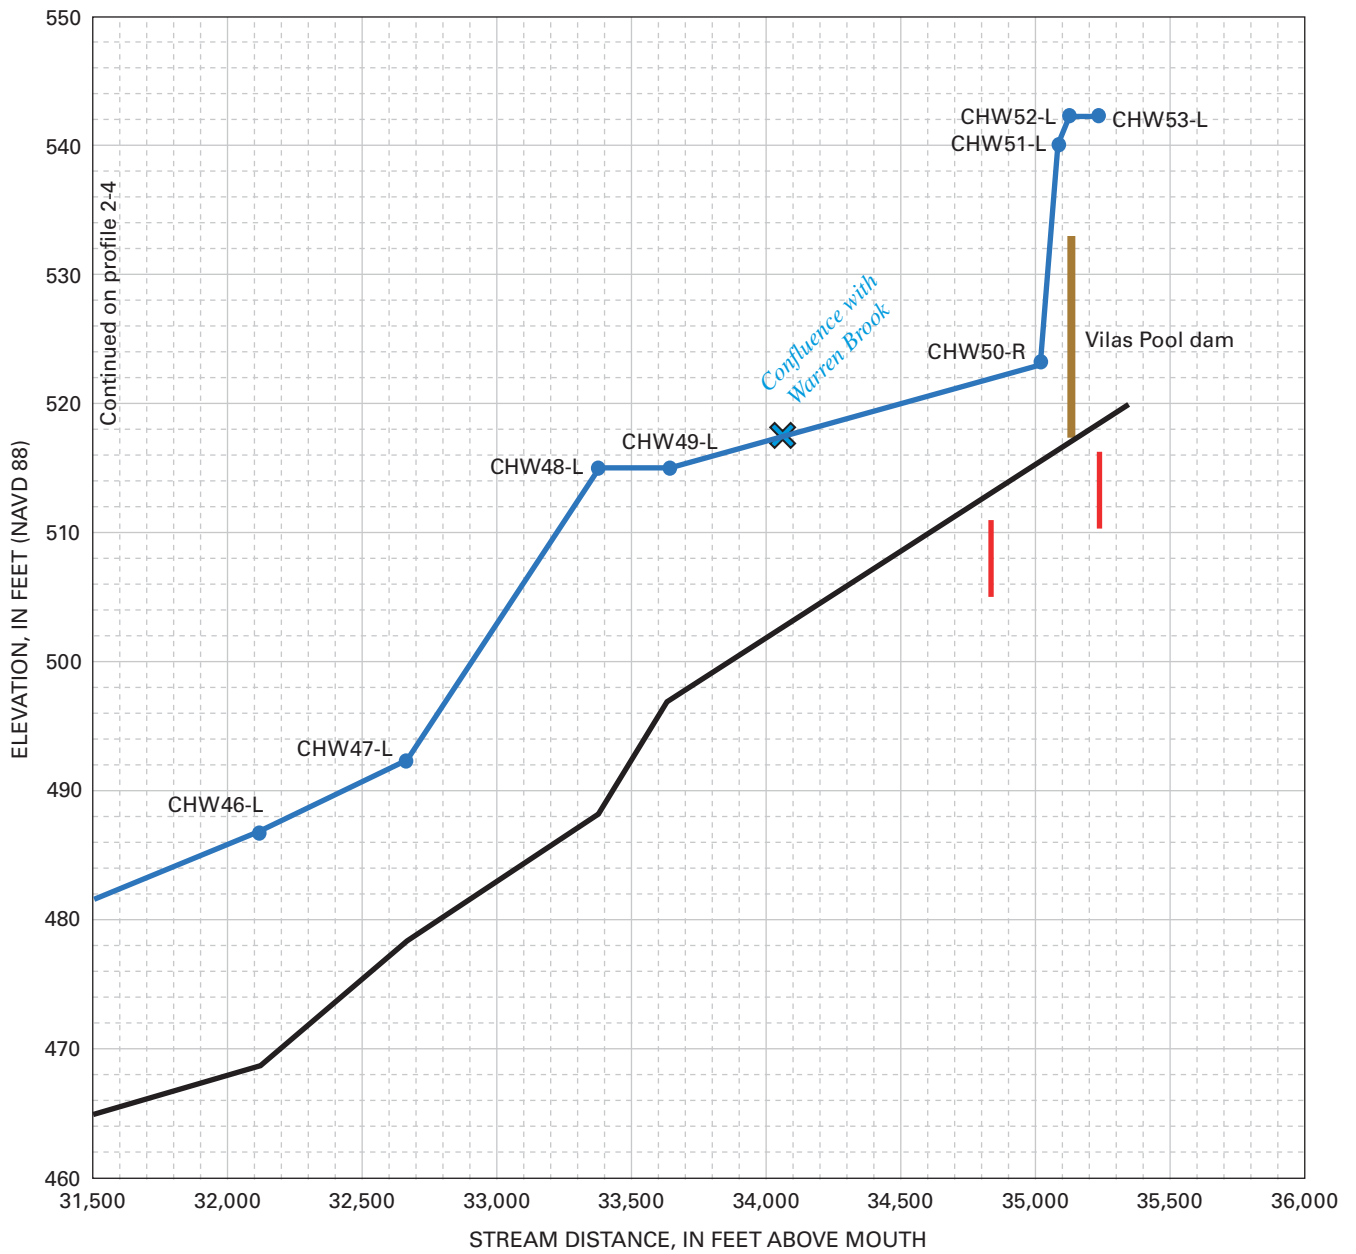
- CHW46-L
- High-water profile, October 2005 flood
- Minimum channel elevation
- Location of cross section shown in figure 1-5

Figure 2-5. Profiles for Cold River, Alstead, NH.

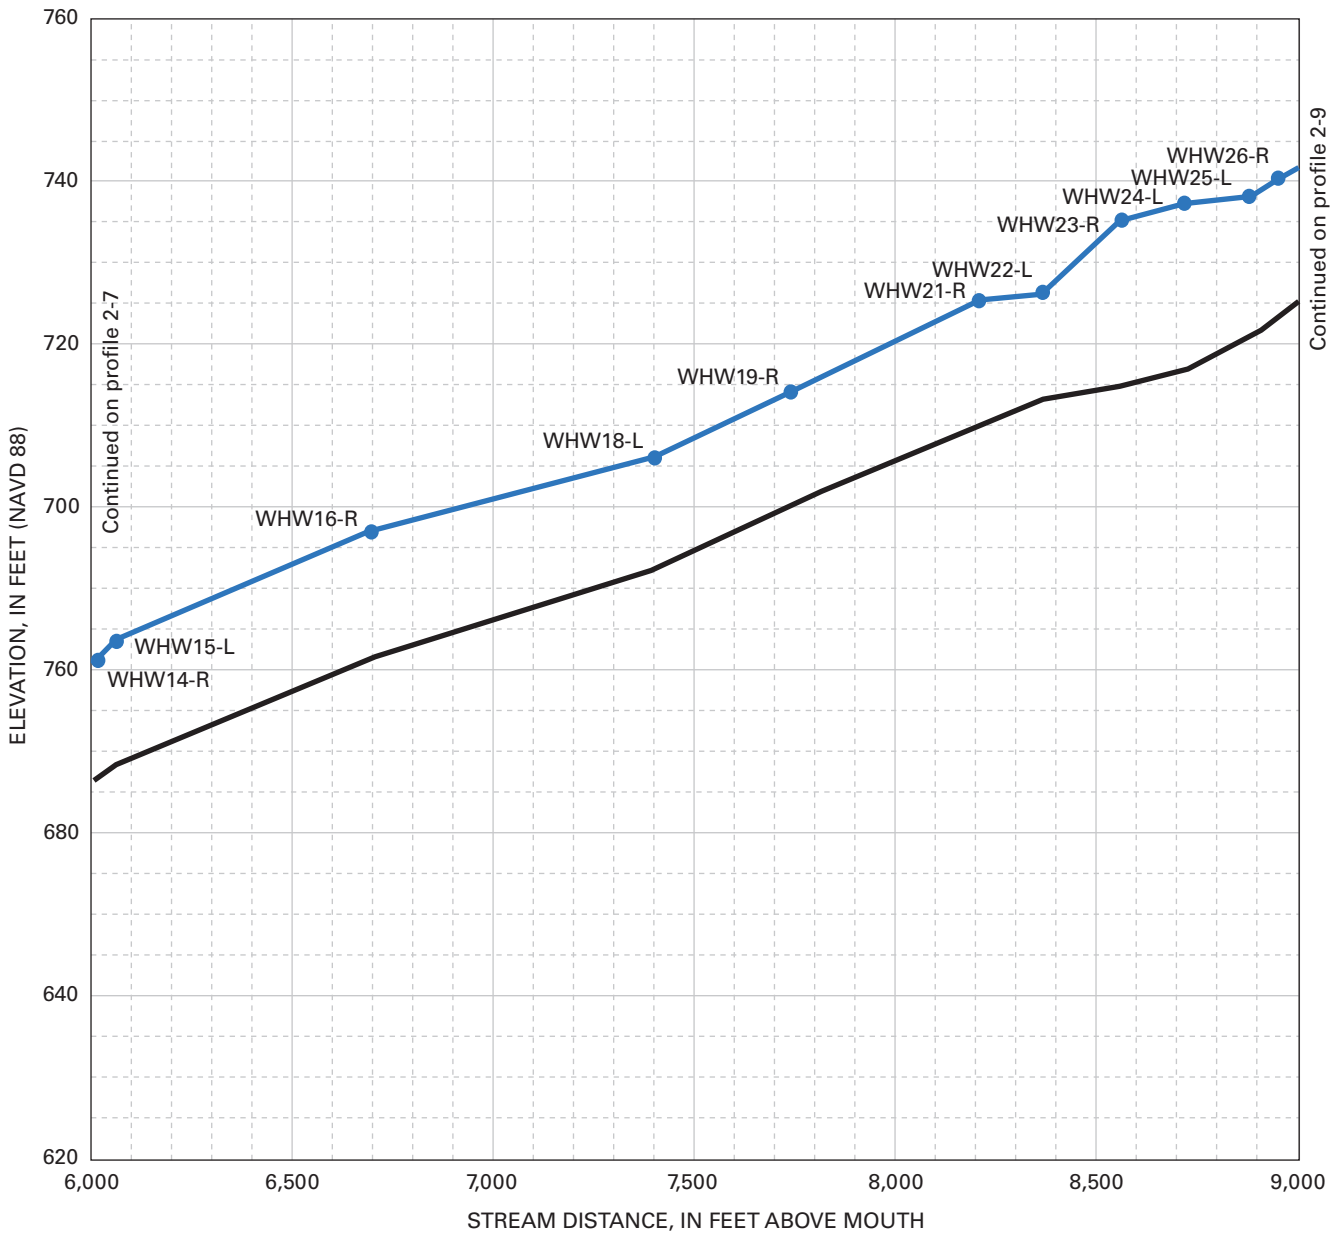
Figure 2-8. Profiles for Warren Brook, Alstead, NH.
