A Recommendation for an
ENHANCED FUJITA SCALE
(EF-Scale)

Submitted to
The National Weather Service
and
Other Interested Users

June 2004

WIND SCIENCE AND ENGINEERING CENTER
Texas Tech University
Lubbock, Texas 79409-1023

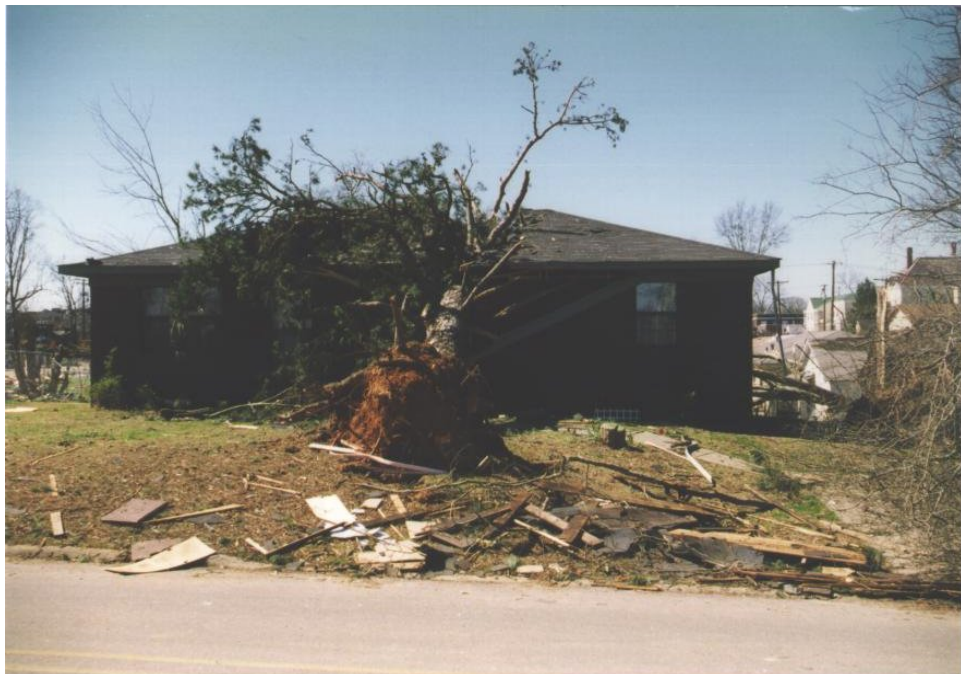
TH: DOD 4: Tree uprooted
