Why the New Orleans Levees Failed

The Levee Breaches Along the 17th Street and London Avenue Canals

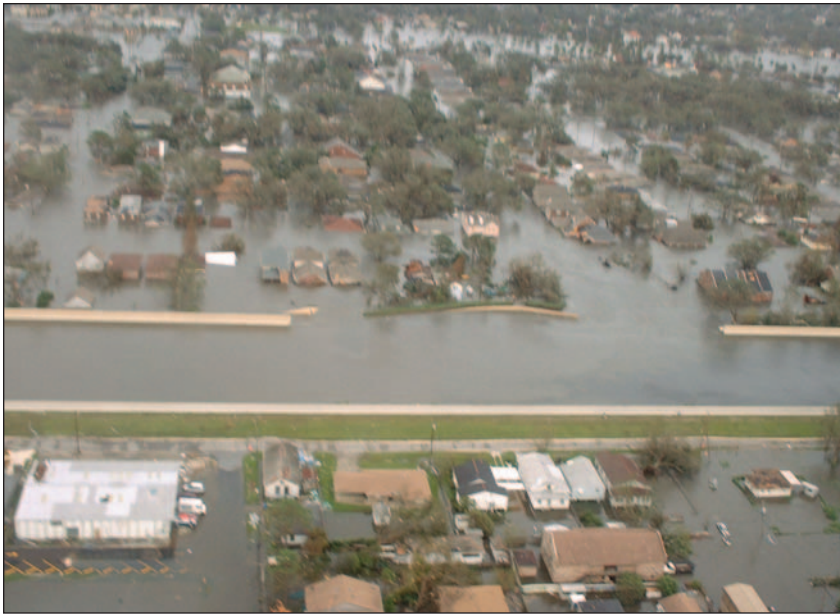
Breached floodwall, New Orleans
Marty Bahamonde photo

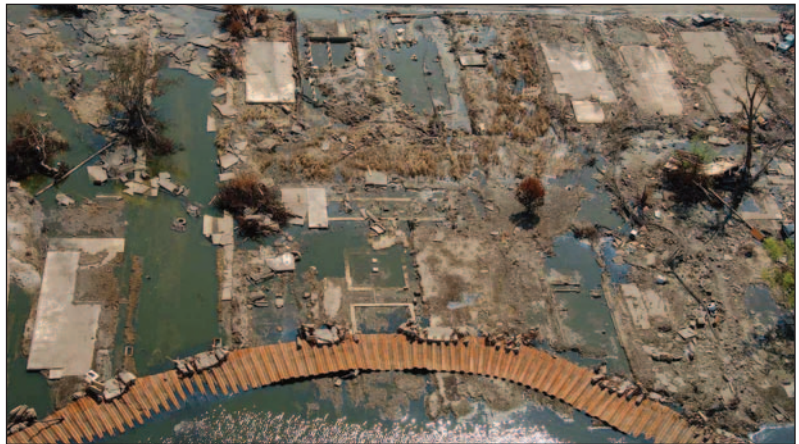
Ripped-out sheetpile with chunks of floodwall attached, New Orleans
Louisiana National Guard photo

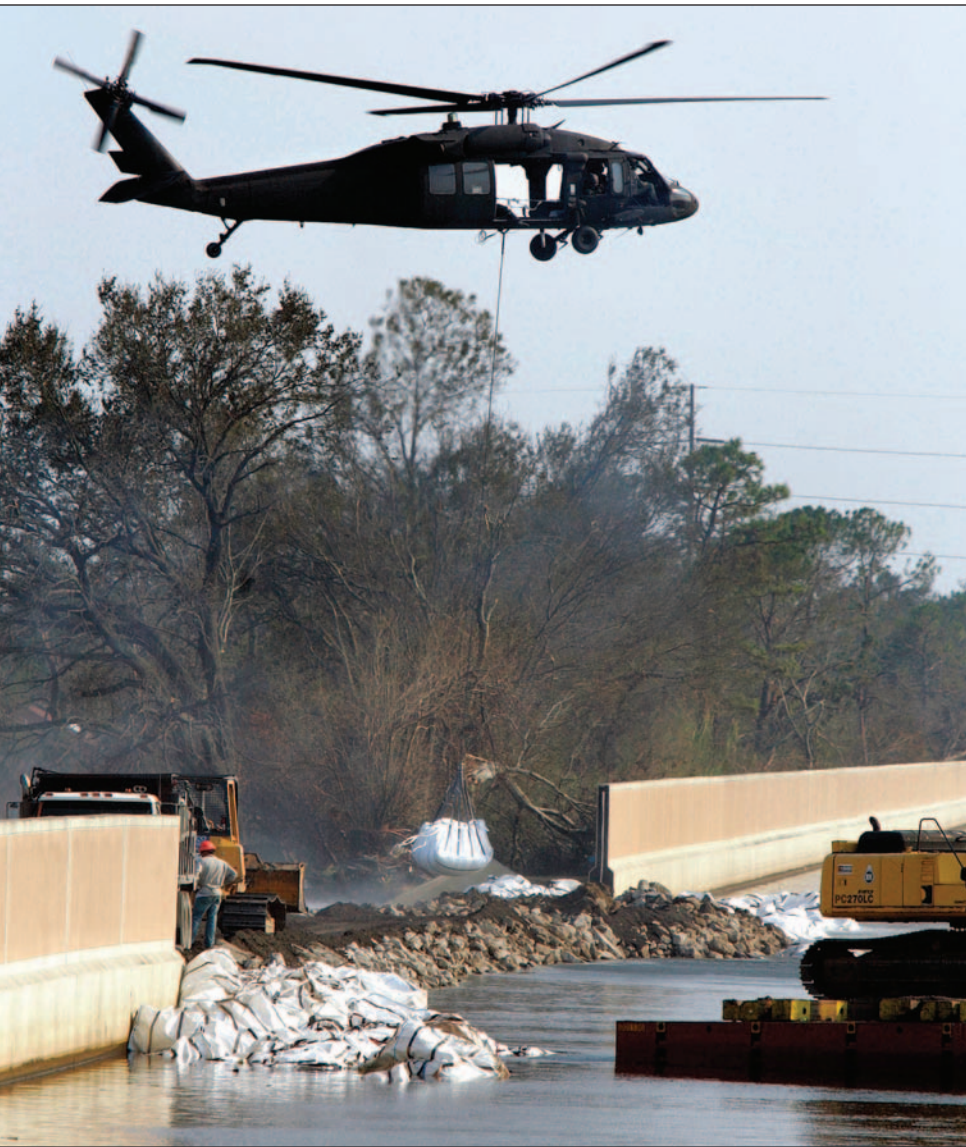
Plugging a breached floodwall,
New Orleans
