NIST Technical Note 1541

**Propagation and Detection of Radio
Signals Before, During, and After the
Implosion of a Large Sports Stadium
(Veterans' Stadium in Philadelphia)**

Electromagnetics Division
National Institute of Standards and Technology
325 Broadway
Boulder, CO 80305

October 2005

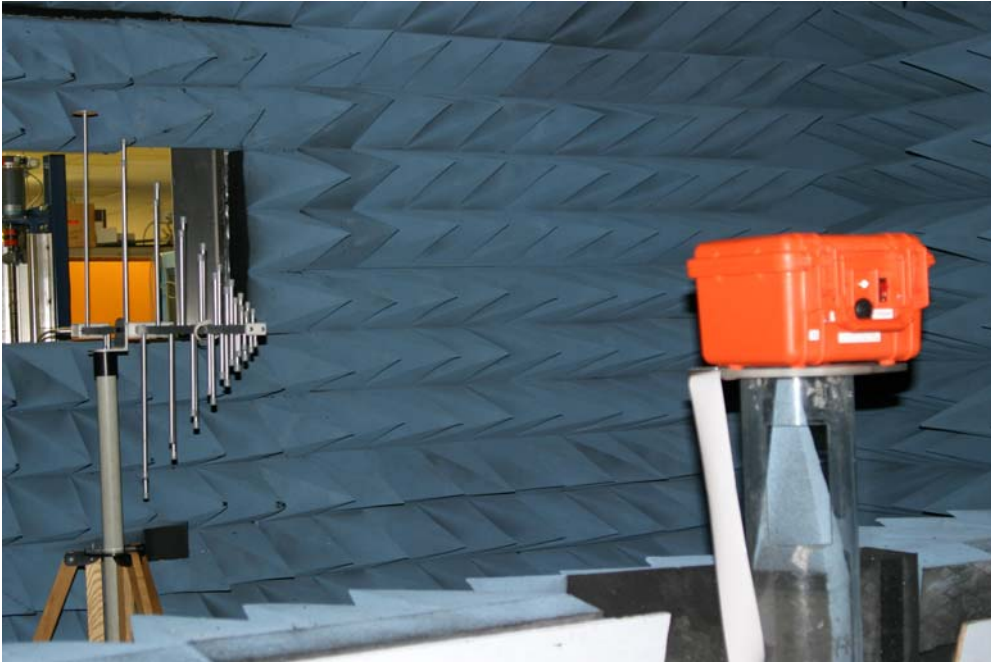
Figure 7. Transmitter in the NIST Boulder anechoic chamber.

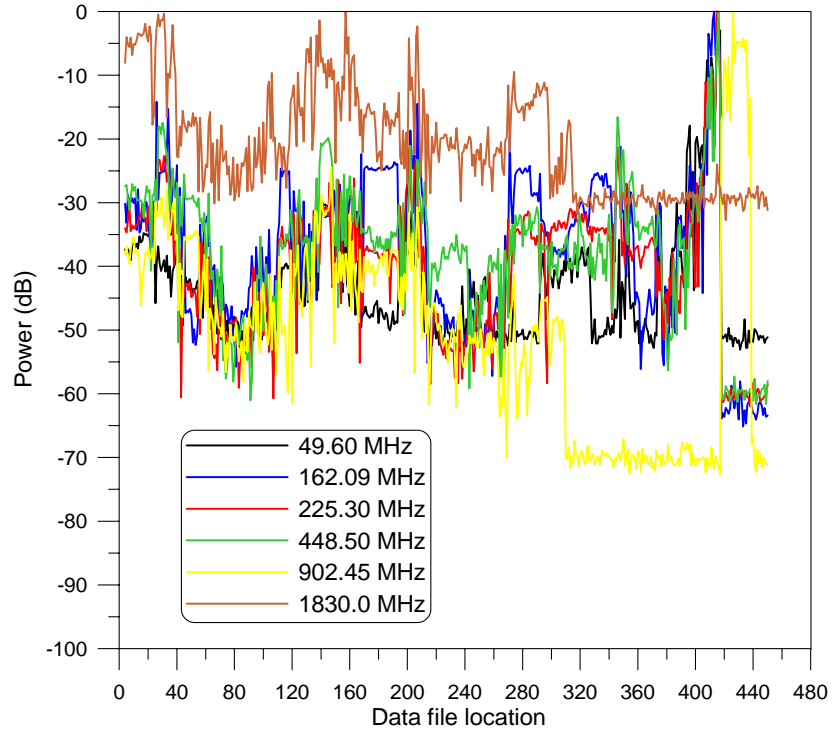
Figure 28. Stadium walk-through for horizontally polarized receiving antennas (playing field).

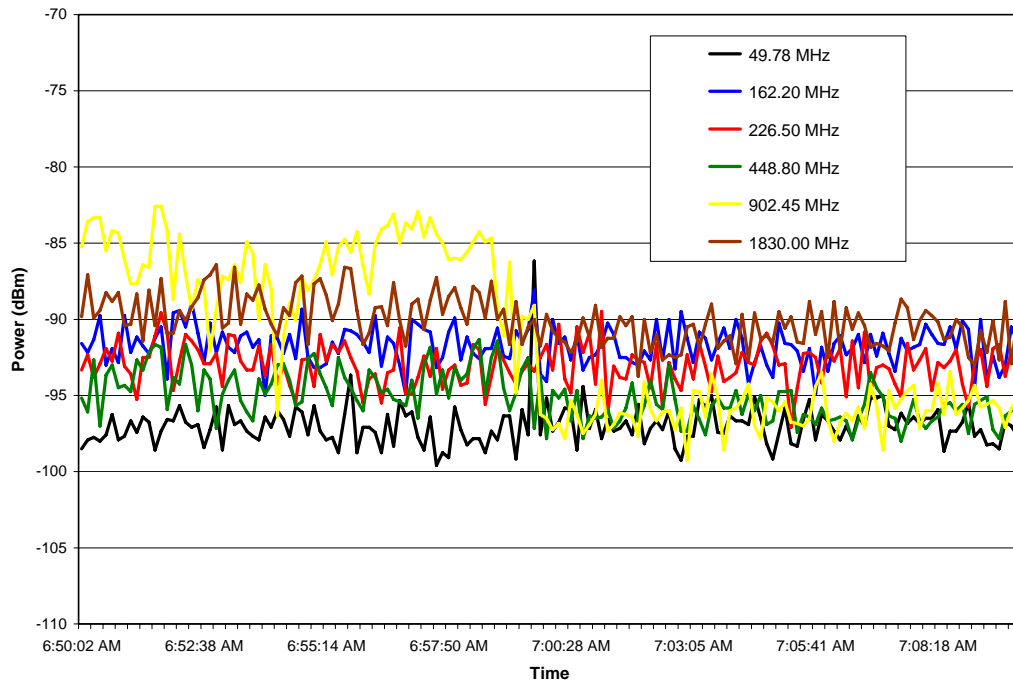
Figure 62. Pre- and post-implosion data collected from Receiver Site 2 for the transmitters located at Site A.

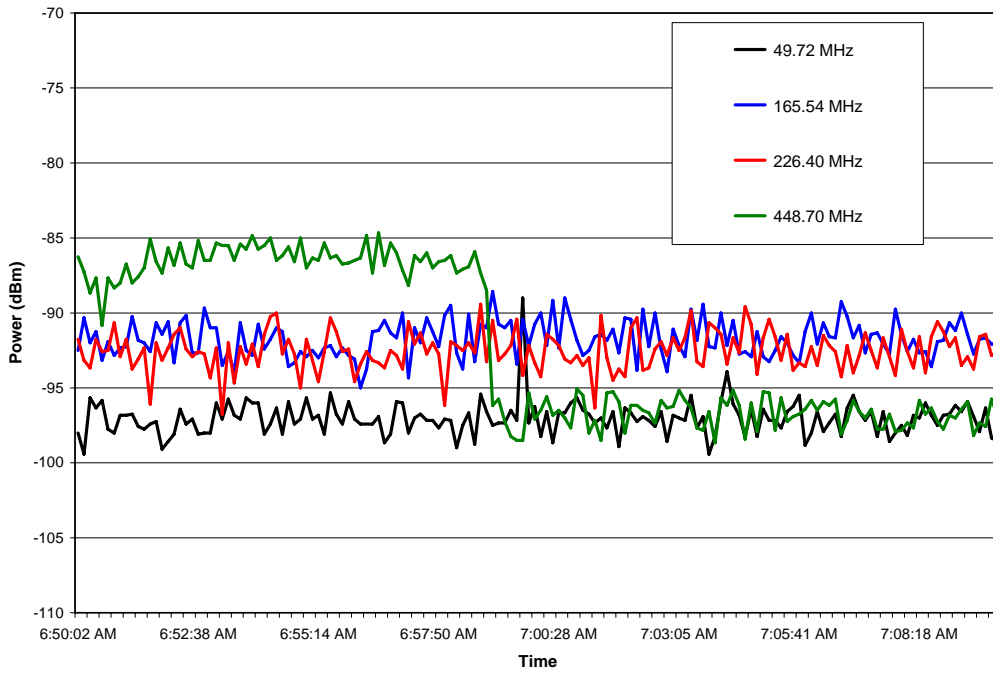
Figure 64. Pre- and post-implosion data collected from Receiver Site 2 for the transmitters located at Site C.

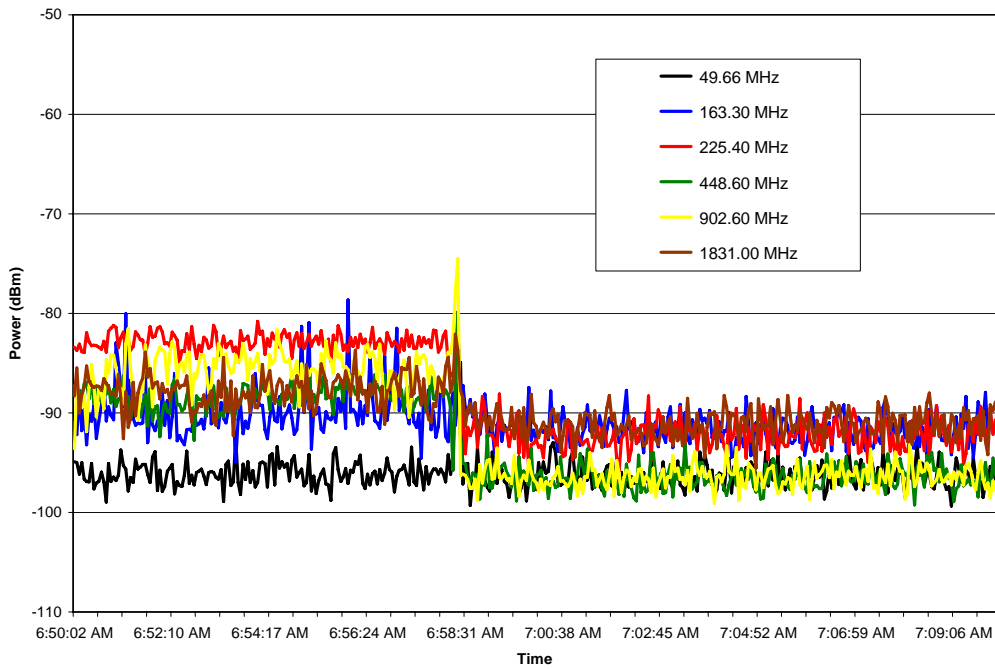
Figure 67. Pre- and post-implosion data collected from Receiver Site 3 for the transmitters located at Site B.

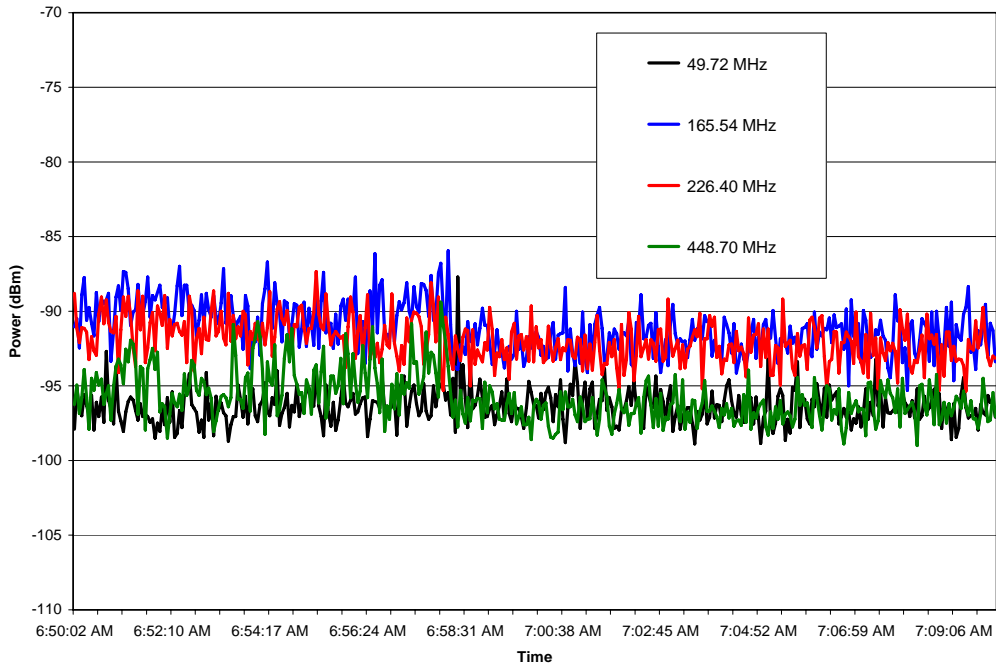
Figure 68. Pre- and post-implosion data collected from Receiver Site 3 for the transmitters located at Site C.

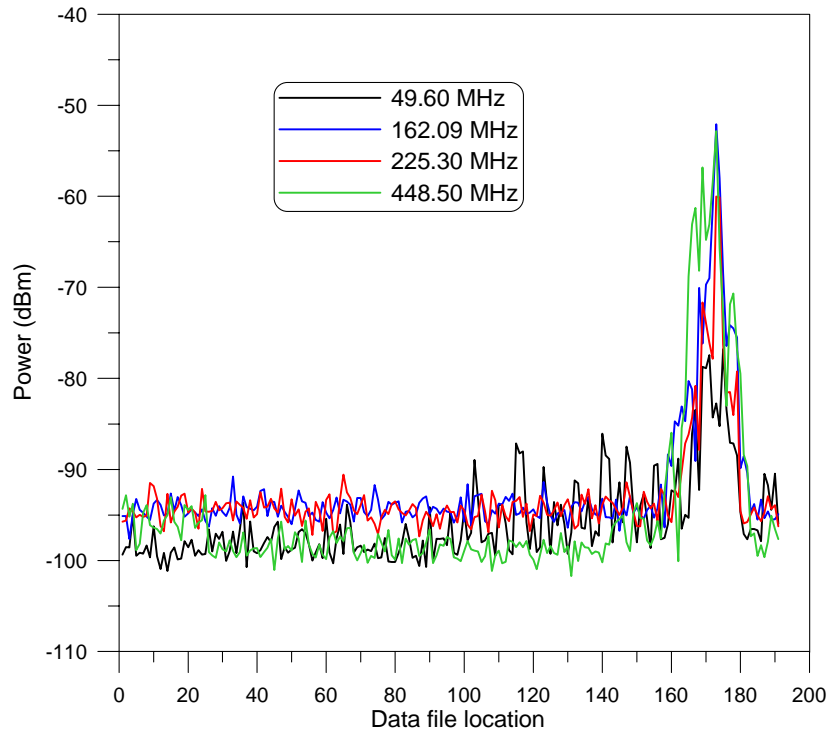
Figure 102. Post-implosion mobile cart perimeter measurements for the transmitters at transmitter Site D for vertical polarized receiving antennas: perimeter walk 1.
