***NIST Technical Note 1540***

**Propagation and Detection of Radio  
Signals Before, During, and After the  
Implosion of a 13-Story Apartment  
Building**

Electromagnetics Division  
National Institute of Standards and Technology  
325 Broadway  
Boulder, CO 80305

May 2005

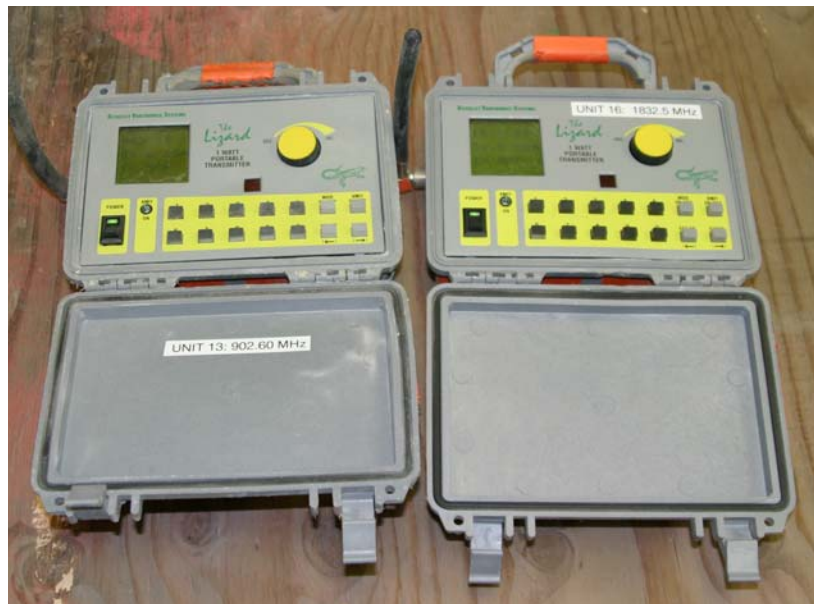
Figure 6. Transmitters used for the two higher frequency bands.

Commercial transmitters were available for the two higher frequency bands (900 and 1800 MHz). These off-the-shelf transmitters were already in plastic protective cases and could transmit continuously for 12 hours. Figure 6 shows these transmitters. Note the higher-frequency transmitters were grey in color and not orange.

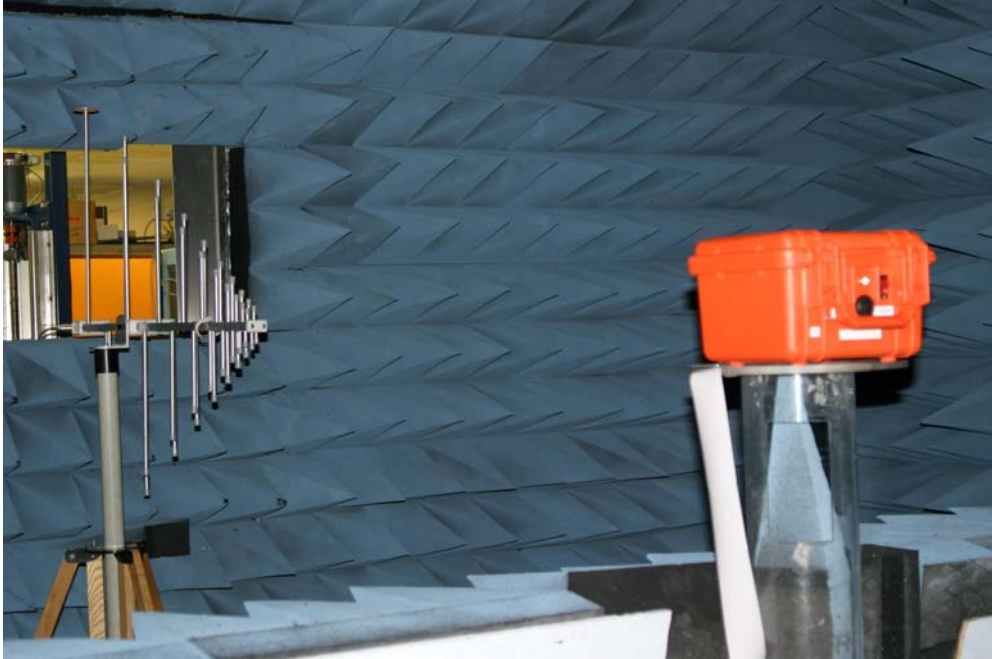
Figure 7. Transmitter in the NIST Boulder anechoic chamber.

To insure that the plastic protective cases did not affect the total radiated power and radiation pattern of the transmitters, measurements of these two quantities were taken in the NIST reverberation and fully anechoic chambers. Measurements of the total radiated power both with and without the plastic cases indicated that the cases had little effect on the total radiated power. Radiated power patterns of the transmitters in the protective cases were also measured to ensure that the cases did not have dramatic effects on the radiation patterns. The transmitters were placed in the NIST anechoic chamber (see Figure 7) for these pattern measurements. Figures 8-10 illustrate the results for 164 MHz, 225 MHz, and 448 MHz. These figures show that the radiation patterns of the transmitters in the protective cases were very similar to the dipole type pattern that the radio would produce in free space.

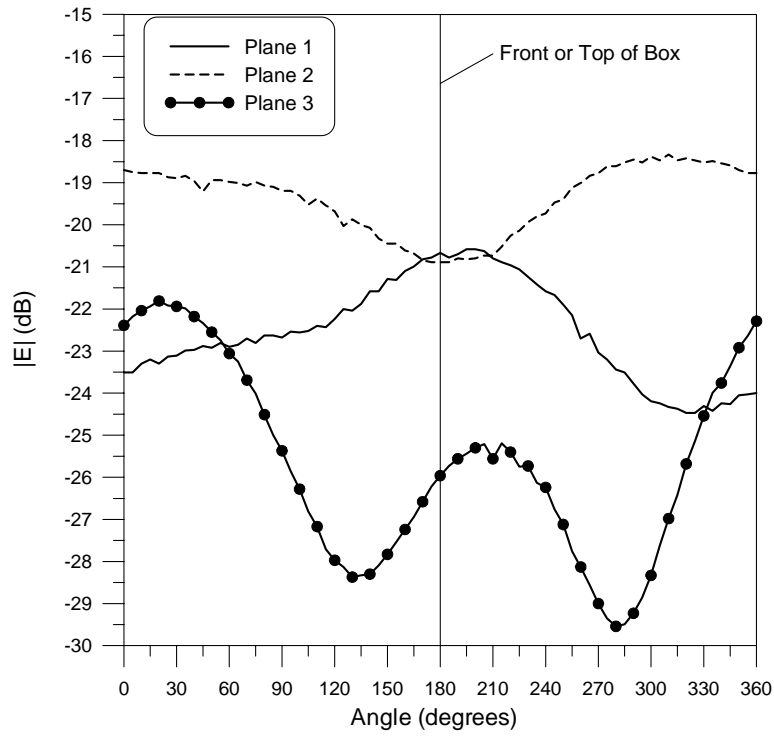
Figure 8. Radiation pattern of a 164 MHz transmitter in a protective case.

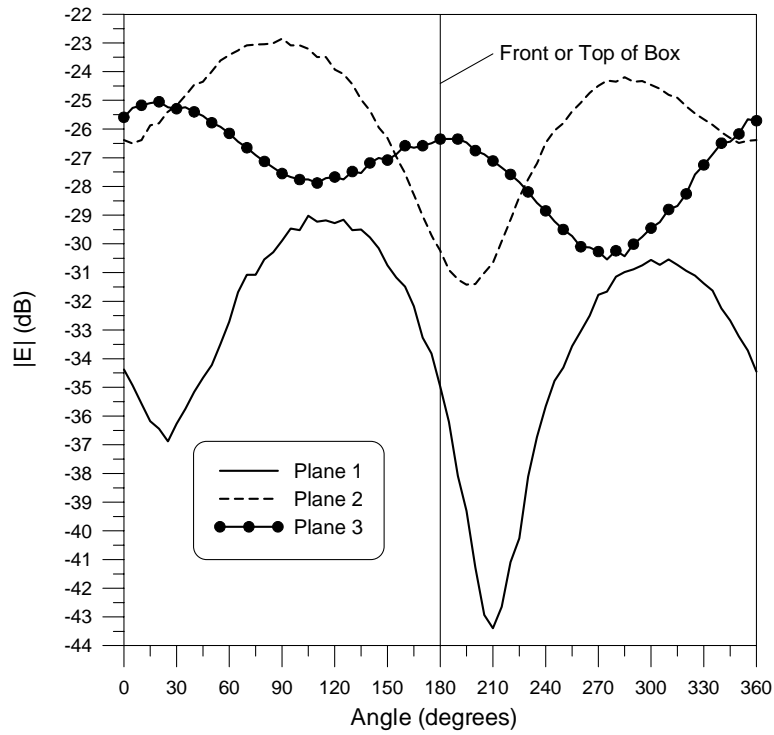
Figure 9. Radiation pattern of a 225 MHz transmitter in a protective case.

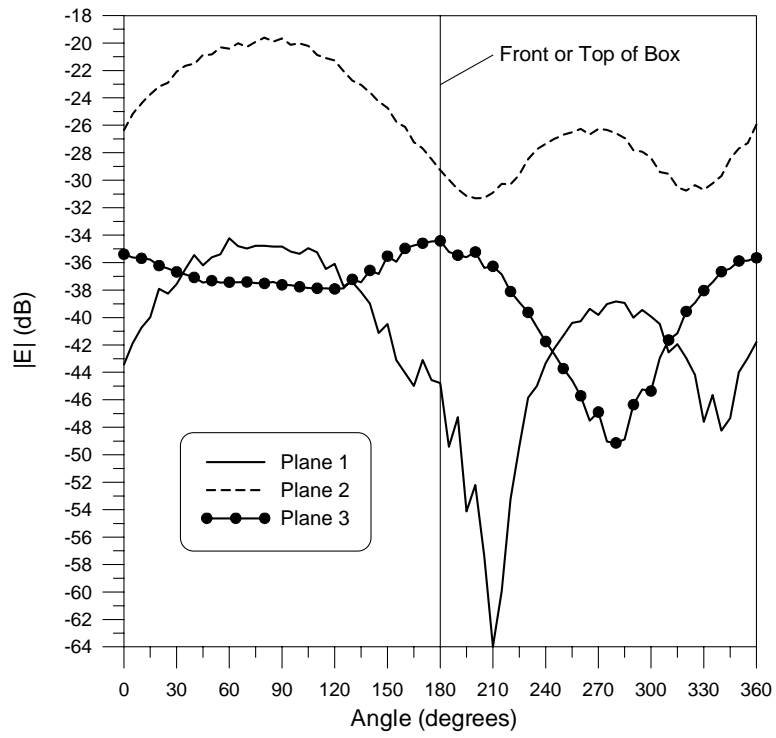
Figure 10. Radiation pattern of a 448 MHz transmitter in a protective case.

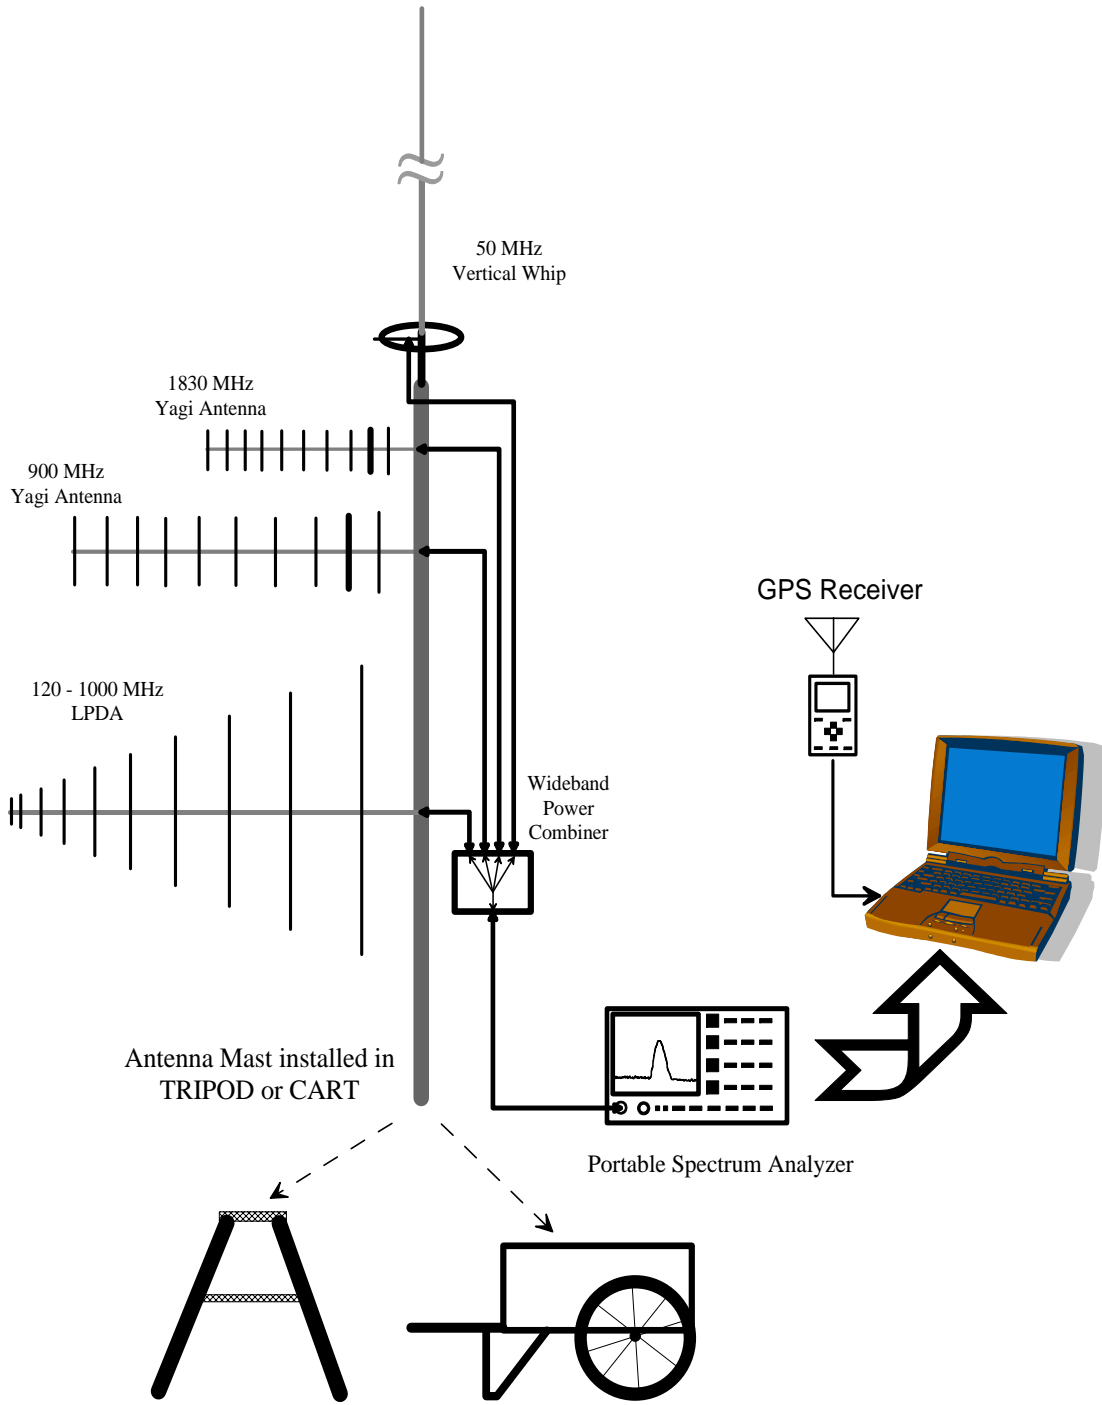
Figure 11. Schematic of the receiving system.

The receiving system is sketched in Figure 11. We assembled four antennas on a 4-meter mast as illustrated. The radio-frequency output from each antenna was fed through a 4:1 broadband power combiner. This arrangement gave us a single input to the portable spectrum analyzer that could then scan over all the frequencies of interest without switching antennas. The four antennas were chosen to be optimal (or at least practical) for each of the frequency bands we were measuring. The selected antennas were an end-fed vertical omnidirectional antenna for 50 MHz., a log-periodic-dipole-array (LPDA) used for the 160, 225, and 450 MHz bands, and

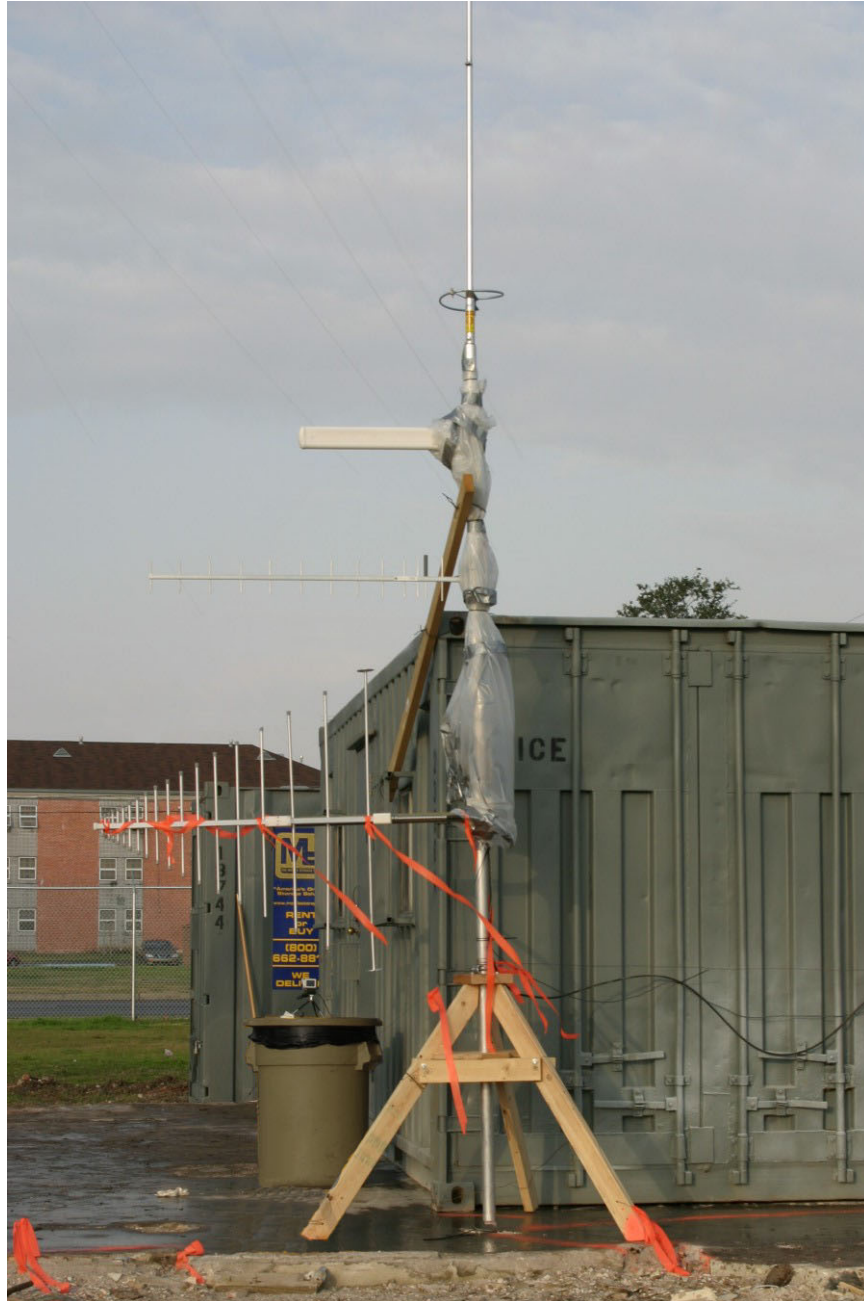
Figure 12. Photo of the weather-resistant antenna system mounted on a tripod and secured to a storage container to prevent tipping during the implosion. The receiving instruments are protected inside the container.

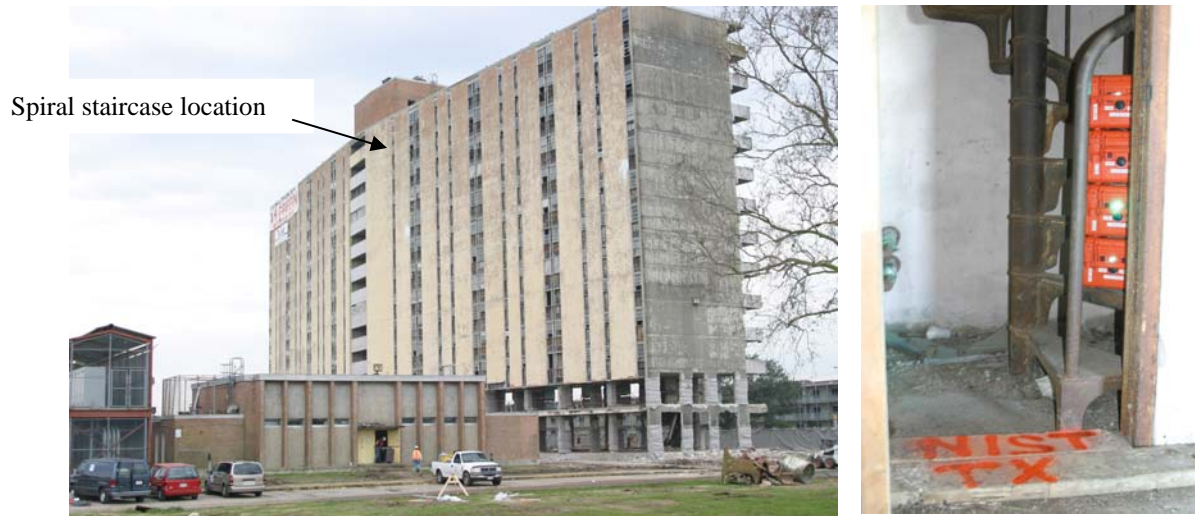
Figure 16. Fixed transmitter location on fourteenth floor.

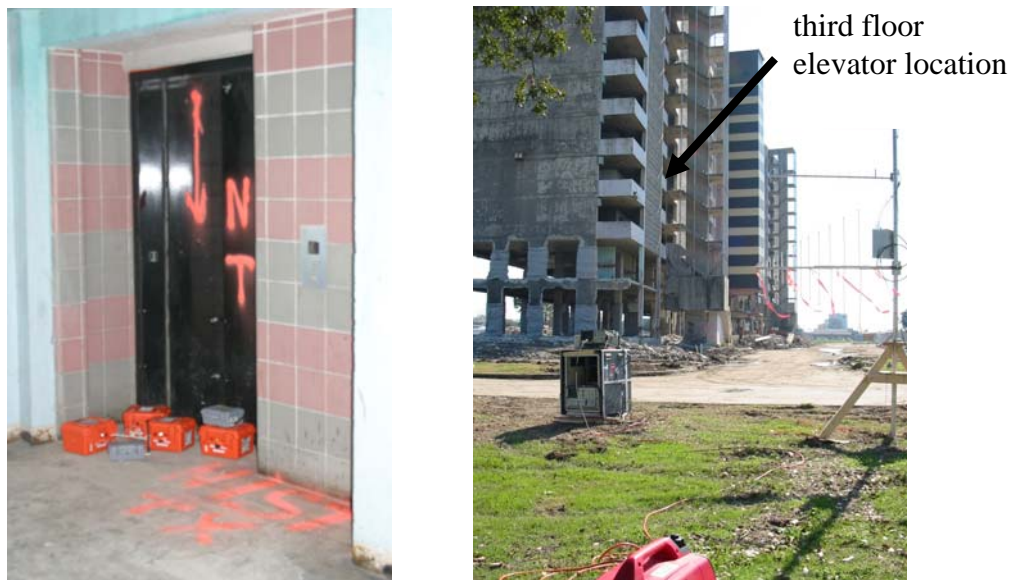
Figure 17. Fixed transmitter location on third floor at elevator.

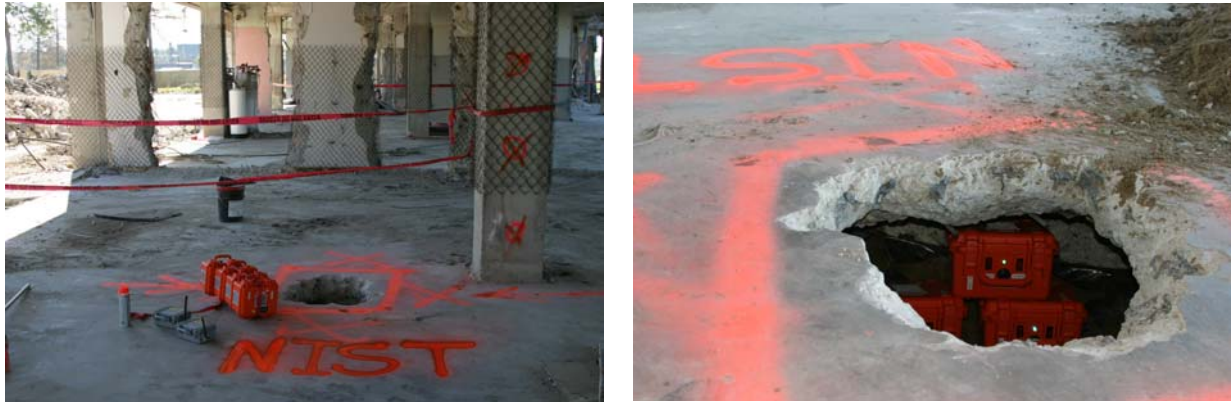
Figure 18. Fixed transmitter location in hole in concrete on bottom floor.

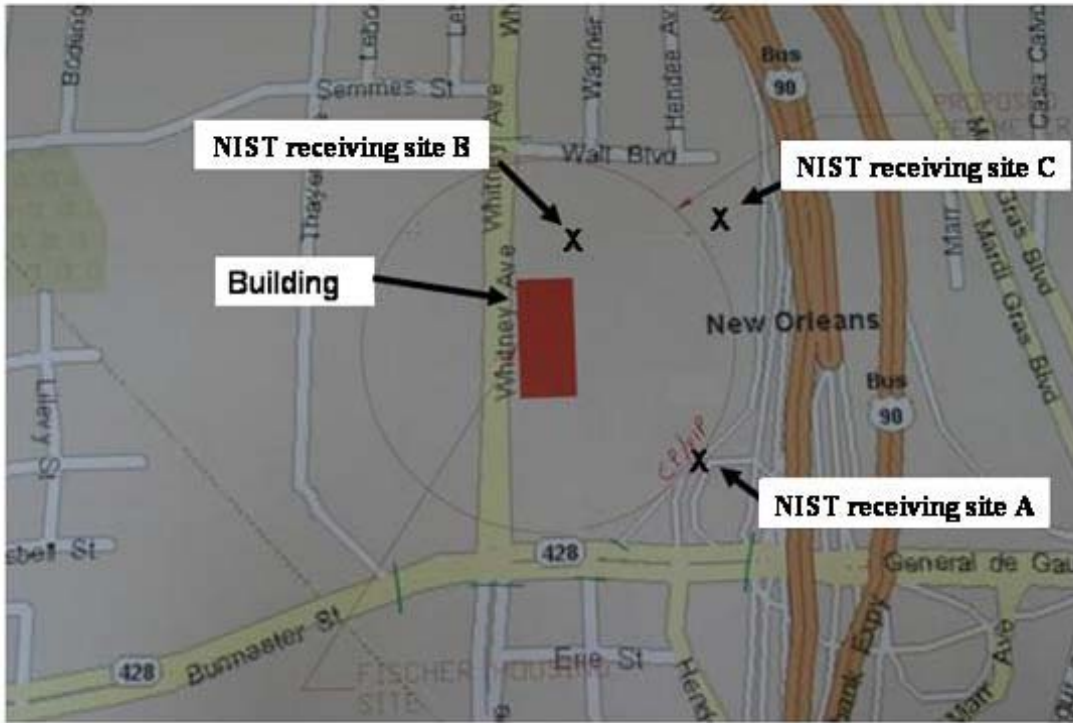
Figure 20. Location of the three fixed receiving sites.

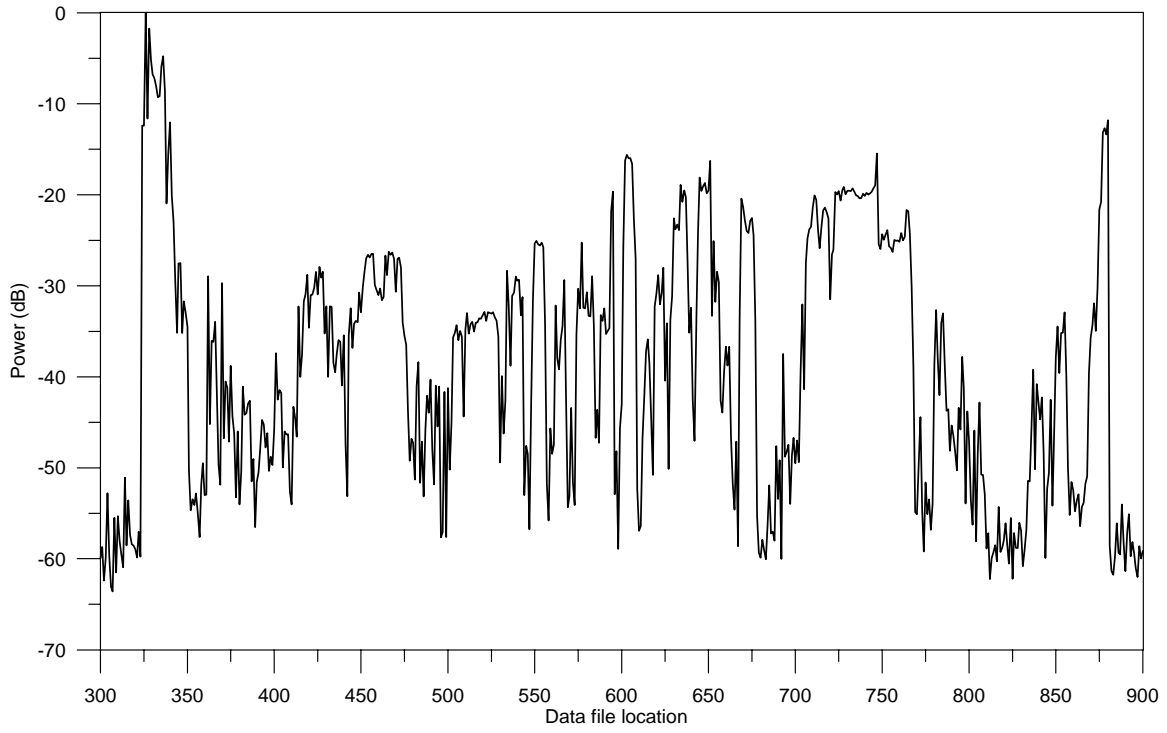
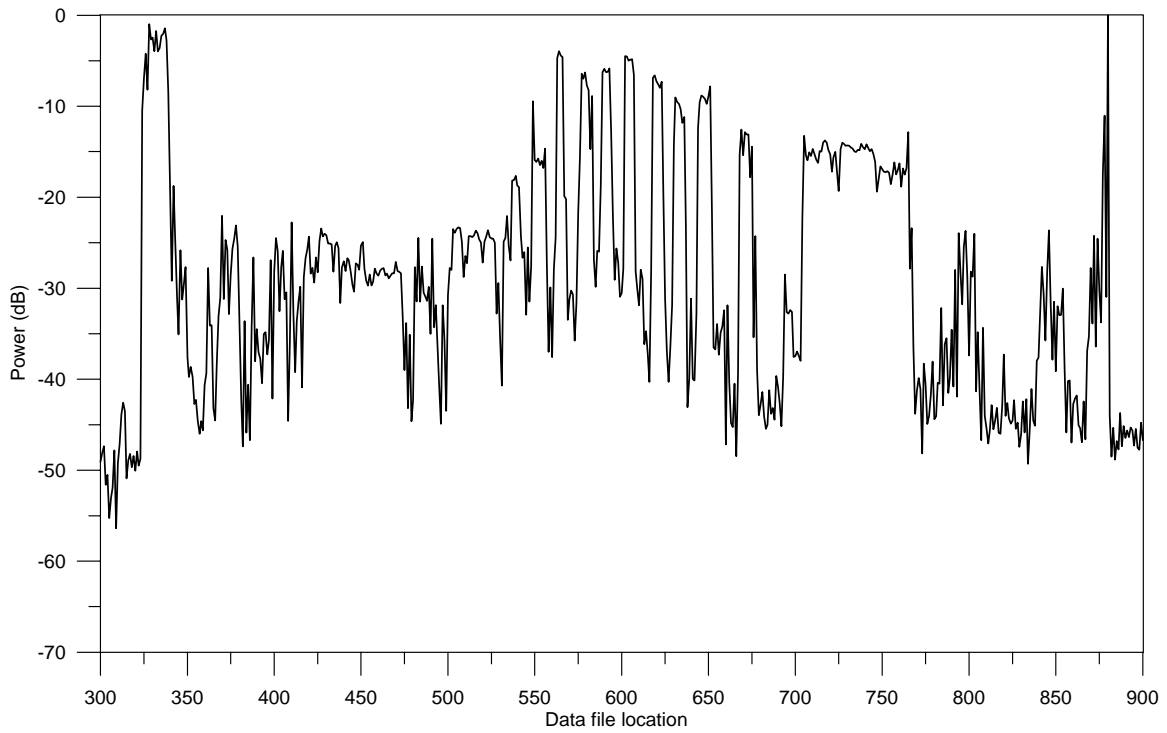
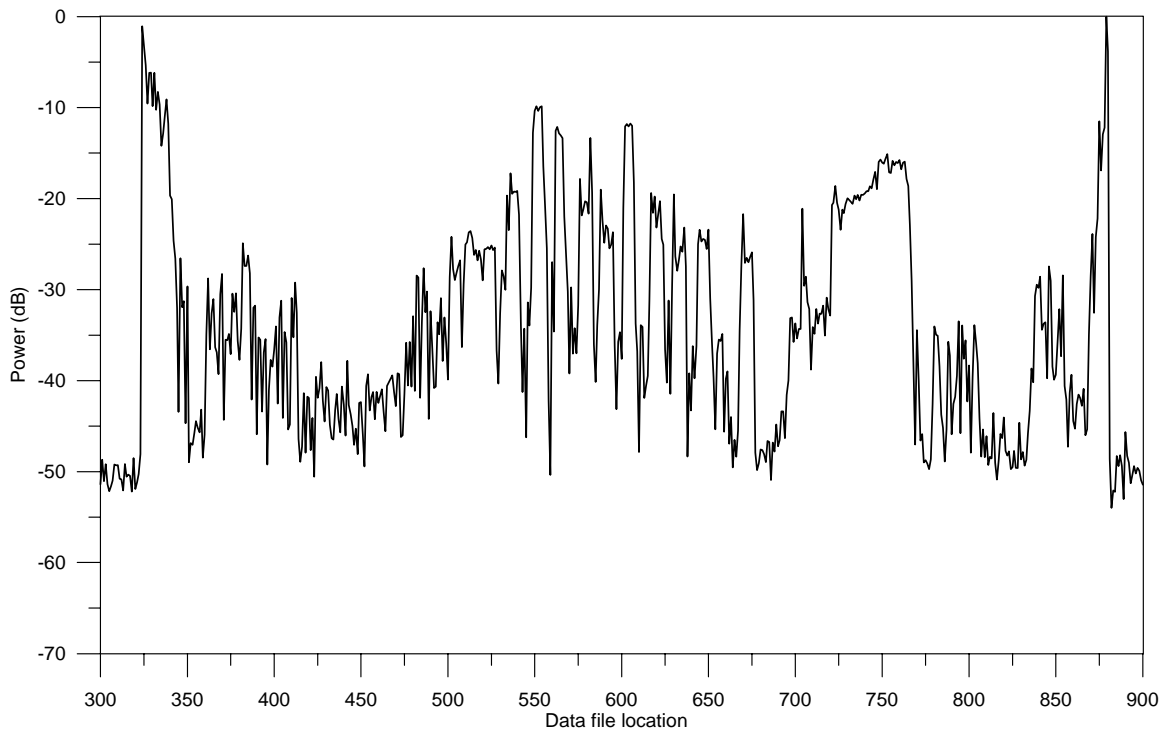
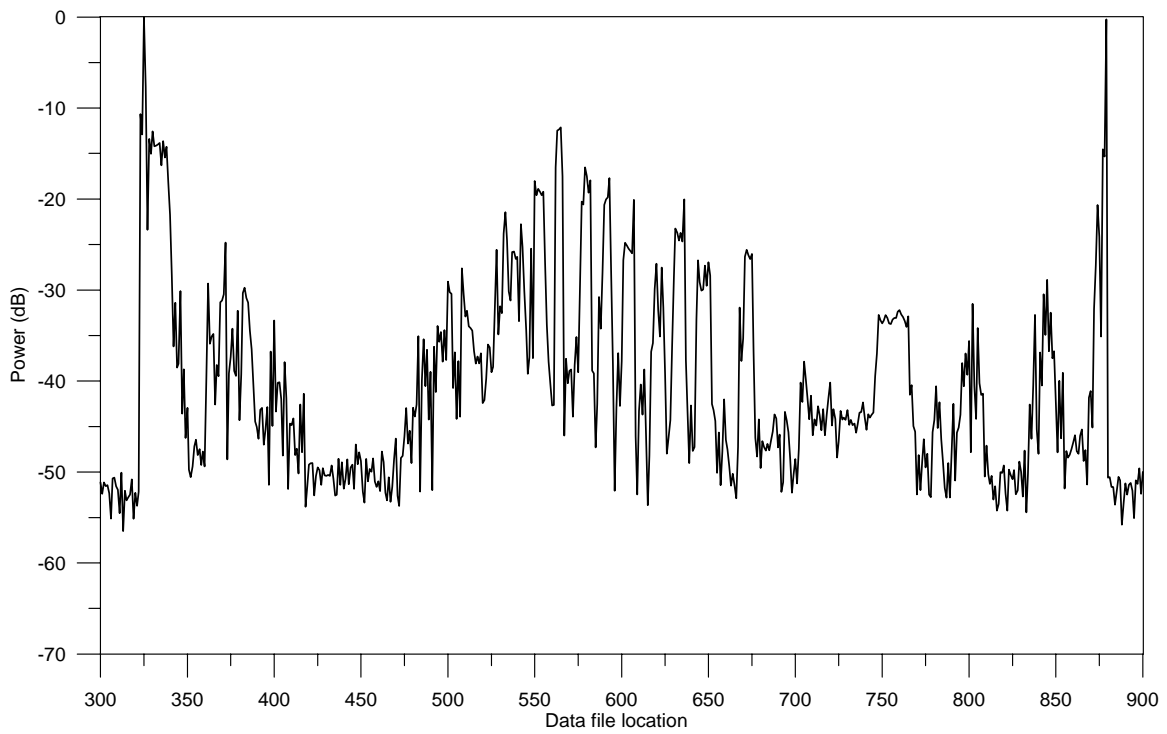
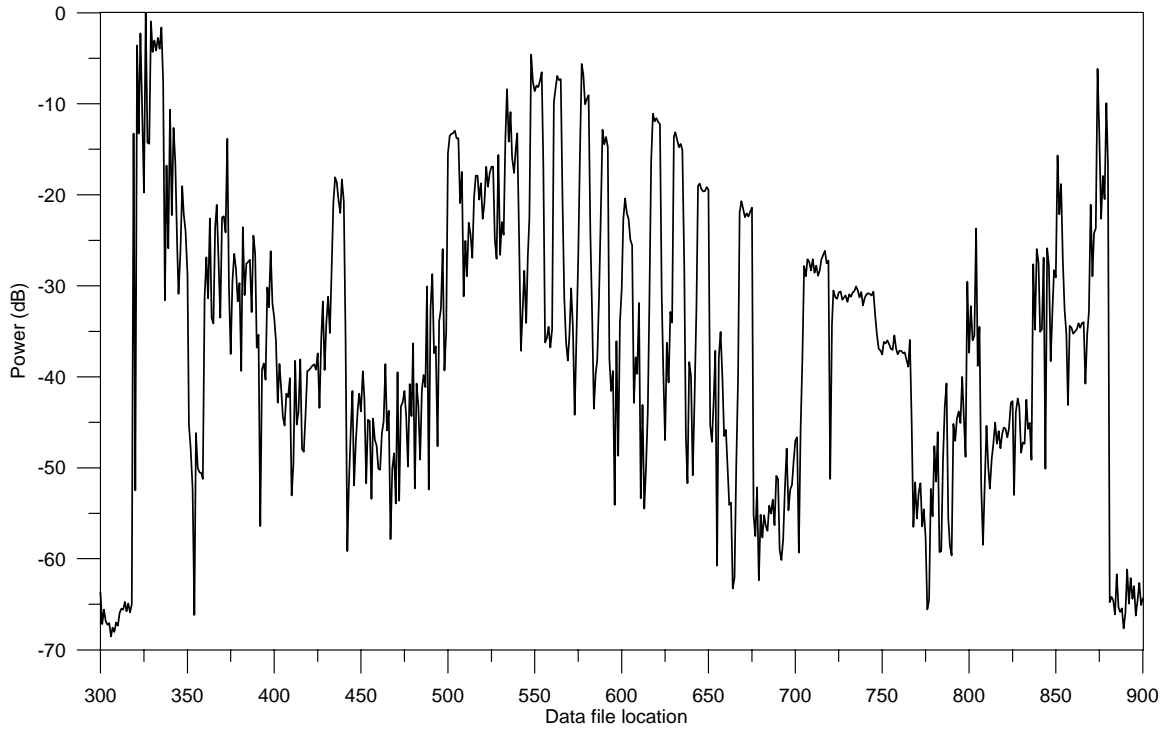
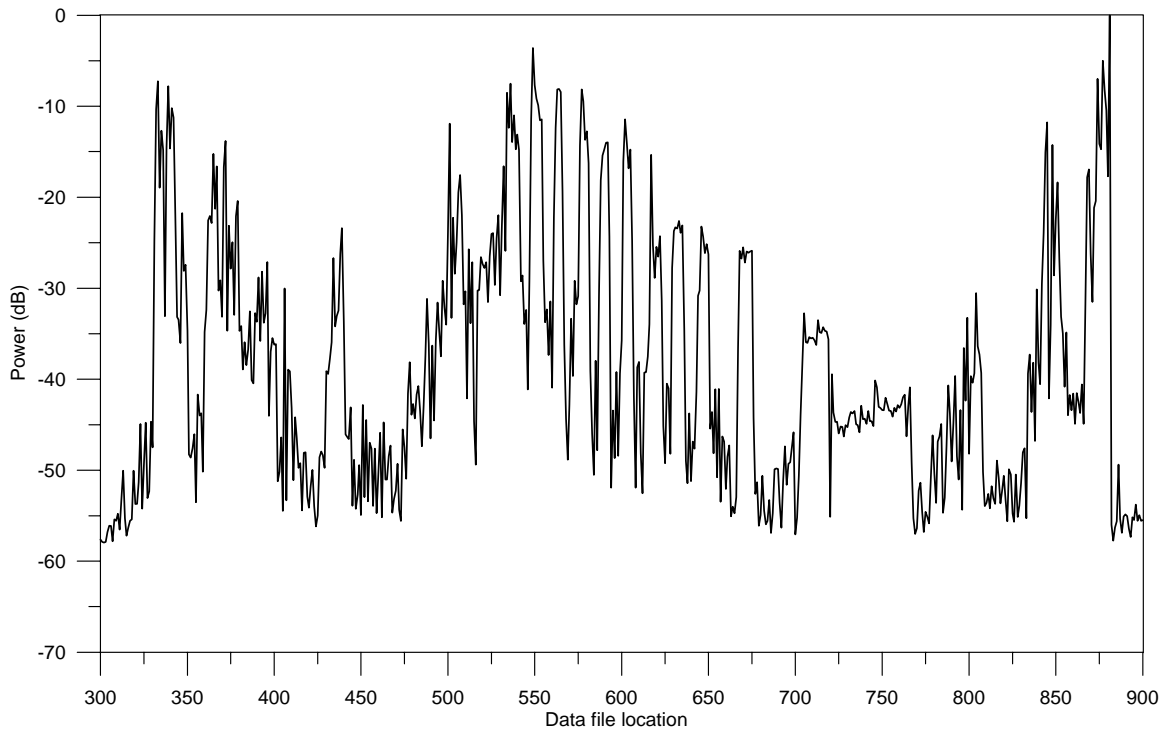
Figure 25. Building walk-through at 49.6 MHz.

Figure 26. Building walk-through at 162.0 MHz.

Figure 27. Building walk-through at 225.375 MHz.

Figure 28. Building walk-through at 448.6 MHz.

Figure 29. Building walk-through at 902.6 MHz.

Figure 30. Building walk-through at 1832.5 MHz.

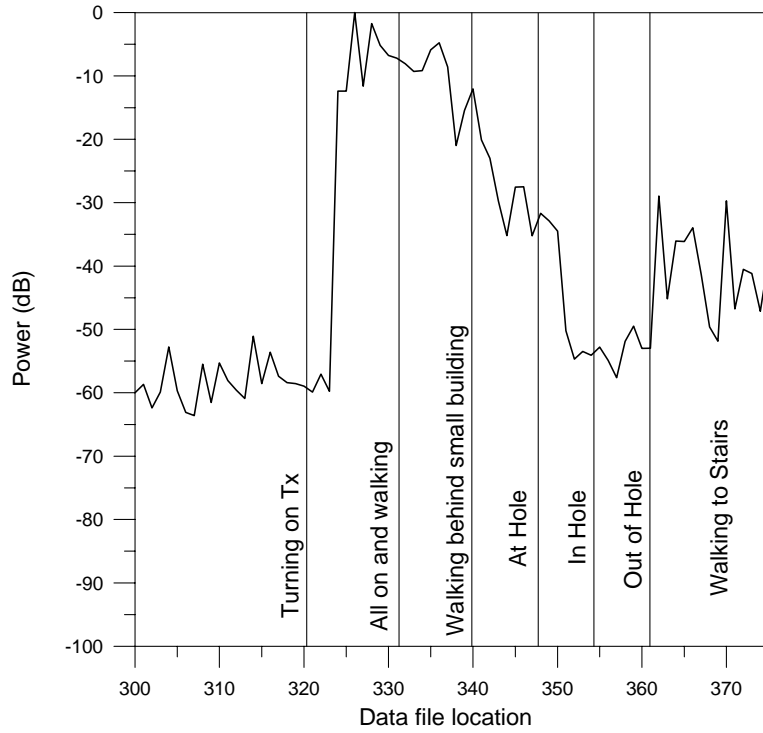
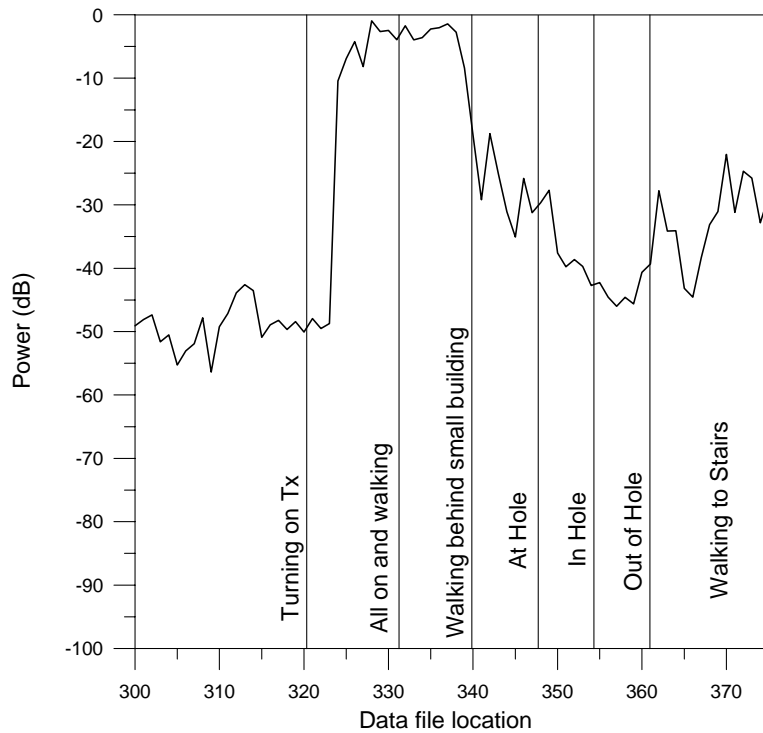
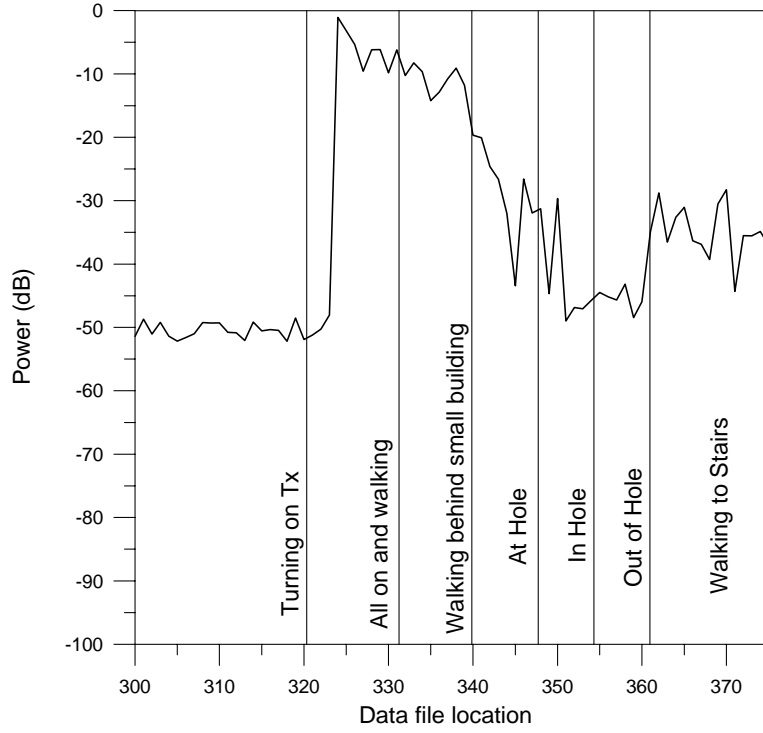
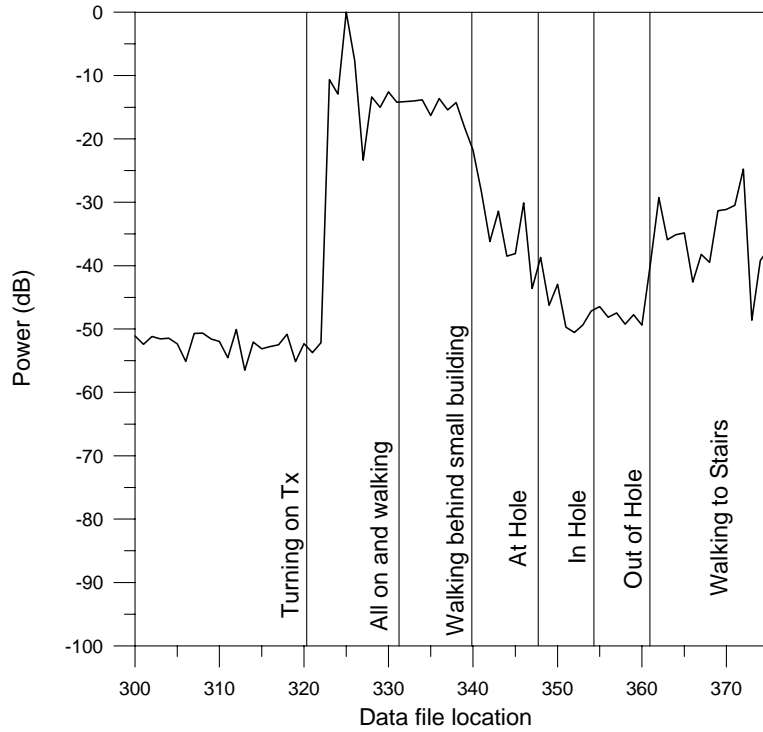
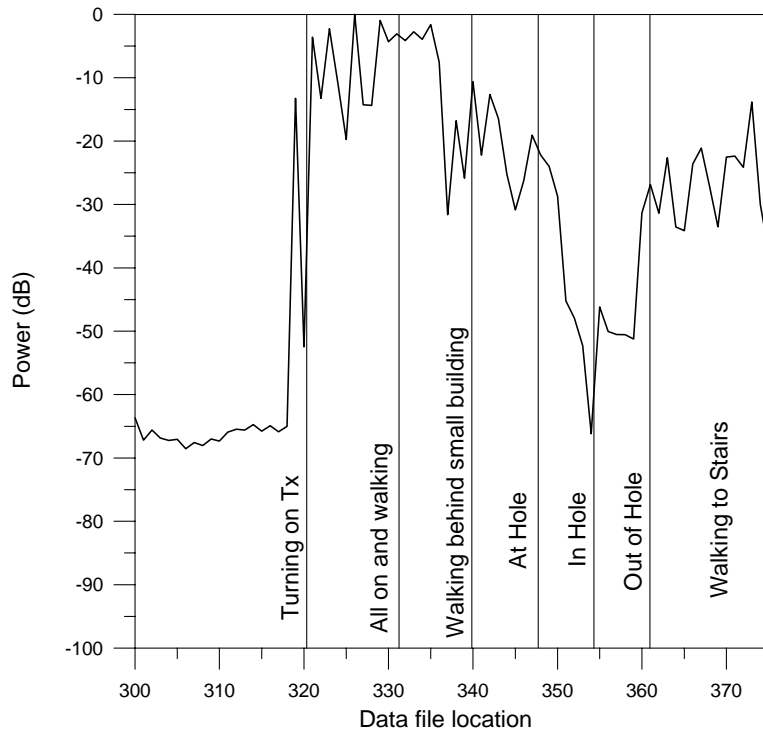
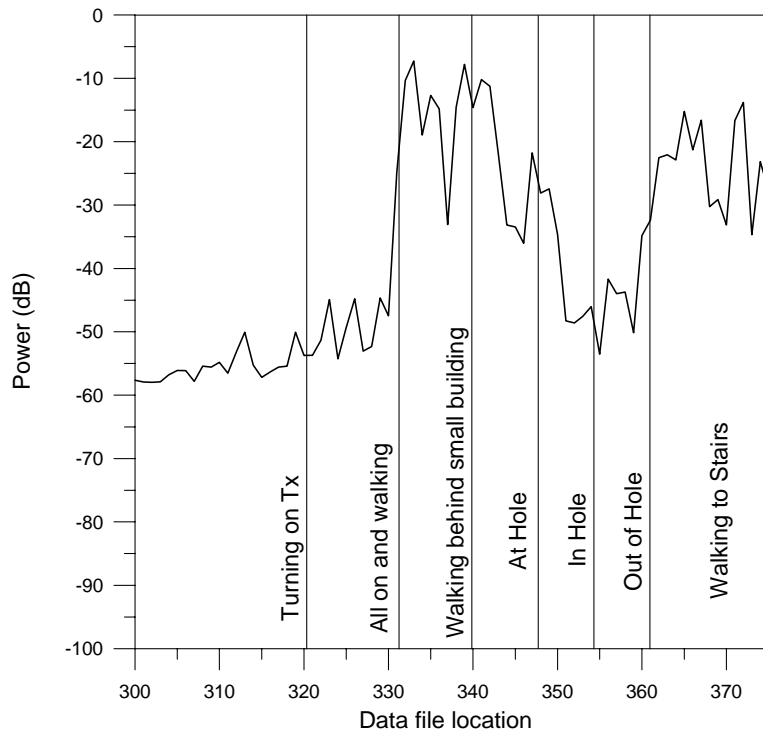
Figure 31. Starting walk-through and hole data at 49.6 MHz.

Figure 32. Starting walk-through and hole data at 162.0 MHz.

Figure 33. Starting walk-through and hole data at 225.375 MHz.

Figure 34. Starting walk-through and hole data at 448.6 MHz.

Figure 35. Starting walk-through and hole data at 902.6 MHz.

Figure 36. Starting walk-through and hole data at 1832.5 MHz.

Since the locations of the transmitters were noted in the dataset during the walk-through, the variability in the received signal at various locations in the building can be investigated. Figures 31-36 show the start of the walk-through and show the effect of placing the transmitters in the hole in the concrete floor. While being taken to the hole in the floor, the transmitters were carried behind a small building (see Figure 13). The results in these figures show the effect of walking behind the building. The decrease in the signal in these figures illustrates the so-called “knife-edge diffraction” of building corners. These figures also show that a reduction of 15 to 20 dB in signal strength occurred when the transmitters were placed in the hole.

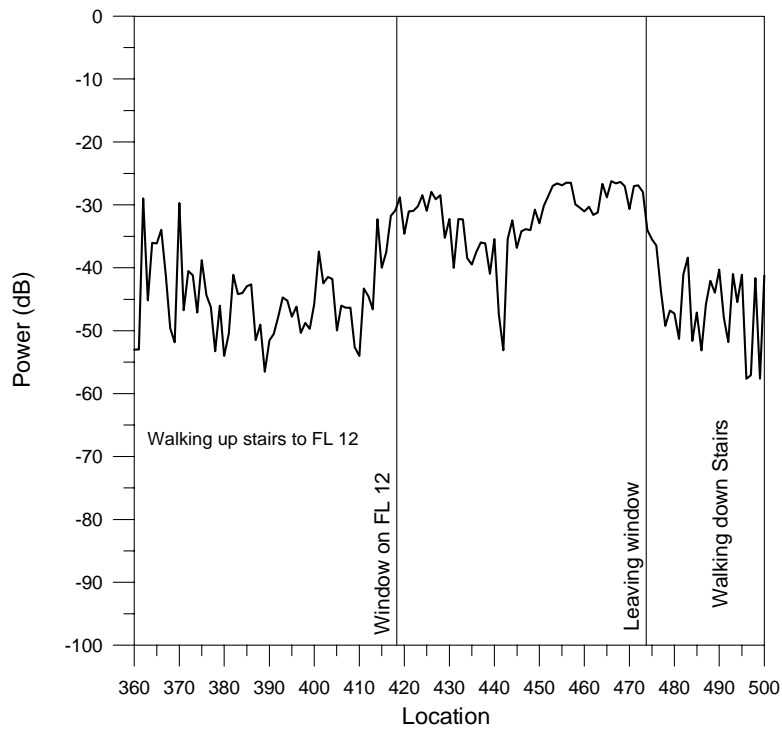
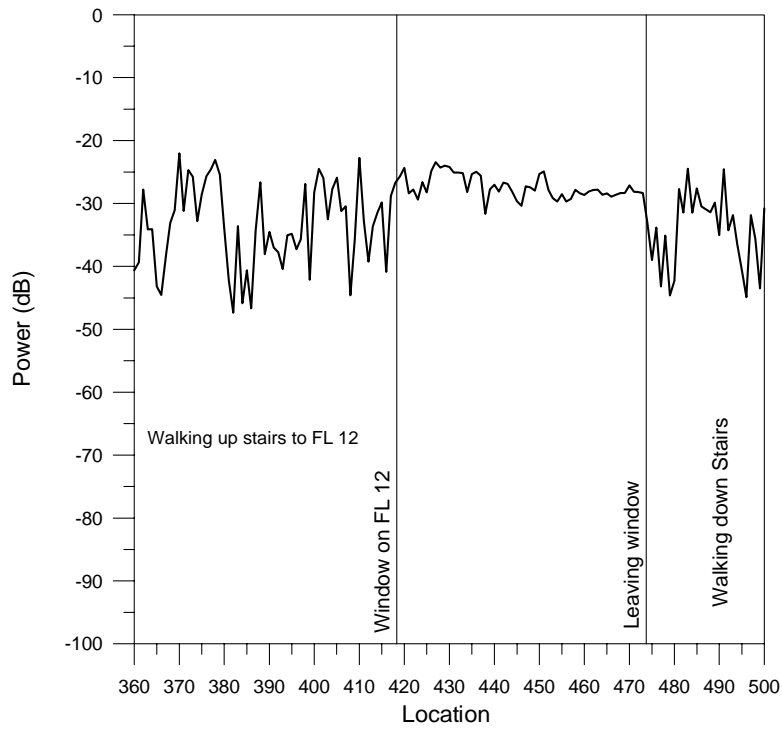
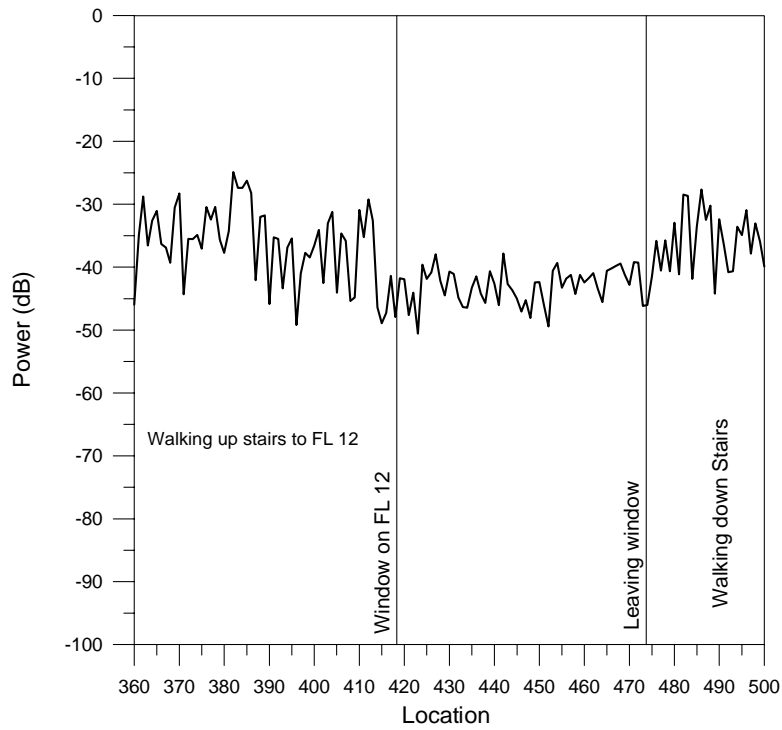
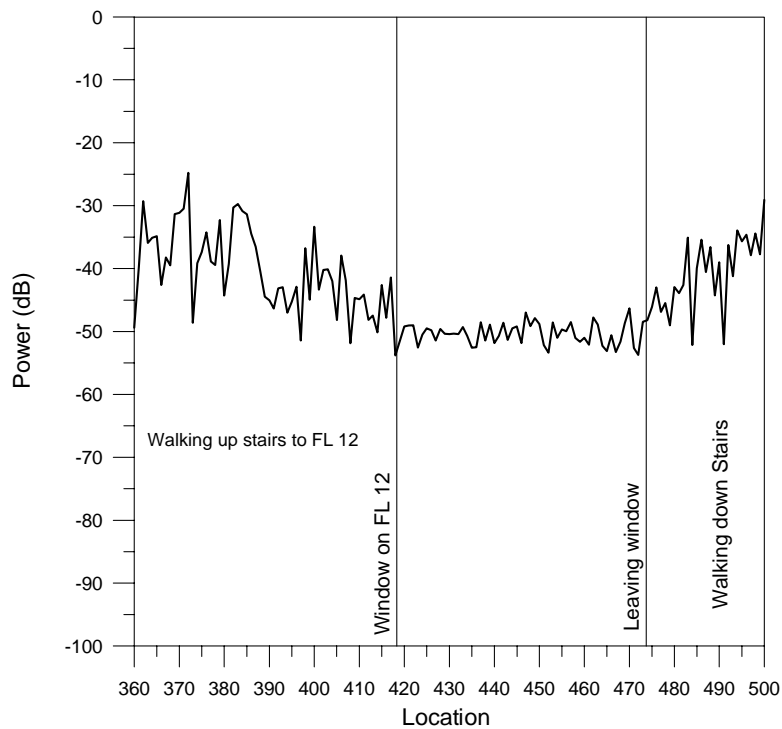
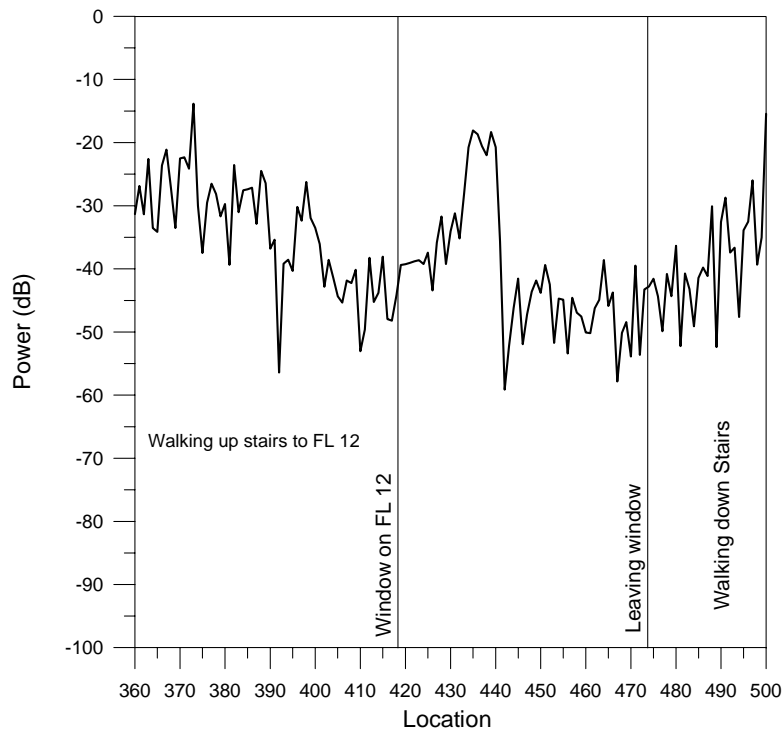
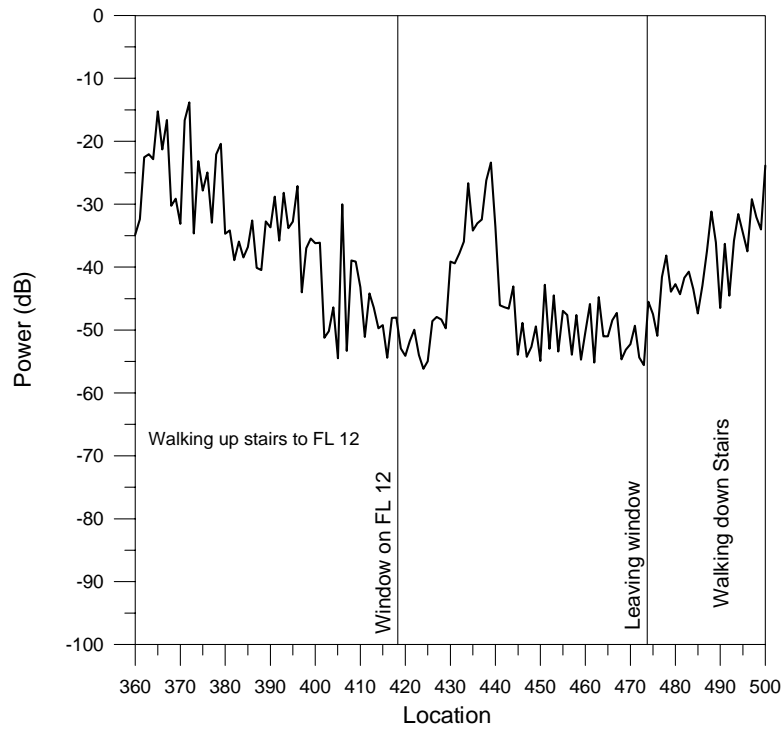
Figure 37. Stairwell data 49.6 MHz.

Figure 38. Stairwell data 162.0 MHz.

Figure 39. Stairwell data 225.375 MHz.

Figure 40. Stairwell data 448.6 MHz.

Figure 41. Stairwell data 902.6 MHz.

Figure 42. Stairwell data 1832.5 MHz.
