***NIST Technical Note 1540***

**Propagation and Detection of Radio  
Signals Before, During, and After the  
Implosion of a 13-Story Apartment  
Building**

Electromagnetics Division  
National Institute of Standards and Technology  
325 Broadway  
Boulder, CO 80305

May 2005

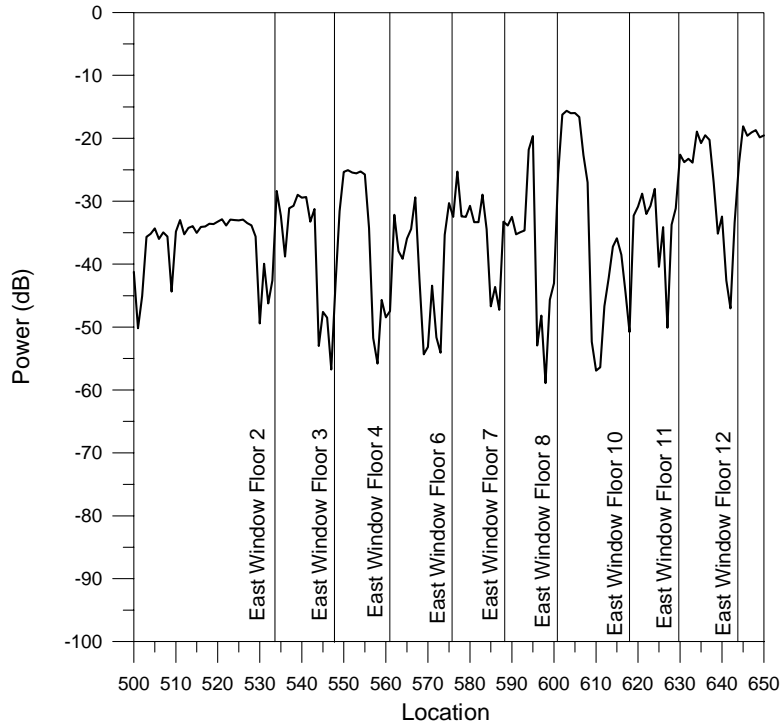
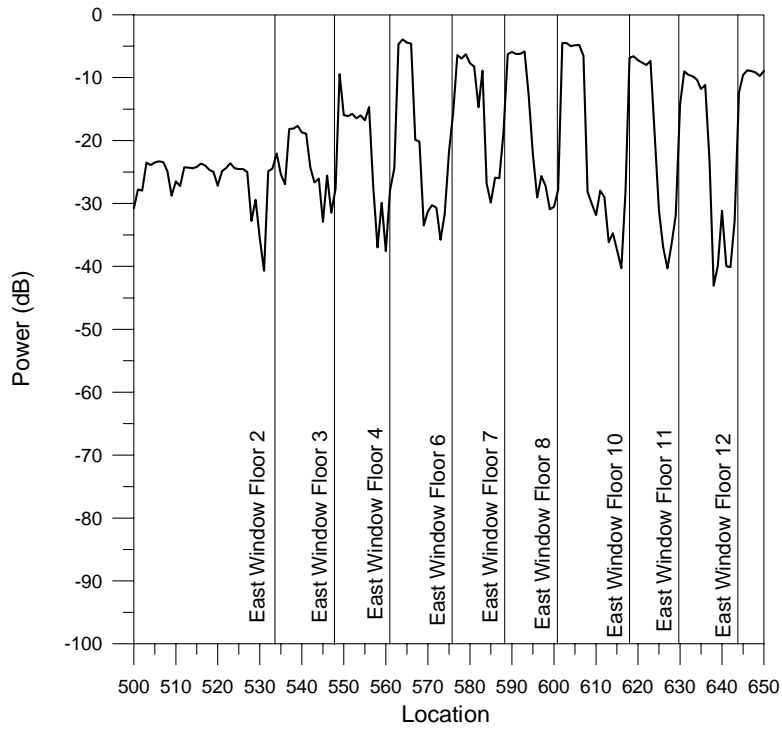
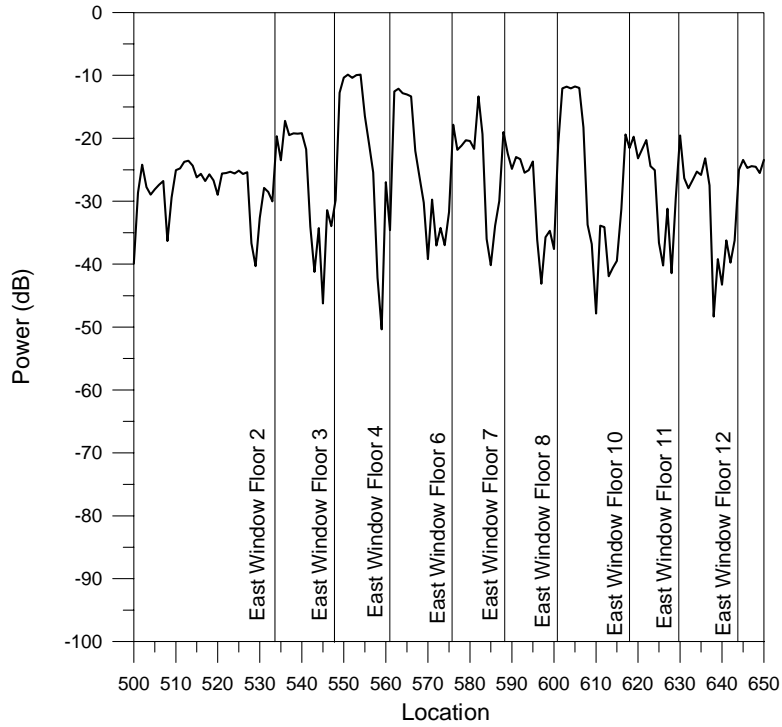
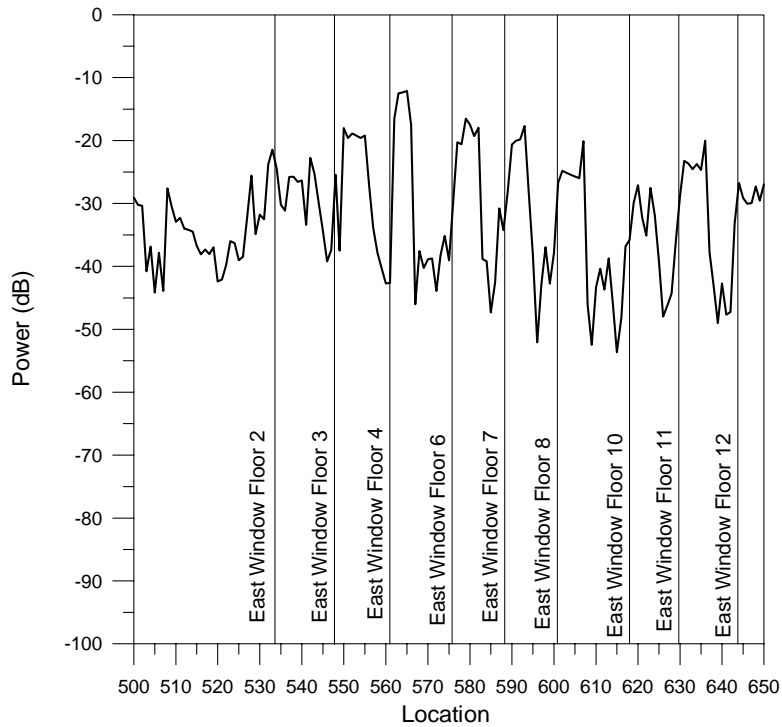
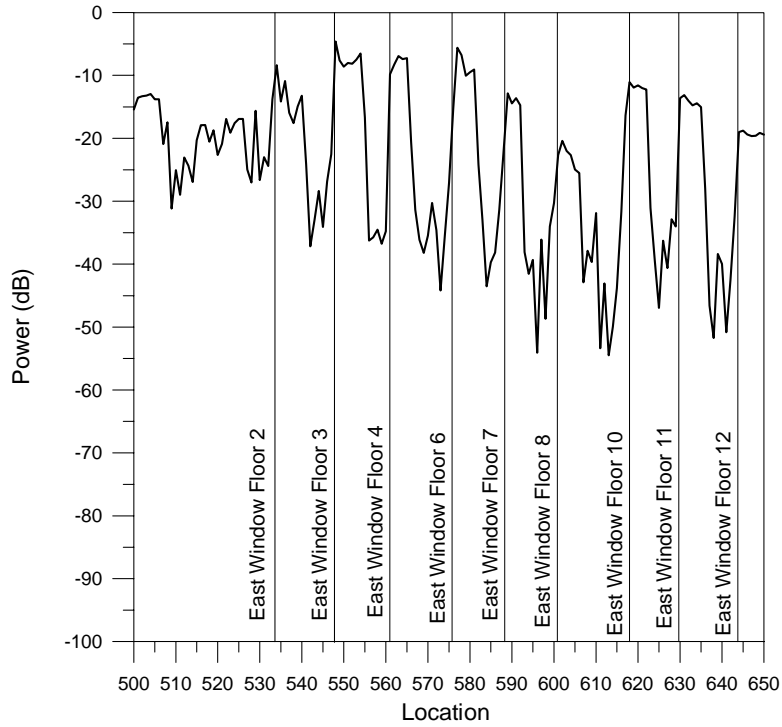
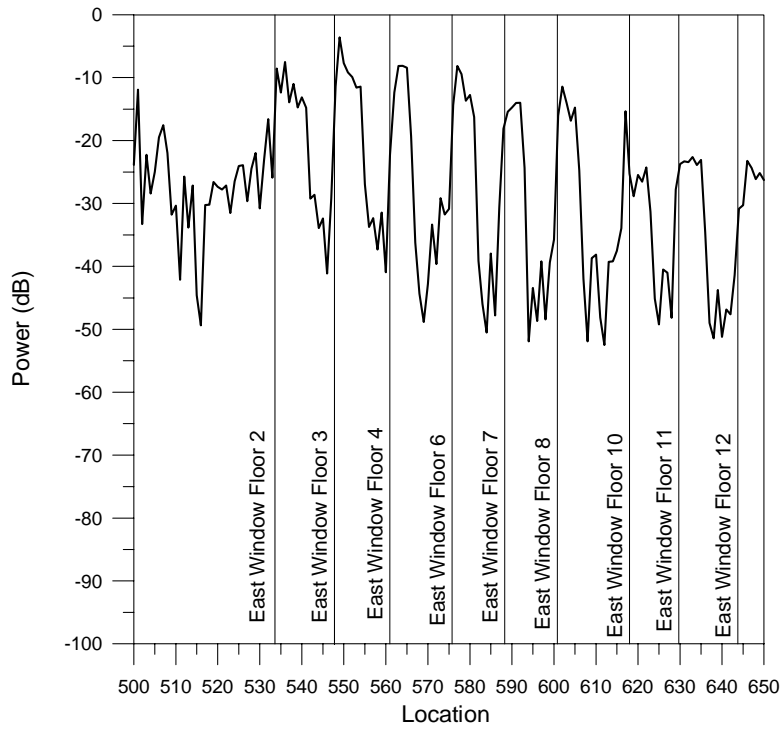
Figure 43. Building walk-through with transmitters at window (LOS to receiver) of each floor at 49.6 MHz.

Figure 44. Building walk-through with transmitters at window (LOS to receiver) of each floor at 162.0 MHz.

Figure 45. Building walk-through with transmitters at window (LOS to receiver) of each floor at 225.375 MHz.

Figure 46. Building walk-through with transmitters at window (LOS to receiver) of each floor at 448.6 MHz.

Figure 47. Building walk-through with transmitters at window (LOS to receiver) of each floor at 902.6 MHz.

Figure 48. Building walk-through with transmitters at window (LOS to receiver) of each floor at 1832.5 MHz.

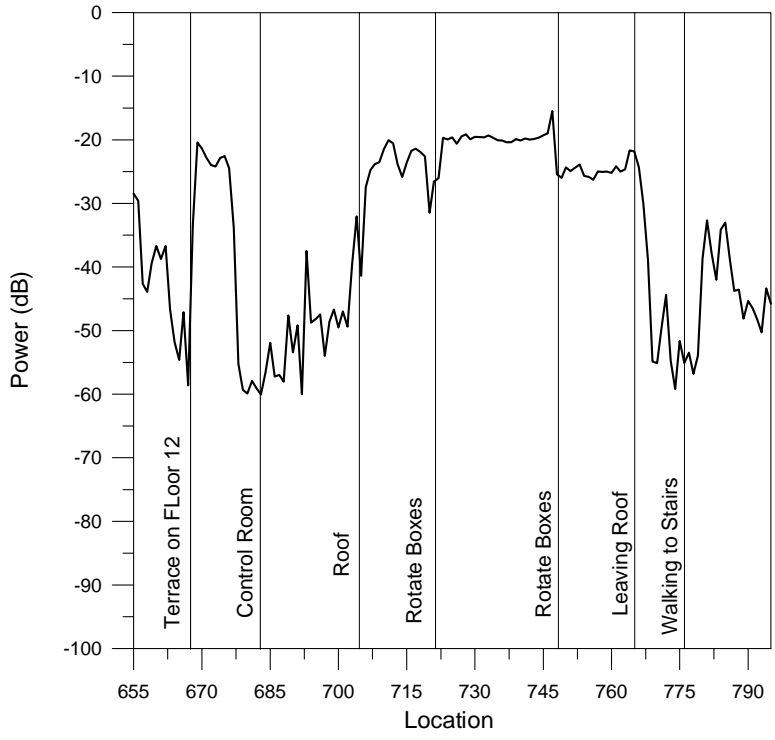
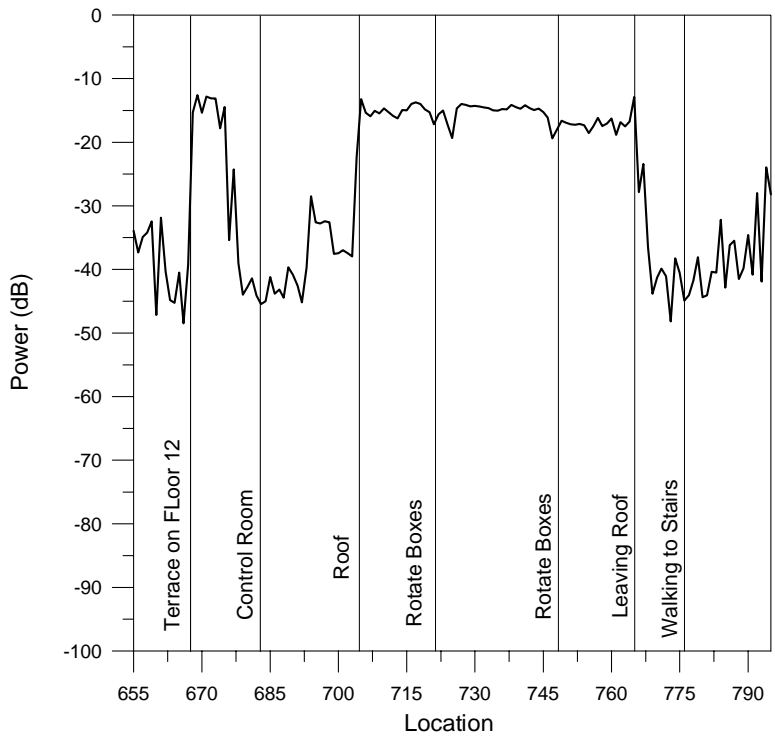
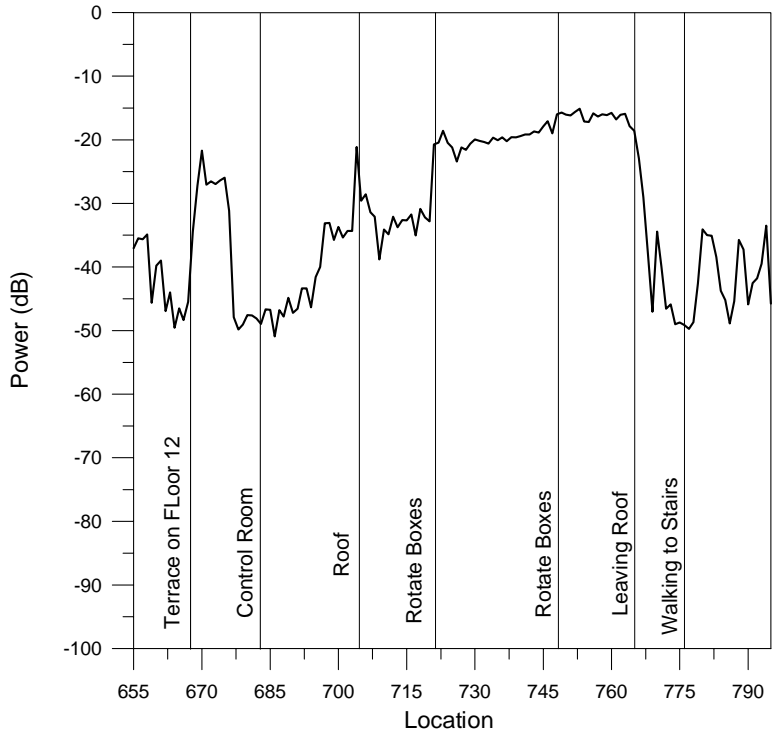
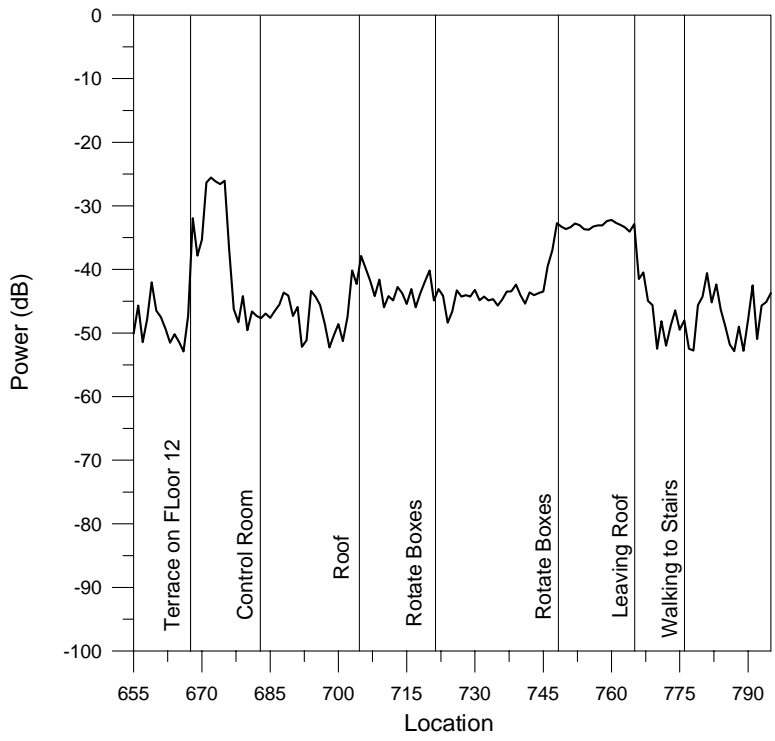
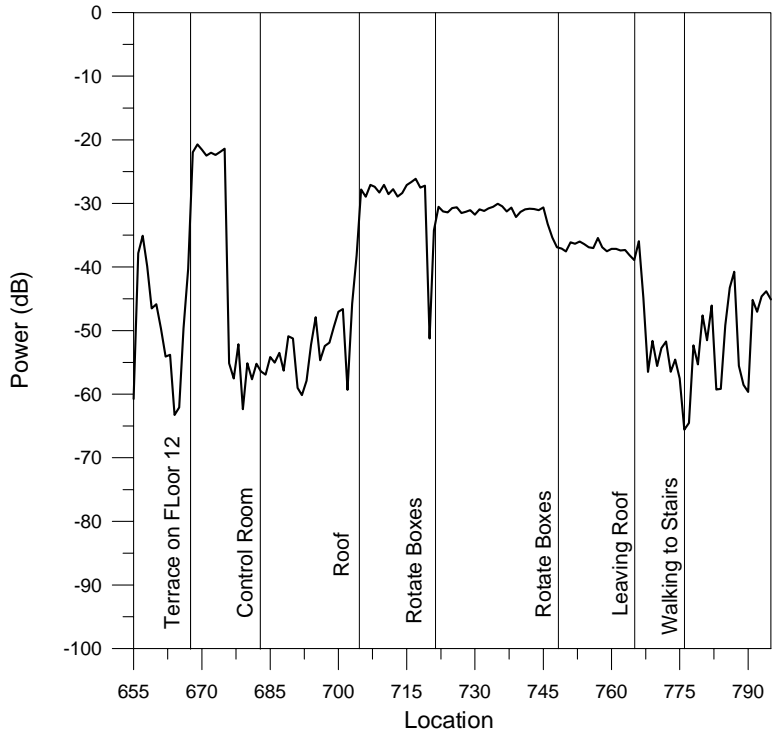
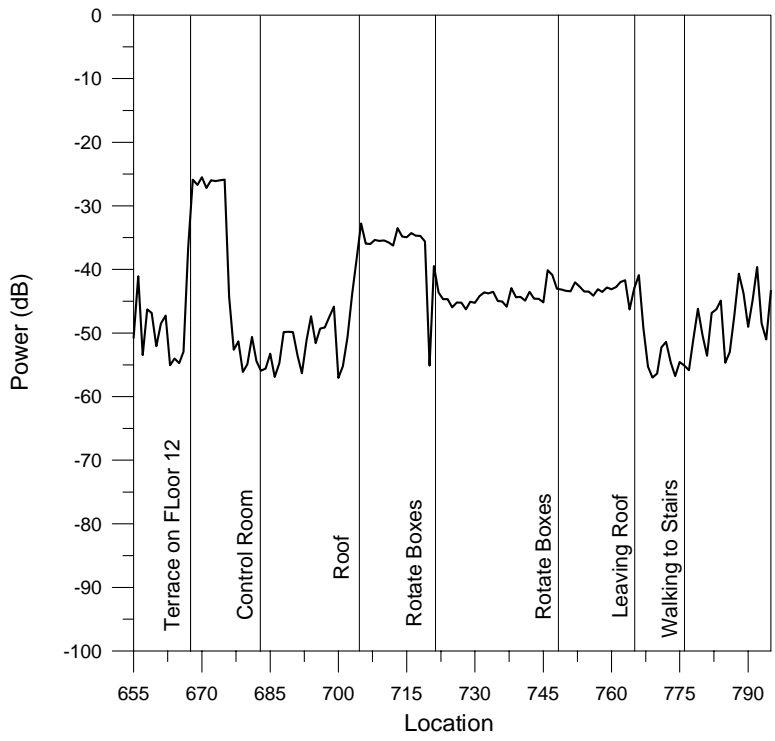
Figure 49. Control room and roof top at 49.6 MHz.

Figure 50. Control room and roof top at 162.0 MHz.

Figure 51. Control room and roof top at 225.375 MHz.

Figure 52. Control room and roof top at 448.6 MHz.

Figure 53. Control room and roof top at 902.6 MHz.

Figure 54. Control room and roof top at 1832.5 MHz.

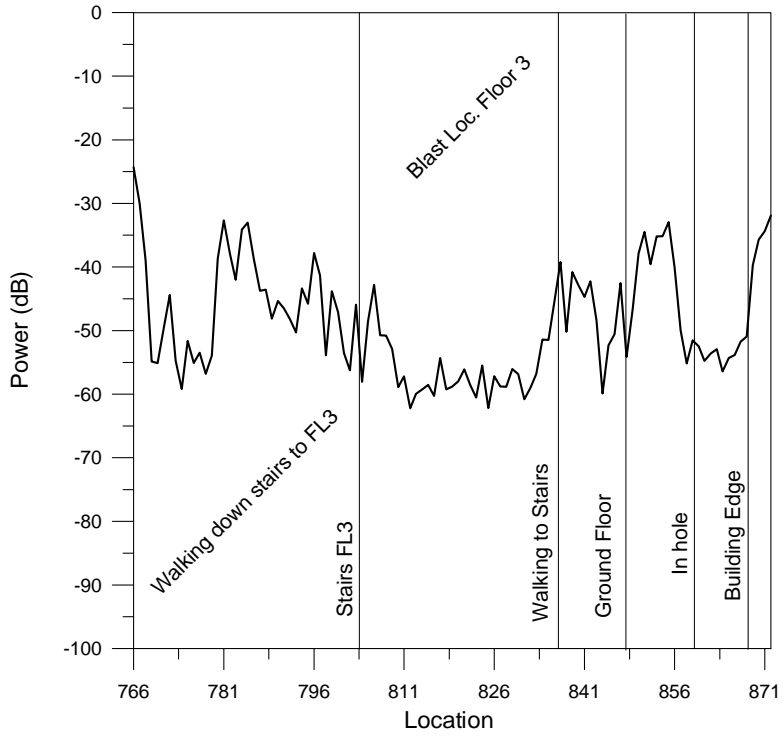
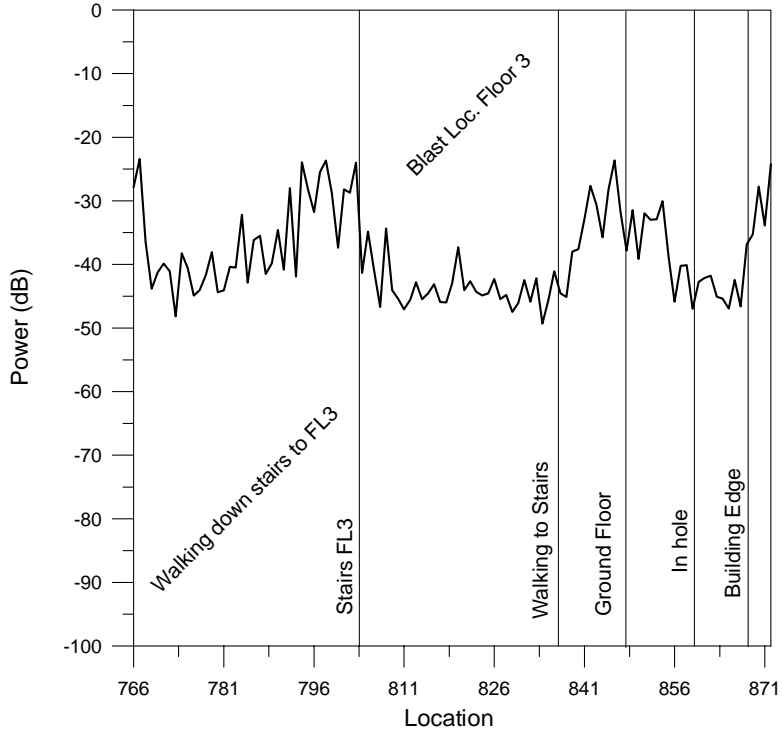
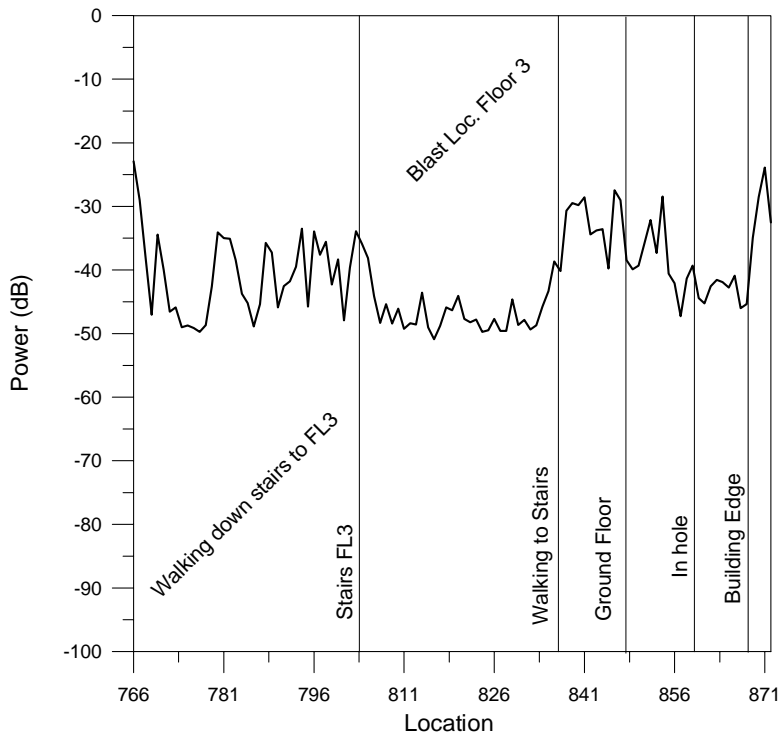
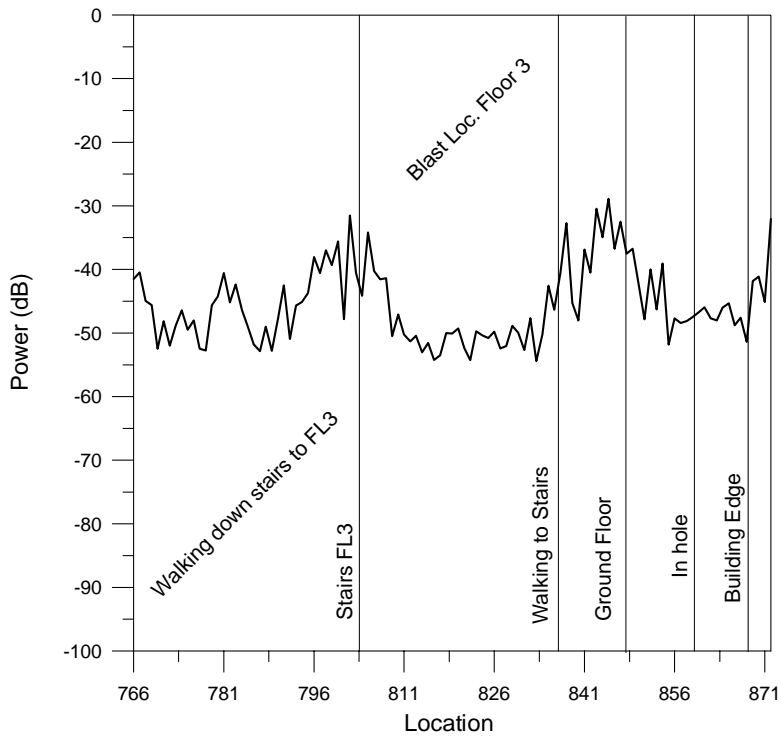
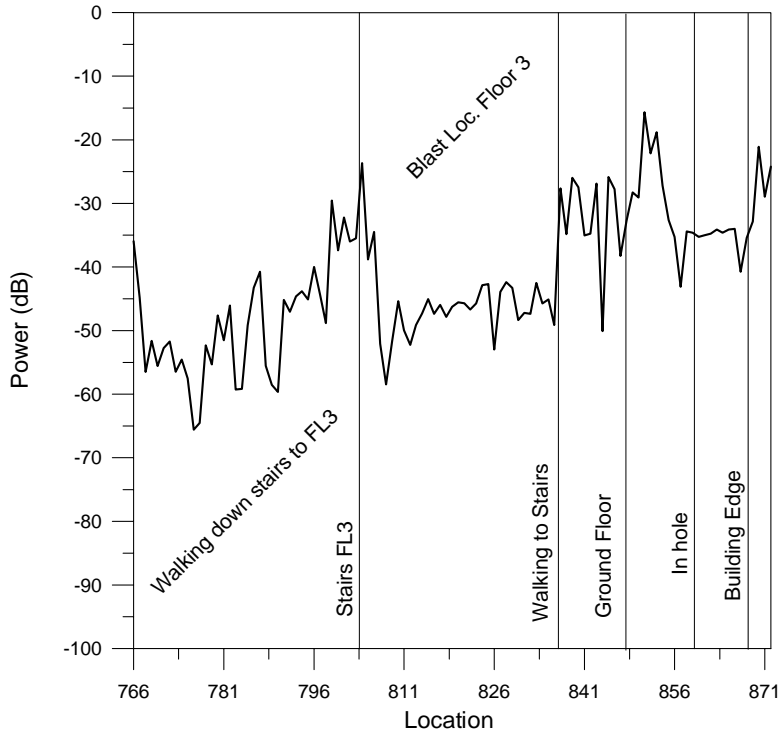
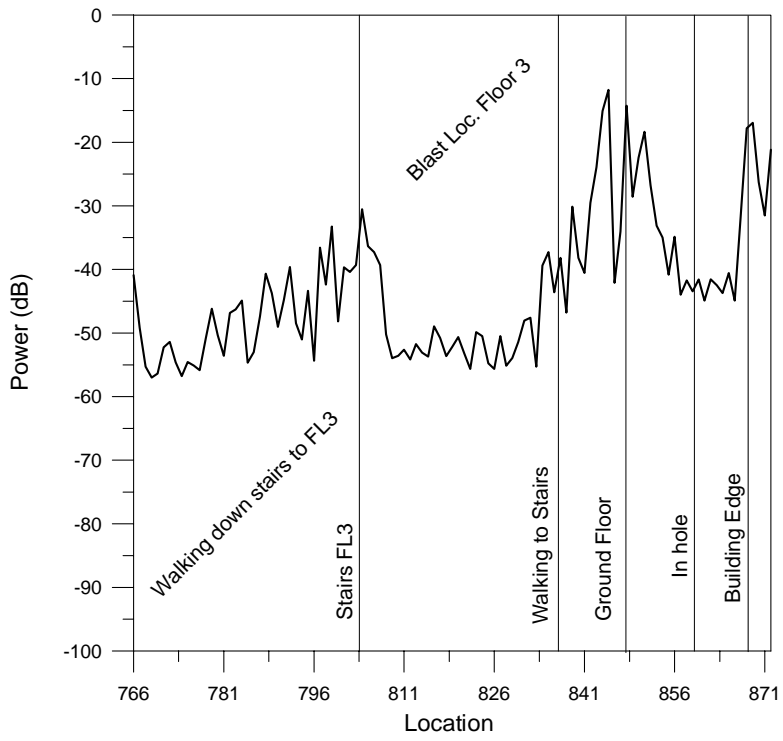
Figure 55. From the control room to exiting the building at 49.6 MHz.

Figure 56. From the control room to exiting the building at 162.0 MHz.

Figure 57. From the control room to exiting the building at 225.375 MHz.

Figure 58. From the control room to exiting the building at 448.6 MHz.

Figure 59. From the control room to exiting the building at 902.6 MHz.

Figure 60. From the control room to exiting the building at 1832.5 MHz.

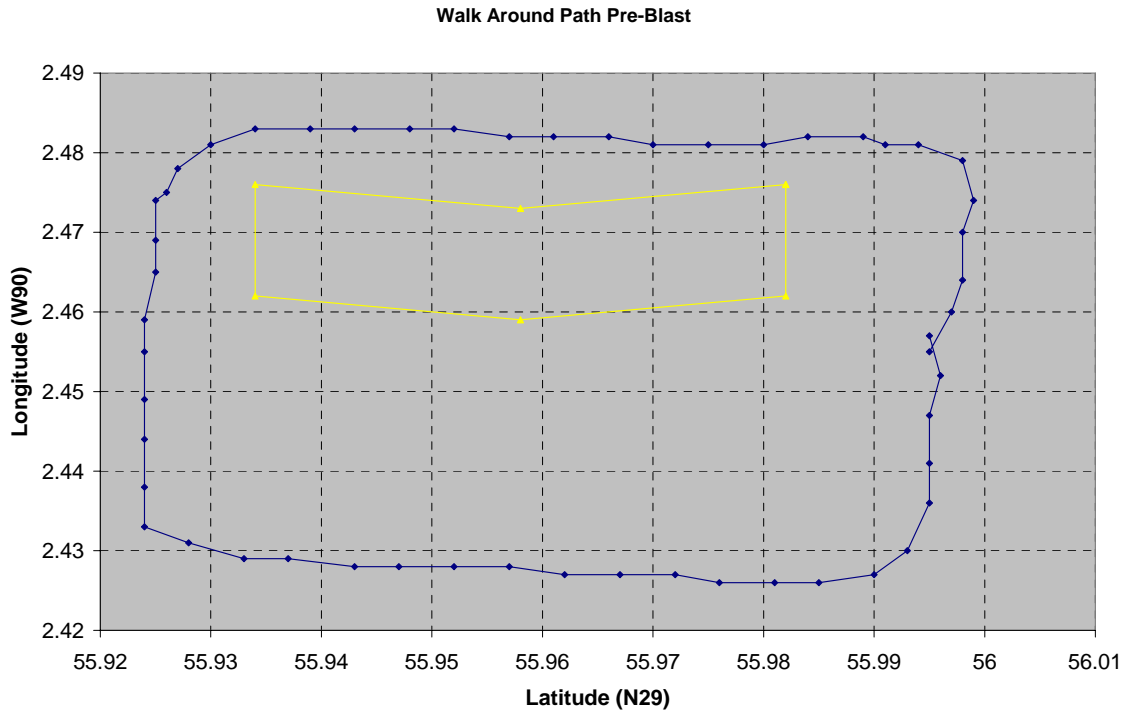
Figure 66. Coordinates of the building footprint (yellow) and cart location (blue).

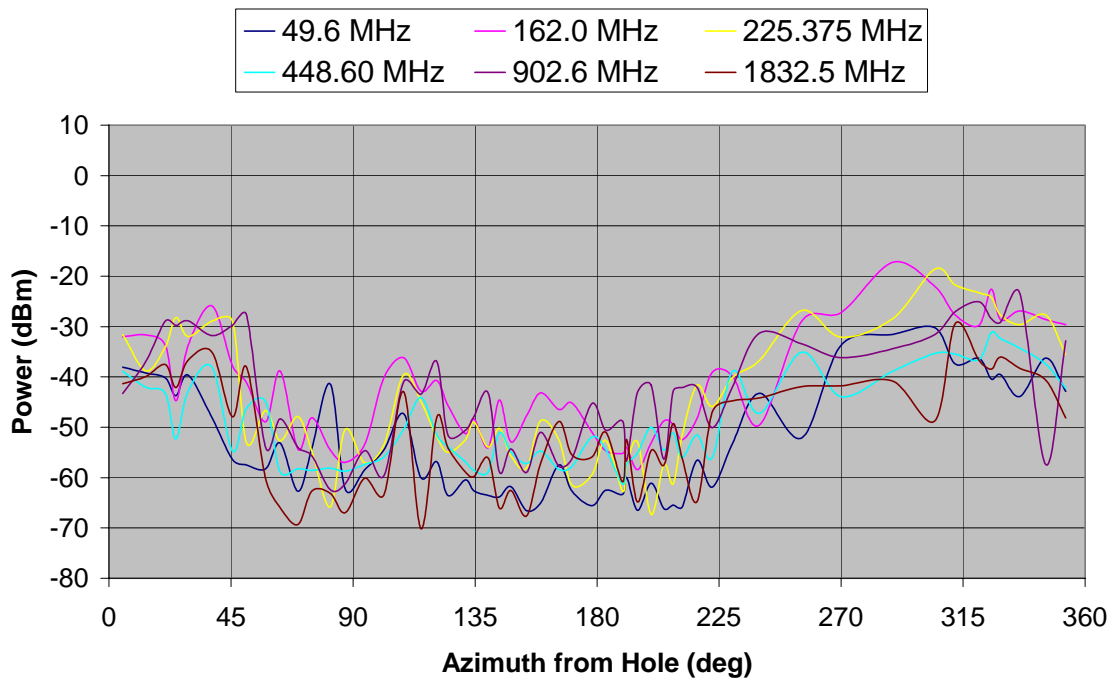
Figure 67. Pre-implosion data from the mobile cart for the transmitters in the hole.

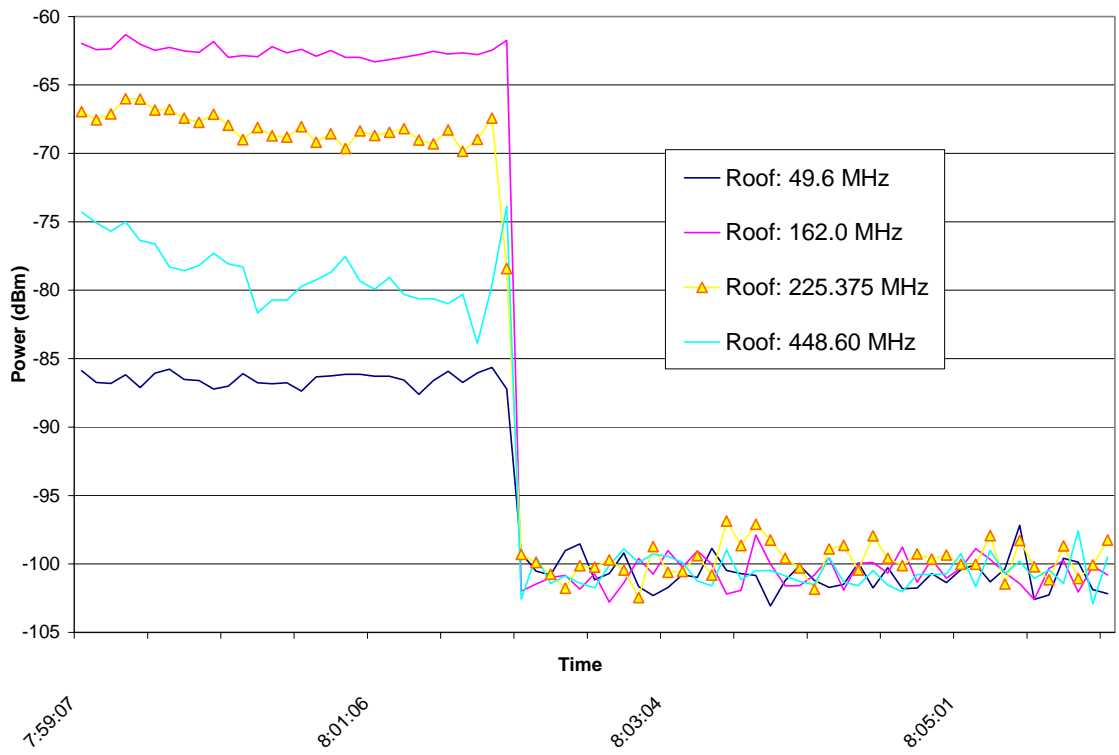
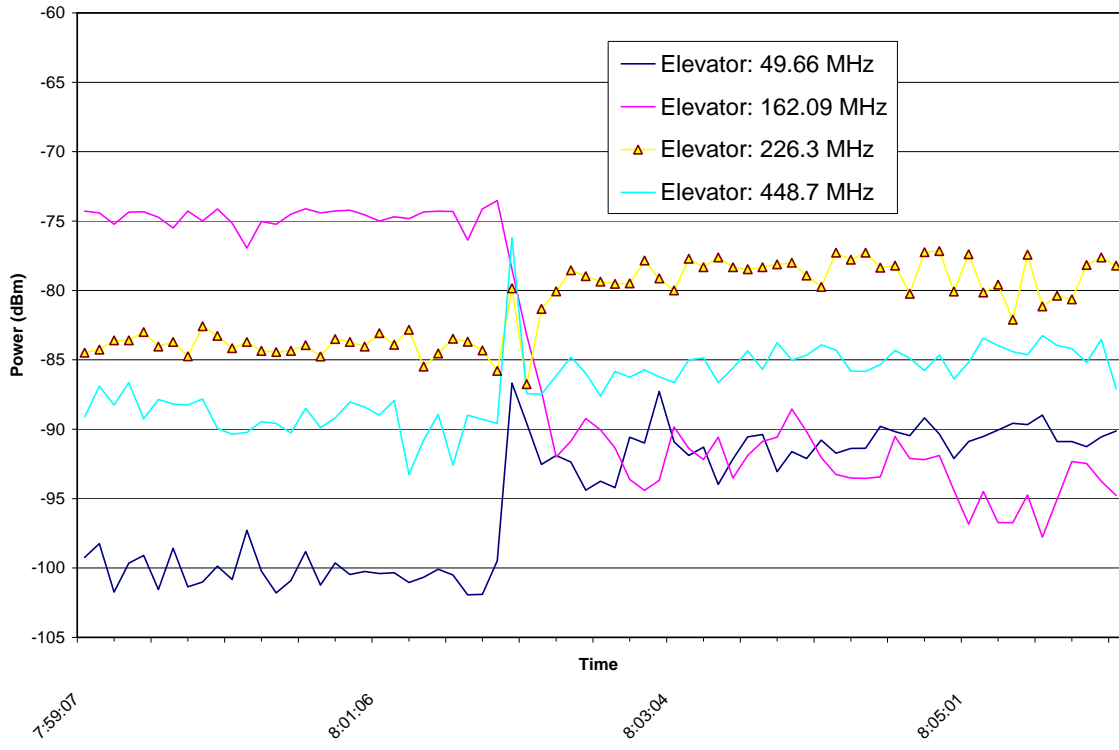
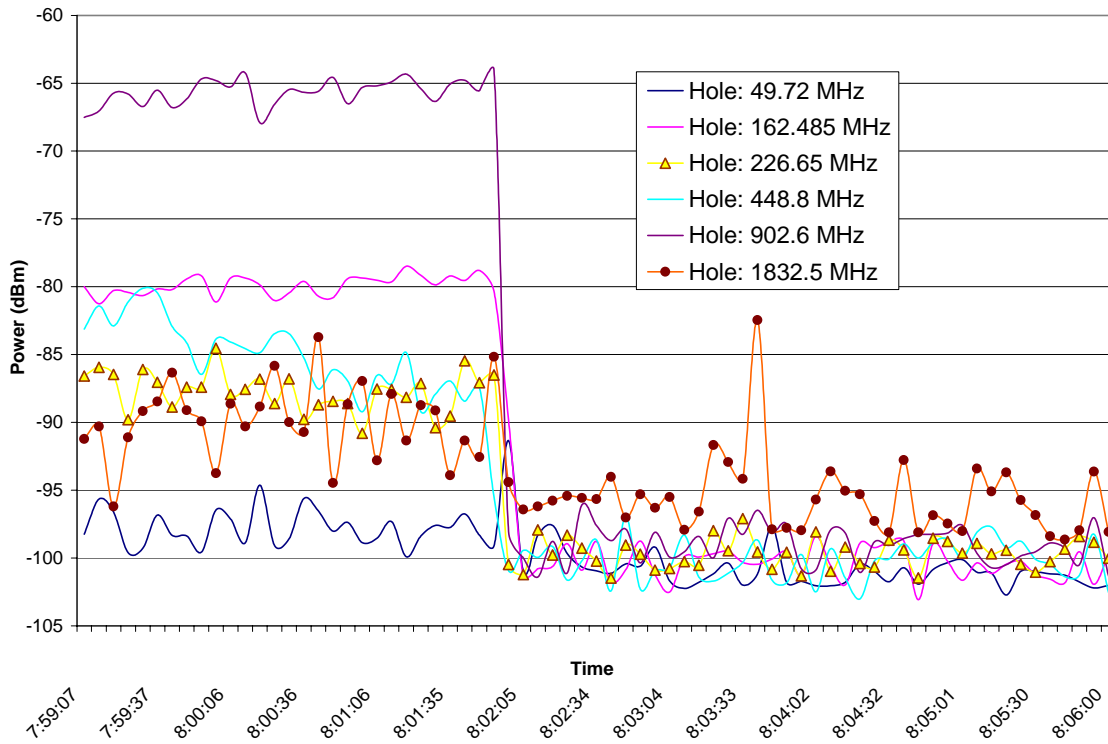
Figure 68. Pre- and post-implosion data collected from Receiver Site A for the transmitters in the control room.

Figure 69. Pre- and post-implosion data collected from Receiver Site A for the transmitters at the third floor elevator.

Figure 70. Pre- and post-implosion data collected from Receiver Site A for the transmitters in the hole.

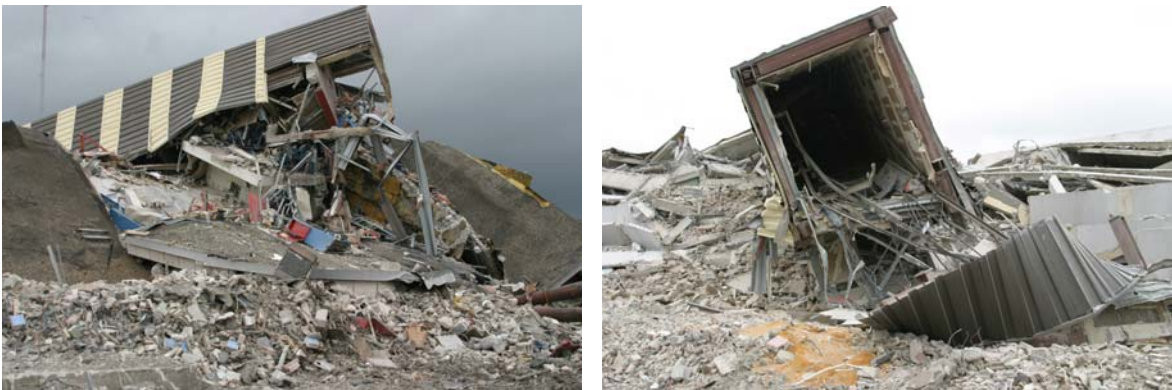
Figure 71. Location of the elevator shaft and transmitters after the implosion.

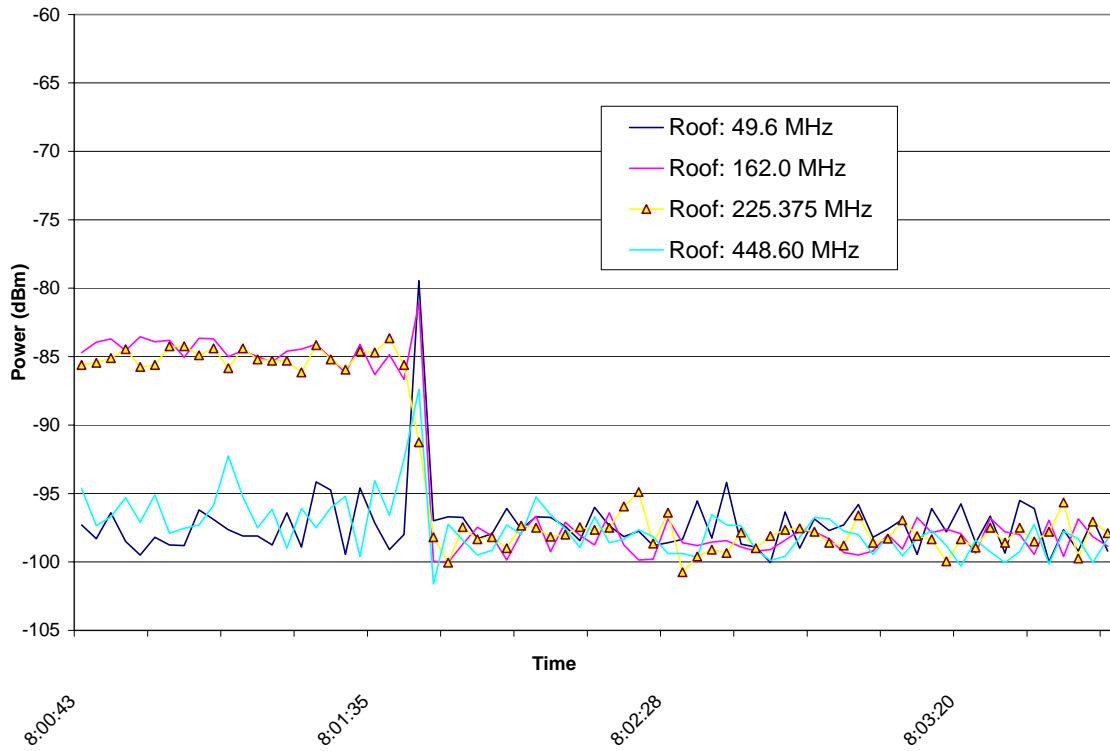
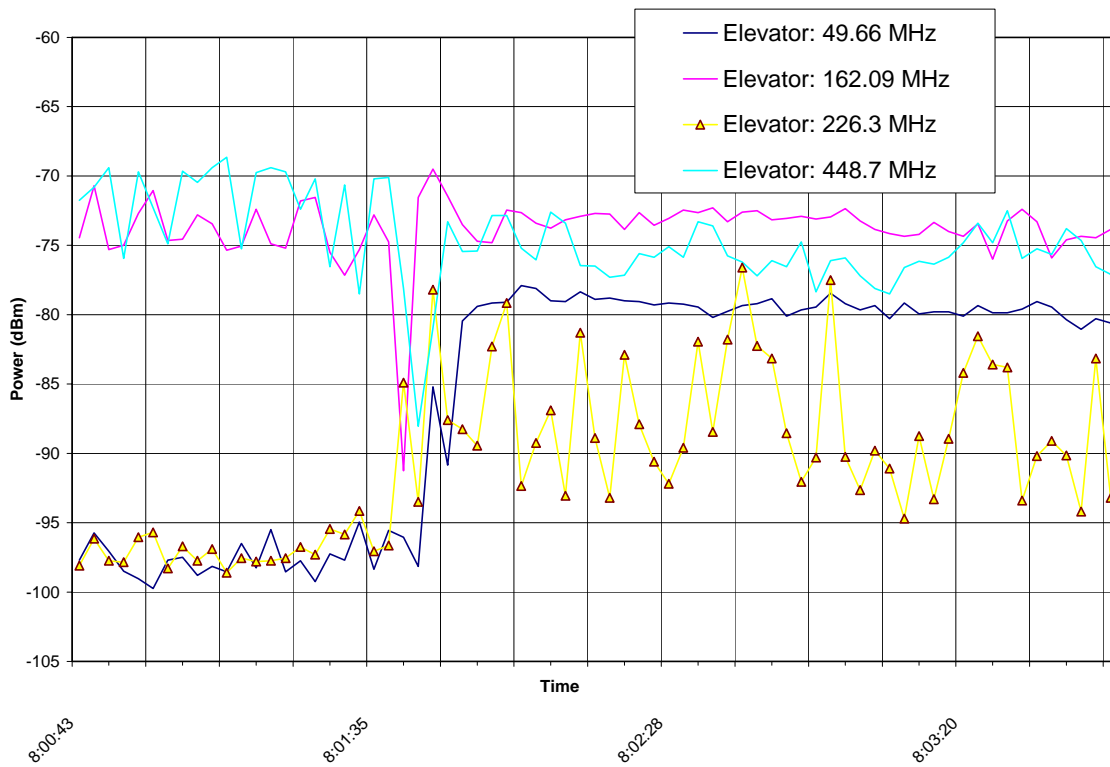
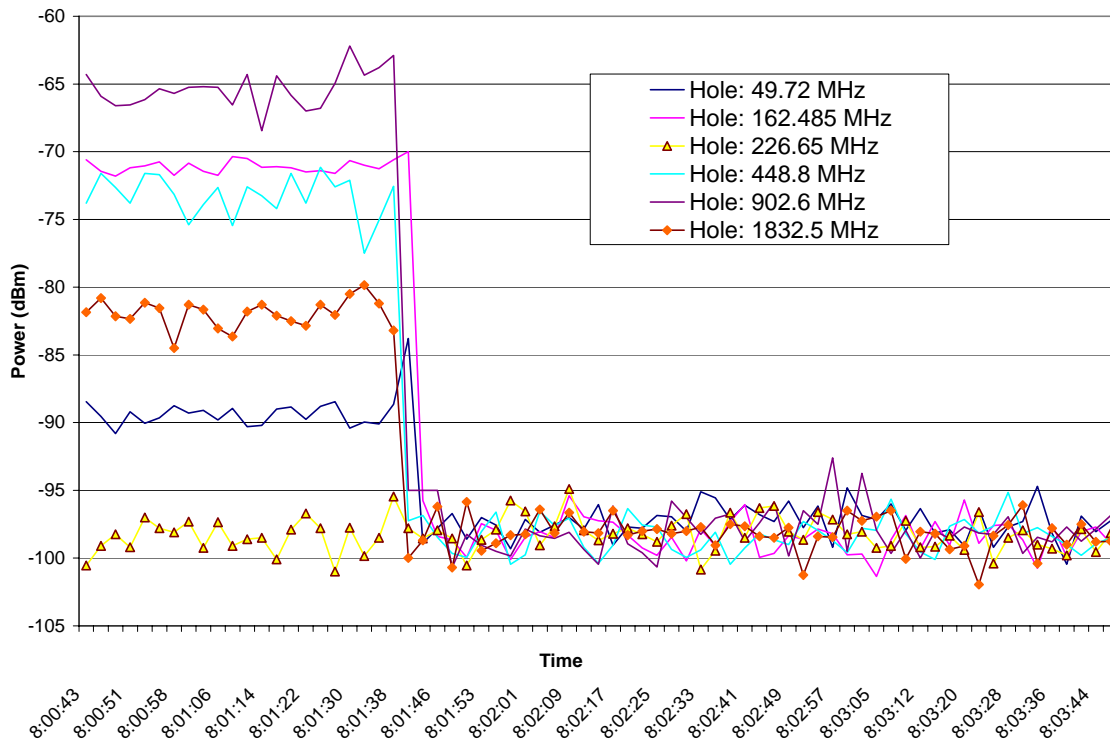
Figure 72. Pre- and post-implosion data collected from Receiver Site B for the transmitters in the control room.

Figure 73. Pre- and post-implosion data collected from Receiver Site B for the transmitters at the third floor elevator.

Figure 74. Pre- and post-implosion data collected from Receiver Site B for the transmitters in the hole.

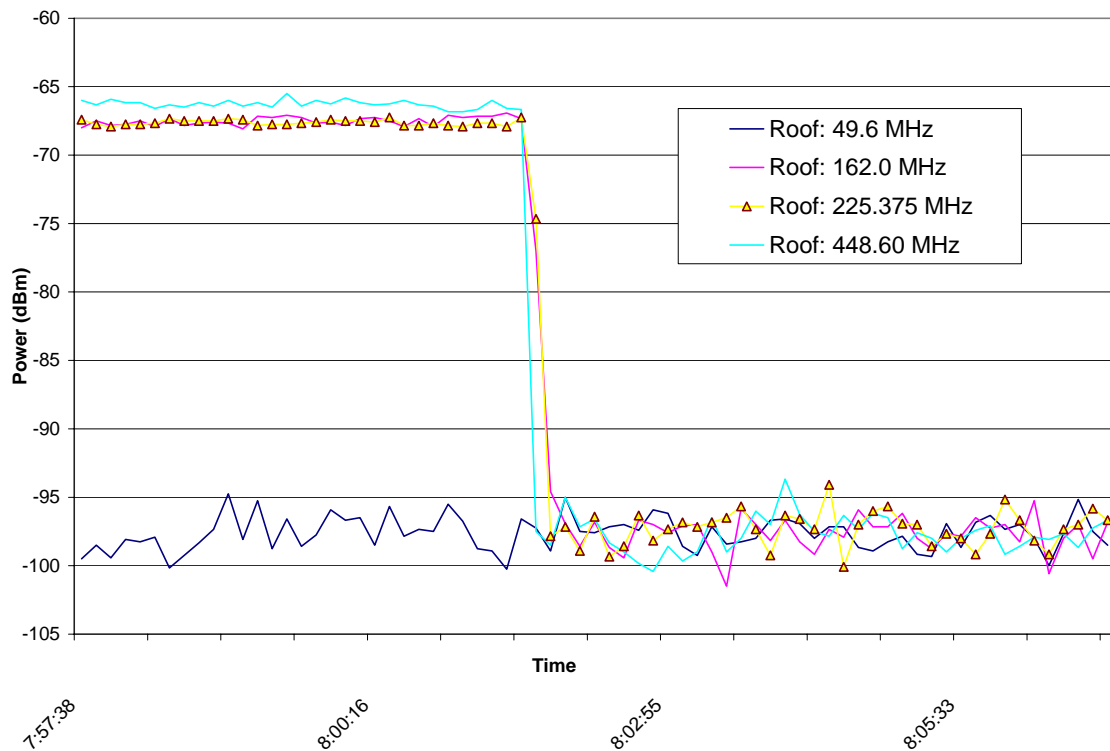
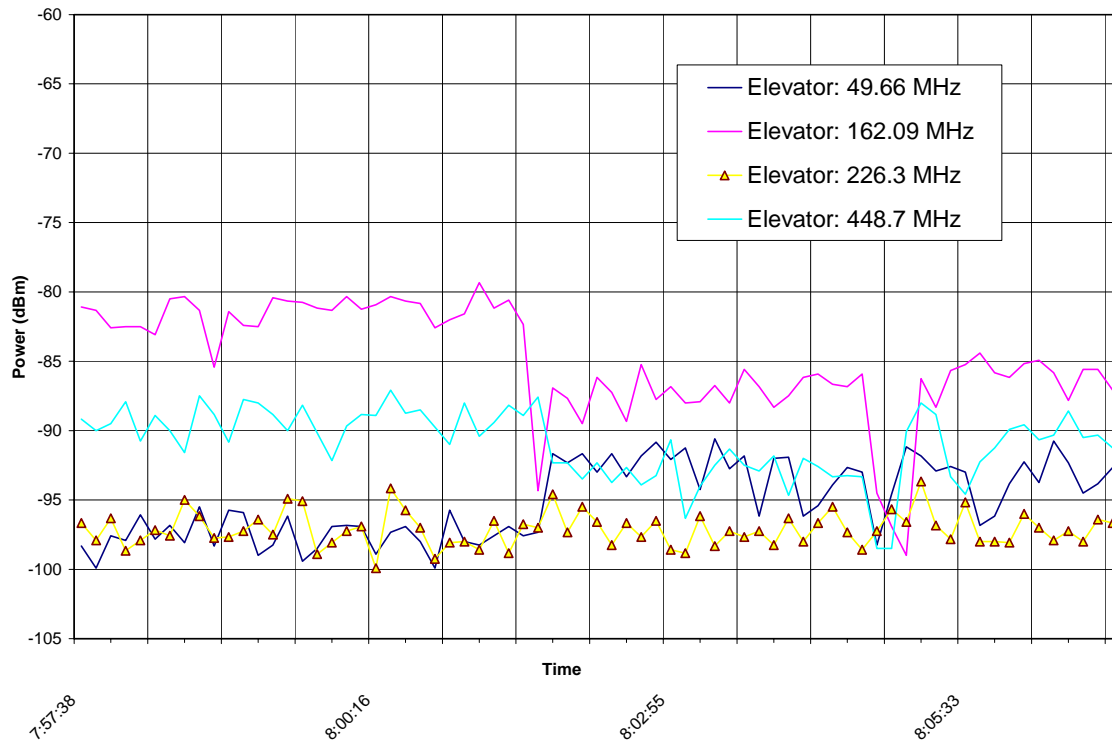
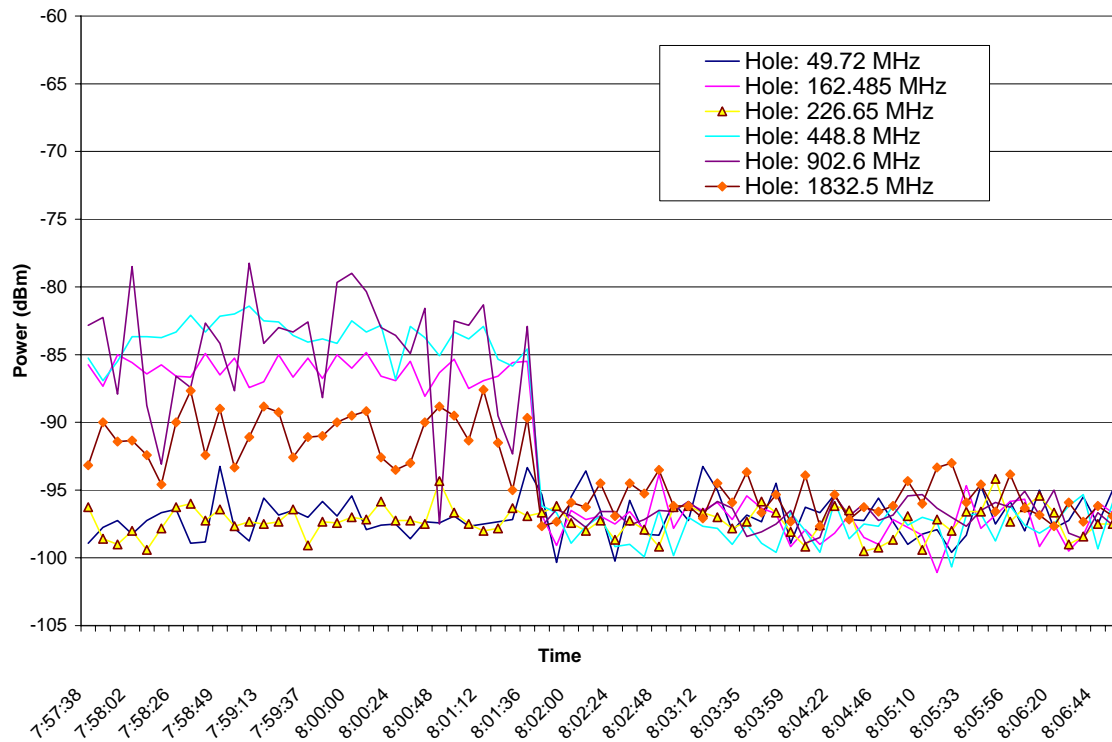
Figure 75. Pre- and post-implosion data collected from Receiver site C for the transmitter in the control room.

Figure 76. Pre- and post-implosion data collected from Receiver Site C for the transmitters at the third floor elevator.

Figure 77. Pre- and post-implosion data collected from Receiver Site C for the transmitters in the hole.

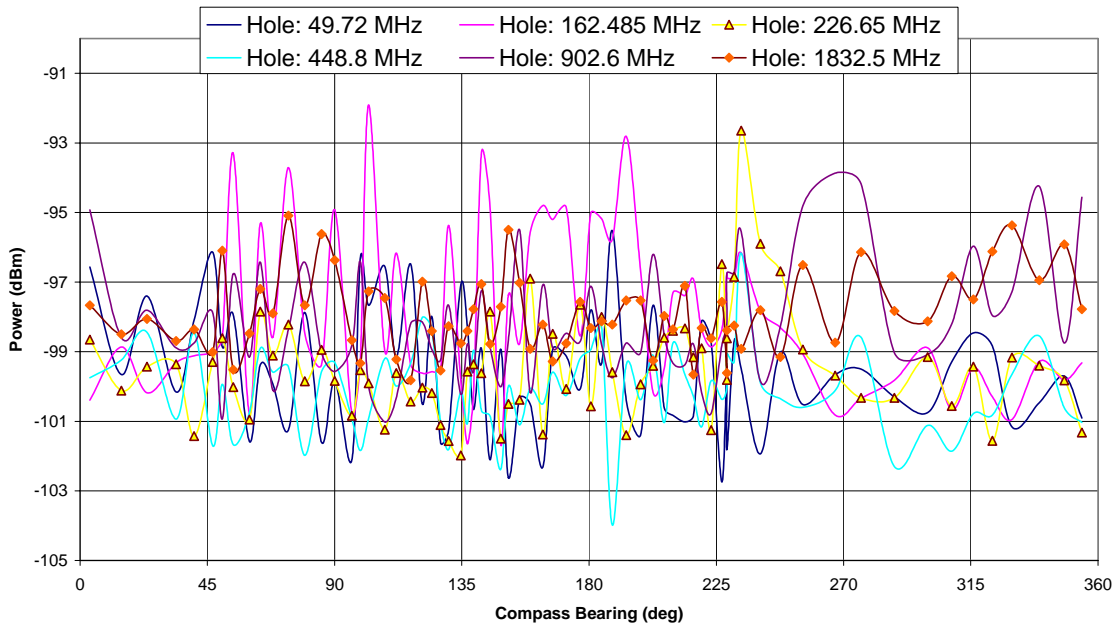
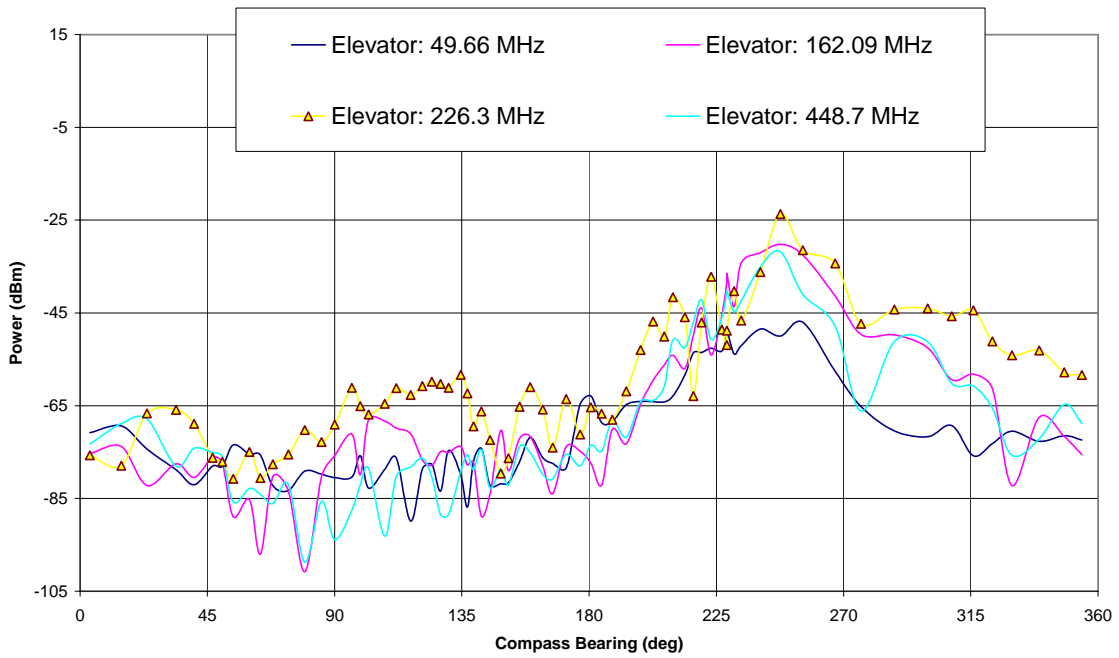
Figure 81. Post-implosion mobile cart measurements for the transmitters in the hole.

Figure 82. Post-implosion mobile cart measurements for the transmitters at the third floor elevator.
