***NIST Technical Note 1540***

**Propagation and Detection of Radio  
Signals Before, During, and After the  
Implosion of a 13-Story Apartment  
Building**

Electromagnetics Division  
National Institute of Standards and Technology  
325 Broadway  
Boulder, CO 80305

May 2005

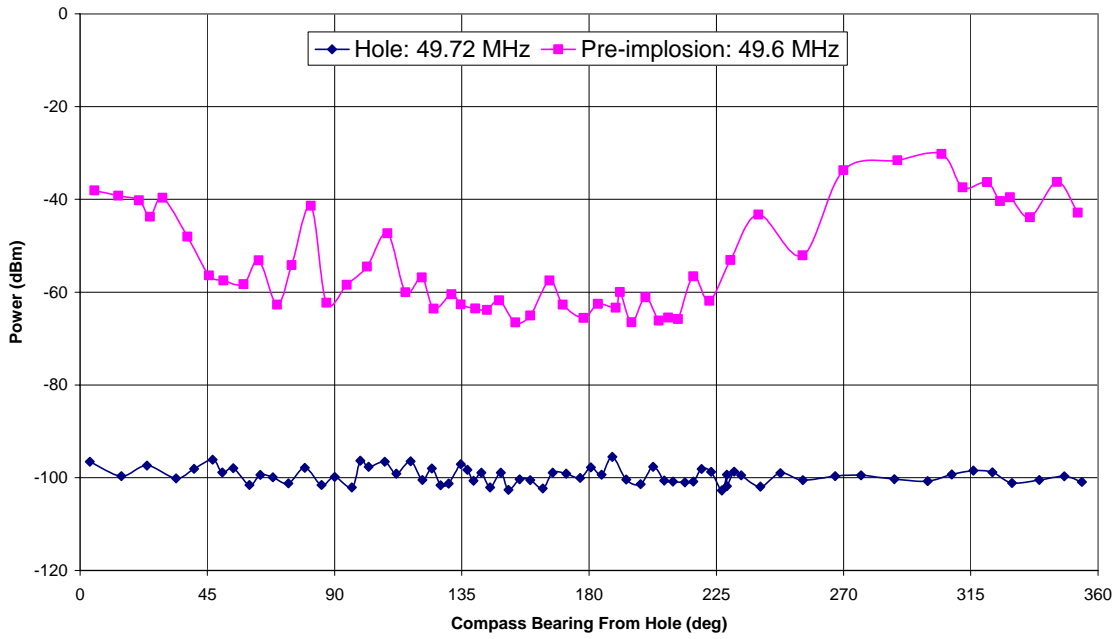
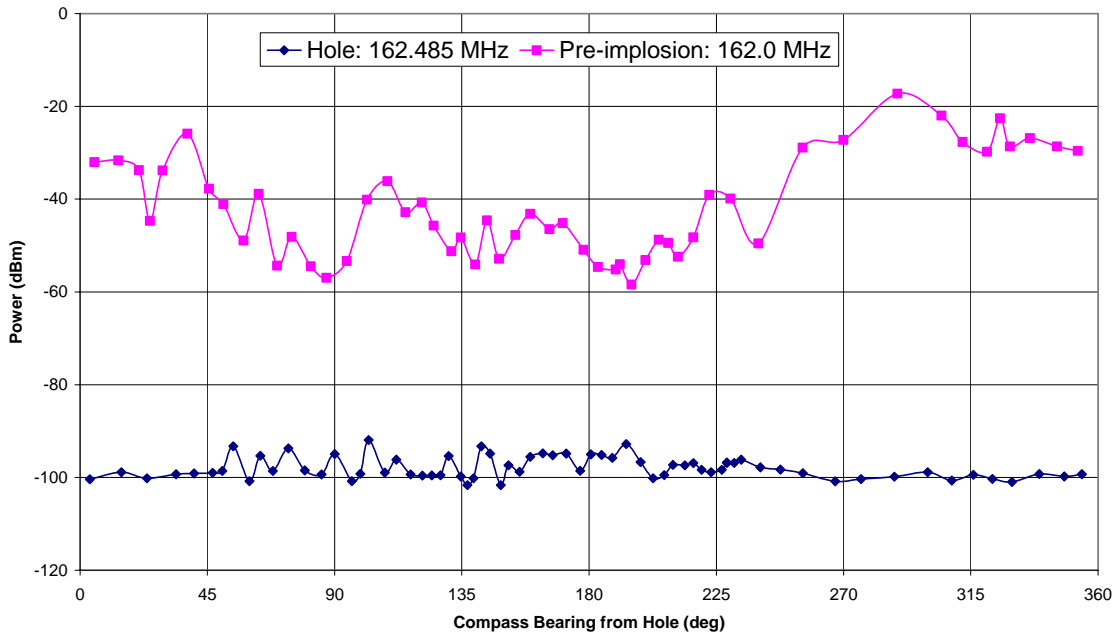
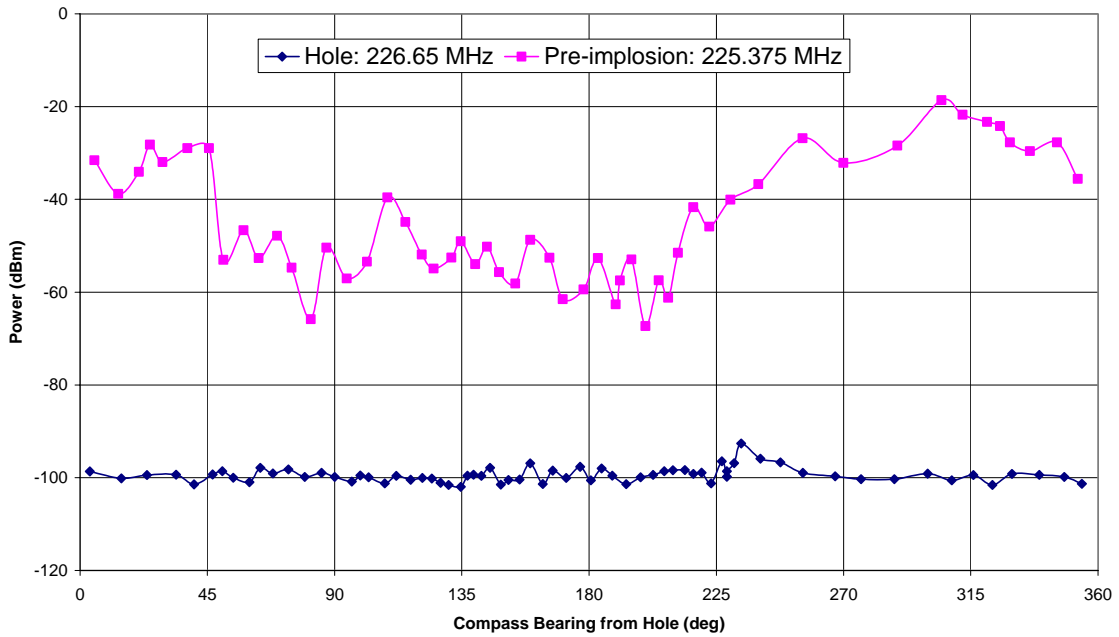
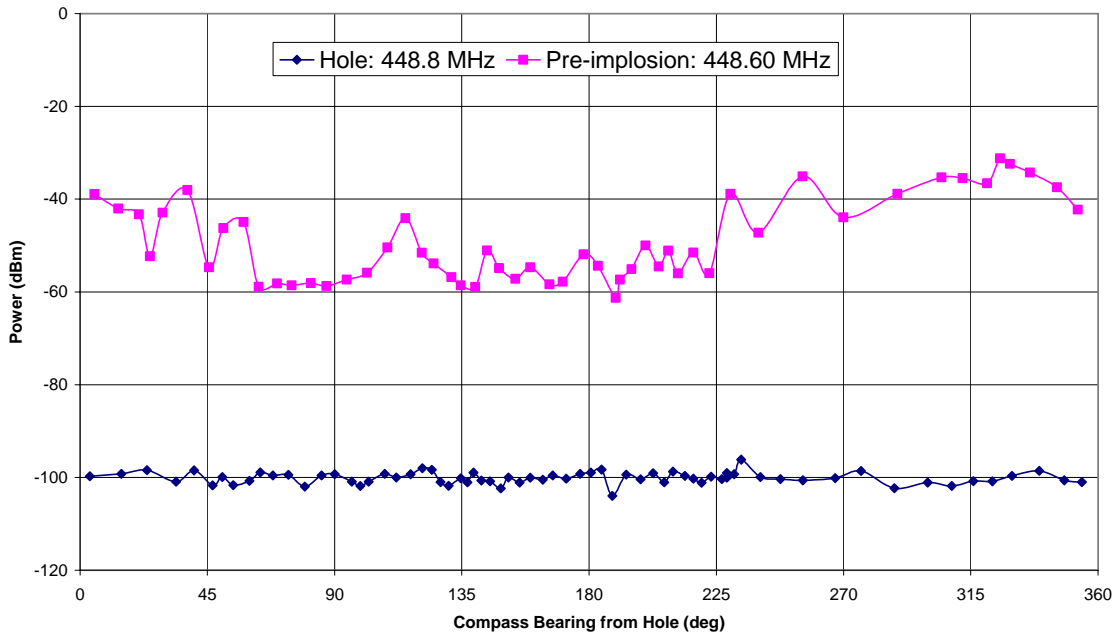
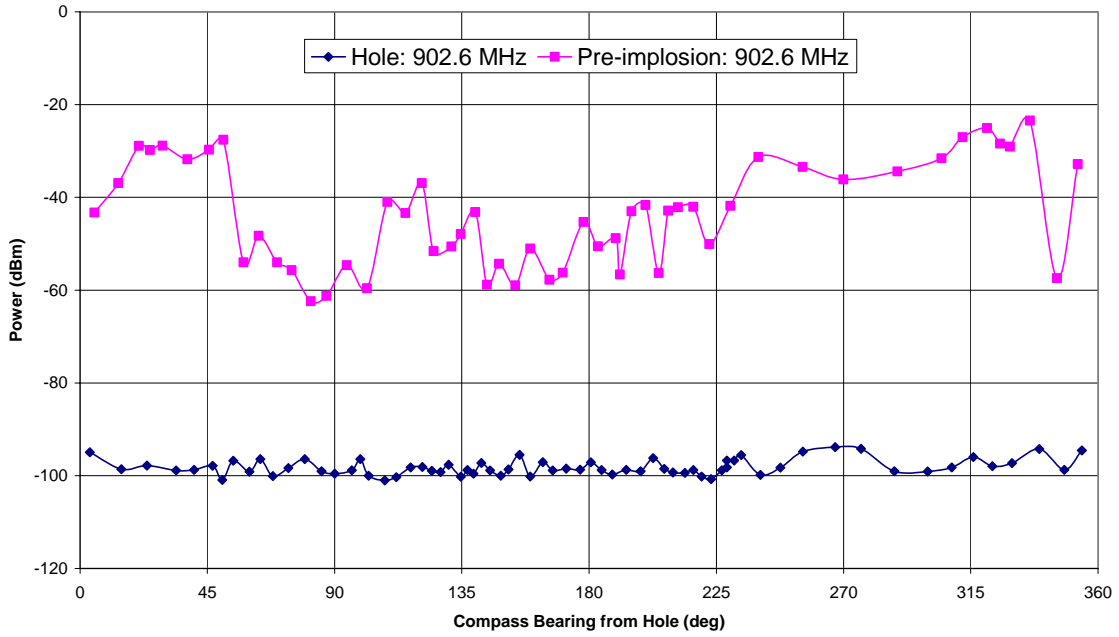
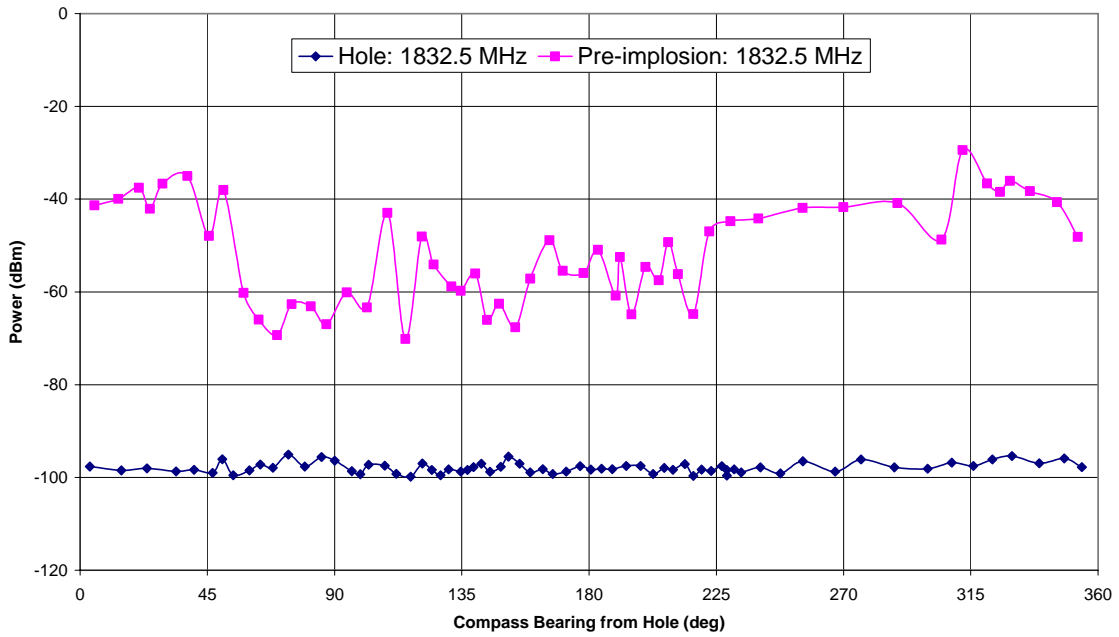
Figure 83. Comparison of pre- and post-implosion mobile cart measurements for the transmitters in the hole in 49 MHz band.

Figure 84. Comparison of pre- and post-implosion mobile cart measurements for the transmitters in the hole in 162 MHz band.

Figure 85. Comparison of pre- and post-implosion mobile cart measurements for the transmitters in the hole in 225 MHz band.

Figure 86. Comparison of pre- and post-implosion mobile cart measurements for the transmitters in the hole in 448 MHz band.

Figure 87. Comparison of pre- and post-implosion mobile cart measurements for the transmitters in the hole in 902 MHz band.

Figure 88. Comparison of pre- and post-implosion mobile cart measurements for the transmitters in the hole in 1832 MHz band.

Measurements for the transmitters in the hole were made before the implosion such that a pre- and post-signal strengths could be compared. These comparisons are shown in Figure 83-88. From these figures, it appears as if the post-implosion signals are either not transmitting or at the noise floor of the measurement instruments. With other measurements (see next section) it was confirmed that the transmitters in the hole were indeed transmitting. Thus, from the results in Figures 83-88, we see that the large amount of building rubble causes as much as 60 to 80 dB of attenuation of the signal. Thus, if someone is trapped under such a rubble pile and is trying to communicate with an emergency responder with a two-way radio or cell phone, their communication link would have to overcome 60 to 80 dB of attenuation.

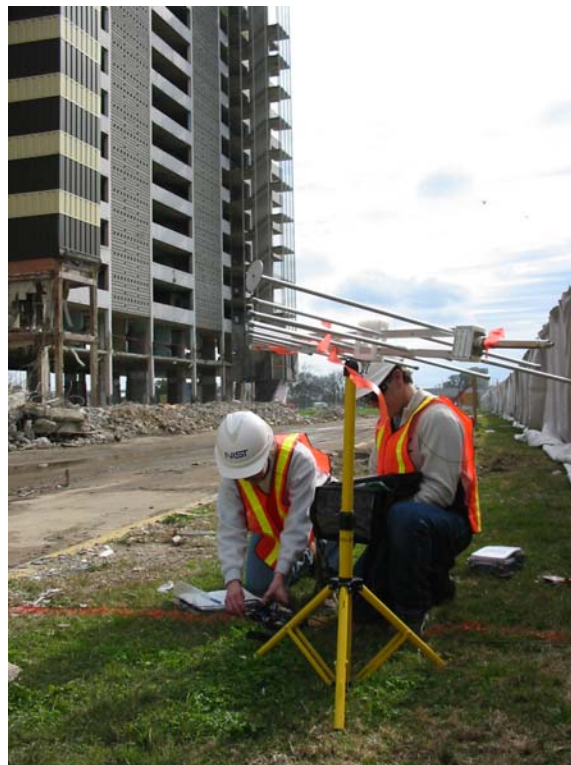
Figure 90. Two NIST scientists connect an impedance tuner between a debris radiator cable and a handheld spectrum analyzer. A log-periodic directional antenna is mounted on the tripod.

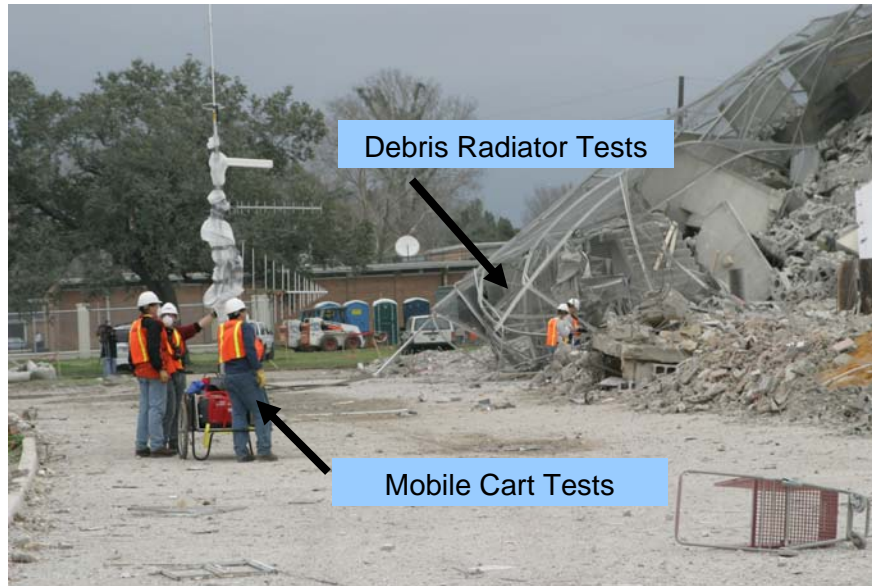
Figure 91. Post-implosion measurements. The mobile cart is in the foreground and the debris radiator tests are at right.
