DEPARTMENT OF ENVIRONMENT & CONSERVATION

DOE OVERSIGHT DIVISION

ENVIRONMENTAL MONITORING REPORT

JANUARY THROUGH DECEMBER 2007

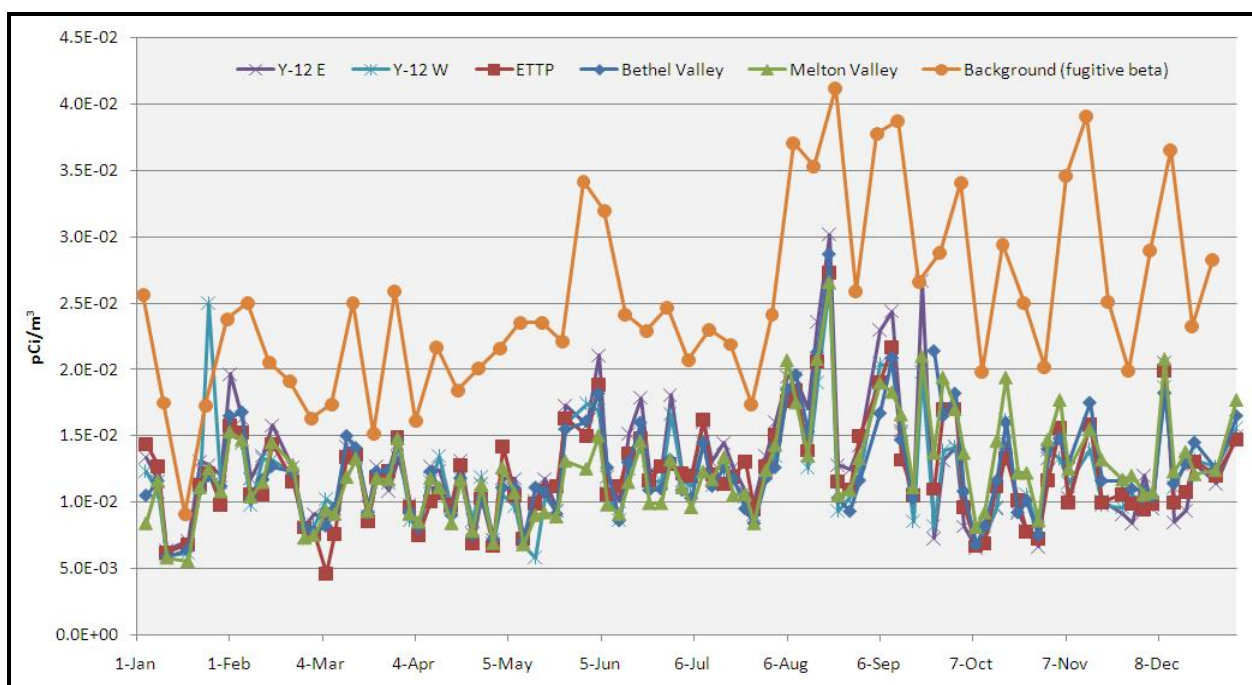
Figure 2: 2007 Gross beta results from air samples taken on the ORR in association with EPA’s RadNet air monitoring program and background measurements from the Division’s fugitive air monitoring program

As seen in Figure 2, the results for the gross beta analysis in 2007 were very similar for each of the five ORR RadNet monitoring stations and nearly all were lower than the results reported for the Fugitive Air Monitoring Program background station (located at Fort Loudoun Dam in Loudon County). While it is not uncommon for concentrations to be less on the ORR than at the background station, data reported for the RadNet stations has consistently been lower than the results reported for the Fugitive and Perimeter Monitoring Programs. This tendency is illustrated in Figures 2 and 3. This bias is believed to be an artifact of the different sampling equipment and monitoring frequency used in the different programs. The fluctuations that can be seen in the results in Figure 2 are largely attributable to natural phenomena (e.g., wind and rain) that influence the amount of particulates suspended in the air and, thus, what is ultimately deposited on the filters.

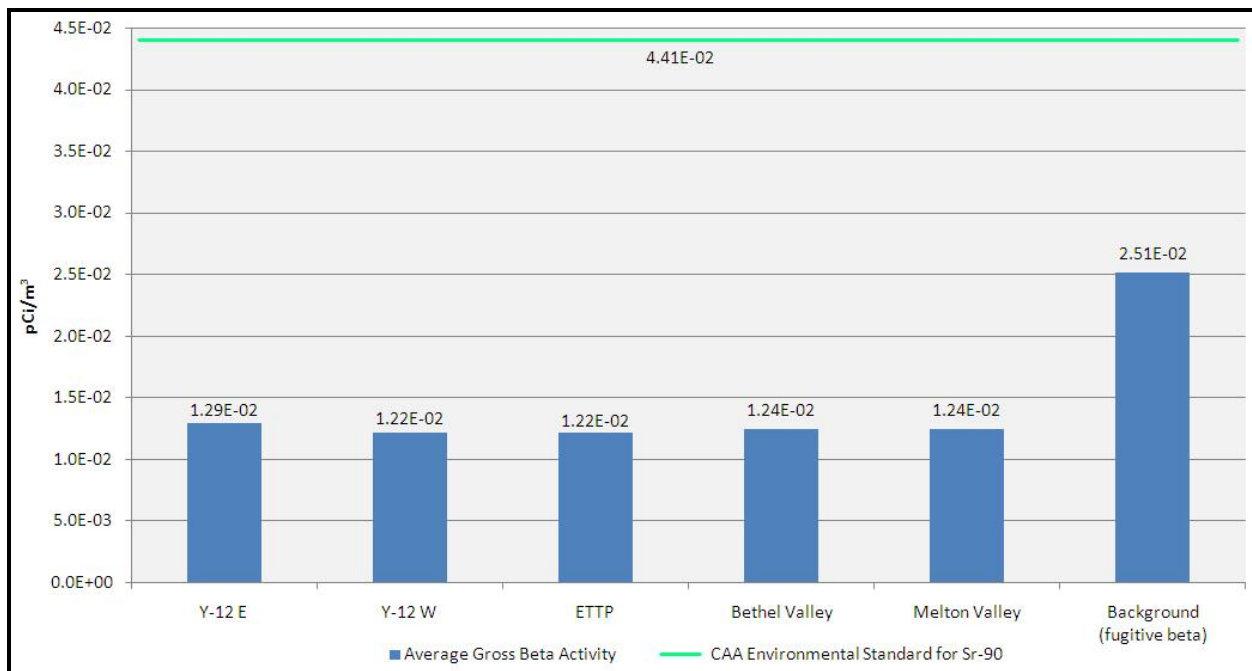
Figure 3: 2007 Average gross beta results for air samples taken on the ORR in association with EPA’s RadNet air monitoring program

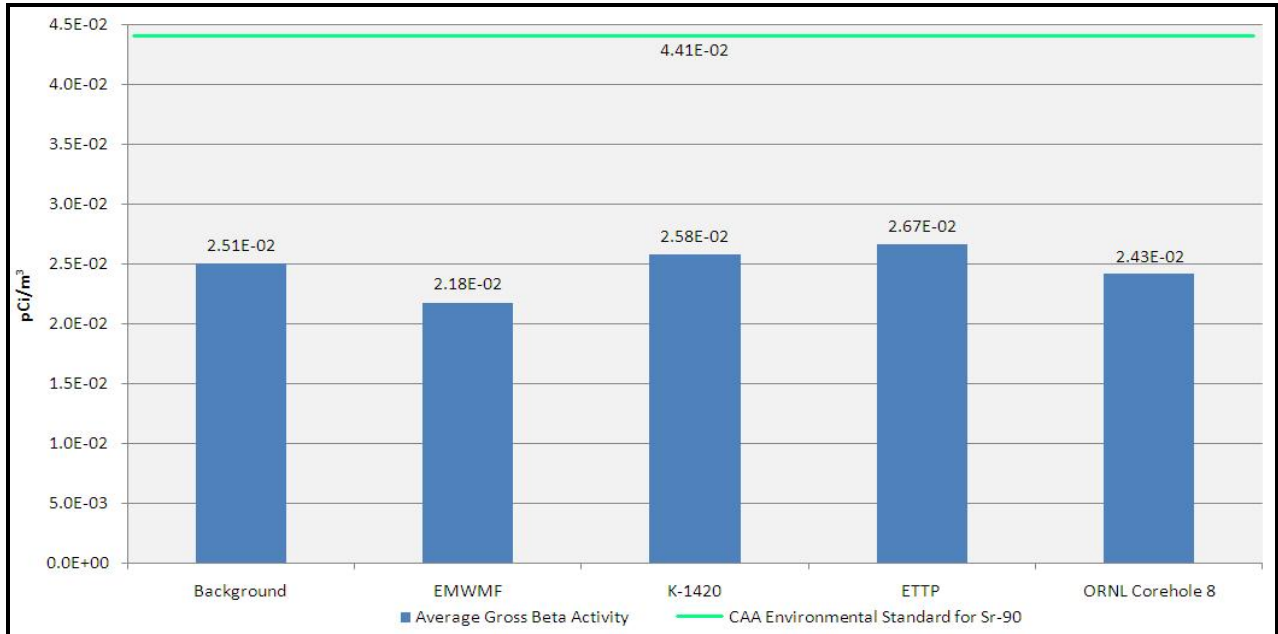
Figure 5: 2007 Average gross beta activities measured at each of the fugitive monitoring locations compared with equivalent background periods and the corresponding CAA environmental standard for strontium-90

In Figures 4 and 5, the average concentrations for the gross alpha and gross beta activity seen at the ORR and background sites are similar and that all results were below the CAA standard. However, there is no level of radiation that has been agreed to be totally safe. Consequently, both state and federal laws require radiations released from a facility to be held to levels as low as reasonably achievable (ALARA). In all decontamination and demolition efforts, ALARA needs to be one of the prime considerations.

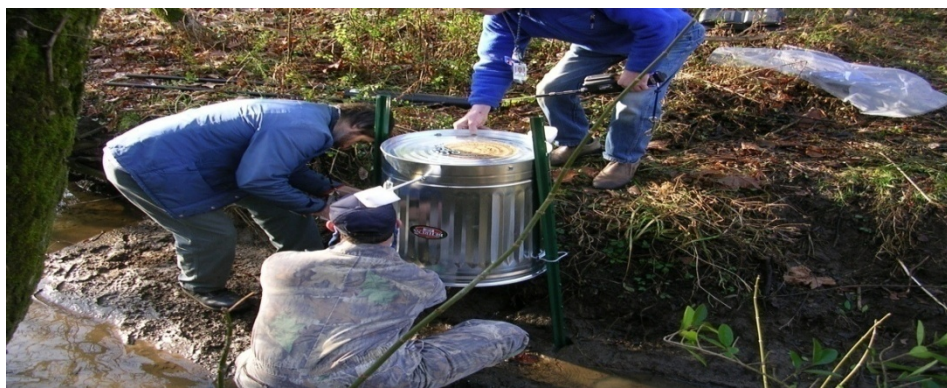
Figure 2: Installation of PID Ambient Air Apparatus

The equipment was to be deployed over Tom's Seep for six days (See Figure 3). The PID was to be retrieved from the field and taken back to the DOEO office. At this point, the PID would be attached to a computer and the data downloaded from the PID's data-logger. Once the data was downloaded it would be exported into an excel spreadsheet for ease of analysis. Analysis would demonstrate if VOCs were detected, possibly in concentrations that could cause potential health concerns.

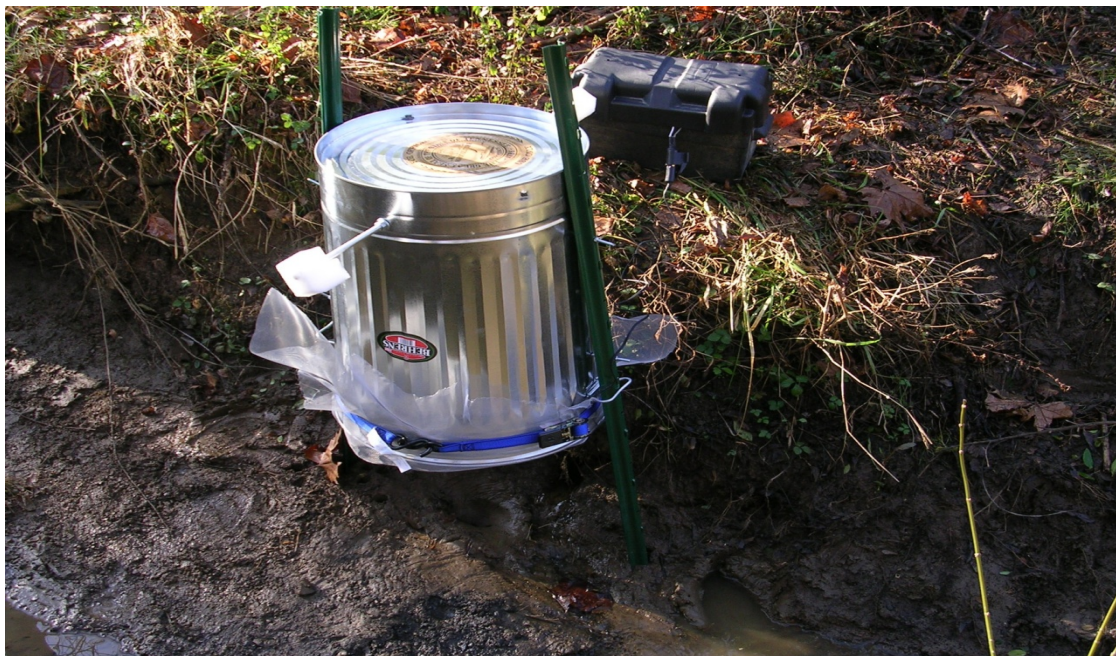
Figure 4: PID Ambient Air Apparatus In Operation

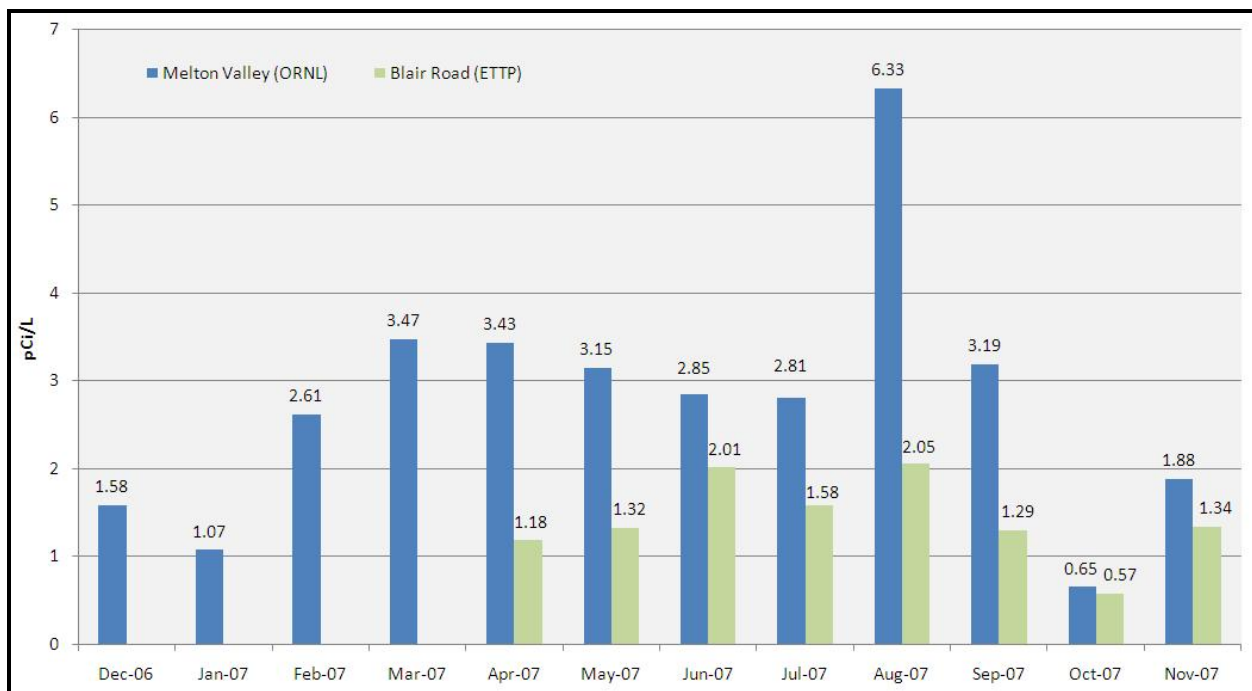
Figure 3: 2007 Monthly gross beta results from precipitation samples taken at Melton Valley (ORNL) and Blair Road (ETTP)

Figure 3 depicts the 2007 monthly gross beta results from precipitation samples in Melton Valley (ORNL) and Blair Road (ETTP). Again, these values can be better understood by comparing the mean, median, and highest values at the Melton Valley (Oak Ridge) location to the mean, median, and highest values at other locations (Table 3). Unlike tritium results, the gross beta results at the Melton Valley location (near Oak Ridge) were similar to results from around the nation, as seen by comparing the mean and median for each. The highest results from Tennessee (53.7 pCi/L), were from the precipitation station in Knoxville. While nationwide data for the same time period was not available for comparison with results from the Blair Road site, all results from the Blair Road site were below the associated results at the Melton Valley location.

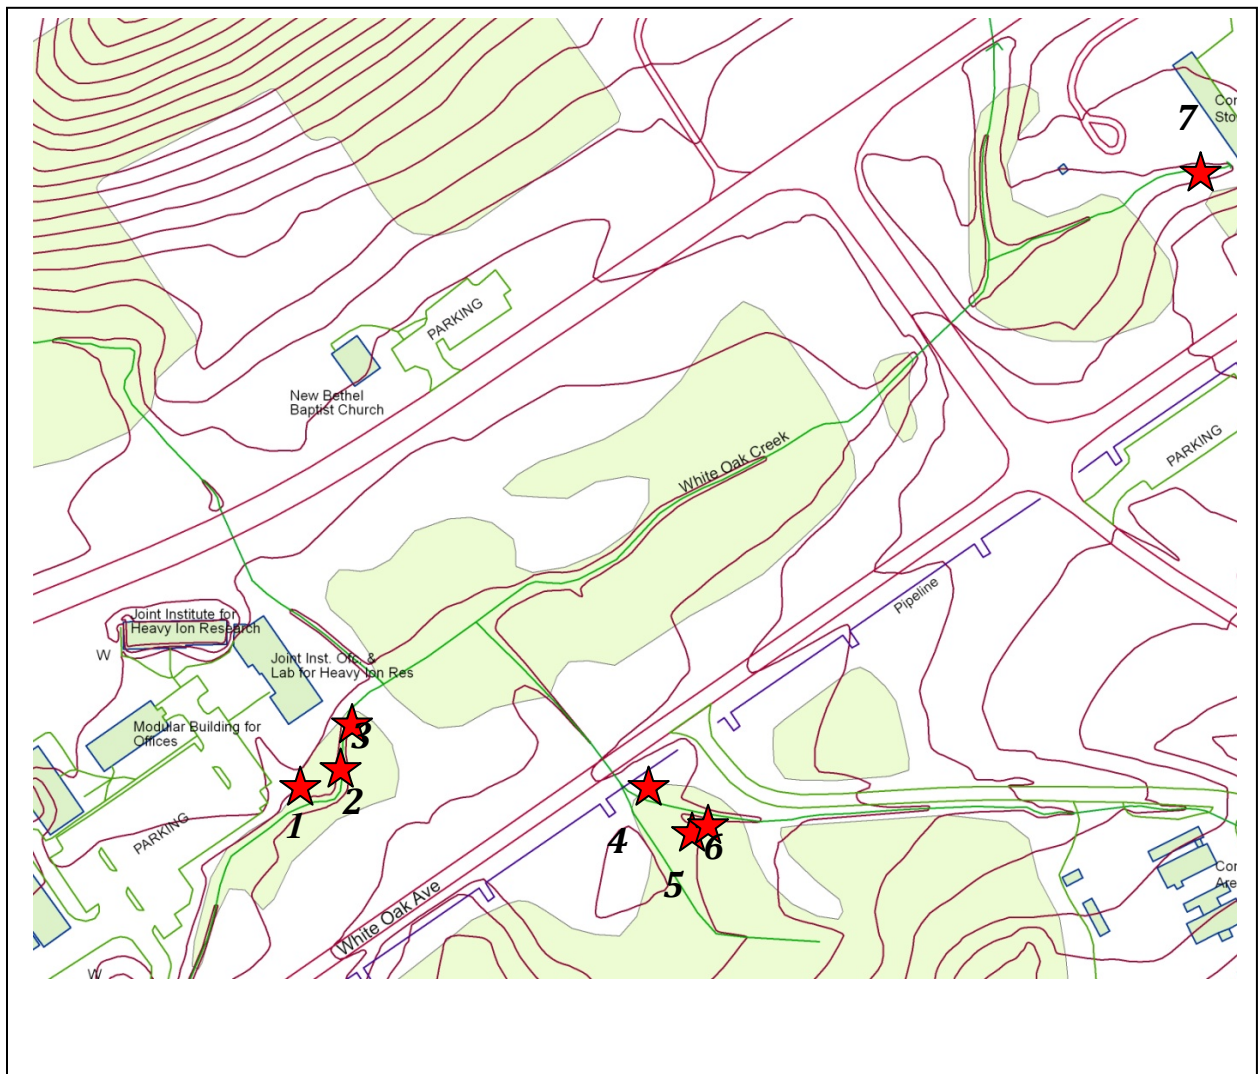
**Figure 1: Locations for December 2006 sampling event in the ORNL 7000 area.
Map scale: 1" = 240'.**

Results for the thirteen samples (seven in 2006 and six in 2008) are given in Tables 1 and 2. Samples from upstream locations in White Oak Creek (see Figure 1, locations 3 and 7 and Figure 2, location 5) and in the eastern orifice of the primary spring feeding this reach of the creek (see Figure 1, location 6) were uncontaminated. Volatile organics found in other samples were limited to trichloroethene and its breakdown products, primarily cis-1, 2 dichloroethene.

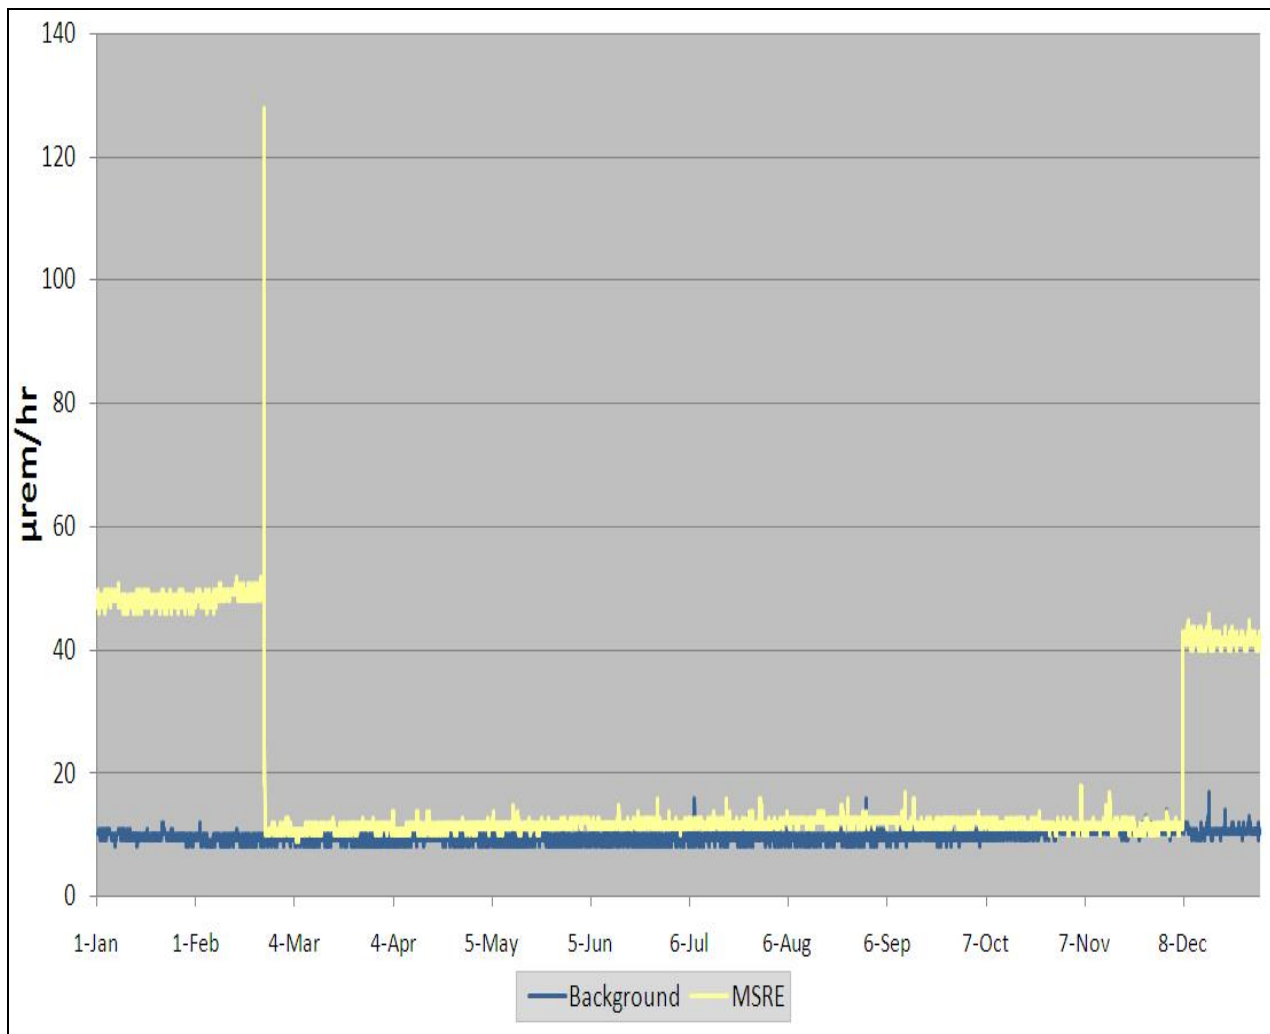
Figure 3: 2007 Gamma exposure rates measured at the gate of MSRE and at the background station at Fort Loudun Dam

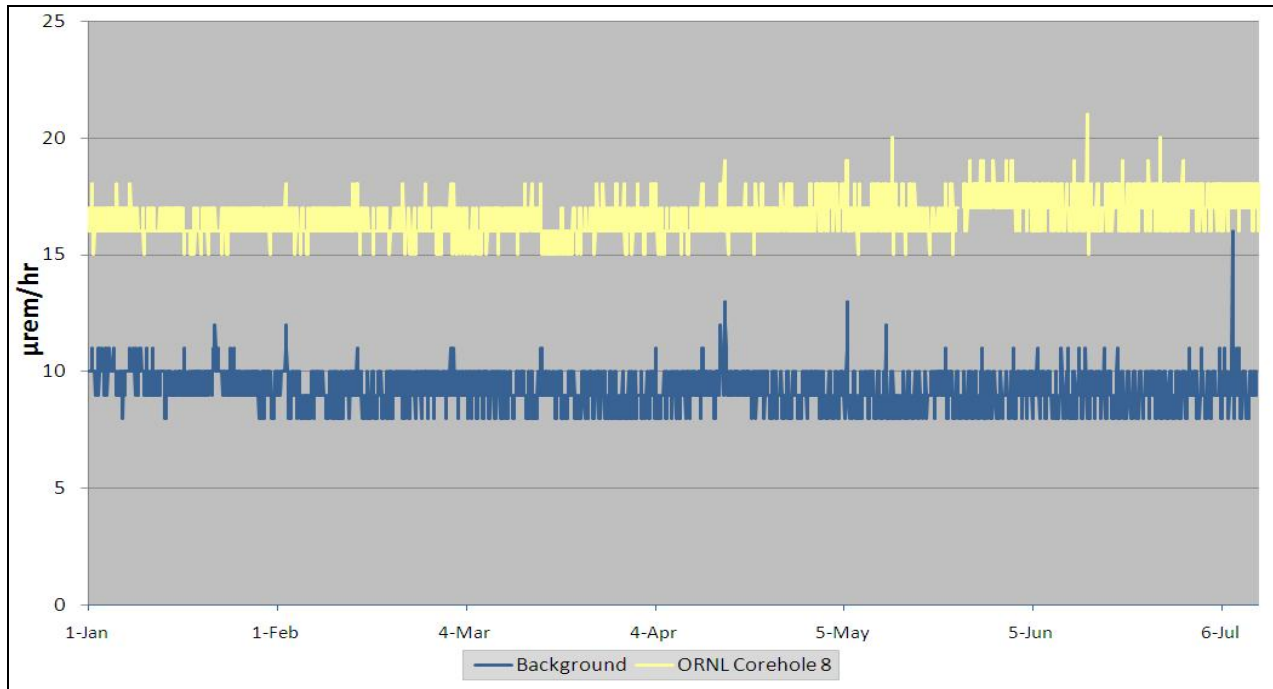
Figure 7: 2007 Results of gamma exposure rate monitoring at the ORNL Core Hole 8 and at the background station

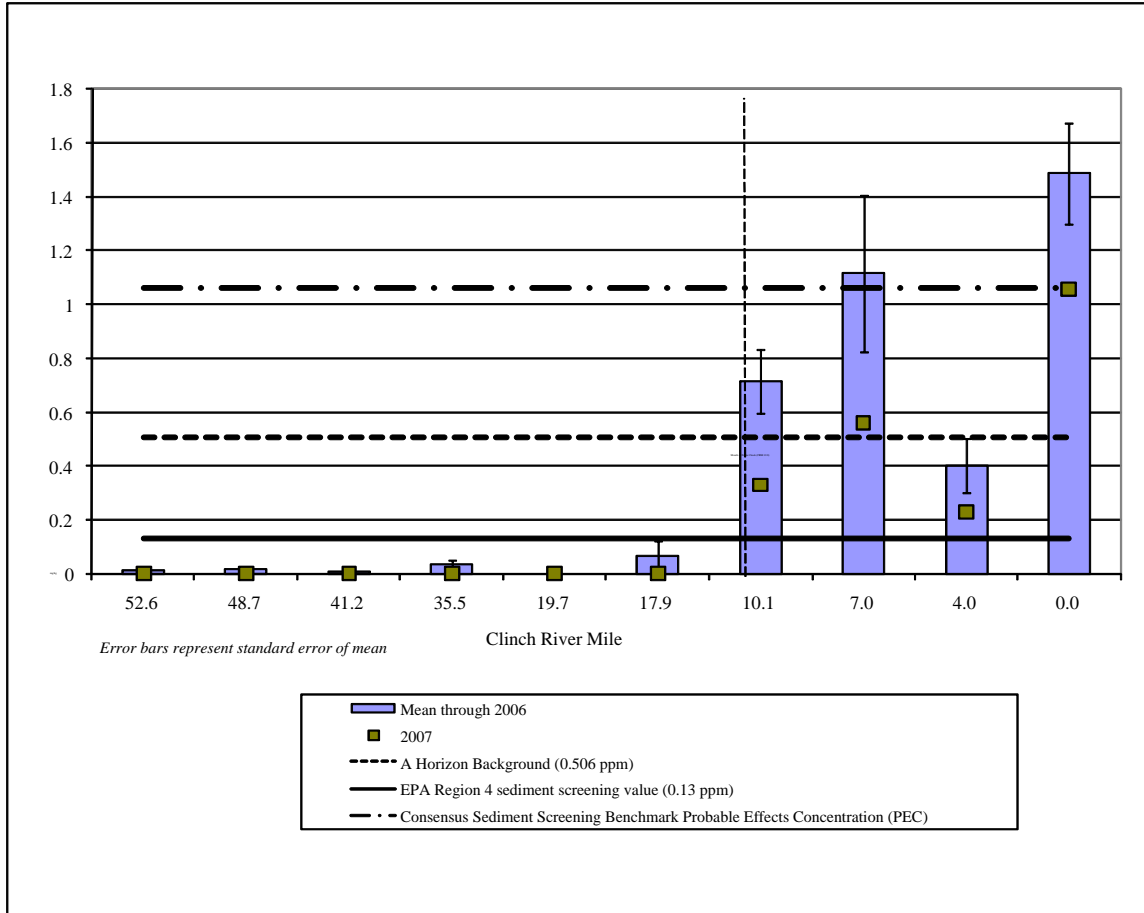
Figure 3: Mercury in Clinch River Sediment Grab Samples (2007)
