Fish/Riparian S&G Implementation 62a

Effectiveness of Riparian Standards and Guidelines 62b

**Proposed, Endangered, Threatened, and Sensitive (PETS)
Fish Species** ^{62c} ⓘ

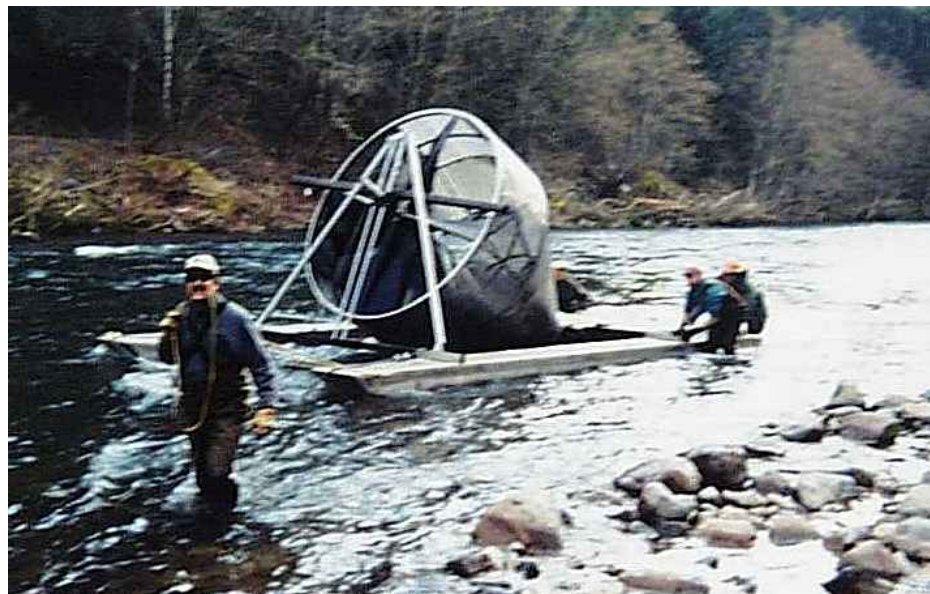
(Figure 23). The resulting data has allowed us to quantify increases in freshwater survival and declines in ocean survival. In addition, the data has allowed us to focus out-year restoration proposals on specific sub-watersheds, such as the upper Wind River. Continued operation of the traps on the Wind River will provide analysis of population trends and additional year's data will provide necessary information to further refine production estimates.

Figure 23. Smolt trap being placed on Wind River, Gifford Pinchot National Forest

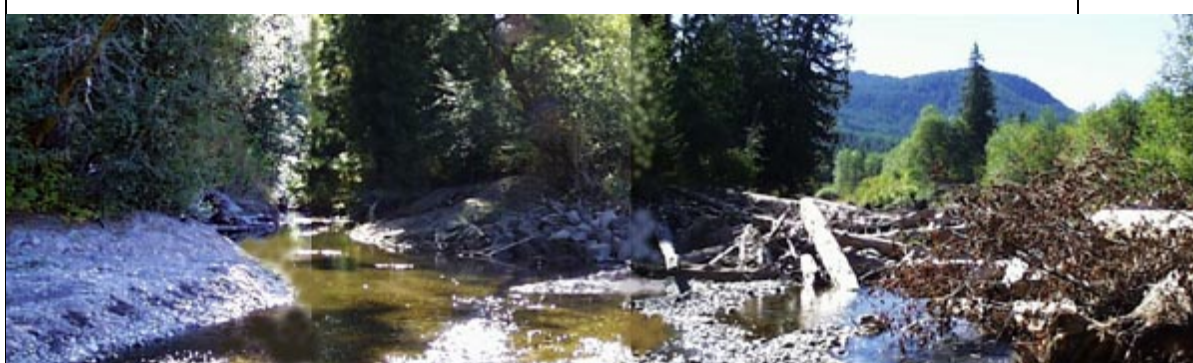
Photo monitoring has allowed the Forest Service to track the effectiveness restoration projects. Figure 30 is a photo of log jam one that was placed where the natural jam was removed in 1981. By placing log jam #1, the stream bed was aggraded over four feet to regain connectivity with flood plain and reactivate 0.8 of a river mile of pristine habitat.

Figure 30. - 1999 Photo of the entrance to the Trout Creek old growth channel after restoration of logjam.

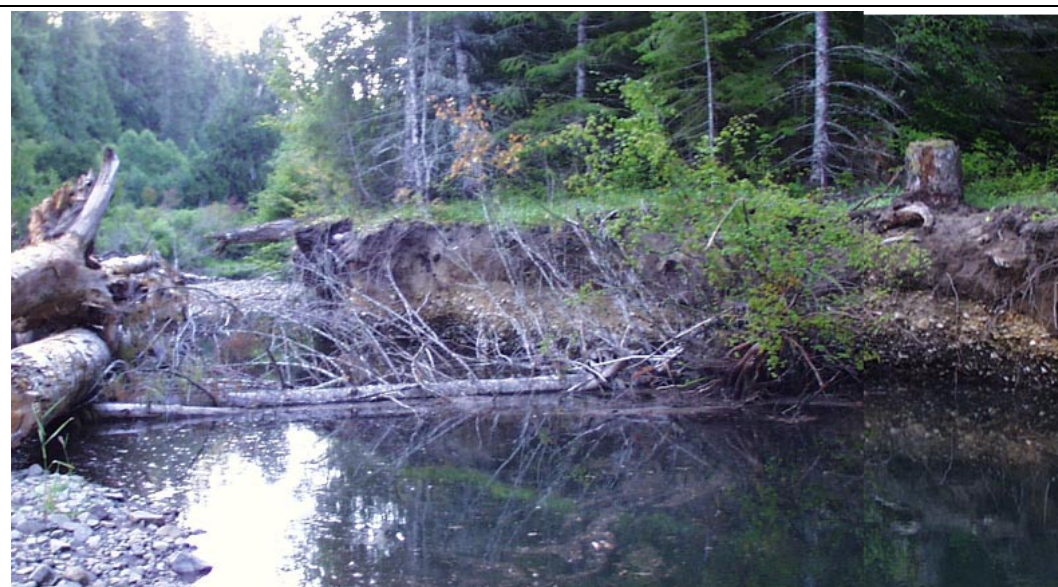
Figure 31, page 71, is a photo of severe bank erosion on Trout Creek (river mile ~ 7.3) caused by removal of riparian vegetation, in-stream large wood removal, and channel degradation. Figure 32 shows the same site after the addition of large wood for reducing further bank erosion.

Figure 31. - Photo of severe bank erosion on Trout Creek (river mile ~ 7.3).

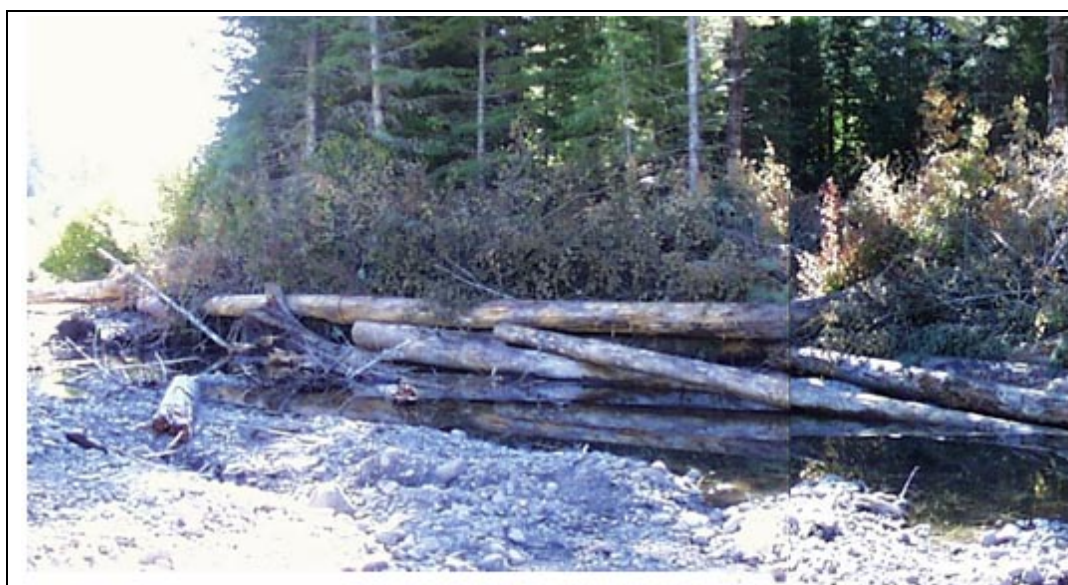
Figure 32. - Photo of large wood revetment at Trout Creek (river mile ~ 7.3).

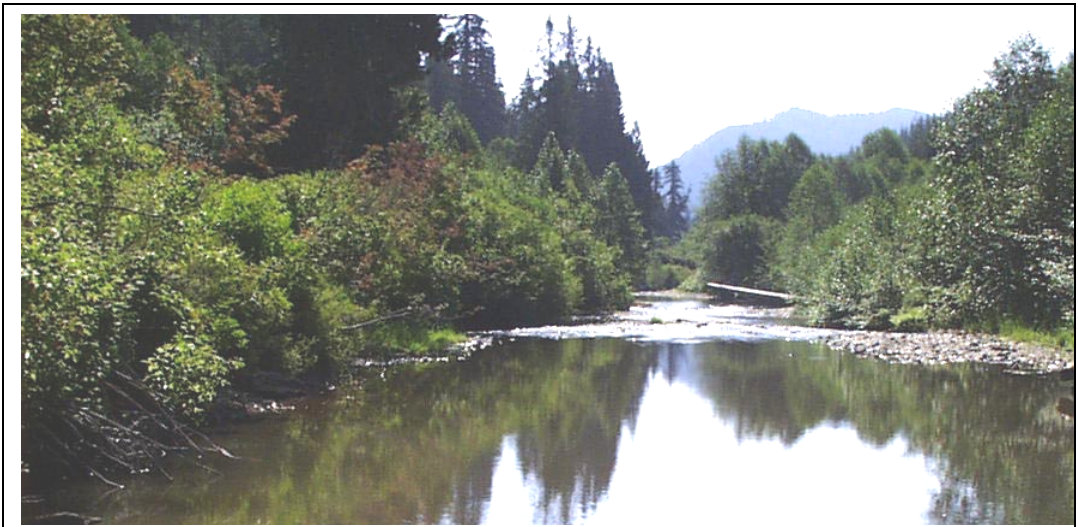
Large width-to-depth ratios and low stream shade increase maximum water temperature and provide poor quality rearing habitat for steelhead on Trout Creek, approximately river mile 7.1 (Figure 33). Width-to-depth ratios were reduced by constructing gravel bars based on empirical hydraulic and geomorphic template data. Width-to-depth ratios for Trout Creek, river mile 7.1, was reduced from 66 to 17 (Figure 34).

Figure 33. - Photo of Trout Creek before restoration work (river mile 7.1).

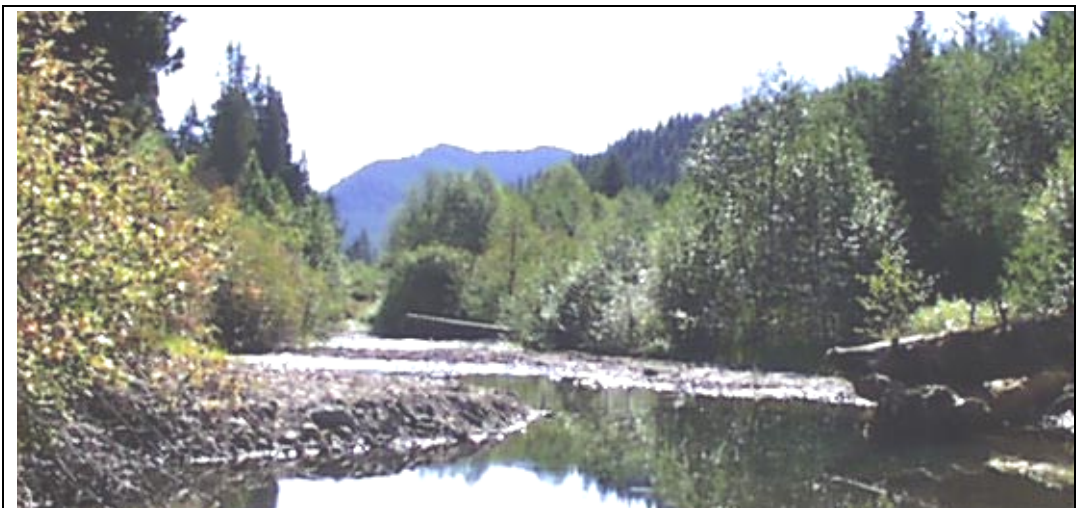
Figure 34. - Photo of Trout Creek following construction of gravel bars (river mile 7.1).
