# The Fisheries Program Response to the Floods of the mid-1990's

## Mt. Hood National Forest

**The Fisheries Program  
Response to the  
Floods of the mid-1990's**

**Mt. Hood National Forest  
2001**

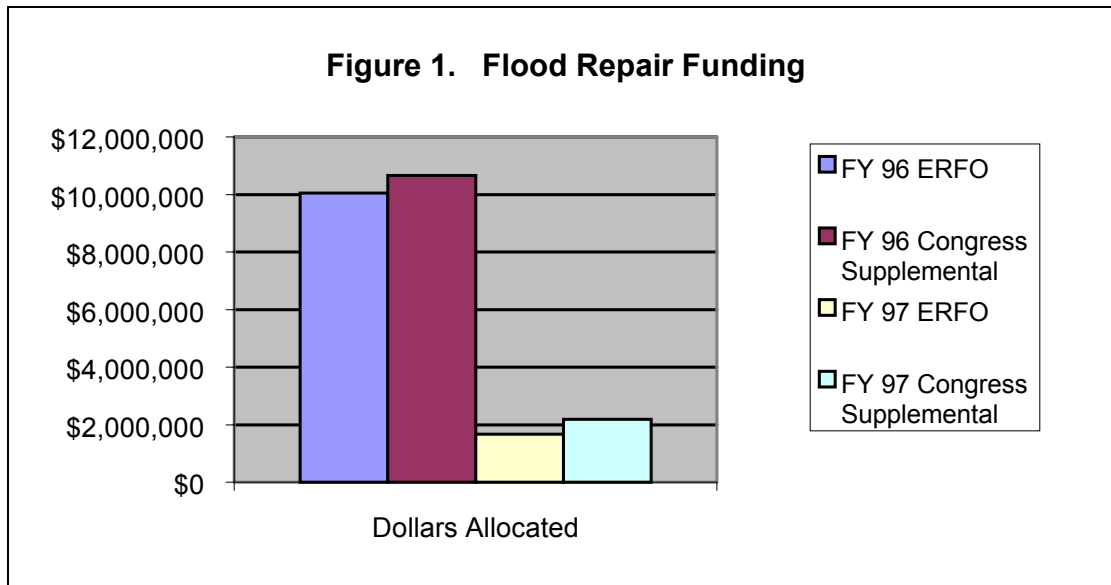
Figure 1, below, displays the total funding received by the Forest for flood repair. The grand total received by the Forest was \$24,550,000.

Flood repair and restoration dollars were allocated during two funding cycles, representing storm events occurring during different fiscal years. The magnitude and impacts of storms during 1995-1996 represent the bulk of flood repair funding. As indicated by Figure 1, a large proportion of flood repair funding was in the ERFO program. The majority of ERFO funding was used for road repair. In a few circumstances, after public comment and environmental analysis, ERFO funding was used to obliterate rather than repair roads. This was after analysis showed it was a more economical option and was determined to better meet resource management needs.

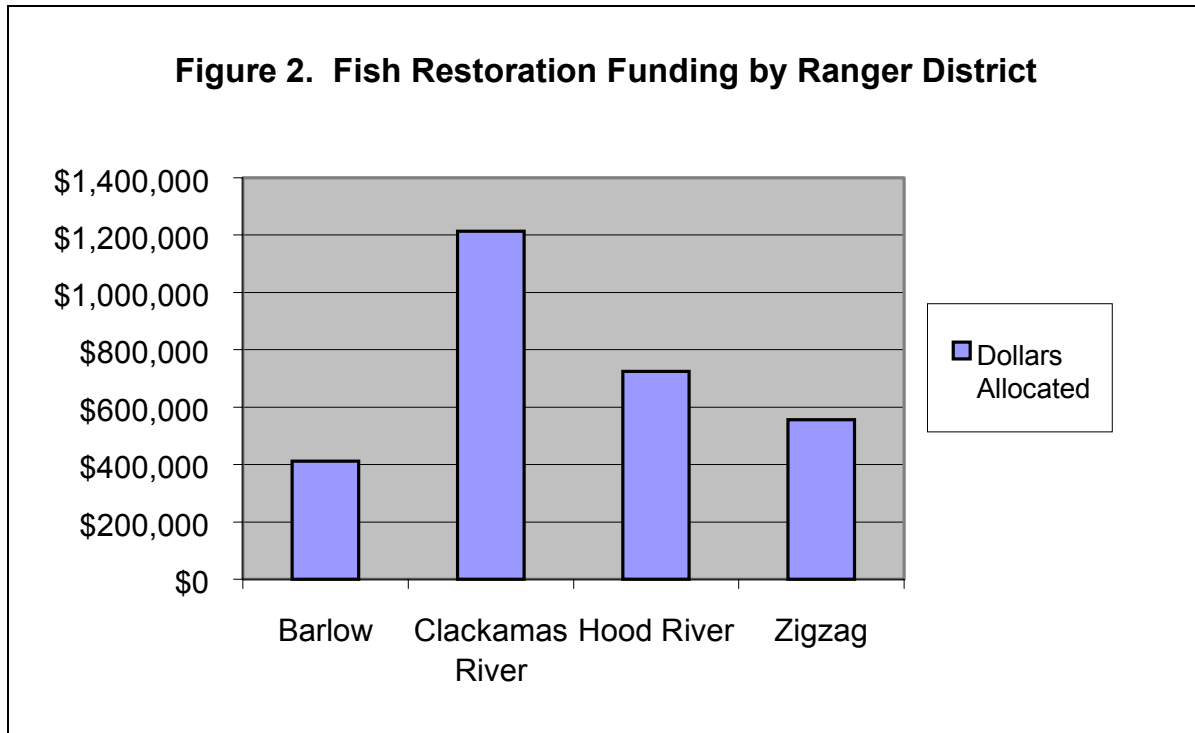
A portion of the funding displayed in Figure 1 was for fisheries restoration projects. Figure 2 displays the total dollar amount received by each ranger district in fiscal years 1996 and 1997 for fish habitat restoration projects. The total allocation on the Forest was \$2,906,000 for fish habitat restoration. Project costs were derived from records provided by the ranger districts and Headquarters (Monitoring and Evaluation Report Fiscal Year 1998). Projects were implemented over the course of the following four years, finishing in 2001.

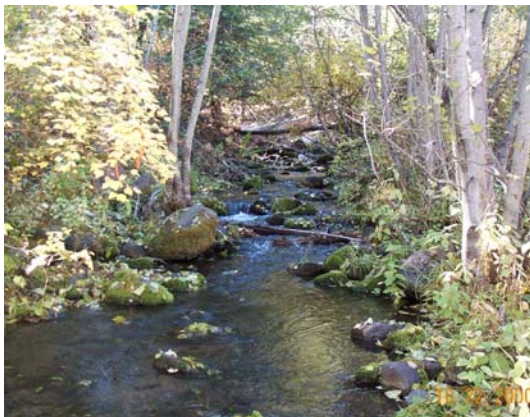
**Before**

This project addresses three miles of Ramsey Creek impacted by the flood of February 1996. Ramsey Creek downcut and straightened during the flood and contributed large pulses of sediment downstream. More than two miles of floodplain was abandoned. The natural surface road next to Ramsey Creek contributed fine sediments. Ramsey Creek has ESA threatened winter steelhead.

- Transport and place wood throughout project area.
- Create log jams within the channel and floodplain with 1,100 logs over 2.9 miles of stream. 56 of 74 project sites were constructed in 2000.
- Stabilize, scarify and plant riparian area and streamside roadbed along Ramsey Creek.

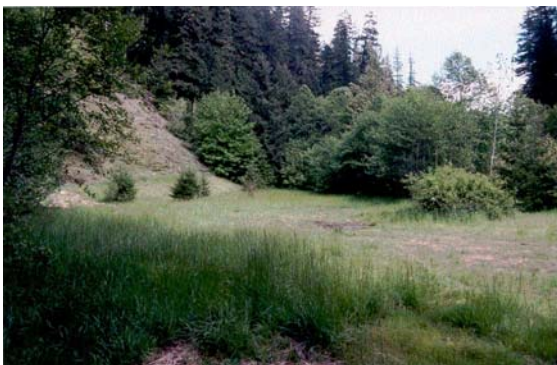
The Wild and Scenic Clackamas River Plan has a management goal of restoring riparian habitats altered by the river-adjacent road. Fill from road construction was dumped in existing side channels. After the flood of 1996 an opportunity was identified to re-establish the connection of side channels with the river channel. There are two ESA listed fish, chinook and steelhead.

**Before - fill site from road construction**

- Create inlets and outlets at historic side channels by removing road surface and fill, and replacing with large, fish-friendly culverts.
- Excavate and remove fill from historic side channels. Re-establish native vegetation.
- Add large wood for fish habitat and hydraulic drops to increase dissolved oxygen levels.

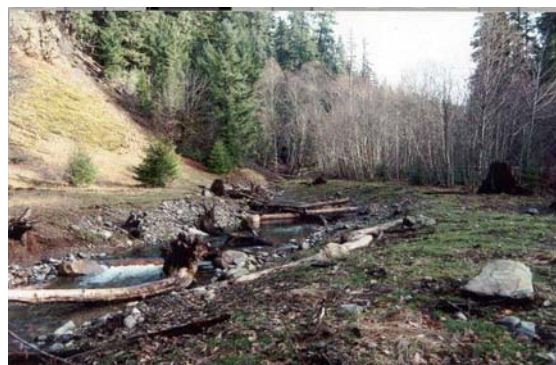
**After - reconnected to river and side channel excavated**

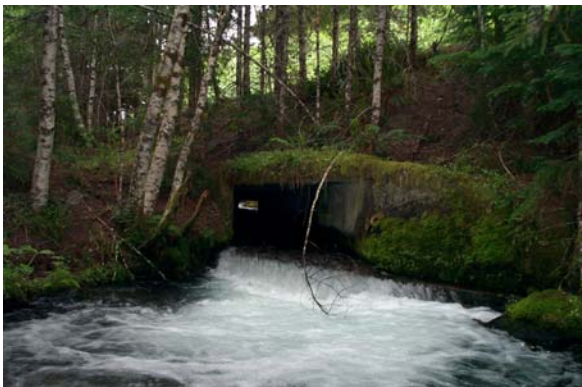
**Before**

The Little Zigzag River is a glacial-fed stream supporting ESA listed steelhead. The original box culvert was built in the early 1950's. The culvert created a velocity and jump barrier. After evaluating interim design proposals, a prefabricated, modular bridge was installed, opening up ½ mile of habitat. Upstream, two more barrier culverts are slated for replacement.

- Install a prefabricated, modular bridge.
- Apply erosion control to disturbed areas.
- Minimize damage to residual riparian vegetation.

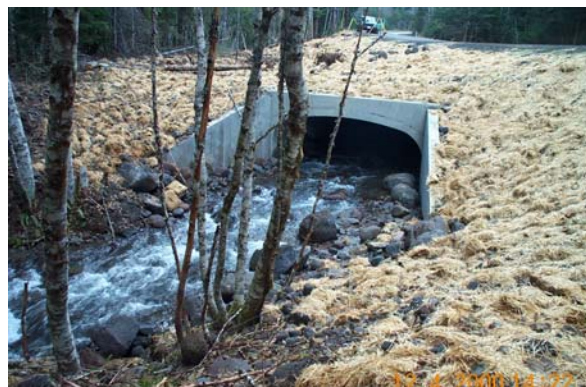
**After (with erosion control)**

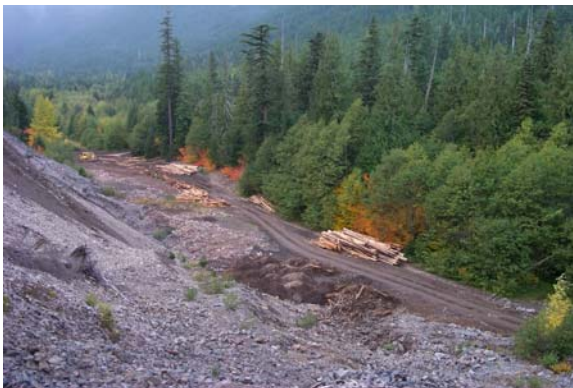
**Quarry Before**

Clear Branch Creek of the Middle Fork of Hood River supports an isolated population of ESA listed bull trout. Three unique, valuable habitat areas were identified for restoration following the 1996 flood. They include an abandoned stream channel, a streamside rock quarry and adjacent road, and a stream channel with poor quality fish habitat. Total project length is about two miles.

- Smooth quarry floor to replicate stream terrace.
- Large wood placed & conifers planted throughout site.

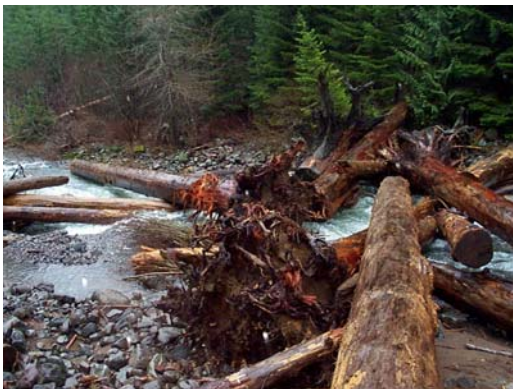
**Windfall Trees in Main Channel**

During the 1960's, Lake Branch Creek and its floodplain were "cleaned" of large wood. Over the decades, the stream channel has scoured and abandoned many side channels. Dominant stream substrate was gravel and is now boulder. After the February 1996 flood, several sites were identified for stream restoration. ESA listed steelhead occur in Lake Branch.

- Fell large (up to 60" diameter) roadside hazard trees and move to project sites.
- Construct multi-log mainstem and off-channel structures.
- Obliterate old skid road.
- Move 20 windfall trees with attached root wads to project site.
- Use the windfall trees to construct five complex stream structures.
