<b>Client Name:</b> Associated Electric Cooperative, Inc.	<b>Site Location:</b> Norborne, Missouri	<b>Project No.</b> 21561720.00200
--	---	--------------------------------------

*Preliminary Jurisdictional Report  
Carroll County, Missouri*

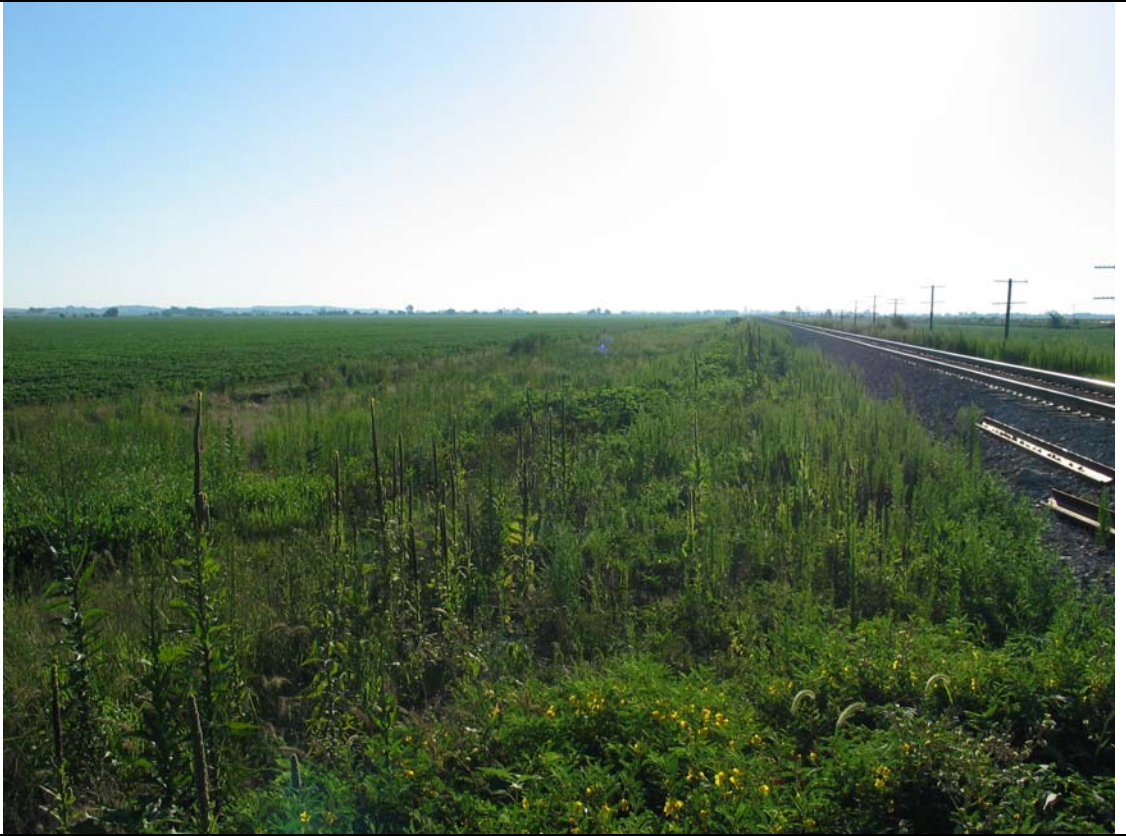
<b>Photo No.</b> <b>1</b>	<b>Date:</b> 8/1/06
<b>Description:</b>  From southwest corner of AECl property, looking east. Corridor of volunteer vegetation. Notice rail line on right side of photo.

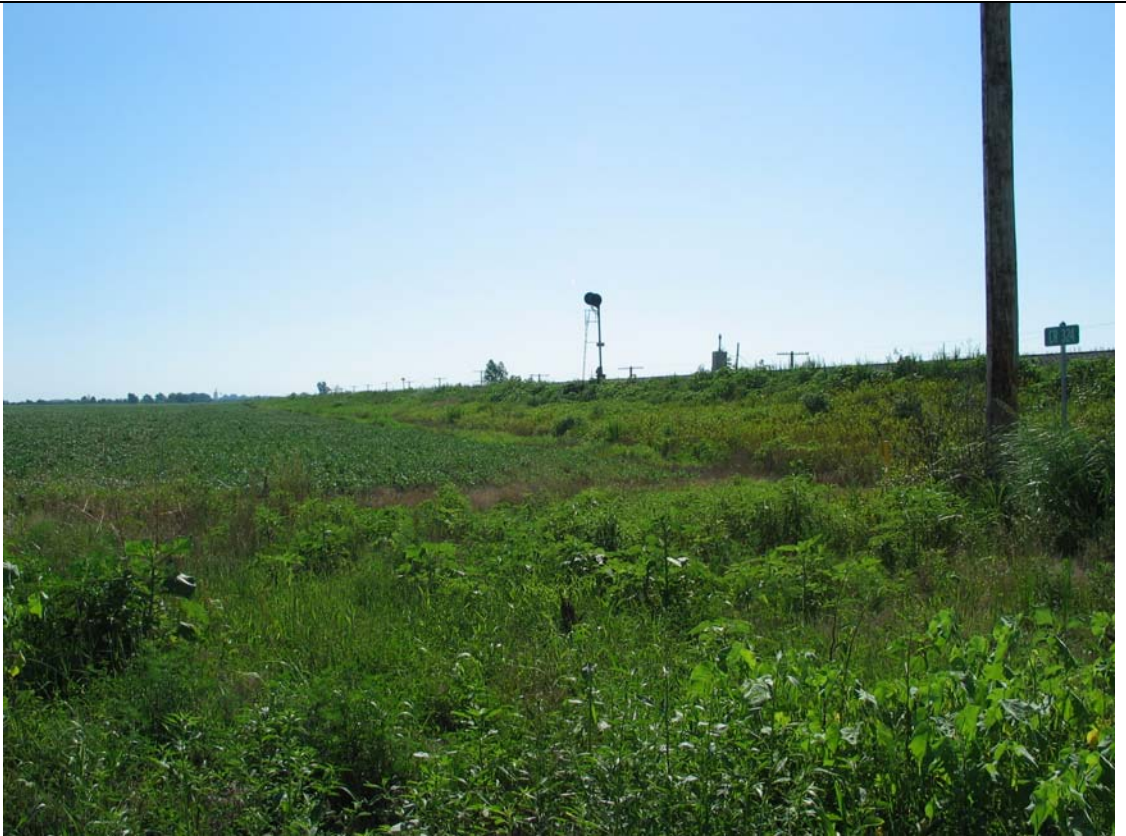
<b>Photo No.</b> <b>2</b>	<b>Date:</b> 8/1/06
<b>Description:</b>  From intersection of County Roads 111 and 324. Looking along north side of rail line.

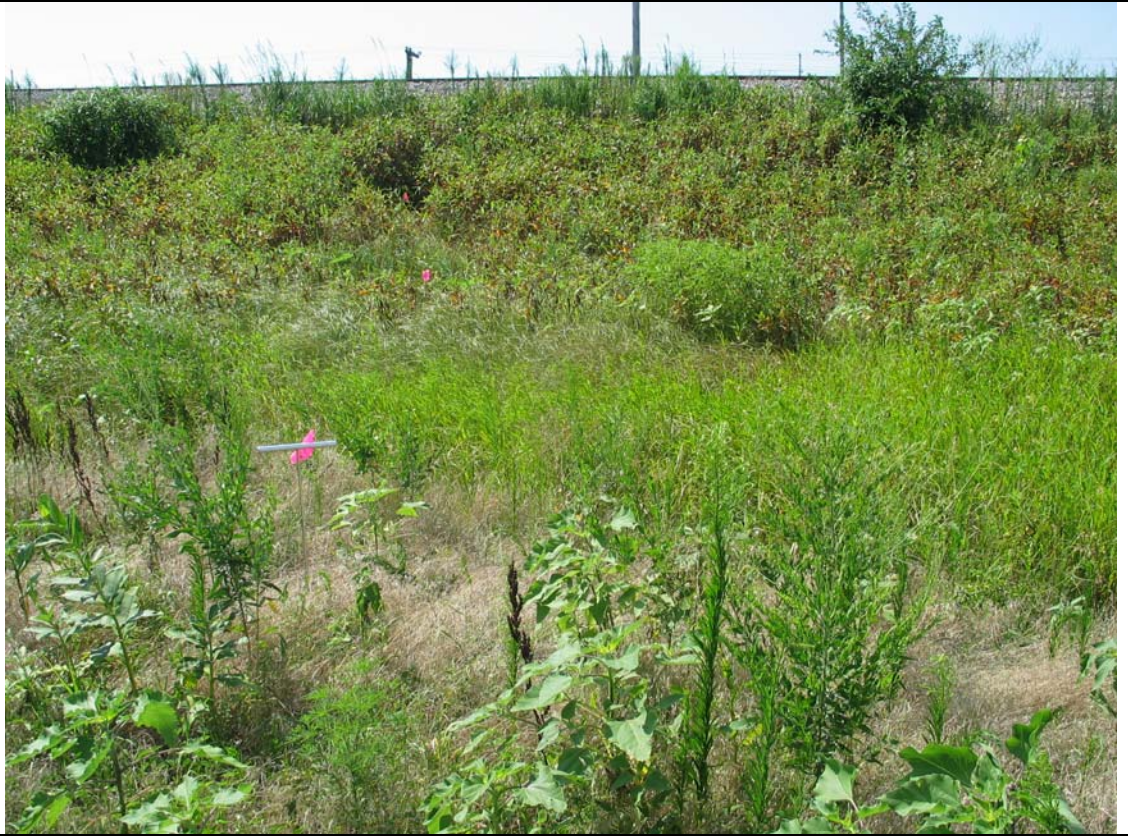
<b>Photo No.</b> <b>3</b>	<b>Date:</b> 8/1/06
<b>Description:</b>  Plot area 2. Plot 2A is nearest the railroad. Plot 2B is in the center and Plot 2C is nearest the roadway at the base of the photo.

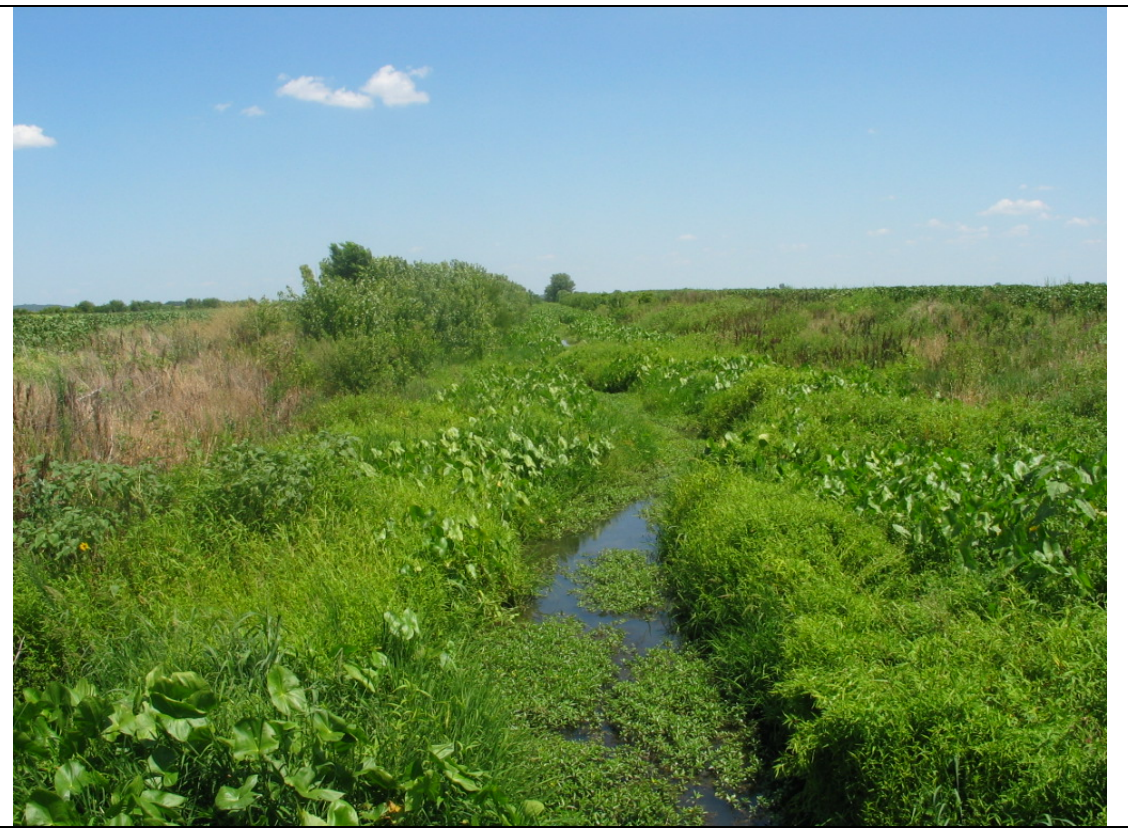
<b>Photo No.</b> <b>4</b>	<b>Date:</b> 8/1/06
<b>Description:</b>  From the intersection of County Road 103 and the north edge of the George Hale Trust property. Looking east at drainage ditch.

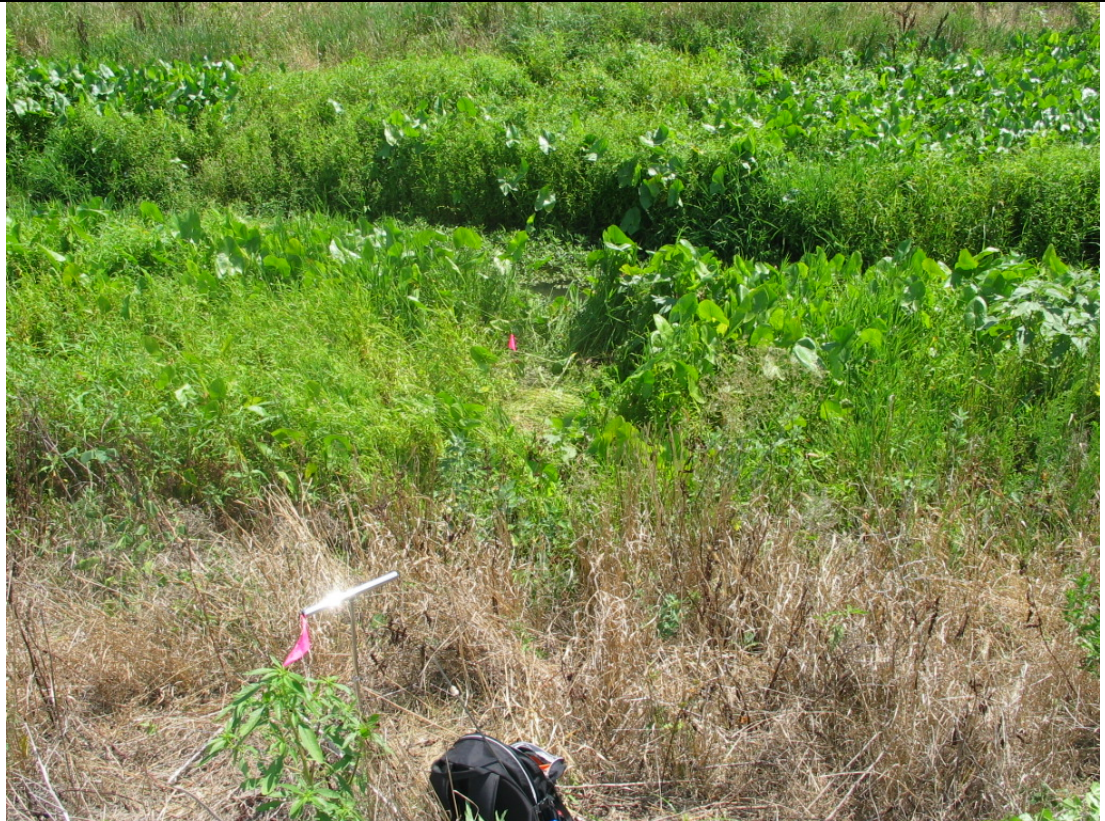
<b>Photo No.</b> <b>5</b>	<b>Date:</b> 8/1/06
<b>Description:</b>  Plot area 4. Plot 4A is upland and 4B is adjacent to the drainage ditch.

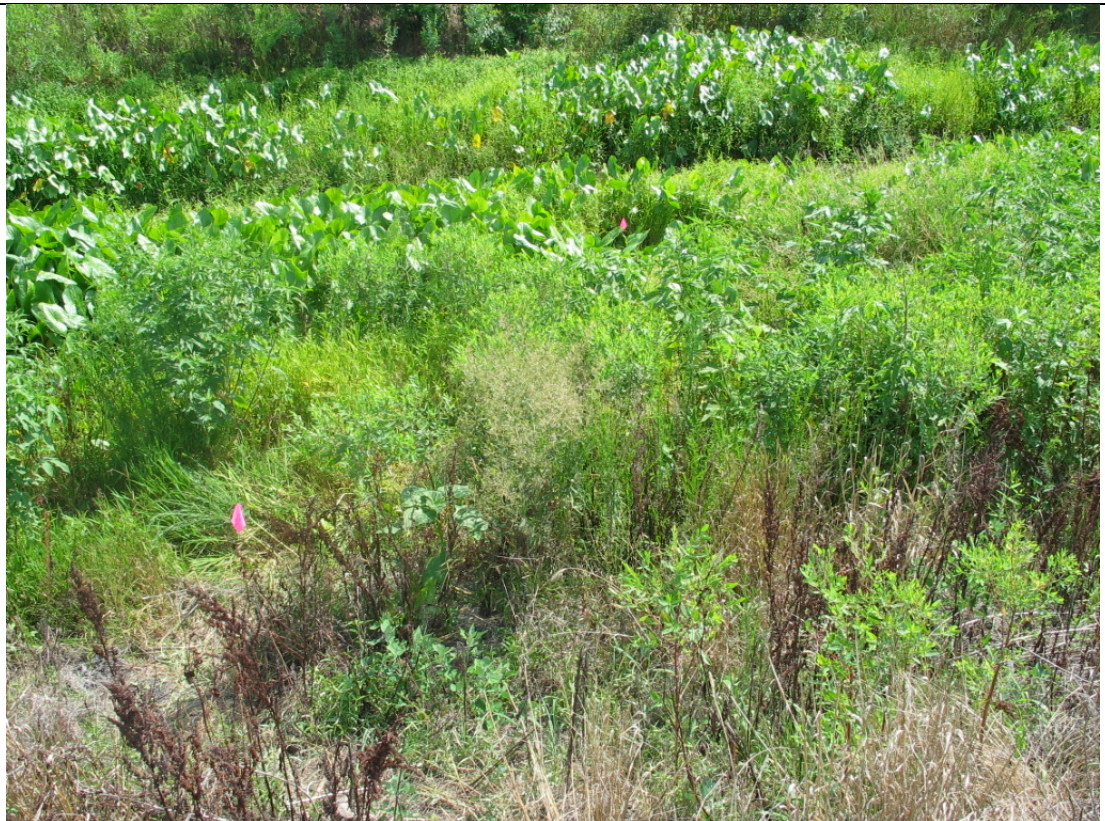
<b>Photo No.</b> <b>6</b>	<b>Date:</b> 8/1/06
<b>Description:</b>  Plot area 5. Plot 5A is upland and 5B is downland.

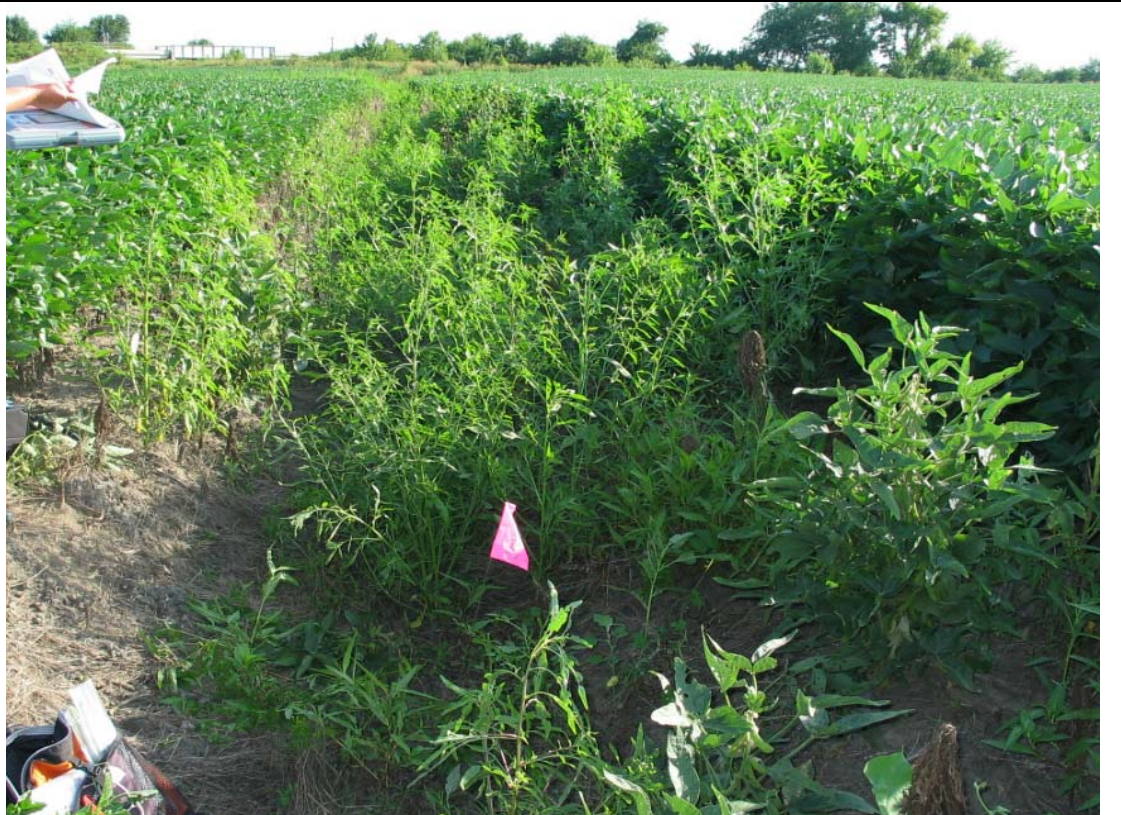
<b>Photo No.</b> <b>9</b>	<b>Date:</b> 8/1/06
<b>Description:</b>  Plot area 8. Looking south at ditch through soybean field.

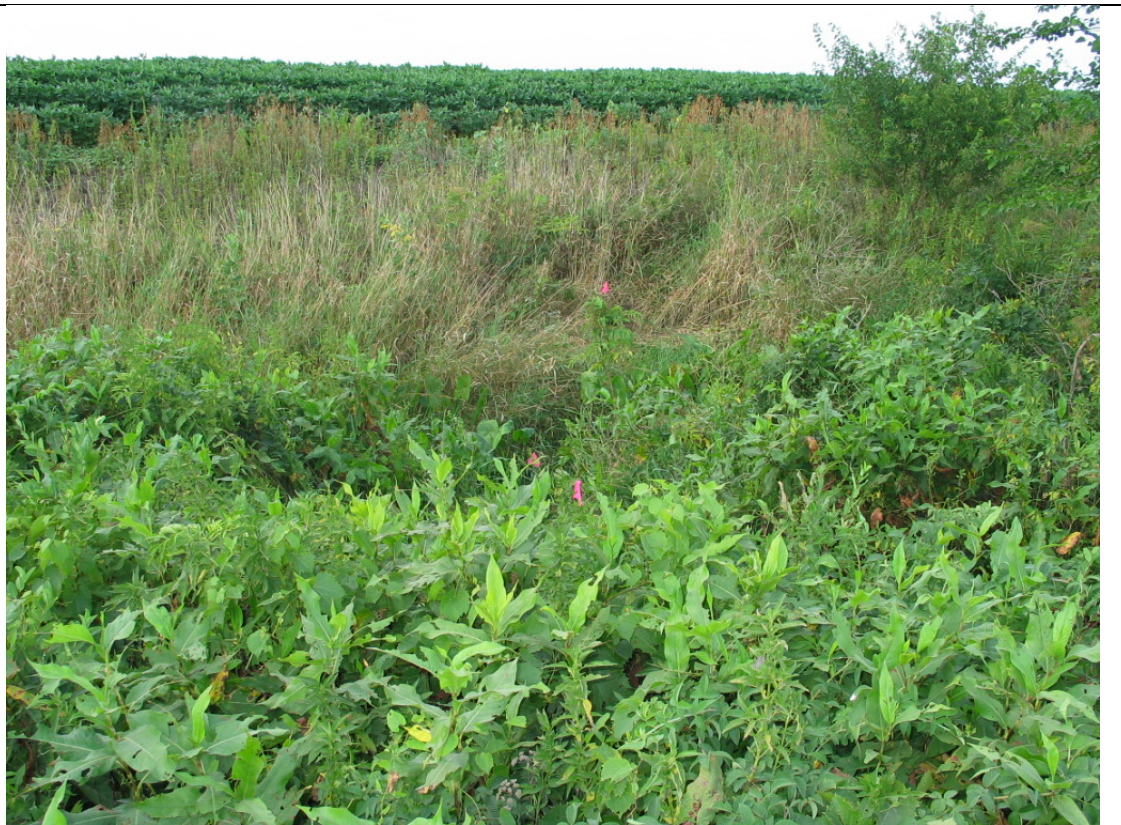
<b>Photo No.</b> <b>10</b>	<b>Date:</b> 8/2/06
<b>Description:</b>  Plot area 9. Looking south from County Road 300. Plot 9B is in the drainage ditch, with Plots 9A and 9C upland on either side of the ditch.

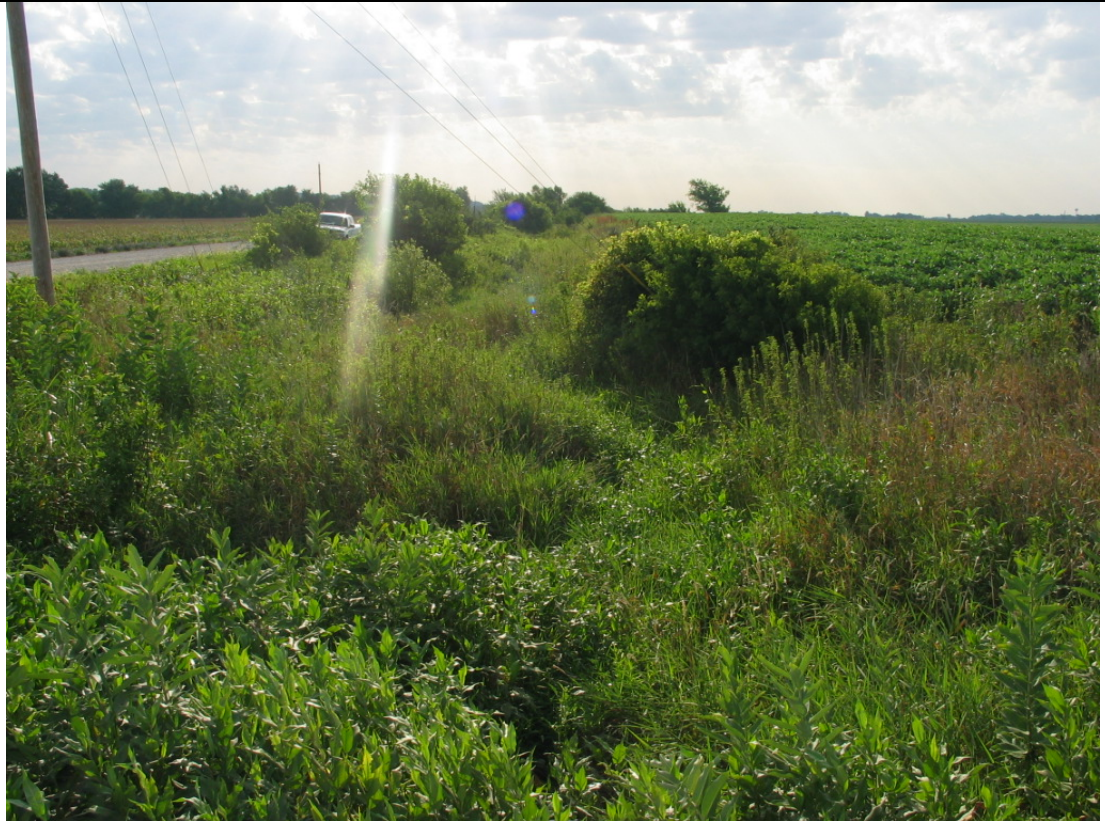
<b>Photo No.</b> <b>11</b>	<b>Date:</b> 8/2/06
<b>Description:</b>  Drainage ditch running parallel to County Road 300, immediately south of road. Photo taken from intersection of Road JJ and County Road 300, looking east. Culvert pipe runs under Road JJ.

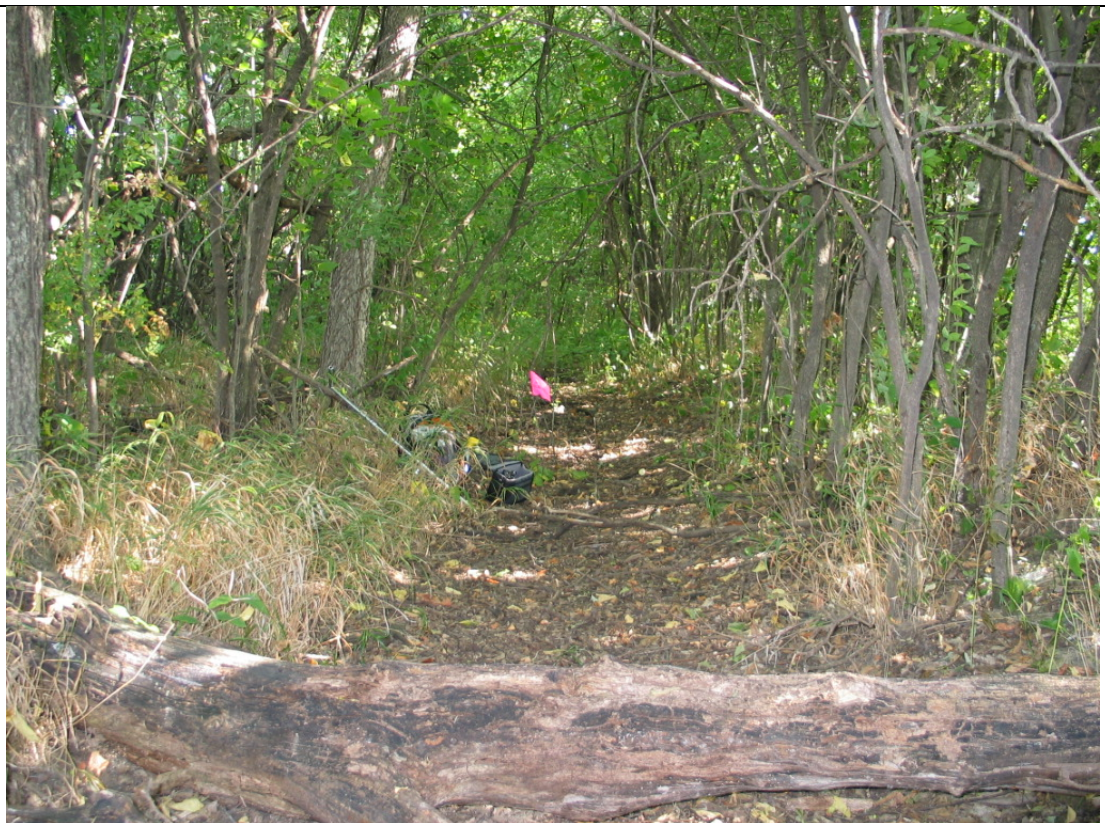
<b>Photo No.</b> <b>12</b>	<b>Date:</b> 8/2/06
<b>Description:</b>  Plot area 10. Looking north from center of drainage way. Plot 10B is within the drainageway. Plots 10A and 10C are on either side of the drainageway.

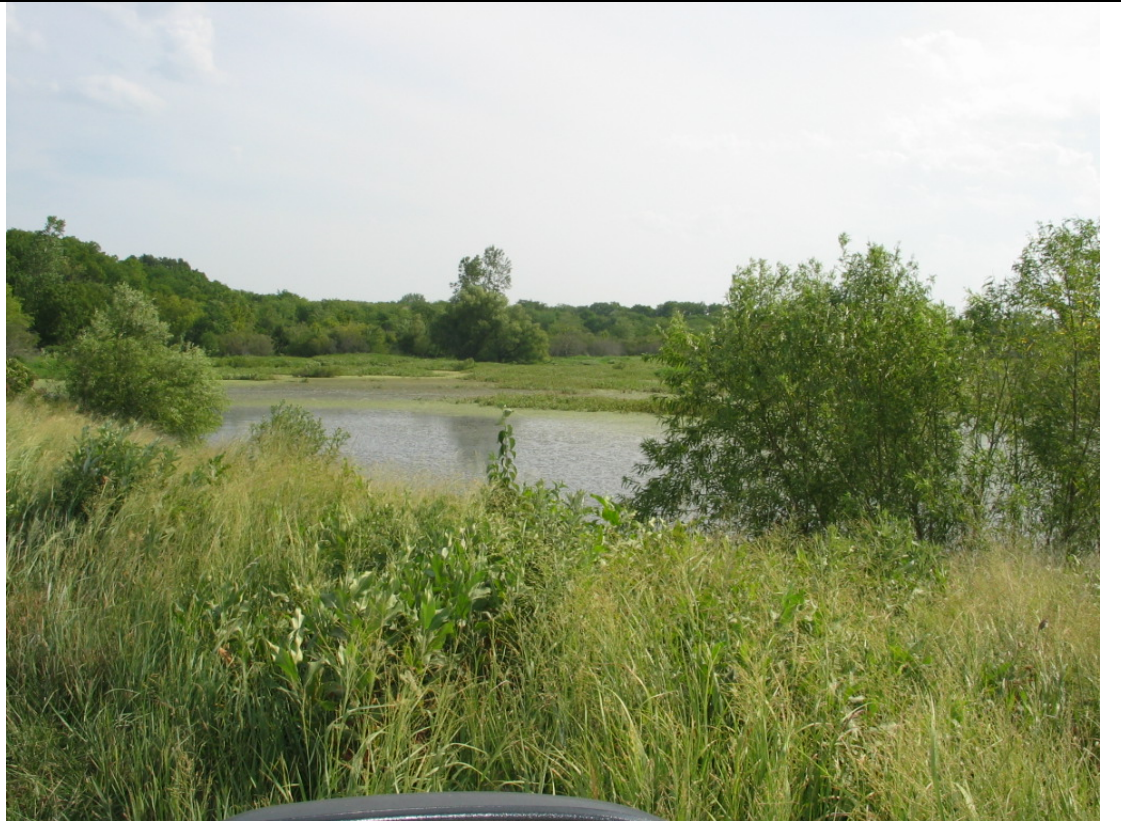
<b>Photo No.</b> <b>13</b>	<b>Date:</b> 8/2/06
<b>Description:</b>  Wet area immediately north of County Road 300. A pond lies west of this area. Appears that this area serves as an overflow for the pond to the west. Based on apparent hydrology and visual identification of species present along water's edge, wetland areas do exist here; however they were not field delineated, as this area appears to be outside of the facility property owned by AECL.

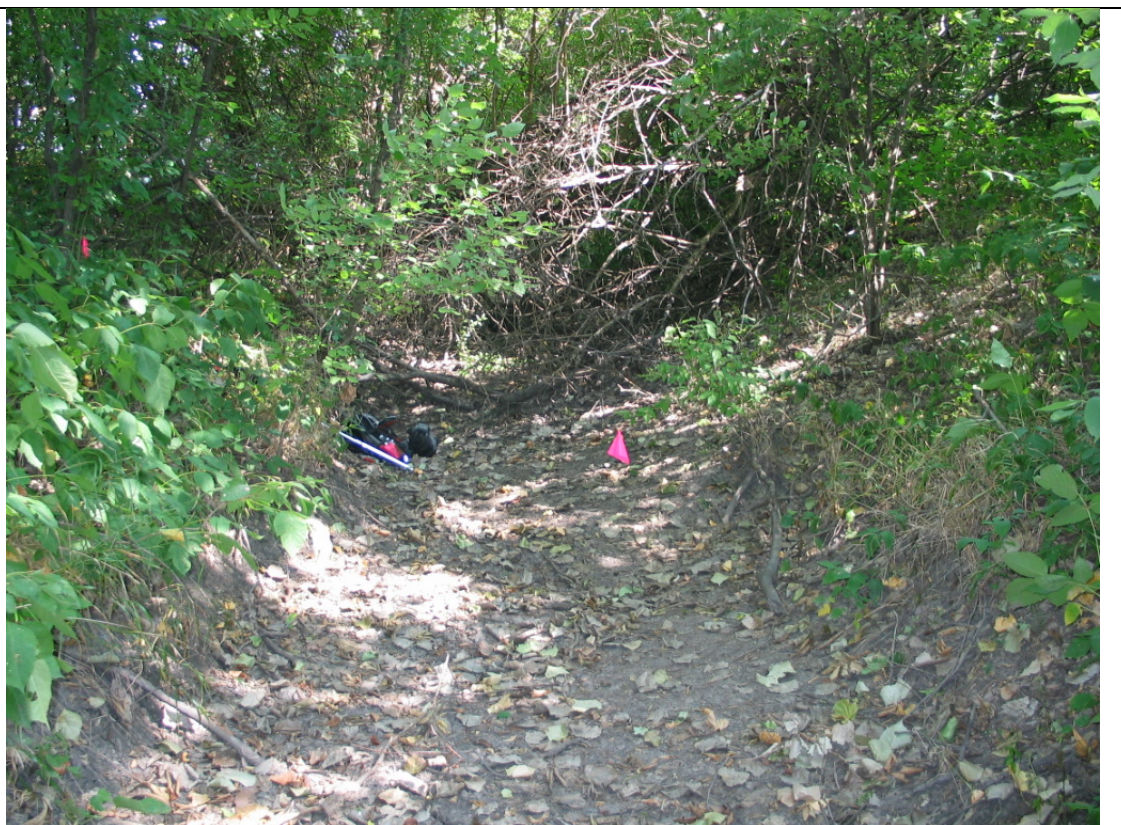
<b>Photo No.</b> <b>14</b>	<b>Date:</b> 8/2/06
<b>Description:</b>  Plot area 11. Standing in drainage way, looking north. Plot 11B is in drainage way, Plot 11A is to the east and Plot 11C to the west.

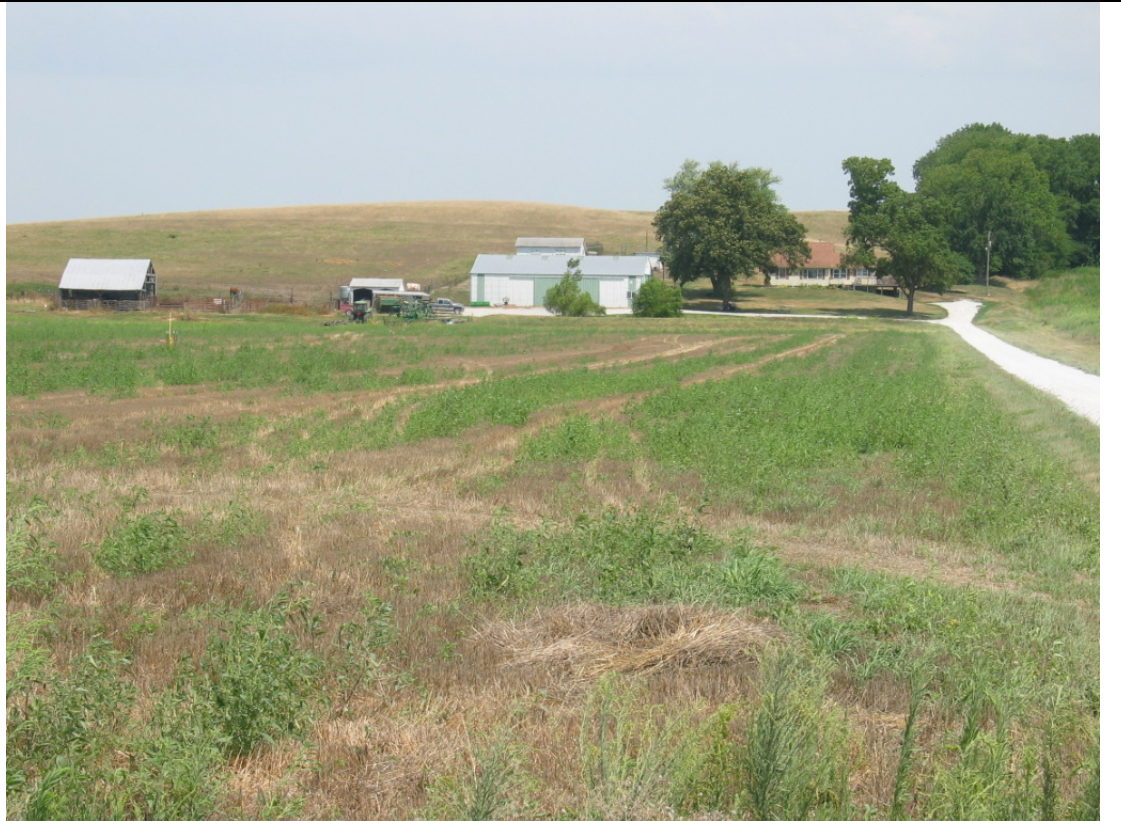
<b>Photo No.</b> <b>15</b>	<b>Date:</b> 8/2/06
<b>Description:</b>  Farmhouse, shed and pond on Randol Craig property. Looking north from County Road 300. Notice the topography beyond the house. This represents the southernmost extent of the upland topography in the study area.

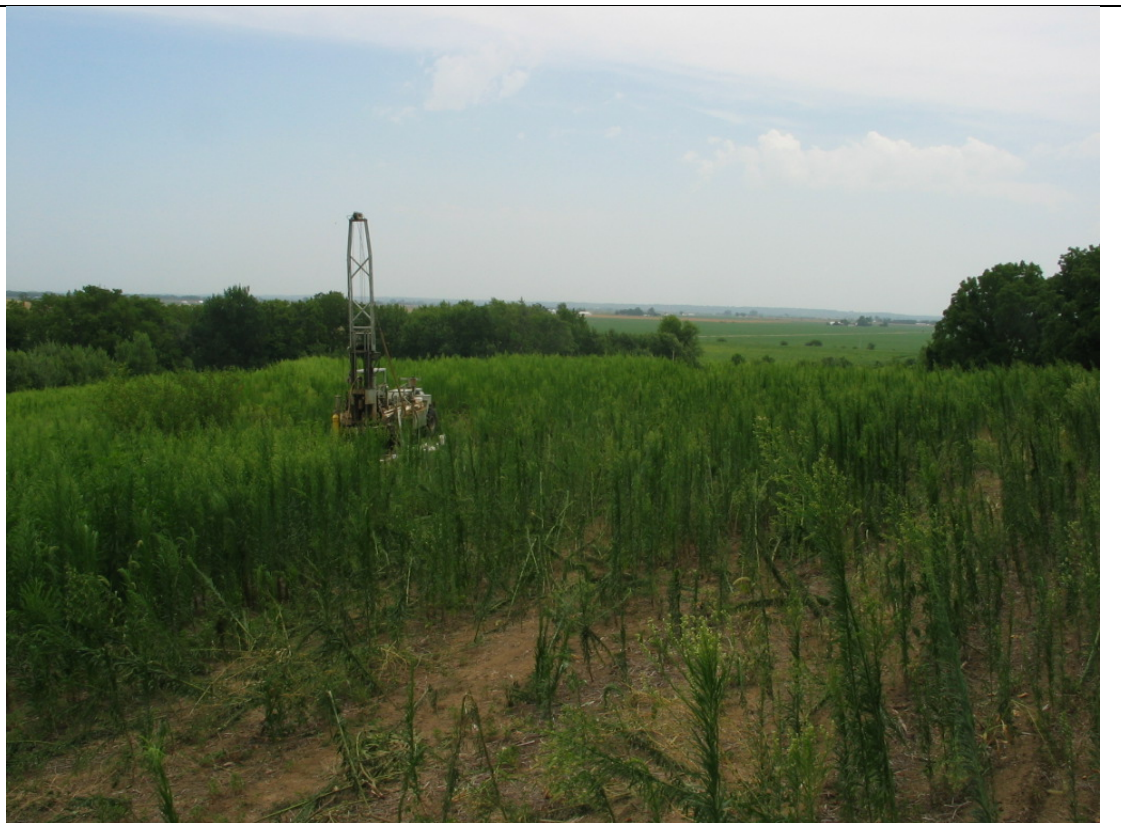
<b>Photo No.</b> <b>16</b>	<b>Date:</b> 8/2/06
<b>Description:</b>  From the northwest corner of the Kevin Edgar property, looking southeast. Looking over fallow field (appears it was formerly planted in corn). Some topography in area. Elevation dips to the east.

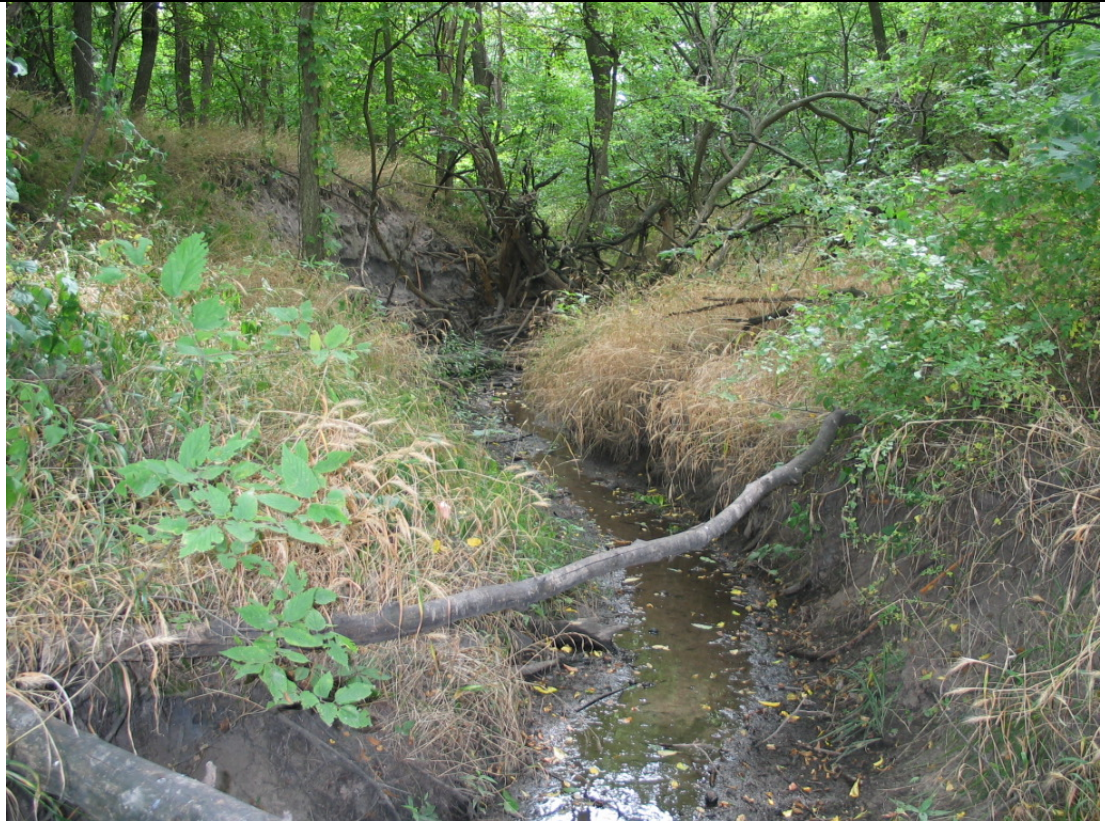
<b>Photo No.</b> <b>17</b>	<b>Date:</b> 8/2/06
<b>Description:</b>  Creek on the Kevin Edgar property. Standing at north property boundary where creek enters property, looking south. Notice the steep cut of the bank.

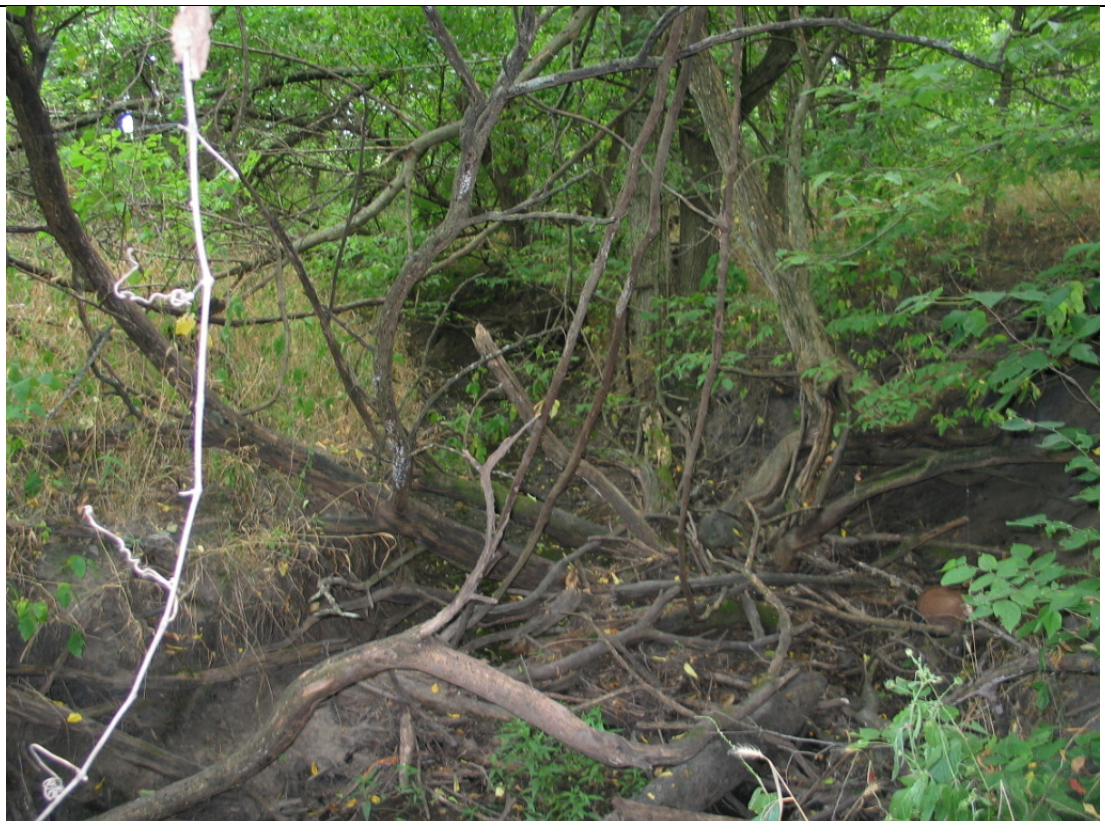
<b>Photo No.</b> <b>18</b>	<b>Date:</b> 8/2/06
<b>Description:</b>  Creek on the Kevin Edgar property. Further south of creek point pictured in Photo 17. Downed trees at various points of creek may impeded water flow, leading to some of the erosion/cutting observed along the bank. Advanced the soil probe at edge of the creek, at an elevation below opposite bank cut. Soils are hard and dry and do not appear hydric.

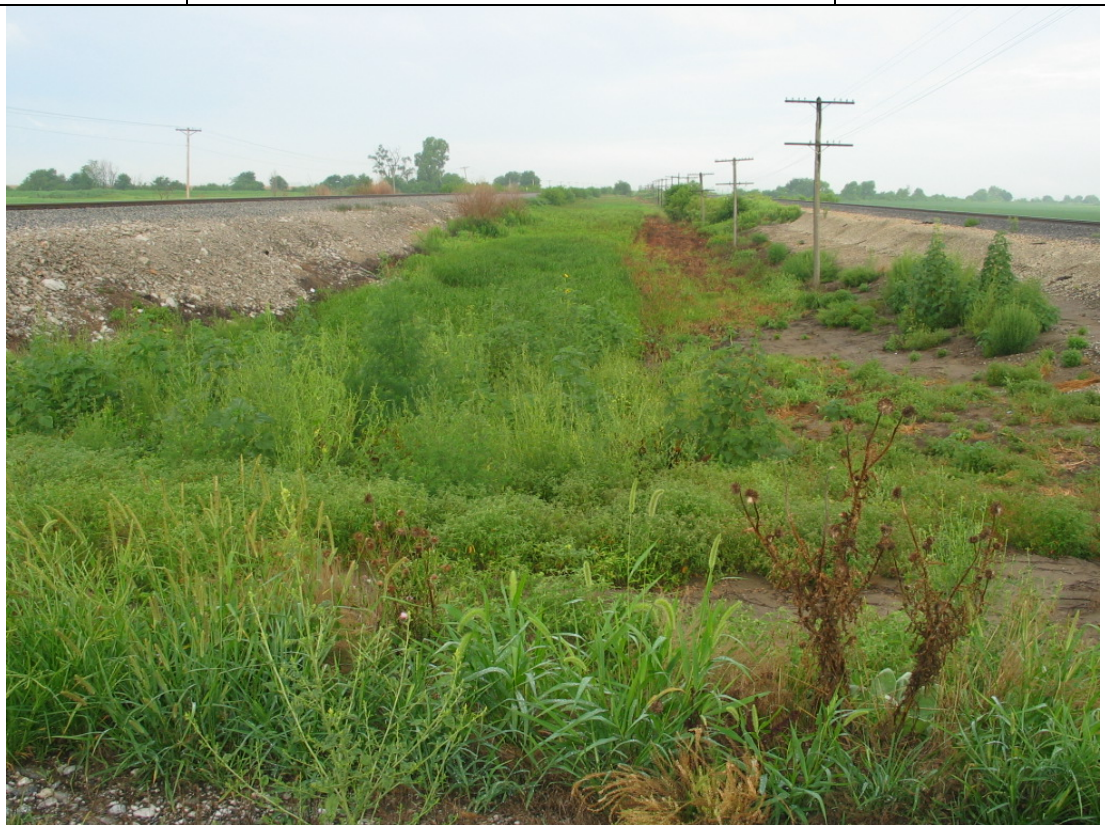
<b>Photo No.</b> <b>19</b>	<b>Date:</b> 8/3/06
<b>Description:</b>  From County Road 121, looking west. Area between Norfolk Southern railroad and Burlington Northern Santa Fe railroad. Notice gravel/rock sidings. Vegetation present (primarily volunteer species). Norborne drainage ditch transmits runoff water from north to waterways to south. The drainage ditch crosses through the area between the tracks. Note that this site is associated with one of the railroad connection alternatives and not the facility.

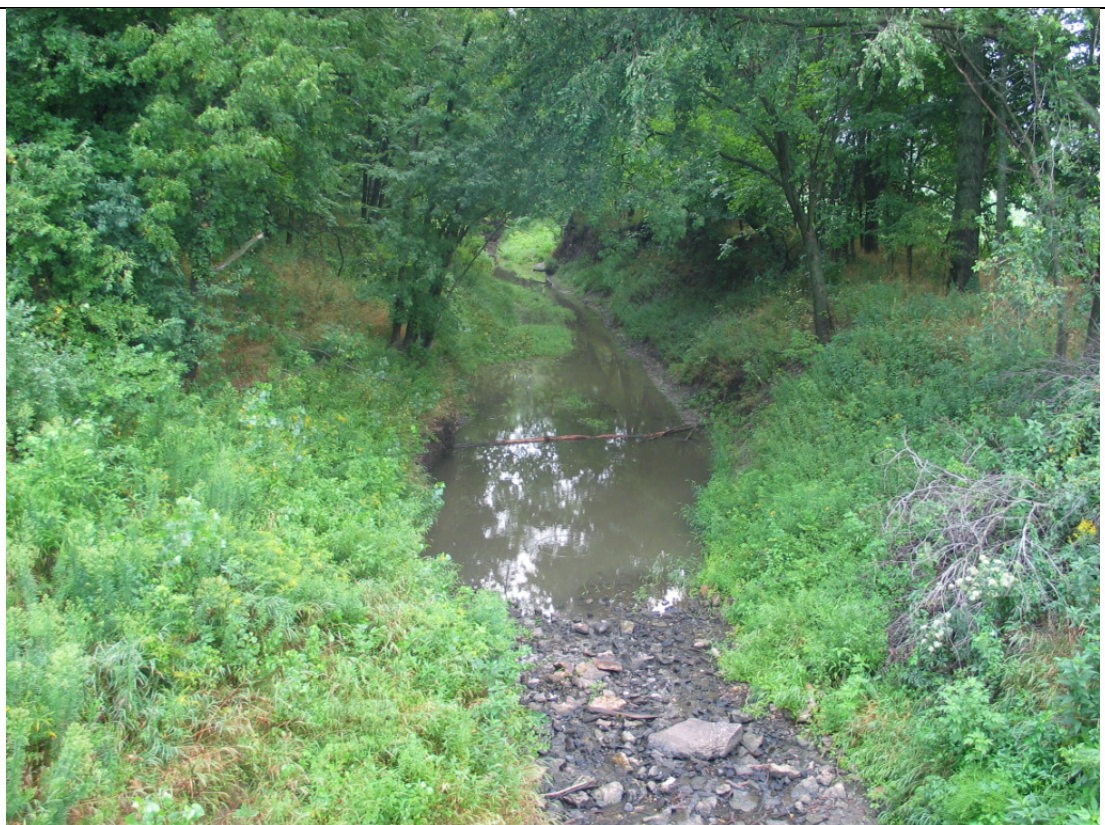
<b>Photo No.</b> <b>20</b>	<b>Date:</b> 8/3/06
<b>Description:</b>  Wakenda Creek West Fork. From County Road JJ crossing, looking east.

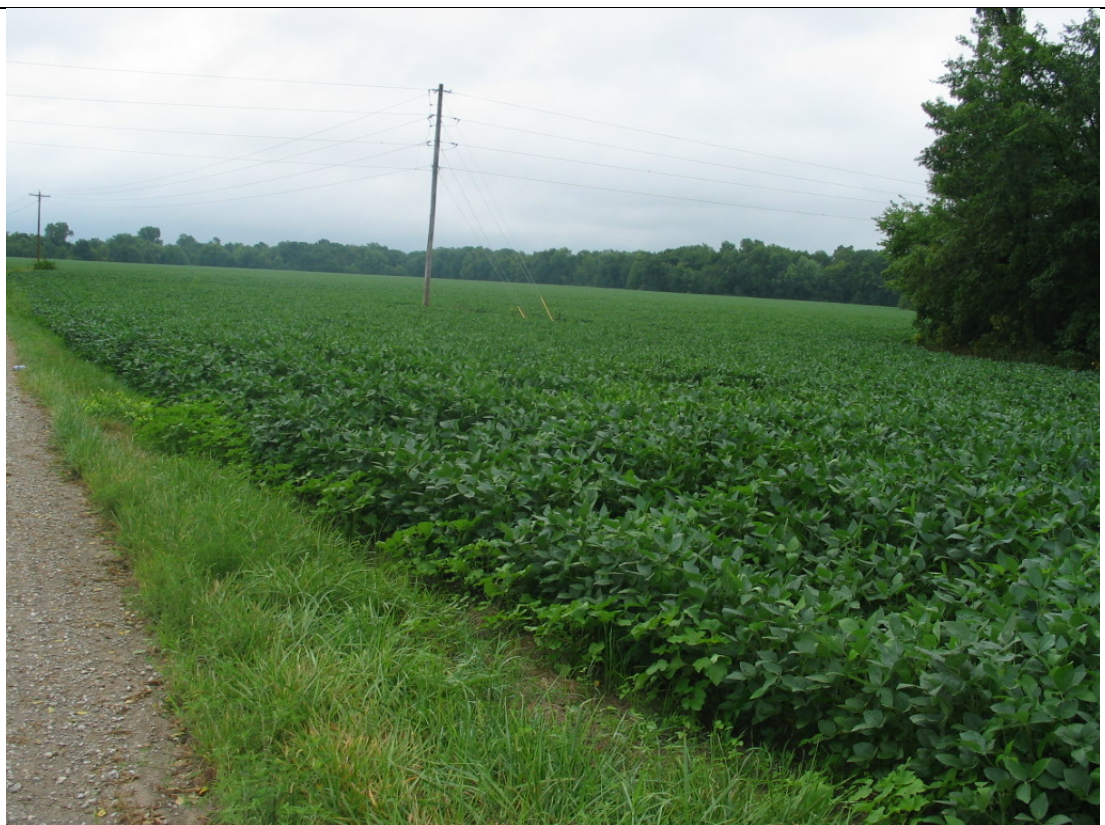
<b>Photo No.</b> <b>22</b>	<b>Date:</b> 8/3/06
<b>Description:</b>  From the intersection of County Roads 280 and JJ. Looking southeast at Section 4 R25W T52N. Tree line bisects this section.

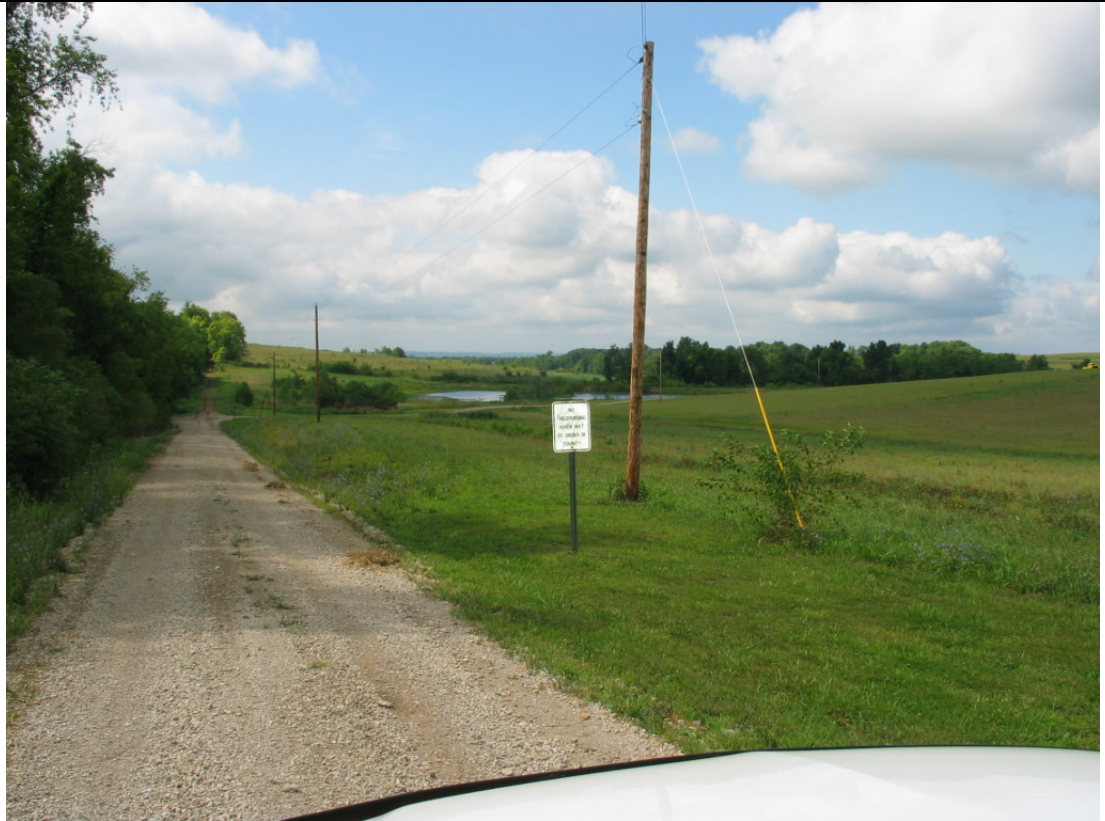
<b>Photo No.</b> <b>29</b>	<b>Date:</b> 8/3/06
<b>Description:</b>  From the intersection of County Roads 290 and 111. Looking southeast at Section 8 T52N R25W. Notice farm pond.

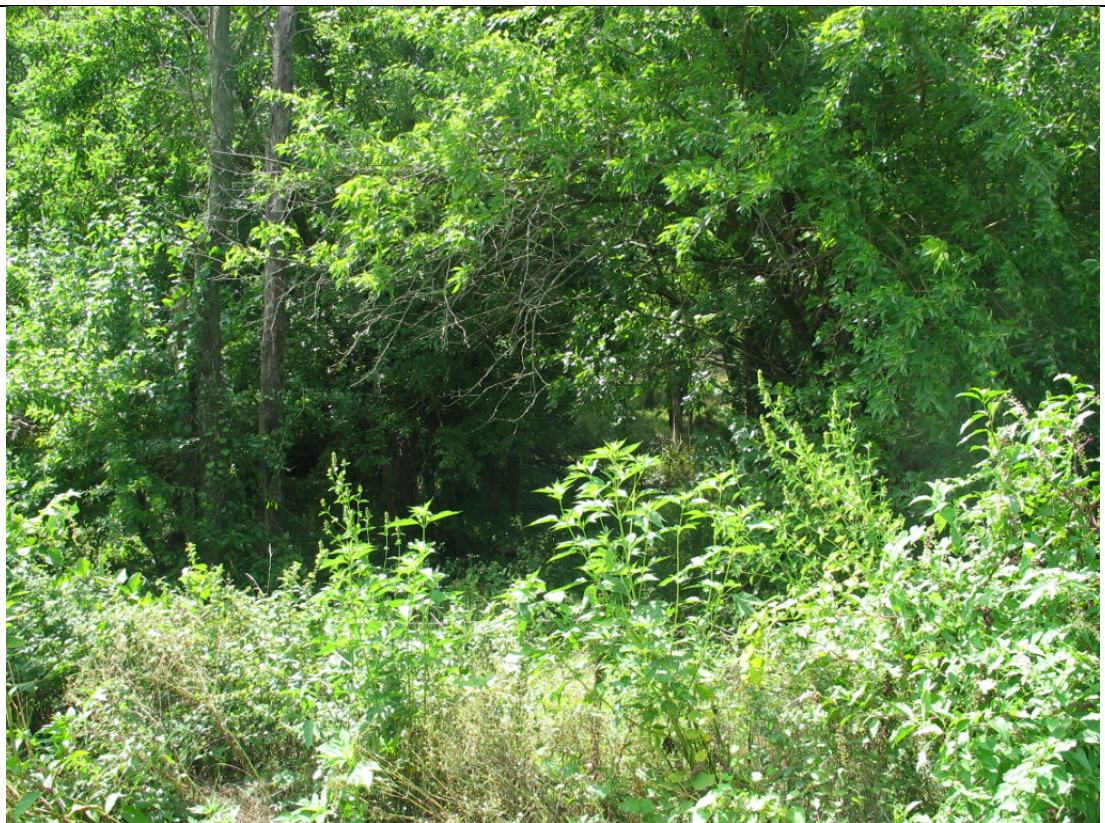
<b>Photo No.</b> <b>30</b>	<b>Date:</b> 8/3/06
<b>Description:</b>  Potential wooded wetland immediately south of County Road 290 between County Roads 111 and 121. This area represents a topographical low, vegetated and mapped drainage way.

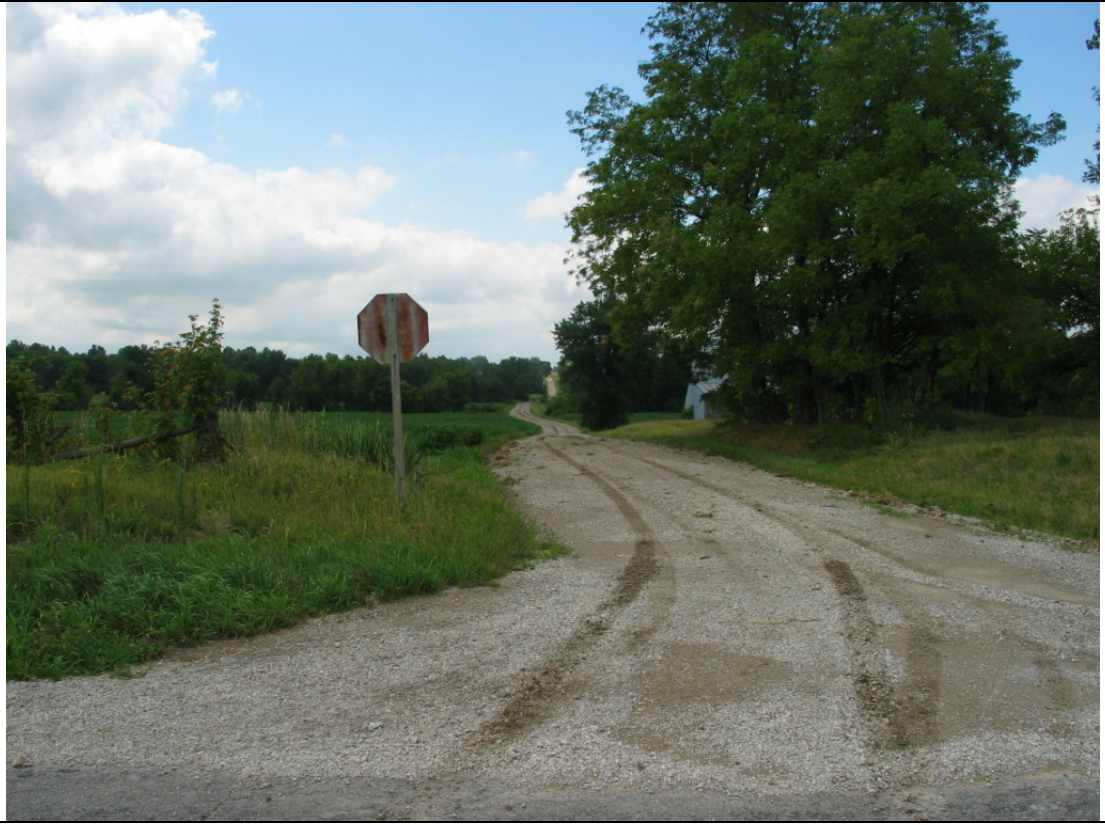
<b>Photo No.</b> <b>31</b>	<b>Date:</b> 8/3/06
<b>Description:</b>  From the intersection of County Roads JJ and 111. Looking south at Section 5 T52N R25W. Notice tree line in distance, this surrounds the Wakenda Creek West Fork.

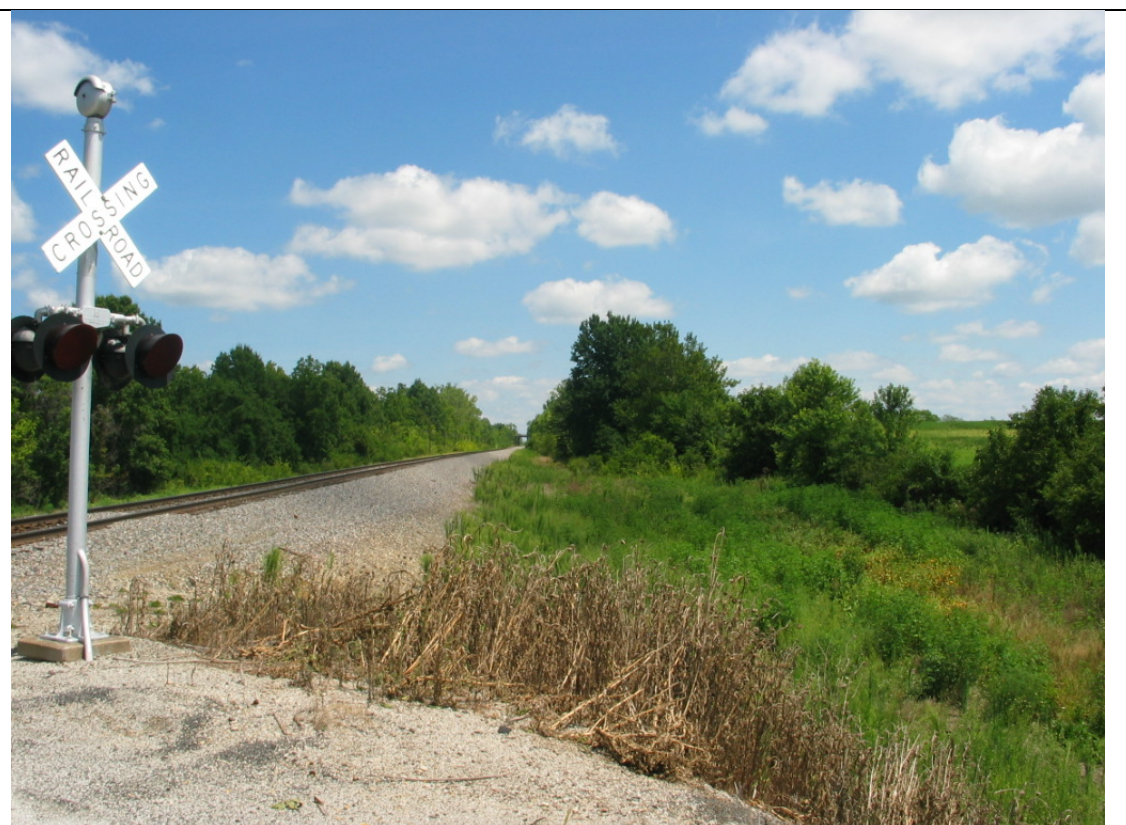
<b>Photo No.</b> <b>34</b>	<b>Date:</b> 8/3/06
<b>Description:</b>  Burlington Northern Santa Fe rail line. Looking east from Road A.
