<b>Client Name:</b> Associated Electric Cooperative, Inc.	<b>Site Location:</b> Norborne, Missouri	<b>Project No.</b> 21561720.00200
--	---	--------------------------------------

*Preliminary Jurisdictional Report  
Carroll County, Missouri*

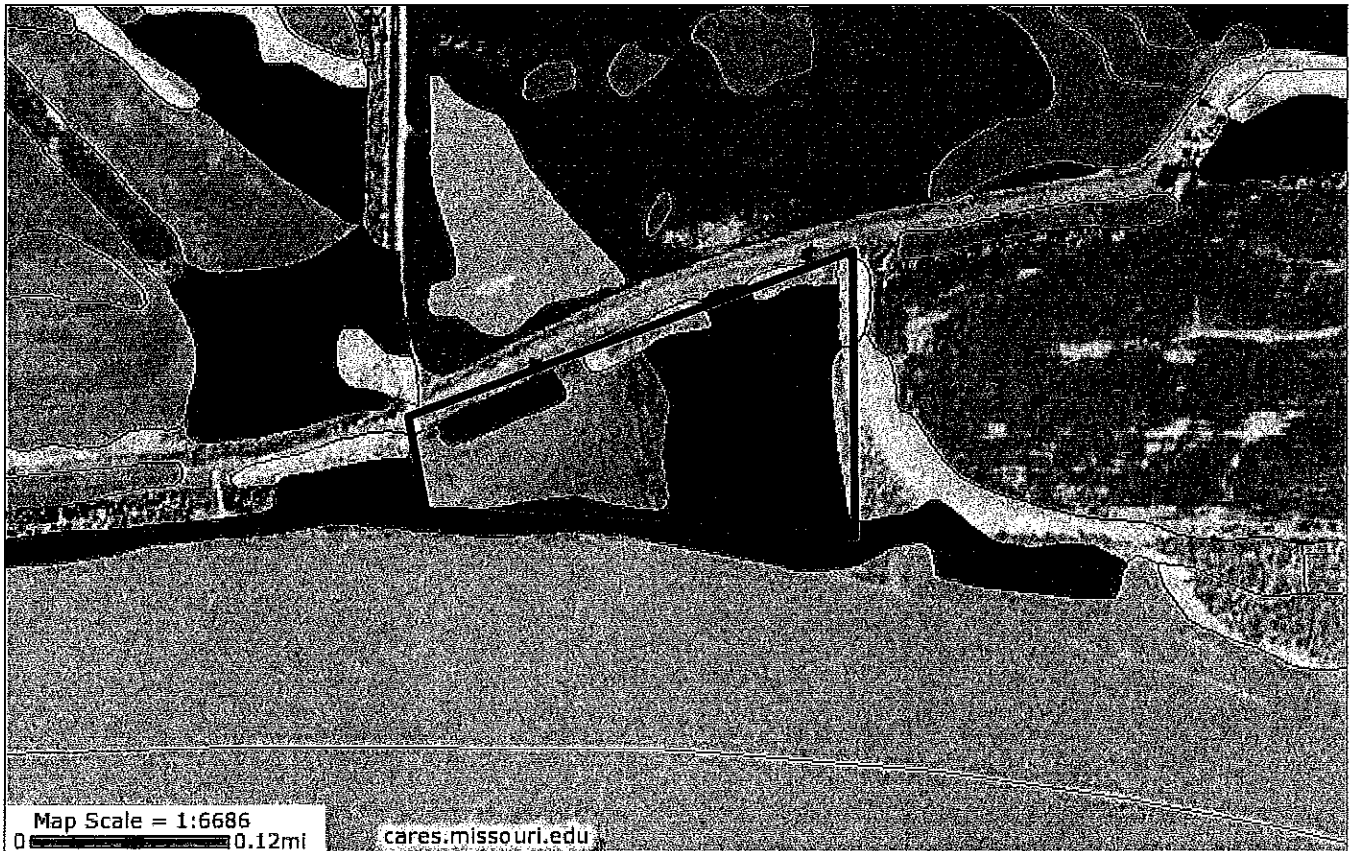
# Figure 4

Source: NWI Map, Carroll County, Missouri

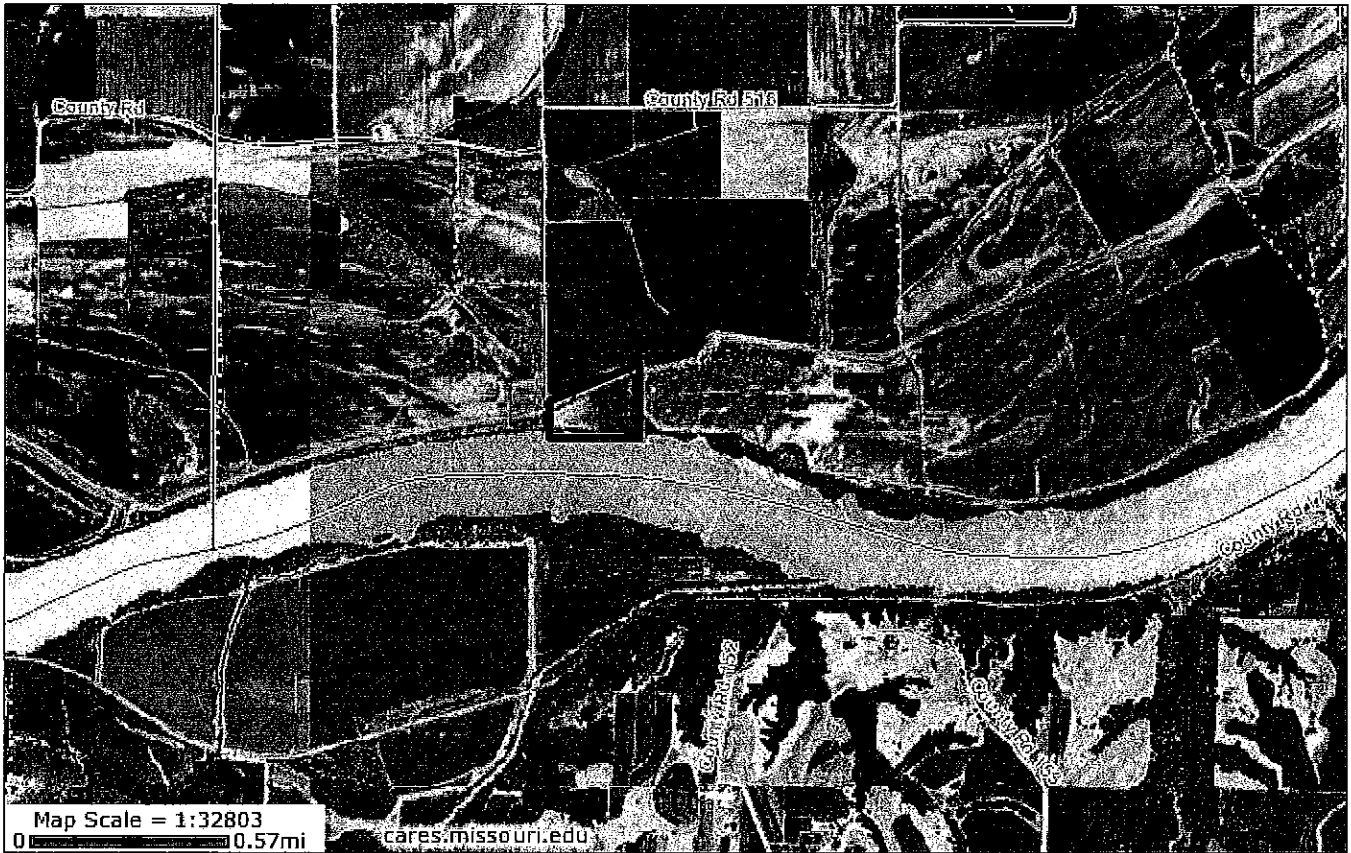
# Figure 5

Source: 2004 DOQQ, Carroll County, Missouri

An aerial photograph (source: 2004 DOQQs) is provided as Figure 5. Photo shows western half of project site as tilled cropland and the eastern half of the project site as forested. No wetland signatures are observed in the aerial photograph.

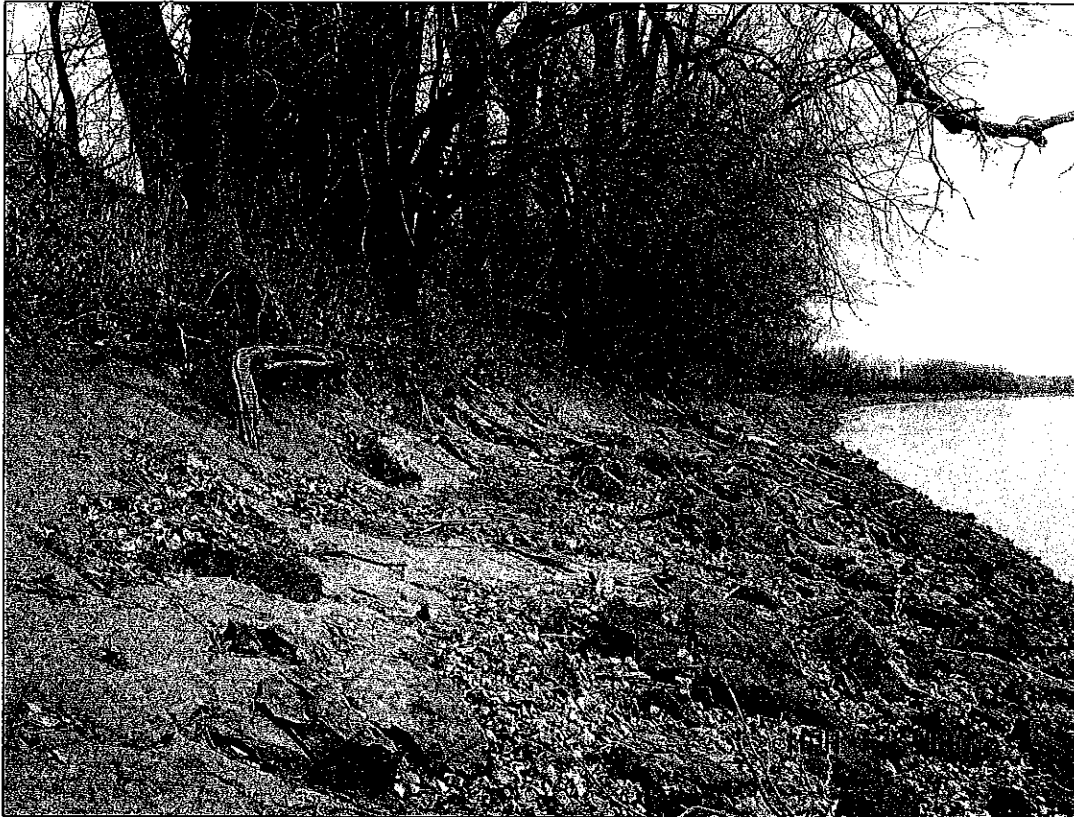
**Photo 5 – Left Bank of Missouri River**

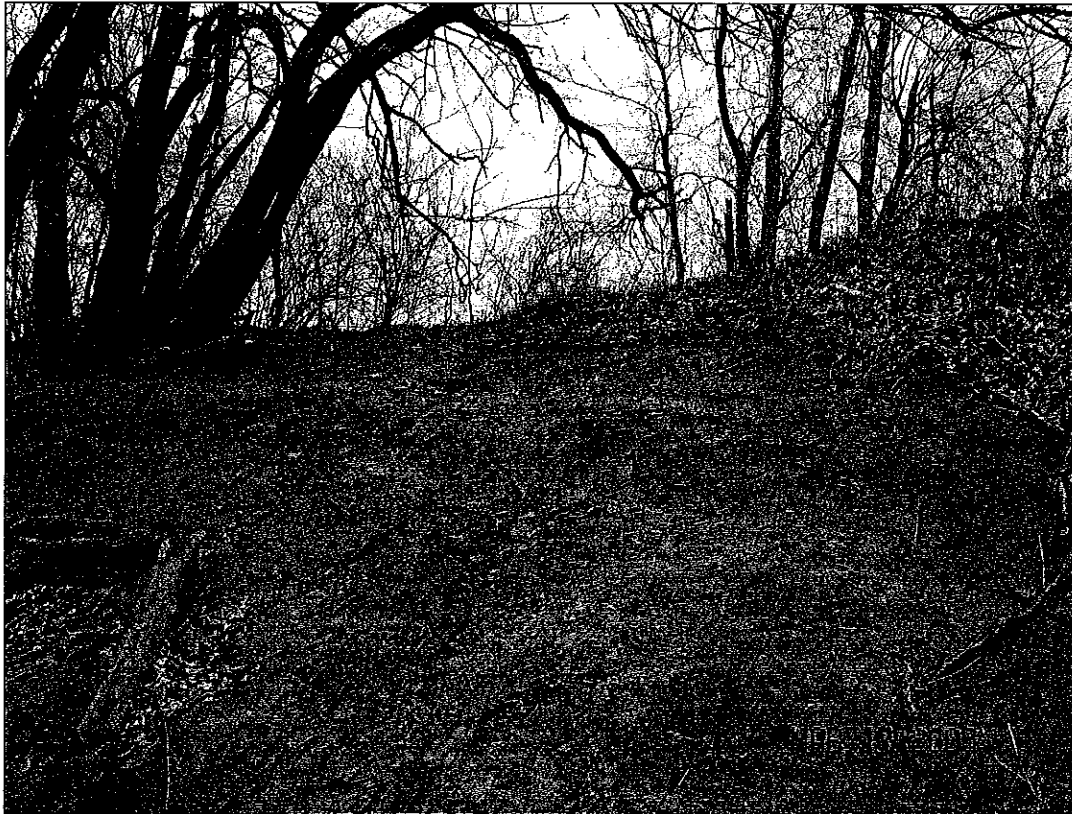
**Photo 6 – Haynie very fine sandy loam**
