## Cle Elum Dam Juvenile PIT Tag Fish Bypass System Report Storage Dam Fish Passage Study Yakima Project, Washington

**Technical Series No. PN-YDFP-004**

## CLE ELUM DAM JUVENILE PIT TAG FISH BYPASS SYSTEM REPORT

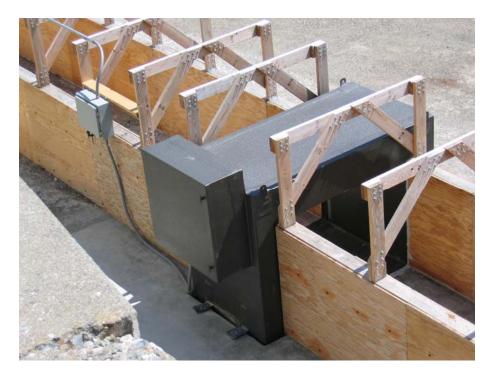
The PIT Tag detectors were installed May 9-12. Bureau of Reclamation personnel on site were: Wayland Huffines, John McCoy, Alan Heilberg, Phil Davis, and Shawn Rucker. The Biomark personnel on-site were Lance Batchelder and Sean Casey, with internal support provided by Brett Turley, Colby Blair, and Anthony Carson. Pictured below is the installation of a single antenna.

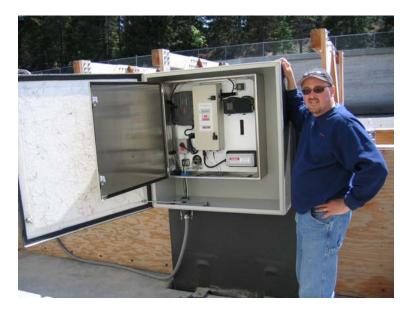
The Bureau of Reclamation decided to use the configuration 3 electronics package based on the performance lab testing at Biomark Inc. (reference the performance data at the top of page 4). In comparing the performance of the systems on-site, it was clear that the Multiplexer with autotuning did not offer the speed of detection as the FS1001A with the new analog board designed for large antenna applications. Therefore we installed the FS1001A system at both sites. Biomark did include DC power supplies that will be available for retro-fitting any new reader systems that may come online in the future or if it will be necessary to use a DC powered system at future sites were AC is not available. The electronics enclosure is pictured below.

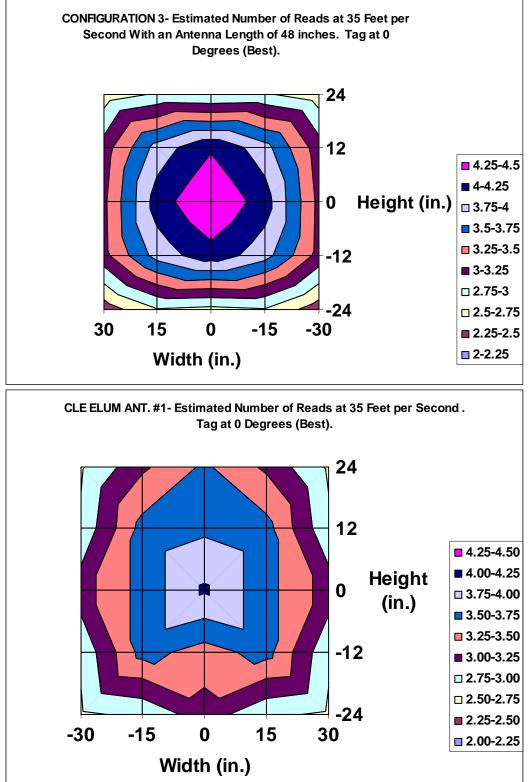
After the installation, the PIT tag systems were checked to determine if the performance in the field was similar to the estimates found in the lab at the Biomark facility in Boise. The field test was not comprised of as many data points as the lab test due to the amount of time that is necessary to take the matrix of data points and therefore does not appear as detailed as the lab data. The field results indicate a trend that the lower edge was slightly better and the center was slightly worse than in the lab. The actual difference is approximately one fourth of a read. Antenna #2 was slightly better with a maximum overall read range of 68 inches, compared to 64 inches for antenna

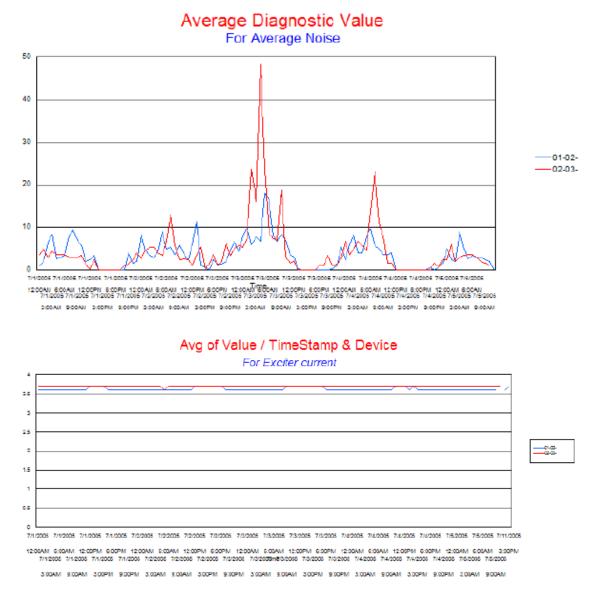
The above average noise graph demonstrates the fluctuation of noise as a function of time. In most cases the noise remains below 10% and is usually in the 5% range. With the implementation of one of the previously mentioned

The tuning of the systems are characterized in the second graph depicting the exciter current variations over time. The changes are .1 Amperes of peak to peak current which is the resolution of the ability of the reader to sense the current. It appears that the tuning is stable over this period of time.

One issue that Biomark Inc. will be addressing is the fact that the system we installed is sensitive to temperature variations. In order minimize this effect it is recommended that the system have a sun shield placed over the antenna assembly, implement increased ventilation, or retrofit the readers with new analog boards that are currently being evaluated at Bonneville Dam. Below is the diagnostic data taken from the reader after this year's fish test. A special thanks to John Tenney of Pacific States Marine Fisheries Commission for the software to reduce this data.

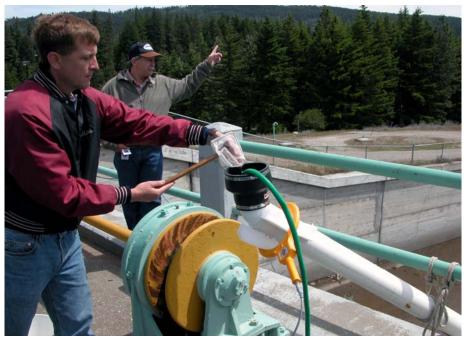
Mark Johnston placing PIT tagged fish into the release apparatus.

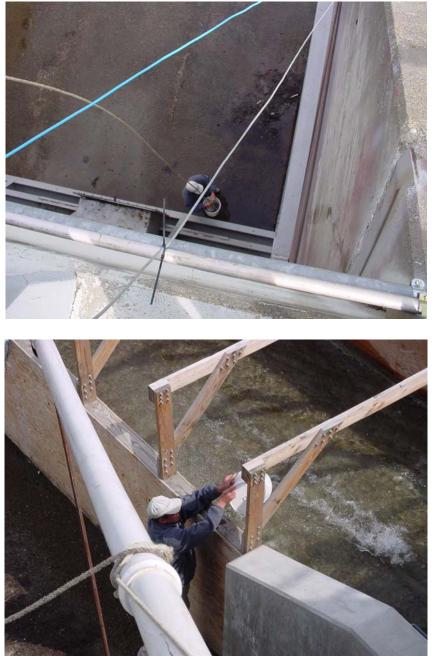
Larger groups of 10, 15, 20, 25, and 61 were released by lowering buckets of pre-scanned fish to the spillway floor and dumping them into the flume.

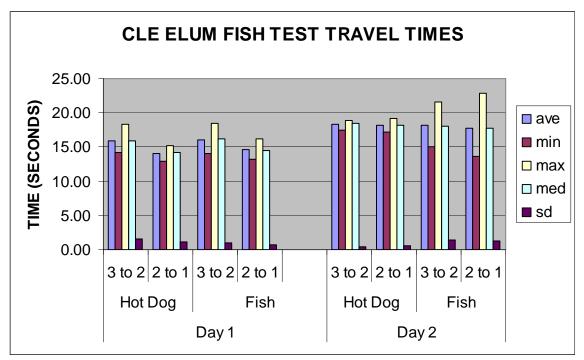
- 3 is the exit of the release tube
- 2 is the upstream antenna
- 1 is the downstream antenna
