Figures

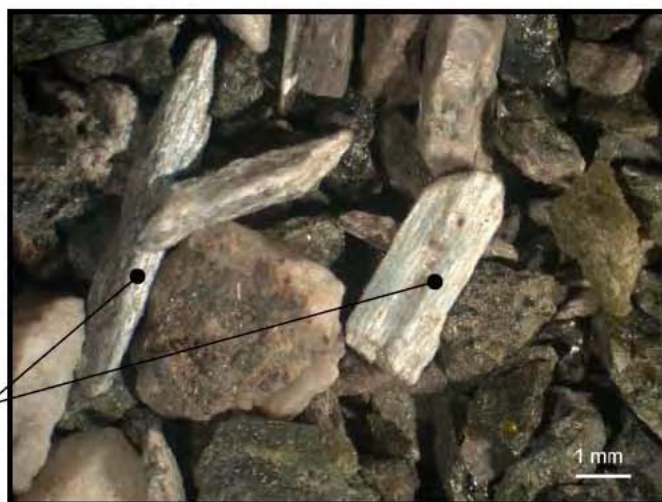
Figure 6. Waste rock

Waste rock from vermiculite exfoliation can look like other types of rock. The only way this waste rock could be present in your yard is if someone brought it there from a vermiculite processing plant in the past. This waste rock often contains visible “bundles” or blocky fragments of asbestos that are grayish-white and about the size of a grain of rice.

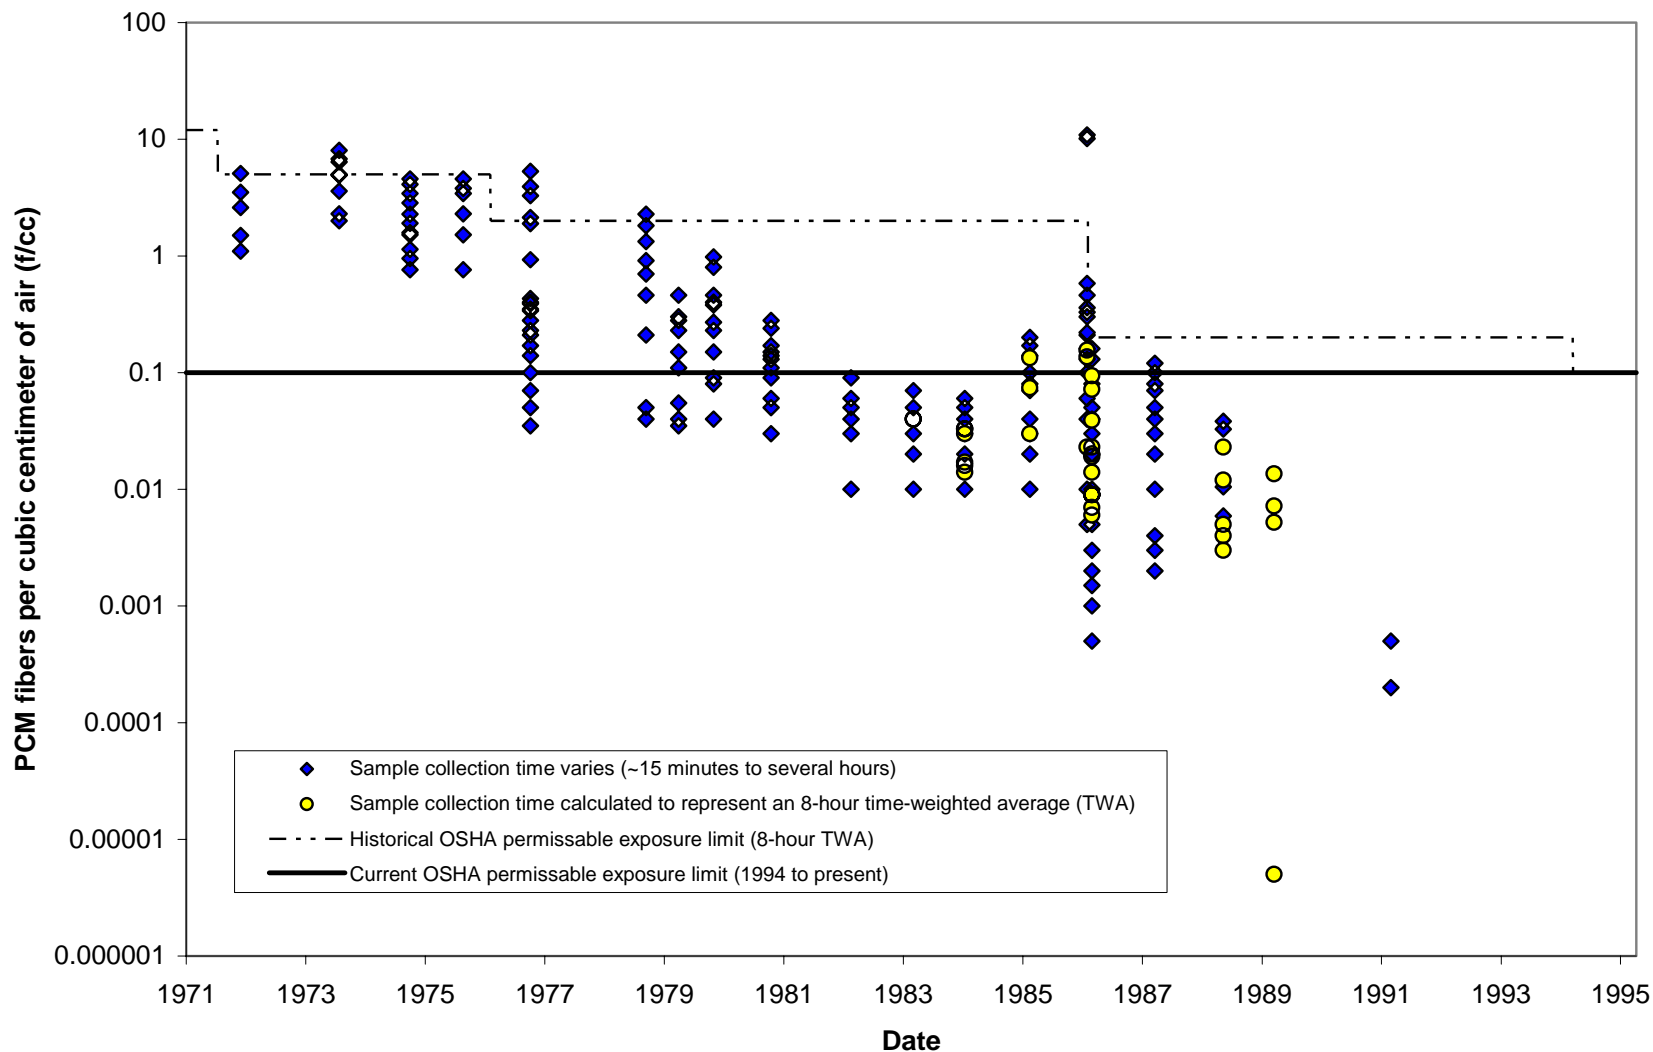
Figure 7. Airborne PCM fiber concentrations over time: personal sample data (N=286*) at the Texas Vermiculite/W.R. Grace Dallas facility, Dallas, Texas

* From W.R. Grace Industrial Hygiene Surveys, 1972–1991. Personal samples were collected within a worker’s breathing zone. Fiber concentrations were determined by phase contrast microscopy (PCM) using counting rules similar to NIOSH Method 7400.

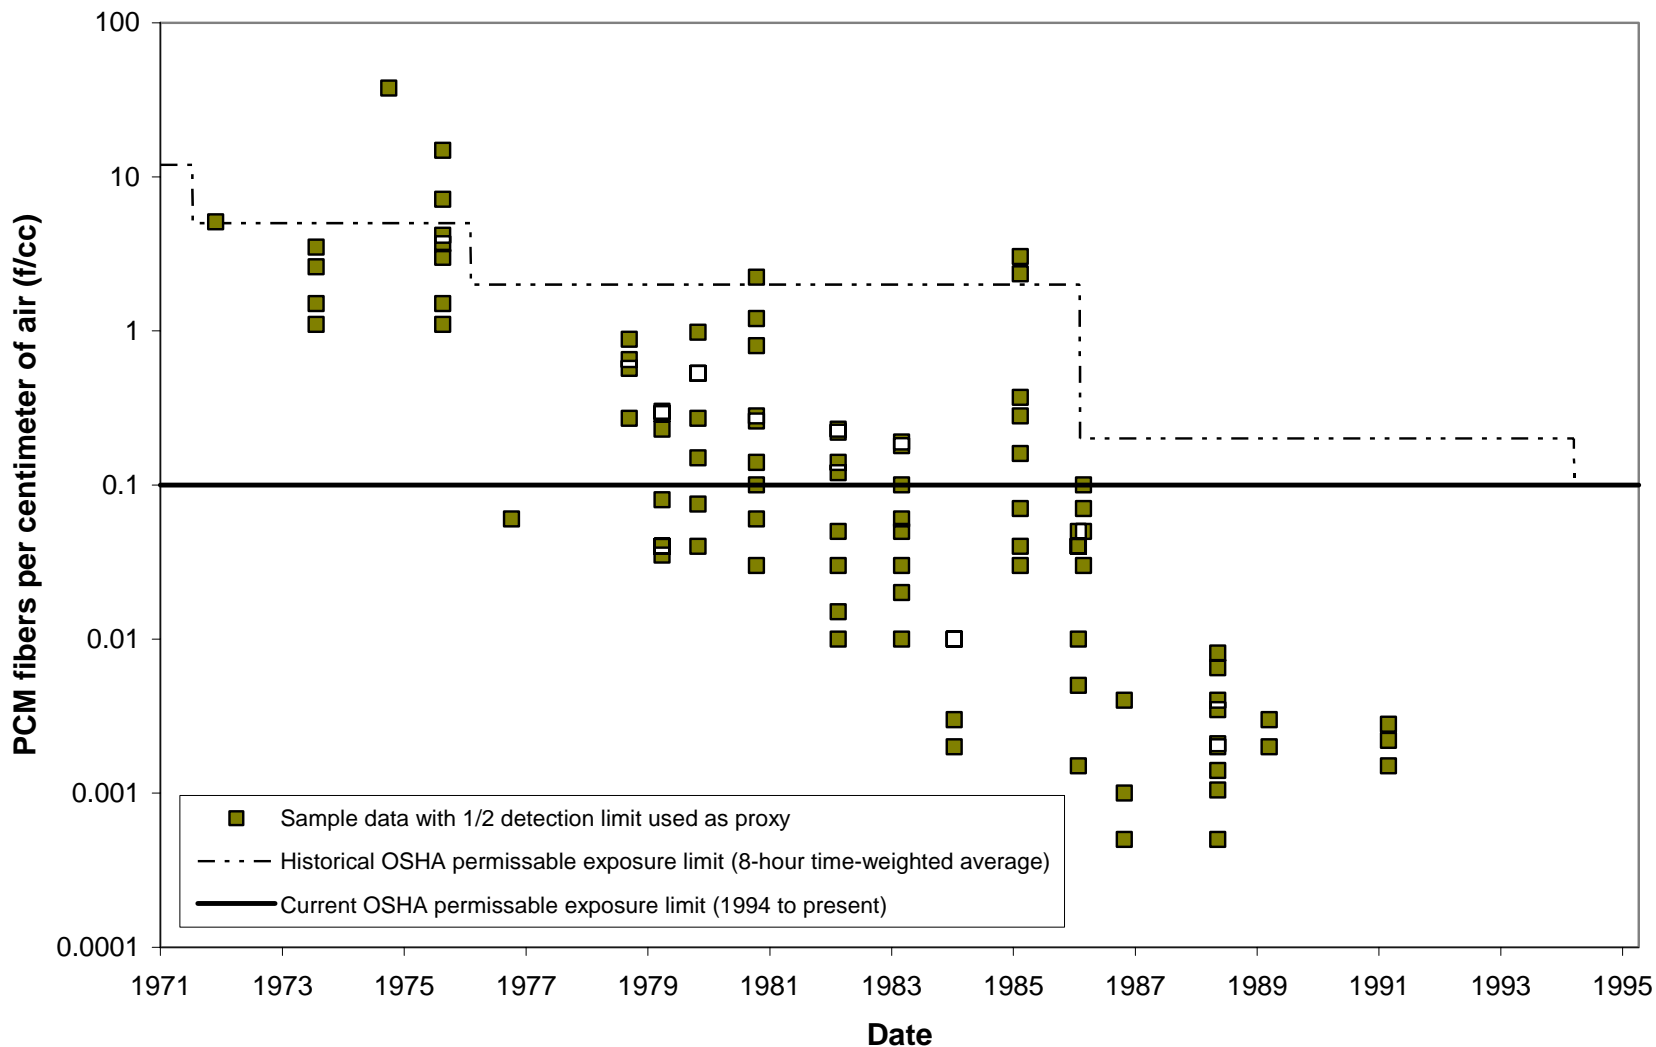
Figure 8. Airborne PCM fiber concentrations over time: area sample data (N=115*) at the Texas Vermiculite/W.R. Grace Dallas Plant, Dallas, Texas

* From W.R. Grace Industrial Hygiene Surveys, 1972–1991. Area samples were collected at various points around the processing equipment or other occupied spaces of the building. Fiber concentrations were determined by phase contrast microscopy (PCM) using counting rules similar to NIOSH Method 7400.
