# Landslide Response to Hurricane Mitch Rainfall in Seven Study Areas in Nicaragua

*Open-File Report 01-412-A*

*By Susan H. Cannon<sup>1</sup>, Kathleen M. Haller<sup>1</sup>, Ingrid Ekstrom<sup>1</sup>, Eugene S. Schweig III<sup>1</sup>,  
Graziella Devoli<sup>2</sup>, David W. Moore<sup>1</sup>, Sharon A. Rafferty<sup>1</sup>, and Arthur C. Tarr<sup>1</sup>*

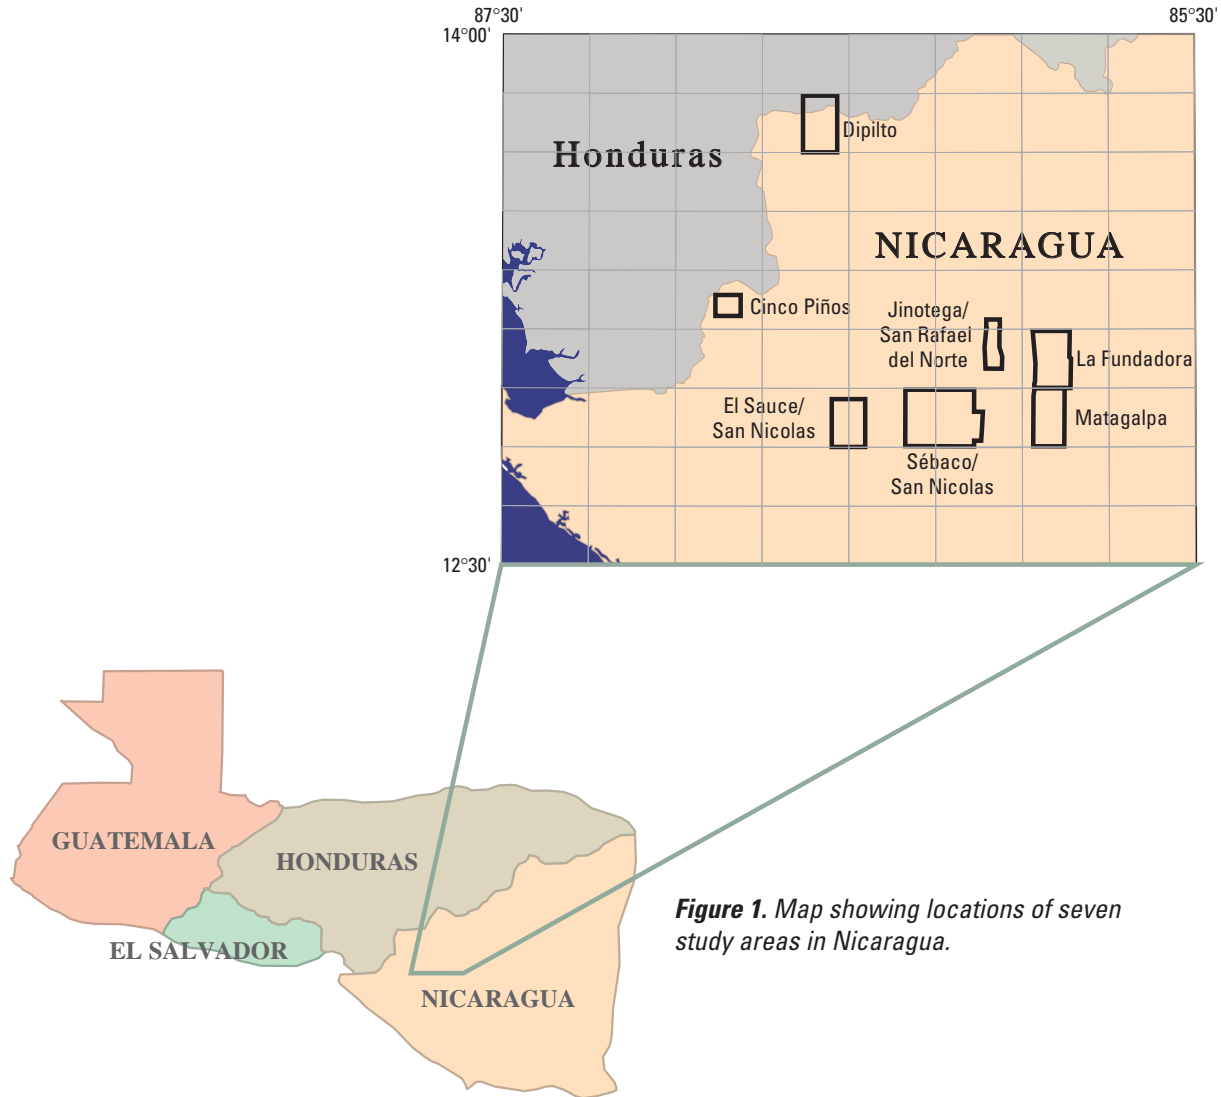
**Figure 1.** Map showing locations of seven study areas in Nicaragua.

**Purpose and Approach:** The passage of Hurricane Mitch through Central America in October and November of 1998 caused widespread and devastating flooding and landsliding. In this work we document the landslide response to the rainfall that accompanied Hurricane Mitch in Nicaragua. We generated 1:50,000-scale maps for seven study areas located throughout Nicaragua that show the areas impacted by landslides and related downchannel effects (fig. 1).

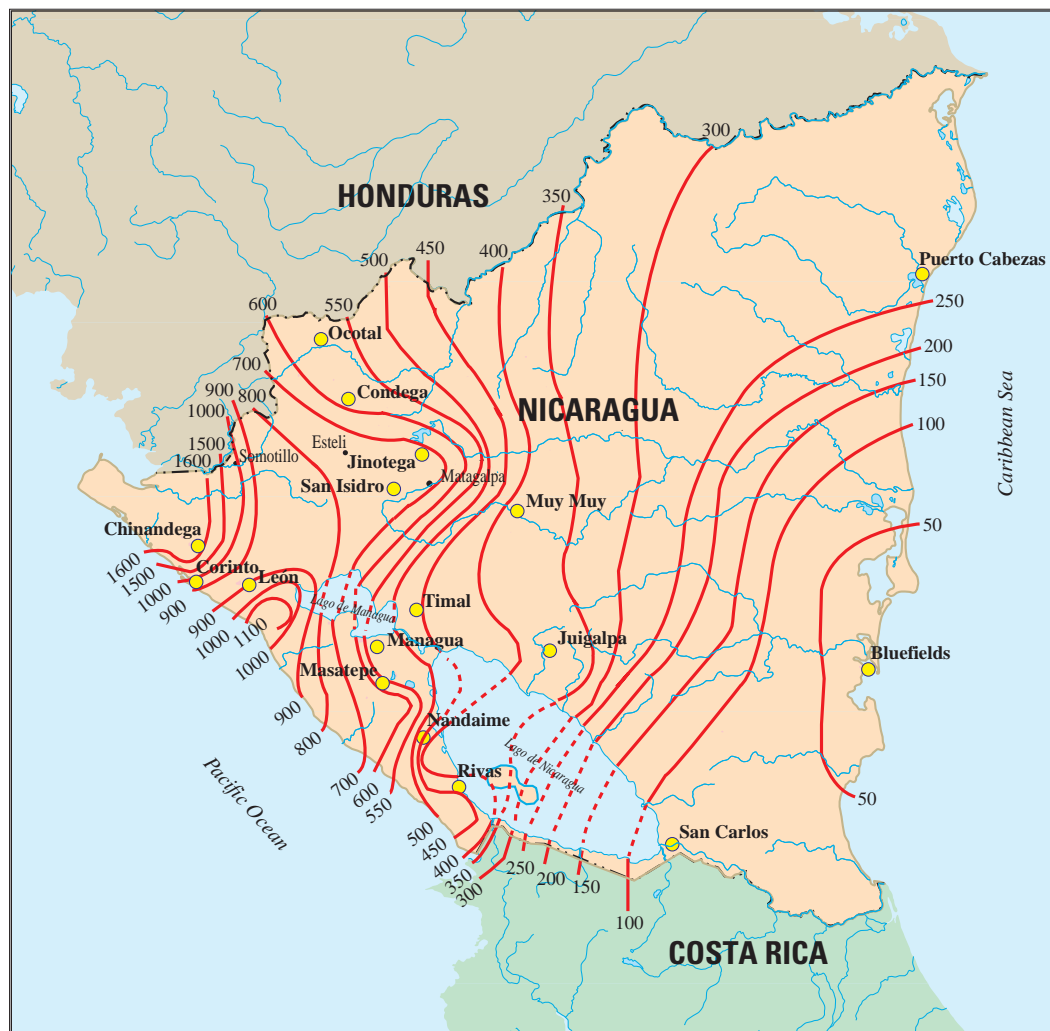
**Figure 2.** Map of rainfall isohyets (in mm) from Hurricane Mitch (21 to 31 October 1998). The principal meteorological stations in Nicaragua are shown by yellow dots. Map adapted from INETER (1998).

tions measured at 14 of 16 gauges located throughout Nicaragua were significantly greater during Hurricane Mitch than those measured during the 10 other hurricanes and tropical storms that have occurred since 1971 (INETER, 1998). Rainfall accumulations measured during the 10-day period that Hurricane Mitch impacted Nicaragua varied between about 50 mm in the southeast portion of the country adjacent to the Caribbean coast, to more than 1600 mm at the northwest corner of the country adjacent to Honduras (fig. 2). These totals ranged between minus 72% of the normal rainfall for the last 10 days of October at the Bluefields gauge located in the southeast of the country (the normal rate being greater than that received during Hurricane Mitch) to 2793% of the normal rainfall for the last 10 days of October at the San Isidro gauge (INETER, 1998).

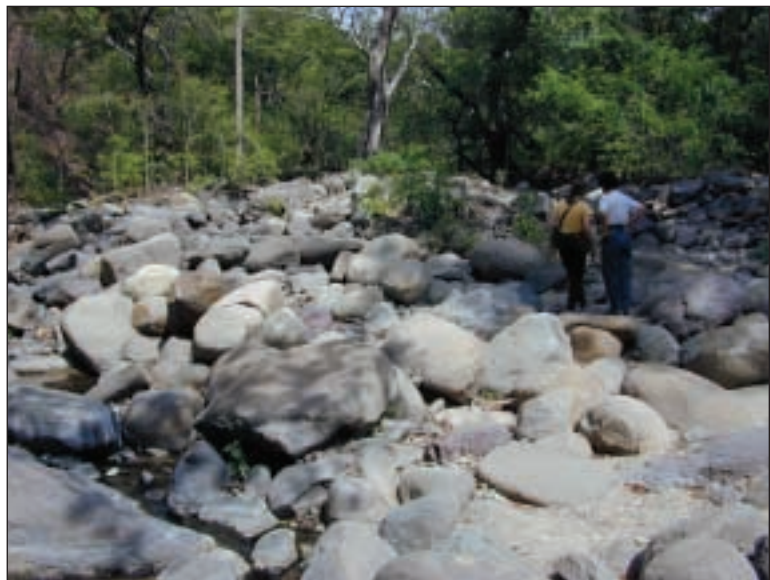
**Figure 3.** Boulder deposit at Quebrada Grande in the El Sauce/San Nicolas study area.

This area was severely impacted by debris flows and downstream effects by Hurricane Mitch rainfall; we mapped 3798 landslides within the 170-km<sup>2</sup> study area, and all of the stream channels that drain toward the west out of the uplands showed evidence of significant erosion and deposition (plate 2; fig. 3). On the northeast side of the area, Río

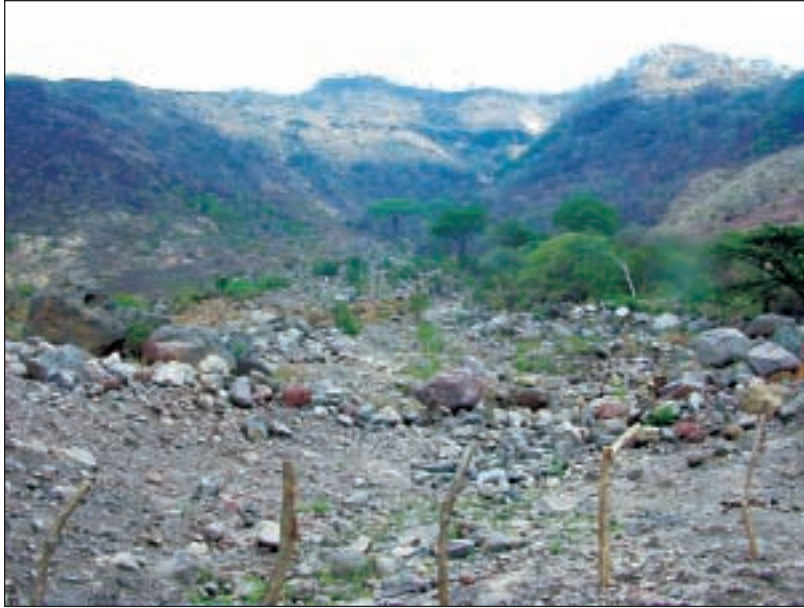
**Figure 4.** Source area and deposits of debris flow near La Caña.

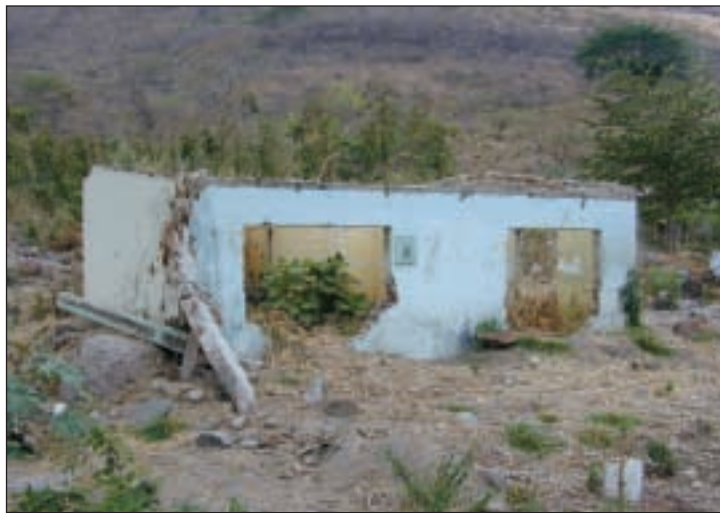
**Figure 5.** Structures destroyed by debris flows behind hospital at La Trinidad.

We mapped 655 landslides in this study area from aerial photographs (plate 3). Most of the debris flows initiated as landslides up to a few tens of square meters in area, a few meters in depth, and traveled less than 1 km downslope, commonly stopping on the gently sloping colluvial apron downslope from the resistant flow unit. However, the landslide density was particularly high and the sizes of the landslides were particularly large, relative to the rest of the study area, on the steep hillslopes that bound the mesas above the towns of San Francisco and La Trinidad in the northwest part of the study area (plate 3). Material from landslides with areas up to about 20,000 m<sup>2</sup> traveled at least 3 km over the colluvial apron and onto the flood plains of Quebradas Seca and La Rancho. Between the towns of San Isidro and La Trinidad, a landslide that initiated in the Coyoil Superior ignimbrite mobilized into a debris flow that traveled approximately 1 km down a steep channel, eroding significant volumes of material (fig. 4). Material from other debris flows crossed the highway between La Caña and La Trinidad in numerous locations. Immediately south of La Trinidad, several structures behind the hospital were damaged or destroyed by a series of coalescing debris flows generated from the steep hillslopes behind the town (fig. 5).

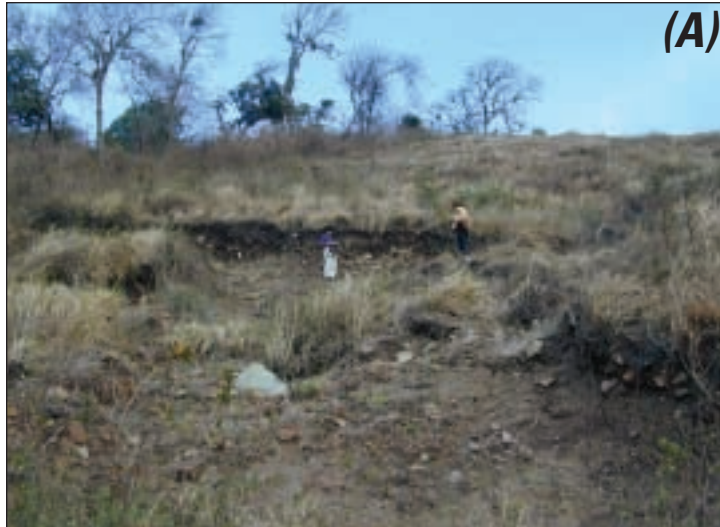
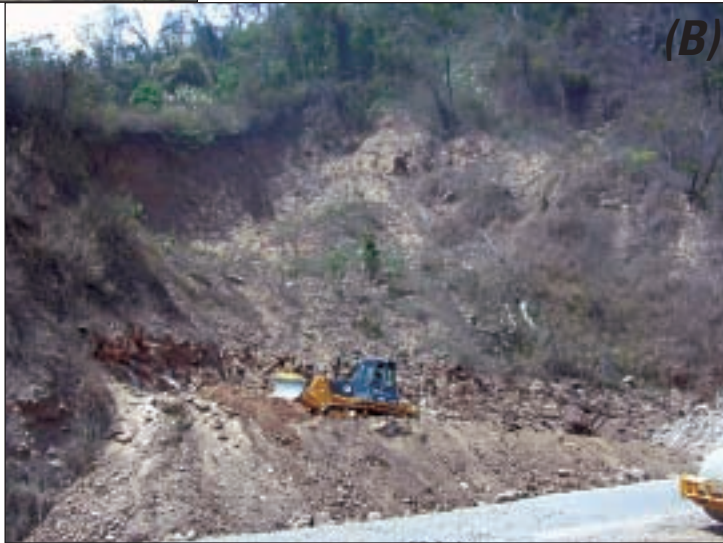
**Figure 6.** Landslides along the road to Jinotega in the La Fundadora study area showing broad scale of response. (A) A failure less than 1 m deep and about 40 m<sup>2</sup> in area. Material from the failure traveled approximately 20 m over an open hillslope. (B) An approximately 5-m-deep failure into weathered material. This landslide was approximately 3000 m<sup>2</sup> in area and traveled at least 100 m down a channel.

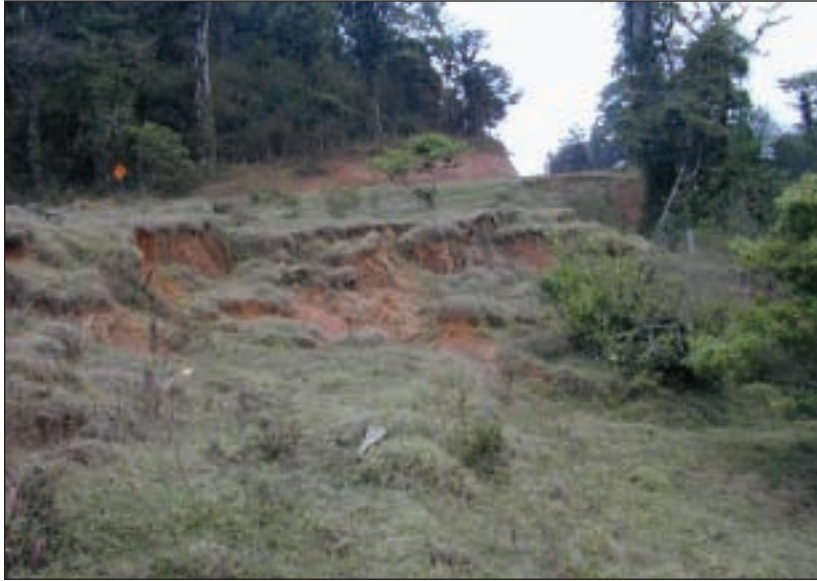
**Figure 7.** Deep-seated, slow-moving earth flow on road to Jinotega. The road crossing this feature was disrupted in many places and was under extensive repair.

We mapped a large, slow-moving earth flow complex along the road to Jinotega (Highway 3), approximately 3.5 km from the southern map boundary, during the field reconnaissance (plate 4; fig. 7). An arcuate headscarp and lateral scarps nearly 2 m high bounded an area of broken ground about 6 km<sup>2</sup> in area. The road that crosses this feature was under extensive repair. We observed active seepage on the south end of the slope below the road. This landslide originated at the break in slope between the steep upper hillslopes and the colluvial apron below.

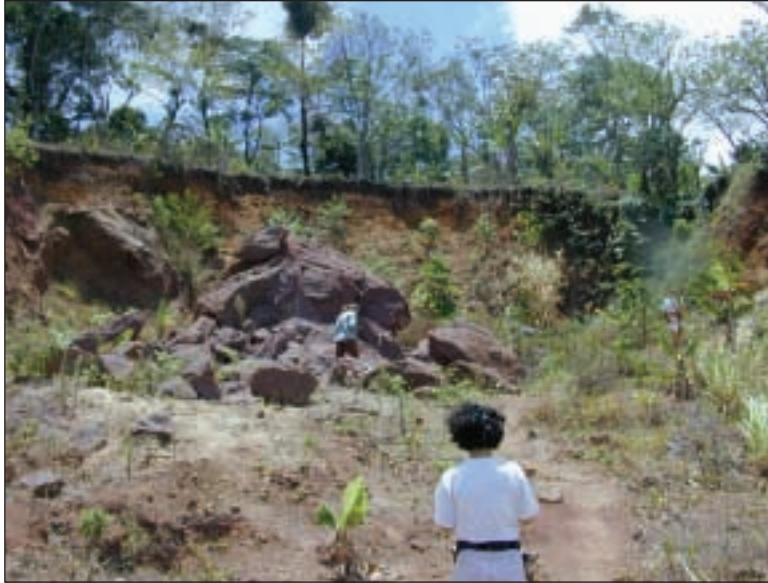
**Figure 8.** Headscarp of landslide that produced a debris flow that traveled through the village of San Francisco, killing one person. Note deep weathering profile in approximately 5-m-high head scarp.

Most of the debris flows initiated as landslides of up to a few tens of meters in area, 1 to 5 m in depth, and traveled tens of meters downslope. Debris flows that moved into well-developed channels traveled the farthest, up to 2 km in one case. During the field reconnaissance we observed that landslide scars most commonly occurred in areas of weathered and/or hydrothermally altered materials (figs. 8 and 9). In addition, depth of

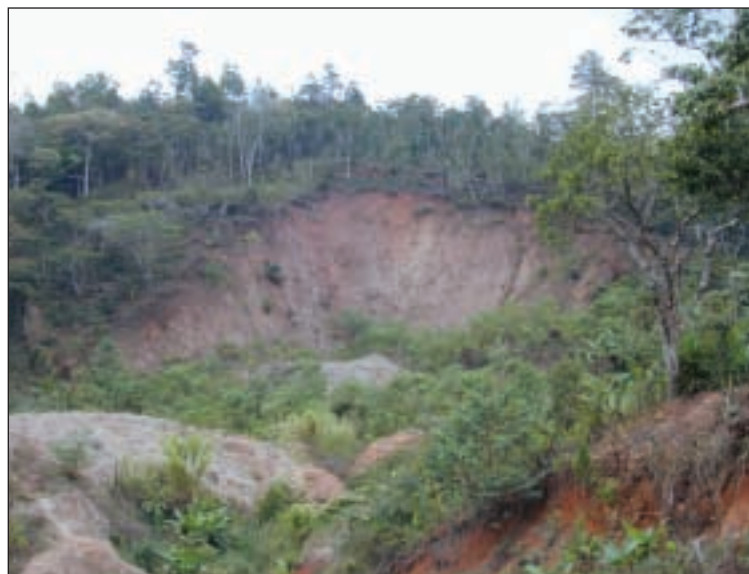
**Figure 9.** Headscarp (approximately 8 m high) of landslide in deeply weathered materials in northern Matagalpa study area.

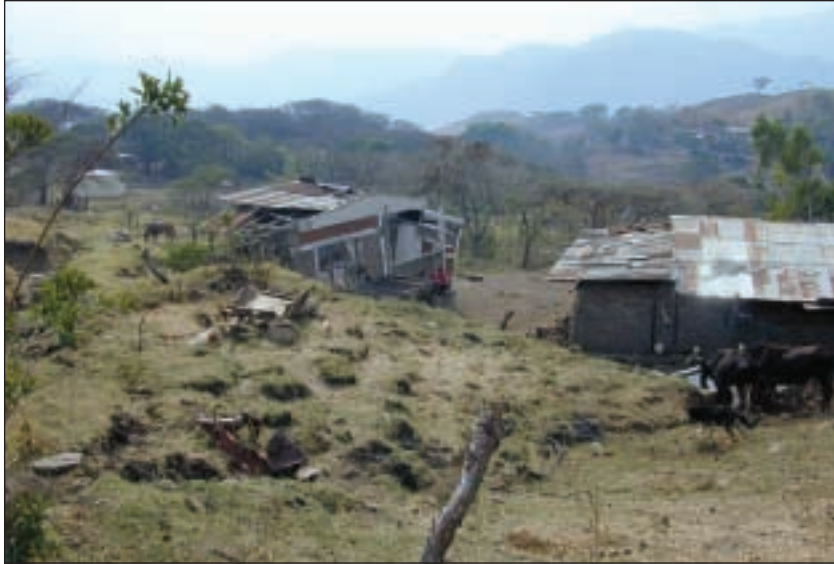
**Figure 10.** Toe of the earth flow at San Simón de Palcila. House on the left was destroyed by movement on the earth flow. An active lobe of the earth flow is impinging on the house at the right.

An earth flow that developed within a pasture at San Simón de Palcila (northwest part of study area) was visited during the field reconnaissance (figs. 10 and 11). Movement on the earth flow has destroyed one house and a church. The earth flow is about 40 m across, 200 m long, with the hummocky topography and the distinct lateral ridges diagnostic of earth flows. The farmers whose house was destroyed reported that the first movement on the earth flow occurred during Hurricane Mitch, but the most significant movement has occurred over a long time period since the hurricane. This earth flow occurred within an apron of deposits that line the ridge. The deposits show evidence of movement by landsliding in the past.

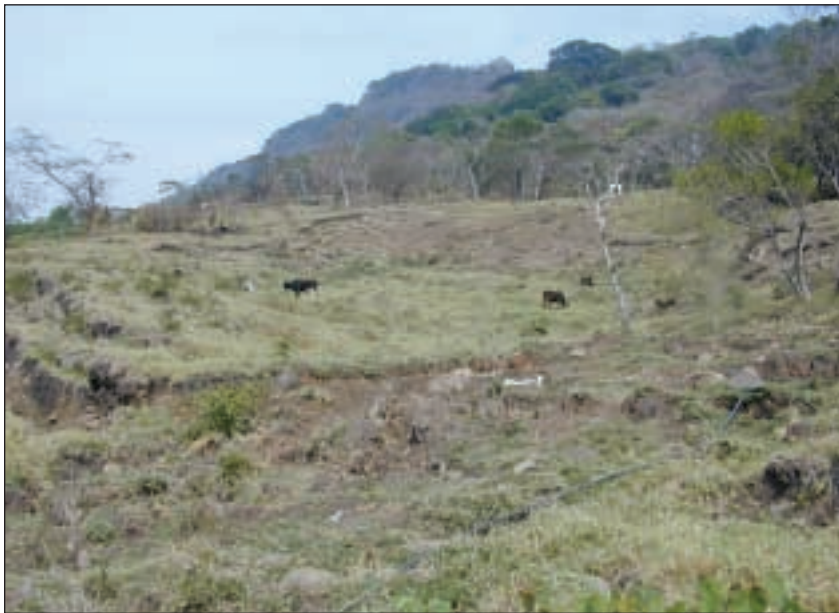
**Figure 11.** View up slope of earth flow at San Simón de Palcila. Note the hummocky topography, large scarps and cracks in the foreground, and headscarp behind the cows.
