# Engineering Geologic Conditions at the Sinkhole Entrance to Logan Cave, Benton County, Arkansas

By William H. Schulz and Jonathan P. McKenna

## U.S. Geological Survey Open-File Report 2004-1357

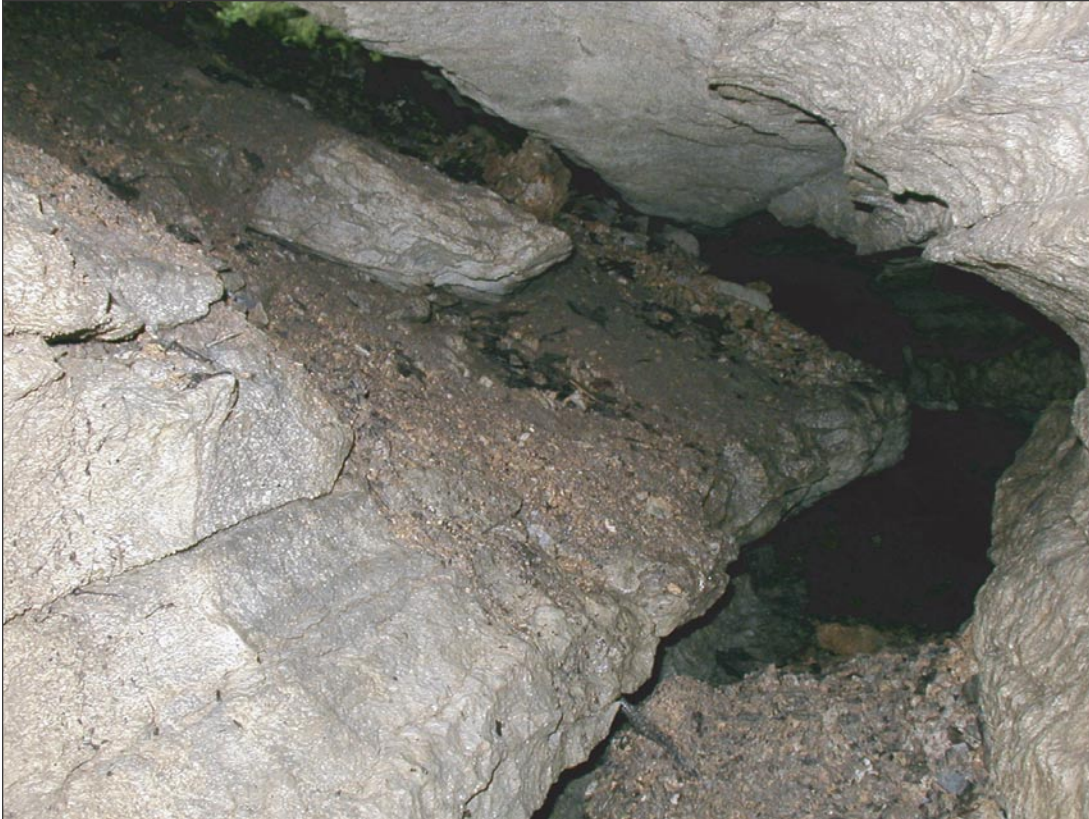
Figure 2. Photograph of the passageway and sinkhole entrance to Logan Cave. View is to the northwest. Passageway is at right, entrance is visible near the upper left (light green vegetation outside of the cave is visible), and sandy gravel and other debris is visible draping most of the slope from the entrance to the passageway and on the floor of the passageway. The width of the passageway at the bottom of the photograph is about one meter.

Geologic Cross Section). Figure 2 shows both of these parts of the cave in a view to the northwest, similar to the view shown in the Geologic Cross Section (pl. 1). Note the soil mantling bedrock in the figure, the green area outside the cave near the upper-left corner of the figure, and the large mound of soil on the floor of the passageway in the lower right part of the figure. Soil locally mantles bedrock on the northeast side of the passageway, as shown in the left center of figure 3, which is a view to the southeast from within the passageway. A stream runs along the floor of the passageway and beneath the bedrock that comprises the cave's northeast wall as shown on the Geologic Cross Section (pl. 1). The stream appears to flow primarily beneath the bedrock downslope of the cave entrance and primarily along the floor of the passageway both upstream and downstream (southeast and northwest, respectively) from the entrance. A thin (less than 0.5-m (1.6-ft) thick) deposit of sandy gravel generally covers the floor of the passageway, but this deposit is much thicker (over 1 m [3 ft]) in some areas downslope of the cave entrance (fig. 4). It is our understanding that a 50-year rainfall event occurred during the summer of 2003, after which soil within the cave entrance and passageway was first observed (Carla Mitchell, oral commun., 2004).

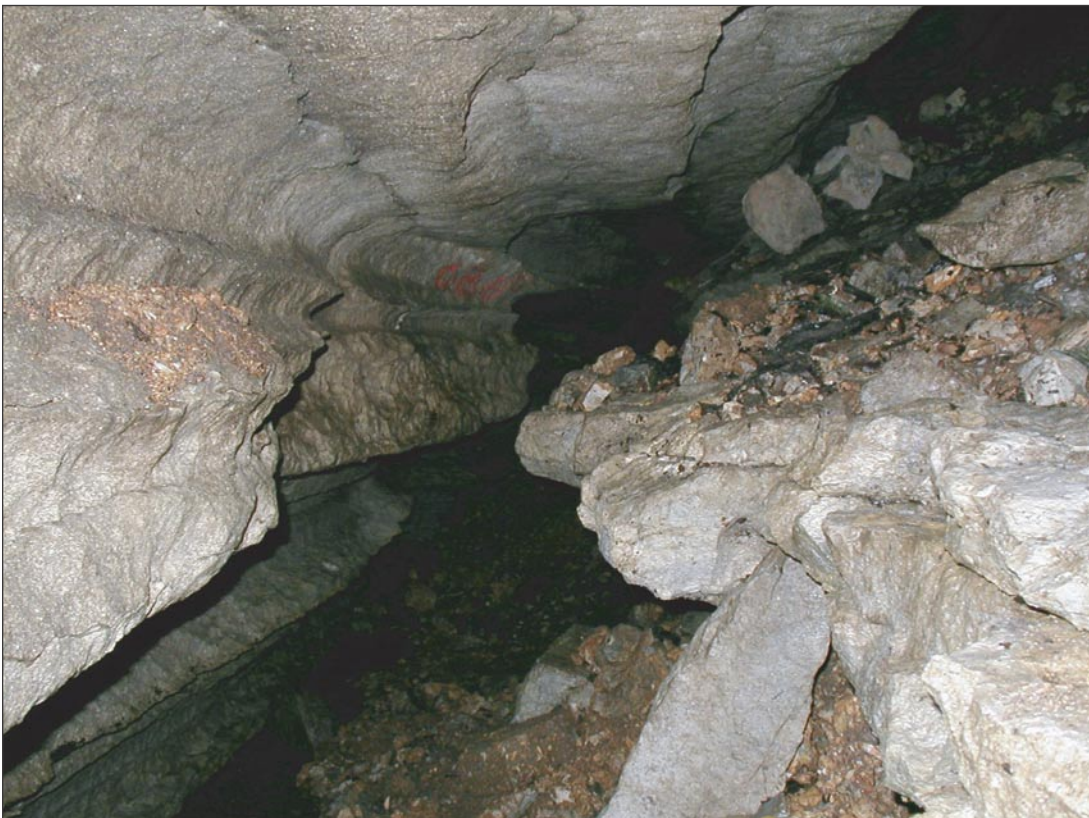
Figure 3. Photograph of the passageway (center of view) and part of the sinkhole entrance (right side of view) to Logan Cave. View is to the southeast. Sediment on the northeast wall of the cave is visible in the left center, as well as on the southwest slope (upper right) and passageway floor. Height of the passageway in the photograph is about two meters.

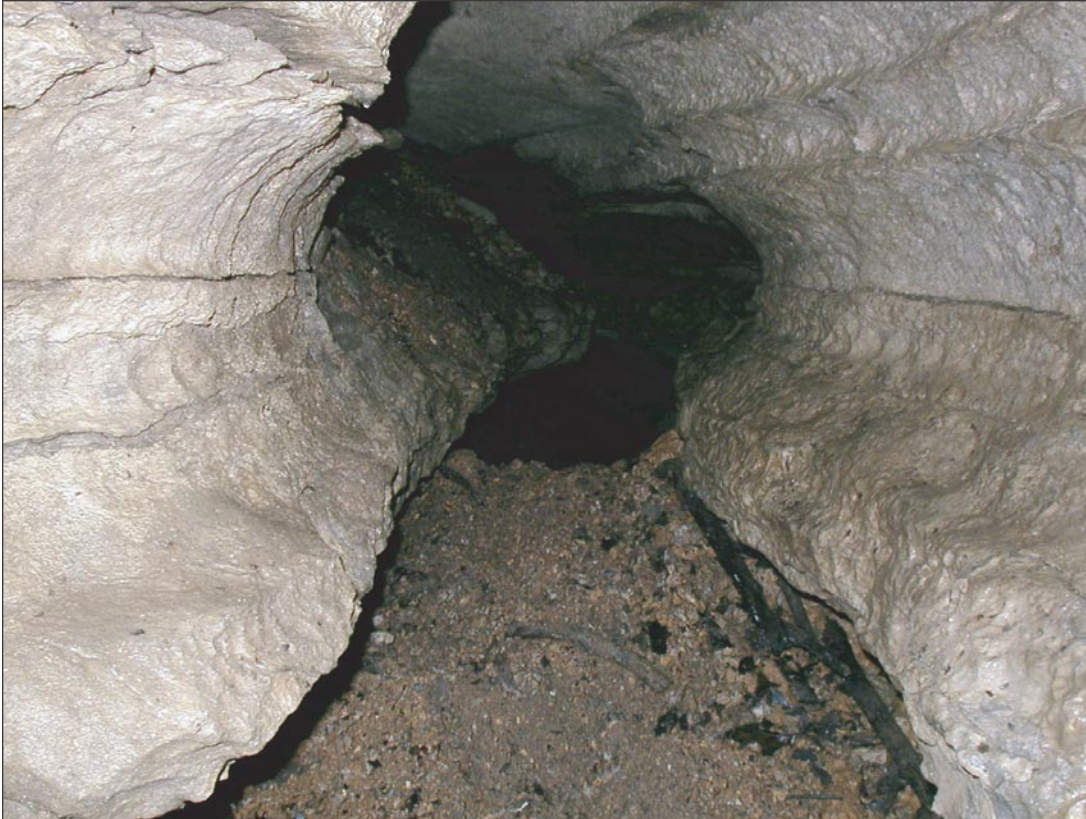
Figure 4. Photograph of the passageway from southeast of the sinkhole entrance showing a thick accumulation of sediment on the floor of the passageway. View is to the northwest. The entrance is to the left and upslope of this accumulation. Passageway is about 2-meters wide at its widest point in this photograph.

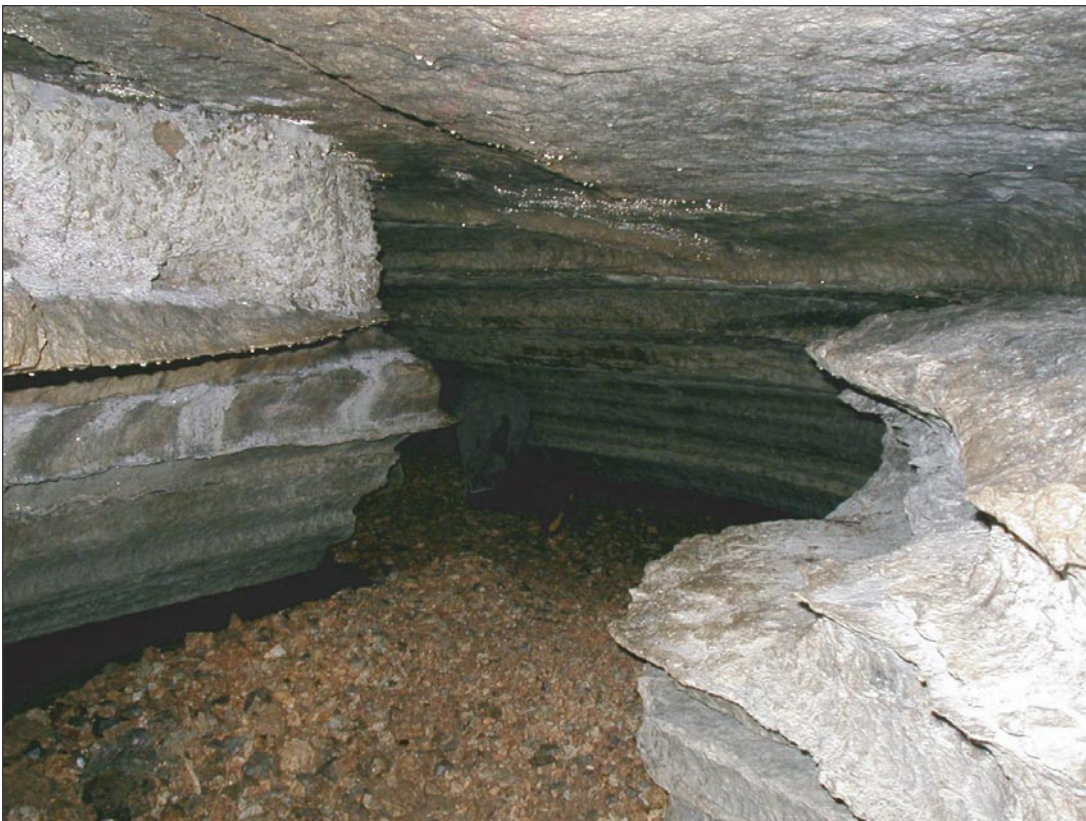
Figure 5. Photograph of the passageway northwest of the sinkhole entrance. View is to the northwest. Sandy gravel deposits between layers of limestone are visible on the left extending down from the roof of the passageway. Height of the passageway is about 1.5 m.

While the previous sinkhole filled (or after it filled), sediment was transported by surface water and shallow slope failures into the present entrance of Logan Cave and also into a similar adjacent entrance located to the northwest. This entrance completely filled with sediment as evidenced by the sandy gravel exposures in the southwest wall of the passageway northwest of the present entrance (fig. 5 and pl. 1; Southwest-Slope Geologic

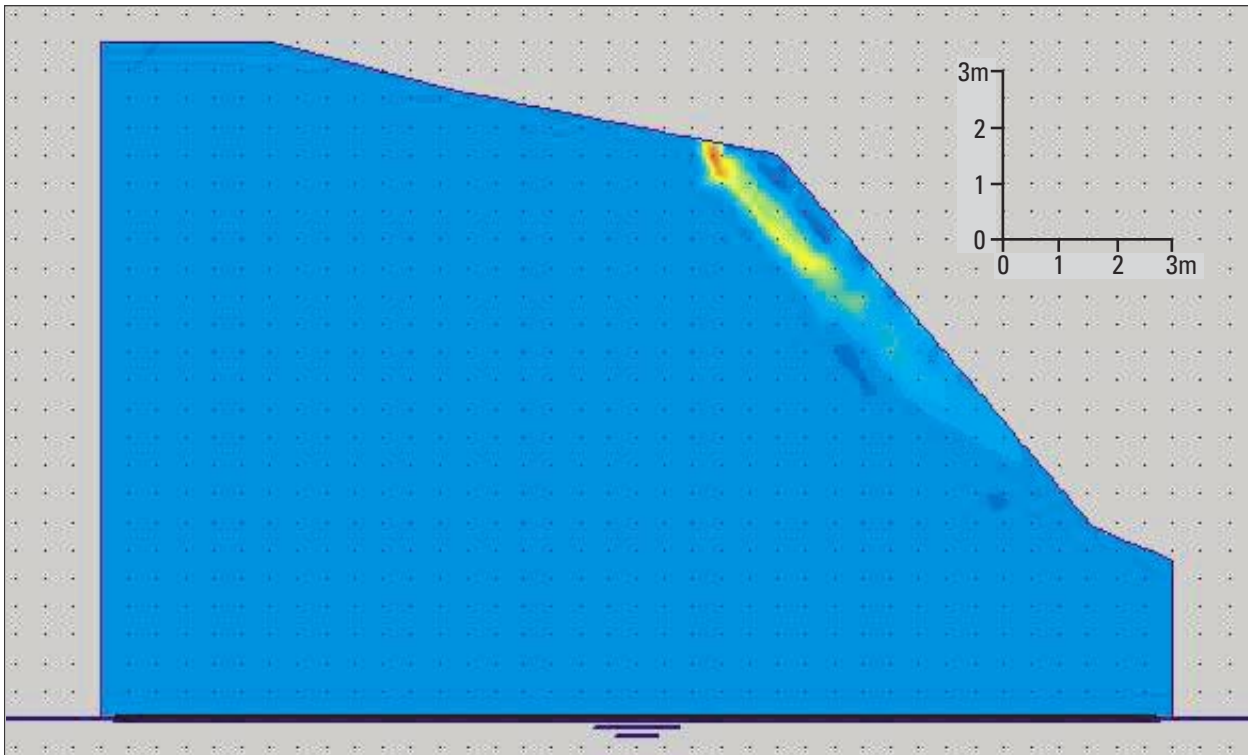
Figure 6. Graphical representation of the Trial 1 slope-stability analysis results showing the modeled southwest slope cross section and calculated stresses. The shear stress field is represented by colors with cool colors indicating low shear stress and warm colors indicating high shear stress. The base of a landslide predicted by this trial would be located where shear stresses are highest (warmest colors).

We analyzed the southwest slope with constant  $\phi=48^\circ$  and unit weight of 14.81 kN/m<sup>3</sup> (94.3 lb/ft<sup>3</sup>), and varied  $c$  until we obtained results of marginal stability. Cohesion of at least 0.7 kN/m<sup>2</sup> (14.6 lbf/ft<sup>2</sup>) was required to provide stability to the slope. This value of  $c$  is quite low and is within the likely range of capillary cohesion for this soil type (Lu and Likos, 2004). Figure 6 shows the modeled slope geometry, which matches that of the Geologic Cross Section (pl. 1), and the distribution of stresses predicted by PLAXIS®. The warm colors indicate high shear stress, while the cool colors indicate low shear stress. Figure 6 indicates that the highest shear stresses, and thus the base of failure predicted if soil strength falls below the modeled values, are concentrated at shallow depth in the upper one-half of the slope. The predicted slope failure has a thickness of about 1.5 m (4.9 ft) (measured normal to the slope) and is classified as a translational failure, meaning that landslide displacement is parallel to the slope.

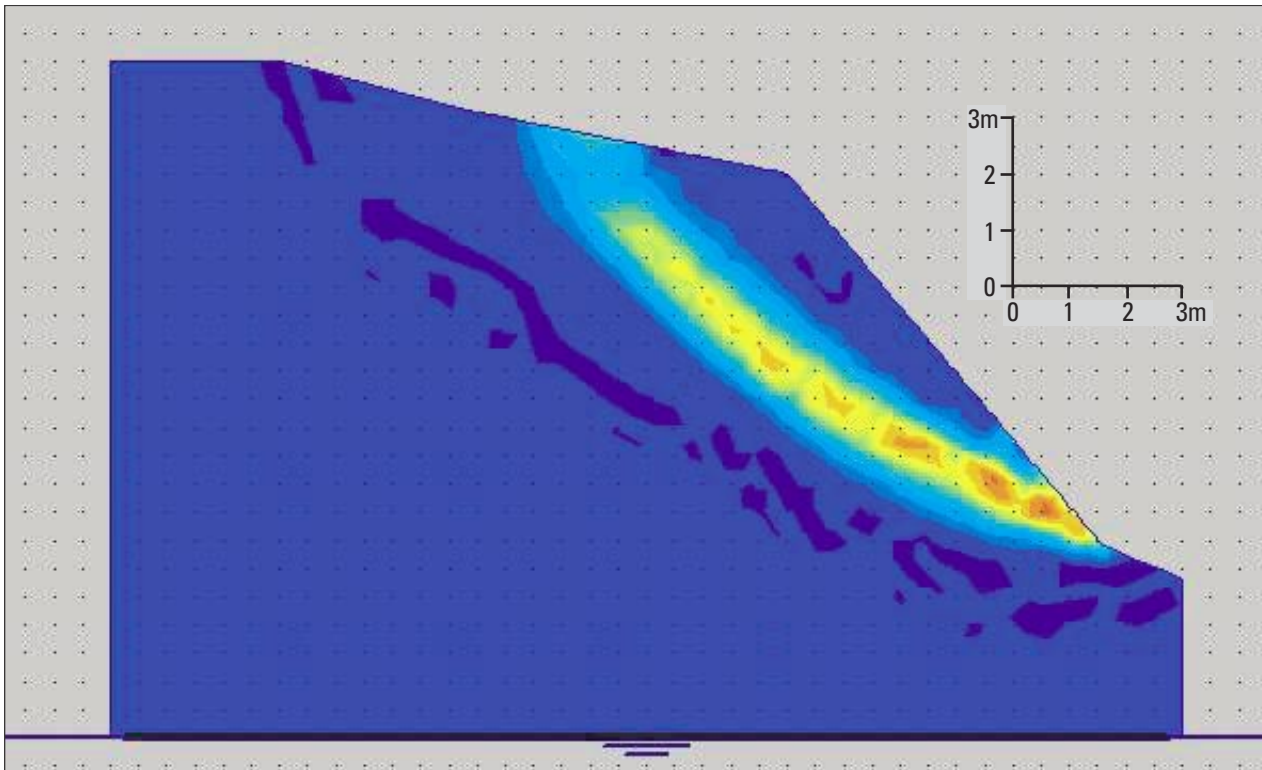
Figure 7. Graphical representation of the Trial 3 slope-stability analysis results showing the modeled southwest slope cross section and calculated stresses. The shear stress field is represented by colors with cool colors indicating low shear stress and warm colors indicating high shear stress. The base of a landslide predicted by this trial would be located where shear stresses are highest (warmest colors).

We modeled the southwest slope with constant  $\phi=24.9^\circ$  and unit weight of  $14.81 \text{ kN/m}^3$  ( $94.3 \text{ lb/ft}^3$ ), and varied cohesion to determine the minimum required for stability. We found that  $c$  of at least  $6.0 \text{ kN/m}^2$  ( $125.3 \text{ lbf/ft}^2$ ) is required for the slope to be stable. As with Trial 1, capillary cohesion of this magnitude is reasonable for the type of soil that underlies the southwest slope. However, the failure predicted to occur if soil strengths drop below the values used during Trial 3 (fig. 7) is much deeper than that predicted during Trial 1. This failure is as deep as  $3.5 \text{ m}$  ( $11.5 \text{ ft}$ ) (measured normal to the slope), extends to the toe of

the slope, and extends back about  $4 \text{ m}$  ( $13 \text{ ft}$ ) from the sinkhole edge. It is classified as a rotational failure, meaning landslide displacement would involve rotation along a concave-upward failure surface.

The slope of Trial 3 was modeled with the soil nearly saturated, such as may occur due to heavy rainfall, by increasing the unit weight to the estimated near-saturation value of  $17 \text{ kN/m}^3$  ( $108 \text{ lb/ft}^3$ ). The strength parameters  $\phi$  and  $c$  were held constant at  $24.9^\circ$  and  $6.0 \text{ kN/m}^2$  ( $125.3 \text{ lbf/ft}^2$ ), respectively. The analysis indicated that the slope would fail under these conditions. The failure geometry is nearly identical to that shown in figure 7.

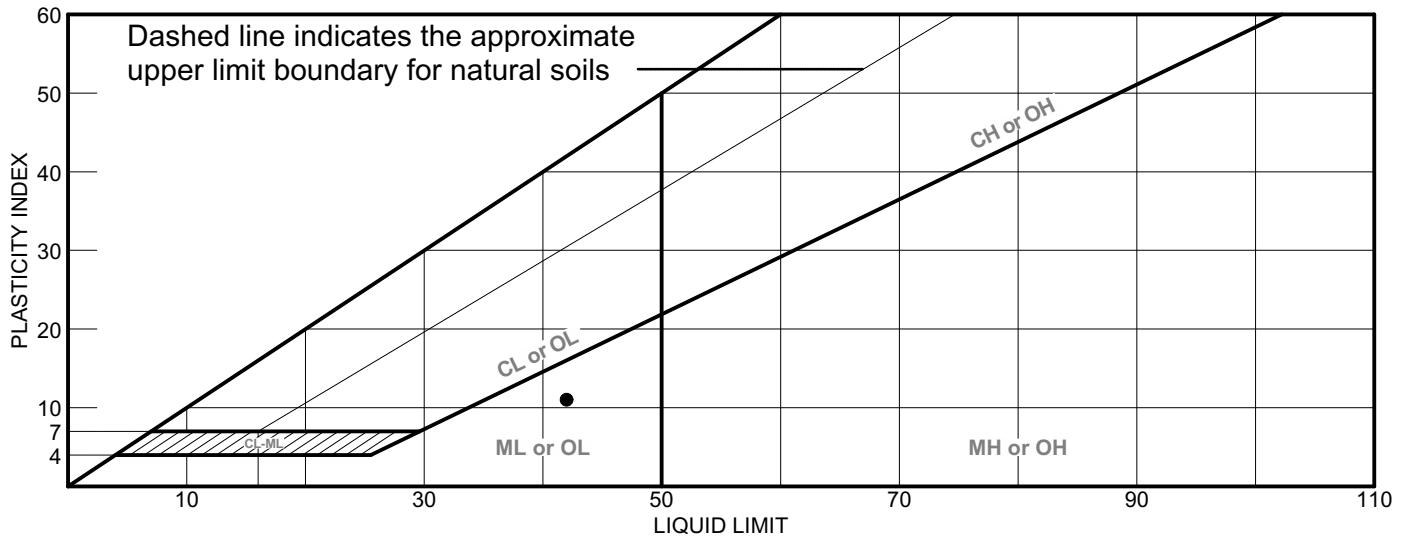
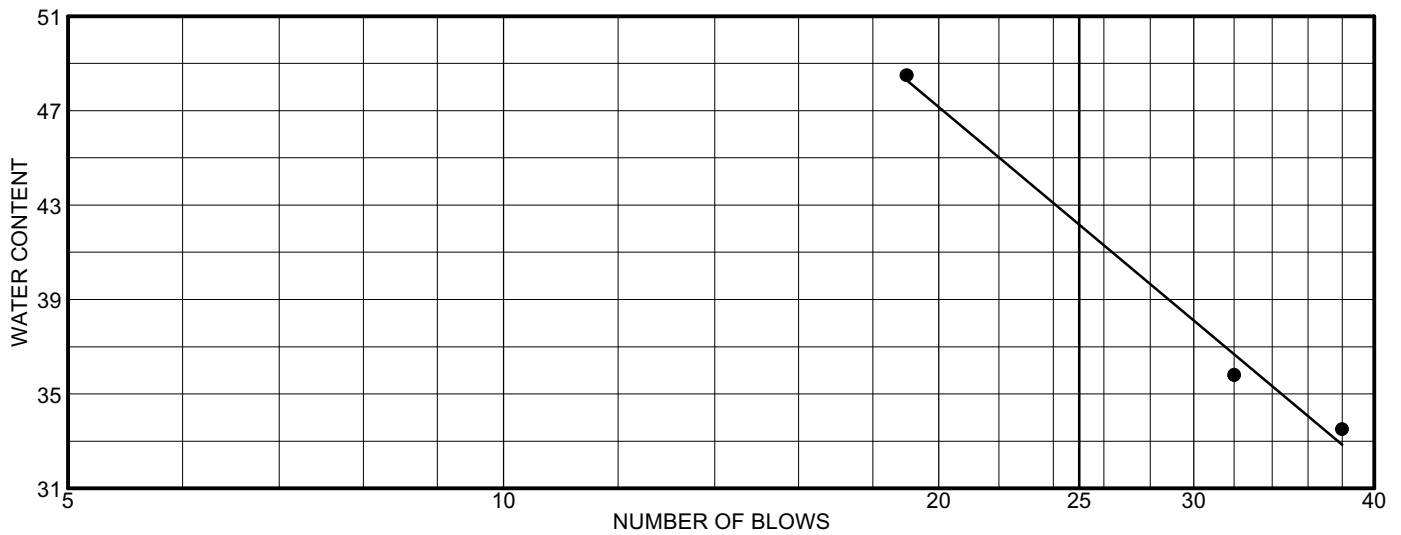
# LIQUID AND PLASTIC LIMITS TEST REPORT

MATERIAL DESCRIPTION	LL	PL	PI	%<#40	%<#200	USCS
● Brown SILT with Sand and Gravel	42	31	11

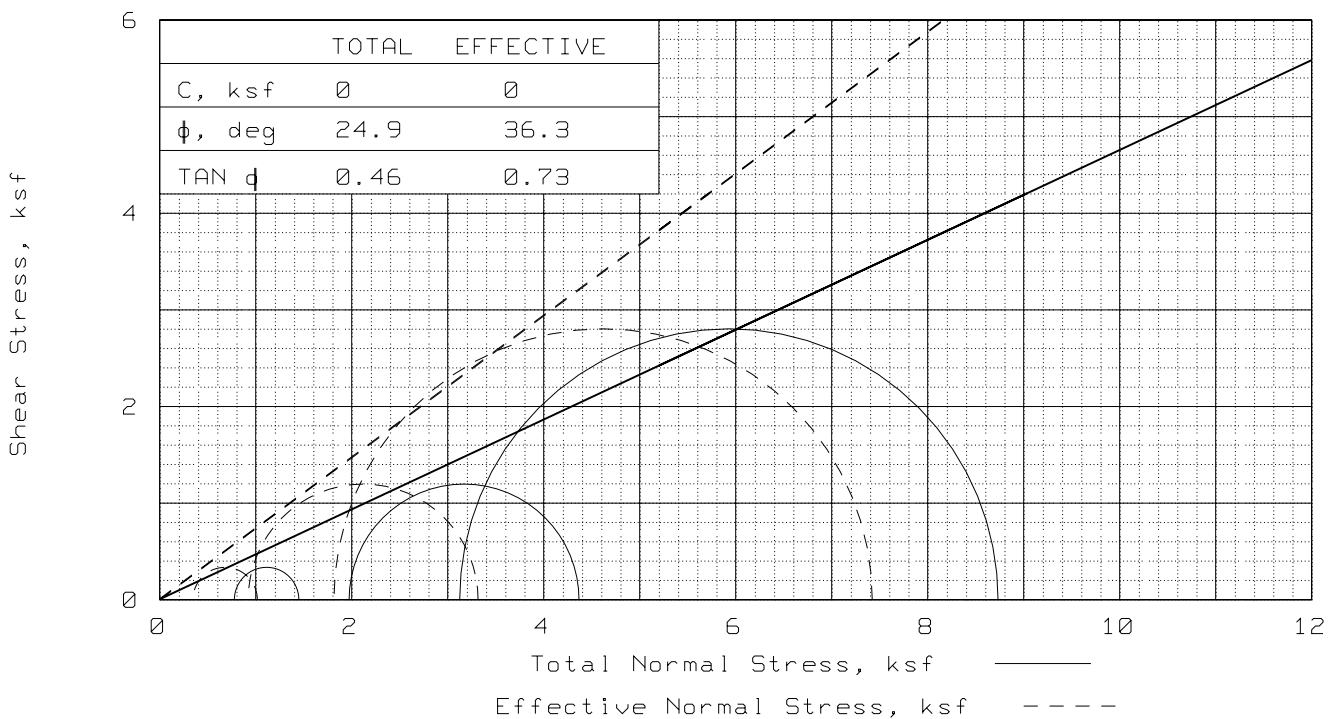
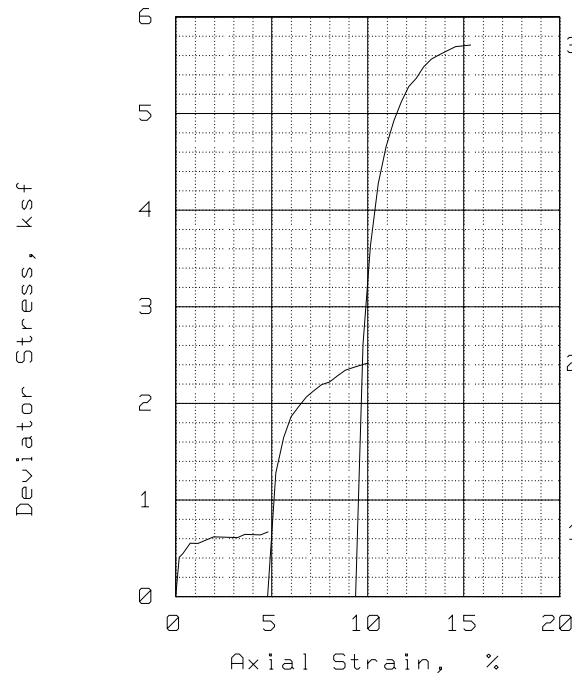
SAMPLE NO.:		1	2	3
INITIAL	WATER CONTENT, %	21.0	21.0	21.0
	DRY DENSITY, pcf	78.0	78.0	78.0
	SATURATION, %	48.8	48.8	48.8
	VOID RATIO	1.161	1.161	1.161
	DIAMETER, in	2.370	2.370	2.370
	HEIGHT, in	5.000	5.000	5.000
AT TEST	WATER CONTENT, %	32.0	28.3	25.9
	DRY DENSITY, pcf	90.4	95.6	99.2
	SATURATION, %	100.0	100.0	100.0
	VOID RATIO	0.864	0.764	0.699
	DIAMETER, in	2.222	2.211	2.223
	HEIGHT, in	4.910	4.688	4.470
Strain rate, %/min			0.04	0.04
EFF CELL PRESSURE, ksf		0.778	1.973	3.125
DEVIATOR STRESS, ksf		0.672	2.395	5.608
EXCESS PORE PR., ksf		0.432	1.051	1.310
STRAIN, %		4.8	5.1	4.8
ULT. STRESS, ksf				
EXCESS PORE PR., ksf				
STRAIN, %				
$\bar{\sigma}_1$ FAILURE, ksf		1.017	3.317	7.423
$\bar{\sigma}_3$ FAILURE, ksf		0.346	0.922	1.814

TYPE OF TEST:  
CU with Pore Pressures
