**BULLETIN NO.
04-04**

EXHAUST WRAP INSPECTION

PRIORITY: Regular P.M. Period Inspections
PURPOSE: Fire Protection
VEHICLES INVOLVED: Getman vehicles utilizing exhaust wrap

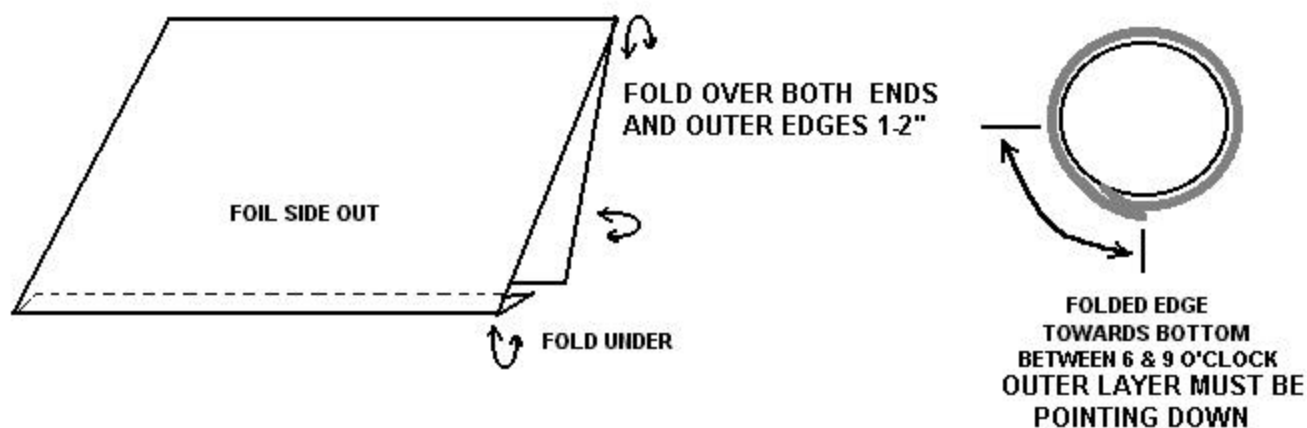
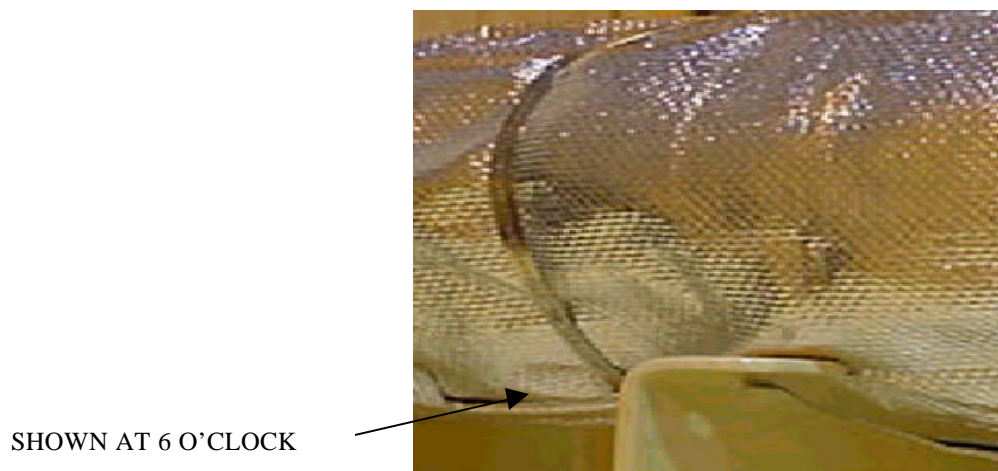
FIGURE 2. Correct Application of Insulating Material

When re-installing the wrap, it should be folded so there is a double layer with the foil facing in towards the exhaust component being wrapped and also foil facing outward. Care should be taken to ensure all ends of the material whether at the bottom or both ends, are folded under minimum 1-2 "to prevent any frayed areas from being exposed. When wrapping any exhaust components, all seams must be at the bottom of the component being wrapped and secured utilizing clamps or wired securely in place. This will ensure any possible infiltration of fluids be allowed to drain out and not collect between the wrap and the exhaust system.

Part No. 605537 - Wrap, Aluminized Heat Barrier (roll = 40" wide X 20' long)

Part No. 605538 - Straps for Wrap 605537 (25' + 25 clips)
