Reactive Solutions

An FHWA Alkali-Silica Reactivity News Publication

What is ASR?

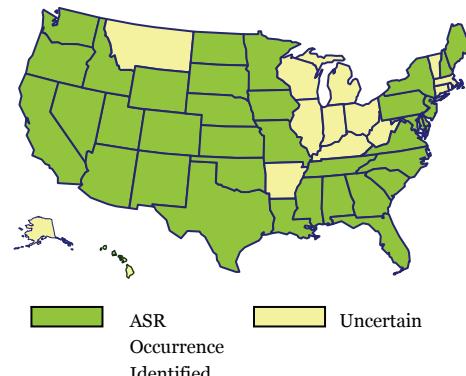
Figure 1. Occurrences of ASR in the United States (from 1994 FHWA Showcase Workshop on ASR)

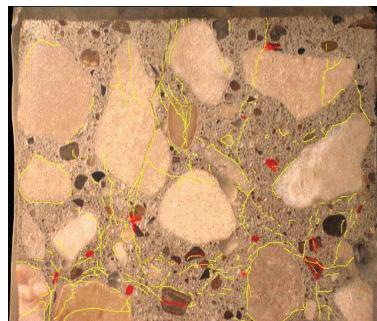
Figure 2. Polished slab of concrete showing cracks through aggregate particles and paste (stained yellow) and alkali-silica reaction gel (stained red).

To determine the cause of the cracking, one must examine cores for petrographic evidence of the mechanisms involved. Examples of typical distress manifested by ASR are shown in Figures 2-3 (on pg. 2), *Handbook for the identification of alkali-silica reactivity in highway structures* (SHRP-C-315) and *State-of-the-Art report on alkali-aggregate reactivity* (ACI 221.1R).

development of rims, particularly on crushed aggregate particles. This type of evidence should also go hand-in-hand with cracking that extends through the paste to indicate that the ASR has resulted in damage to the concrete itself. This type of cracking is best viewed on lapped slabs (Figure 2 on pg.2) and thin sections (Figure 3 on pg. 2). Other deterioration mechanisms that cause damage by swelling of the paste alone will exhibit cracks that extend through the paste; however they will bypass the aggregate particles resulting in peripheral gaps around the particles.

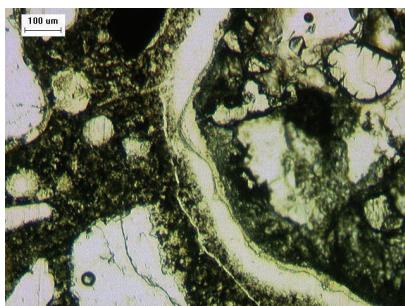
Figure 3. Thin section of concrete showing crack lined with alkali-silica reaction gel.

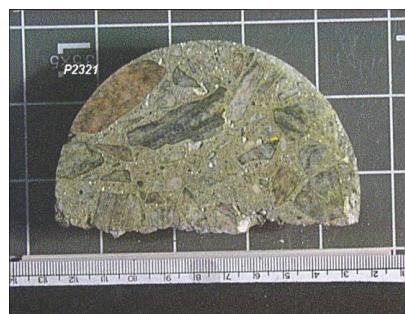
Figure 4. Polished slab from concrete pavement showing expansive cracking of coarse aggregate particles.

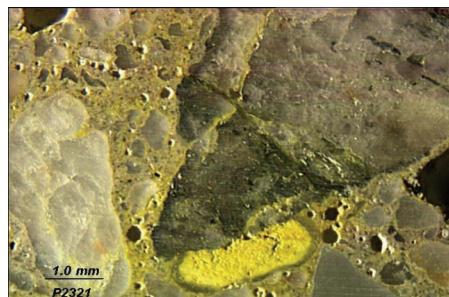
Figure 5. Lapped section from core of damaged bridge deck treated with sodium cobaltinitrite.

Figure 6. Close-up of Figure 5 showing positive indication for potassium in void-filling deposit, along crack in aggregate and in paste around aggregate.

Chemical spot tests (stains) can be useful in locating reaction product, especially if it is sparse. The spot tests work on the basis of ion exchange and thus provide an indication of the accumulation of the particular ion in the material at a specific location. Two stains are useful in diagnosing ASR: sodium cobaltinitrite, specific for potassium (K); and uranyl acetate, specific for sodium (Na). Of these, the sodium cobaltinitrite is more user friendly since it does not have the environmental issues of uranyl acetate and it imparts a yellow stain visible in ordinary light to K-bearing materials (Figures 5 and 6, pg. 2) whereas a UV light is needed to examine specimens treated with uranyl acetate. Additionally, potassium is the more prevalent alkali metal in North American portland cements, making it the logical choice to focus on. Keep in mind that the spot test merely indicates the presence of the specific ion in the stained material and that further analysis is necessary to confirm that its characteristics are consistent with ASR gel.

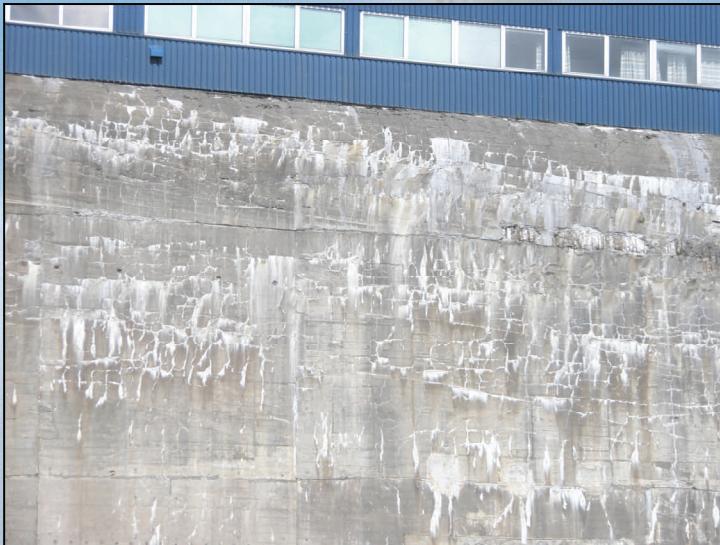
Wall built with ASR susceptible aggregate showing ASR gel extruding from the cracks. (Photo taken during the 13th ICAAR field trial trip in Norway, submitted by Gina Ahlstrom)
