**SAND2003-0719
Unlimited Release
Printed May 2003**

Blade Manufacturing Improvements Remote Blade Manufacturing Demonstration

TPI Composites, Inc.
373 Market Street
Warren, RI 02885

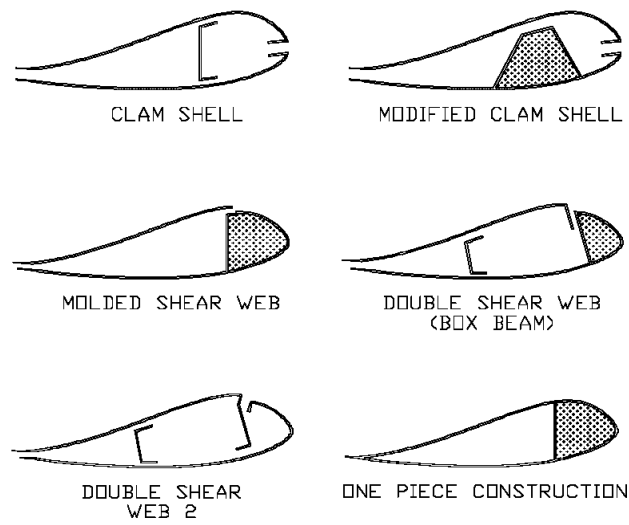
Figure 1.1 Schematic of Candidate Mold Configurations

During the original BMI contract (first phase), TPI Composites considered a number of different mold configurations (Figure 1.1). The concepts ranged from a conventional, low risk clamshell design to a high risk one-piece construction method. Each of the molding methods showed merit, but our goal was to select the most cost-effective mold configuration and produce a finished blade that met the design criteria for structure and airfoil shape.

Several configurations included a double shear web in the blade design. These designs were removed from consideration because the structure of the blade did not warrant an additional shear web. The material cost of this additional web made these methods less than ideal in a small blade; however, these molding methods may have merit in larger blades where a second web is necessary to offset panel buckling.

Integrally molded shear webs and one piece construction were also studied. Each of these concepts was found to have merit, but were considered to have significant technical and manufacturing risk. However these concepts should be reviewed in the context of large blades, which should have less space restrictions.

TPI Composites performed detailed studies of the standard clamshell and modified clamshell approaches. The modified clamshell approach was attractive because it eliminated one bond line. Further study and experimentation proved that the method was not as efficient as it first appeared.

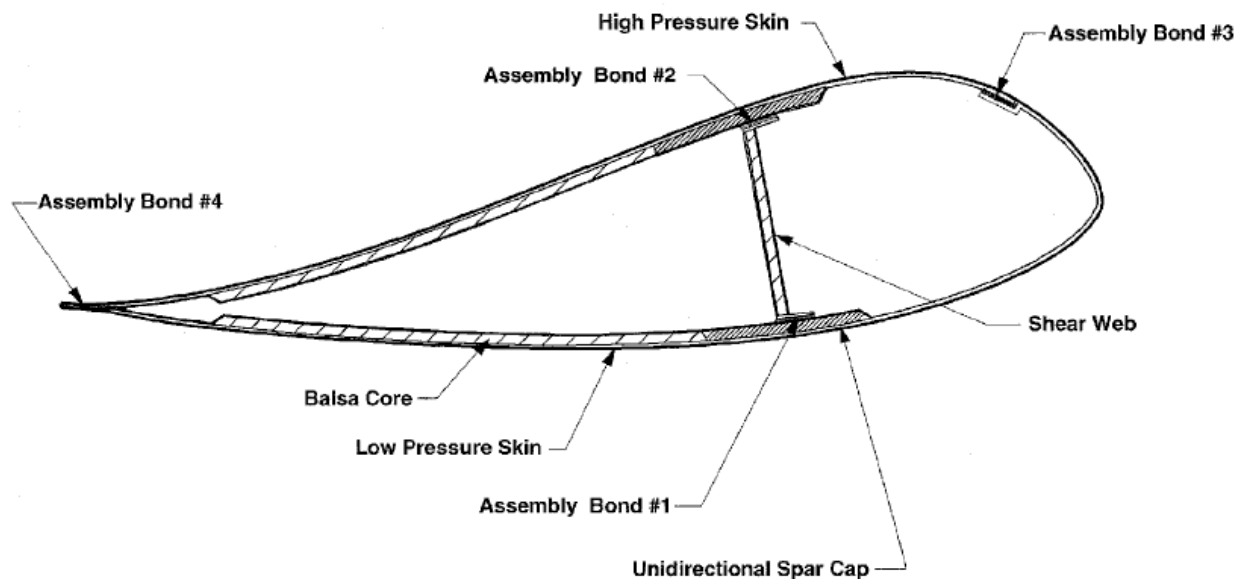
Figure 1.2 Typical Blade Cross-Section

The clamshell design proved to be the most cost effective method for building the blades, but presented significant challenges in maintaining leading edge profile tolerances. To overcome these challenges, the mold parting line was modified to move the bond line to an area with less aerodynamic significance (Figure 1.2, assembly bond #3).

This configuration offered material and labor savings in addition to quality assurance improvements. By offsetting the mold split line, the design maintained the leading edge profile as a molded surface. After resin infusion, the blade shells and web can be easily inspected for flaws prior to bonding. The bond assembly fixture provided precise alignment of the blade skin and placement of the shear web.

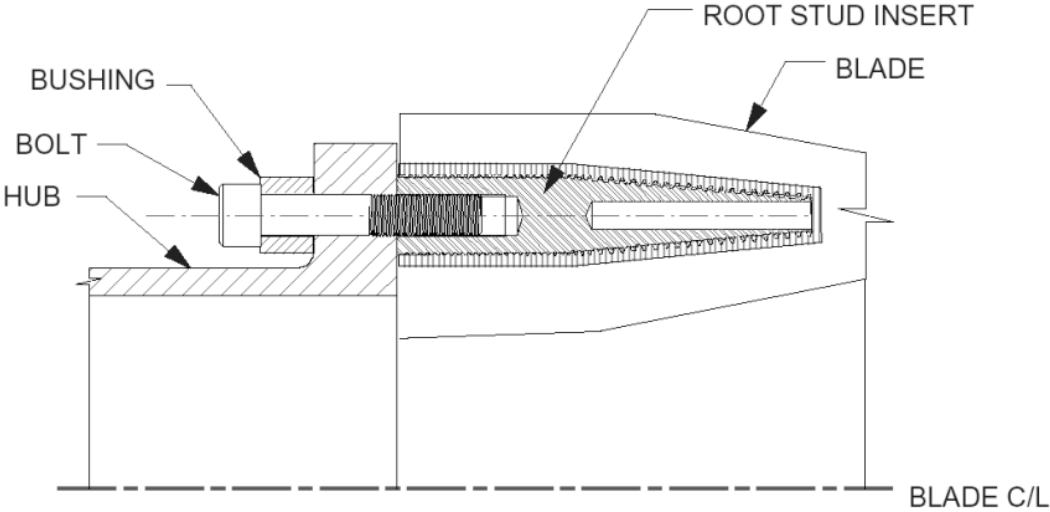
Figure 1.3 Illustration of Blade Root Stud Design

Blade root studs have been a reliable method for attaching the blade to the hub. Root studs have been used by LM Glasfiber, Mitsubishi Heavy Industries, and others with good success. TPI Composites elected to adapt a strain compatible root stud technology originally developed for wood-epoxy blades manufactured by Gougeon Brothers, which had a long and successful history in wind turbine blades dating to the early 1980's. These studs have undergone considerable engineering development and fatigue testing [2]. The approach provides smooth, strain compatible load transfer between the composite blade root and the steel hub (Figure 1.3). The steel root studs were bonded using an epoxy adhesive into cavities (Figure 1.4) molded into the blade laminate. The laminate design approach and the processes for molding the cavities were developed as part of the BMI effort.

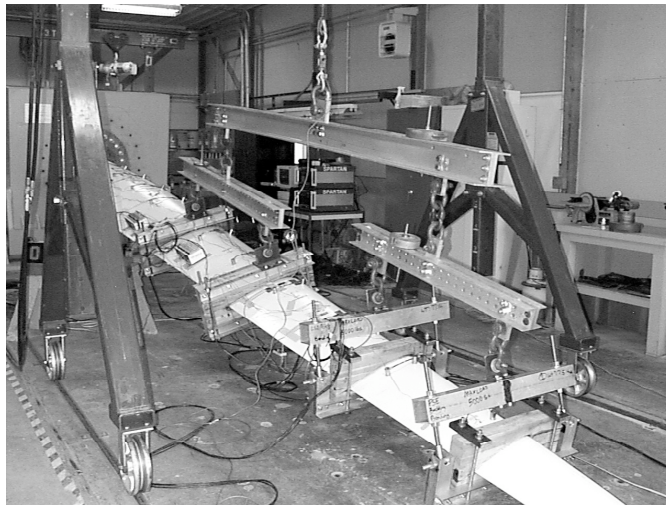
Figure 1.5 NWTC Static Test Load Application System

Static load testing of the first ERS-100 prototype blade was conducted at the National Wind Technology Center (NWTC) and the test results [3] were used to assure the accuracy of engineering models and identify areas for additional design effort. Test loads were applied using a 5-ton hydraulic gantry crane and loading was distributed with a four-point load application system, or “whiffle tree”. The whiffle tree was composed of three spreader-bars, which distributed the crane load to each of four saddles (Figure 1.5). The spreader bars were made from two opposing C-channels to form an I-beam. Linkages between spreader bars and saddles were constructed as short as possible to maximize overhead clearance. The whiffle tree assembly was statically balanced by attaching ballast weight. This eliminated bending moments in the blade caused by the whiffle tree apparatus.

Airfoil shaped saddles were used to introduce the test loads into the blade shells. The two outboard saddles incorporated a pivoting mechanism to allow the load to be applied at or near the blade chord line. This pivoting yoke design reduced the moment that would be introduced due the large deflection angles. For these blades, only the outer saddles required the pivoting design. Deflections were measured using linear scales at each saddle (load introduction) location and at the blade tip.

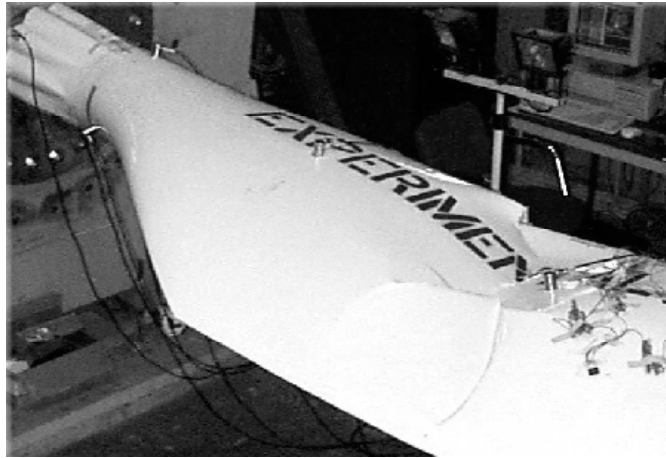
Figure 1.6 Photograph of the ERS-100 Blade After Static Failure

The procedure for static testing consisted of monotonically increasing the applied load until the blade failed. The applied load was slowly increased to 4.5 kN (1000 lbf), then held at that position so that the displacement measurements could be read and recorded. This procedure was repeated, in 2.3 kN (500 lbf) increments, until an obvious failure occurred. The blade failure was characterized by catastrophic buckling and was preceded by local dimpling of the forward panel near the point of failure (Figure 1.6). The ERS-100 blade failed at a root flange moment of 123 kNm (90,601 ft-lbf).

The ERS-100 blade failure region was characterized by a slanted chordwise crease that extended from about 1.73 m at the leading edge to 2.16 m at the trailing edge which is approximately at 31% span (Figure 1.7). The location was on the leading edge side of the shear web. Also noted from the video and observed during the test was that at least one other buckling zone, at about 40% span, was oil canning or dimpling at the time of failure.

The buckling strength of the ERS-100 blade was improved during the BMI Extension effort by modifying the laminate design in the failure region and by changing the shear web design. Failure investigations conducted after the static blade test suggested that the leading edge panel stiffness could be easily improved by the addition of coring in the leading edge panels forward of the shear web. The root end of the shear web was modified to include a “half moon” that reduced localized stiffness and stress gradients. Additional design improvements included modification of the laminate schedule to smooth load transitions in the root region and reduce stress concentrations.

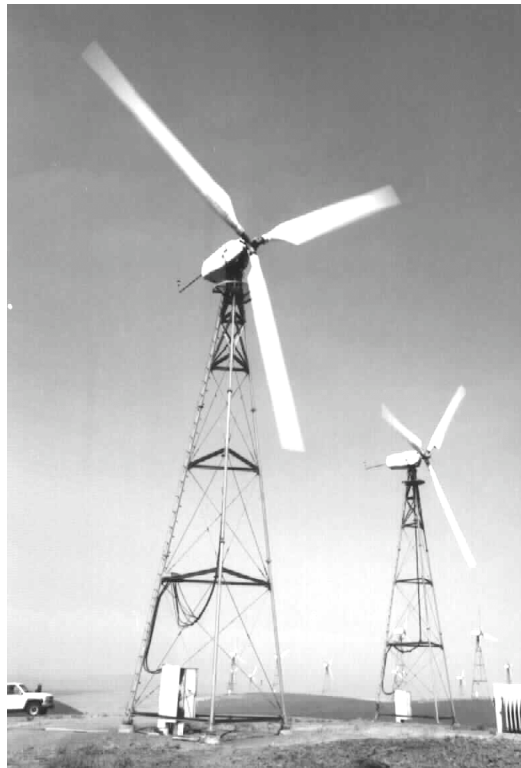
Figure 1.8 Operational Test Turbines

Operational testing of the original ERS-100 prototype blades was conducted within a large commercial wind plant comprising more than 600 turbines. The test site was located in Solano County, California in a region of low rolling hills. Field testing was used to compare performance (power) and blade loads between the baseline USW 56-100 blade and the ERS-100 replacement blades. Two turbines were instrumented for testing, as shown in Figure 1.8. Turbine A (located in the foreground) had the ERS-100 replacement blades installed, while Turbine B (in the background) was equipped with newly constructed LS(1) baseline blades.

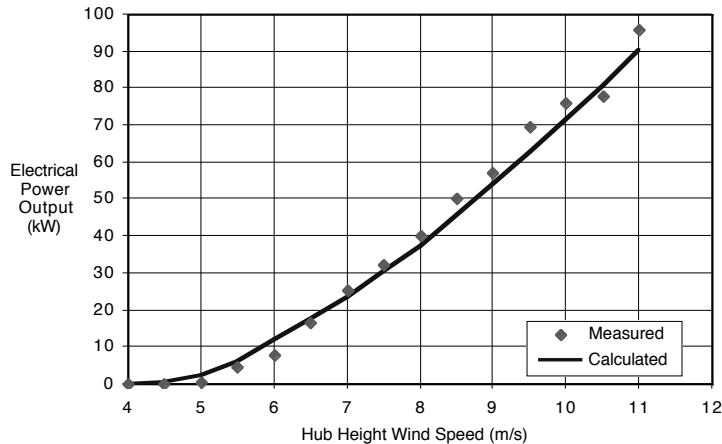
Figure 1.9 Performance Test Comparison

The operational test results provided good confidence in the performance of the ERS-100 blade design (Figure 1.9). The measured loads were also found to be in agreement with design expectations. The ERS blades remained operating in a normal commercial production mode after the completion of the field test effort in October 1999. Normal operation continued for approximately 9000 hours, until July 2001, when one of the test blades failed and cracks were identified in the root region of the two remaining blades.

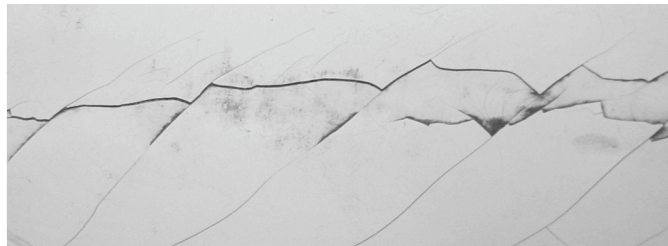
Figure 1.10 Gelcoat Cracking at the Bond Line

The prototype blades were removed from the test turbine and returned to the NWTC for detailed inspection. Cracks in the gelcoat were found along the bond line between the blade shells (Figure 1.10). These cracks were believed to result from the high elasticity of the bonding adhesive relative to the protective gelcoat coating. Although these cracks were not structurally significant, they provide a break in the protective coating and degrade its moisture and UV protection. In addition, the presence of visually observable cracks on the blade surface creates a maintenance problem, since technicians will not generally know if the cracks are structural or not.

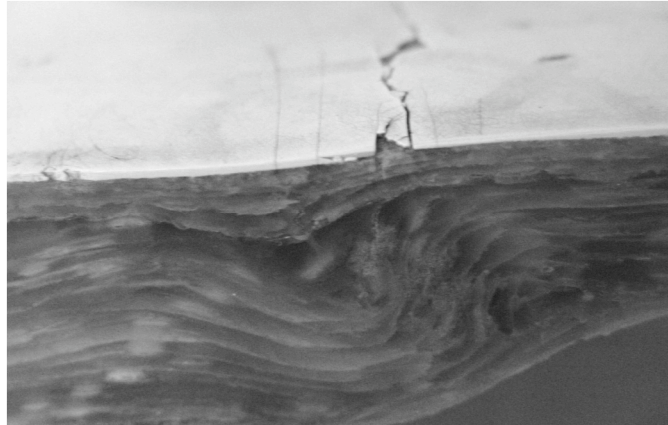
Figure 1.11 Cross-Section of Root Laminate Showing Fiber Folding

Other cracks found in the root region were determined to be structural in nature. These cracks occurred approximately 400 mm outboard of the blade mounting flange. The failure investigation showed that there was significant folding of the fiber in the region of the external root cracks (Figure 1.11). These folds were believed to have been produced during the manufacturing process as the vacuum pressure compacted the glass layers. The root region contains a large build-up of laminate thickness, which is necessary to provide geometric (strain) compatibility between the e-glass composite and the steel root studs. The rapid change in thickness created a slope angle and resulted in movement of the glass fabric under vacuum pressure. The root laminate design was subsequently

modified to provide smoother transition of the root laminate and a much-reduced tendency for the fabric to move axially during infusion. The original 3:1 slope angle of the root laminate was modified by staging the thickness change in two separate steps. In the low strain region closest to the root, the slope was reduced to 4:1 and in the higher strain region outboard of this the slope was adjusted to 12:1.

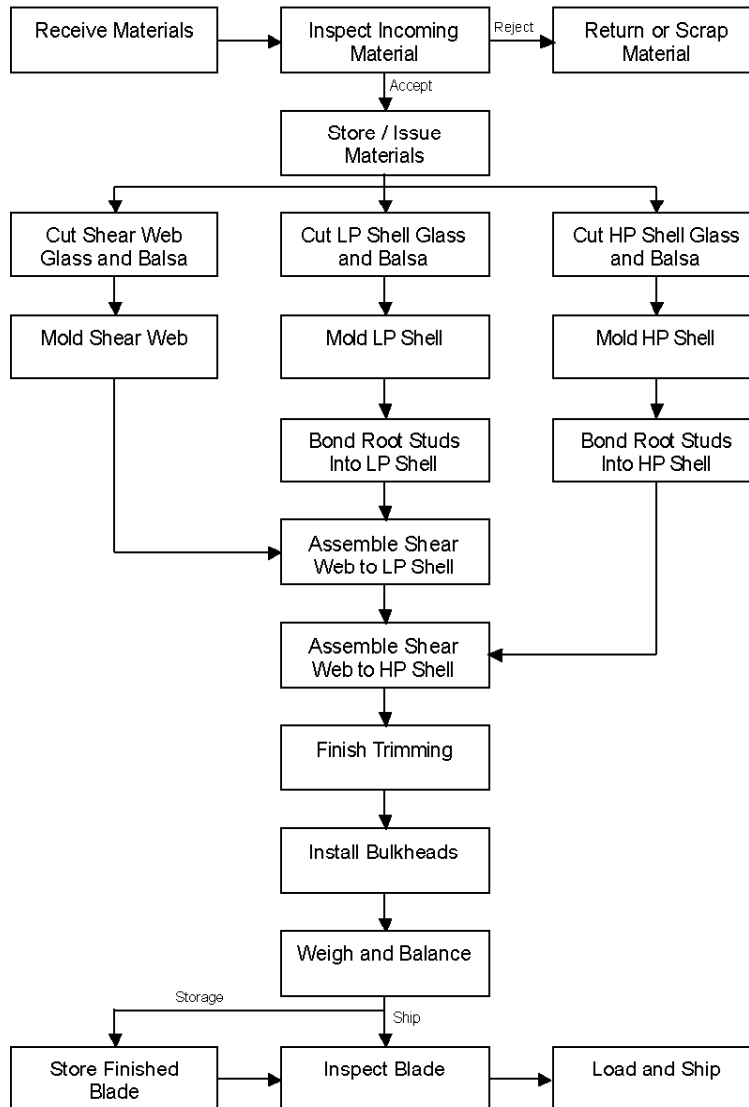
Figure 2.1 Blade Manufacturing Process Schematic

remote manufacturing approach is designing the individual process steps so that they can be controlled and monitored properly under field conditions.

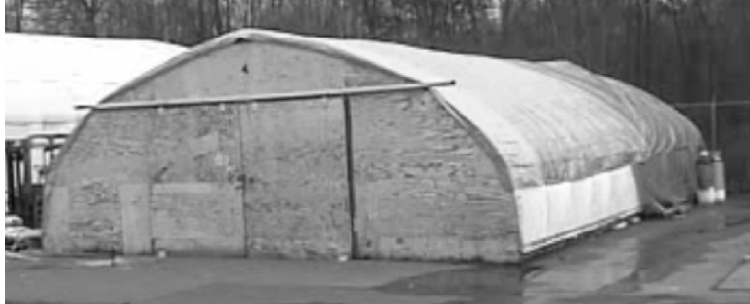
Figure 2.2 Remote Manufacturing Demonstration Building Exterior

The remote manufacturing demonstration was conducted in a simple greenhouse structure such as might be available near wind plant sites (Figure 2.2). The interior work space of the remote manufacturing demonstration building measured 14.6 m (48 ft) long by 9.4 m (31 ft) wide, with an overhead clearance of 3.4 m (11 ft) (Figure 2.3).

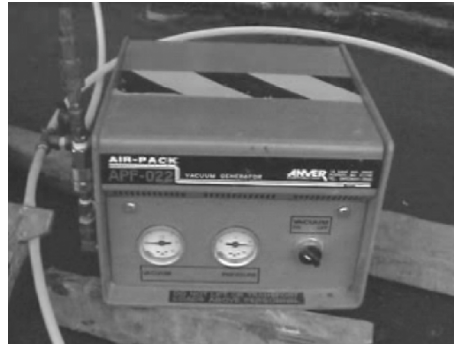
Figure 2.5 Portable Vacuum Generator

The building had an asphalt floor and was heated by a portable propane heater (Figure 2.4), which maintained the temperature of the work area between 65° to 70° F. Weather conditions during the manufacturing demonstration period included rain, sleet, and snow. A portable gasoline powered generator (Figure 2.4) provided electricity for lighting and tools. Suction to operate the infusion process was provided by a portable vacuum generator (Figure 2.5).

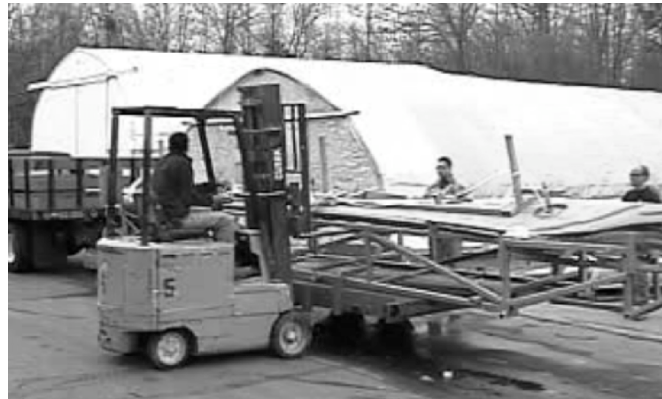
Figure 2.6 Delivery of the Bond Assembly Fixture

The tooling and fixtures were delivered to the remote demonstration site by truck and unloaded with a small forklift (Figures 2.6, 2.7, and 2.8). The tools and equipment used were typical of those available at locations where wind turbines are installed and operated.

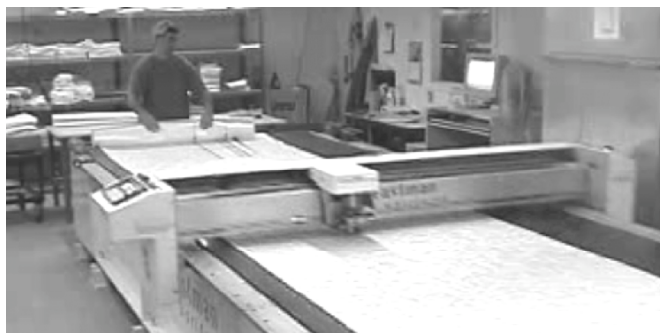
Figure 2.9 Automated Fabric Marking and Cutting

All fiberglass, peel-ply and balsa were cut and organized into kits during a separate manufacturing operation prior to shipment to the remote manufacturing demonstration site. Material was cut and numbered using an automated cutting machine (Figure 2.9) and then organized into “blade kits”.

This automated cutting machine numbered each layer in the blade construction and printed markings for proper placement of the glass material. Once numbered, the materials were placed on a cardboard roll and loaded onto a material transport truck. Materials were weighed (Figure 2.10) prior to organizing them into the blade kits (Figure 2.11).

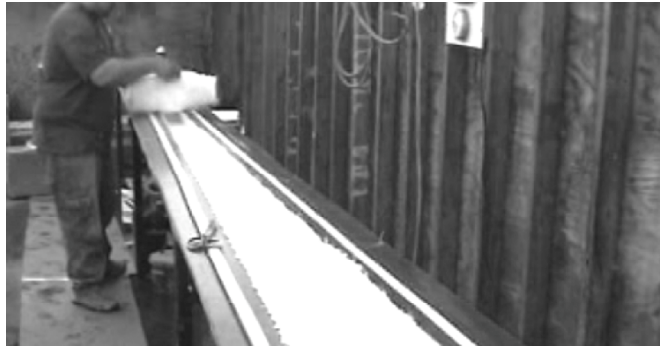
Figure 2.12 Placement of Dry Fabric in the Shear Web Mold

Glass materials were positioned in the mold so they lie flat and are free of wrinkles, folds, bumps or air pockets. Material alignment is critical inside the root and along the shear web axis (Figure 2.12). Orientation of the fabric in each layer was specified by the locating marks placed by the automated cutting machine. All layers contained complete lengths of glass, and no splices were used in the skin laminate. At locations where filler pieces were necessary, they were neatly butt jointed, not overlapped. All loose strands and balsa chips were removed from the lay-up surface before the next layer was unrolled. The pre-cut balsa sheets were inserted in a numbered sequence (Figure 2.13), and any gaps were filled with balsa slivers or 0.25" chopped fibers. After the last layer of glass was inserted into the mold, a layer of peel-ply was applied as the last layer.

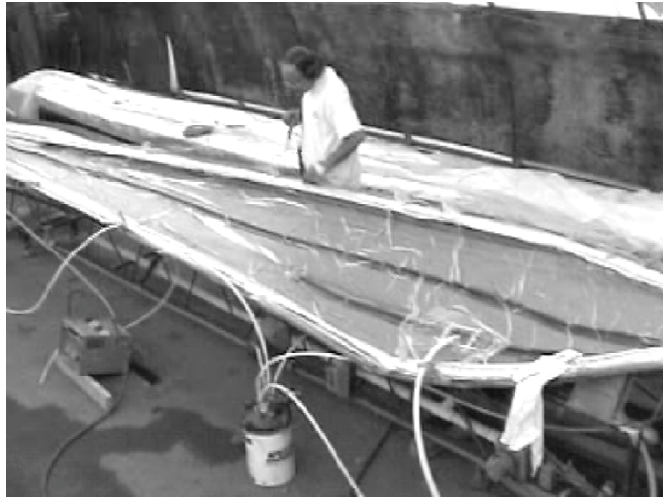
Figure 2.14 Inspecting for Vacuum Leaks Before Skin Infusion

Next, the SCRIMPTM distribution materials were placed over the mold; including the feed and vacuum lines and nylon bag. Prior to infusion, the mold was inspected for vacuum leaks (Figure 2.14) and any leaks were repaired before the process continued.

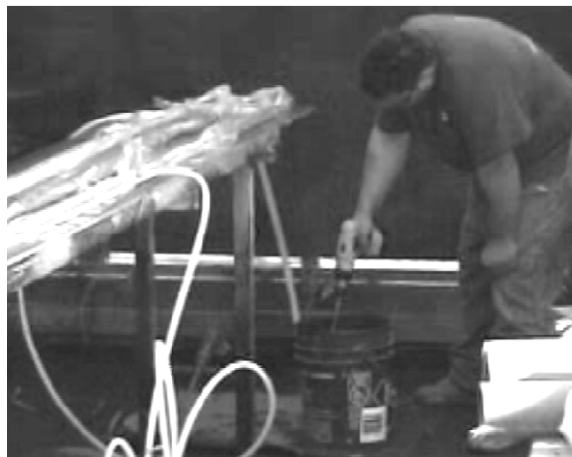
Figure 2.15 Mixing Resin Prior to Infusion

The group leader or other trained personnel prepared the resin batches required to infuse the parts (Figure 2.15). Standard manufacturing recipes were used in conjunction with appropriate adjustments for atmospheric conditions (temperature, humidity and resin activity). Extra attention was given to measuring amounts precisely and mixing the ingredients uniformly to reduce unexpected variations in gel times. Once the decision was made to infuse the part, the resin batches, one after another, were mixed with catalyst. Test samples from each resin batch were taken and placed on the process control timer.

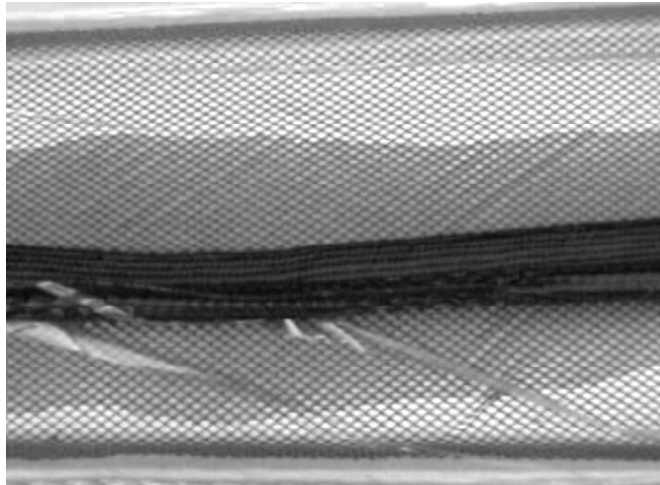
Figure 2.16 Partially Infused Shear Web

The resin batches were placed near the feed lines and opened in sequence once the resin reached its respective feed line. Resin was then infused into the mold via the pressure differential between resin feed ports and vacuum (Figure 2.16).

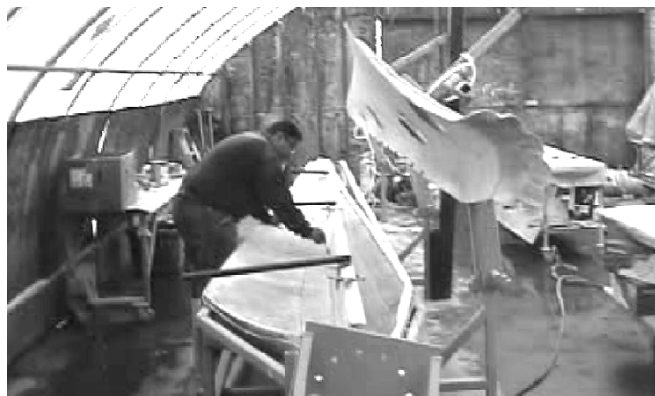
Figure 2.17 Blade Skin and Shear Web in the Bond Assembly Fixture

The LP shell of the blade was placed on a stationary saddle which is part of the bond assembly fixture (Figure 2.17). The shell location was adjusted until correct and secured in position using clamps along the leading edge. A bonding surface was prepared (with 100 grit sandpaper) along the leading edge, trailing edge, and lower shear web bond area. All dust was removed with a vacuum.

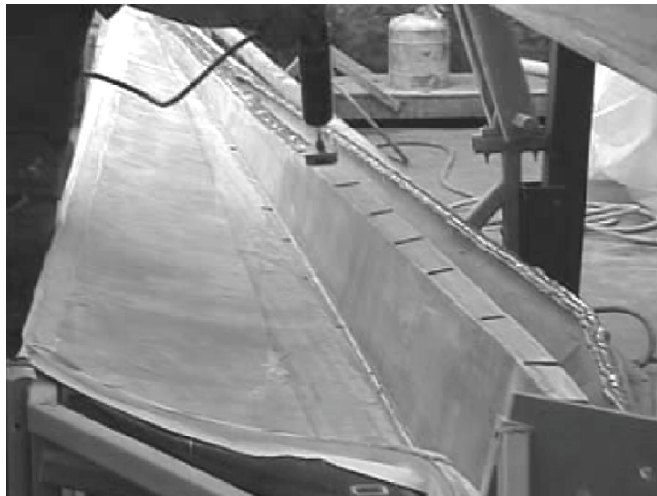
Figure 2.18 Blade Skin and Shear Web Preparation for Bonding

The low-pressure shell was placed in the bond assembly fixture and the shear web lowered until it was properly seated on the LP shell (Figure 2.18). A tip alignment guide was used to aid in positioning the shear web along the length of the skin. One by one, the shear web positioning arms were set up. Once all the arms were tightly clamped into place, the shear web was properly positioned along the blade axis, and the position recorded.

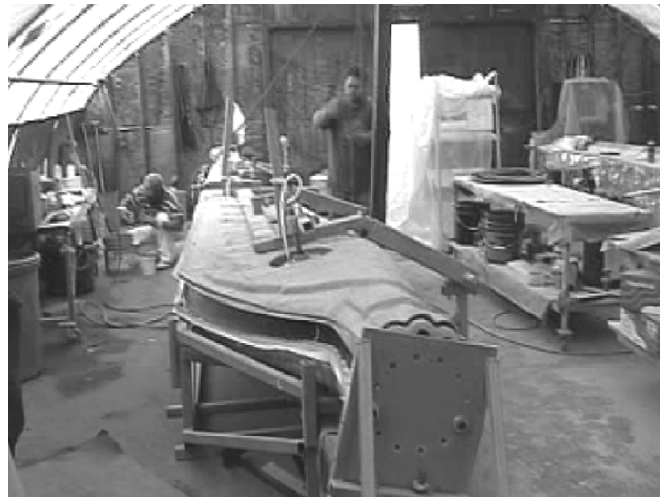
Figure 2.19 Closure of the Bond Assembly Fixture

A hoist was attached to the middle arm of the HP shell moveable saddle. Suction cups were used on the HP shell, and visual feedback was provided to the operator to insure that vacuum was maintained in each cup. The HP shell saddle was lifted and rotated toward the LP shell/shear web. Once the HP shell pivoted past the vertical position, it was slowly lowered onto the LP shell/shear web (Figure 2.19). Any gaps or areas of misalignment were noted and corrected. After the HP shell was properly aligned, it was rotated back into the original resting place. A 6 mm (0.25") bead of a adhesive was applied to the three bonding surfaces. The HP shell was rotated back into place verifying proper alignment of the leading edge. Excess adhesive was wiped and allowed to cure for 90 minutes.

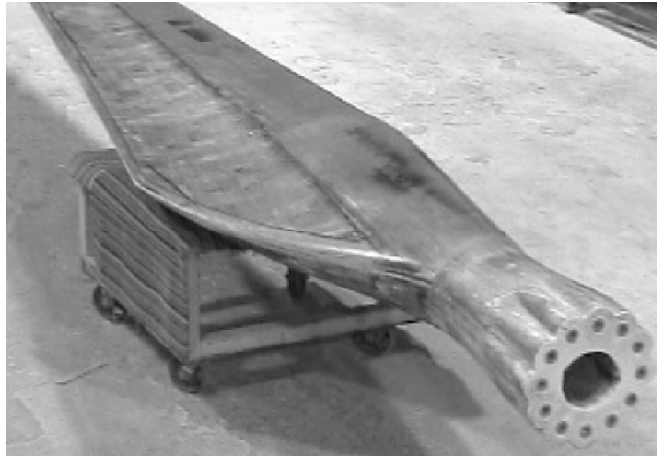
Figure 2.20 Final NPS-100 Blade Assembly

After curing the blade was removed from the bond assembly fixture (Figure 2.20) and prepared for finishing. As noted earlier, the remote demonstration blades were fabricated without the gelcoat surface coating to facilitate inspection and testing.

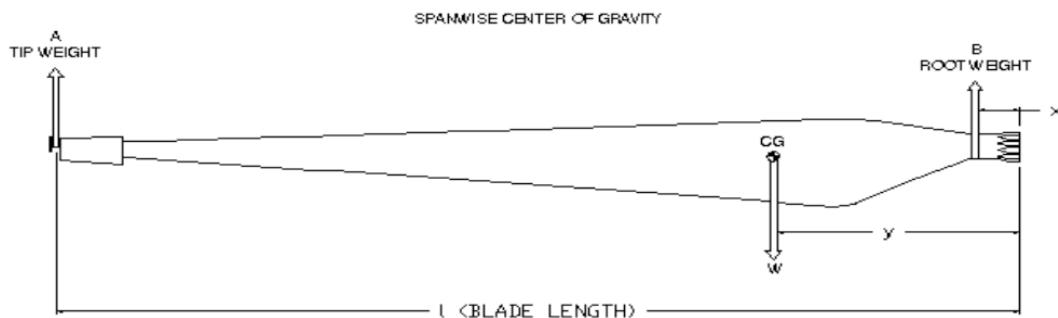
Figure 2.21 Static Balance Measurement Locations

TPI Composites performed weight and balance tests on the prototype blades after fabrication (Figure 2.21). The blade was moved to the balancing and weighing area and placed in holding saddles with the leading edge up. The balance scale used to weigh the blades was set to zero. Then blade root and tip jigs were secured and the blade was raised off the saddles and leveled with an aluminum leveling pole. In the horizontal position the blade root, tip, and total weight were recorded on the process quality information sheets.

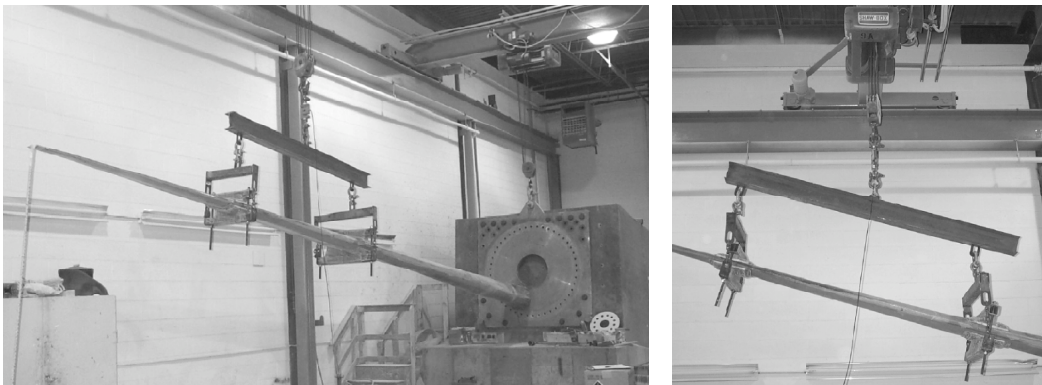
Figure 2.22 TPI Composites Static Blade Test Stand

One of the remote demonstration blades was cut into sections shortly after fabrication. Each of the blade sections was inspected to verify construction details. After reviewing the blade sections, TPI Composites conducted static load testing of three NPS-100 blades at its blade test facility (Figures 2.22). The procedure for static testing consisted of monotonically increasing the applied load in 892 N (200 lbf) increments until the blade failed. Blade loads were applied using a hydraulic winch mounted to a gantry crane and transmitted through a two-point load application system used to approximate the blade design loading distribution.

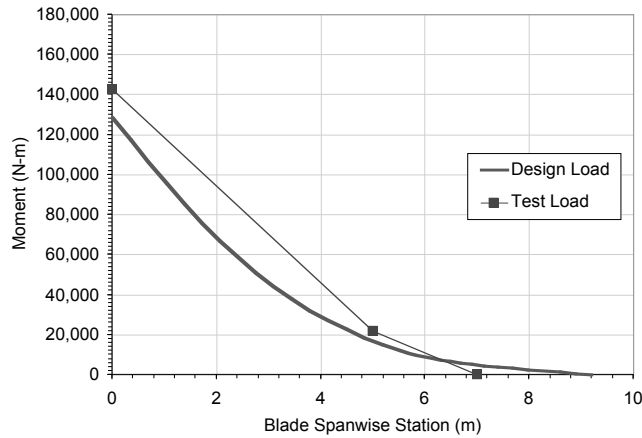
Figure 2.23 Static Failure Moment on 15 February 2002 Test

TPI Composites performed the blade static tests on 15 February, 5 March, and 11 March 2002. The NPS-100 blade design bending moments included partial load factors and test load factors in accordance with the IEC blade test standards [4]. Each of the blades was successful in meeting the ultimate static test loads (Figures 2.23, 2.24, 2.25, and 2.26) and the maximum bending moments at the root flange were 15% to 30% greater than measured on the original ERS-100 prototype. Prior testing had identified buckling as the static failure mode and it remained the primary static failure mode in all three tests. At the failure location the two point loading system generated bending moments that were 30% to 50% greater than the required static test loads.

from the skin surfaces. This failure mode was not anticipated and suggested the epoxy adhesive did not have sufficient peel strength. Another NPS-100 blade was fabricated using a methylacrylate adhesive with higher peel strength and tested statically (test #3). The failure load for the third was somewhat higher than either of the two prior tests and peeling of the adhesive was not observed.

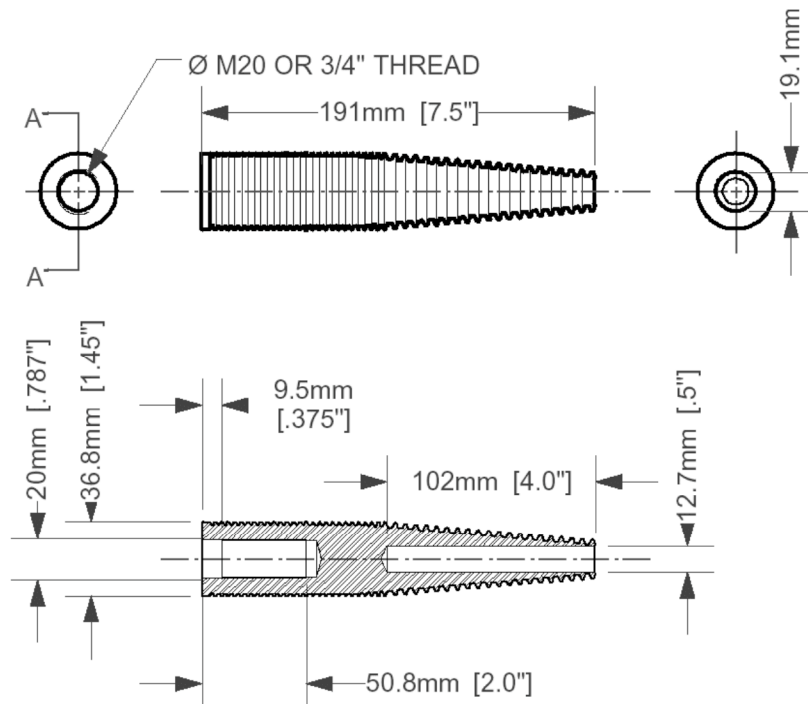
Figure 3.1 Illustration of the M20 Blade Root Stud

Casting the studs has the potential to eliminate some of the design constraints and may offer cost advantages as well. The primary technical difficulty with the use of steel castings is the increased potential for material defects. Reducing the cost of the cast studs also requires somewhat larger manufacturing quantities than machined parts. Overall our preliminary evaluations suggest that casting could likely be the preferred approach for volume production of root studs.

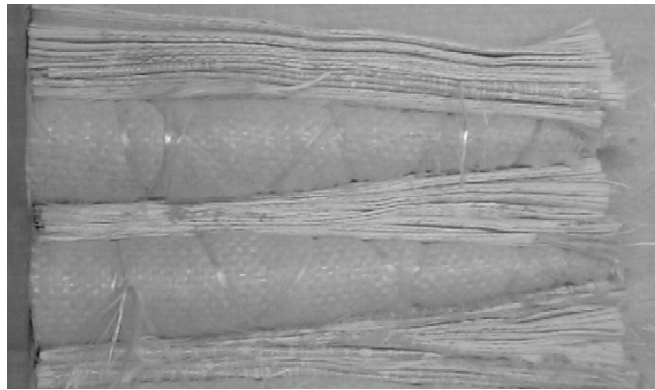
Figure 3.3 Root Stud Preparation for Direct Embedment

An alternative method for installing the root studs in the blade is to directly embed them within the laminate. This approach has been widely applied by LM Glasfiber and offers several advantages. The primary improvement offered by direct embedment is a reduction in the number of manufacturing process steps and tooling requirements. Generally this tends to simplify production and reduce labor cost. TPI Composites investigated the use of direct embedment and developed a methodology for preparing the root studs for resin infusion. Dry fabric was rolled around each stud and folded material was placed between studs (Figure 3.3).

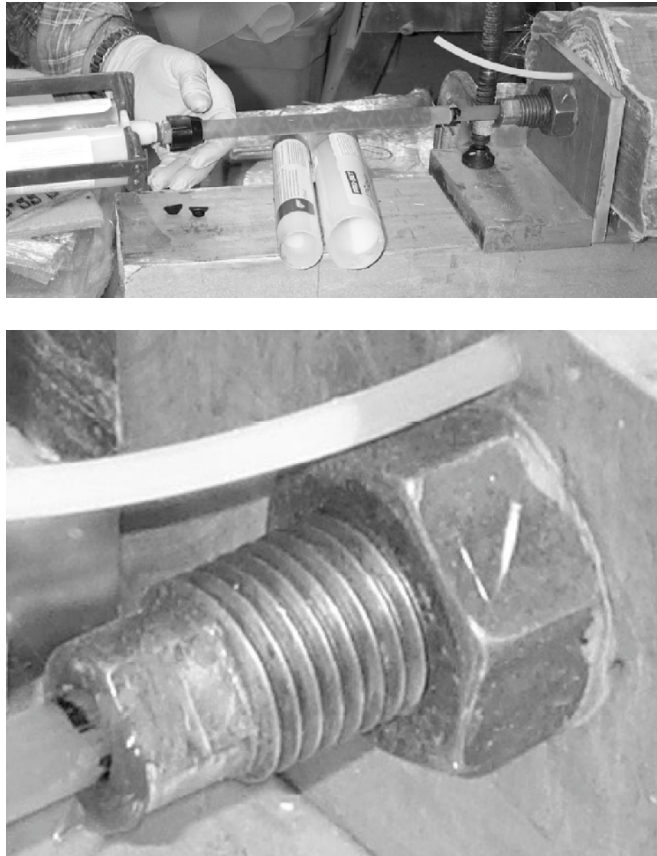
Figure 3.4 Thru-Stud Bonding

The main advantage of the thru-stud approach is that it can accurately locate a sizable number of individual studs to a high tolerance on large bolt circles. The studs are bonded after the blade shells are assembled and installed as a unit while attached to the alignment fixture. This contrasts with direct embedment, in which the studs are infused with each of the two blade shells and aligned during final assembly. Directly embedded studs are subjected to movements due to thermal stresses and resin shrinkage. Developing this process proved more difficult than anticipated and many of the test articles contained voids or areas of poor bonding adhesion. It is believed that those defects could be eliminated with additional manufacturing development effort.

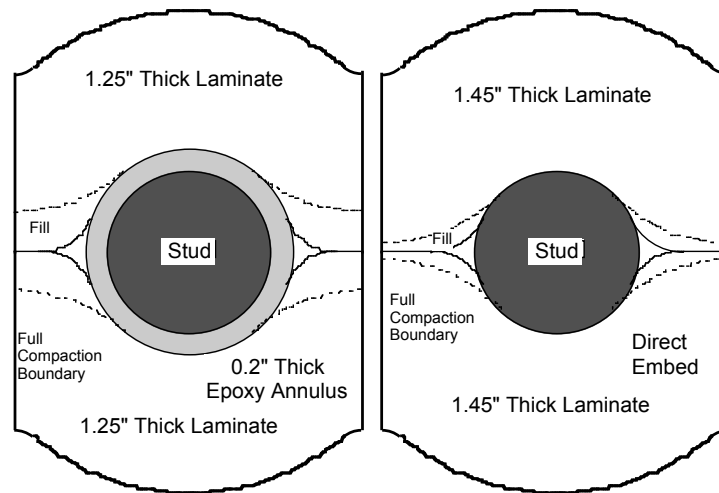
Figure 3.5 M20 Stud Test Specimen Cross-Sections

The original 191 mm (7.5”) long stud for a 3/4-16 UNF (or M20) bolt was dimensioned to be machined from 38 mm (1.5”) steel bar stock. The first use of this stud by TPI Composites was for the ERS-100 blade, which used 10 studs on a 251 mm (9.9”) diameter bolt circle. The nominal stud spacing for this blade was thus $(\pi * 251) / 10 = 79 \text{ mm (3.1”)}$. The second use of this stud was on the NPS-100 blade, which used 12 studs on a 300 mm (11.8”) bolt circle, so the stud to stud spacing was very similar $(\pi * 300) / 12 = 78.5 \text{ mm (3.09”)}$. Since the bolt spacing was nearly equal for both blade variants, only one root stud test specimen size was used. An illustration of the cross-section of the M20 root stud test specimens is provided in Figure 3.5.

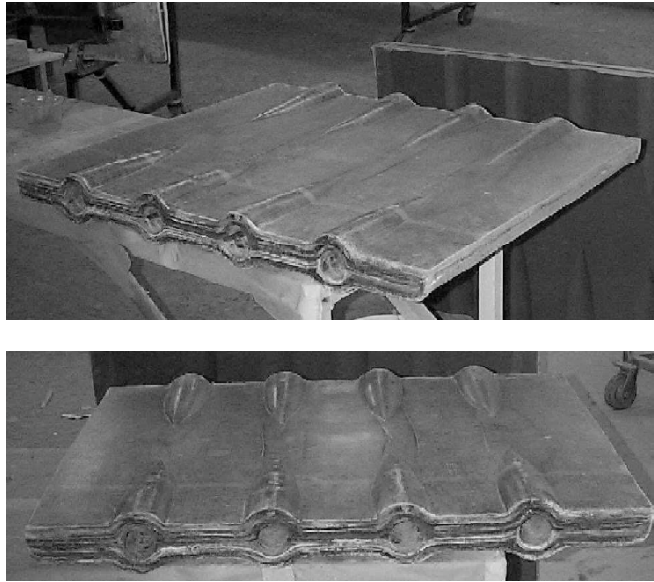
Figure 3.6 M20 Blade Root Stud Specimen Sheets

Special tooling was created by TPI to produce double ended specimens with a stud in each end. The M20 specimens were fabricated in sheets that contained four specimens each (Figure 3.6). Individual root stud test specimens were then cut from the sheet (Figure 3.7) and prepared for testing.

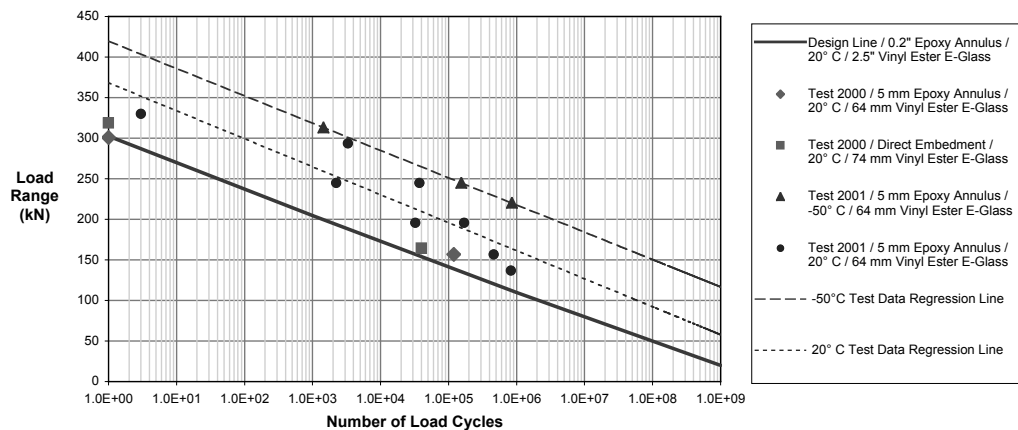
Figure 3.8 Summary of M20 Root Stud Test Results

A specimen of each root attachment type was tested to failure in static tension. The 0.2” epoxy annulus design failed under a static load of 301 kN (67.6 kip), while the directly embedded stud failed at 318 kN (71.5 kip). These results were in good agreement with predicted strength values, thereby generating confidence that the design methodology had been accurately transferred to the new design.

The static results were reviewed prior to fatigue testing of the two root stud approaches. For each root attachment type, an R = 0.1 tension load fatigue test at 65% of the static load result was used to provide an initial fatigue test at intermediate cycle levels. A summary of the M20 root stud test results is provided in Table 3.1 and Figure 3.7. Tests of the root stud documented strength at room temperature (20°C) and under low temperature conditions (-50°C). The measured static and fatigue strength of the root studs exceeded the design values and strength was improved at low temperatures. The results also showed that the direct embedment approach could achieve necessary performance levels under fatigue loading.

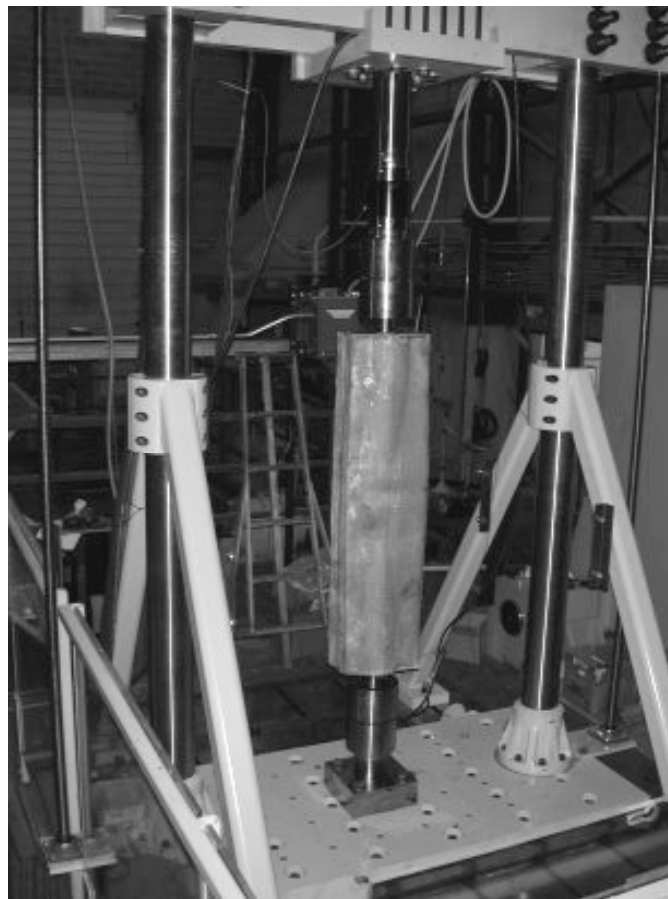
Figure 3.9 Root Stud Fatigue Test Equipment

Specimen #1 was loaded in fatigue with a range from 446/44.6 kN (100/10 kip) using a 3-Hz cycle rate. This specimen failed in 83 cycles (Figure 3.9). Several large voids were identified in the epoxy annulus and the bonding of the stud was incomplete.

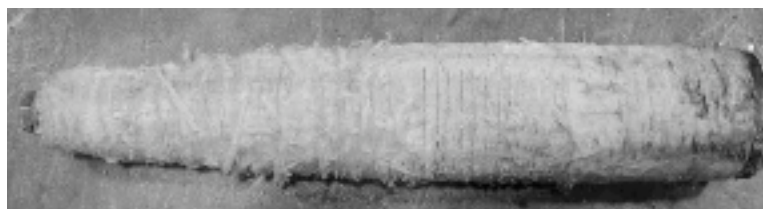
Figure 3.11 Failed M30 Stud From Specimen #6

Specimen #6 was fabricated using direct embedment and was tested using two load blocks at a testing frequency of 4-Hz. The first block was run at loads of 223/2.2 kN (50/5 kip) for 1,000,000 cycles. The second load block was run at loads of 290/2.9 kN (65/6.5 kip) for 31,400 cycles at failure when the top stud (end A) pulled out (Figure 3.10).

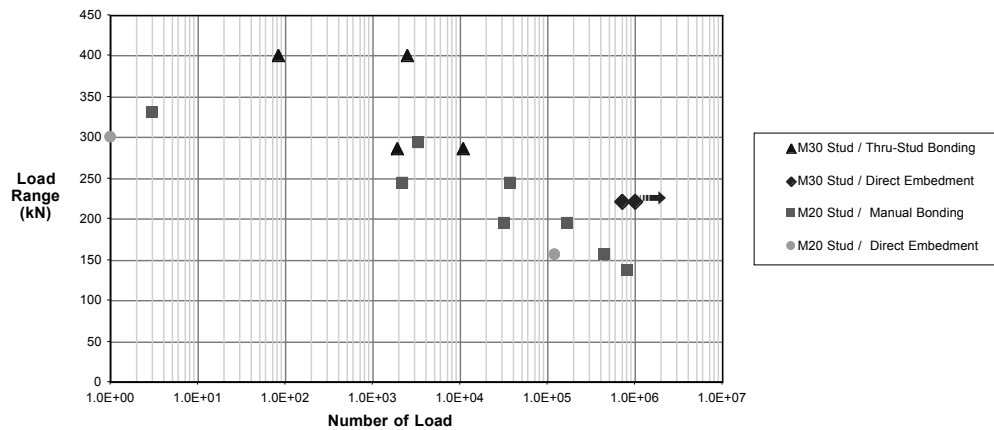
Figure 3.12 Comparison of M20 and M30 Root Stud Test Results

The M30 tests showed lower-than-expected strength data from the specimens and a comparison with the M20 test results is provided in Table 3.2 and Figure 3.11. Simple scaling would suggest that the bond strength for the M30 stud would be 225% of the M20. Observations after failure revealed voids in nearly all of the specimens, but that might not be the only issue involved in the strength shortfall. The test engineers noted a surface condition that would indicate a poor glass-to-epoxy bond at the fracture surface. Widespread areas of glossy and smooth epoxy gave evidence of this, with little evidence of fracture resistance, particularly in the tapered tip region. Further test work will be needed to qualify the performance of the M30 stud design.
