NOAA Technical Memorandum OAR PMEL-130

KEO Mooring Engineering Analysis

June 2006

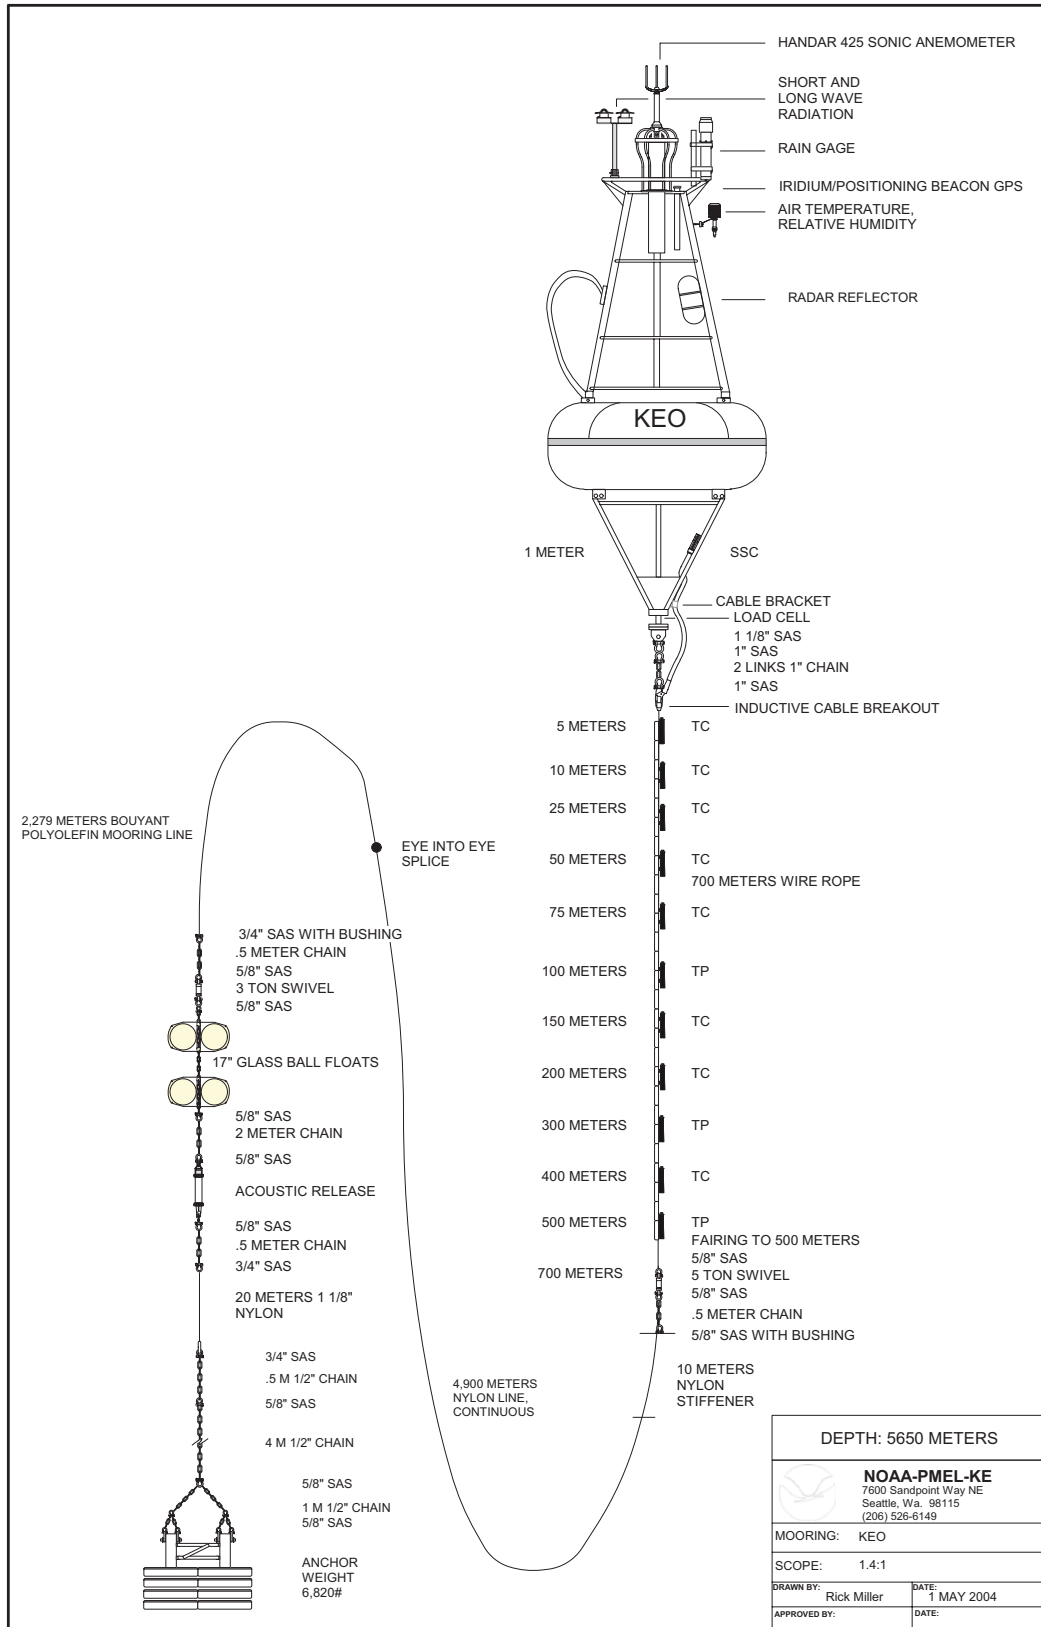
Figure 3: 2004 mooring configuration.

For the 2004 deployment, the mooring was rigged as shown in Fig. 3. The mooring modeling program, WHOI CABLE, was used to evaluate the mooring design prior to the initial deployment.

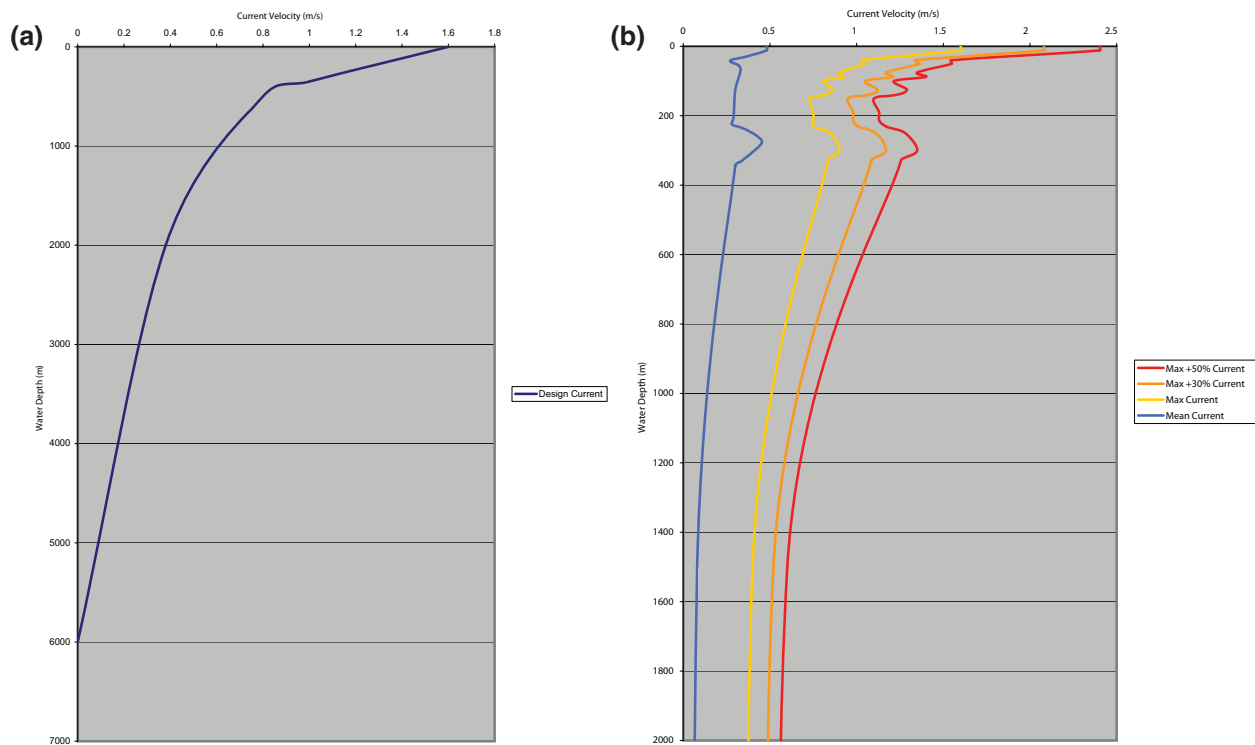
Figure 7: (a) Initial “best guess” current profile, used to design the 2004–2005 KEO mooring. (b) Observed 2005 current profile at KEO site (please note that the current profile is only shown to 2000 m; beyond 2000 m the current remains constant all the way to the bottom at ~ 5650 m).

Before the initial deployment, the mooring was statically analyzed in WHOI CABLE using a “best guess” current profile (see Fig. 7a), and without the addition of the subsurface instrumentation (see Fig. 22). WHOI CABLE is a time domain numerical simulation of moored and towed oceanographic sys-

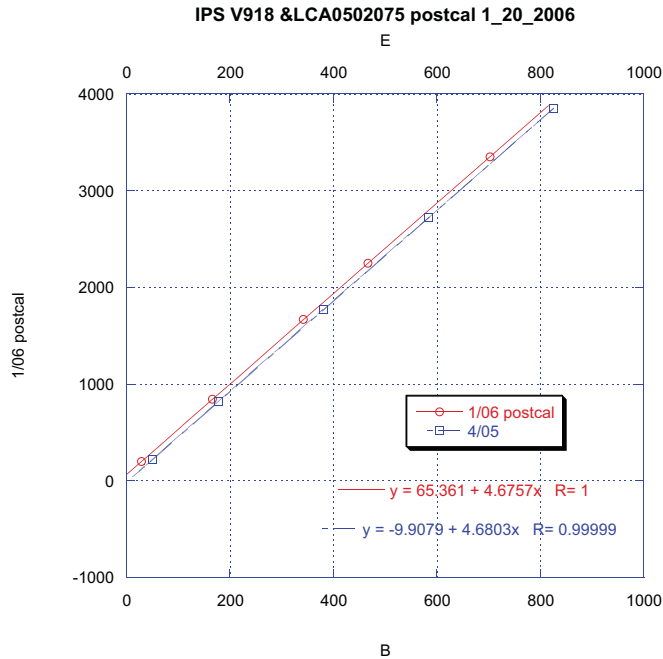
Figure 10: Pre and post-2005 deployment load cell calibration curve.

Upon recovery, a post calibration routine was run on the load cell. Comparing this post-calibration to the pre-deployment calibration showed that sometime during the KEO deployment the load cell drifted ~ 75 lbs. in the positive (heavy) direction (see Fig. 10). After consideration, it was determined that this drift could be attributed to errors in the calibration process, and that a 75-lb. error would be lost in the “noise” during deployment and considered insignificant to the overall load cell results.

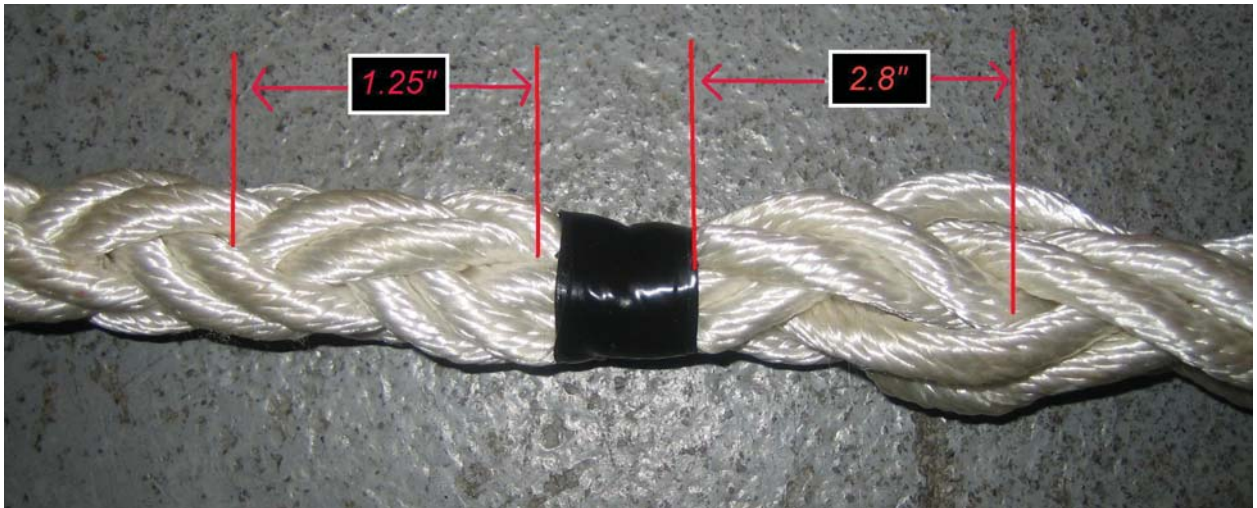
Figure 11: $\frac{3}{4}$ " 8-strand plaited nylon: section A change in pik length.

1. Variable pik lengths of the nylon weave in the segment of line within ~ 3.0 m of the break (see Figs. 11, 13, 14, and 17). Visual inspection of the rest of the 350 m of nylon line recovered did not show this structural abnormality in any other location.
2. Strange loops in the line just before the break point that seem to be caused by two strands of the 8-strand line getting hung on each other and missing the weave for 2–3 pik lengths (see Figs. 15 and 16).
3. Kinks in the individual line strands in the areas of the line that have an especially long ($\sim 4''$) pik length (see Fig. 14)

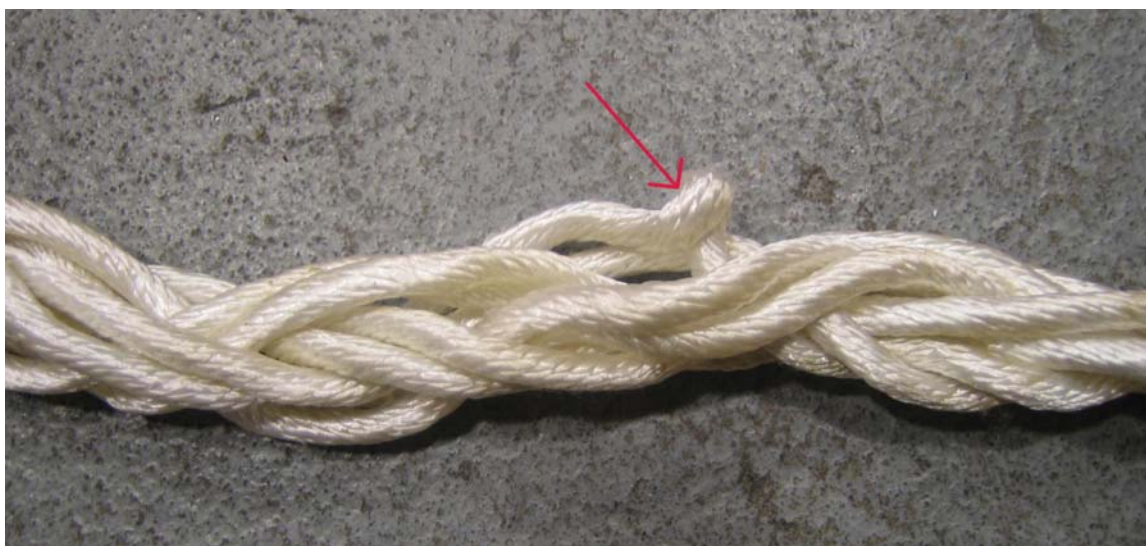
Figure 14: $\frac{3}{4}$ " 8-strand plaited nylon: section C kink.

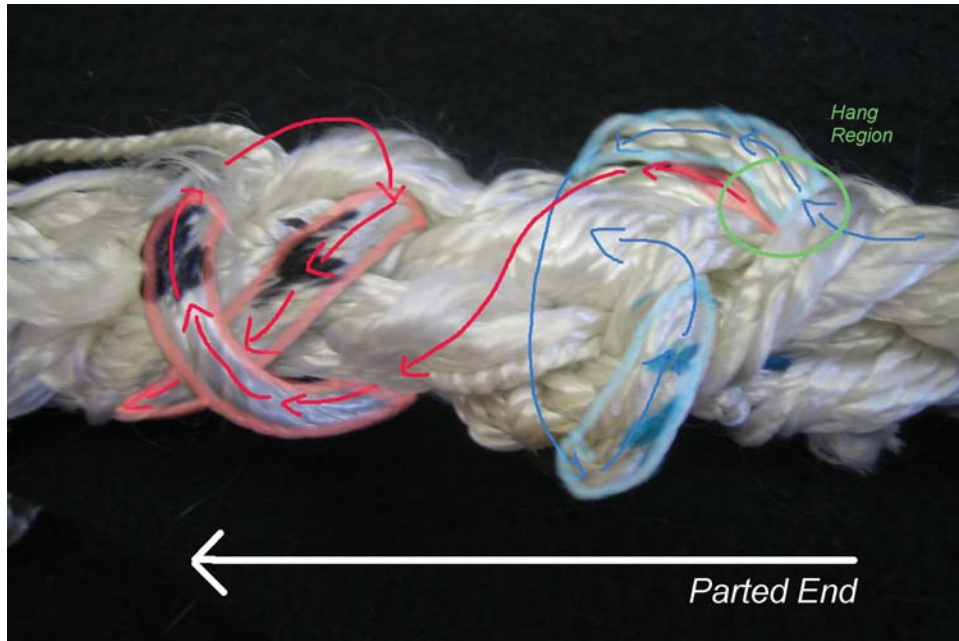
Figure 15: 3/4" 8-strand plaited nylon: section F (top view).

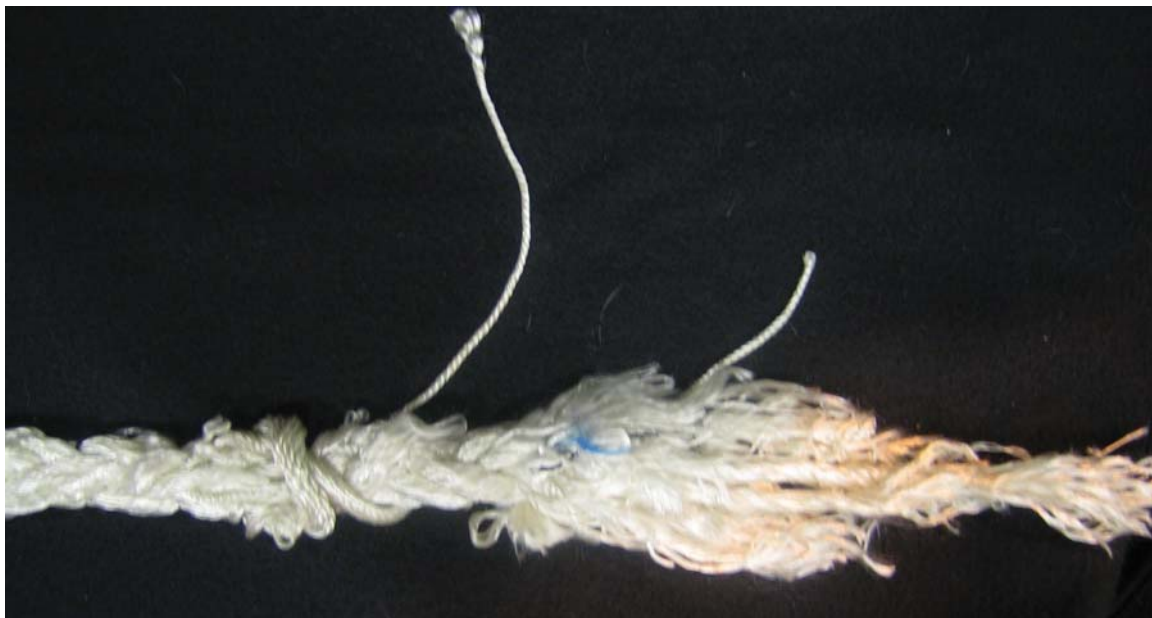
Figure 17: $3/4''$ 8-strand plaited nylon: section F–G parted end.

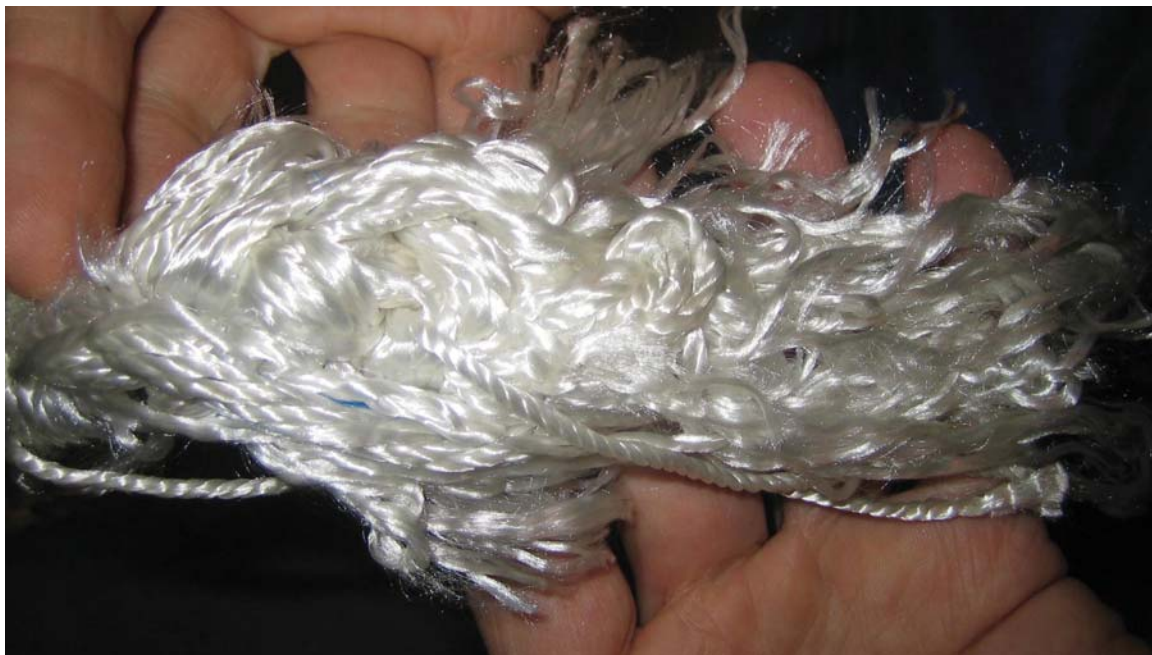
Figure 18: $3/4''$ 8-strand plaited nylon: section G parted end.

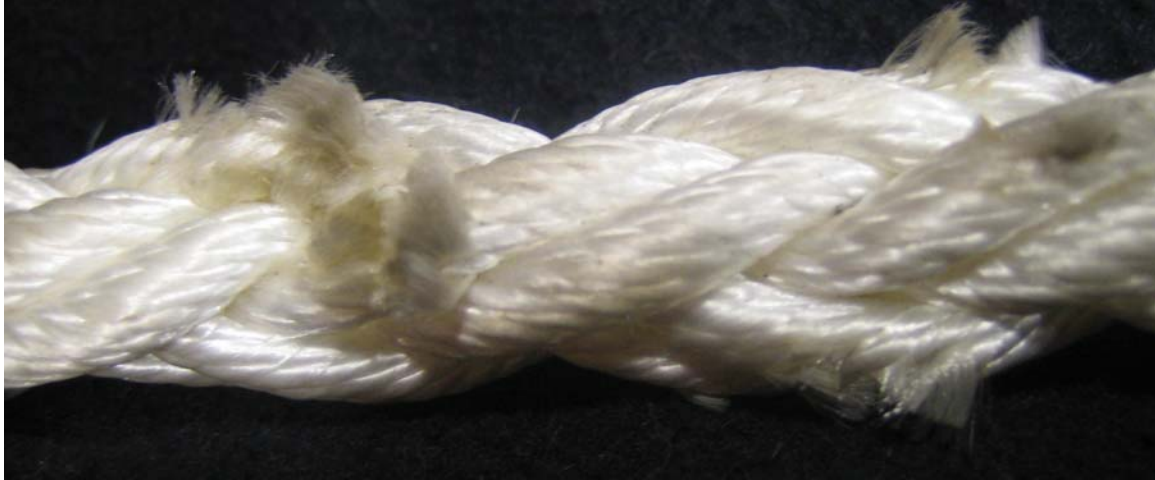
Figure 19: $\frac{3}{4}$ " 8-strand plaited nylon: KEO recovered nylon cut fiber patch.

In addition to the unusual line structure in the vicinity of the break, the rest of the 350 m of recovered line exhibited regularly spaced patches of cut fibers along the outside of the woven strands (see Fig. 19). Studying pictures and notes of the deployment layout failed to yield an explanation for these cut fibers, although the line could have been damaged during recovery operations.

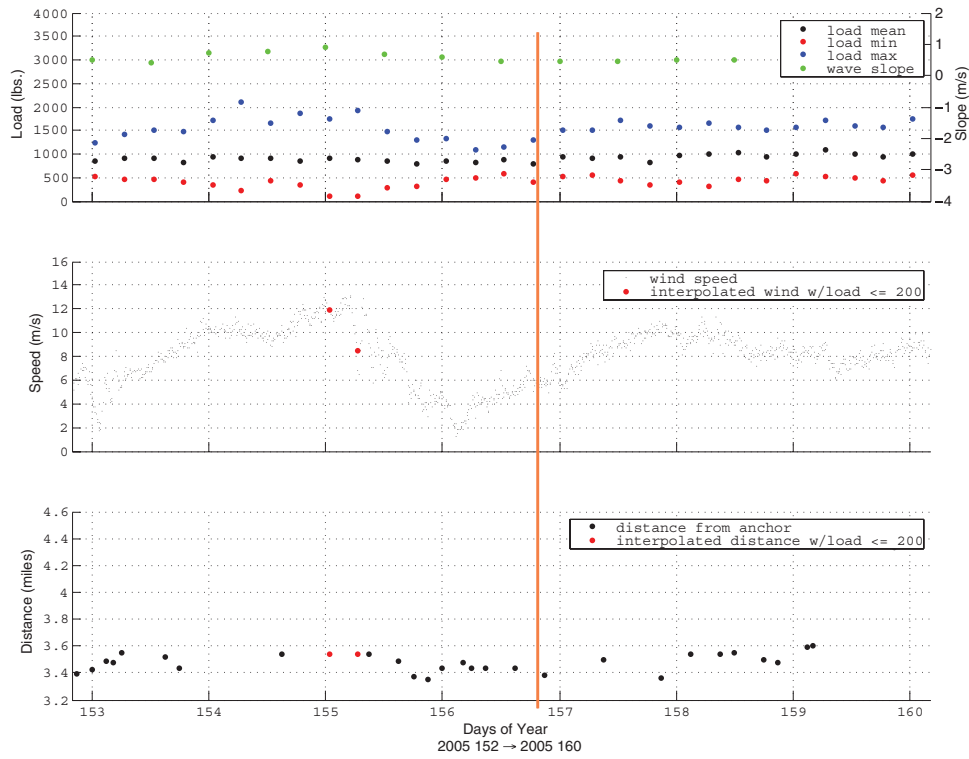
Figure 23a: Loads, wave slope, winds, and KEO buoy distance from anchor for 6 days bracketing 2005156190000.

The dynamic results of these mooring models, and the actual conditions observed, are shown below (See Figs. 23–27). The dynamic output of this CABLE file for the time frame in the vicinity of the break is shown in Fig. 27 (see Fig. 9 for observed forces).

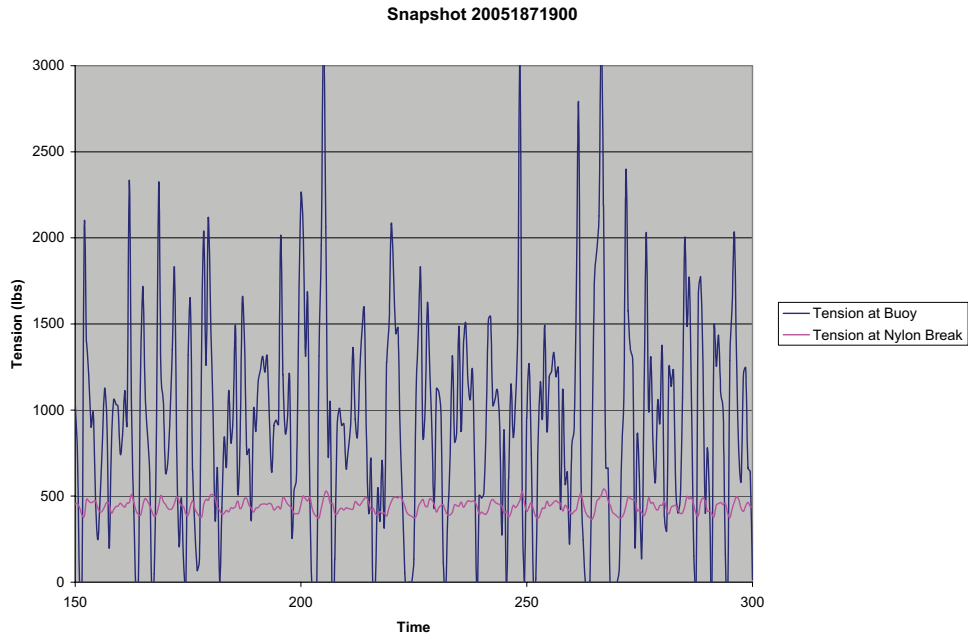
Figure 24b: CABLE dynamic line tension vs. time, 2005 deployment instruments modeled as materials for 2005187190000.

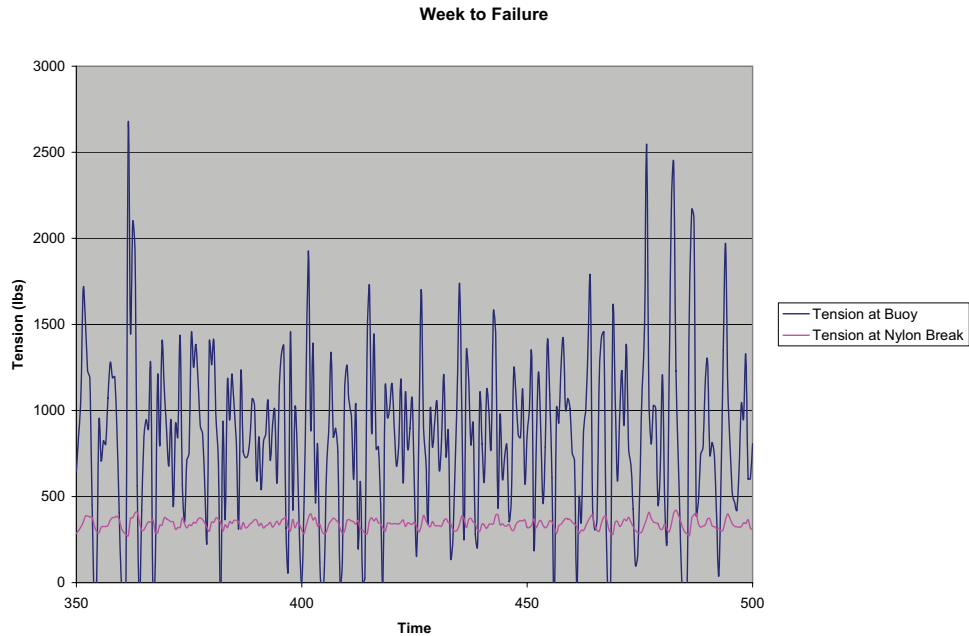
Figure 27: CABLE dynamic line tension vs. time, 2005 deployment instruments modeled as materials for the week preceding failure. Note the many instances of zero tension.

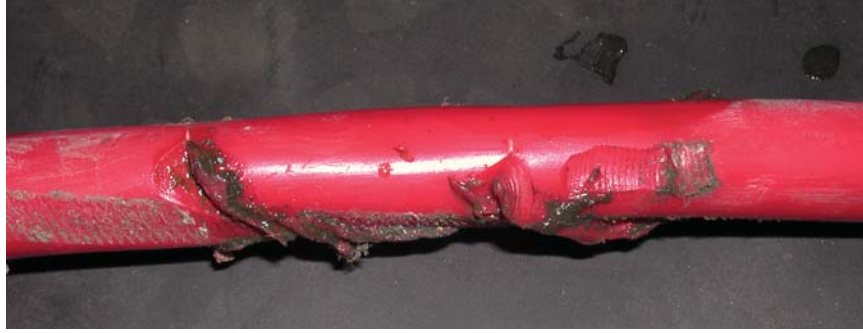
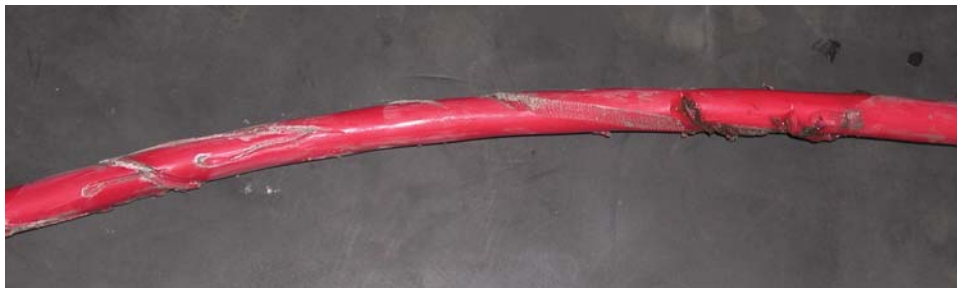
Figure 28: Damage to $3/8''$ jacketed wire rope at a depth of ~ 547 m.

Figure 29: Damage to $3/8''$ jacketed wire rope at a depth of ~ 547 m.

the upper line segment splice, and ~ 250 m above the lower splice). The recovered inductive cable did show apparent fish bite damage at ~ 547 m of water depth (Figs. 28 and 29).
