Post Storm Data Acquisition Aerial Wind Mapping Mission Hurricane Jeanne

October 18, 2004

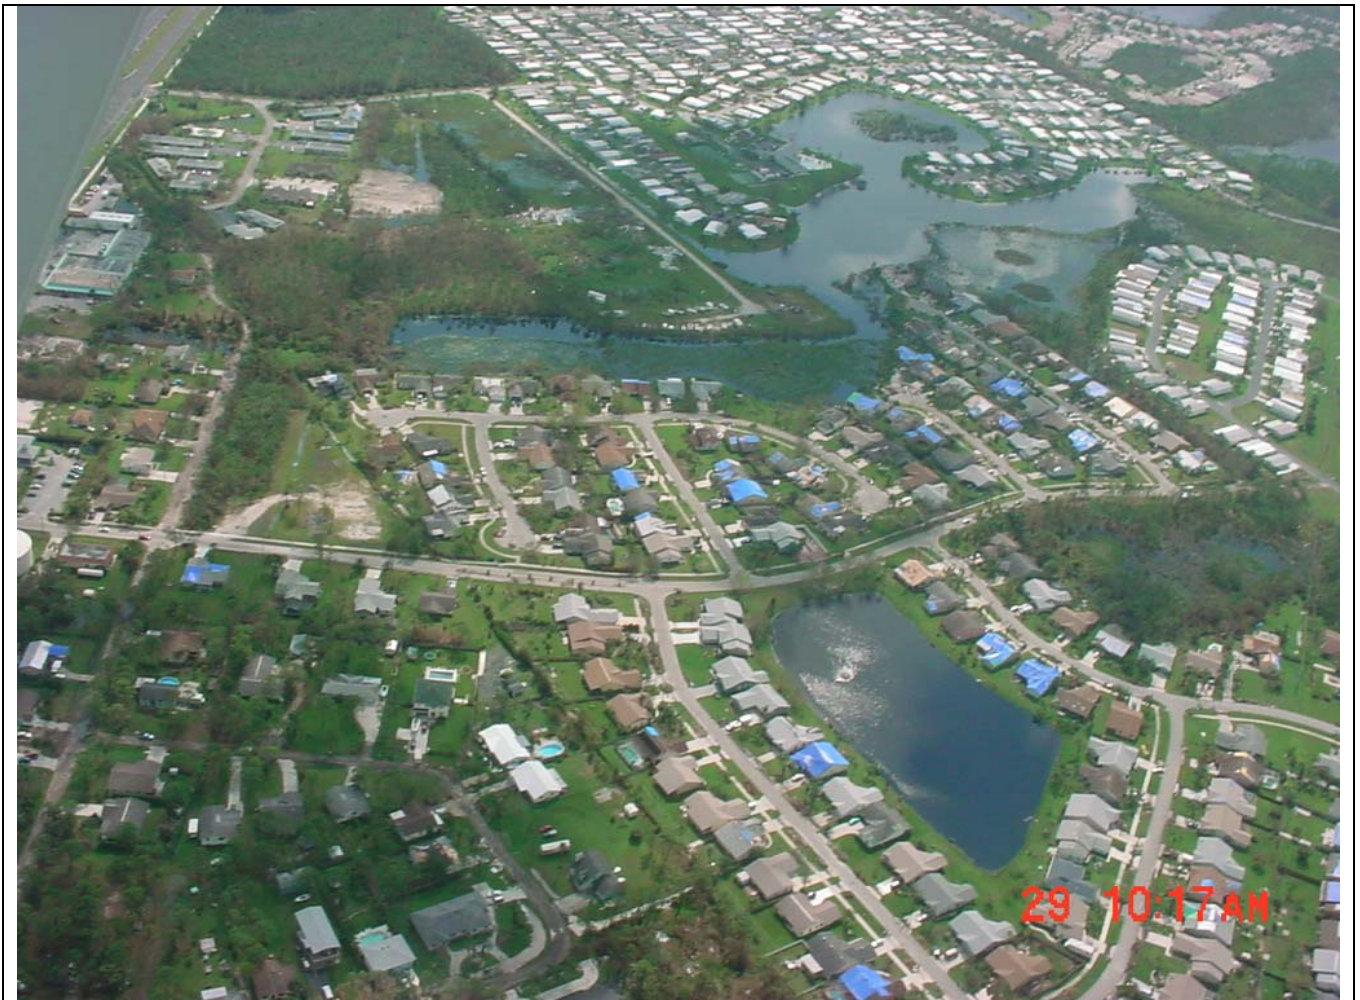
Figure 6 –Most common damage encountered, mainly scattered significant roof damage. (September 26, 2004 10:17 AM EDT)

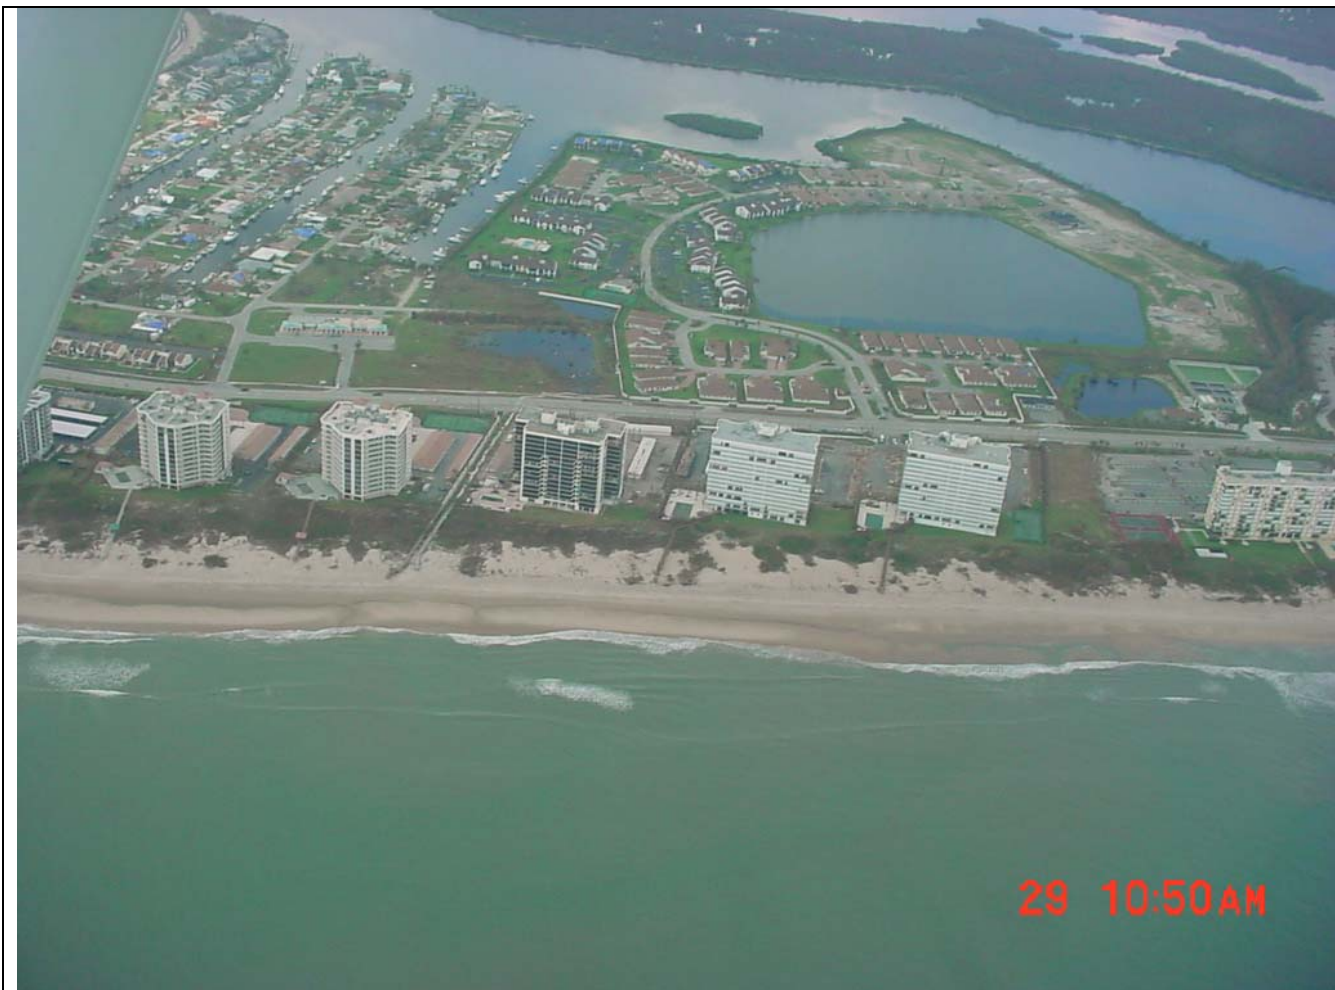
Figure 7 – Damage to oceanfront buildings where many of the windows were blown out and roof damage occurred. (September 26, 2004 10:50 AM EDT)
