FEMA-1672-DR-OR

### Motel Open for Business after Elevation

Tillamook, OR

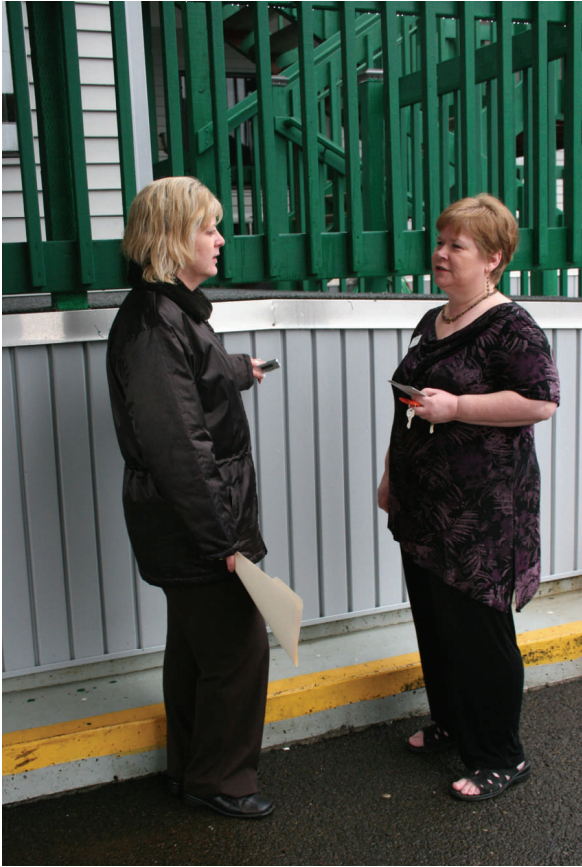
*Joan Huston, FEMA Mitigation Branch Director (DR-1672), and Debi Smith, General Manager of the Western Royal Inn, discuss the fiberglass skirting used to hide the concrete block anchors.*

After the motel was anchored, work began on renovating the damaged rooms and building a ramp to provide access for disabled guests. Contractors also installed a flood-damage resistant skirting to conceal the concrete pilings. The elevation project took about six months.

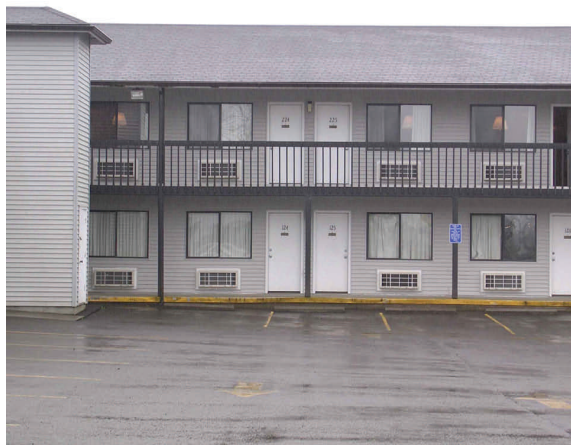
The Western Royal Inn has not always been a safe haven from raging flood waters. In 1996, another violent rain storm slammed into Tillamook and other nearby coastal communities. Three feet of flood waters swamped the first floor of the motel and destroyed 20 of the 40 rooms. The motel owner struggled to keep the business open.

*Western Royal Inn before motel was elevated to prevent repetitive flood damage.*

In 2003, MKT Investments bought the motel and began the task of repairing it with the goal of making sure that when the next big flood arrived, Western Royal Inn would stay open for business. The first task was to raise the building almost four feet. The four foot elevation requirement was determined by FEMA flood maps and the local ordinance requiring the first floor be two feet above

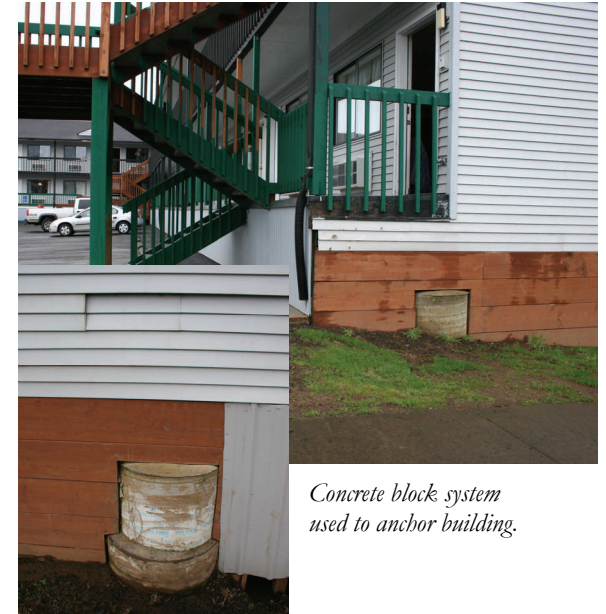
*Concrete block system used to anchor building.*

the 100-year base flood elevation. Contractors brought in many hydraulic jacks to raise the structure and pour cement support pilings. The building was then anchored to the concrete pilings.
