REDESIGN, CONSTRUCTION,
AND
FIELD TESTING
OF A
PROTOTYPE FLOTATION SYSTEM
FOR A
WATER JET BARRIER

Environment Canada
RFP 4808-3-2

October 1992

**Fleet Technology Limited
311 Legget Drive
Kanata, Ontario
K2K 1Z8**

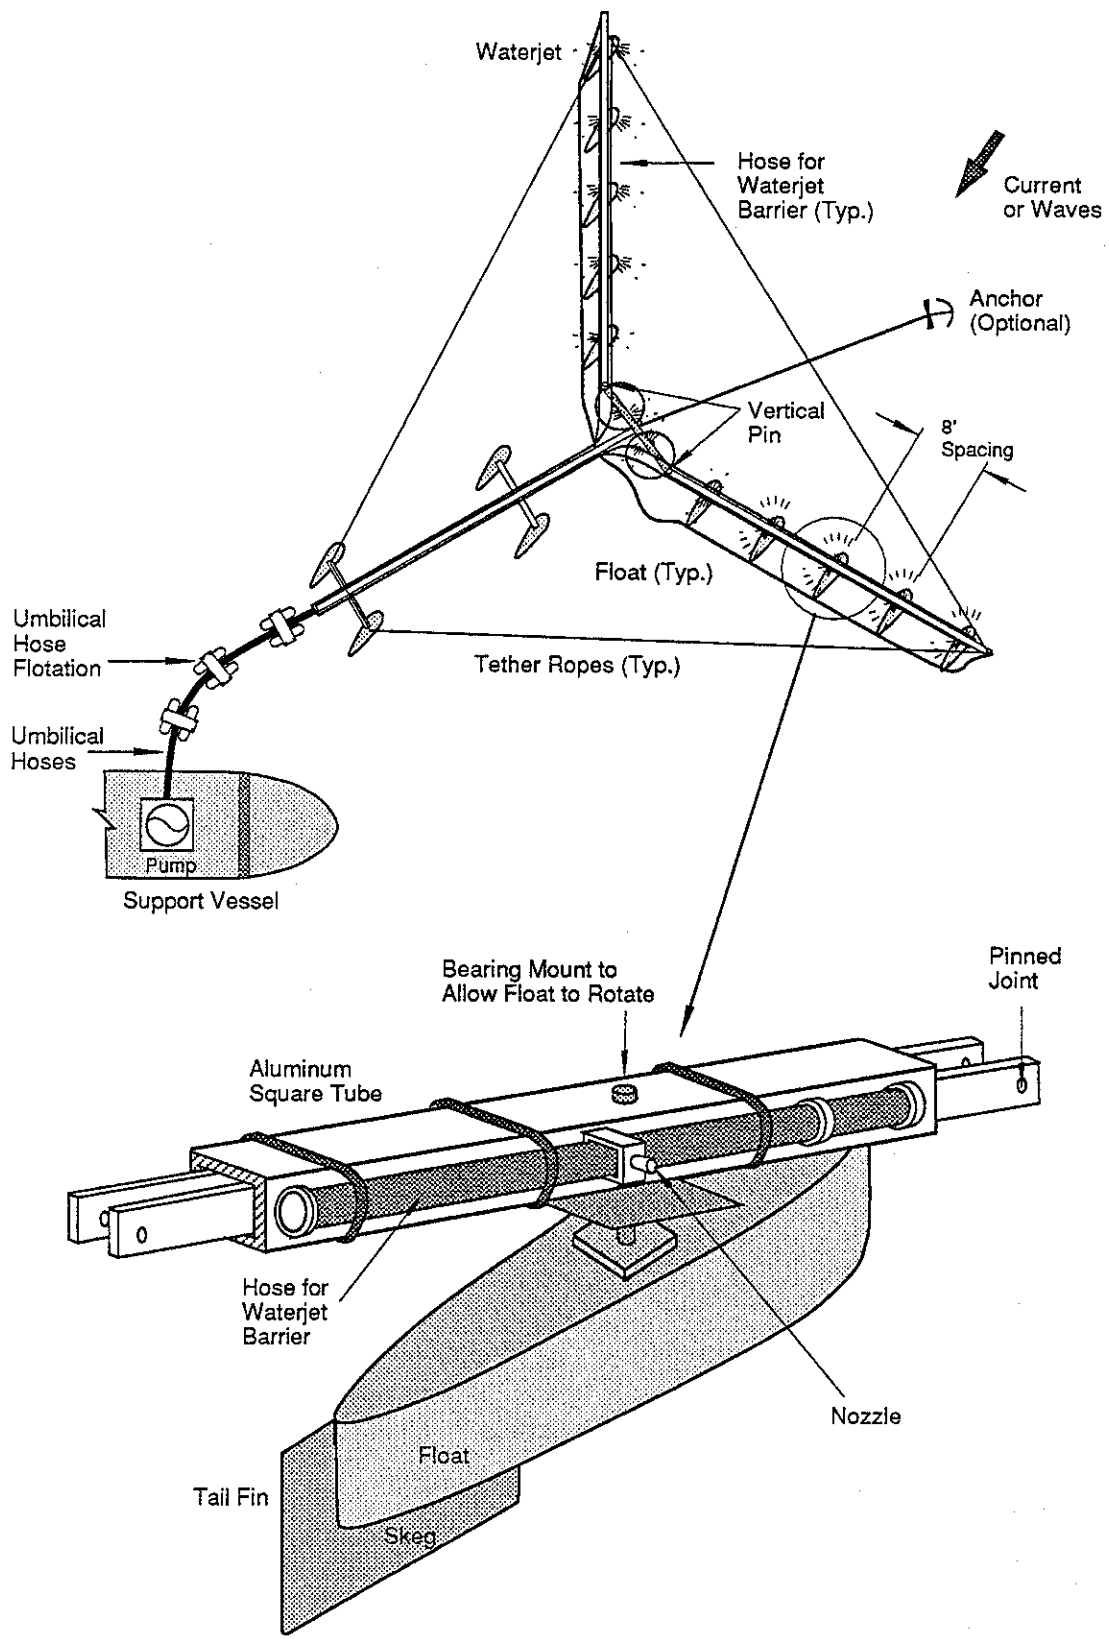
Figure 1: Schematic of Revised Waterjet Barrier

In concept, the waterjet barrier consists of a series of nozzles mounted on floats to emit flat, fan-shaped, high velocity jets of water horizontally about 15 to 30 cm above the surface of an oil slick. The nozzles are spaced so that the sprays overlap to create a continuous front. A series of opposing nozzles are mounted on the "back" side of the barrier to balance the thrust from the forward nozzles. As the flow to the forward and back nozzles is separately controlled, the waterjet barrier can be manoeuvred in the field to suit local conditions (e.g., to respond to changes in winds, spill conditions, or tidal currents).

The **general arrangement** of the system was also changed. To reduce the flexibility of the waterjet barrier and reduce the number of floats required, it was decided to support the hydraulic hoses rigidly with aluminum square tube sections between the floats. Each support section was pinned together to allow movements in the vertical direction. The intent was to limit the stress induced on the boom structure by wave action.

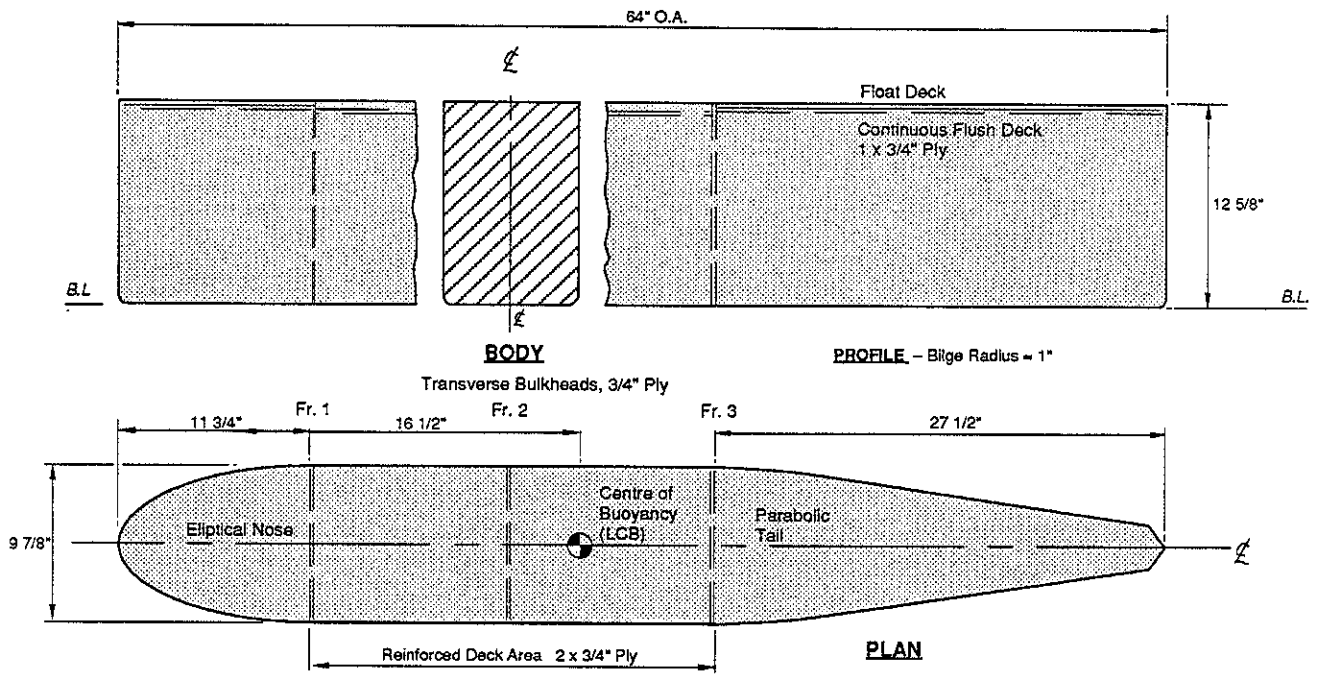
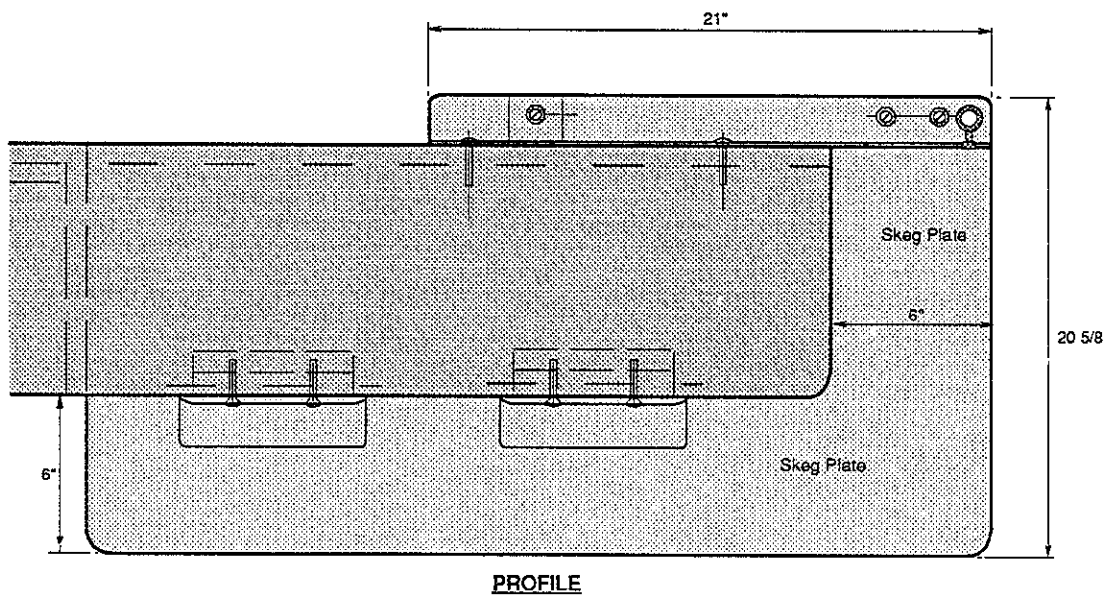
Figure 2: Airfoil Float Design

- a) the use of an "airfoil-type" float that was able to "weathervane" in the current.
- b) a reduction of the number of floats by spacing them at 2.4 m (8 ft.) centres, rather than at 1.2 m (4 ft.) centres as in the "original" design.

2a: General Arrangement of Float

2b: Float Skag Details

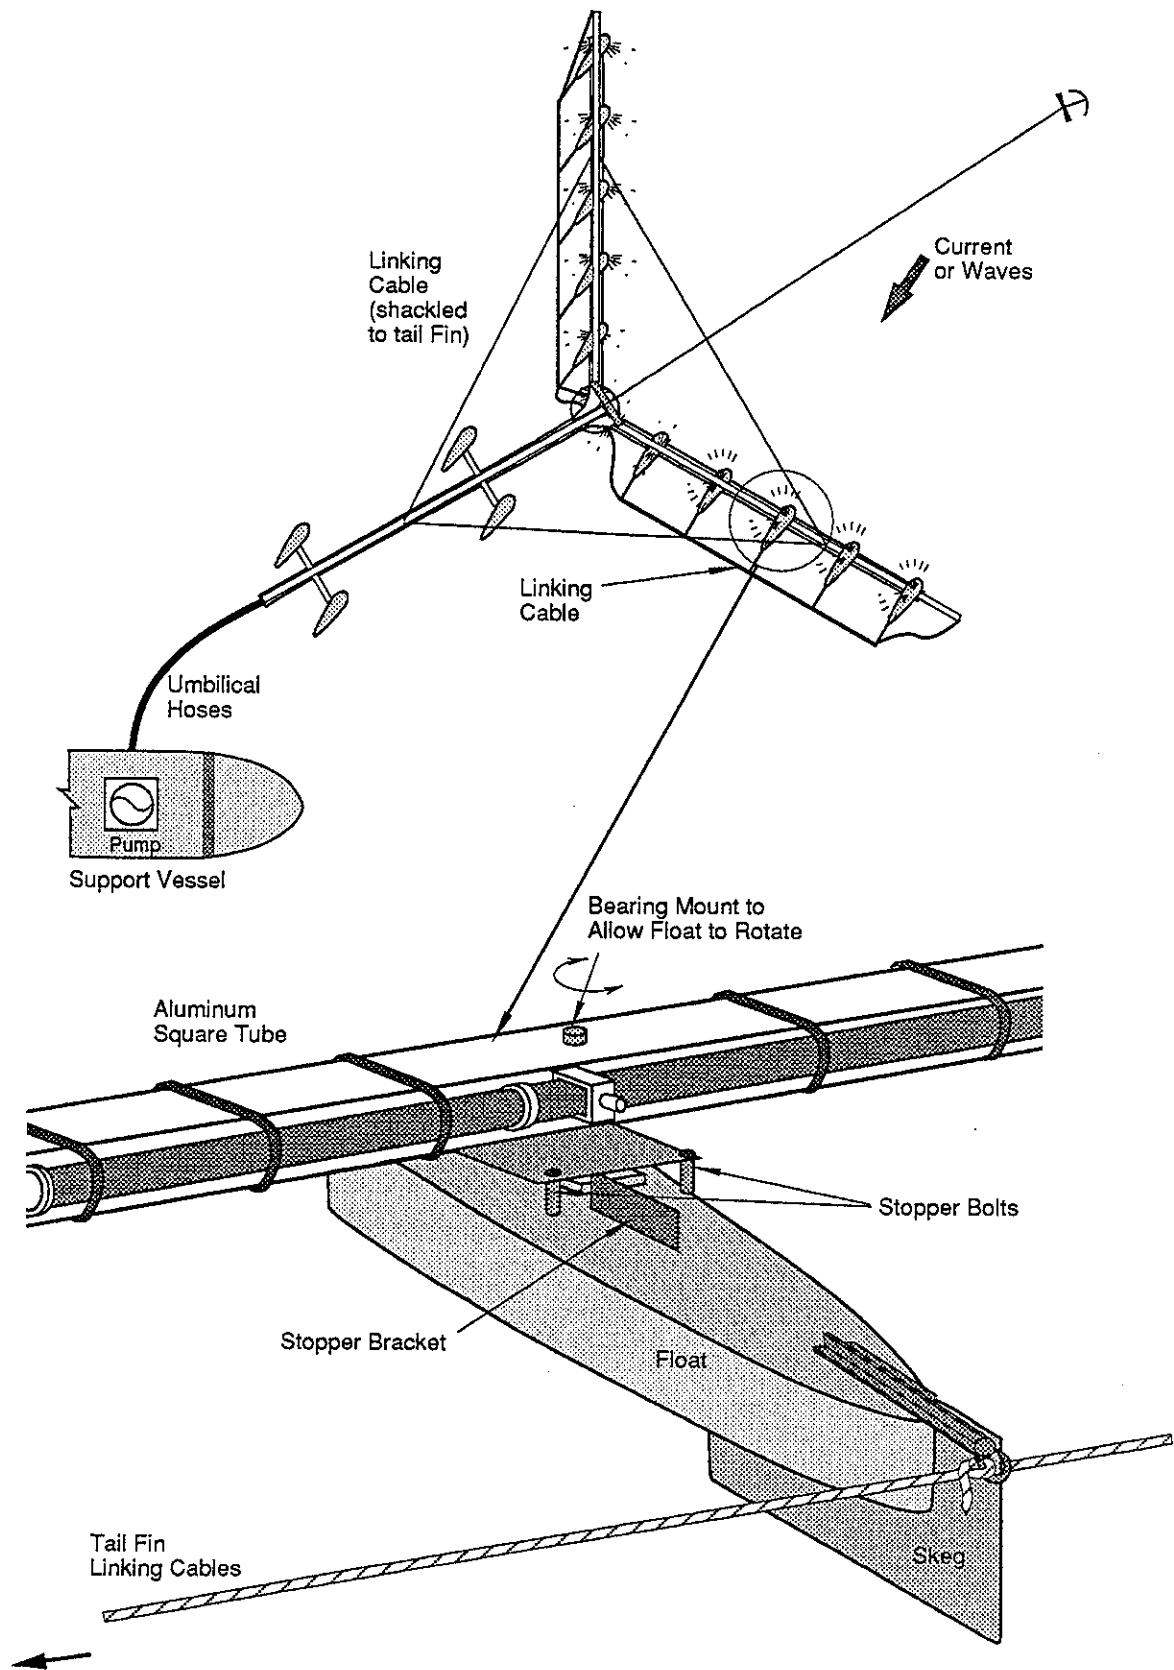
Figure 3: Constraints on Float Weathervaning Action

It was expected that some constraint on the weathervaning action of the floats might be required, particularly during deployment and during low current conditions. Because the floats are slender, with weight of the boom arms well above their centres of buoyancy, the individual arm can capsize should the floats align too closely with the axis of the boom arm. Two types of float constraint were eventually fitted, which allow the float to weathervane through an angle of about 90°, centered on a line perpendicular to the boom arm:

- a) Stops fitted to each float, as shown in **Figure 3**.
- b) Linking cables joining each float at the tailfin, such that they weathervane in unison as shown in Figure 3. A level of redundancy is also introduced should a stop fail.

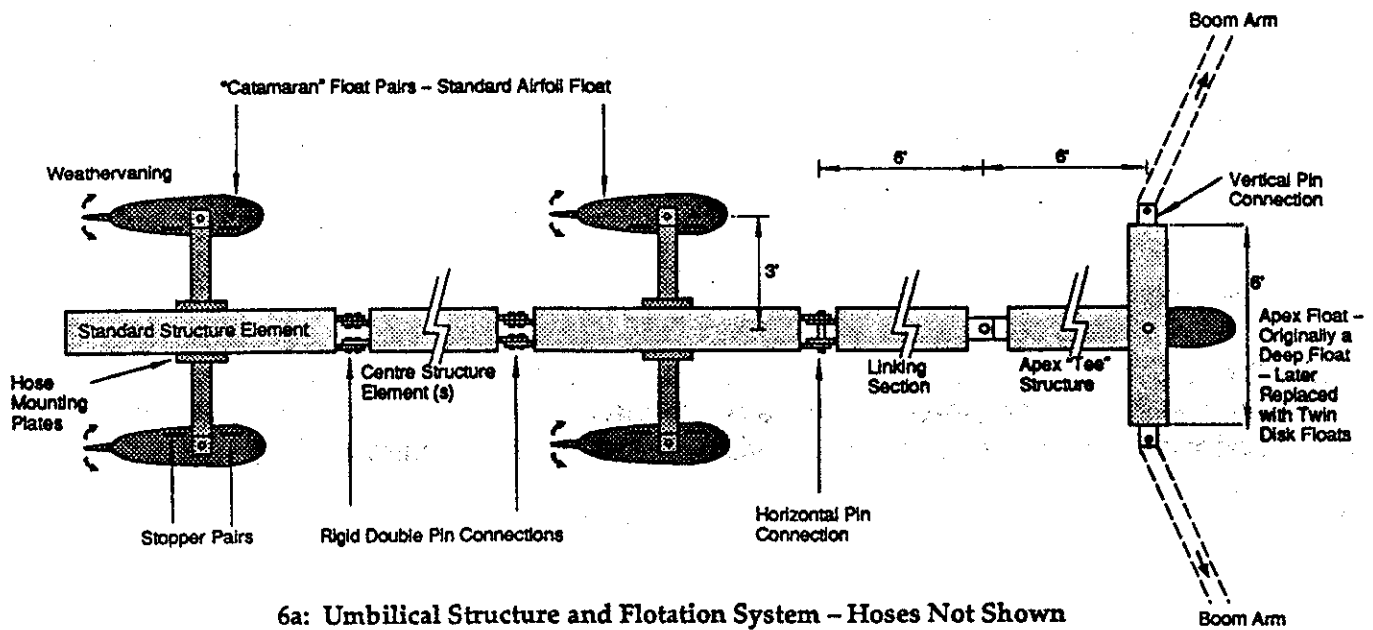
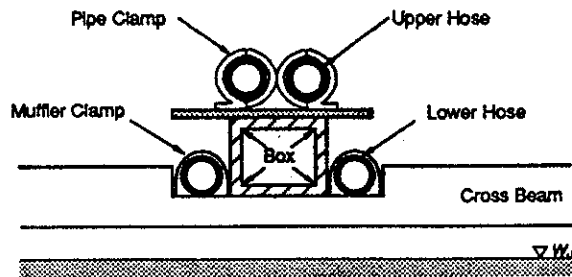
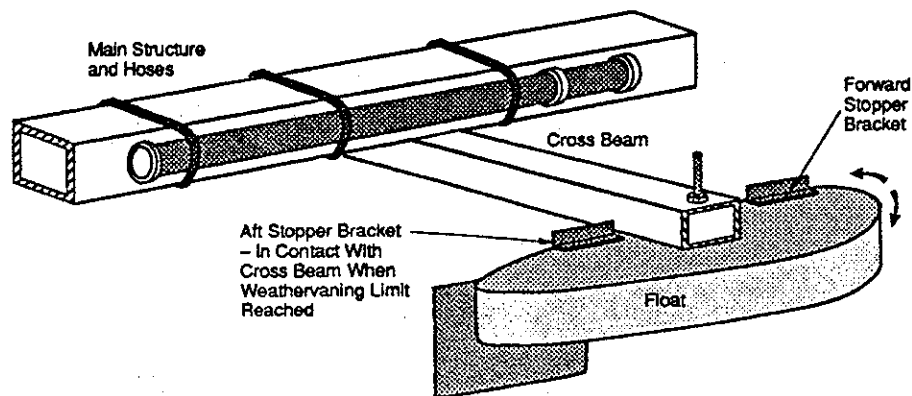
Figure 6: Revisions to Umbilical Hose Flotation System - 1992

6a: Umbilical Structure and Flotation System - Hoses Not Shown

6b: Section Showing Hose Arrangement

6c: Weathervaning Constraints on "Catamaran Floats"

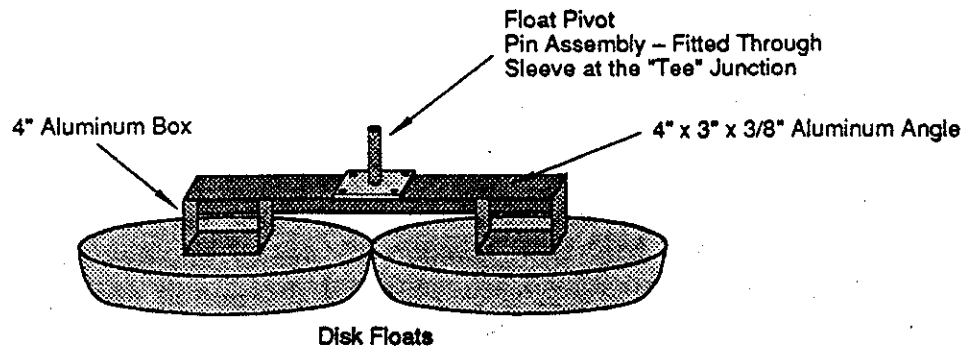
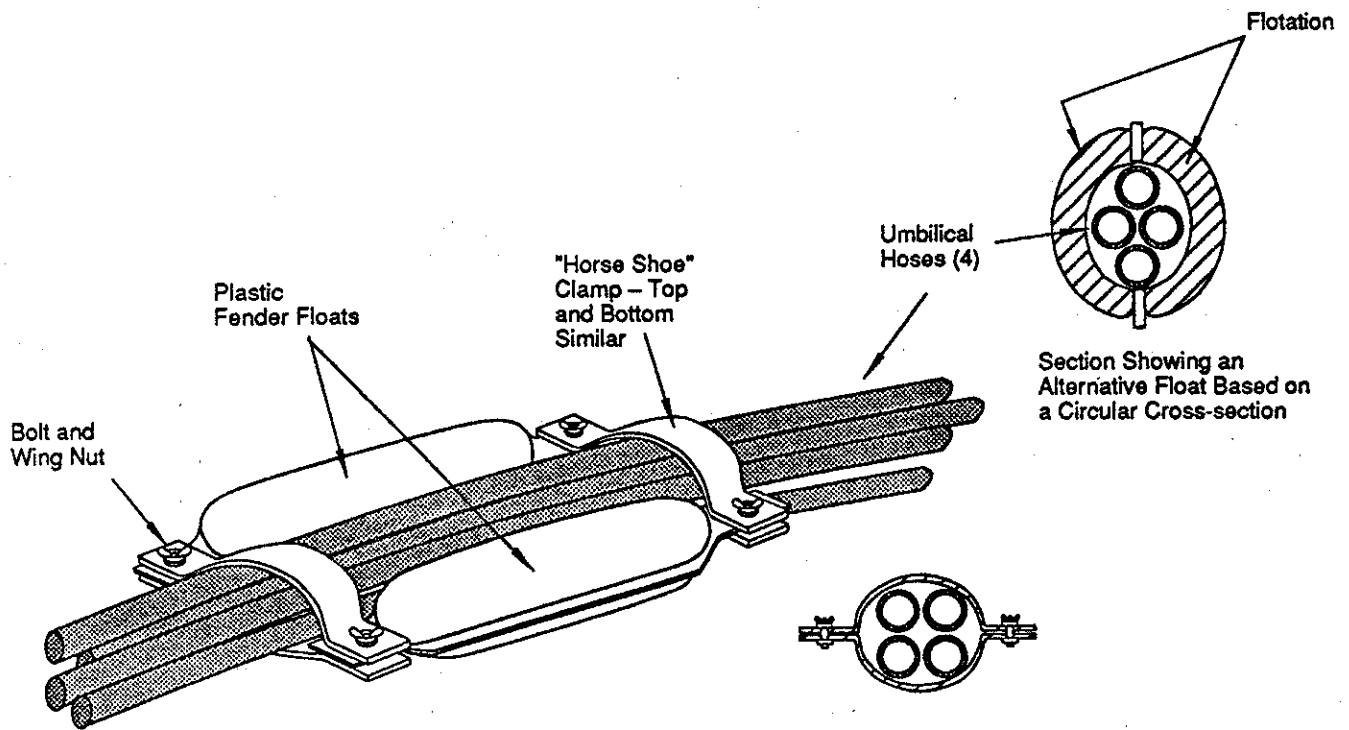
Figure 8: Field Modifications to Flotation System

8a: Modified Apex Float Consisting of Twin Disk-Type Floats

8b: "Clip-on" Fender Floats — On Loan from CCG

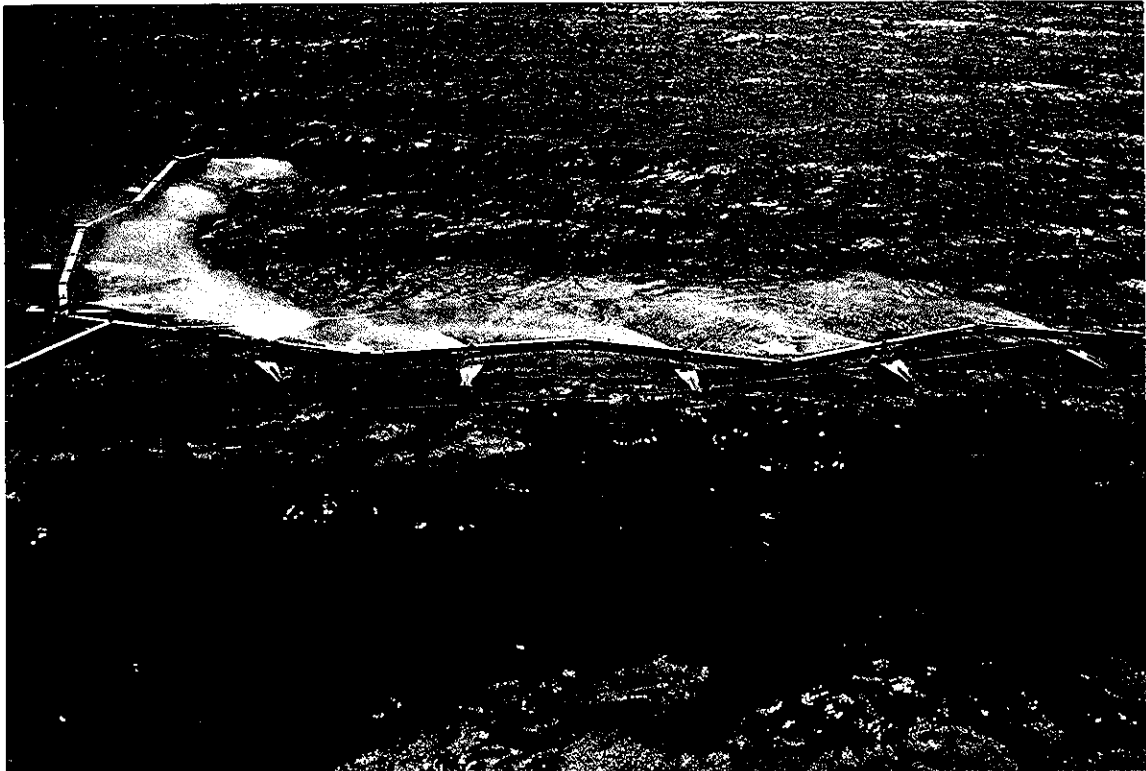
Figure 10: Boom Deployed off CCGS SIMCOE – Wednesday, 19 August, 1992

Manoeuvring tests with the waterjet barrier were conducted from approximately 1230 - 1300. The barrier was able to move up on the anchor position, change opening angle and direction despite the prevailing wind and wave conditions. Floats appeared to maintain steady "platforming" and weathervaning action in the waves, despite distortions in boom arm structure due to the towing damage. Photographs of the tests in Figure 10 indicate some of the distortion to the boom arms.

The currents measured at test site were quite low; a 0.1 m/s back eddy (upstream to the main current direction) was measured. The low velocity was also due to the deep water depth maintained off the quay for berthing the ships. The boom was in fact oriented away from the current direction to face into the wind, as the wind was expected to control the spill direction. Thus the weathervaning action of the outboard floats appeared somewhat "confused", as shown in the photographs in Figure 10.

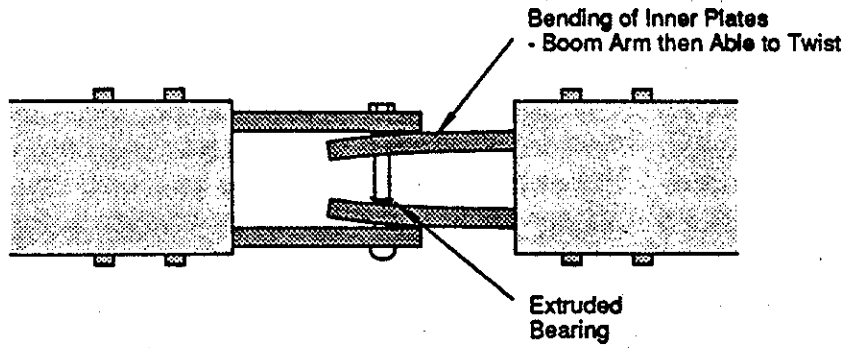
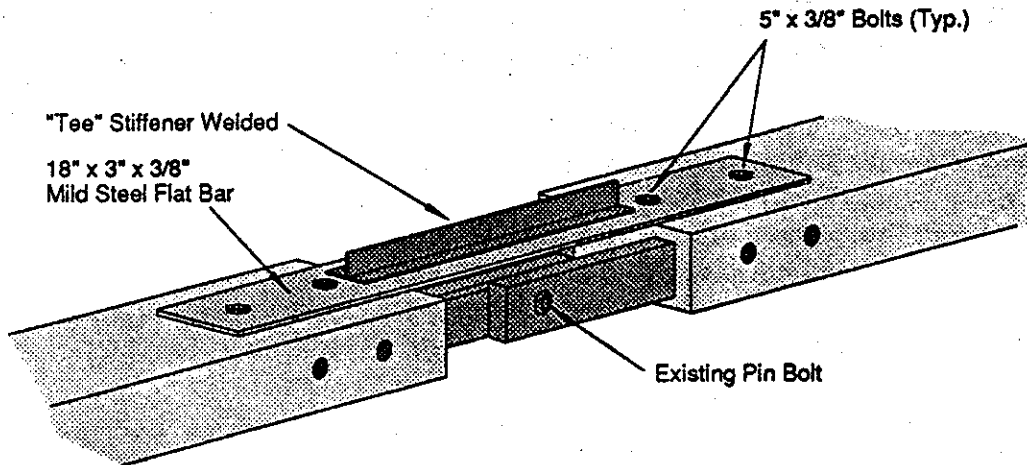
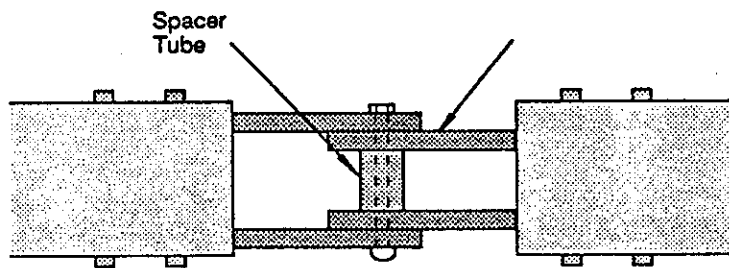
Figure 11: Modifications to Pin Joint Connections

11a: Typical Towing Damage to Pin Joint Connections

11b: Arrangement of Rigid Joint

11c: Spacer Tube Fitted to Pin Joint

A survey of the damage to the structure showed that some of the inner plates in the pinned joints had been bent and many of the Teflon bearings had been extruded out of the bolt holes. This is shown in **Figure 11**. The joints were modified by introducing spacers over the connection bolts to prevent bending of the inner plates. In view of the wave response characteristics demonstrated by the floats, it was decided to dispense with the flexible joints in the boom arms. A 3" (7.6cm) stiffened steel flat bar, was double bolted across the top of each joint in the boom arms. This arrangement is also shown in Figure 11. These modifications were prepared late Wednesday and fitted the next morning.

When exposed to the wave conditions, the boom assumed a skewed angle to the tow craft which resulted from a combination of: wind action on the structure; excessive constraint of weathervaning action of floats, and too much slack in the tether lines. Efforts to shorten the tether lines from a second Sea Truck were unsuccessful. As a result the boom was towed very slowly into position with one arm perpendicular to the tow direction; some structural damage to joints occurred; specifically, bending of the inner plate in pin joint and extrusion of the teflon bearings.

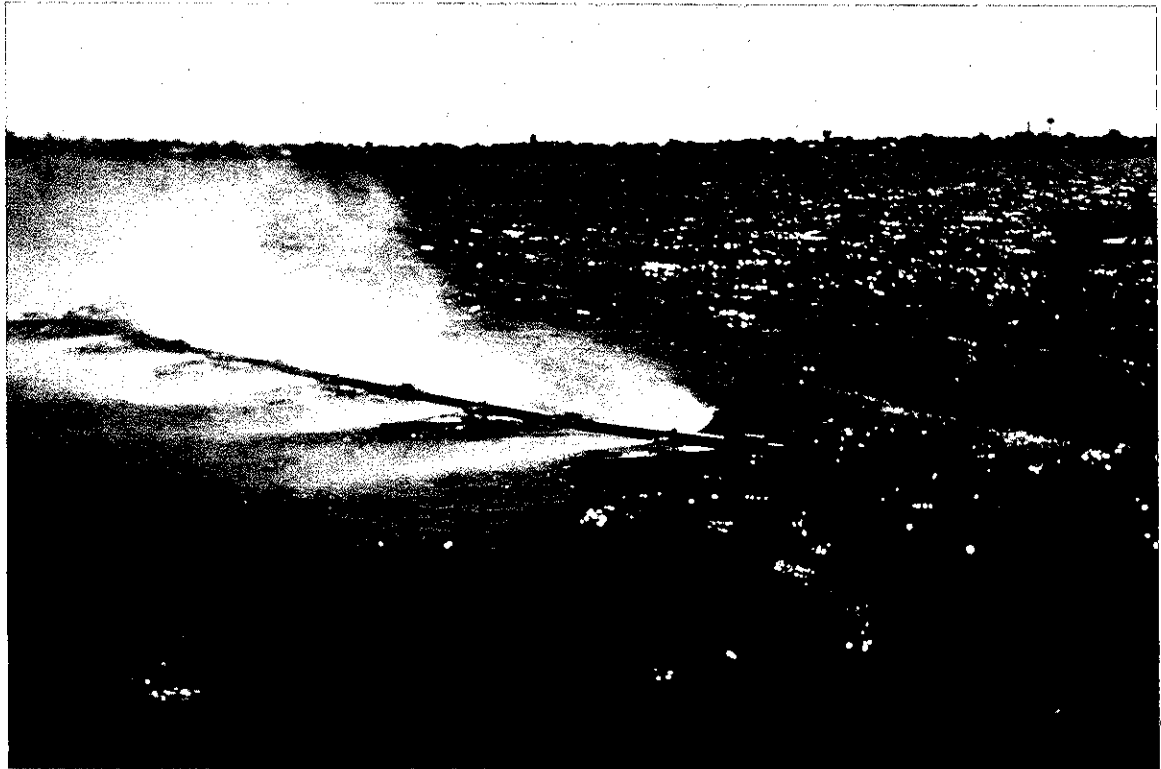
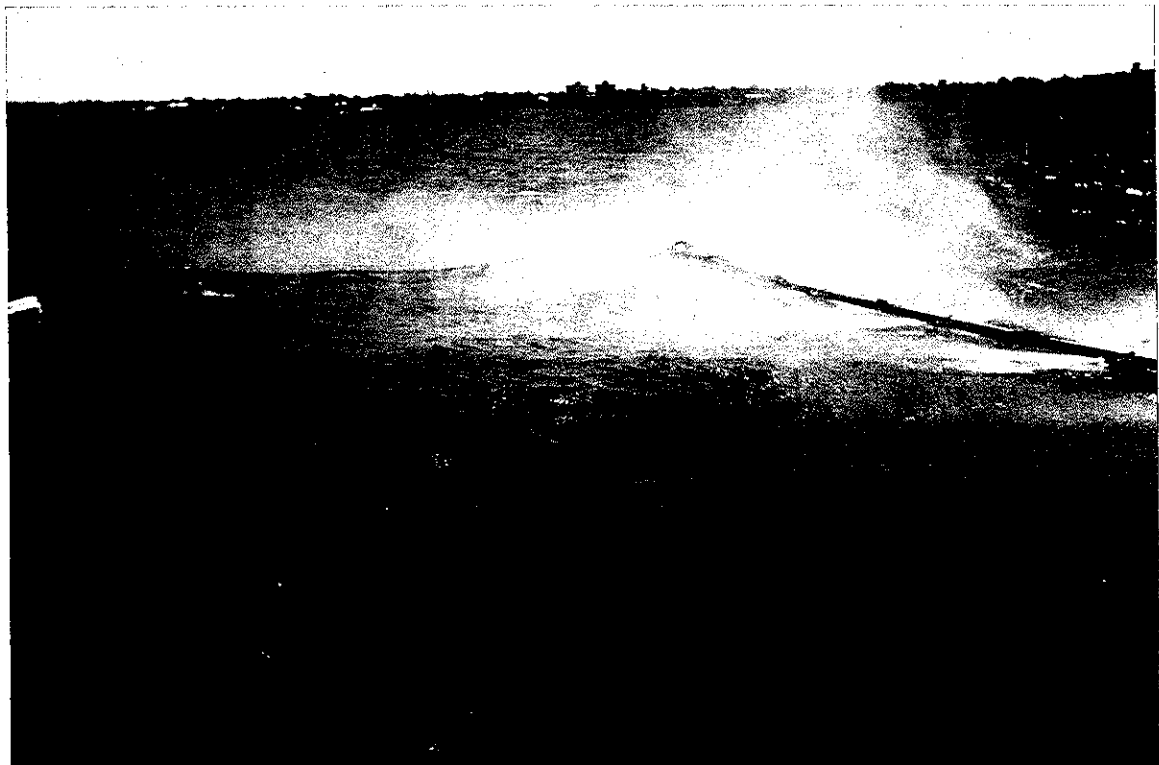
Figure 14: Photographs of Spill Simulation – Friday, 21 August, 1992

A spill was simulated using approximately 104 litres of canola oil spilled from a Sea Truck located upwind of the barrier, as the wind was the dominant factor. The sequence of events is diagrammed in Figure 13. The barrier was initially positioned close to the dockside, facing out into the river. Weather conditions persisted, with substantial wave reflection from the dock wall; this may have resulted in wave heights in excess of those measured at the wave buoy location due to constructive interference between the incident and reflected waves. Some oil escaped between the end of boom arm inshore and the dock wall until the spill was forced away from the wall.

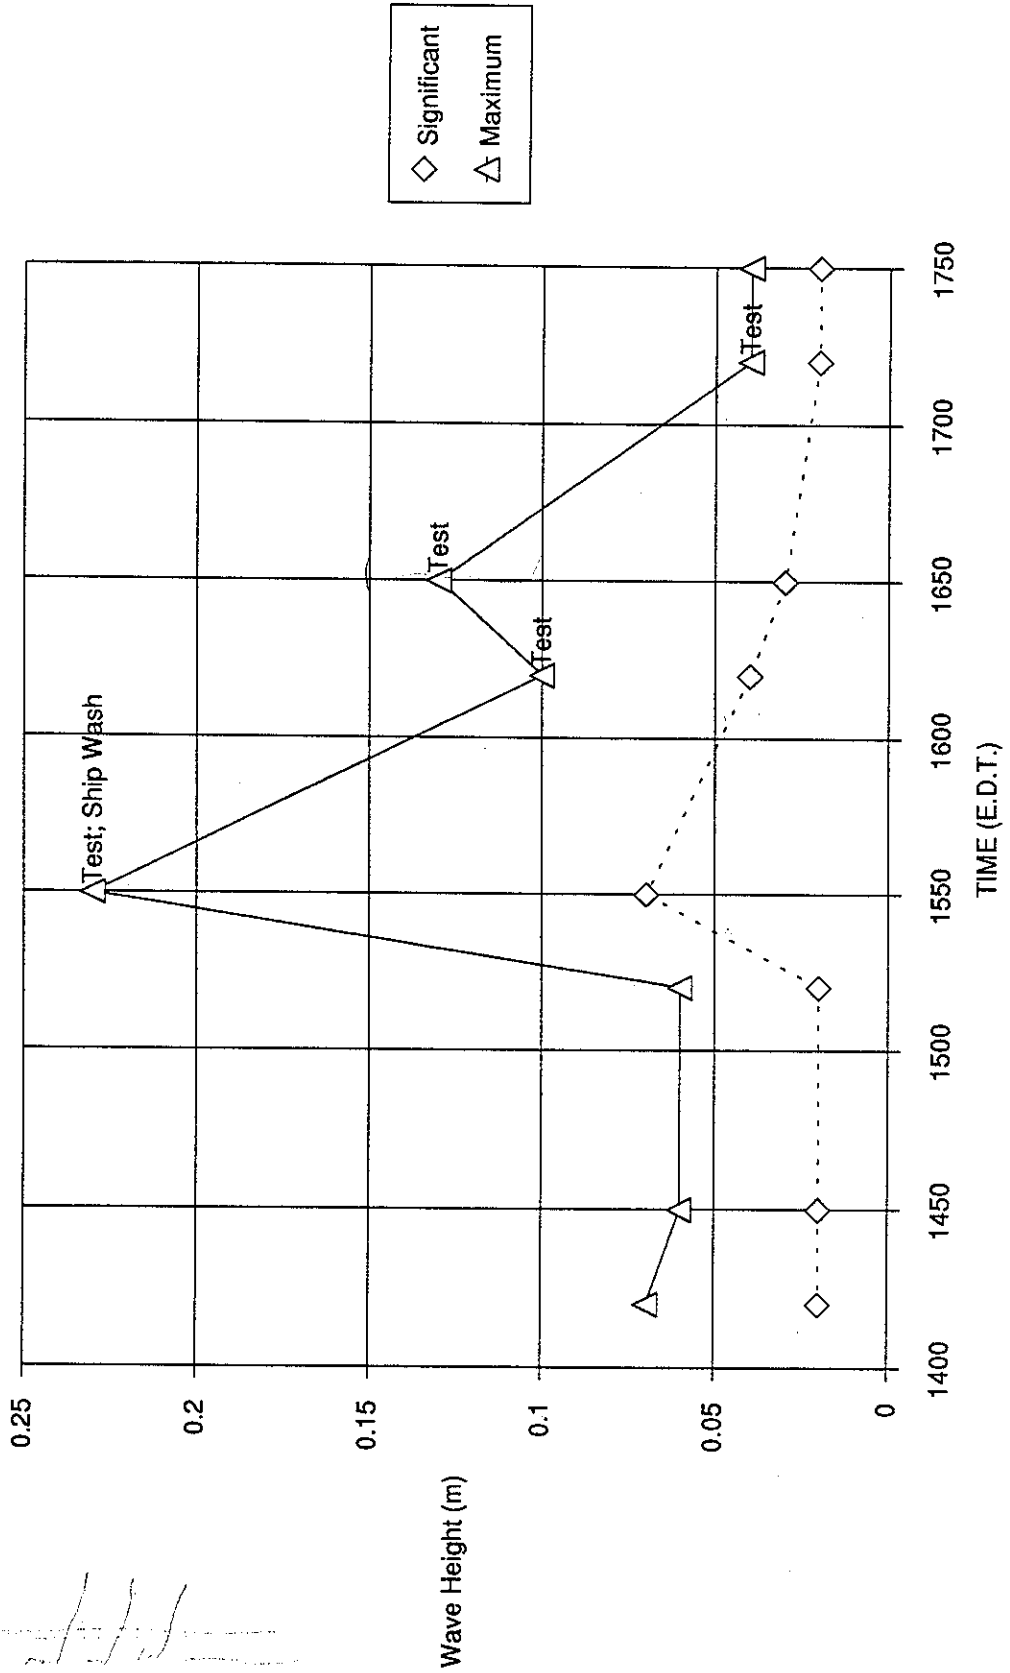
WATERJET BARRIER TRIALS - CCG PRESCOTT - 21 August 1992 - Wave Heights

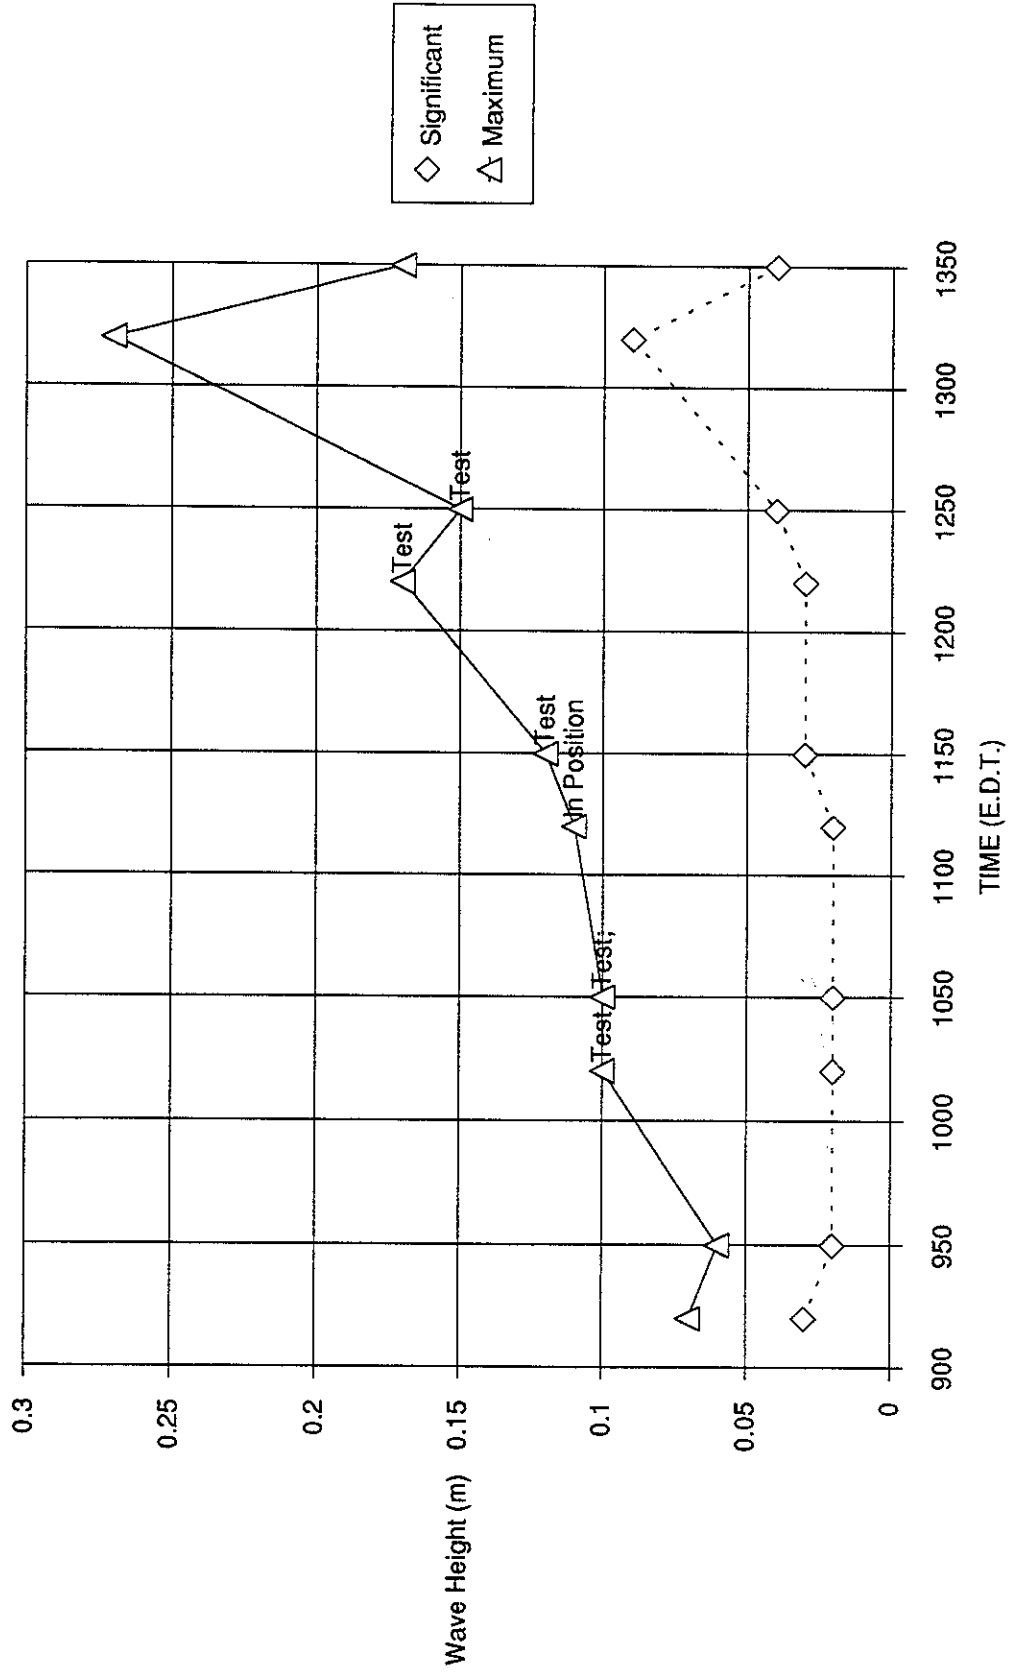
WATERJET BARRIER TRIALS - CCG PRESCOTT - 19 August 1992 - Wave Heights
