**Re-engineering of a Stainless-steel Fire Boom for Use in Conjunction with Conventional  
Fire Booms**

**Final Report**

**SL Ross Environmental Research  
200-717 Belfast Road  
Ottawa, ON K1G 0Z4**

**August 31, 1999**

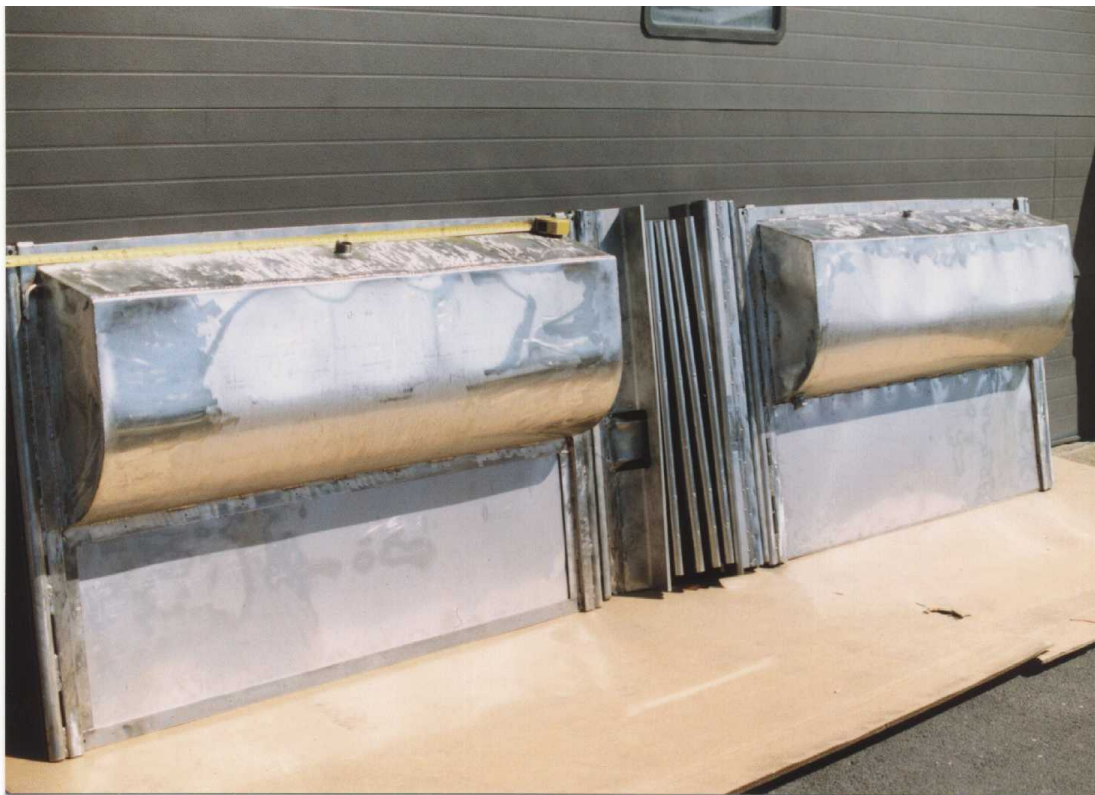
Figure 3-3. Redesigned Pocket Boom as Built by Applied Fabric Technologies.

A prototype length (16 m or 52 ft) of the new boom, consisting of seven flotation units and seven flexible connector units, was constructed by Applied Fabric Technologies, Inc. in Orchard Park, NY. Figures 3-3 and 3-4 show the boom as built. Complete fabrication drawings may be found in Appendix A, and are available in digital form as AutoCad 12 files.

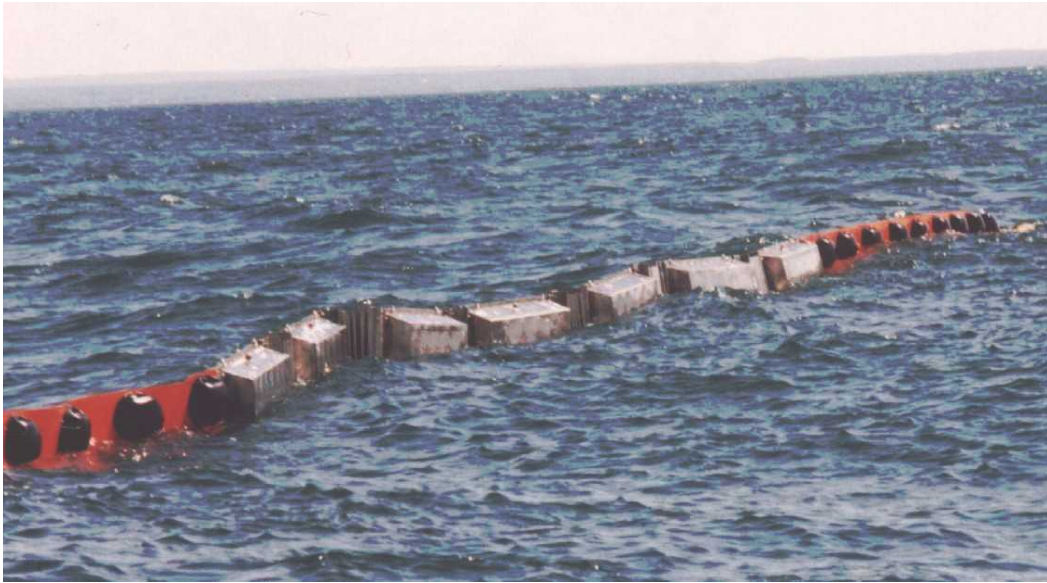
Figure 4-2. Pocket Boom Straight-Line Towing Trials in Lake Erie.

no evidence of heel, at speeds of up to 2.5 m/s (5 knots). It also followed the waves very well in this configuration (Figure 4-2). No overtopping was observed in 0.6 to 1-m (2 to 3-ft) waves and 30 km/hr (15 knot) winds and no planing was noted at U tow speeds up to 0.8 m/s (1.5 knots) as shown in Figure 4-3. The attachment of the Globe boom directly to the Pocket Boom end floats worked very well, with no wear or undue motion noted.

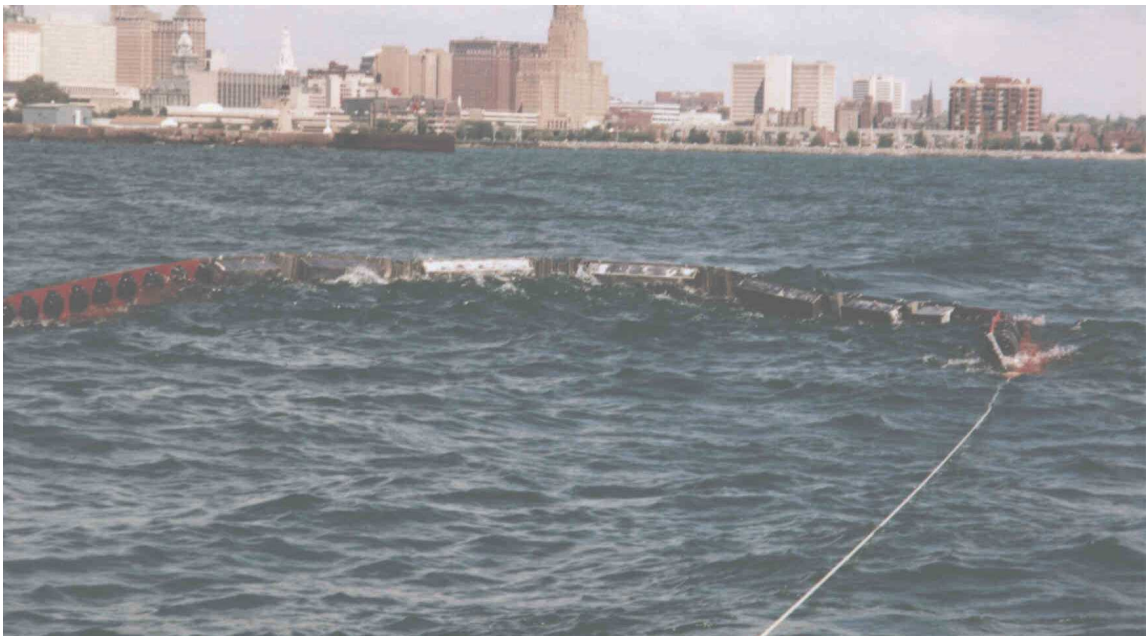
Figure 4-3. Towing in a U Configuration off Buffalo.

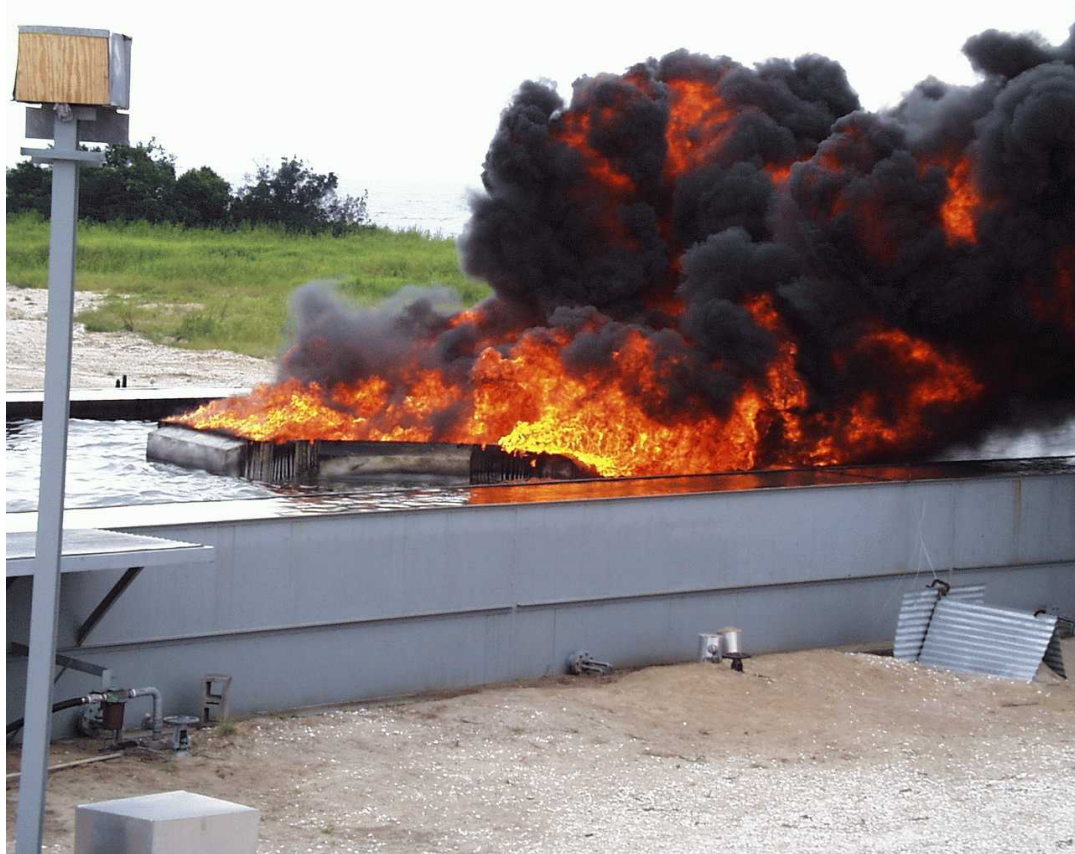
Figure 6-1. Second Pocket Boom Fire Test at Mobile, AL.

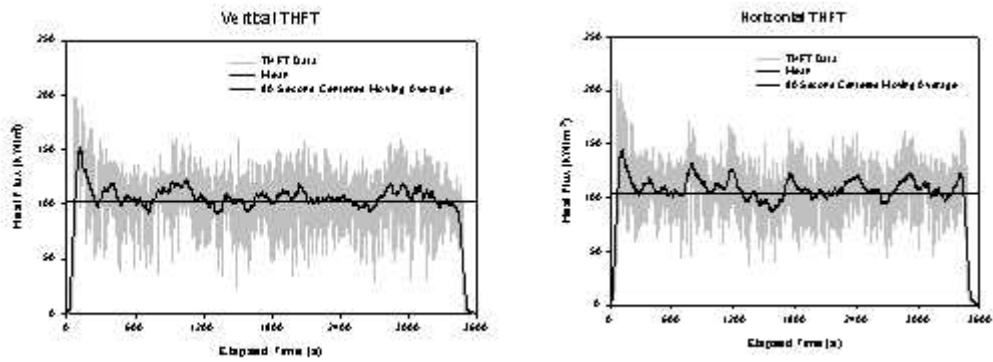
Figure 6-2. Total Heat Flux Measured on Downwind Side of Pocket Boom - 2<sup>nd</sup> Burn.

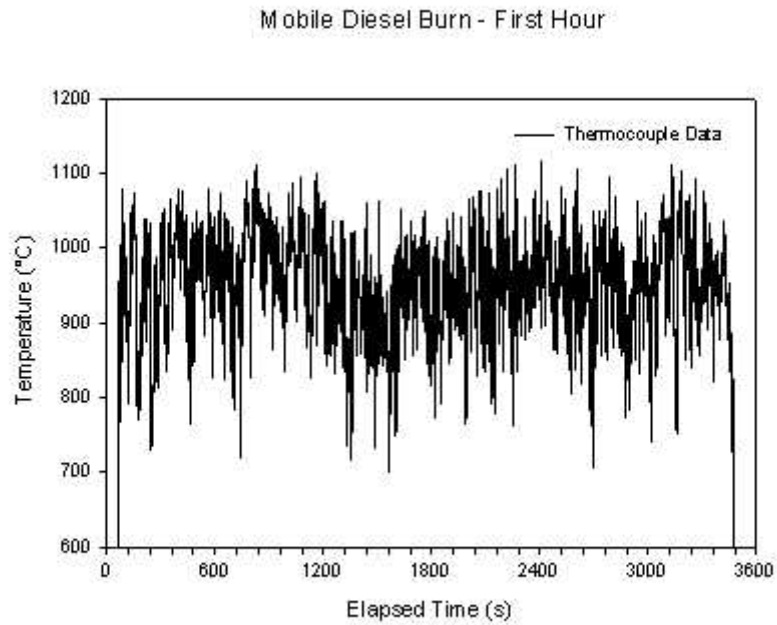
Figure 6-3. Temperature Measured during Second Test Burn (First Hour-long Burn) with Pocket Boom.

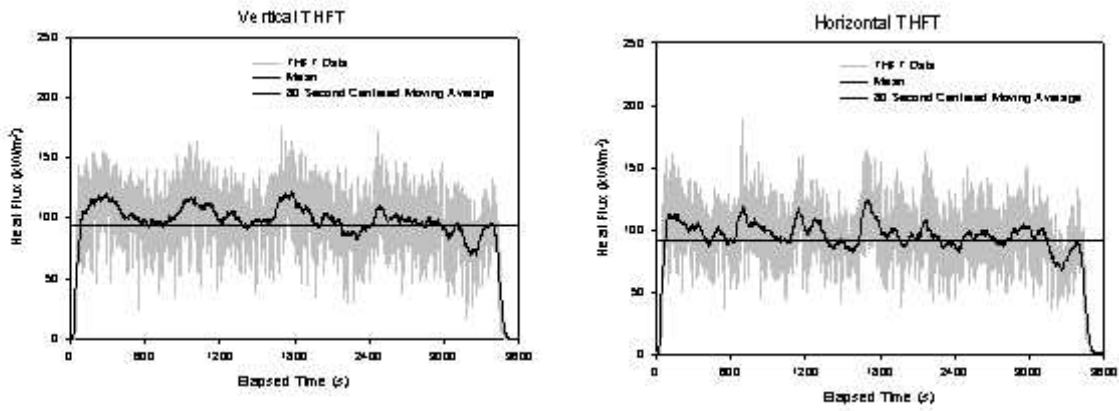
Figure 6-4. Total Heat Flux Measured on Downwind Side of Pocket Boom - 3<sup>rd</sup> Burn.

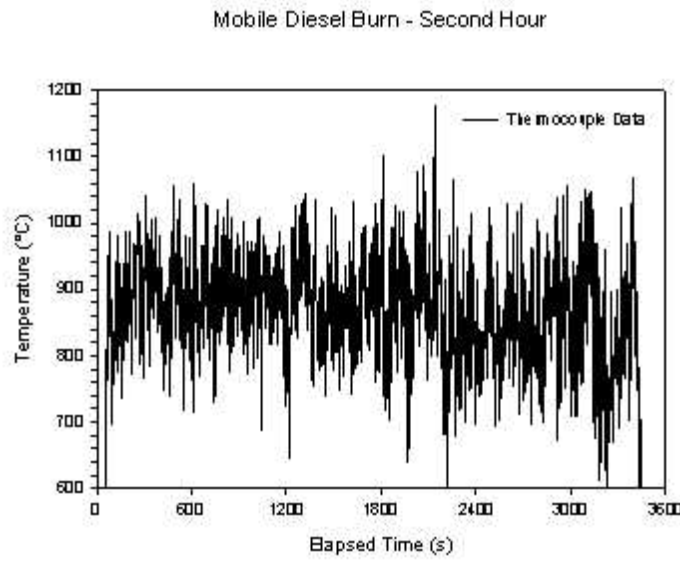
Figure 6-5. Temperature Measured during Third Test Burn (Second Hour-long Burn) with Pocket Boom.

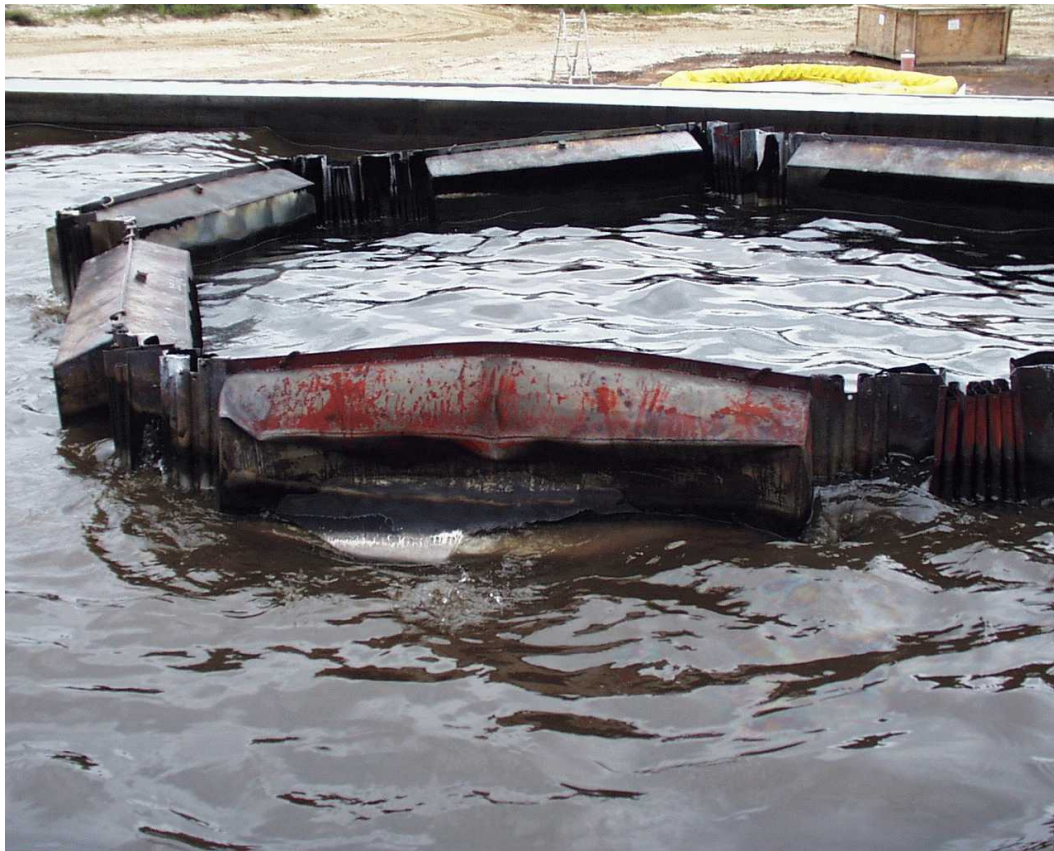
Figure 6-6 View of Flotation Unit After Crumpling Incident at End of Third Burn

units crumpled inward, apparently due to low pressure developing inside the unit. Figure 6-6 shows the affected section. It was suspected that this was due to the presence of tank sealant used to fill small leaks in the flotation unit during previous tests. Something (perhaps this sealant), under fire conditions, restricted the vent tube (designed to allow the free flow of air into and out of the tank) and caused the crumpling. The crumpling did not appear to detract from the boom's ability to contain oil or float. The vent tube diameter has been increased in the final design to alleviate this problem. No other damage was noted after the second burn. Again, as the boom was filled with the pre-load of diesel for the third one-hour burn, slight leakage from the connectors on the downwind side of the boom was again noted.

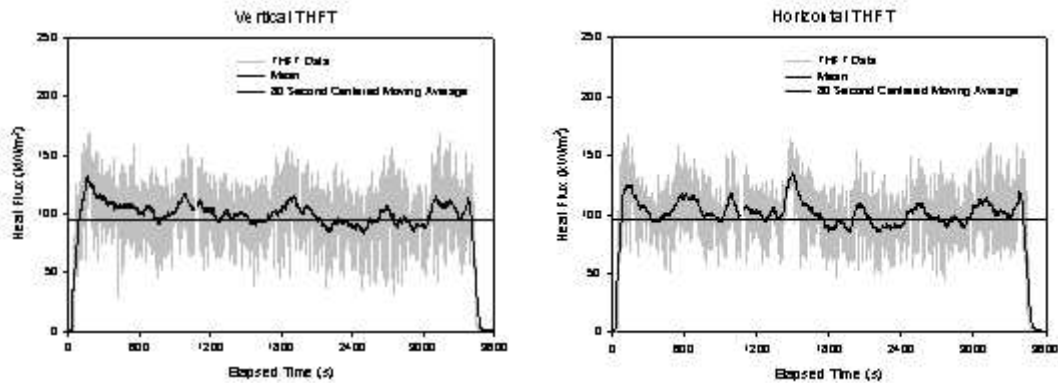
Figure 6-7. Total Heat Flux Measured on Downwind Side of Pocket Boom - 4<sup>th</sup> Burn.

The fourth burn (the third one-hour burn) consumed 3420 L (904 gal) of fuel and lasted 58 minutes (56 minutes of full flame coverage). Figures 6-7 and 6-8 show the heat flux and temperature data for this burn. Four minutes after ignition the crumpled float unit re-expanded to nearly its original shape: it did not re-crumple at the end of the third one-hour burn. No leakage or boom failure was noted during the third one-hour burn. At the end of the burn the boom was re-inspected and it appeared that a flotation unit adjacent to the one that crumpled had expanded slightly due to over-pressure. Again, the vent tube must have been restricted. Despite this, the boom appeared to be maintaining its freeboard and no other damage was noted.

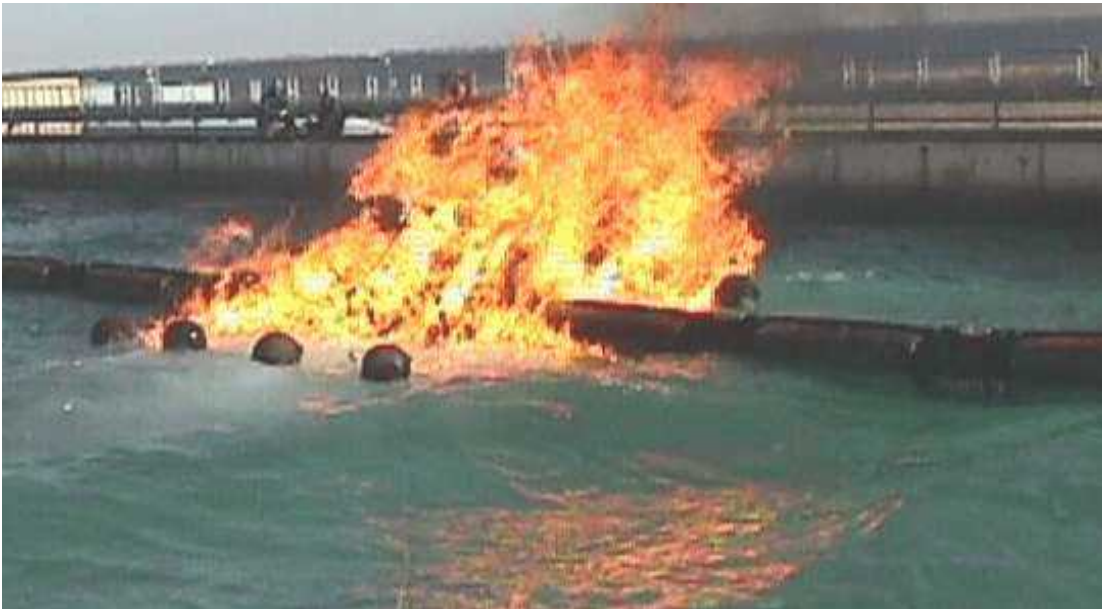
Figure 8-1. Pocket Boom in Enhanced Propane Flames at Ohmsett.

On November 24, 1998 the prototype Pocket Boom was put through Ohmsett's new enhanced propane fire test protocol (see McCourt *et al.* 1999). These tests involved three cycles of one hour of exposure to compressed air-enhanced propane flames in waves, followed by a one-hour cool-down period in waves alone. The tension on the boom was maintained at 1560 N (350 lbf). The test plan and data may be found in Appendix F. Figure 8-1 shows the burn during a test cycle and Figure 8-2 shows the total heat flux to the two sides of the boom during each of the three test burns. After several of the fire tests the boom was observed to be glowing bright cherry red in the daylight, an indication that the boom had reached temperatures on the order of 900 C (1650 F).

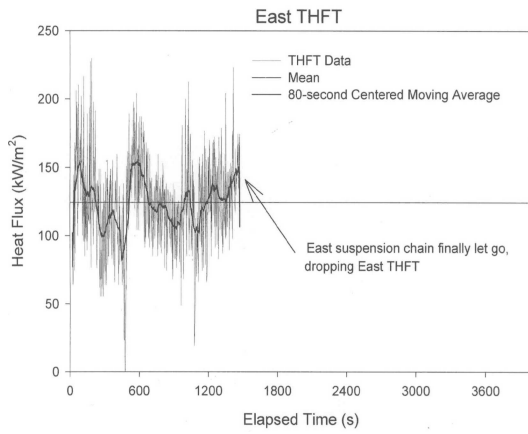
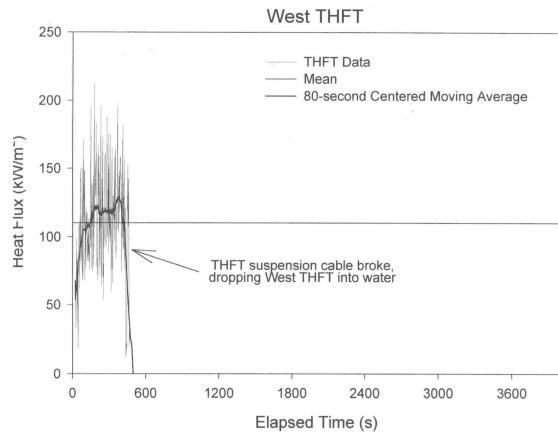
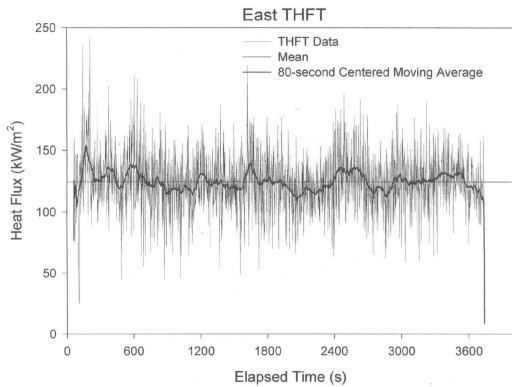
Figure 8-2. Total Heat Flux Readings for Enhanced Propane Test.

For the first two tests at Ohmsett the total heat flux transducers (Medtherm model 64-20-20, the same as those used in the diesel burn test in Mobile, AL) were suspended by chains from a cable passing across the center of the boom. The total heat flux transducers (THFT) were oriented to look across the boom at the flames on the other side.

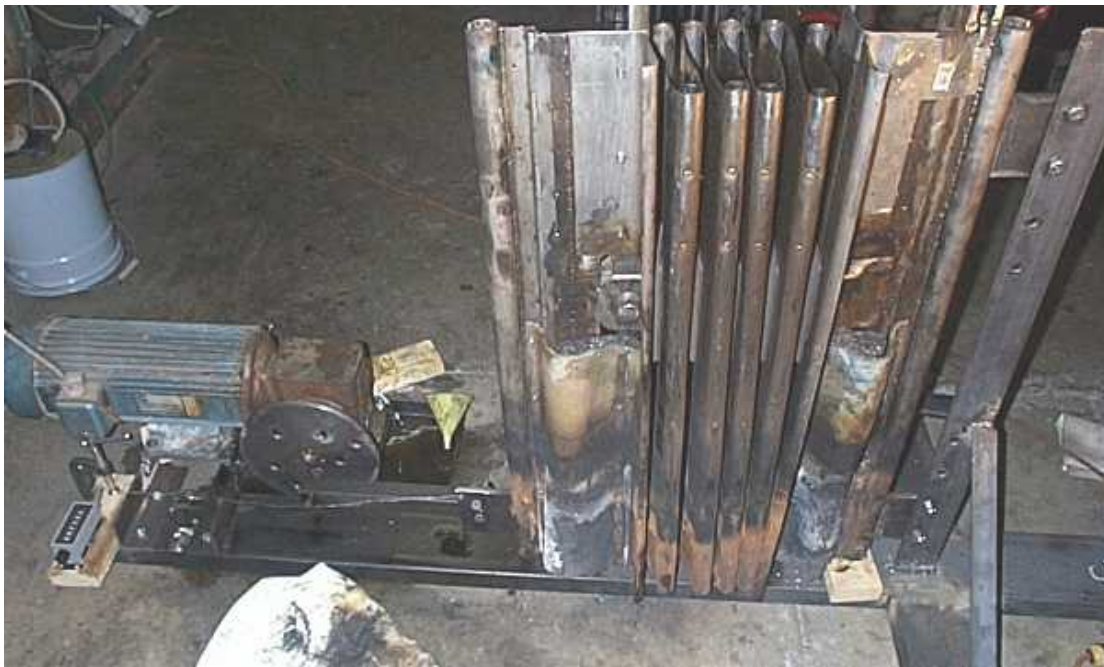
Figure 9-1. Jig for Cycling Connector Sections (connector is mounted upside down).

One of the key components of the Pocket Boom are the pleated connector sections. Over the month of January 1999, five of the pleated connector sections were tested, three to failure. The test involved mounting the connector in a specially-constructed jig that held one side of the connector (the side opposite the universal bearing) immobile and cycled the other side through its range of motion in the vertical plane. One end of the connector was cycled by a push rod mounted on an off-center wheel driven by a variable-speed electric motor (Figure 9-1). All five connector sections had been exposed to a total of six hours of flames, three during the diesel fire tests in Mobile, AL and three during the enhanced-propane fire tests at Ohmsett.

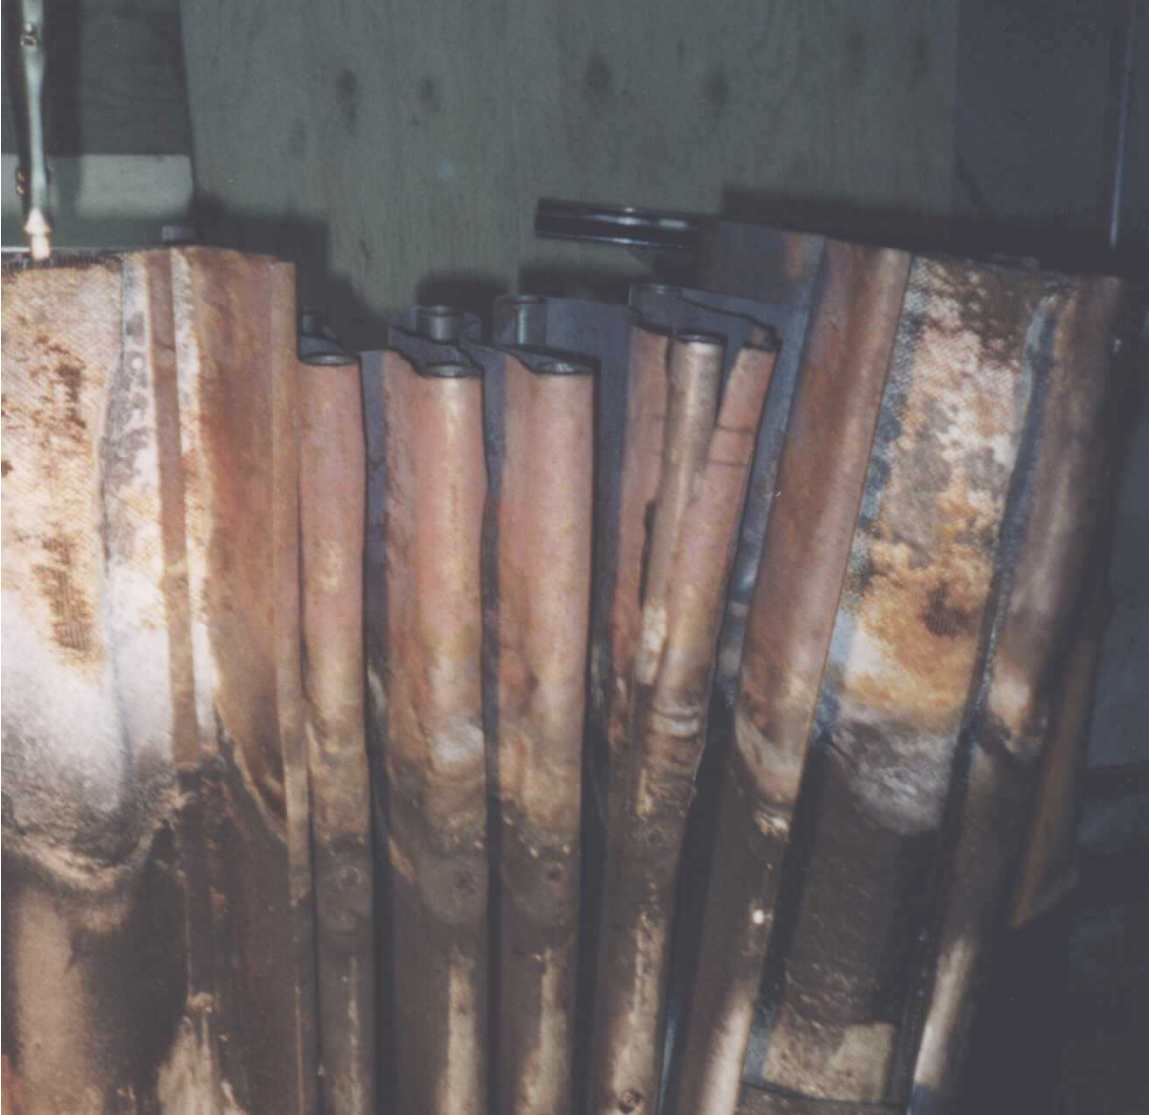
Figure 9-3. Crack in Pleat Material of Connector 1 after 500,000 Cycles with a 15-cm (6-in.) Stroke.

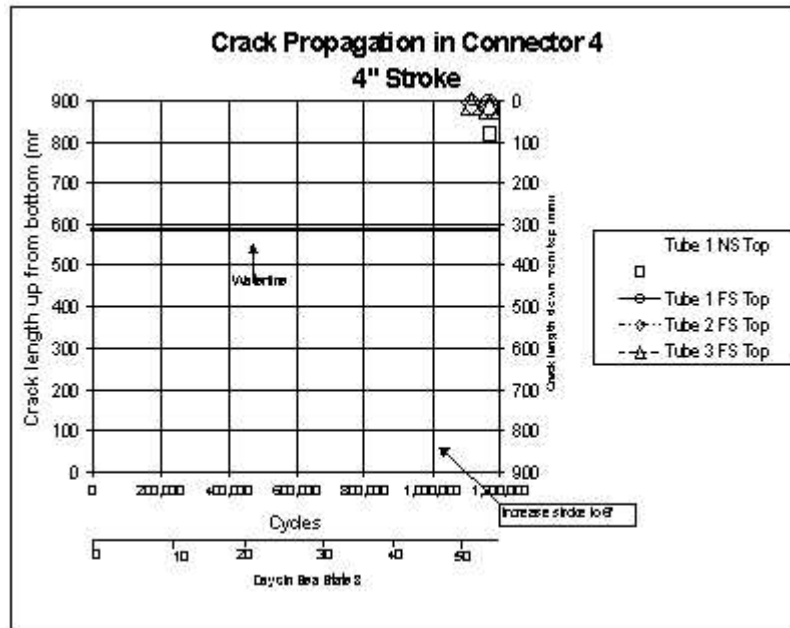
Figure 9-4. Crack Propagation in Connector Cycled Through a 10-cm (4-in.) Stroke.

The fourth connector was operated with a stroke of 10 cm (4 in.). This connector survived 1,000,000 cycles (equivalent to 45 days in Sea State 4) without any cracking (Figure 9-4). At 1,000,000 cycles the stroke was increased to 15 cm (6 in.); cracks began to appear and propagate in the next 100,000 cycles. The fifth connector was cycled with a stroke of 13 cm (5 in.). After 1,000,000 cycles only minor cracks, the longest being 57 mm, had appeared (Figure 9-5). The final design of the connector through-beam has been modified to restrict the stroke to 13 cm (5 in.). This will not impede the ability of the boom to respond to waves in its design operating environment (protected and semi-protected waters, up to Sea State 3 with a 1-m, 4-s significant wave).

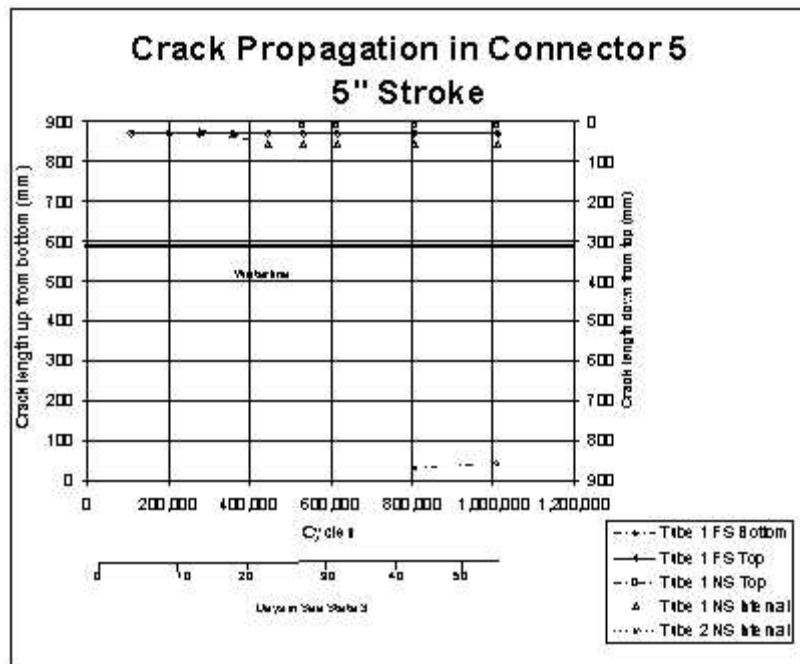
Figure 9-5. Crack Propagation in Connector Cycled Through a 13-cm (5-in.) Stroke.

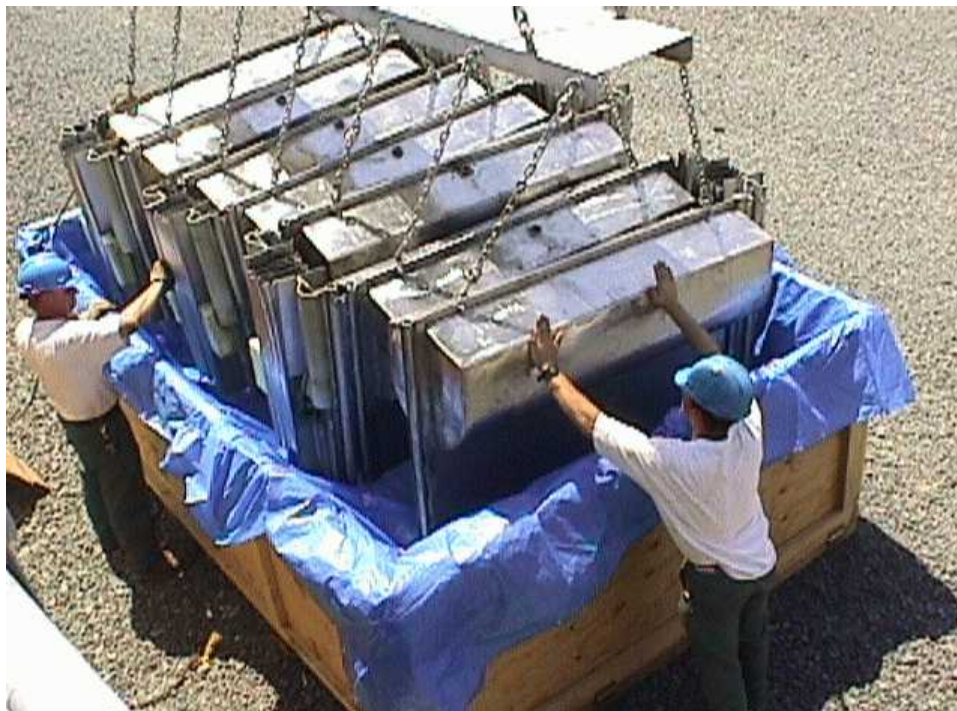
Figure 10-2. Deployment of 15 m (50 ft) of Pre-connected Pocket Boom.

Figure 10-2 shows the prototype Pocket Boom being lifted from its wooden storage box in this manner. Over the life of the project the 15-m (50-ft) prototype was deployed and retrieved five times, using both cranes and forklifts, with relative ease using this system.
