Final Report

Accuracy of Polyester Subrope Damage Detection by ROV Inspection and Assessment of Remaining Rope Strength and Life

Contract M07PX13203
Issued by the Minerals Management Service
U. S. Department of Interior

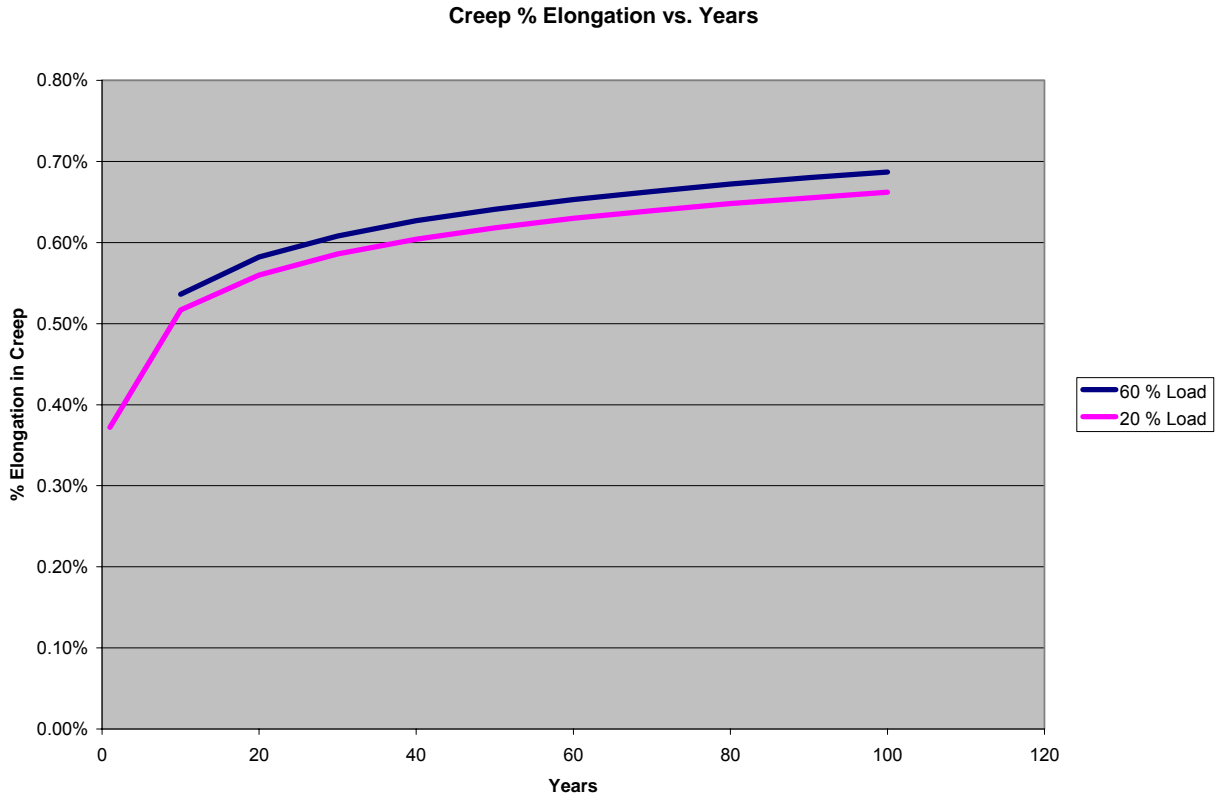
Table 1 shows the elongation in creep for decades of years. If we focus on 20–60% loads, elongation due to creep over time has a trend as shown in Figure 1. Typical preloads on polyester mooring systems in the Gulf of Mexico are 20% or less.

Figure 1. Elongation in Creep vs. Years

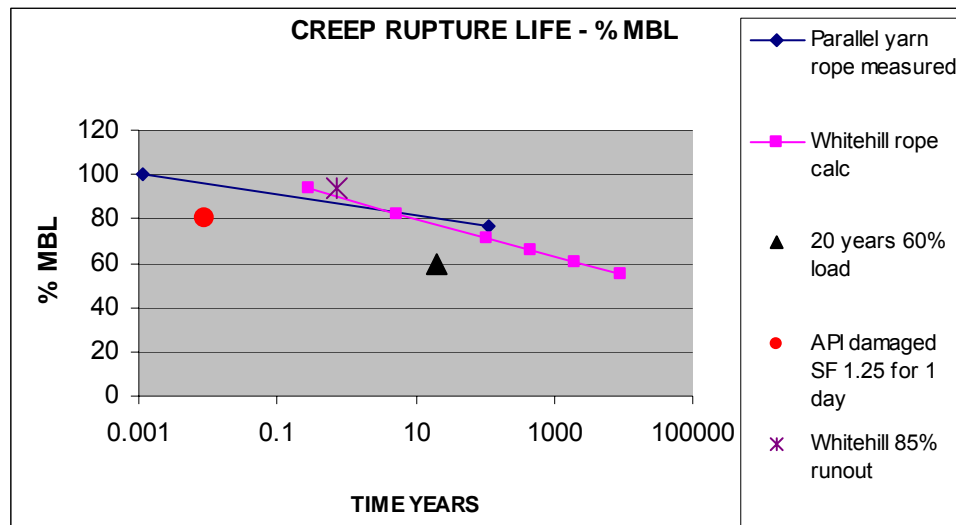
The Parallel yarn rope data is from a private communication between TTI and Linear Composites, and is based on dead load creep tests of up to 13 years at 80% of nominal break load.

Figure 2. Rope Creep Life

The figure above shows that the rope (not yarn) data that we have is well above the plotted point for 20 years life for 60% load. Since typical pretensions used in the Gulf of Mexico for polyester mooring systems are 20% or less, there is a very large factor of safety against creep rupture failure. Hurricanes and loop current events over the 20 year life of a mooring system represent a relatively short duration, so the majority of creep occurs at 20% MBL or less. We have plotted the API RP 2SK load allowable (80% MBL) for a factor of safety of 1.25 on the remaining ropes, to show that even the one mooring leg damaged condition (of short duration until a mooring leg can be reinstalled) is not an issue with creep.

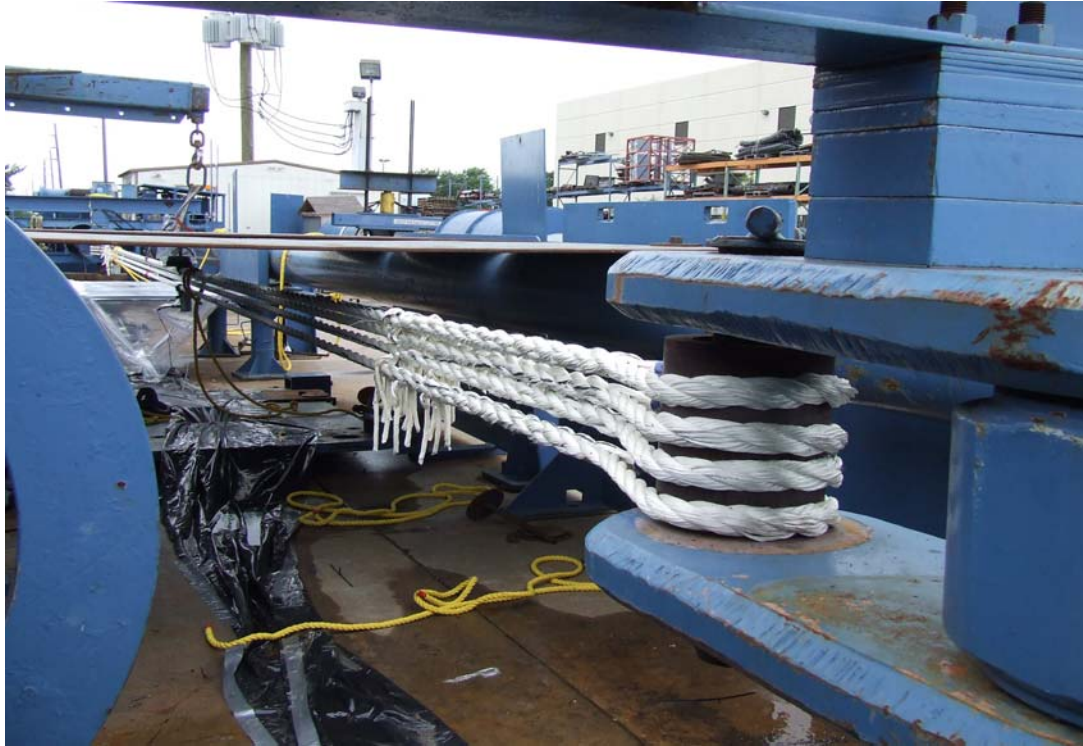
For this project four subropes provided by Sampson Ropes were loaded in parallel in Stress's L 2000 Test Fixture and subjected to 20,000 cycles simultaneously. The samples were all placed on the same pins as shown in Figure 3.

Figure 3. Test Setup for Cycling Four Subropes in Parallel

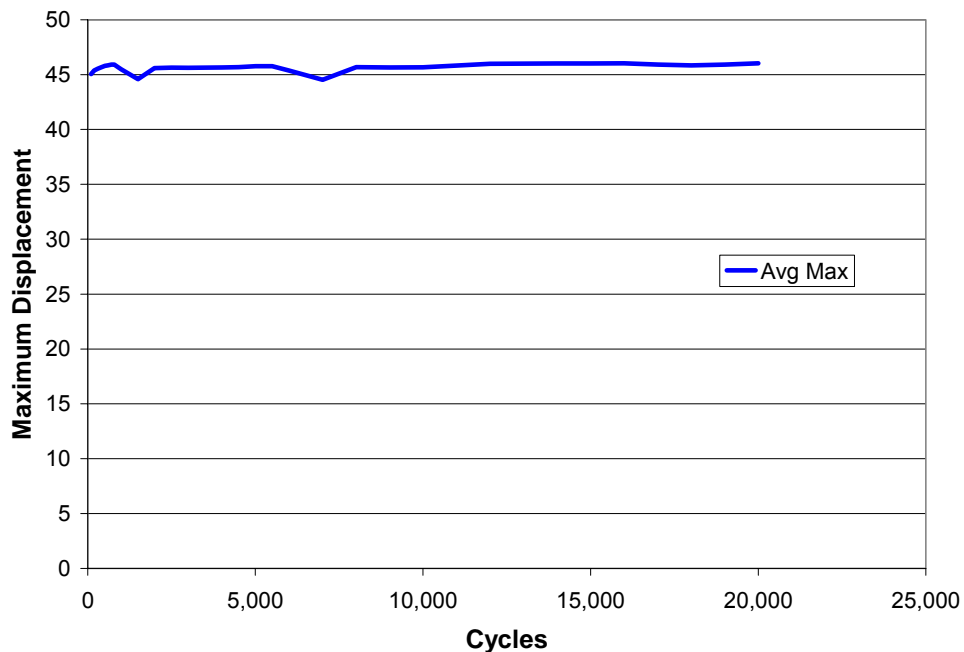
Maximum elongation was recorded versus the number of hurricane-level load cycles. Results showed that for 20 hurricanes, the elongation is nearly constant (Figure 4). Note that the maximum displacement shown is the displacement of the four subropes being cycled in parallel as shown in Figure 3.

Figure 4. Maximum Displacement vs. Cycles

The elongation data appear constant, but in actuality, if the durability study curves of maximum elongation vs. number of cycles for four rope samples are considered, there is a slight positive slope indicated after thousands of hurricanes, as shown in Table 5.

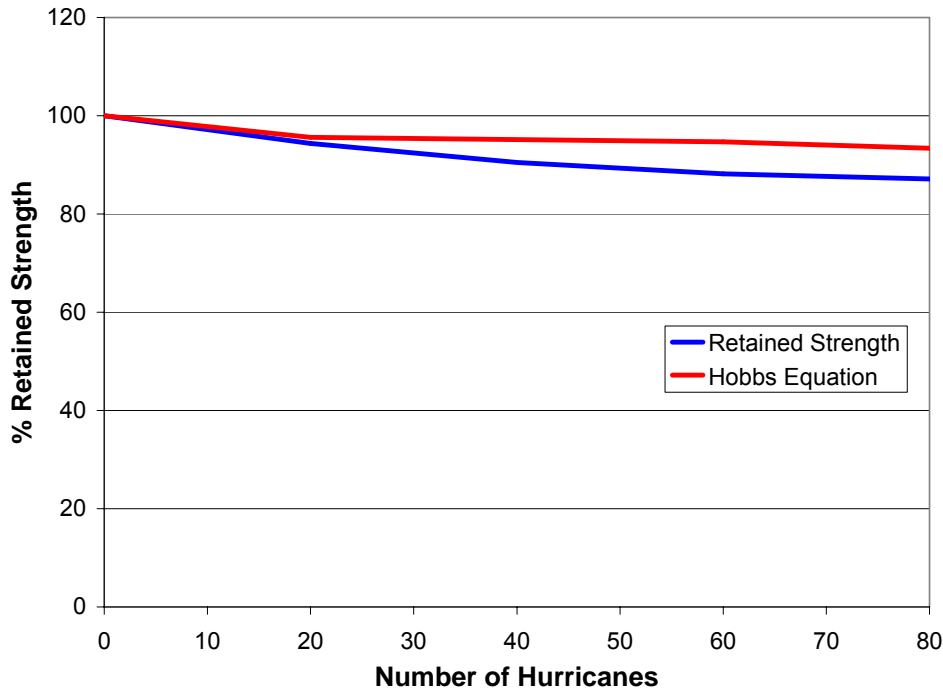
The results from these two methods are compared in Figure 5. It would be prudent to use the lower (blue) curve as a conservative estimate of retained strength as a function of number of hurricanes experienced.

Figure 5. Retained Strength vs. Number of Hurricanes

An important conclusion is that for this particular (Samson) subrope design, **6% strength loss after 20 hurricanes is less than the 10% strength loss (for damaged rope) allowed by API RP 2SM**. In this case all damage is due to cyclic wear, not third-party damage.

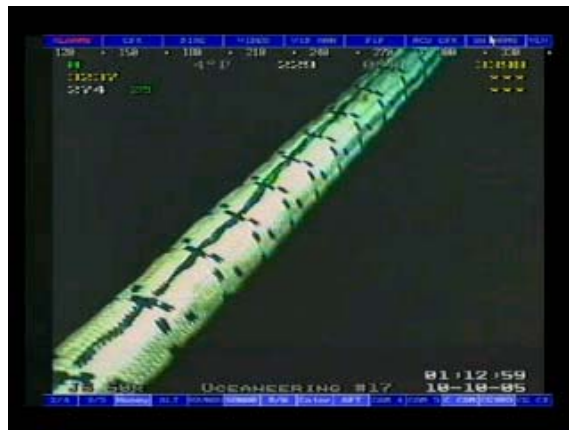
Following are several photographs selected from a typical video taken along the mooring leg. Figure 6 is a shot of the mid-length of a rope segment, showing the straight black marker line, which reveals that this rope segment has very little twist in it.

Figure 6. ROV Photograph of Rope Twist

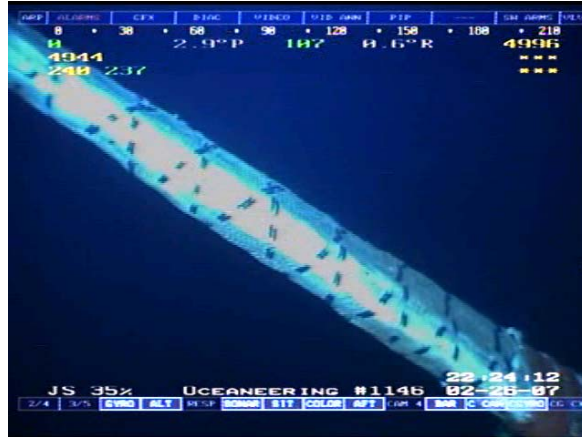
Figure 7 is another view of the rope body. Note that visual clarity is fairly good, and that even small damage to the rope jacket would be visible.

Figure 7. Close-Up View of Rope Condition

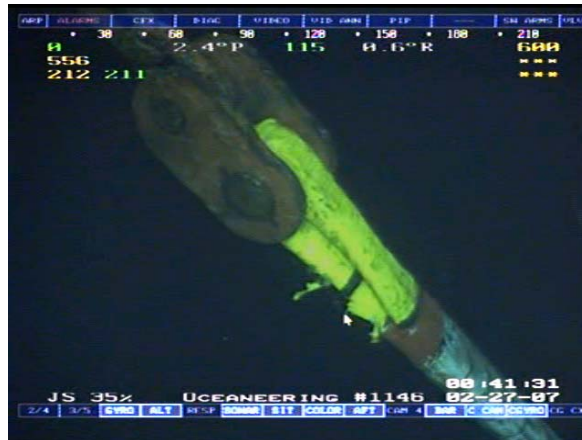
Figure 8 is the eye splice joining the H-Link with a pin.

Figure 8. Photograph of Eye Splice and H Link

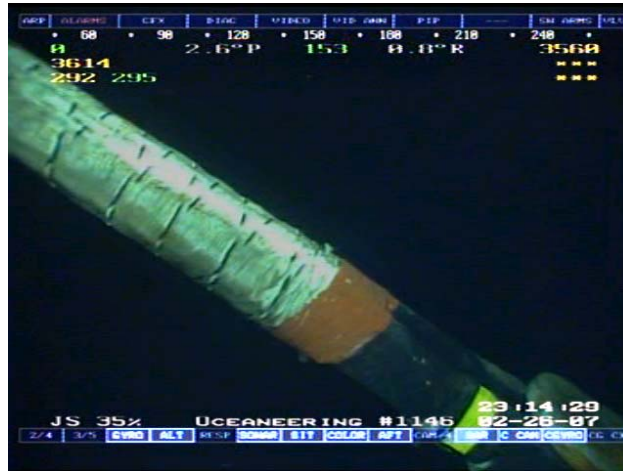
Figure 10 shows the rope (upper left) approaching the toe of the eye splice (lower right) and the red tape covering the cut ends of the splice.

Figure 10. Photograph of Toe of Splice Region

These photos were recorded during a video fly-by. The ROV operator maneuvers the ROV so that the video is close enough to the rope to show any potential defects, yet far enough away from the rope to avoid any contact. Standard procedure calls for first lowering the ROV cage or hanger from the ROV support vessel, then flying ROV out of the cage to inspect all rope in range of the ROV umbilical. In this way, the video inspection is completed in segments.

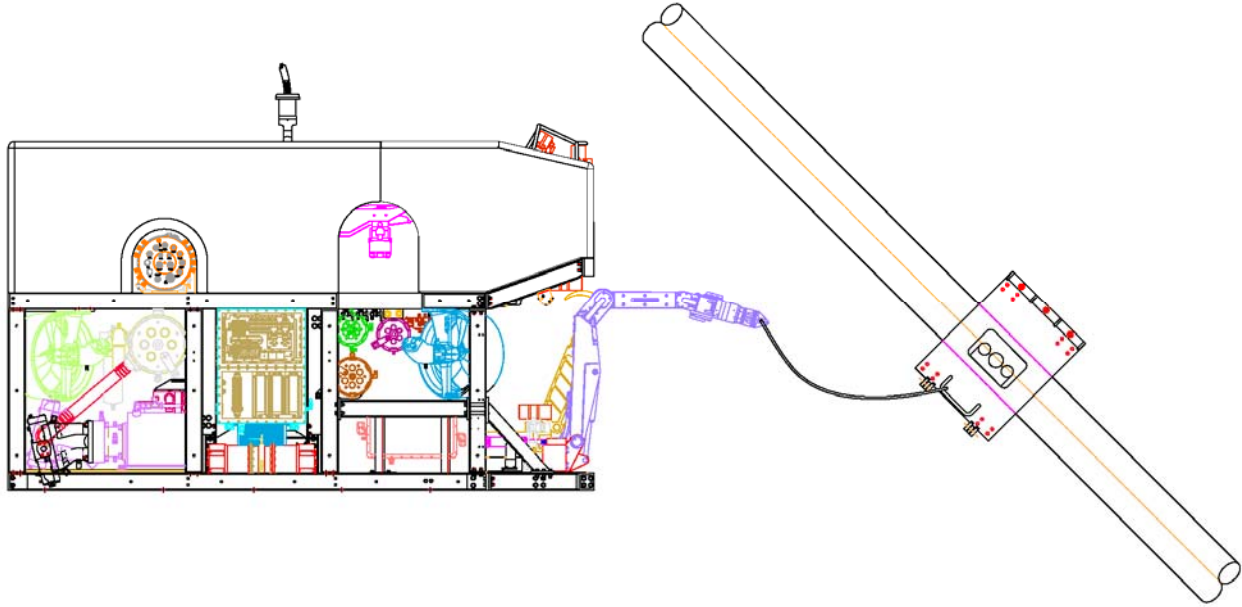
Each of the three ROV operators contacted during the project said that they could develop a rope measuring "bug" to traverse along the main segments of the rope, recording video from fixed points and recording rope diameter changes. Figure 11 is a profile of an ROV with a measurement bug tethered off.

Figure 11. ROV-Supported Measurement Bug

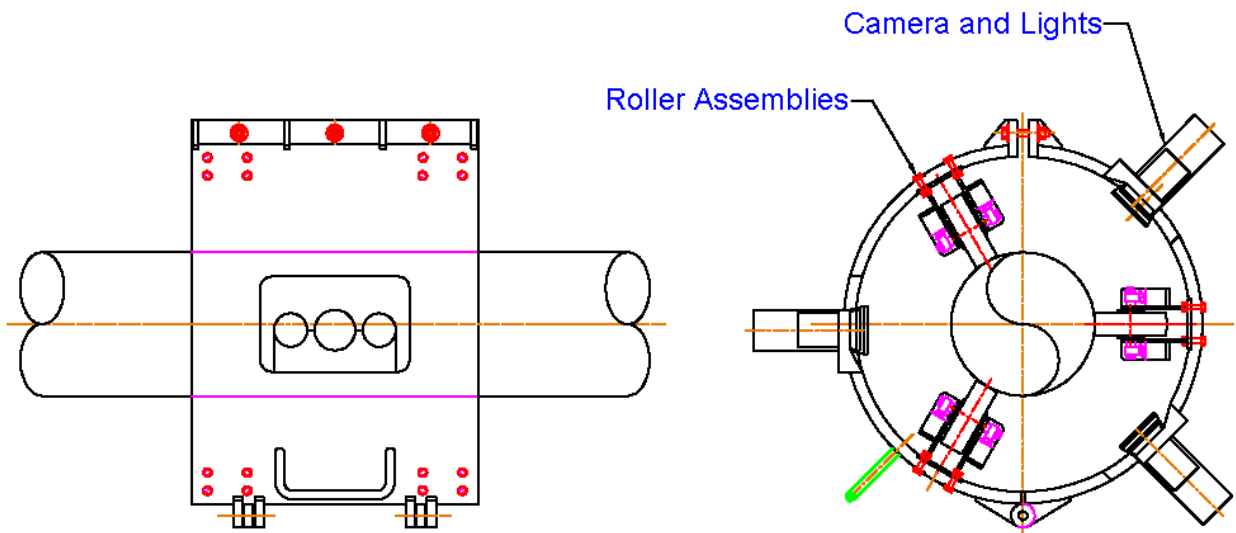
The measurement bug might function as shown in Figure 12.

Figure 12. Measurement Bug Details

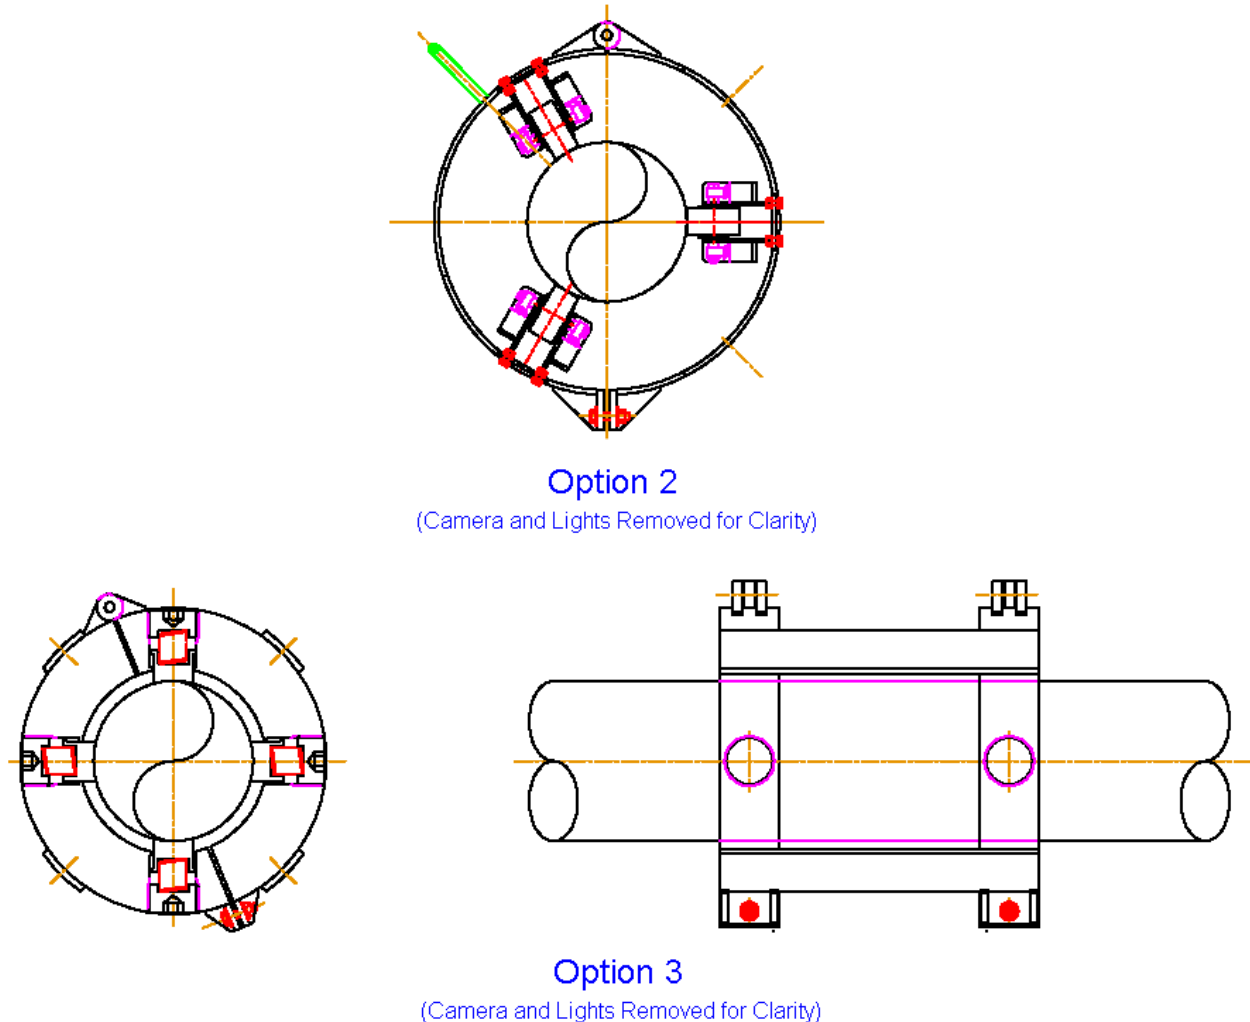
Other alternatives for the bug configuration are shown in Figure 13.

Figure 13. Alternate Bug Configurations

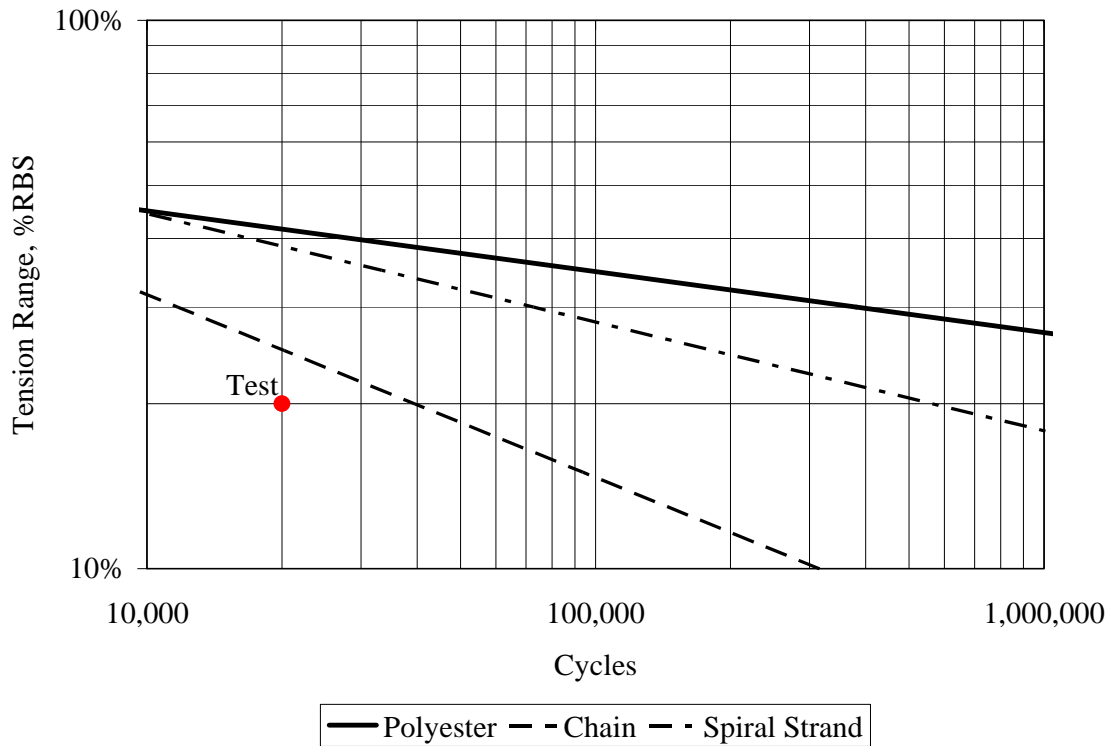
With these parameters, the equivalent tension range is approximately 20% of MBS. Loading from 30% to 50% MBS (mean = 40%) represents extreme loading conditions. The number of cycles to represent 20 storms is about 20,000. The test condition is plotted together with the design T-N curves for reference.

Figure 1. T-N Design Curves

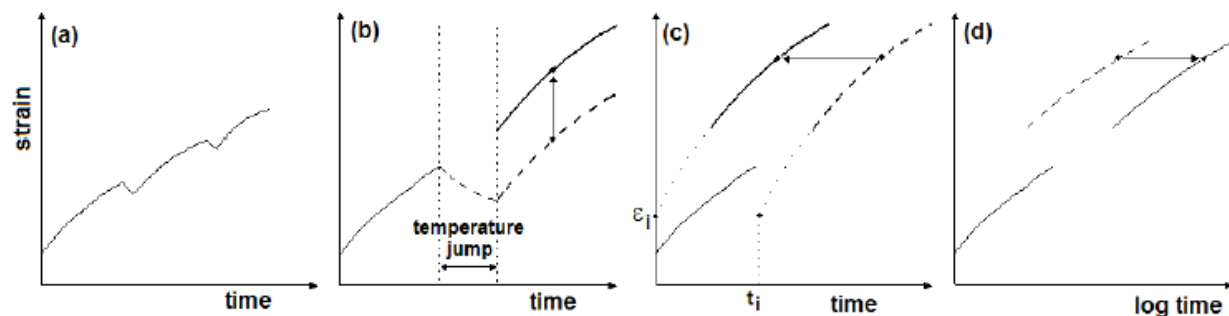
Figure 5: Schematic diagram for SIM procedure, based on Alwis' work [2].

Figure 5 shows a schematic diagram of the procedure for SIM testings and a graphical diagram of the mathematical treatment that is done from the original data collected. There are a number of different things that have to be accommodated in this process:

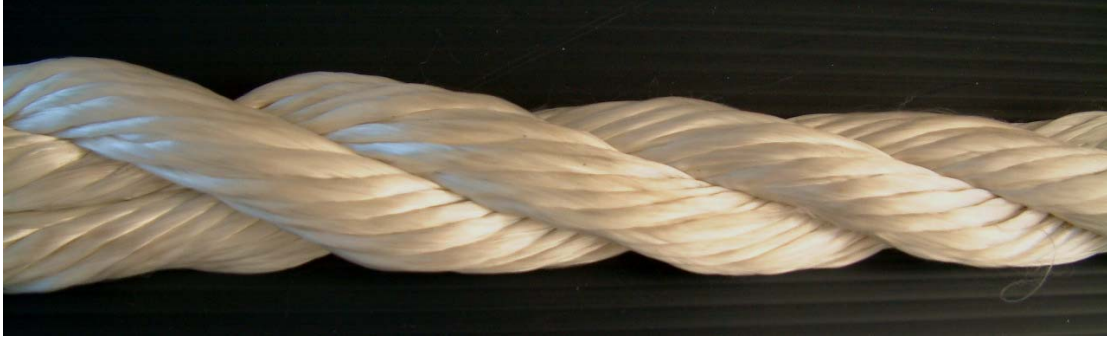
Photograph 1 shows a general view of the new sample and Photograph 2 shows a general view of the tested sample

Photograph 1 - General view of new sample

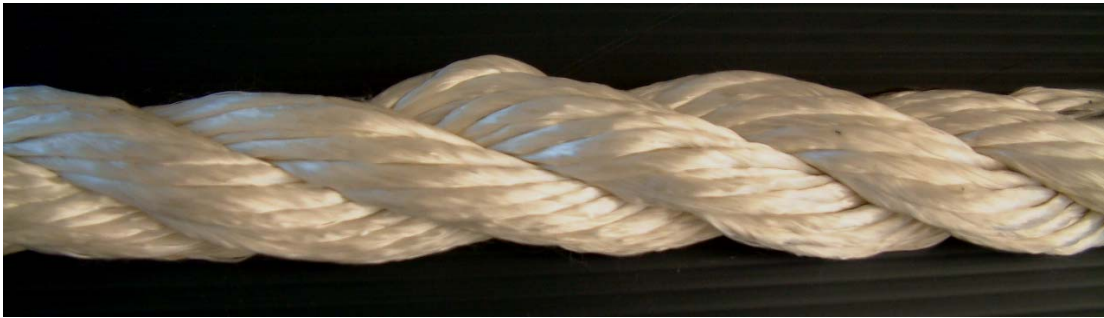
Photograph 2 - General view of fatigued sample

The strands of the tested sample had a slightly 'crumpled' appearance but there was no sign of external damage to either sample.

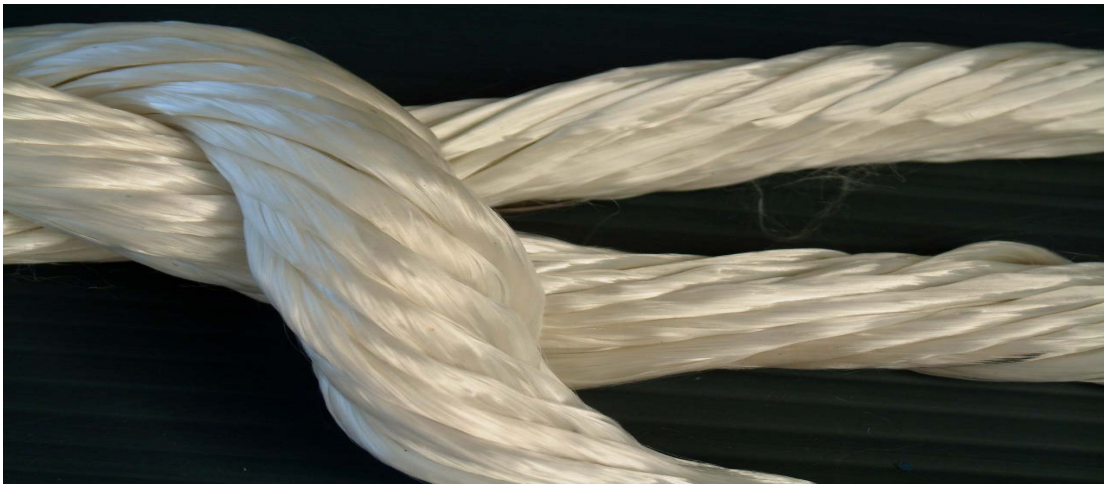
Photograph 3 shows the strands of the tested sample, opened out to reveal their inner faces

Photograph 3 - Detail of fatigued sample

Only minor internal damage was seen, as raised filaments

The visual inspection revealed no significant difference between the two samples in terms of their general condition. Some minor internal abrasion was seen on the strands of the tested sample.

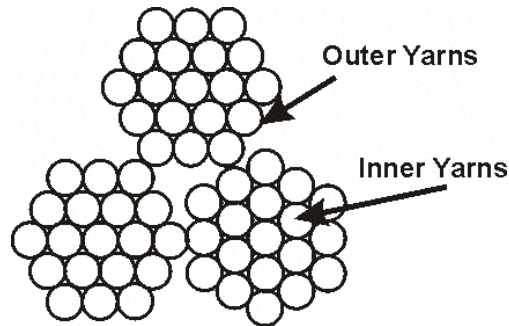
Figure 1- Schematic of Outer and Inner Yarns

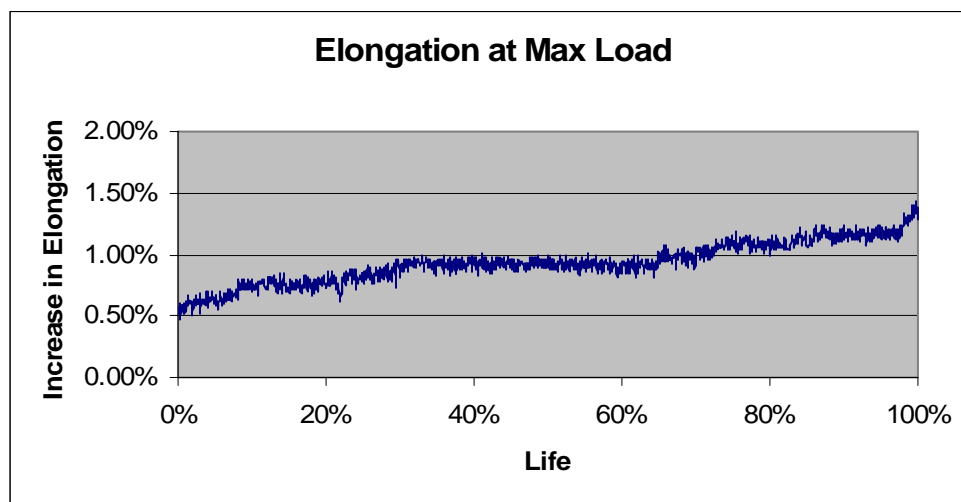
Test 1 40% +/- 17.5%, Endurance 13,424,920 cycles

Figure 4 - Elongation at maximum load during 40% +/-17.5%

From these results, we can see immediately that polyester parallel strand mooring lines are capable of withstanding extreme abuse. Actual failure occurs after some 10,000,000 cycles which represents 10,000 Hurricane Katrinas. After 20 Hurricane Katrinas the ropes will be at the beginning of their fatigue lives (0.2%); virtually on the Y axis. Consequently, the ropes will have compacted to remove constructional elongation but without any long term creep.

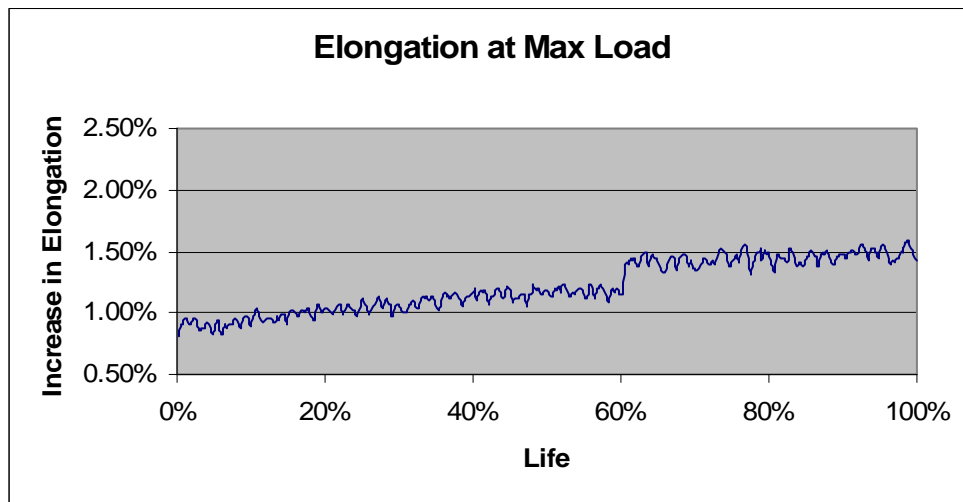
Test 2 40+/-20%. Endurance 8,181,270 cycles

Figure 5 - Elongation at maximum load during 40% +/-20%

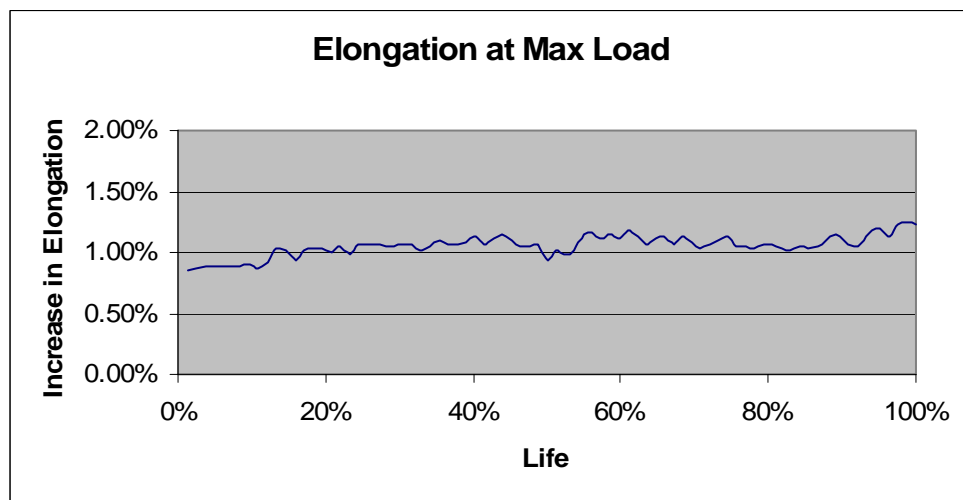
Test 3 40+/-22.5%. Endurance 3,624,620 cycles.

Figure 6 - Elongation at maximum load during 40% +/-22.5%

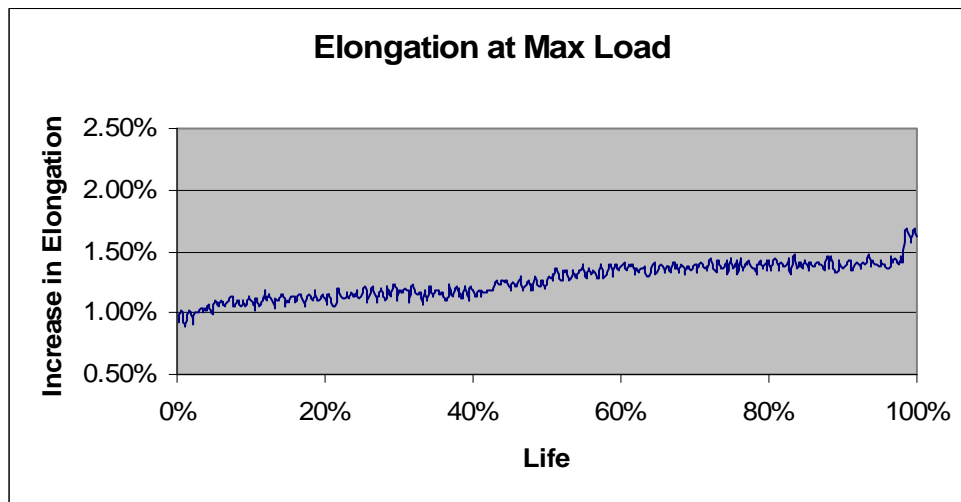
Test 4 40+/-25%. Endurance 2,046,520 cycles

Figure 7 - Elongation at maximum load during 40% +/-25%

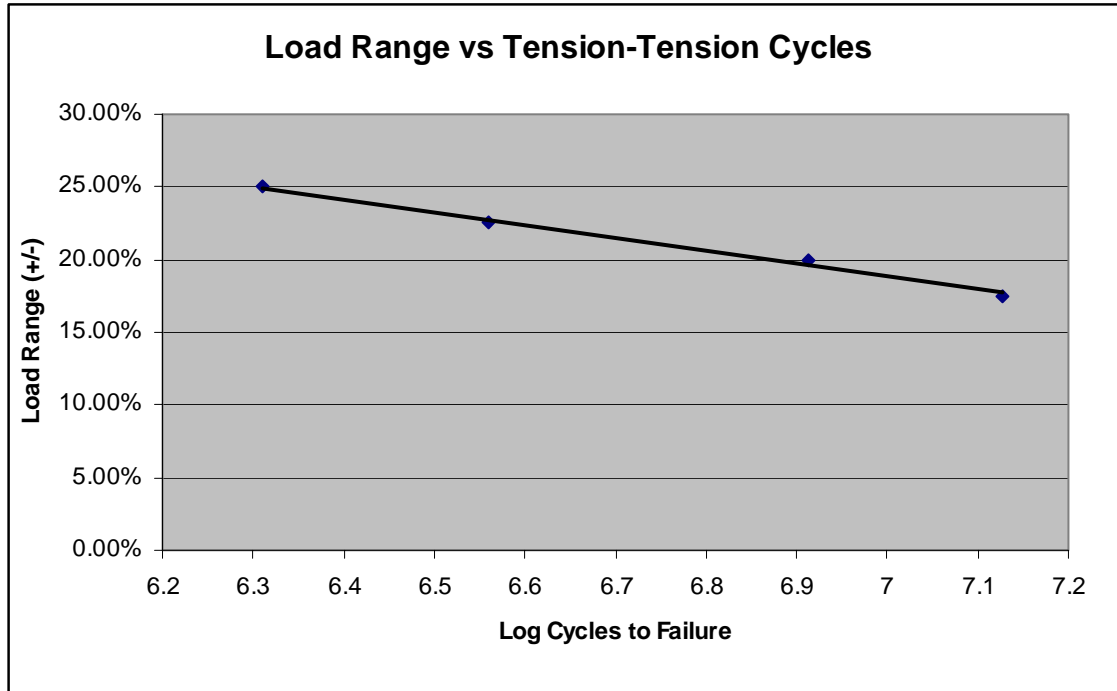
The log of the number of cycles to failure can be plotted as a straight line vs load range.

Figure 8 – Tension-tension fatigue cycles vs load range

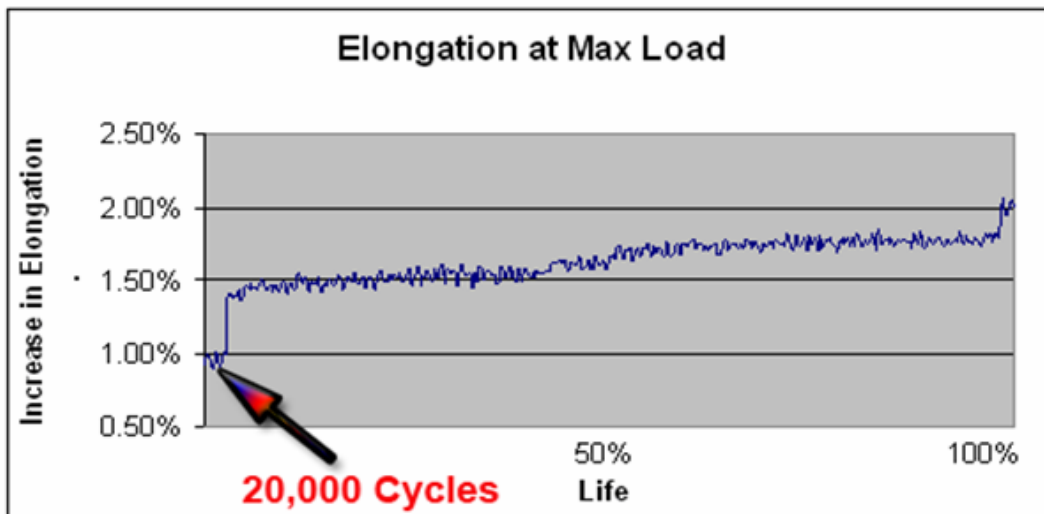
It is worth noting that the 20,000 cycles, representing 20 Hurricane Katrinas represent the very early stages of the tension-tension fatigue cycling

Figure 9 – 20,000 cycles vs 100% life

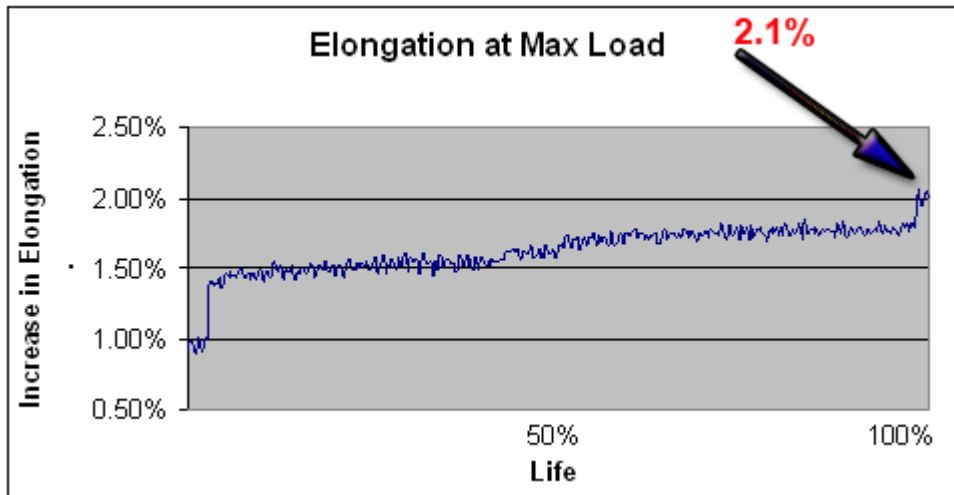
Referring again to the fatigue curves we see that there is a gradual increase in elongation. Taking for example the 40% +/- 25%

Figure 10 – Increase in Elongation at Failure (40% +/- 25%)

This 2.1% increase in elongation should be added to the elongation at 40% (the mean load). In the durability study this was not recorded. With a new rope elongation to failure of 11% , the elongation at mean load can be estimated to be 4.4%. In the example above this should be added to the 2.1% to give a failure elongation of 6.5%.

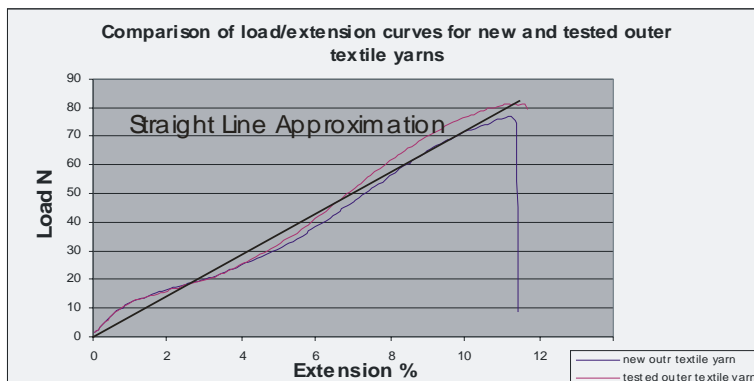
The actual rope load elongation curves were not recorded in the Durability Study. The curves for polyester ropes are not linear but, as a first order approximation, a straight line is reasonable and always fairly close to the actual elongation

Figure 11 – Straight Line Approximation for Polyester Yarns and Ropes

Thus in the durability study the actual elongations from new to failure were some 6% to 7%. These values are considerably lower than the nominal 11% to break of a new rope.

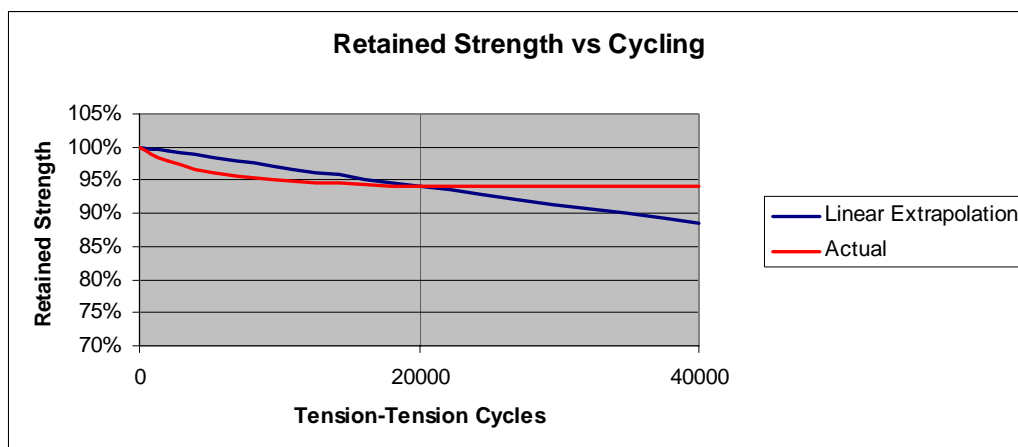
In practice, it seems that there is a small body of filaments that are vulnerable, for example, that cross over each other or are partially damaged in manufacture. These break early on and the remainder share the load and provide the exceptionally long lives we have come to expect with polyester mooring lines.

Figure 12 – Retained Strength vs Cycles

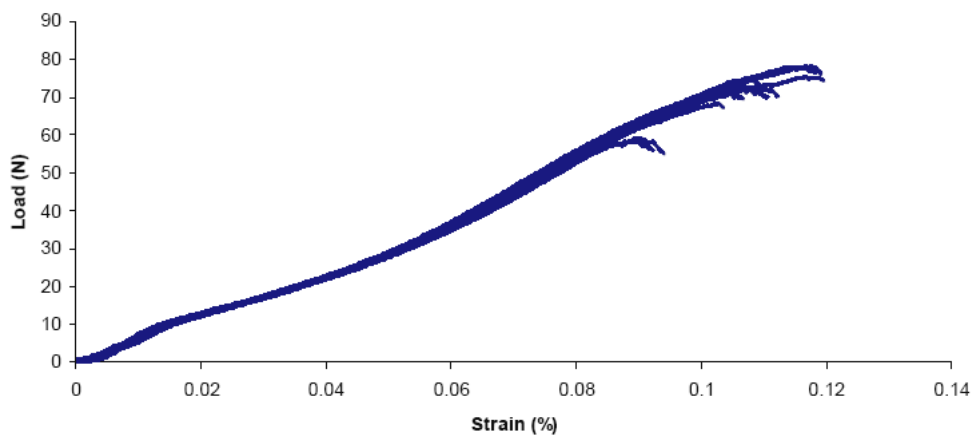
The first curve (figure 13 from the thesis) shows the new yarn stress/strain curves with tensile failures typically around 10% to 12% elongation.

Figure 13 - Tensile curves for polyester fibres, tested at 20°C, of different gauge lengths, total of 12 curves on the plot.

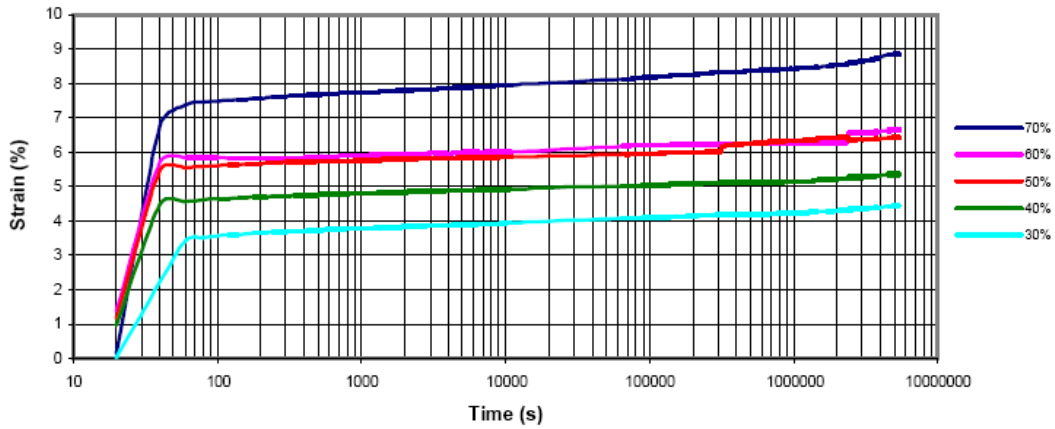
Creep tests were then conducted on these yarns and the results are plotted in the following 2 figures

Figure 14 - Creep tests at varying loads

As can be seen, the reproducibility shown in these two tests series is good..

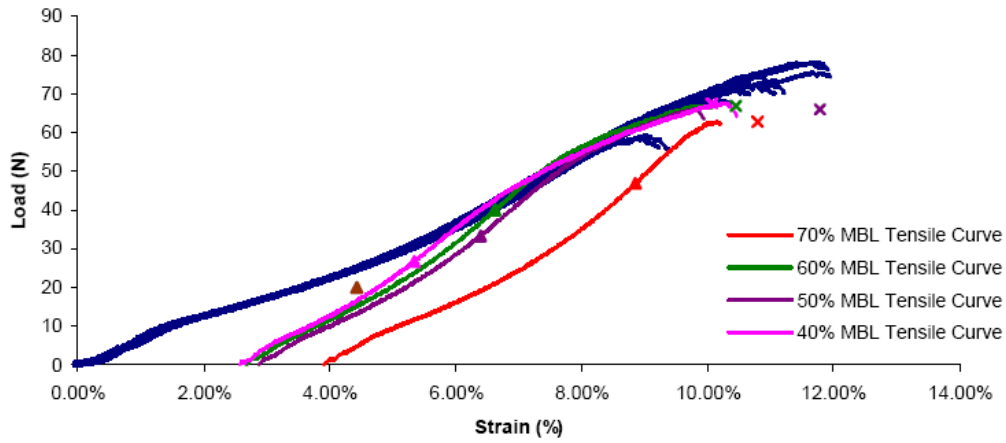
Finally the stress strain curves were measured after creep and the results are presented in the graph below. The starting point on the x-axis is the measured accumulated creep.

Figure 15 - Tensile test results after creep

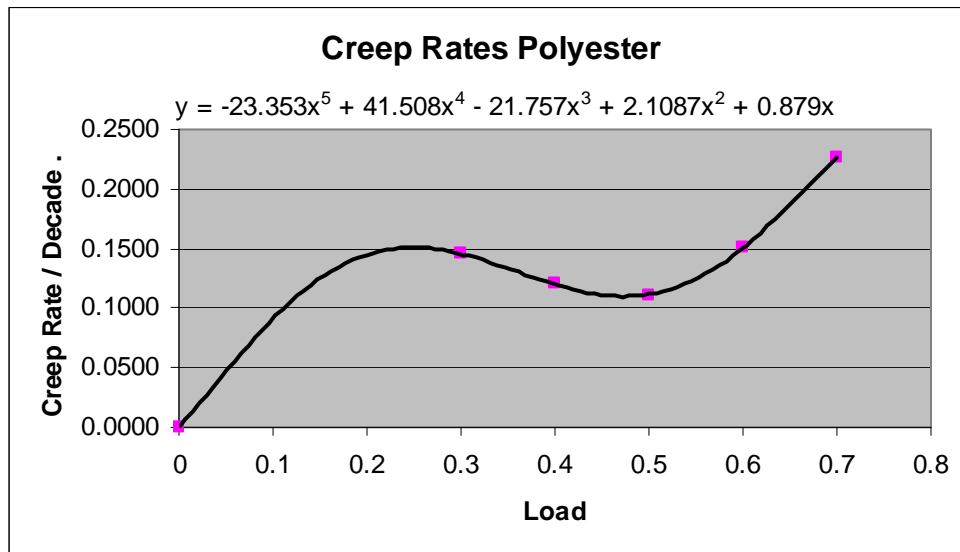
The creep rates given in the Higson paper can be averaged and graphed. They show a good fit to a fifth order polynomial.

Figure 16 – Creep rates

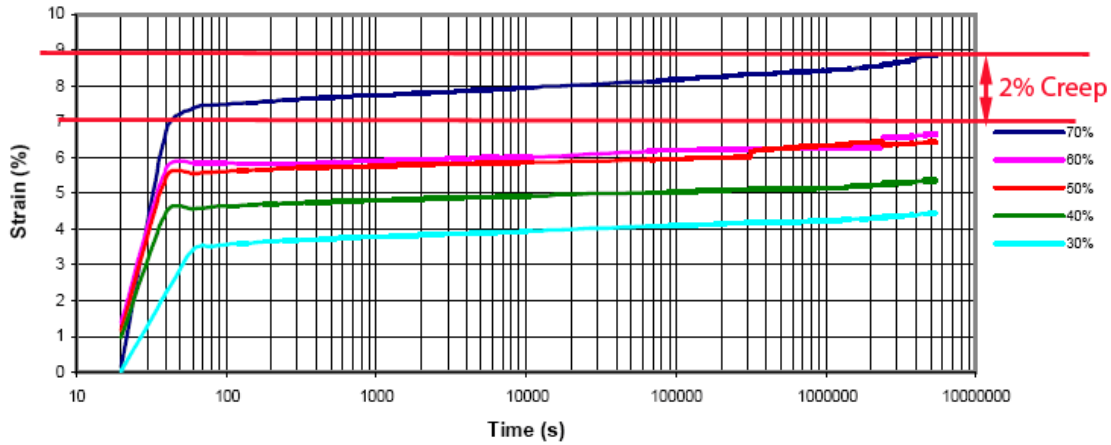
Figure 17 – 2% creep elongation at 70% load

There is a difference between the creep recorded in the creep test and that shown on the subsequent tensile test curves. For example, the creep results for 70% load, show an elastic elongation to 7% strain followed by 2% creep to a total of 9%. The yarn was removed from the creep tester and then allowed to relax to zero load, when the length was measured and then immediately taken to break. This showed a 4% increase in length, or twice the apparent creep over the test period. All the results show the same trend; that is the apparent creep measured during the creep test is less than the residual elongation measured immediately after the test. After one week this residual elongation will have reduced, possibly even halved. This can be explained by “delayed elastic creep”. After unloading, yarns contract and continue to contract over a period of time, stabilizing after a week or so.

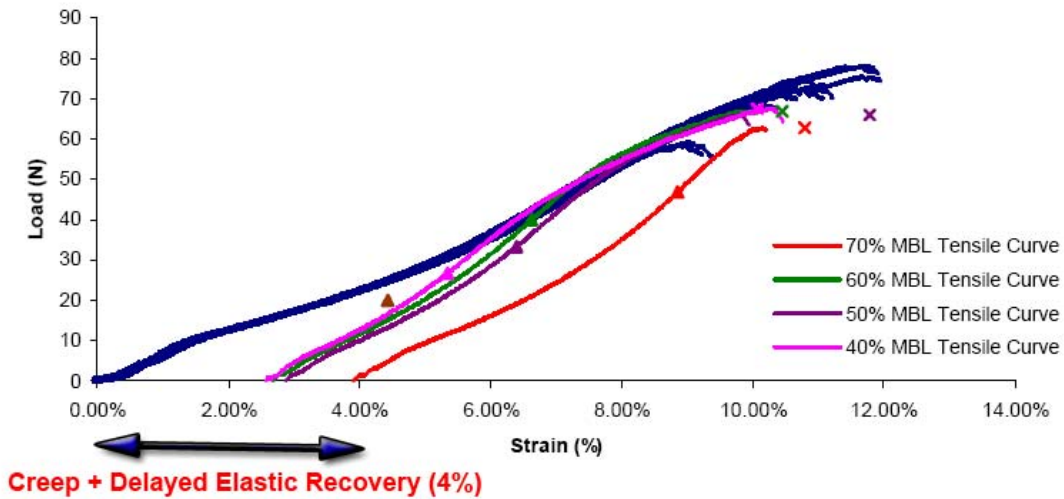
Figure 18 – 4% creep elongation plus delayed elastic recovery at 70% load

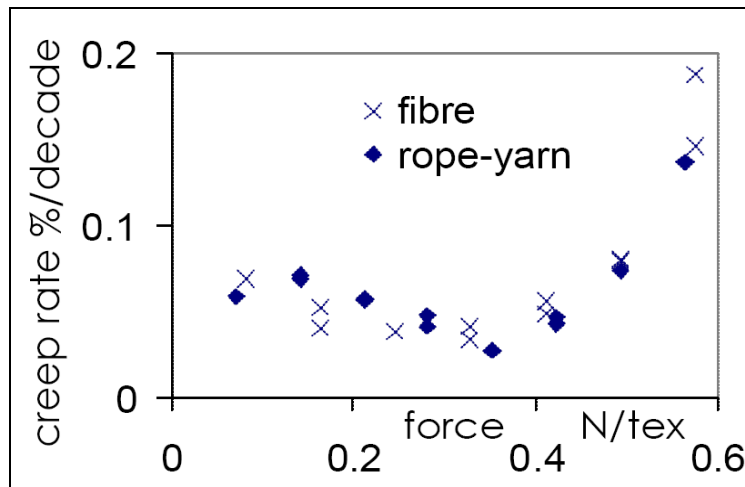
Stiffer polyester yarns have even lower creep rates. Work conducted by Celine Lechat at the Ecole des Mines in Paris produced the results shown in figure 23.

Figure 19– Creep rates for stiff polyester yarn (Celine Lechat)

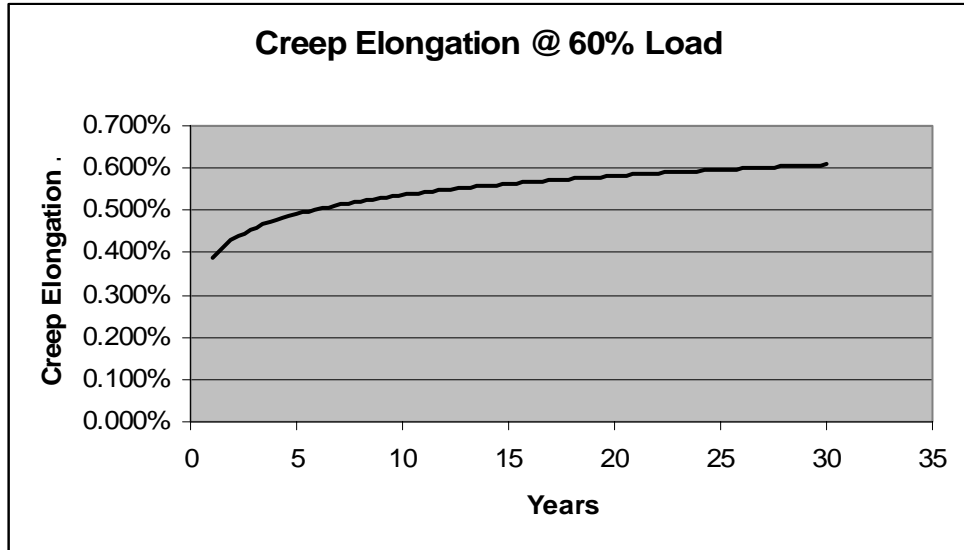
The data can also be presented graphically showing the maximum expected creep.

Figure 20 – Maximum expected creep

If the rope creep is greater than that of the curve in Figure 20, then the rope is exhibiting unusual behaviour and merits further investigation. This could trigger insert recovery and tests to confirm the residual lifetime.

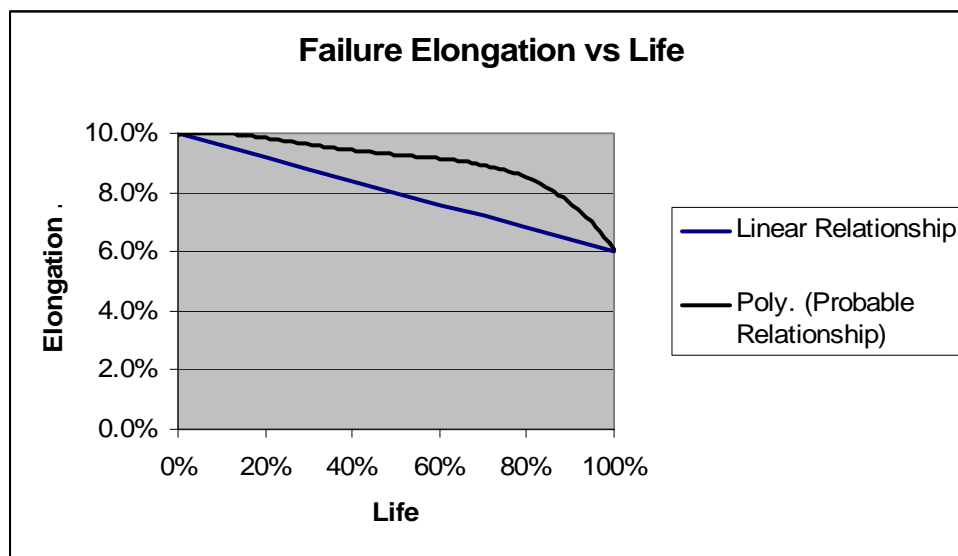
This is illustrated in Figure 24

Figure 21 – Possible Failure Elongation Relationships

It should be emphasised that , in platform mooring, only a tiny fraction of the fatigue life is expended in fatigue during 20 or 30 years and the reduction in failure elongation is very small.

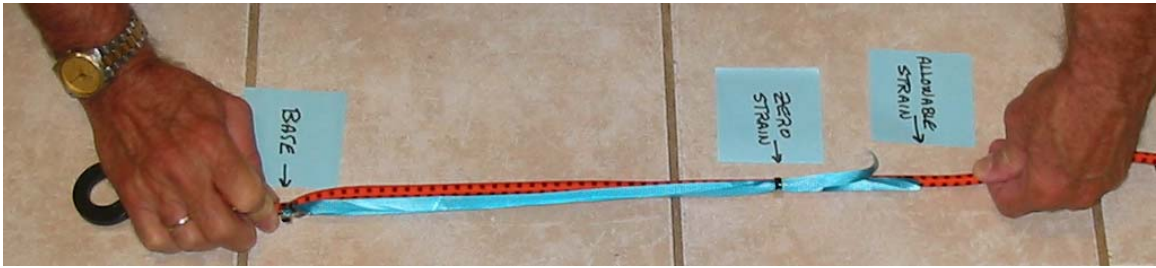
As I pulled on the bunji cord, the ribbon slipped under the right tie-wrap, and when the excess ribbon had passed under the right tie-wrap, the ribbon popped free on the right hand side, while it maintained its attachment to the left tie-wrap. See Figure 2. Thus the allowable strain was exceeded and the ribbon deployed to show this fact.

Figure K1. Model Test: Ribbon In Place – Zero Strain. Note that distance between Zero Strain and Allowable Strain is the Maximum Allowable Strain.

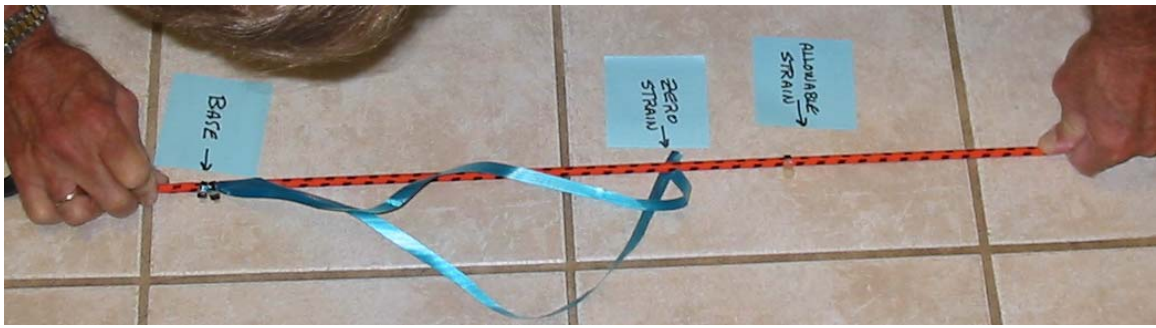
Figure K2. Model Test: Allowable Strain Has Been Exceeded by Stretching the Orange Rope. Now the Blue Ribbon is Loose, Indicating Allowable Strain Exceedance.

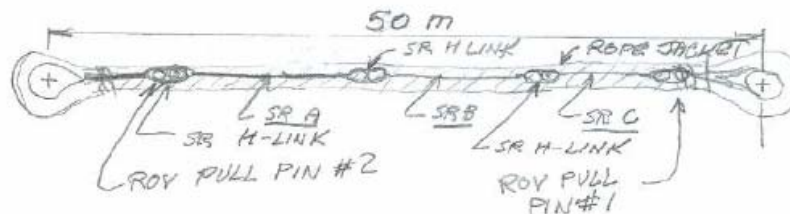
1. Make a “special” 50-meter rope insert in which the number of subropes in the rope insert (n) is increased to $n+1$.
2. Cut the extra subrope say in the middle and temporarily coil each end and tuck it in the crotch of the rope splice.
3. Jacket the n subropes to form the rope, leaving the extra subrope out from under the rope jacket.
4. Re-terminate the added subrope by forming 3 shorter subropes in series (using compact subrope H links) as shown in this sketch:

Super Subrope Insert Concept
