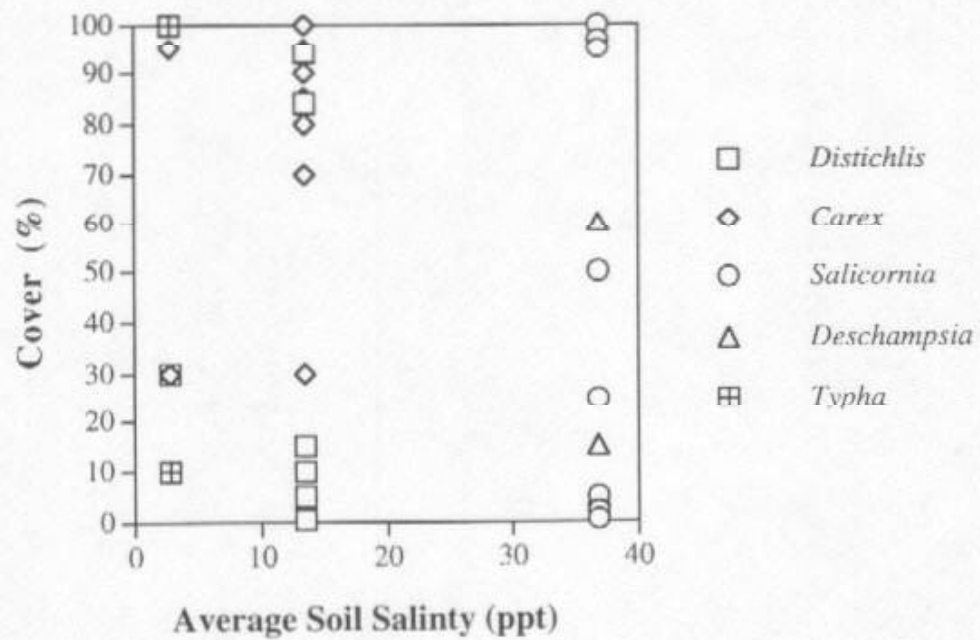
Figure 11. Soil salinity versus cover of five major species

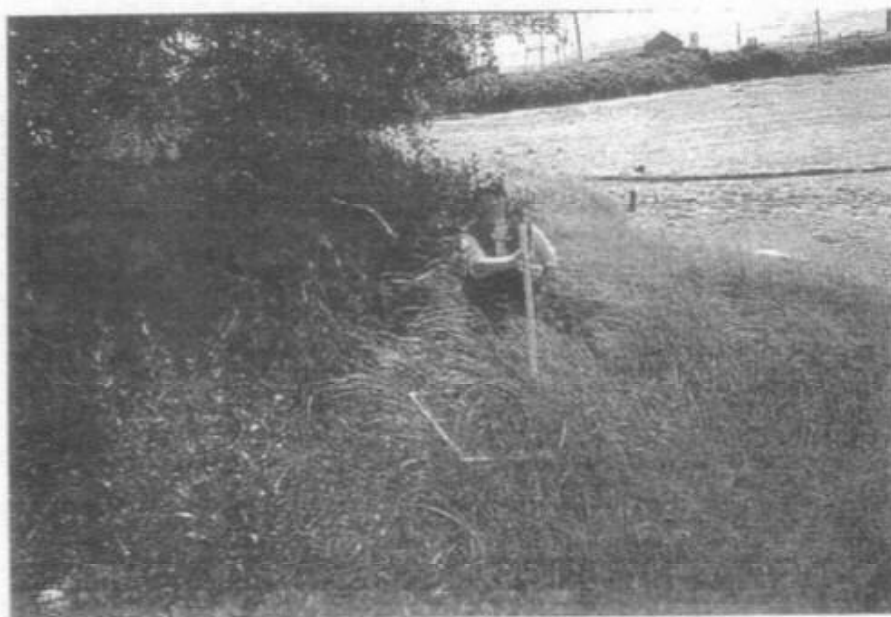
Appendix B. Nursery site showing quadrat in *Carex lyngbyei*
