**MIDDLE WATERWAY SHORE RESTORATION PROJECT
ADAPTIVE MANAGEMENT REPORT
1999 - 2002**

THE COMMENCEMENT BAY NATURAL RESOURCE TRUSTEES

U.S. Fish and Wildlife Service, Western Washington Fish and Wildlife Office

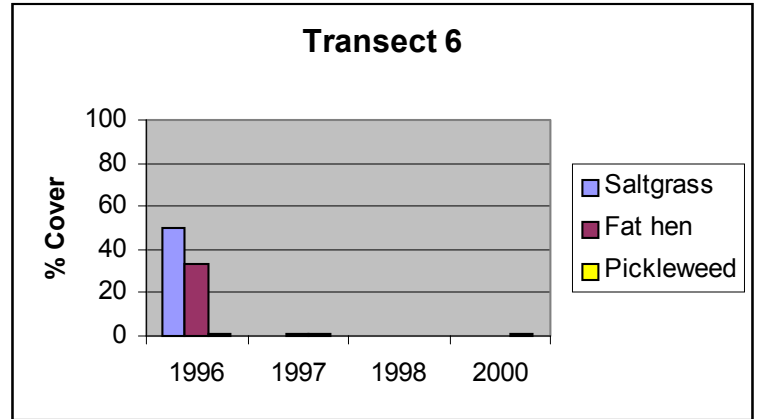
Figure 6

Tufted hairgrass plantings at the southern end of the site (transect 10) have been very successful, ranging from 75 to 100 % cover by the fifth year of monitoring (Figure 6). This planting is adjacent to a more gradual slope and has provided an area for natural colonization by pickleweed. The pickleweed first established itself at the edge of the goose excluder. By 2001 it had expanded outside the goose excluder and by 2002 it had increased in area and moved north along the shoreline (Photo 21). An additional area, at the north end of the northern peninsula,

The first year of monitoring the plots along transect 5 had between zero and ten percent cover of pickleweed (Parametrix 1996a). Pickleweed was not encountered along this transect in the following four years. Transect 6 had reasonably high cover of saltgrass the first year and none in the following years. Small amounts of pickleweed were found along transect 6 in all but one of the years monitored. Transect 7 had small occurrences of both saltgrass and pickleweed which declined to trace amounts by the end of the monitoring period (Figure 6, Table 1).

Vegetation Percent Cover 1996-2000

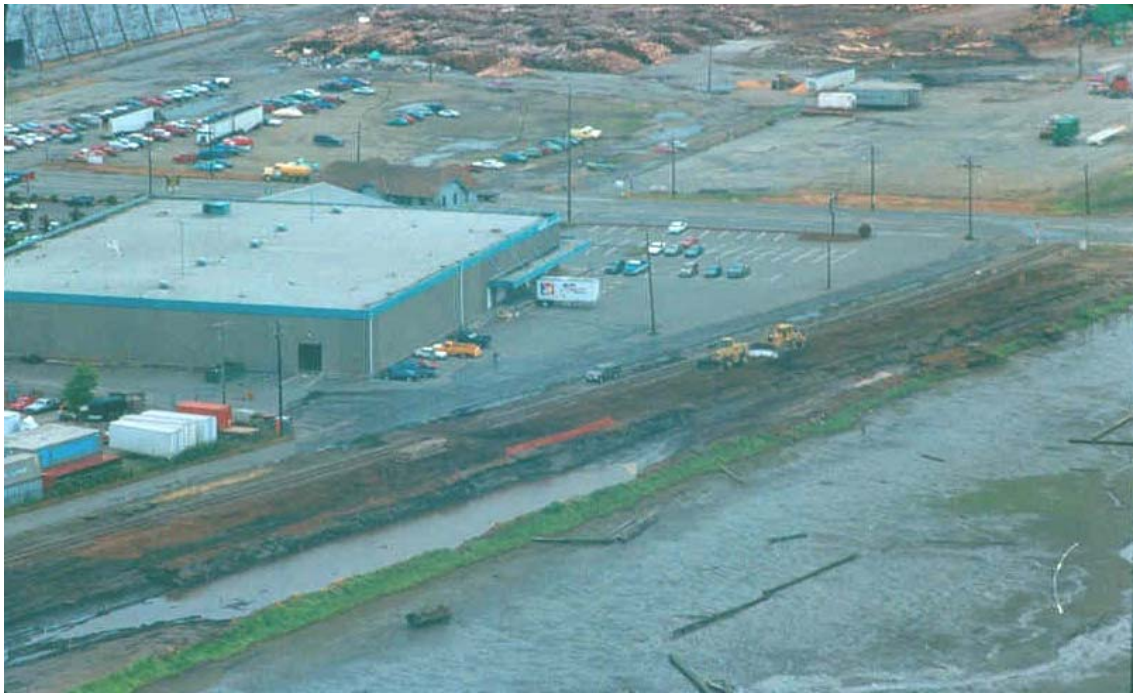
Photo 3 1995 Construction
(photo courtesy Simpson)

approximately 1.5 acres of industrial fill was excavated to create estuarine habitats (Photo 3). Site construction fulfilled objectives 1, 2 and 5, and fulfilled the basic intent of objective 3, to “establish approximately 1.2 acres of habitat at known high and low salt marsh elevations” by excavating portions of the site to between 9.5 and 12.5 feet MLLW, providing the known elevations for establishment of both low and high salt marsh communities in the Bay (Photo 4).

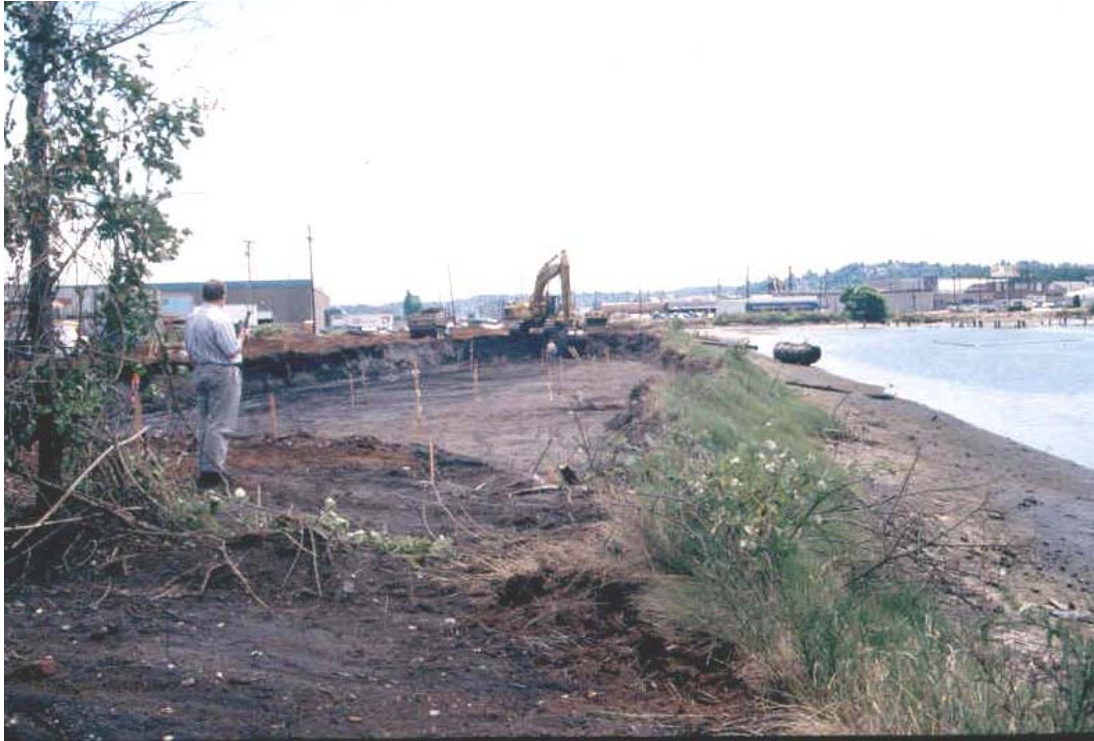
Photo 7 Construction of North Peninsula 1995

Fill on the northern end of the project was excavated to form a wide peninsula at elevations between 10.5 and 12.5 feet MLLW for establishment of salt marsh vegetation (Photo 7). To reduce project costs historic fill material (Puyallup River sand) was retained on-site (Photo 8). One of the assessments was evaluating the ability of plants to colonize and grow in this substrate.

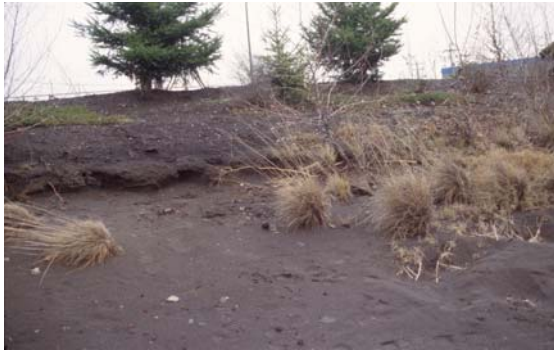
Photo 20 January 2003
Erosion @ base of berm

Tufted hairgrass plantings were relatively successful at the site. Plants flowered the first year following planting and by the third year were naturally seeding into higher elevations on the site. Transects 2 and 10 are located in areas that were planted with tufted hairgrass. Monitoring results are shown in Figure 6. No data were collected along transect 2 in 1997 as the transect was placed in the wrong location. Plantings along transect 2 were initially successful at this location; however, these plantings are being impacted by erosion along the base of the berm (Photo 20).

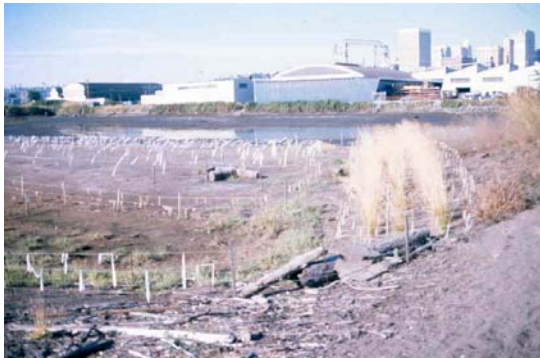
Photo 22 August 1997

was also planted with tufted hairgrass. This planting has also been very successful and has not been impacted by erosion (Photo 22). Since tufted hairgrass was planted in the high intertidal areas all these plantings likely benefited from the adjacent upland irrigation.

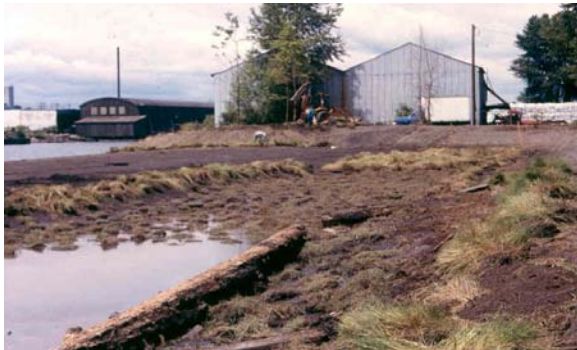
Photo 24 June 1995 Salvage in progress

The first year of monitoring, in conjunction with visual observations throughout the year, revealed that the above-ground portions of the salvaged vegetation died rapidly (Photos 24, 25). This may have been due to a variety of conditions. The plant material was moved between the middle and end of June, and the weather over the next month was very dry. When the salvaged plants were placed in their new locations the root mass was not dug into the new substrate and plant material was subject to desiccation (Photos 26,27). By the middle of July the above-ground portions of salt grass were mostly brown.

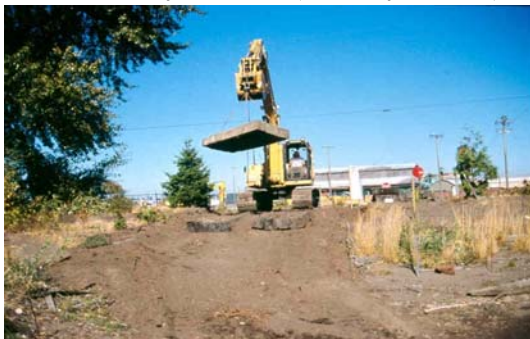
Photo 30 September 1999

The Western Washington Fish and Wildlife Office of the U.S. Fish and Wildlife Service, in cooperation with the Nisqually National Wildlife Refuge, provided personnel and equipment to conduct soil amendments and initial log placement during the first two weeks of September 1999. During the first week of September access to the site was constructed. Trees and shrubs growing on the access over the berm were dug and healed in for later replanting. A temporary access road was constructed over the berm and onto the northern peninsula (Photo 30).

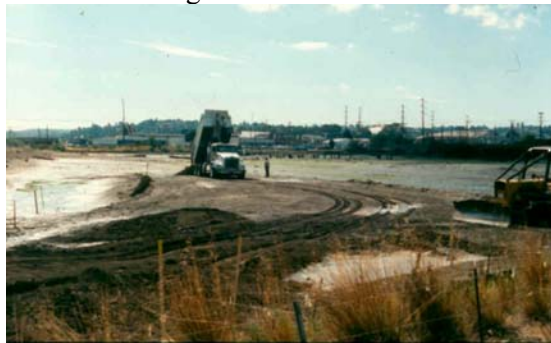
Photo 31 September 1999

During the second week of September sand was excavated from the peninsula and was replaced with 375 yards of pro gro topsoil mix. Topsoil was spread over the site and a swale was constructed through the center of the peninsula to provide an area for potential settling of drift and marsh seeds (Photos 31, 32). Onsite logs were also moved and placed along the shoreline. A trench was dug along the west shore of the peninsula; logs were placed in the trench and then backfilled (Photo 33).

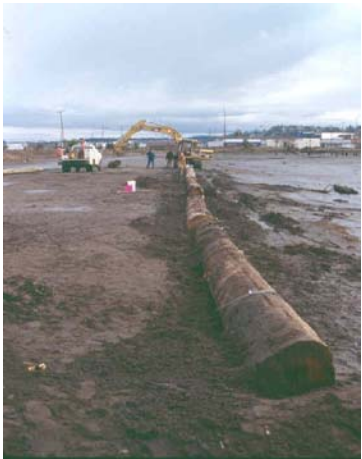
Photo 34 January 2000

anchored in place on January 25, 2000 utilizing contractor installed Manta Ray anchors, with a cabling system around the logs (Photos 34, 35). David Adams, the site steward, has adjusted the cable system on a few instances; otherwise the log anchoring system has remained in place.

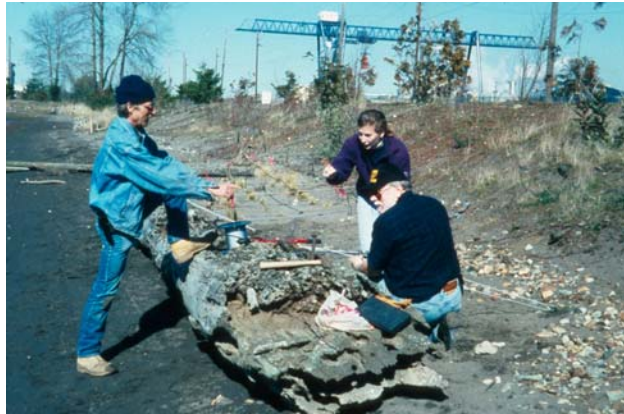
Photo 36 March 2001

Trustee representatives and volunteers anchored drift logs along the base of the berm using commercially available anchors (Photo 36). Logs were those that had floated onto the site and were in locations that would provide benefits to ameliorate erosion along the base of the berm. A goose excluder was also constructed on the middle peninsula to assess plant establishment in a protected area without conducting any planting. These activities were accomplished on March 6, 2001.

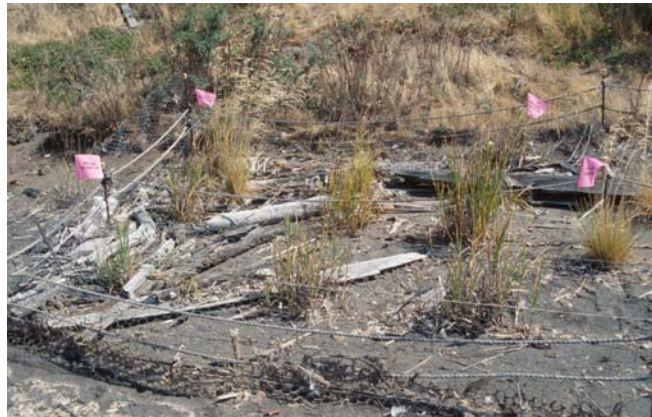
Container plants had various survival rates. Seaside arrowgrass had 98% survival by year three, plantain had 39%, seacoast bulrush 92%, and American threesquare 15% (Figure 9). All of these species had flowering individuals, however, seaside arrowgrass was the only species that clearly showed reproduction (Photo 37). Many of the plants appeared not to have spread much beyond their original root mass. The seacoast bulrush, though flowering, appeared stressed and had expanded only slightly (Photo 38). Though overall, the American threesquare had very low survival, in one location plants have spread via rhizomes and are forming a small patch. One planting of seaside plantain (in area I) has suffered from browse but appears to be recovering. This planting area is located at the head of the north embayment and benefits from longer tidal inundation and is a more sheltered area of the site. The other planting of seaside plantain, in area A, has suffered a 40-50% loss in both years 2 and 3 (Appendix D, Figure 8).

Photo 38 August 2002 Seacoast bulrush

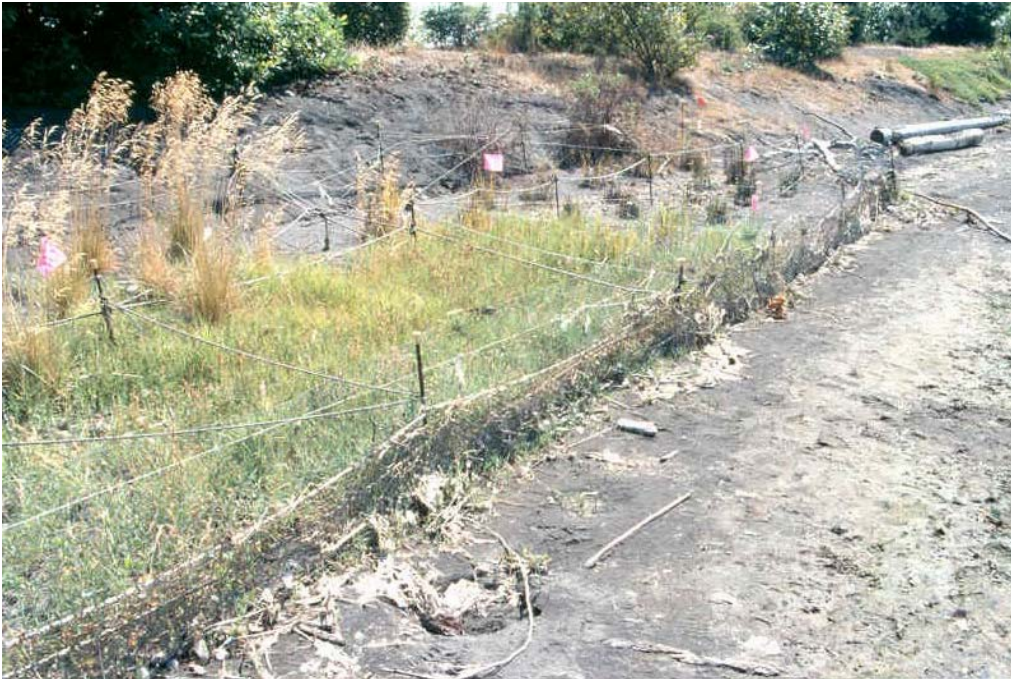
Bareroot plantings of saltgrass have been difficult to quantitatively monitor, however, these plantings are spreading by rhizome. In some areas the saltgrass plantings are expanding outside goose excluders and in most areas the plantings are flowering and appear robust (Photo 39).

Photo 39 Saltgrass expanding and flowering August 2002

Considering how the unplanted goose excluder has colonized in one year's time, it may also be possible to accelerate marsh establishment by simply constructing additional exclosures at prime locations. An additional concern was noted in December of 2002. Saltgrass expanding outside of exclosures was severely impacted by Widgeon grazing (Photo 49). It may be beneficial to expand existing excluders to allow existing marsh areas to expand. If plantings are able to expand and fully cover an area their root mass may be able to withstand grazing by wildlife. If a larger area of the site were covered by salt grass, grazing would be spread over a larger area and plantings might be better able to withstand grazing pressure.

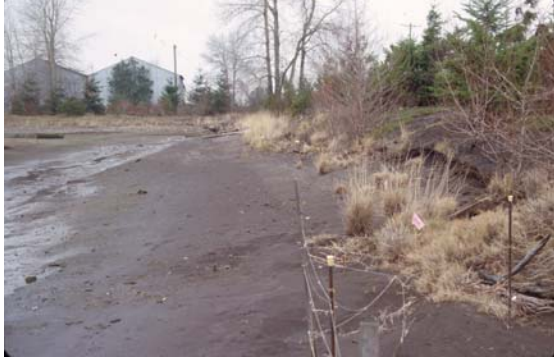
Photo 40 January 2003

Tufted hairgrass plantings have been fairly successful. However, some of the earlier plantings are being severely impacted by erosion at the base of the berm (Photo 40). Some plantings have set seed and natural reseeding has occurred at a few places higher on the berm (Photo 41).

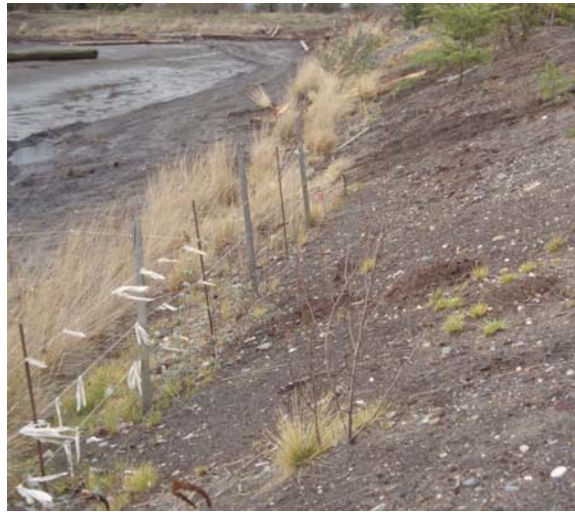
Photo 41 tufted hairgrass naturally reseeding
January 2000

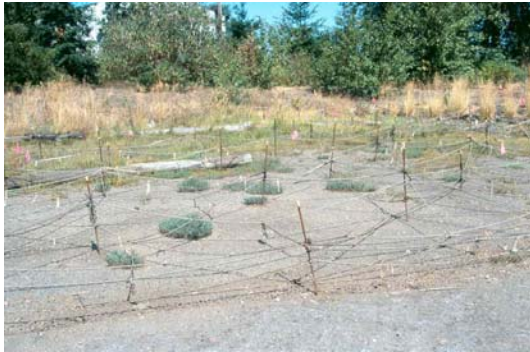
Photo 42
Colonizing pickleweed August 2002

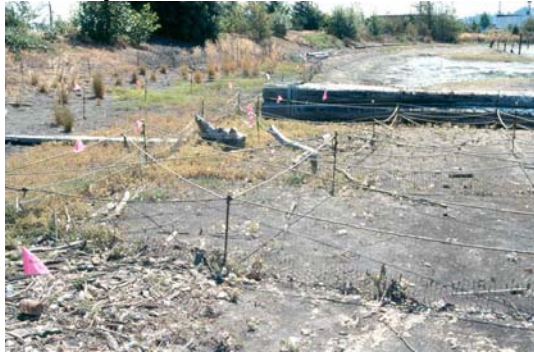
Photo 43
Unplanted excluder August 2002

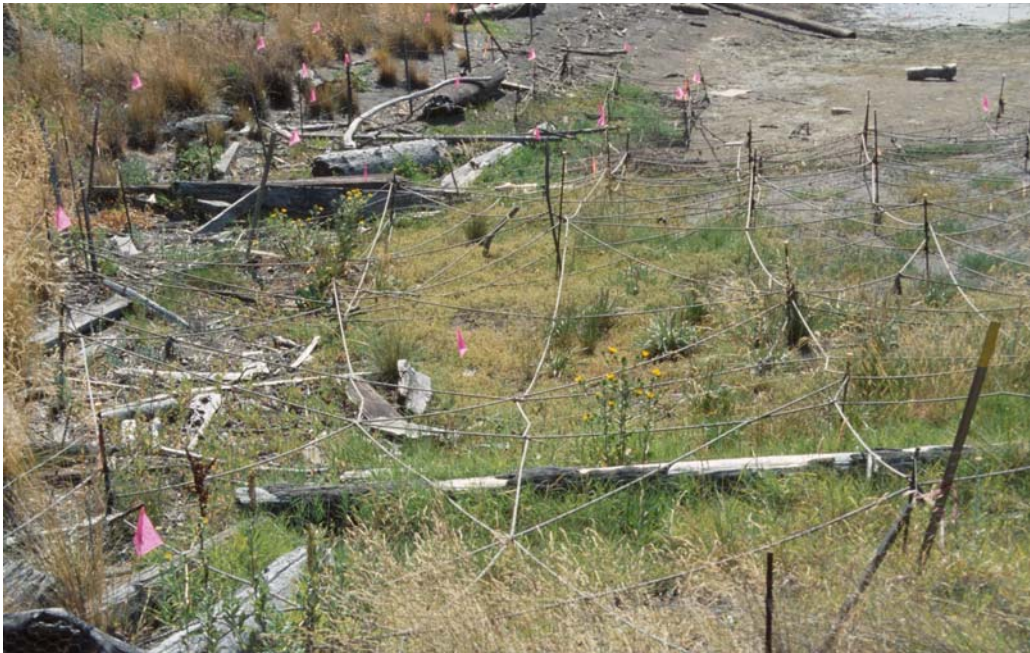
Photo 45 Northern embayment Colonizing pickleweed, fat-hen, sandspurry and gumweed

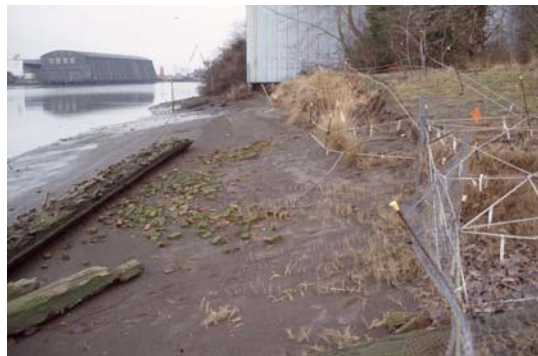
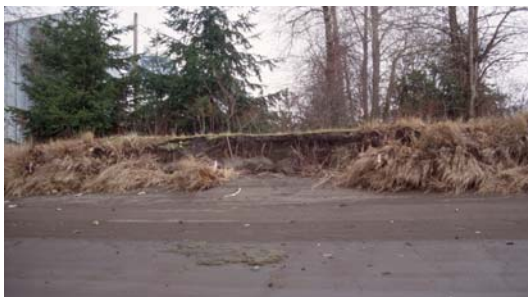
A further recommendation would be to evaluate site erosion. Where logs have been adventitiously placed along the base of the berm, erosion has been reduced in localized areas. However, adjacent areas are being impacted by erosion. Erosion has been occurring along the base of the berm since site construction in 1995, but log placement may have exacerbated or localized site erosion. This may also be true for the logs placed along the water side of the northern peninsula in December of 2000. The northern end of the site has been experiencing erosion for years, but was severely impacted by erosion during the winter of 2002/2003 (Photos 46-487). Review by a hydrogeologist would be helpful.

Photo 47 January 2003

Photo 48 January 2003
