RESIDENTIAL FIRE SPRINKLERS RETROFIT DEMONSTRATION PROJECT

Final Report

Phase II:
Single-Family
Structures

Project No.: 2091

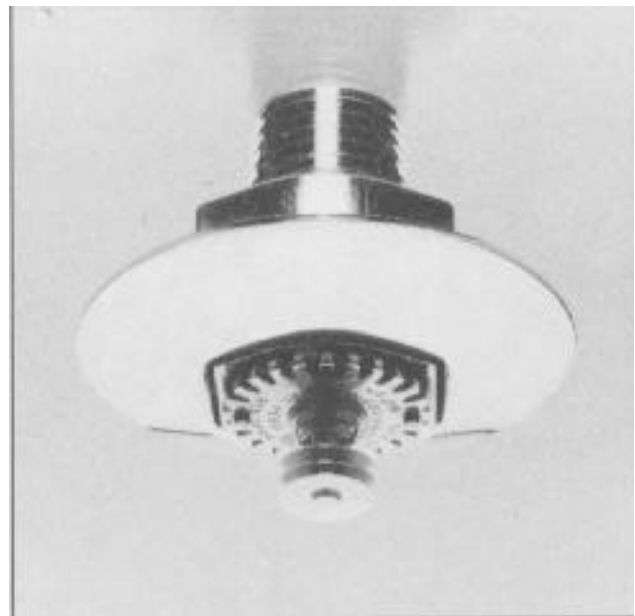
Figure 1. Typical Quick Response Pendent Sprinkler Head for Residential Applications. (Courtesy of the Central Sprinkler Company).

The “quick response” sprinkler heads used in all these installations and required by NFPA-13D differ from commercial sprinkler heads in the properties of the fusible element. The time required for the sprinkler head to be exposed to the activation temperature before flow is initiated has been significantly decreased in quick response heads. Also, the physical appearance of the residential heads is designed to be less obtrusive. Figure 1 shows a typical quick response head for residential installations. Most sprinkler head manufacturers now offer quick response heads for residential and light commercial applications. The design premise of NFPA-13D residential fire sprinkler systems utilizing quick response heads is to control incipient fires in the room of fire origin for up to 10 minutes.
